# **Division Avenue Road Safety Audit**

**Prepared for:  
Sandpoint, Idaho**

December 14, 2020

UT20-2220

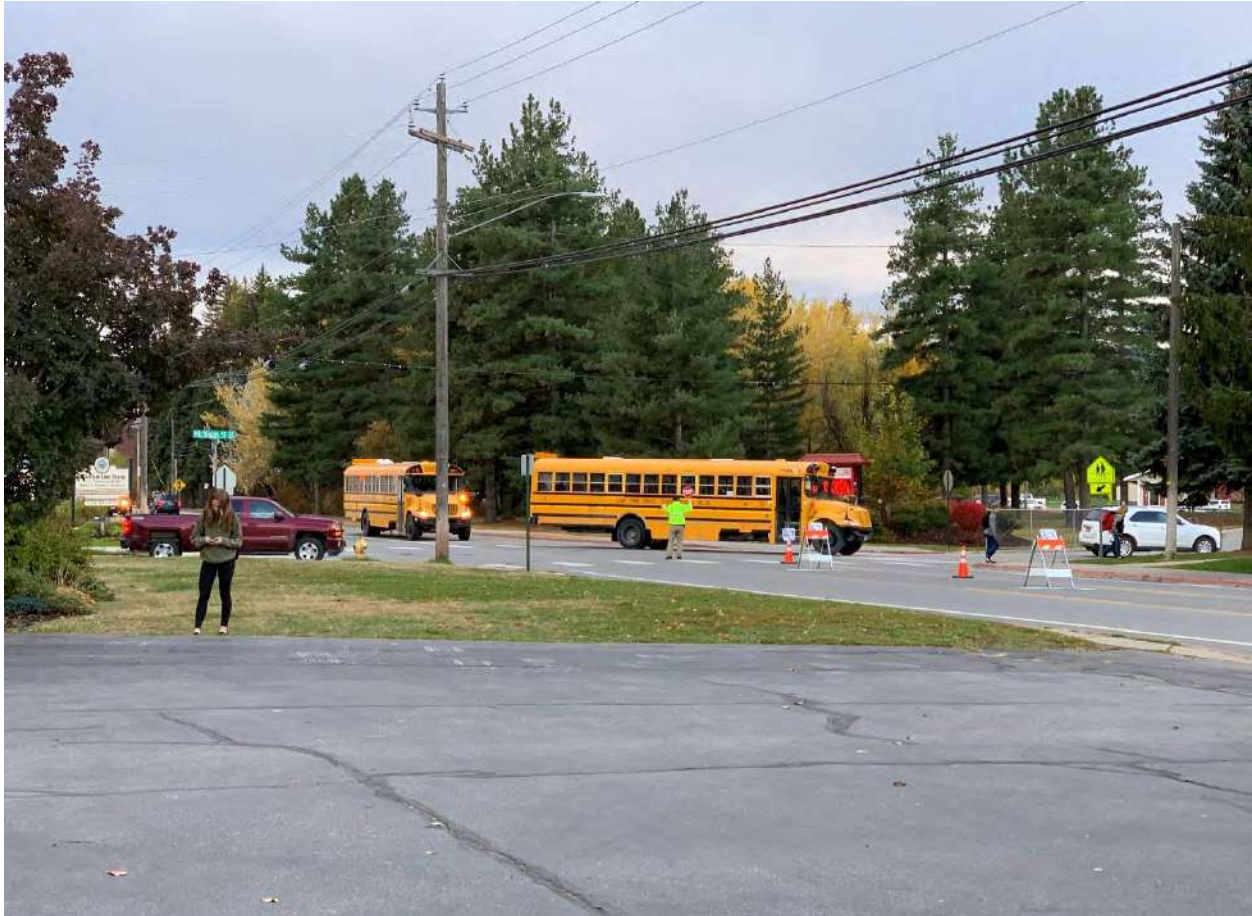
Observation 1: Significant traffic peaks at school start and end times (Photo: Fehr & Peers).

Traffic was observed to exhibit significant peaking characteristics at school start & end times. The City has made incremental improvements to this area to improve safety and address citizen complaints.

During the school start peak period, a trained crossing guard closes the southbound left turn lane on Division Avenue and directs traffic at Michigan Street. The crossing guard was observed to be effective in managing both vehicle and pedestrian traffic to reduce pedestrian/vehicle conflicts during the AM peak.

No additional traffic or pedestrian control was observed during the school closing peak.

Due to the effectiveness of the crossing guard during the school opening peak period, the City is recommended to coordinate with the school district to implement a similar crossing guard in the school closing peak to provide additional protection to pedestrians and reduce pedestrian/vehicle conflicts.

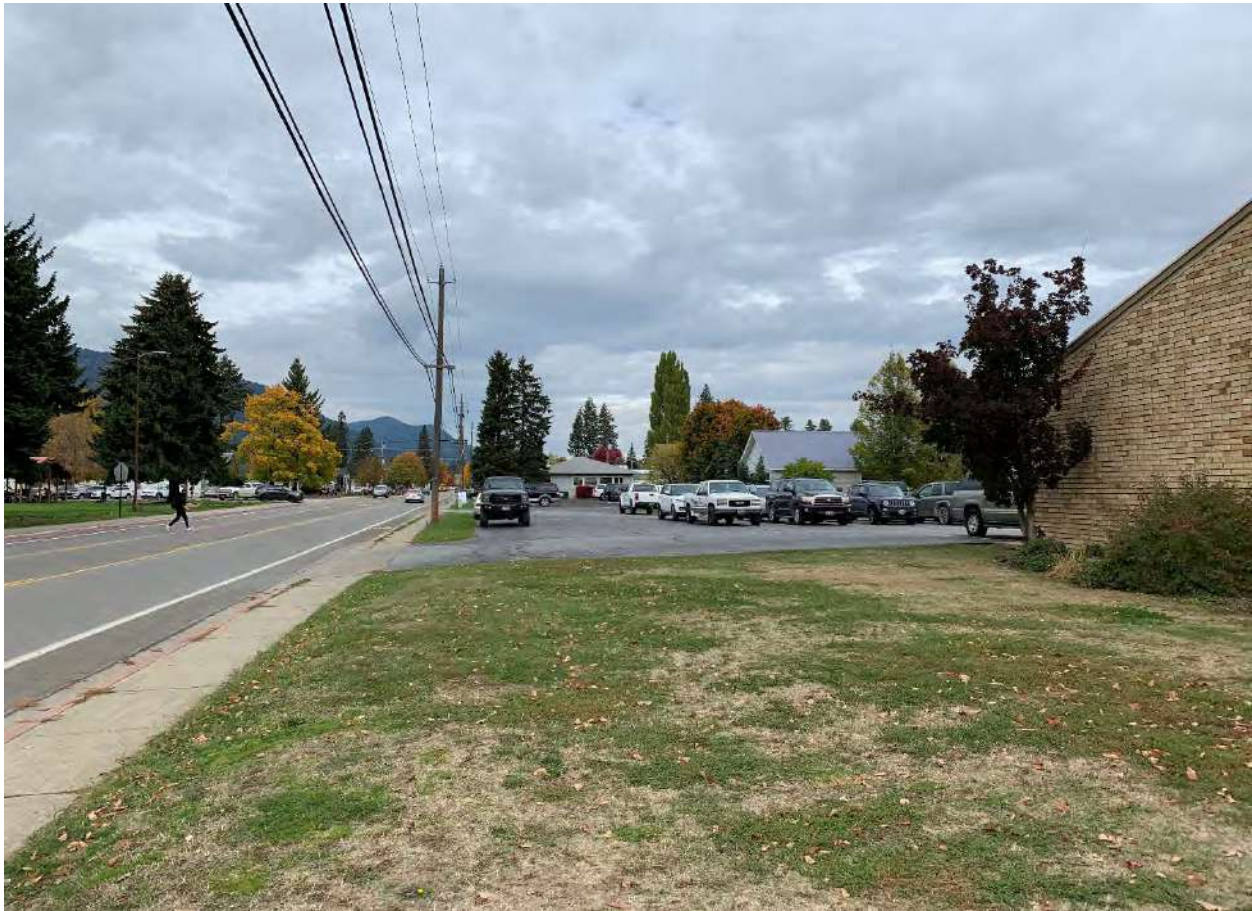
Observation 2: Jaywalking between school and church parking lot (Photo: Fehr & Peers).

Jaywalking was occasionally observed between the high school and the church parking lot on the other side of Division Avenue. As shown in Observation 2, many parents use the church parking lot as a pick-up/drop-off parking lot for the school. The jaywalking at this location was observed to be more frequent during the school closing peak, likely because the crossing guard provided additional protection to pedestrians in the school opening peak.

Division Avenue currently has no crosswalks between Cedar Street and Spruce Street. Fehr & Peers recommends adding an east-west crosswalk at Fir Street to improve pedestrian connectivity and to reduce the likelihood of jaywalking in areas without a crosswalk.

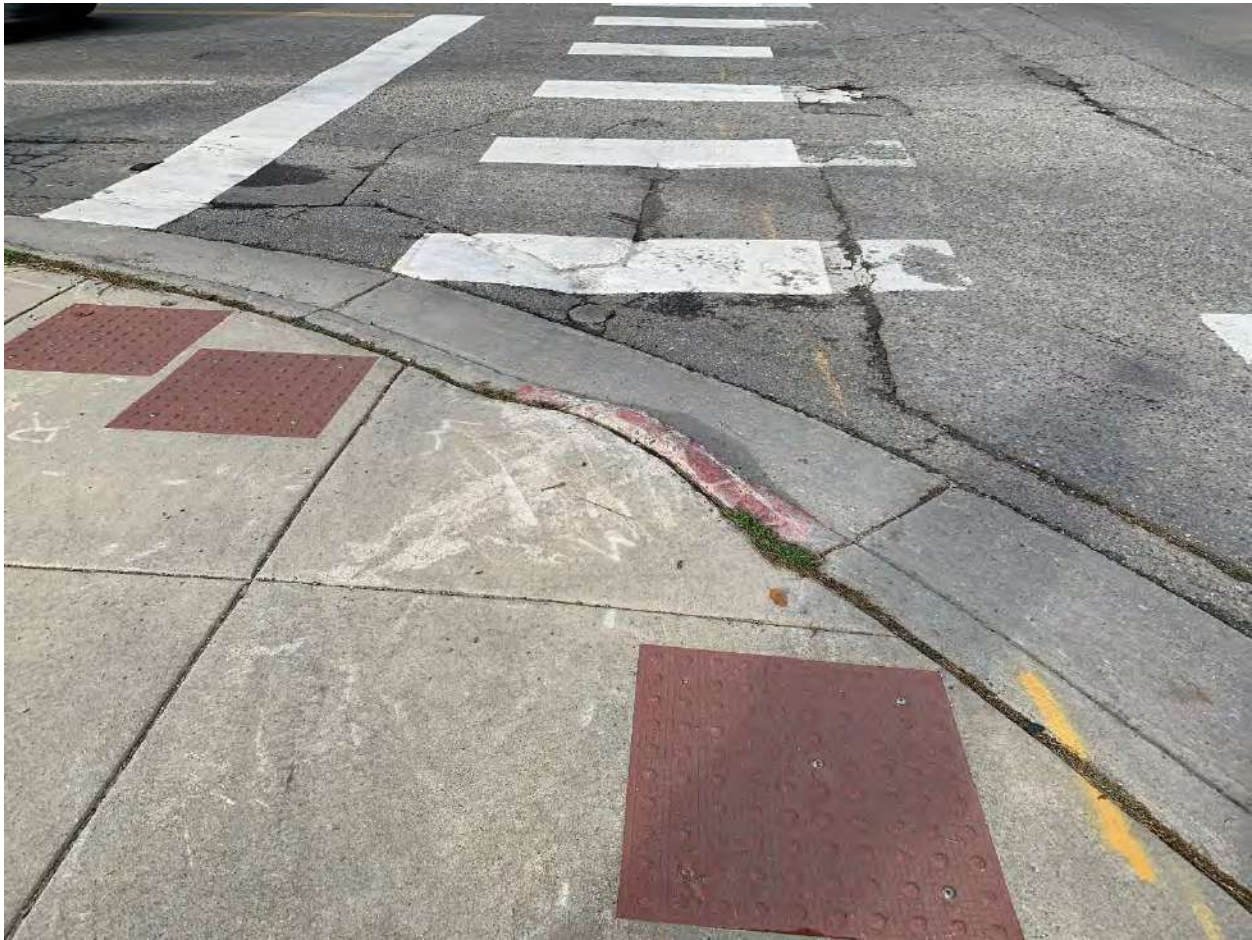
Observation 3: Non-ADA-compliant pedestrian ramps and crosswalks (Photo: Fehr & Peers).

At the Division Avenue intersections at Michigan Street, Superior Street, and Pine Street, the RSA team observed that pedestrian ramps and crosswalks were not ADA compliant. More specifically, the team observed that the crosswalks did not properly align with the pedestrian ramps. Furthermore, the truncated domes used at the Pine Street intersection were not installed correctly, and the raised curb in the middle of the pedestrian ramps creates an additional hazard for pedestrians.

The pedestrian ramps at Division Avenue & Michigan Street, at Division Avenue & Superior Street, and at Division Avenue & Pine Street are not ADA compliant and should be reconstructed to achieve ADA compliance.

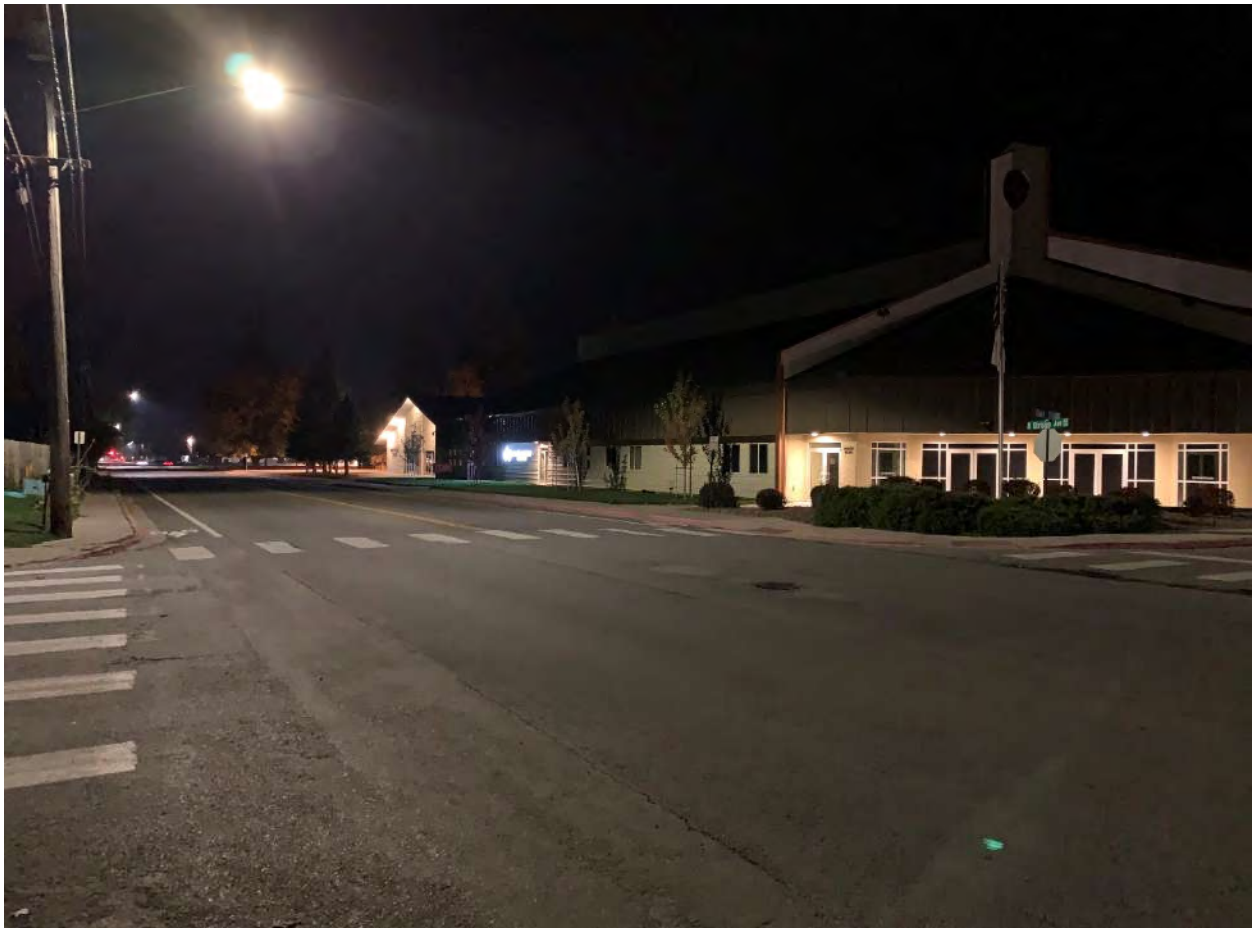
Observation 6: Street lighting observed to be sparse for pedestrians. (Photo: Fehr & Peers).

Division Avenue was not observed to be continuously lit at night. Crosswalks were lit from one corner of each intersection. However, lighting was observed to be sparse in some sections, especially for pedestrians and cyclists on the multi-use path along the west side of Division Avenue.

Fehr & Peers recommends performing a lighting study to determine where additional lighting is needed along Division Avenue, especially for pedestrians and cyclists on the multi-use path. The study should aim to provide sufficient lighting for the multi-use path, sidewalk, and crosswalks along Division Avenue.

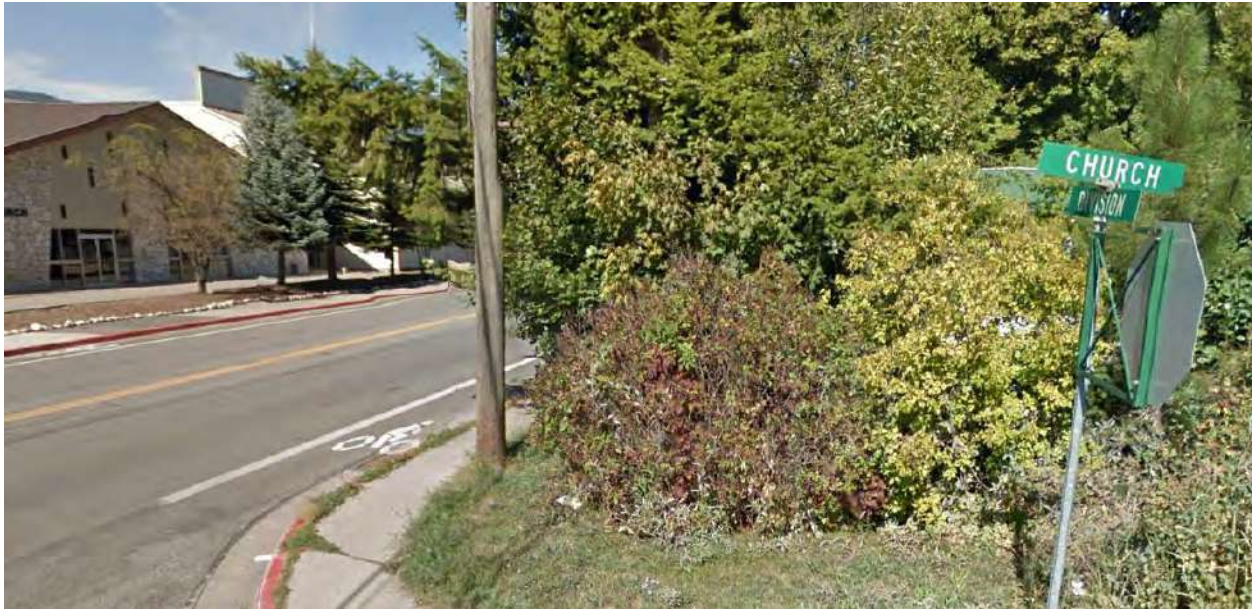
Observation 7: Sight distance obstructed at Division Avenue & Church Street (Street view image: Google Earth, September 2013).

The RSA team observed that vegetation and a light pole at Church Street obstructs the westbound sight distance. The RSA team also observed several instances of low-hanging tree branches over sidewalks occasionally obstructing the pedestrian walkway. Low-hanging branches were observed along Division Avenue near Alder Street, Church Street, Cedar Street, and Pine Street.

Fehr & Peers recommends removing or limiting the vegetation on the northeast corner of Division Avenue & Church Street to prevent the westbound sight distance from being obstructed. Fehr & Peers also recommends managing or limiting the vegetation along the sidewalk and multi-use path to prevent low-hanging tree branches over sidewalks from obstructing the pedestrian walkway.

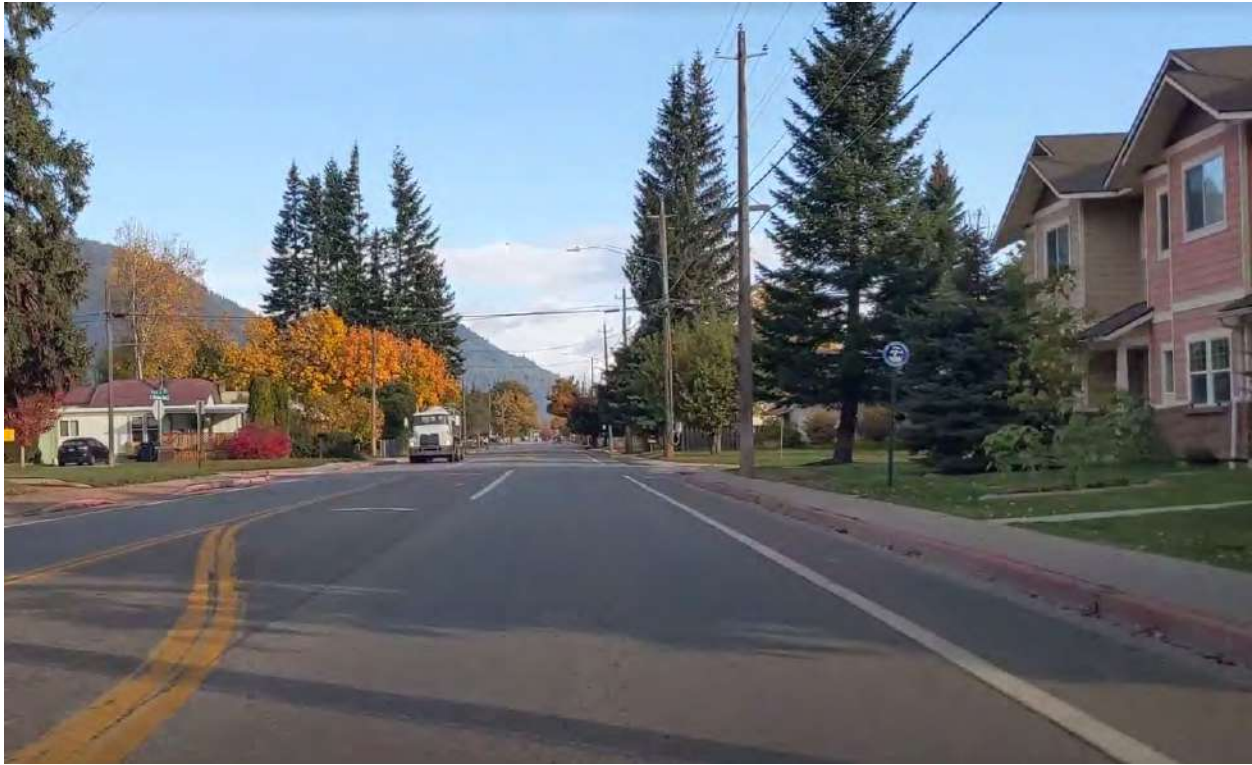
Observation 8: Substandard bus stop (Photo: Fehr & Peers).

The northbound bus stops on Division Avenue were observed to lack pedestrian amenities such as waiting areas, bus shelters and benches.

Fehr & Peers recommends providing pedestrian amenities such as concrete waiting areas, benches and/or shelters for transit users. The southbound bus stop near the library between Cedar Street and Oak Street currently provides a bus shelter with a bench that could serve as a template for other bus stops along the corridor. Depending on the location of the bus stop, relocating the bus stop poles may also be necessary to adequately provide space for a bench or shelter.

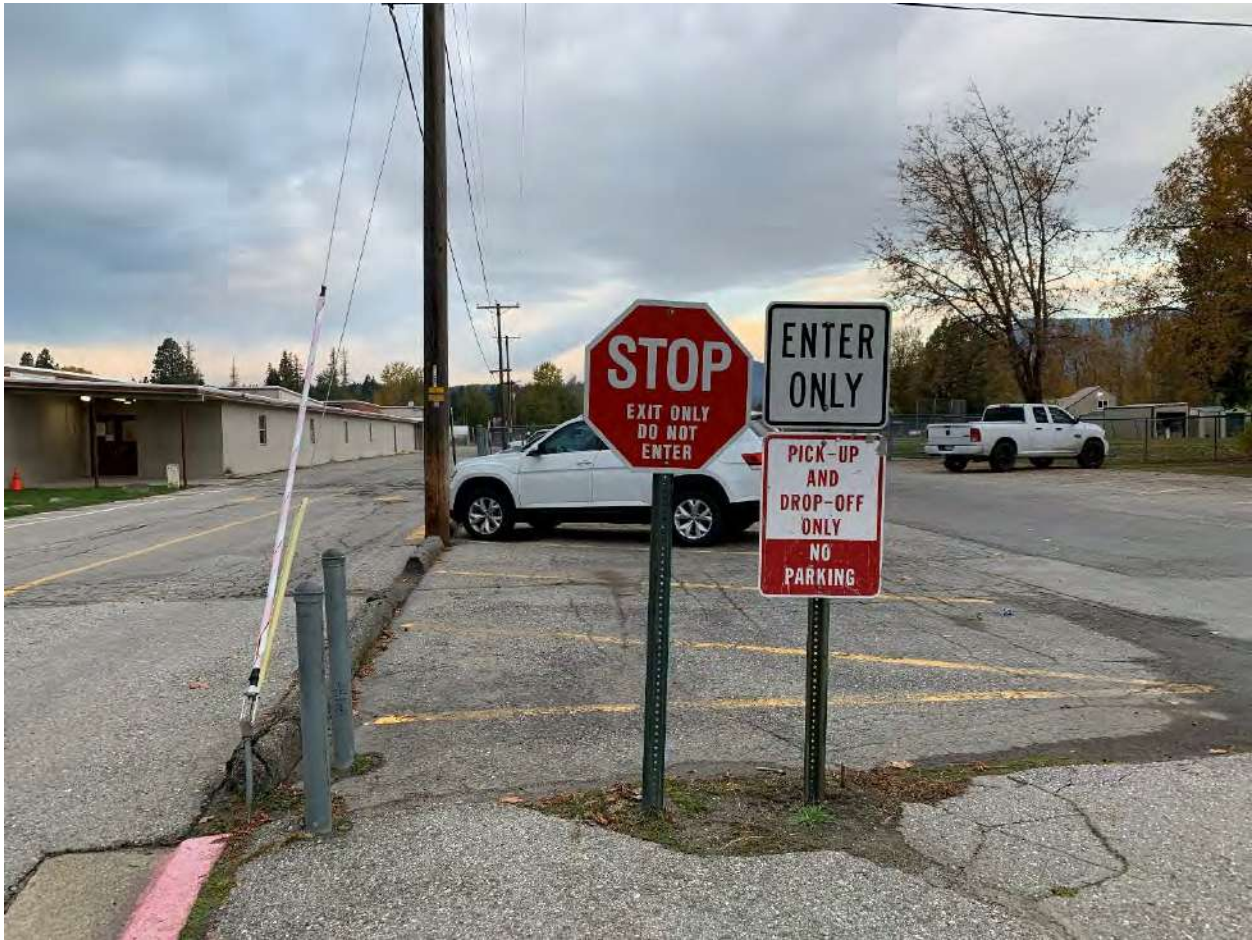
Observation 9: Nonstandard signage near Sandpoint High School (Photo: Fehr & Peers).

As shown in the Observation 9 photo, the driveway north of the middle school uses nonstandard signs to indicate which driveway is enter only, and which is exit only. These signs may be confusing to drivers since the STOP EXIT ONLY DO NOT ENTER sign is directly adjacent to the ENTER ONLY sign.

Fehr & Peers recommends replacing and relocating the nonstandard signs located at the driveway north of the high school. The signs should be replaced with standard MUTCD signs to better indicate which driveway is enter-only and which driveway is exit-only. The sign marked STOP EXIT ONLY DO NOT ENTER is an improper use of a stop sign and should be replaced with an R5-1 (DO NOT ENTER) or R5-1a (WRONG WAY) and relocated closer to the exit-only driveway. The ENTER ONLY post should be relocated to the other side of the entry-only driveway.

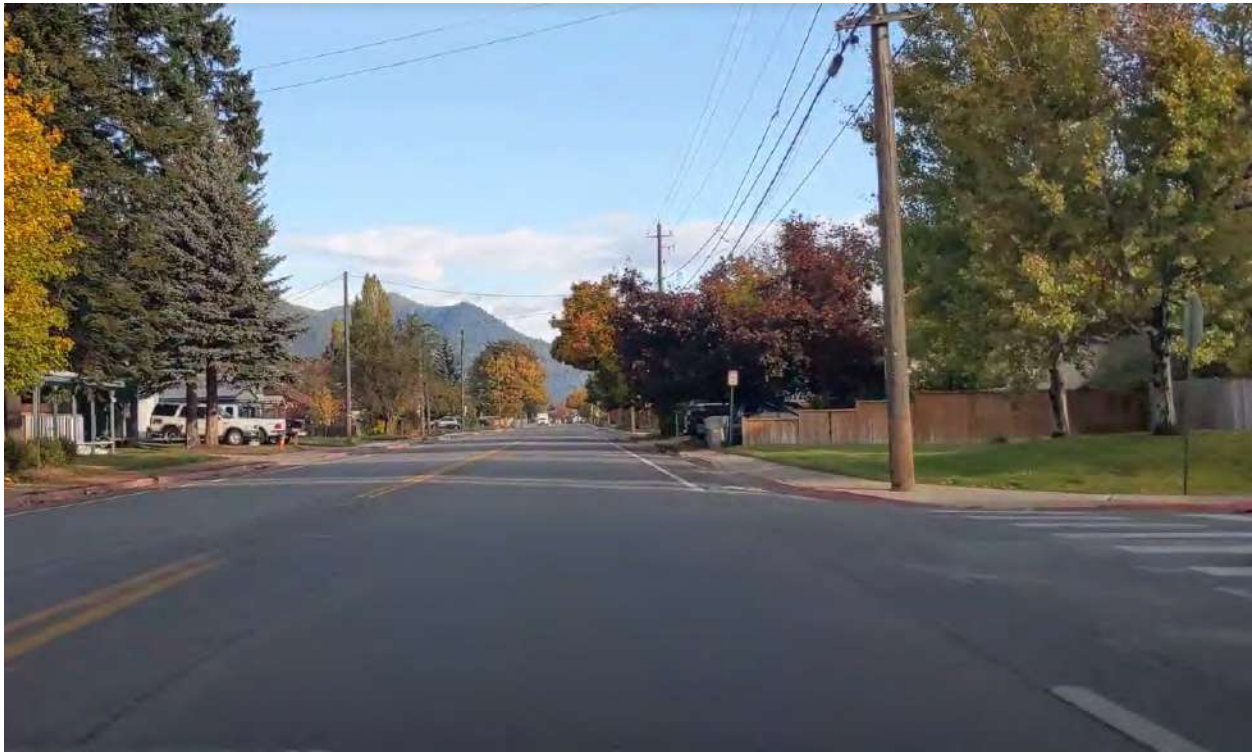
Observation 10: Power pole in the center of sidewalk at Division Avenue & Fir Street (Photo: Fehr & Peers).

As shown in Observation 10, a power pole is placed in the center of the sidewalk on the northeast corner of the intersection at Division Avenue & Fir Street. This pole is obstructing the walkway and is preventing the sidewalk from being ADA compliant. Similarly, a pole obstructs the sidewalk the northeast corner of the intersection at Division Avenue & Larch Street.

The power poles placed in the center of the sidewalk on the northeast corner of the intersections at Division Avenue & Fir Street and at Division Avenue & Larch Street should be relocated to prevent them from blocking the walkway.

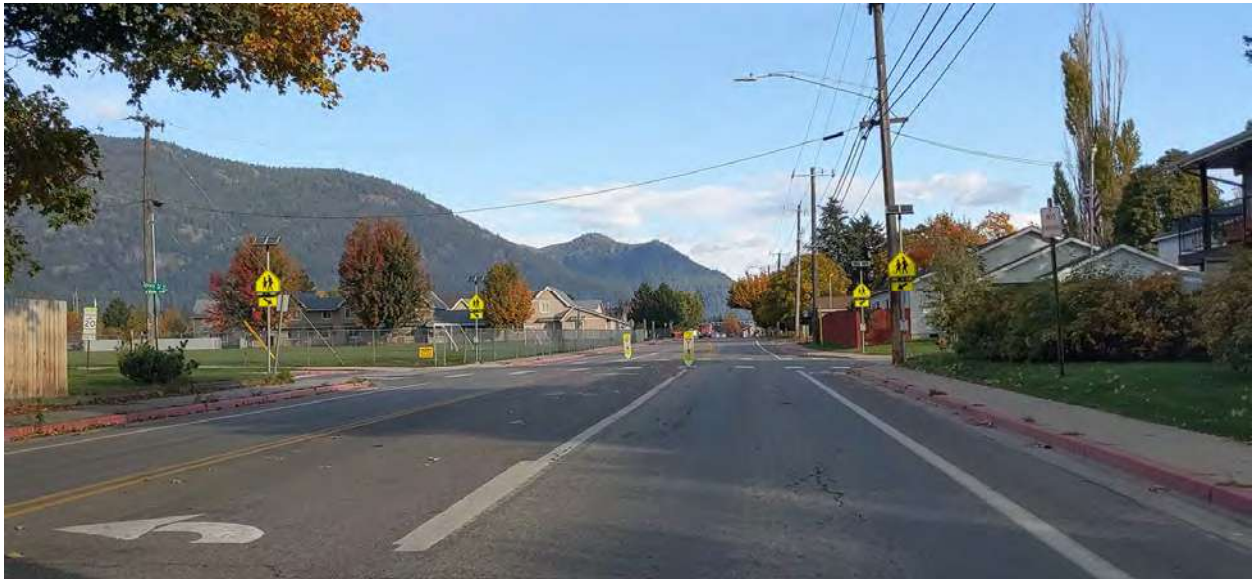
Observation 11: RRFB at Division Avenue & Spruce Street (Photo: Fehr & Peers).

The City has implemented an RRFB crossing at Spruce which was observed to be effective at managing both vehicle and pedestrian traffic to reduce pedestrian/vehicle conflicts during all observed times of the day. The RRFB was observed to operate well and drivers were observed to comply with the sign during the team's field visits.

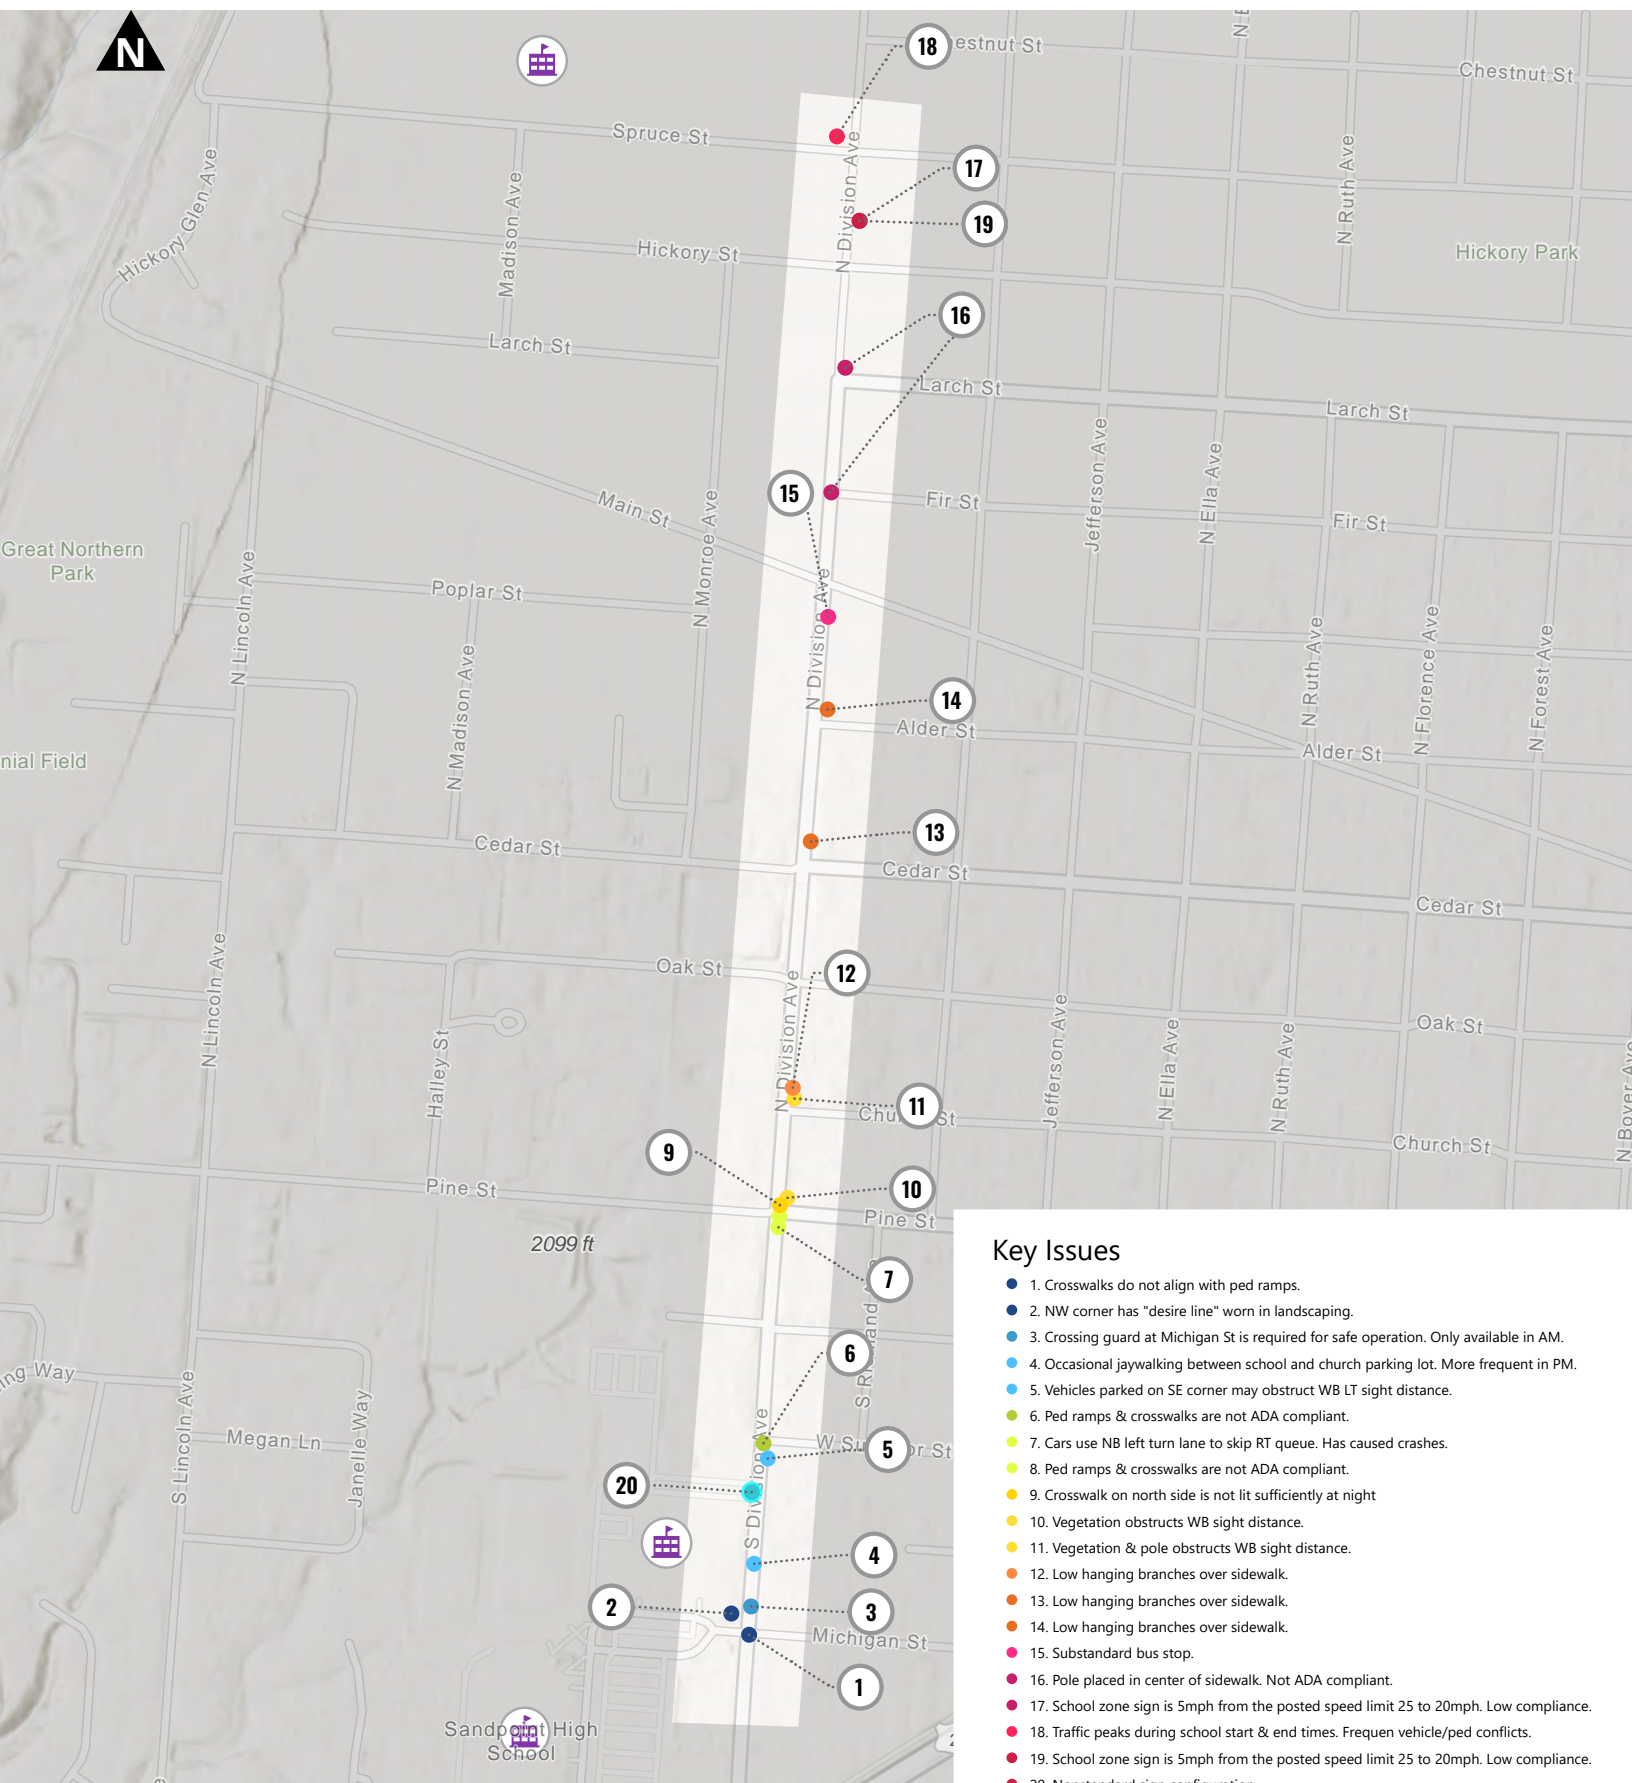
**Figure 6** outlines the key issues and their locations along Division Avenue that were mentioned in this section.
