Idaho Pollutant Discharge Elimination System

Wastewater Treatment Plant Compliance Evaluation Inspection Report

Sandpoint, City of – Sandpoint WWTP

Permit Number: ID0020842 Inspection Date: March 19, 2025

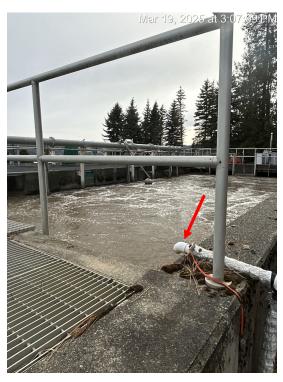
- Headworks building (mold)
- Skimming tank vault (aggregate on walls is degraded)
- Underground pipes (leaking and degraded)
- Breezeway pumps (leaking oil)
- Chlorination basin (solids floating)
- Belt press (degraded and temporary repairs implemented)

Photograph 4. Skimming tank vault for solids collection from the primary clarifiers, degraded aggregate indicated by red arrow.

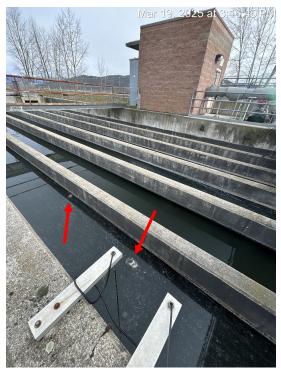
Secondary Treatment notes:	served con instances, increased Operators struggle to Other inst detergent	During normal, dry weather flows, the operators see effective treatment with the current served community. Increased flow, whether from future population growth, or wet weather instances, causes concern as secondary treatment shows signs of overcapacity. During increased flow, turbidity increases in the secondary treatment portion of the plant. Operators stated that the clarifiers are relatively shallow (8 feet along the outside edge) and struggle to keep up with the treatment process. Other instances that cause issues at the secondary treatment include the addition of detergent products. Occasionally when the operators notice issues during dry weather, they have attributed it to soap and detergent that has entered the collection system. The secondary treatment basins show wear due to the age of the system. Recently, one section of digested sludge pipe had to be completely replaced as it was completely deteriorated. Overall, the aeration basin can handle routine, dry weather flows but does not perform adequate treatment of wet weather or additional, nonroutine flows. Upon inspection, a pipe was present on the north corner of the aeration basin. Operators

section of deteriorate perform a					
				ers pumped groundwater to the a ter to go (Photograph 5).	neration basin	as there is no
Inspection - Convention						
Does facility use a chlorine d						⊠Yes □No
What type of chlorine treatm	Calcium hypochlorite (tablet) Sodium hypochlorite (liquid)					
Specify Other: None						
Are there any issues with the	chlorine syst	tem?			□No ⊠ <mark>PI</mark>	EV 4.2.5 □AOC
The operators explained that when E. coli values increase, chlorine is increased which occasionally causes TRC exceedances. During the site inspection, floating solids in the chlorine					ises TRC	
				contact chamber were observed	d (Photograph	s 6 and 7).
Inspection - Convention		it - Dechlori	natio	n System		
Does facility use dechlorinat	ion system?					⊠Yes □No
Indicate type of dechlorination			$\boxtimes S$	ulfur dioxide Sulfite salts		
Are there any issues with the dechlorination system? \square No \square PEV 4.2.5 \square AOC

It is a violation of the permit that the facility is diverting groundwater into the aeration basin.

Photograph 5. Aeration basin overview with groundwater pipe discharging to the basin indicated with red arrow, facing southwest.

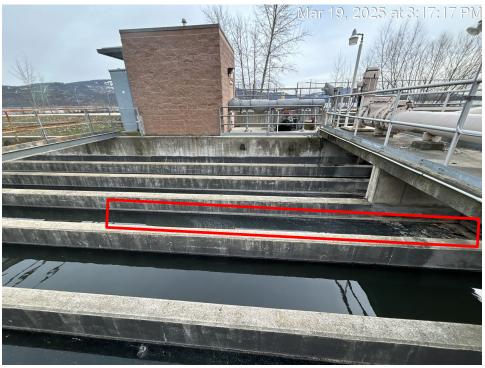
Photograph 6. Chlorination contact chambers, red arrows indicating floating solids, facing east.

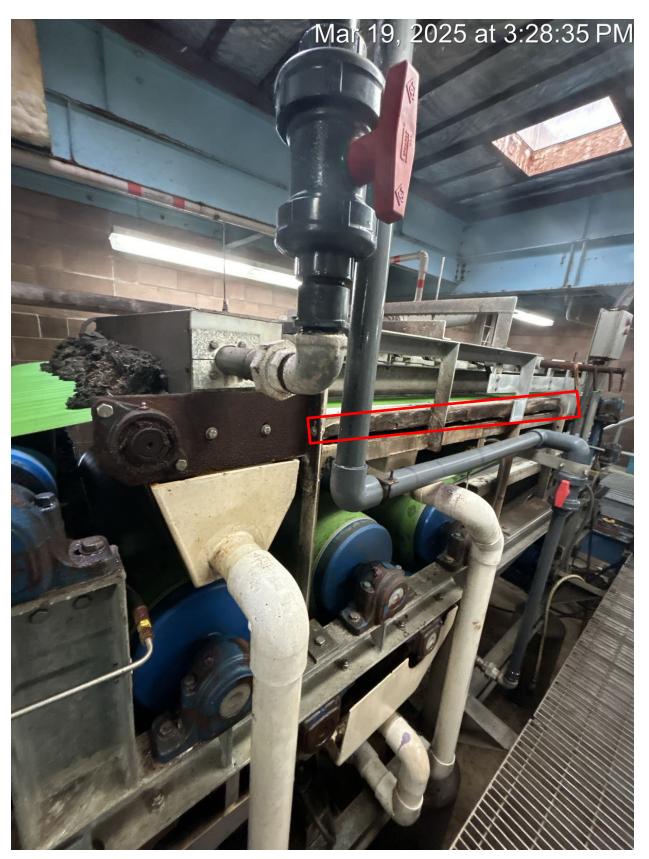
Were any issues identified with thick	kening o	r dewateri	ing?	are field applied. □ No ▷	☑ <mark>PEV 4.2.5</mark> □AOC		
Thickening and Dewatering Notes:	Upon in the below	<mark>nspection</mark> t press we	, the belt ere rusting	presses used were showing signs of were and degrading and portions of the equitie-downs (Photographs 8 and 9).	ar. Metal portions of		
Inspection - Sludge Volume Re							
Does permittee use any biological or					⊠Yes □No		
What type of biological stabilization	is used?	,		ligestion \square Aerobic digestion \square Composization \square Other	osting		
What type of chemical stabilization	is used?	□Lin	ne □Cem	nent kiln dust □Alkaline □Other ⊠N/	/A		
Specify other:		N/A					
Were any issues identified with either	er biolog	ical or ch	emical st	abilization? ⊠No □	PEV 4.2.5 □AOC		
Is there any other sludge treatment used?					-		
Specify other:	1	None		<u> </u>			
Were any issues identified with 'other' sludge treatment?

Photograph 8. Implemented measures to keep belt press one of two operational, wrench and tie down connection points indicated by red arrows.

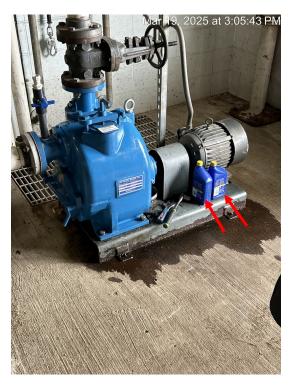
Photograph 11. Breezeway pumping building, oil bordering northern pump indicated by a red circle.

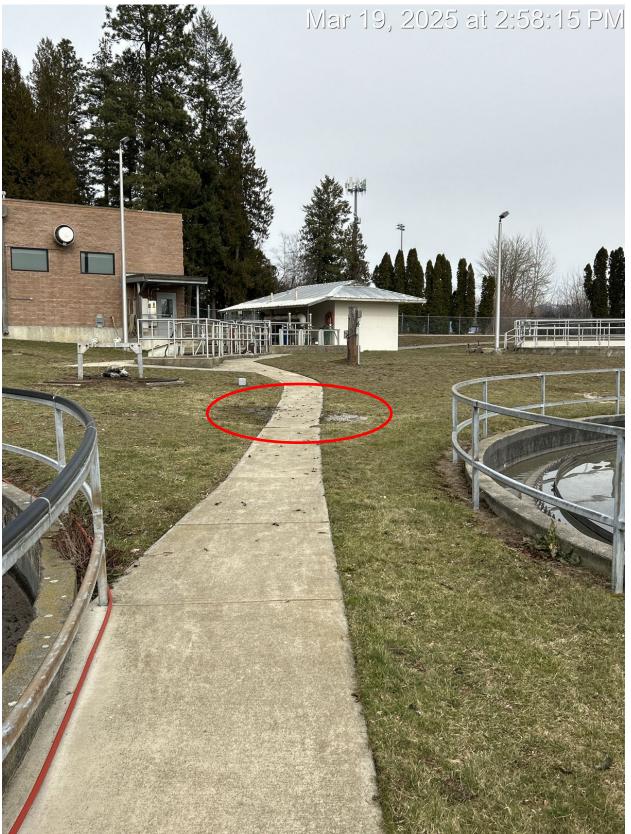
QAPP appears to be impler	aplemented fully as written?				
Were any chemical storage	or containment issues	identified?		□No □PEV 4.2.5 ⊠ <mark>AOC</mark>	
Describe chemical issues. i.e., open containers, exterior containers not covered, secondary containment, dikes/berms in disrepair, etc.: Multiple containers were on site without secondary containment (Photograph 12). One underground pipe was leaking during the inspection between the primary clarifiers and the headworks building. The operators explained that much of the pipe around the facility is in need of replacement (Photograph 13)					
1 1			⊠Yes □	PEV 3.0 □N/A	
Has permittee failed to submit permit renewal application at least 240 days in advance or a full application including monitoring results?			⊠No □		
Permit waiver conditions have issues?			\square No \square	PEV 3 \square AOC \square N/A	
Emergency Response Plan Notification is being implemented as required?				PEV 4.1.3 □AOC □N/A

Photograph 12. Breezeway pumping building, northern pump leaking oil, containers without secondary containment indicated by red arrows.
