# ARCHITECTURAL BUILDING ASSESSMENT

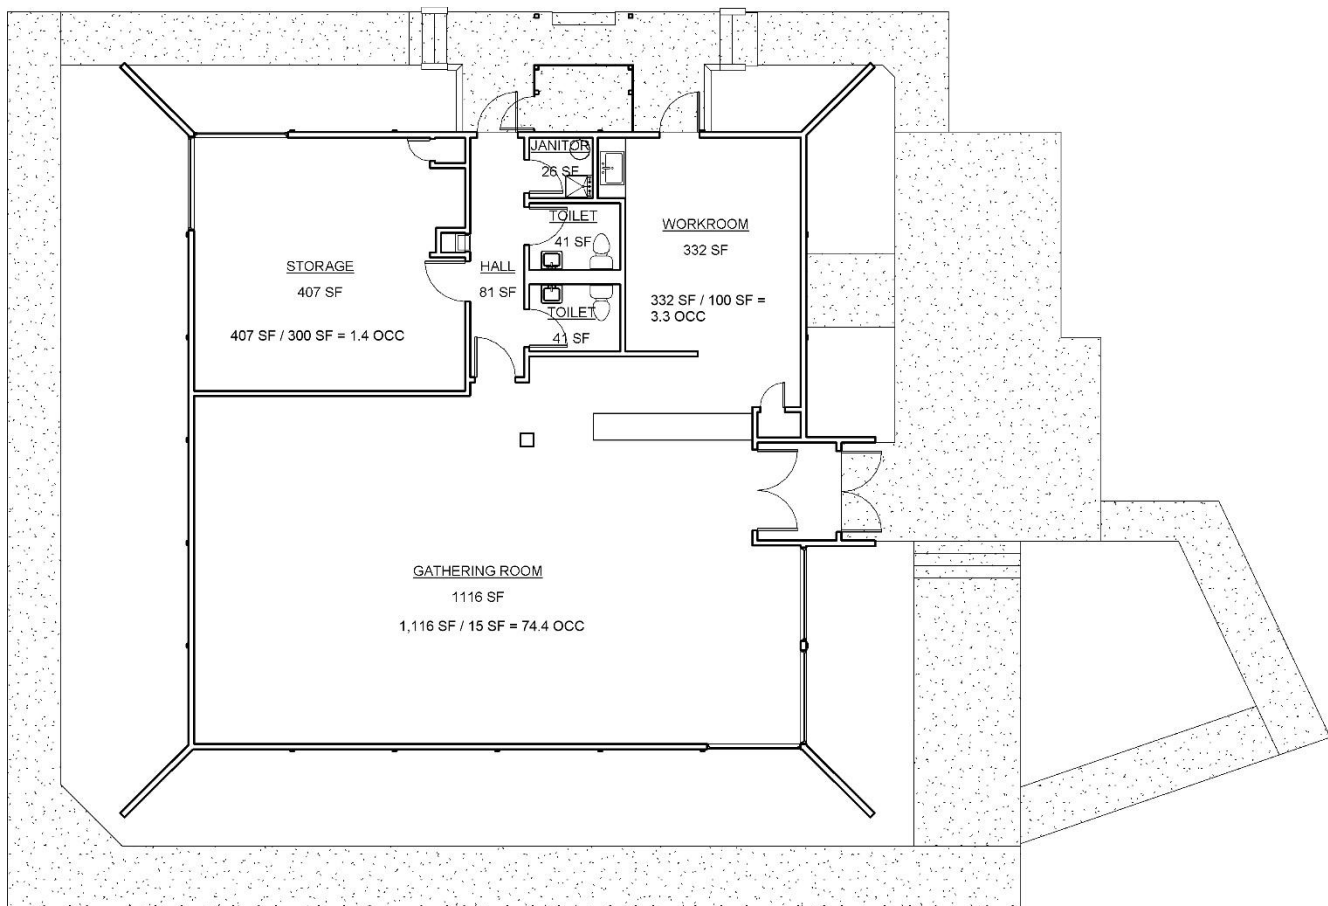
**Current Condition:** The building is broken up into 3 main spaces, with 2 toilet rooms and a janitor closet. The 3 main spaces function as an assembly room, work room and storage room. The assembly room is 1,116 SF, the work room is 332 SF, and the storage room is 407 SF. Overall building is 2,148 SF.

**Code Requirement:** An assembly space such as this will be calculated at 1 person per 15 square feet, the work room would be 1 person per 100 square feet, and the storage room is 1 person per 300 square feet. This results in an overall occupant load of 80 people.

**Solution/Recommendation:** N/A

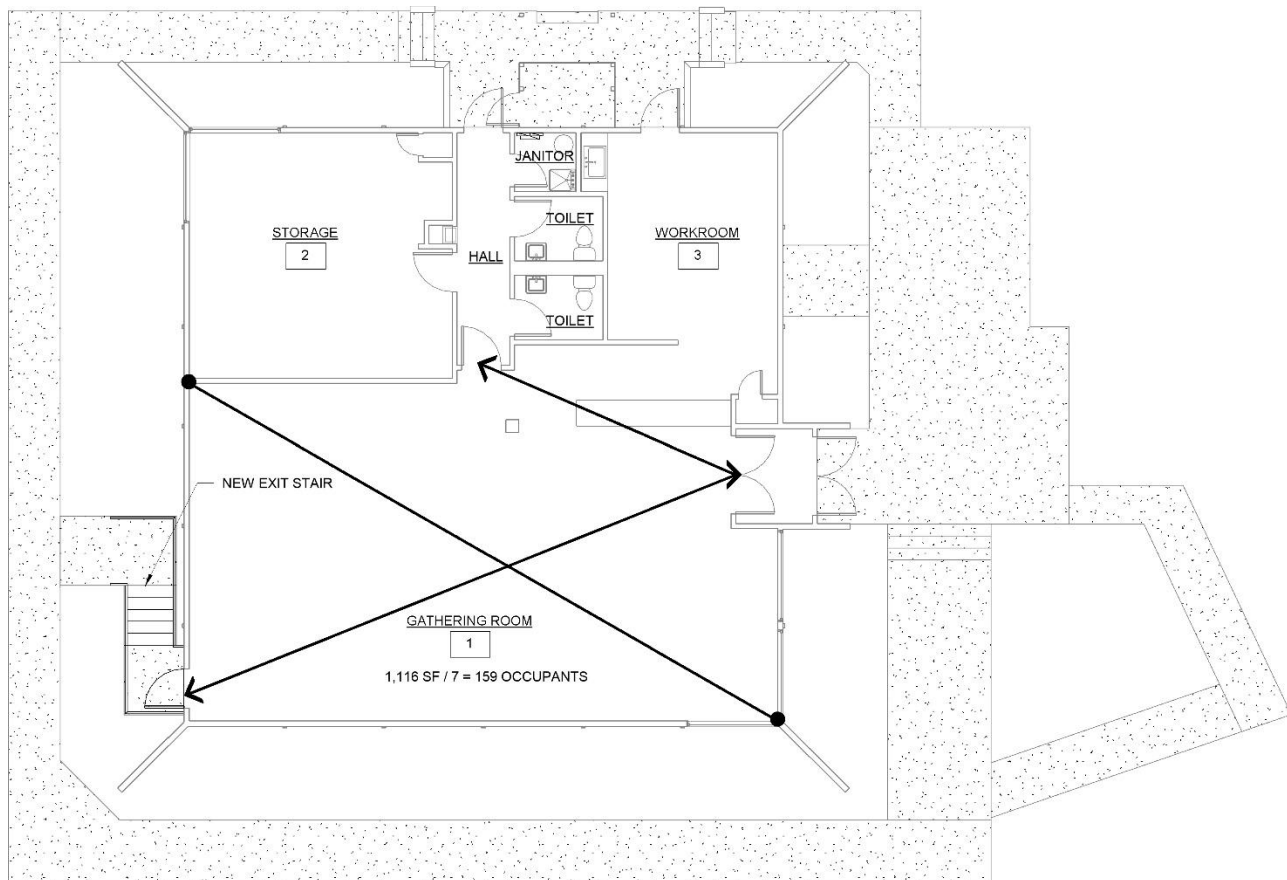
**Current Condition:** The building has 3 exterior exit doors. One exit in the assembly room, one exit in the hallway, and one exit in the workroom.

The maximum travel distance required to reach an exit is 46'.

The diagonal dimension of the building is 64'-1". The maximum separation of exits is 33'-0".

The diagonal dimension of the assembly room is 52'-2". The distance between the entrance door and the door to the hallway is 21'-2".

Number of exits- For any building or space with an occupant load 50 or greater, two exits are required. (IBC 1006.2.1)

Exit separation- Where two or more exits are required, exits must be separated by at least  $\frac{1}{2}$  the diagonal dimension of the building/space. (IBC 1007.1.1)

Building meets code for number of exits and travel distance.

However, the separation of exits for the assembly room does not meet code. The likely solution is to add a new exit on the west side of the room that goes directly outside. A staircase or ramp would be provided to the sidewalk.

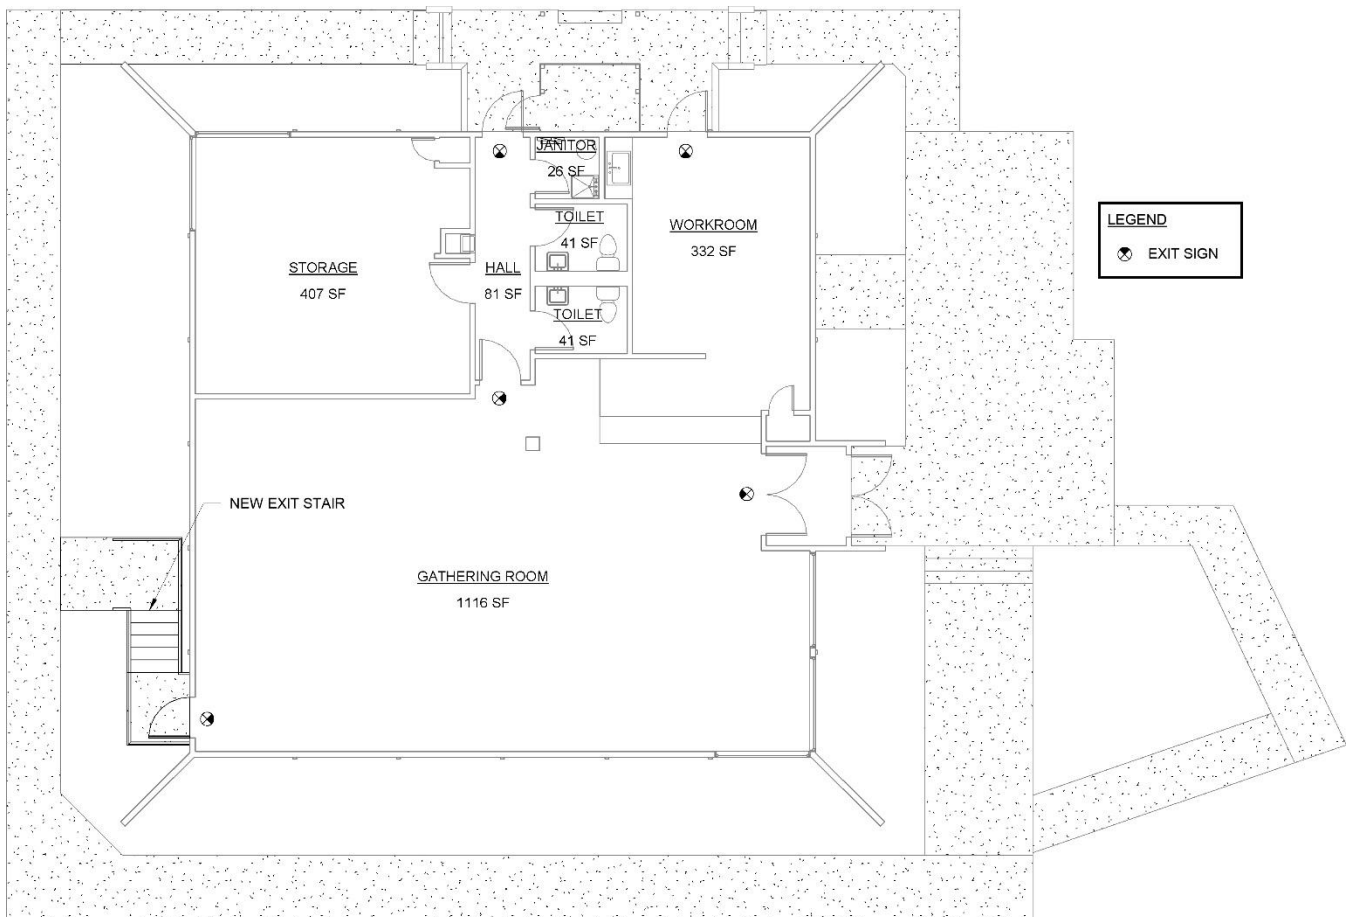
**Current Condition:** There are no exit signs located in the building.

**Code Requirement:** Exit signs need to be provided at exits, hallways and in large rooms. (IBC 1013.1)

**Solution/Recommendation:** Provide exits signs at locations shown on below floor plan. An exit sign should also be provided above any new exit in the assembly room.

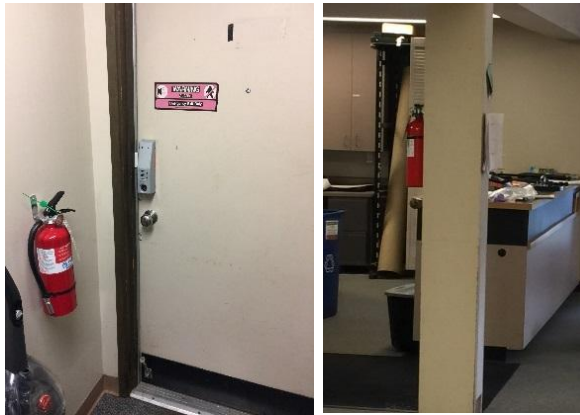
**Current Condition:** There are 2 fire extinguishers in the building. One near the back door in the hallway, and one on the column in the assembly room.

**Code Requirement:** The building is required to have portable fire extinguishers and the maximum distance of travel allowed to an extinguisher is 75'. An extinguisher must be within 30' of commercial cooking equipment. (IBC 906)

**Solution/Recommendation:** Leave existing extinguishers in current/similar locations. If a kitchen is constructed, add a new extinguisher. However, the fire extinguishers should be recessed into the walls so that they do not protrude into walkways, which does not meet ADA.

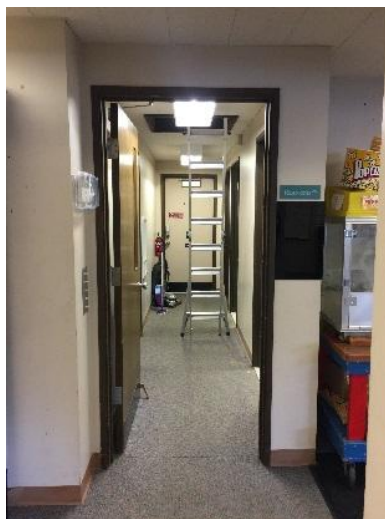
**Current Condition:** There is no emergency lighting in the building.

**Code Requirement:** Per section 1008.3.1 of the IBC "In the event of power supply failure in rooms and spaces that require two or more means of egress, an emergency system shall automatically illuminate all of the following areas: 1. Aisles, 2. Corridors, 3. Exit access stairways and ramps."

**Solution/Recommendation:** Install new exit signs with built in emergency lights. Emergency lights should also be installed on the exterior side of exit doors.

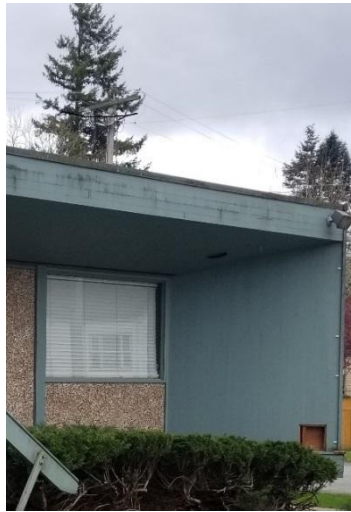
**Current Condition:** The building currently has recessed cans in the soffits above each of the exterior doors.

**Code Requirement:** Per section 1008.2.1 of the IBC "The means of egress illumination level shall be not less than 1 footcandle at the walking surface."

**Solution/Recommendation:** The building was not analyzed at night so it is not known if the existing lighting is adequate. This should be verified.

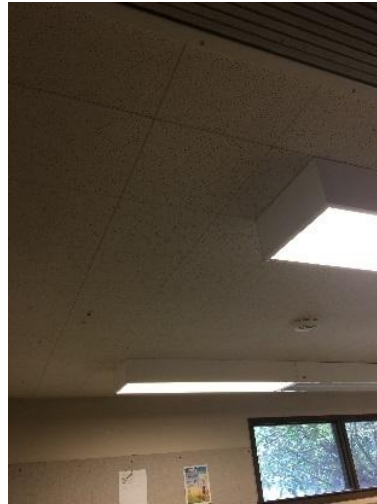
**Current Condition:** There is one smoke detector located in the workroom. Likely because this is where popcorn is cooked.

**Code Requirement:** Per 15.06.030 of the Snoqualmie Municipal Code – buildings under 3,000 SF do not require Smoke Detectors. It was determined from a phone conversation with the Fire Marshal that the City does not require smoke detectors for this type and size of facility.

**Solution/Recommendation:** No action required.

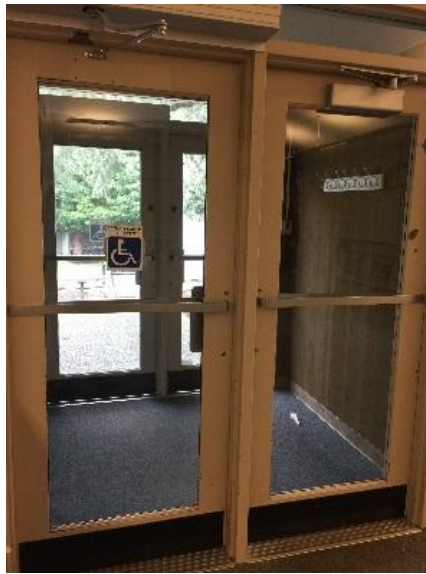
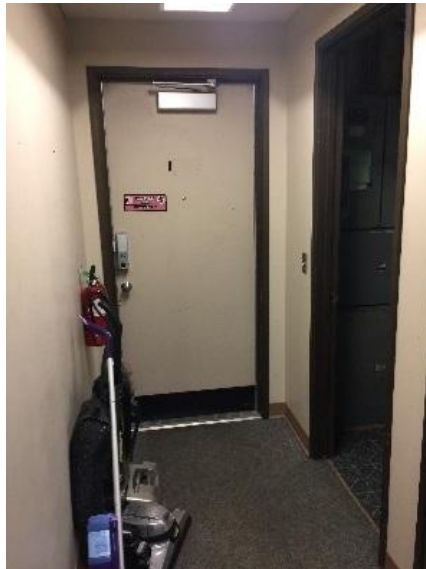
**Current Condition:** The double doors at the main entrance have deadbolt locks.

The back exits are operated by knobs.

**Code Requirement:** Per section 1010.1.9.3 of the IBC "Locks and latches shall be permitted to prevent operation of doors where any of the following exist: 2. In buildings in occupancy group A having an occupant load of 300 or less...the main door or doors are permitted to be equipped with key-operated locking devices from the egress side provided: 2.1 The locking device is readily distinguishable as locked. 2.2. A readily visible durable sign is posted on the egress side on or adjacent to the door stating: THIS DOOR TO REMAIN UNLOCKED WHEN THE SPACE IS OCCUPIED."

Per section 1010.1.9.1 of the IBC "Door handles, pulls, latches, locks and other operating devices on doors required to be accessible by Chapter 11 shall not require tight grasping, tight pinching or twisting of the wrist to operate."

**Solution/Recommendation:** Add sign at entrance door stating that the door is to remain unlocked when the space is occupied. Also install locking devices that are readily distinguishable as locked.

Switch door knobs out for levers.

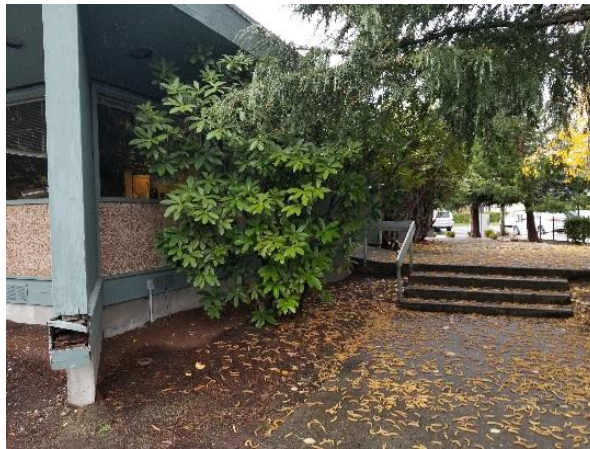
**Current Condition:** There is a set of concrete stairs leading from the sidewalk to the front door. There are 4 steps from the grade level up to the patio/front door. The steps are 5  $\frac{3}{4}$ " high x 14" deep.

**Code Requirement:** Per section 504 of ICC A117.1-2017 "504.2 All steps on a flight of stairs shall have uniform riser heights and uniform tread depth. Risers shall be 4" min. and 7" max. in height. Treads shall be 11" min. in depth.

**Solution/Recommendation:** No changes required to the current steps. If patio is raised, stairs will need to be rebuilt. (See Doors - Hardware - Thresholds)

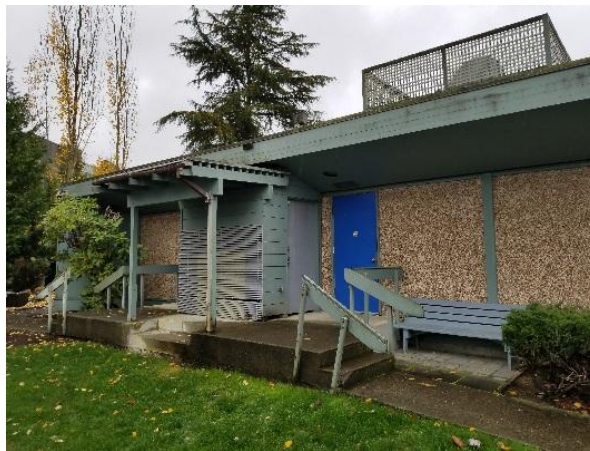
**Current Condition:** There are 2 sets of concrete stairs leading from the exterior exit doors down to the walkways. These stairs have 2 steps each. Each step is 7" and 1'-0" deep. On one tread, the concrete has broken where the railing was attached.

**Code Requirement:** Per section 504 of ICC A117.1-2017 "504.2 All steps on a flight of stairs shall have uniform riser heights and uniform tread depth. Risers shall be 4" min. and 7" max. in height. Treads shall be 11" min. in depth.

**Solution/Recommendation:** No change to the stairs is required other than patching the broken concrete.

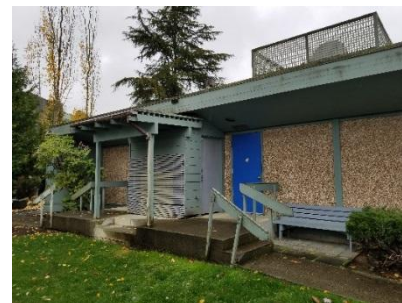
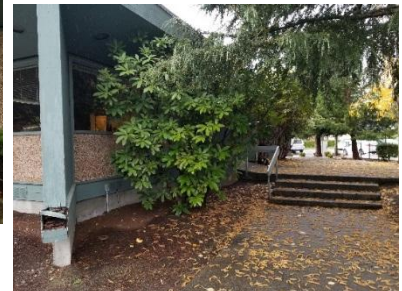
**Current Condition:** Railing at all three stairs are in poor condition. One of the railings on the stairs by the hallway exit has broken off of the concrete stairs. None of the railings meet code. There is no railing provided at the ramp.

**Code Requirement:** Per section 505 of ICC A117.1-2017 "505.2: Handrails shall be provided on both sides of stairs and ramps."

**Solution/Recommendation:** Install new railing and handrails on each side of front stairs and ramp that meet code.

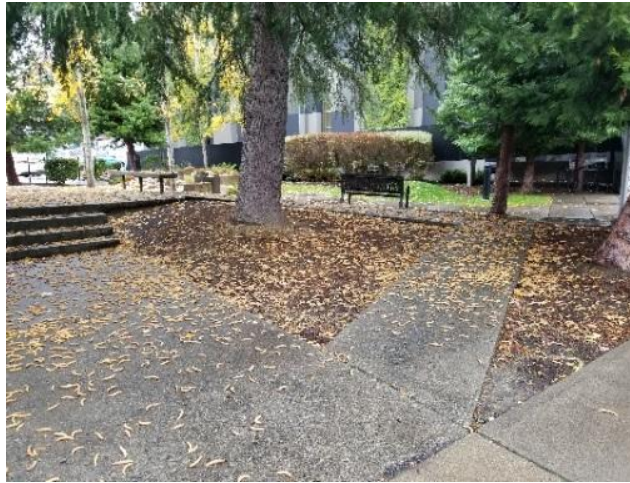
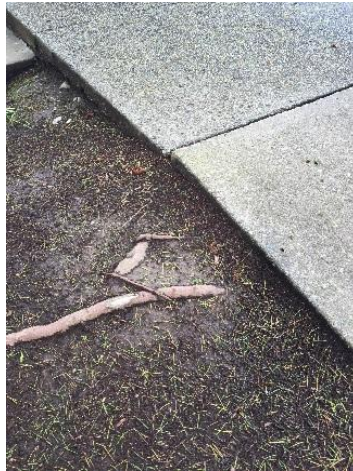
**Current Condition:** The ramp leading up to the front entrance is 45'-3" in length and rises 26 ½" inches. There are no railings along the ramp and no landings at the directional changes. The tree in the middle of the ramp has moved the concrete and creating uneven transitions between concrete sections.

- Slopes shall be greater than 1:20 and not steeper than 1:12.
- Max rise without a landing shall be 30".
- Landings shall be provided at directional changes and be 60" in length.

**Solution/Recommendation:** Current ramp does not conform to ADA standards and needs to be rebuilt. While the existing location could be reused to create an ADA compliant ramp, it would be beneficial to construct a much shorter ramp closer to the bridge in the City Hall plaza. This would also greatly reduce the distance from the ADA parking stalls to the main entrance. Additionally, rebuilding the existing ramp to code could impact the root system of the adjacent tree.

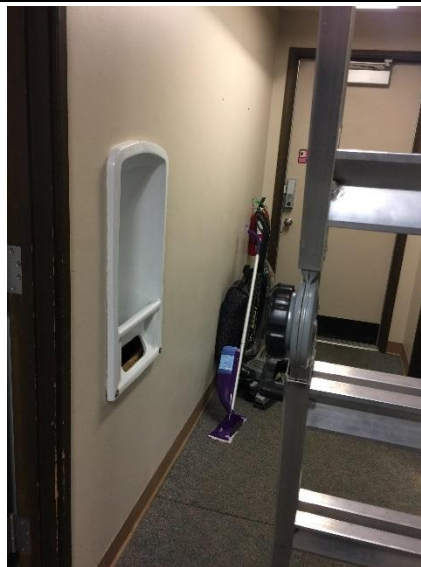
**Current Condition:** There is currently only a single drinking fountain and it does not allow for a front approach by a wheelchair.

- A drinking fountain needs to be provided for standing individuals with a minimum spout height of 38".
- A drinking fountain needs to be provided of wheel chairs with a front approach (knee space under fountain) with a maximum spout height of 36".

**Solution/Recommendation:** Provide an alcove for a new dual height drinking fountain.

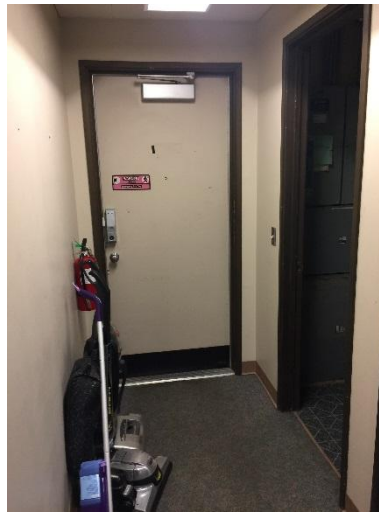
**Current Condition:** All doors are 3'-0" or 2'-10" except the janitor's closet which is 2'-6".

**Code Requirement:** Per section 1010.1.1 of the IBC "The required capacity of each door opening shall be sufficient for the occupant load thereof and shall provide a minimum clear width of 32 inches."

**Solution/Recommendation:** Often building officials will allow unoccupied spaces like janitor's closets to have doors smaller than the minimum width. The space may be able to accommodate a 2'-10" door, but the utility sink would be impacted.

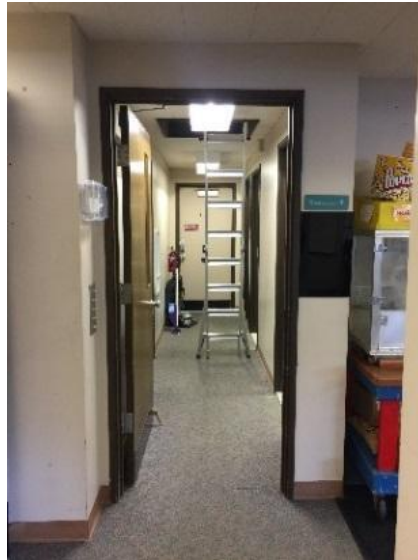
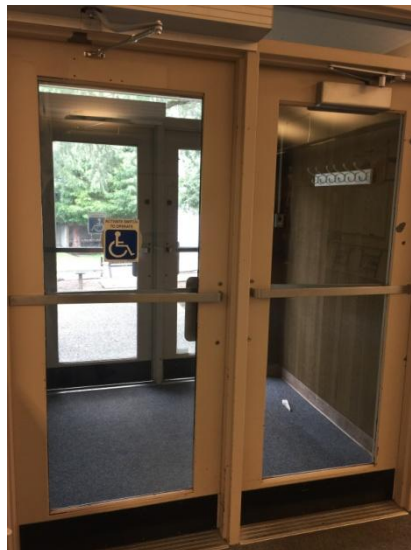
**Current Condition:** The hallway does not provide the required clearances for the exit door and the door between the hallway and the assembly room.

The required clearance between the main entrance and the vestibule doors is not provided.

- 18" must be provided on the pull side of a door between the door and the adjacent wall.
- 12" must be provided on the push side of a door between the door and the adjacent wall.
- For the current arrangement of the main entrance and vestibule doors, 48" minimum must be provided between the fully opened vestibule door and the closed main entrance door.

- Hall to Exit-Enlarge the hallway by taking space out of the storage room.
- Hall to assembly- enlarge hallway towards storage room and relocate door, or remove door.
- Main entrance- Relocate vestibule wall 12" towards the assembly room.

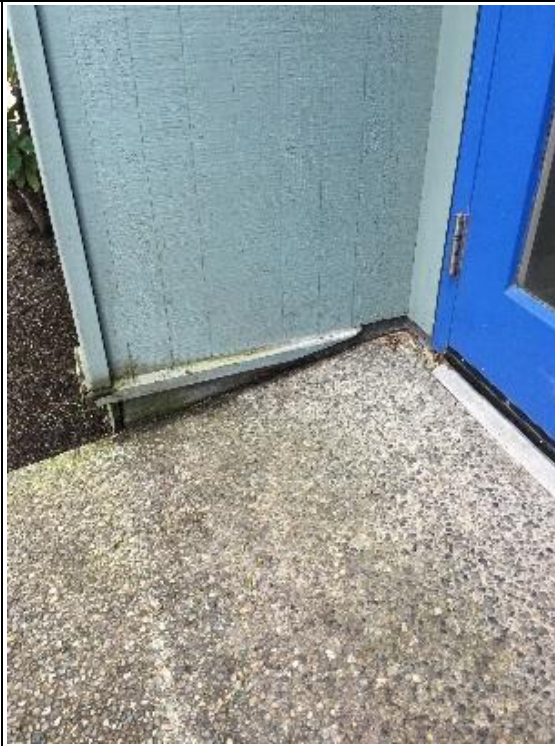
**Current Condition:** All doors have a flat landing in front of them except for the main entrance which has a slope greater than 2% leading to the patio. Paving drops 8" over a 5'-6" span. If the 2" threshold is added, this increases to 10".

- Landings shall have a slope of not steeper than 1:48
- Landing need to have a depth of at least 60" for front approach from the exterior.

**Solution/Recommendation:** Raise the concrete pad on the exterior side of the door to bring the landing up to door level. Due to the adjacent stairs, this will likely result in a large portion of the patio being raised.

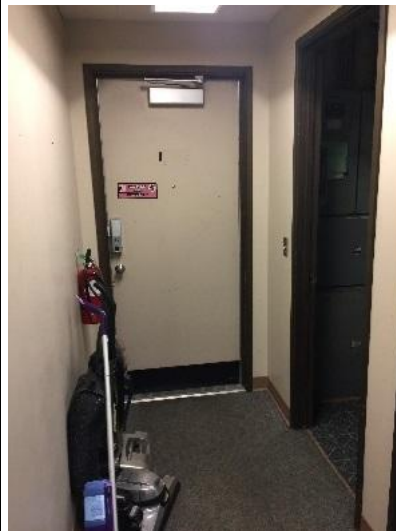
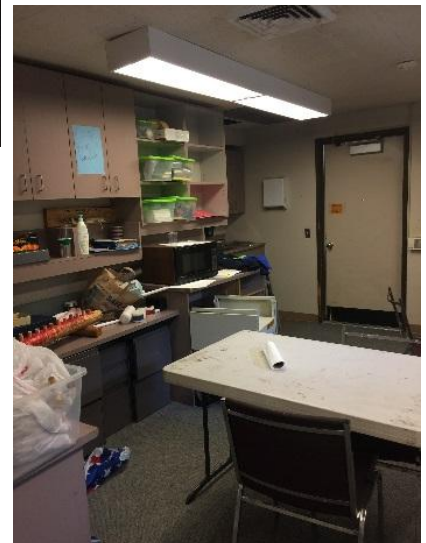
**Current Condition:** All interior and single exit doors have knobs that require twisting to open. The main entrance doors have a deadbolt lock and handles to push/pull when unlocked.

**Code Requirement:** Per section 1010.1.9.1 of the IBC "Door handles, pulls, latches, locks and other operating devices on doors required to be accessible by Chapter 11 shall not require tight grasping, tight pinching or twisting of the wrist to operate."

**Solution/Recommendation:** Provide new lever handles, automatic doors or panic hardware at doors.

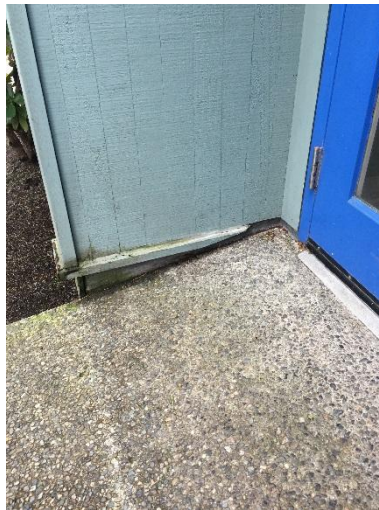
**Current Condition:** All door thresholds appear to be ADA compliant except main entrance which is 2" high.

**Code Requirement:** Per section 303 of the ICC A117.1-2017 "Changes in level of  $\frac{1}{4}$ " max. in height shall be permitted to be vertical. Changes in level greater than  $\frac{1}{4}$ " in height and not more than  $\frac{1}{2}$ " max. in height shall be beveled with a slope not steeper than 1:2."

**Solution/Recommendation:** Raise the patio elevation to bring main entrance into code compliance, or create a ramp in the patio.

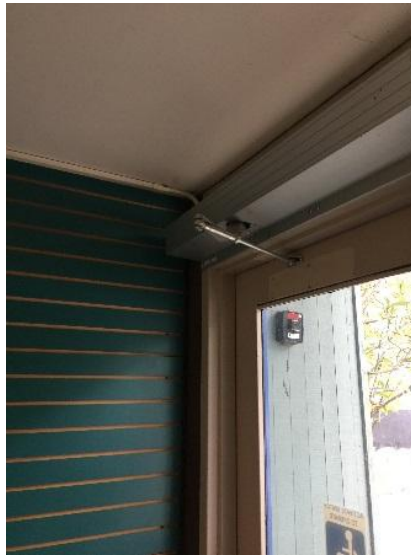
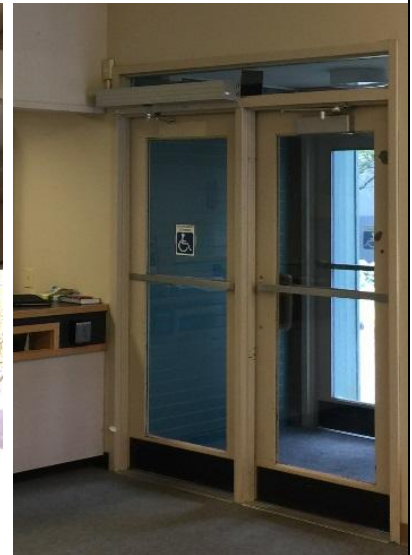
**Current Condition:** All door closers close the doors in faster than 5 seconds.

**Code Requirement:** Per section 404.2.7.1 of the ICC A117.1-2017 "Door and gate closers shall be adjusted so that from an open position of 90 degrees, the time required to move the door or gate to an open position of 12 degrees shall be 5 seconds minimum."

**Solution/Recommendation:** Adjust automatic closer speeds or provide new closers.

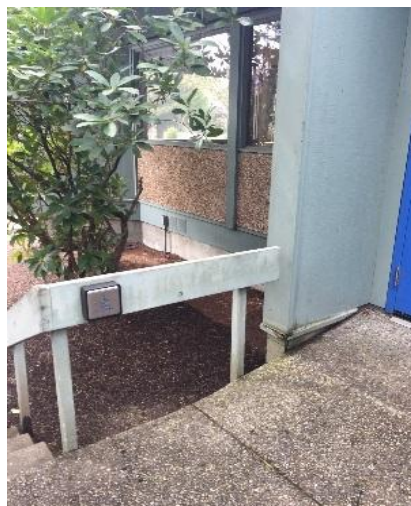
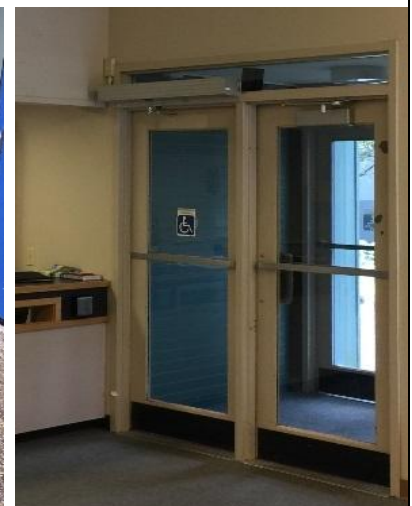
**Current Condition:** The main entrance doors have ADA push buttons that are not currently functional.

**Code Requirement:** Buttons are not required by code.

**Solution/Recommendation:** Although not required, they should be fixed or removed as to not confuse people.

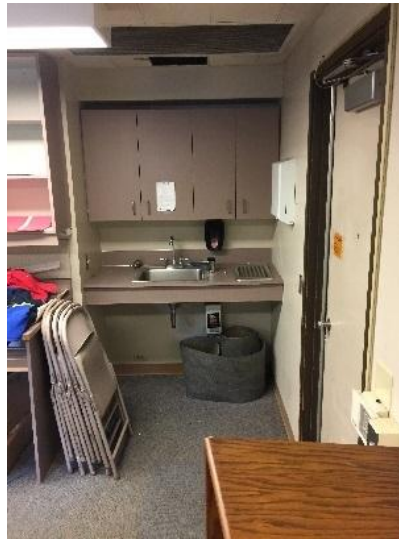
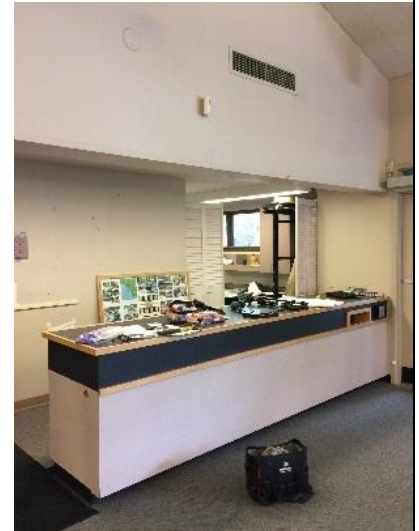
**Current Condition:** The front service counter is 39" high and the counter with a sink in the work room is at 38".

- Work counters shall have a height between 28" and 34".
- Service counters shall have a 30"/36" minimum width portion of the counter with a maximum height of 36", depending on parallel/front approach.

**Solution/Recommendation:** Lower existing countertop in work room to be at a max. height of 34". At the front service counter, provide a new countertop with lower section for ADA access. The rest of the counter could remain higher.

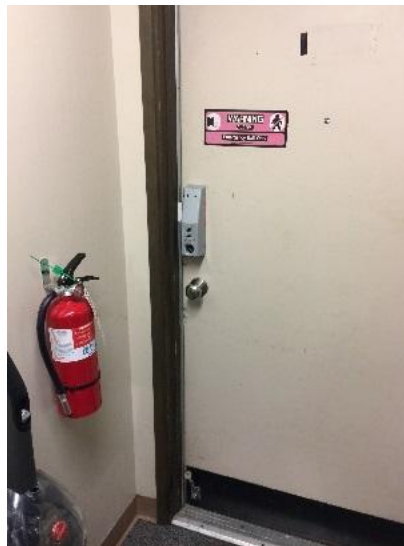
**Current Condition:** The fire extinguisher near the back exit door is protruding 5" into the clear access way.

**Code Requirement:** Per section 307.2 of the ICC A117.1-2017 "Objects with leading edges more than 27 inches and not more than 80 inches above the floor shall protrude 4 inches max. horizontally into a circulation path.

**Solution/Recommendation:** Install the fire extinguisher to be recessed into the wall.

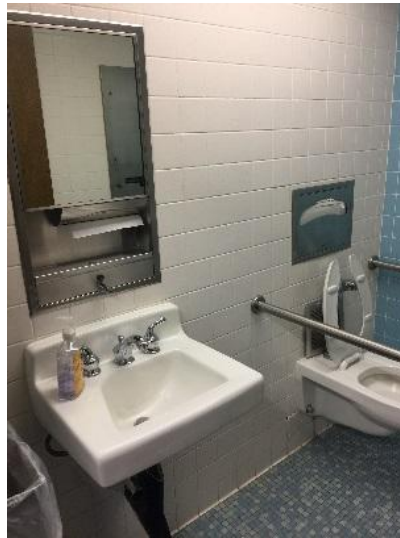
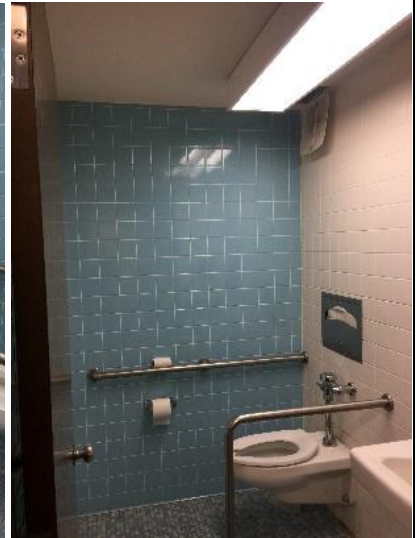
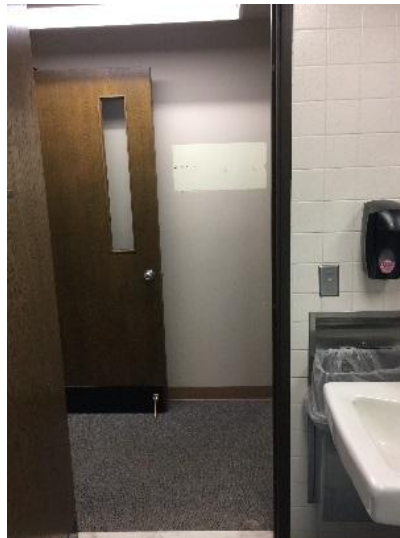
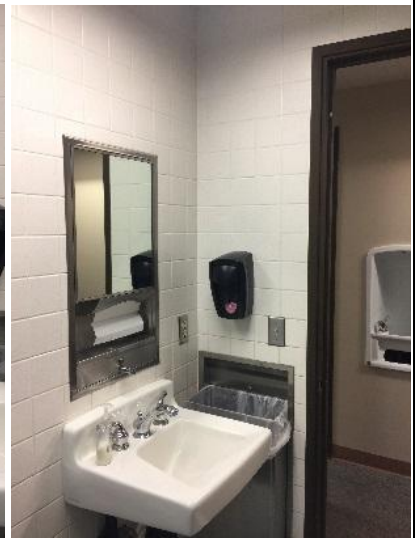
- Clearance Around Toilets – there is not the required 60" clearance from the wall adjacent to toilets to the edge of the sinks. Currently at 52" to the sink.
- Sink Height- sinks are mounted at 34 ½". Should be at a max of 34".
- Mirror height- mounted at 52" inches to bottom of mirror. Should be at a max of 40" to bottom of mirror.
- Faucet Controls (no grip required) – The sinks currently have lever handles that appear to be ADA compliant.
- Distance of toilet from wall – 19" to center. Requirement is 16-18".
- Toilet height – 19" to top edge. Requirement is 17-19".
- Grab bars – mounted at 33" high. Requirement is 33-36". Missing required vertical grab bar and grab bar behind toilet.
- Accessories heights – soap and paper towel dispensers are mounted too high.
- Hot water and waste pipes are insulated and appear to meet code.

**Solution/Recommendation:** The current toilet rooms are too small and cannot be altered to meet code without relocating walls. A complete rebuild of the toilet rooms is needed. It appears the sinks, toilets, toilet paper holders, waste receptacles, sanitary napkin receptacle and soap dispensers could be reused, if desired.

Enlarging the toilet rooms will greatly impact the other spaces. Widening the rooms will eliminate the janitor closet or move into the assembly room. Lengthening the rooms will move the east wall roughly 12" into the work room.

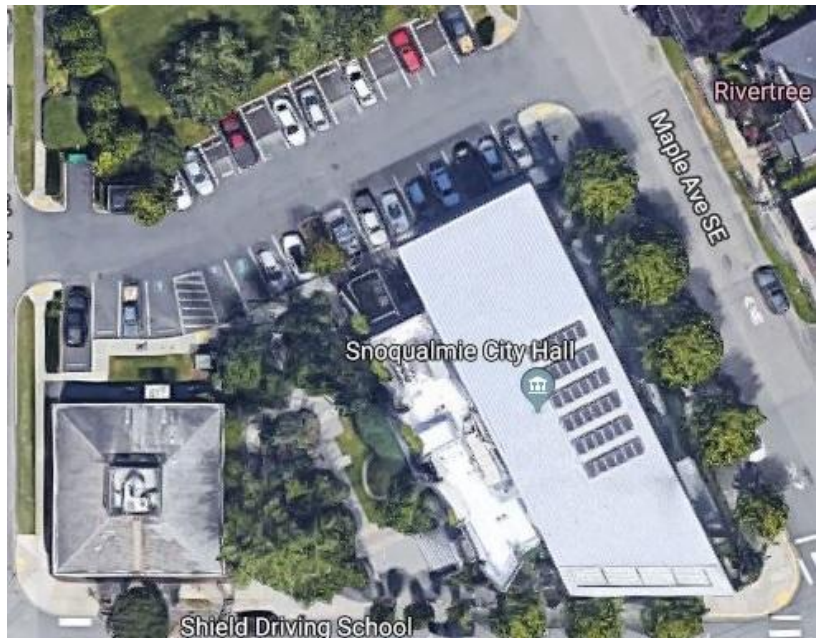
Number of stalls in parking lot– 30

Number of ADA stalls – 2, with an 8' aisle

The ADA parking stalls appear to have been built w/ the construction of City Hall and appear to meet ADA.

**Code Requirement:** 26-50 spaces require 2 ADA parking spaces, 1 of which must be Van accessible. (ADA Standards 208.2)

**Solution/Recommendation:** No action necessary.

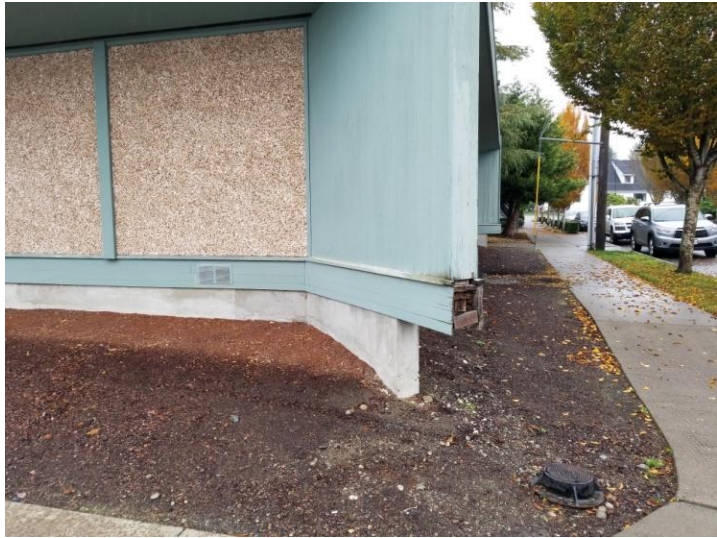
**Current Condition:** The vertical and horizontal wood siding is in poor condition in locations exposed to the elements. Construction has severely deteriorated at the wing walls.

**Solution/Recommendation:** At a minimum, damaged areas of siding should be replaced. It is recommended that all wood siding be removed so that the extent of water intrusion and rot can be addressed and proper flashing installed.

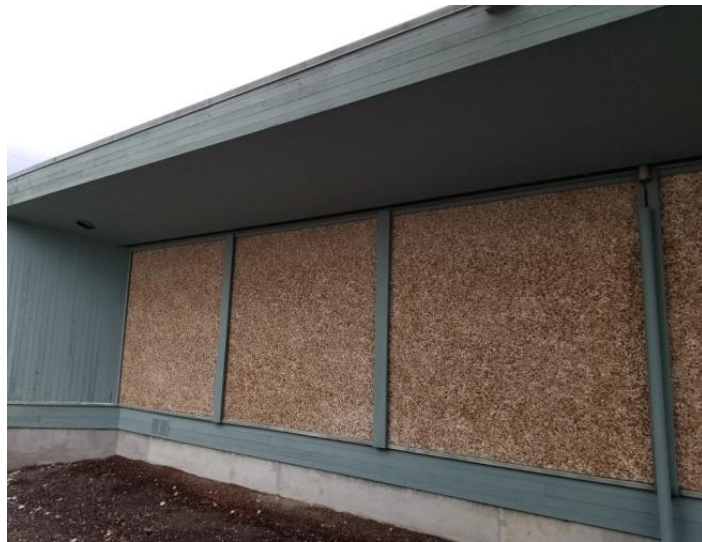
**Current Condition:** Panels appear to be in good condition and there are no signs of water intrusion.

**Solution/Recommendation:** Panel can be left in place. However, the panels date the building and replacing them will give a more current appearance to the building.

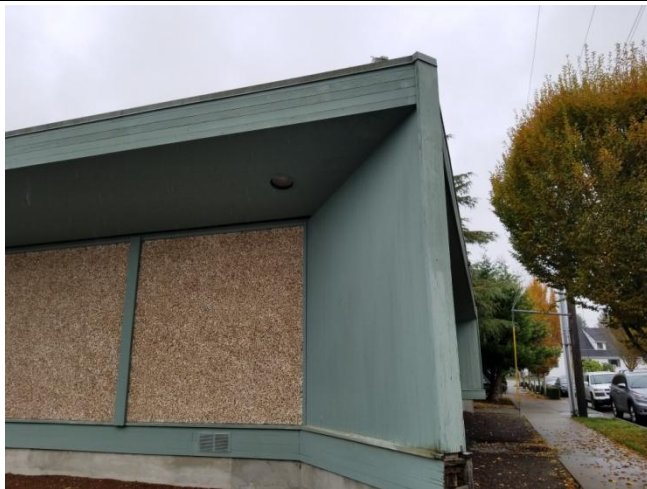
**Current Condition:** The top of the exterior walls have metal flashing, but flashing is not provided at the bottom of the wing walls where the siding transitions from vertical to horizontal. This likely has created/added to the deterioration of the framing in the wing walls.

**Solution/Recommendation:** Metal flashing should be provided at material transitions that are exposed to the elements.

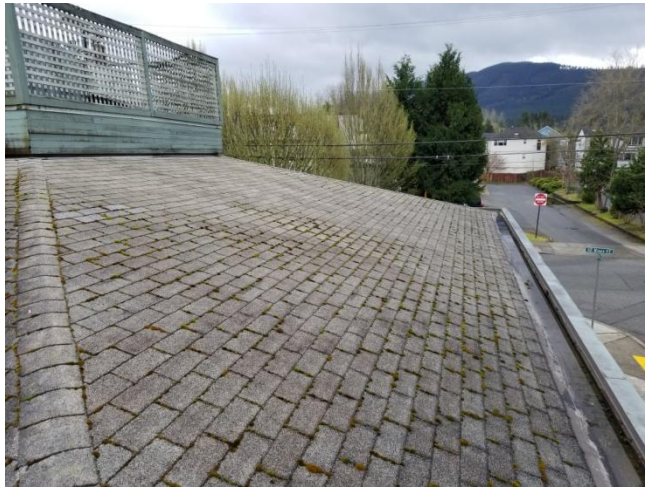
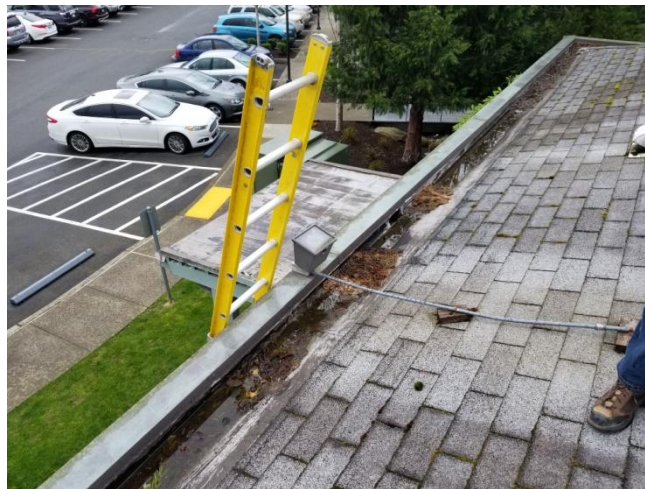
**Current Condition:** The main roof is asphalt shingles that look to be original. During sampling, they were easily torn manually.

A few years ago, an inspector looked at the roof and determined there were no leaks at the time.

**Solution/Recommendation:** Roofing appears to be at the end of its useful life and should be replaced. At a minimum, it needs to be cleaned.

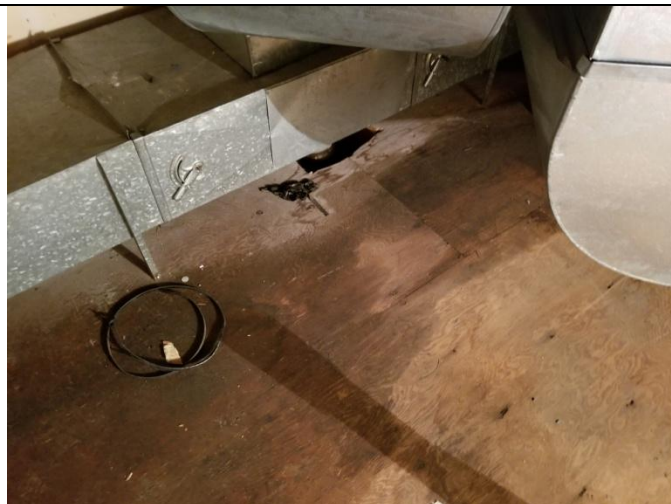
**Current Condition:** There is water damage on the plywood flooring of the mechanical mezzanine and light can be seen through the opening for the HVAC ducting. It is not known if this water came from condensation in the ducts or if rain water entered the building through the small gaps in the ducting penetration.

**Solution/Recommendation:** The HVAC ducting penetrations should be resealed and then verify if any new water damage occurs.

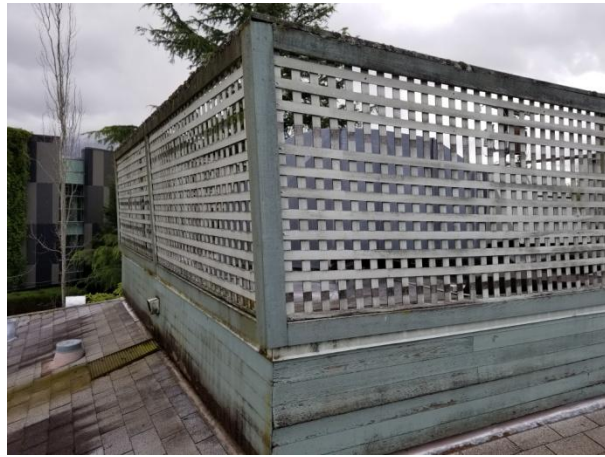
**Current Condition:** The HVAC screening is in poor condition. It is leaning and is easily shifted by pushing it lightly. It appears the screening could collapse in a strong storm.

**Solution/Recommendation:** The screening needs to be immediately replaced or removed.

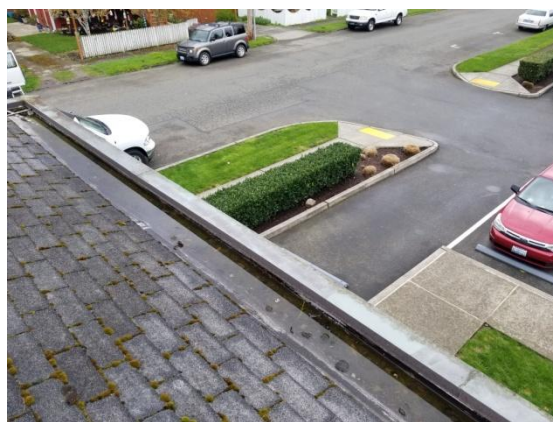
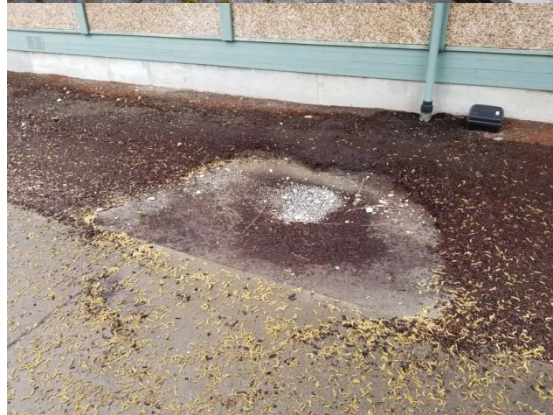
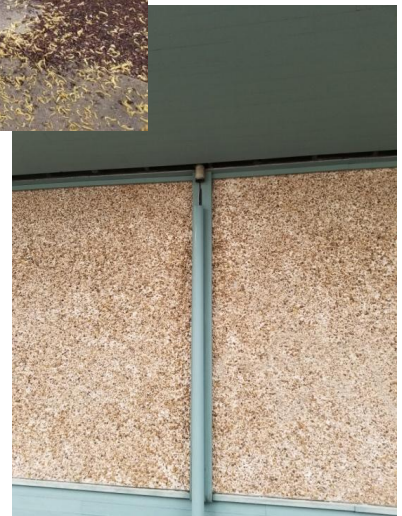
**Current Condition:** There are 4 downspouts on the main roof, one on each side. They appear to tie into a below grade stormwater system. There are no wire baskets, which has caused all of the openings of the downspouts to clog. Due to the clogs, water leaves the roof via the overflows and has washed away soil below. The down spout on the south side has become detached from the scupper. The shed roof has a downspout that opens directly onto the grass.

**Solution/Recommendation:** The roof needs to be cleaned and wire baskets installed. The south downspout should be reconnected to the scupper.

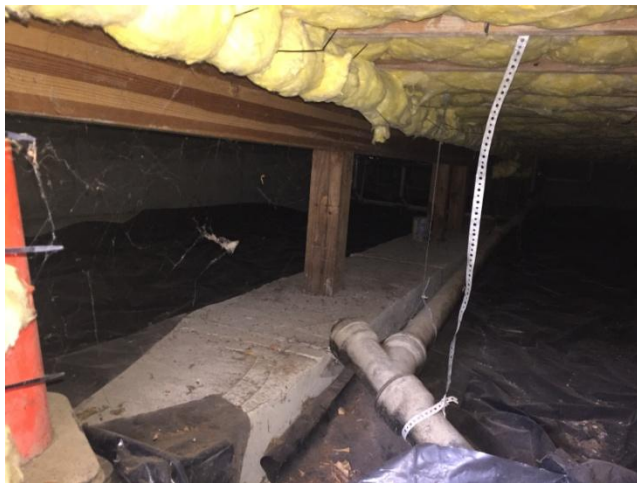
**Current Condition:** The crawl space appears to be dry and in fair condition. There are two vents on each side of the building. The vapor barrier on the ground has been shifted in places. The floor insulation is batt and is 9" thick.

**Solution/Recommendation:** Reposition the vapor barrier.

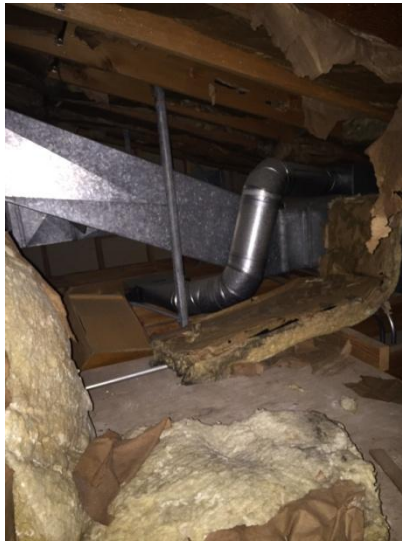
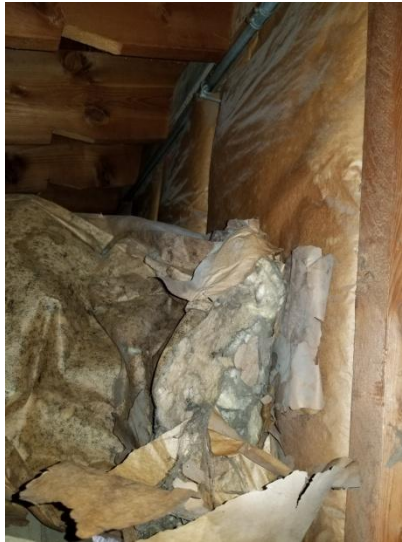
**Current Condition:** Paper faced, batt insulation is installed between the joists that create the roof structure. In a number of locations, the insulation has been damaged and has fallen on top of the ceiling joists. The insulation is 9" thick.

**Solution/Recommendation:** Upgrading to current code R-values for insulation is not required but providing insulation with a higher R value would improve the energy efficiency of the building. If not entirely replaced, the damaged insulation should be fixed. Replacing the batt insulation with spray foam could correct any issues caused by the lack of an airspace above the insulation.

Any material with mold present should be replaced and the mold remediated.

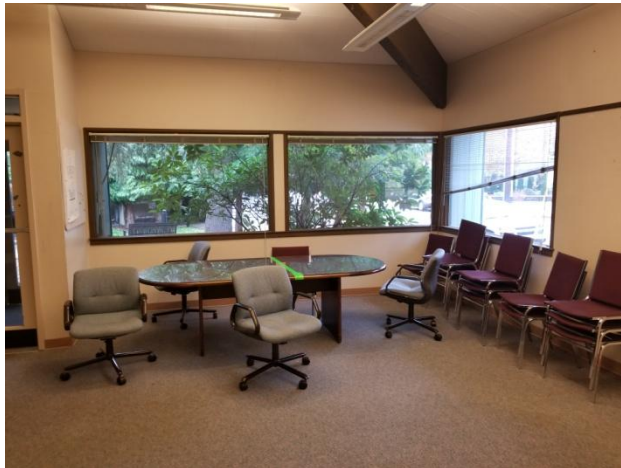
**Current Condition:** Existing windows are wood and single paned.

**Solution/Recommendation:** While upgrades are not required, replacing the windows will improve the energy efficiency of the building.
