## Memorandum

**Re:** **Geologic Hazard Assessment – Canyon Springs Water Transmission Pipeline, King County, Washington**

**Project No.:** 26000080

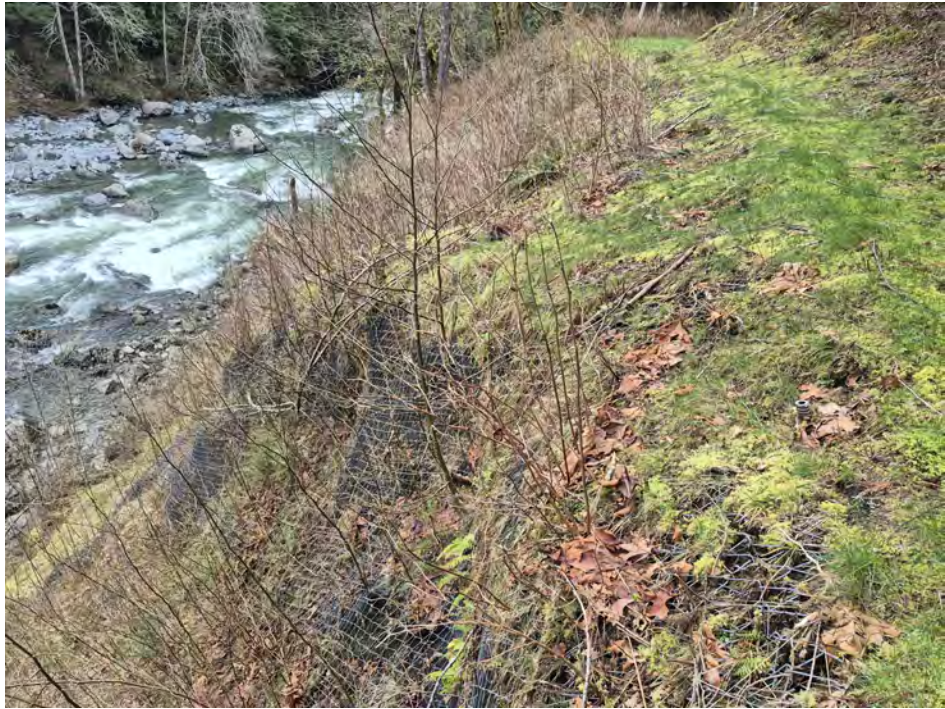
During the spring 2026 traverse, we observed that the anchored mesh installed to stabilize the 2017 landslide area was in generally good condition and functioning as intended. We observed some areas where a 1- to 2-inch gap was visible between the mesh and underlying colluvial material (Figure 4: Photograph 1). Small deciduous trees and brushy vegetation have become established within the anchored mesh of the slide repair.

**PHOTO 1:** 2017 landslide repair area. Mesh is in generally good condition. Pipeline is under path in the upper right of the photograph. View to the south.

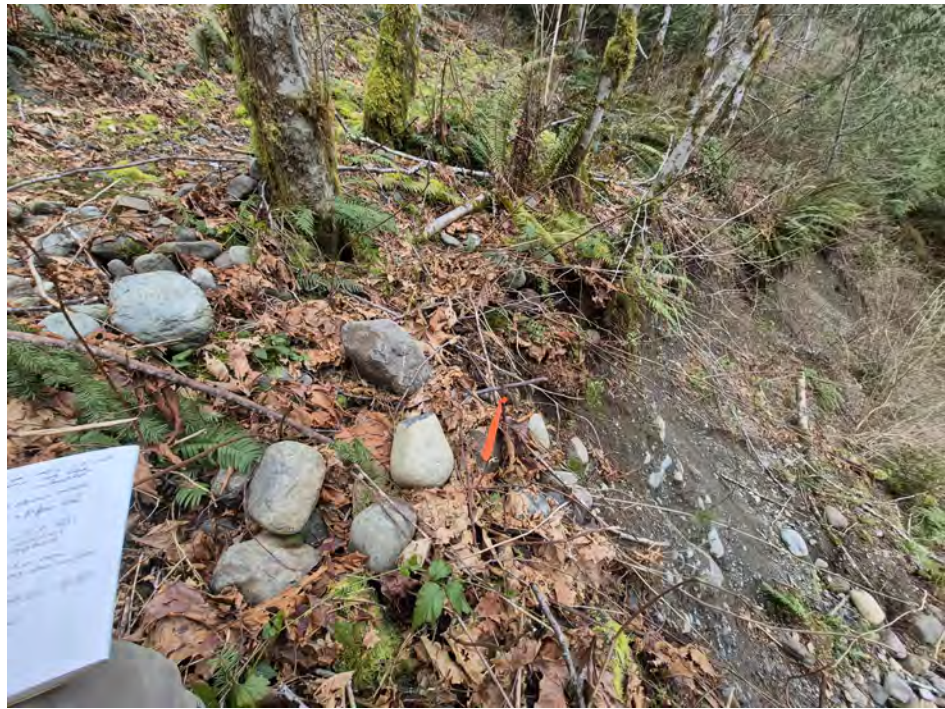
**PHOTO 4:** Landslide headscarp downslope of the pipeline. Orange flag is AMP-04, STA 41+80. Pipeline is in upper part of photograh, about 11 feet from head scarp.

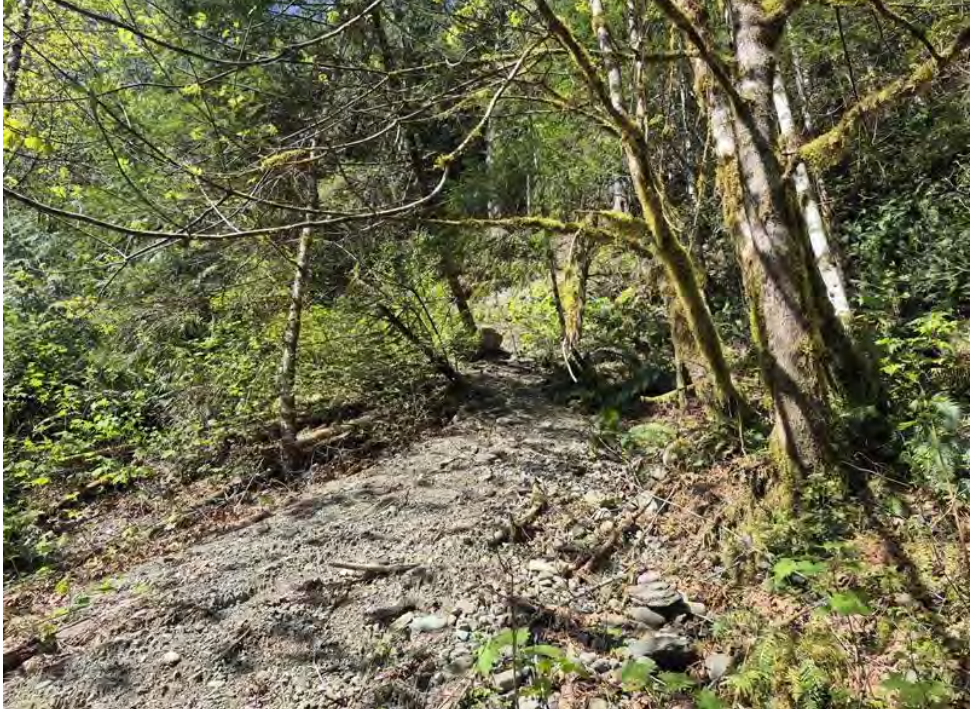
The colluvial slide that originates approximately 80 feet upslope of the access trail and pipeline between STA 40+00 and about 41+50 continues to actively slough and ravel. The vertical head

scarp is about 5 feet high and appears to have continued to retreat upslope since the autumn 2025 site visit. Glacial outwash, including boulders, cobbles, and gravel in a sandy matrix, are exposed in the head scarp. The fan below the head scarp consists of glacial outwash, deadwood, and organic debris in several “chutes” that overlap the pipeline alignment and the access trail (Figure 4: Photograph 2). At the toe of the fan, at about the location of the pipeline alignment, immature deciduous trees are growing, and we observed boulders up to a few feet in diameter that were retained on the slope only by resting against tree trunks.

Continued mass movement within the slide area will deposit more material at the toe of the fan, burying the pipeline deeper and restricting access to the trail. While the growing debris fan does not itself present a significant hazard to the integrity of the buried pipeline, if material is removed from the toe of the fan, either by construction activities or by natural slope failure processes, the hazard to the pipeline would increase.

**PHOTO 2:** Slide debris from colluvial slide above pipeline near Sta 41+00. Pipeline is approximately under the photographer's boots. View to the west, up slope.

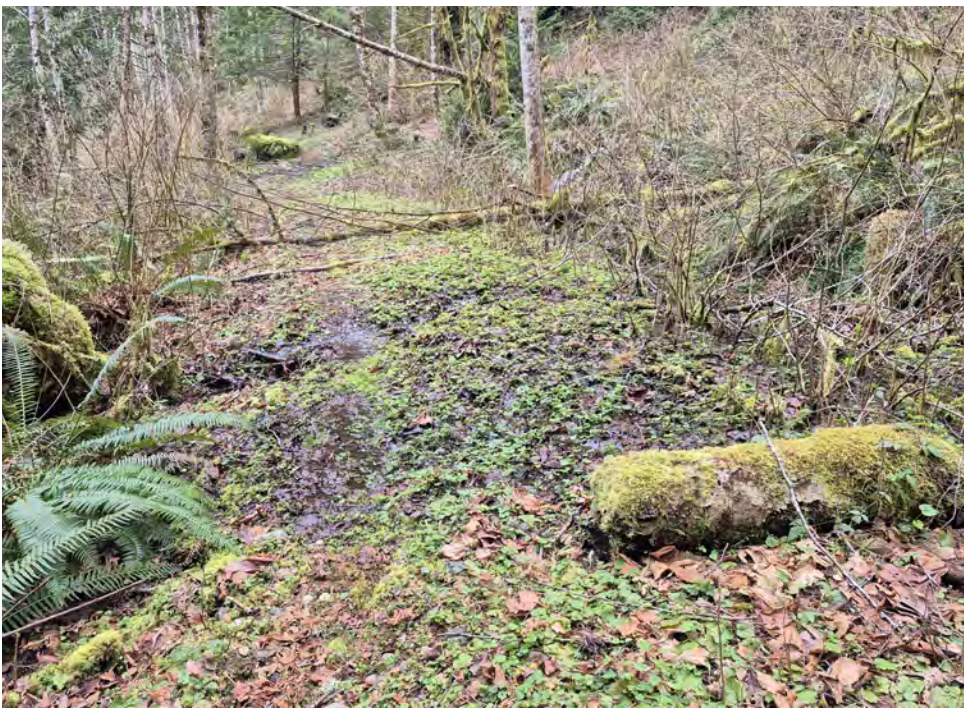
During the spring 2026 site visit, we observed woody debris and sediment causing partial blockage of the culvert inlets from about 51+00 to 51+40, which has resulted in water ponding upslope and flowing over the trail in places. Water still flowed freely through the culverts despite the partial blockage. We observed a greater degree of trail erosion due to water flowing from upslope in the vicinity of the spring boxes located near STA 49+50 (Figure 4; Photograph 5). Several pieces of black corrugated plastic pipe appear to have broken off from the culvert near STA 49+50 and are scattered in the stream below the trail.

**PHOTO5:** Ponding upslope of embankment and flow of water over embankment near culverts at STA 49+50 resulting in minor trail erosion. View to the west.

The inlets for these culverts should be inspected and cleared of blockage periodically and following storm events. Even with the inlets only partially blocked, heavy streamflow can overtop the access path and quickly erode down to the pipeline. Action should be taken to remove blockage from culvert inlets as needed. We recommend inspecting culverts in this area for damage and repairing when needed. Flow from upslope should be conveyed through culverts under the trail and should not be allowed to flow uncontrollably over the trail surface. The slopes below the culvert outlets in the vicinity of 52+00 should be monitored for ongoing erosion.

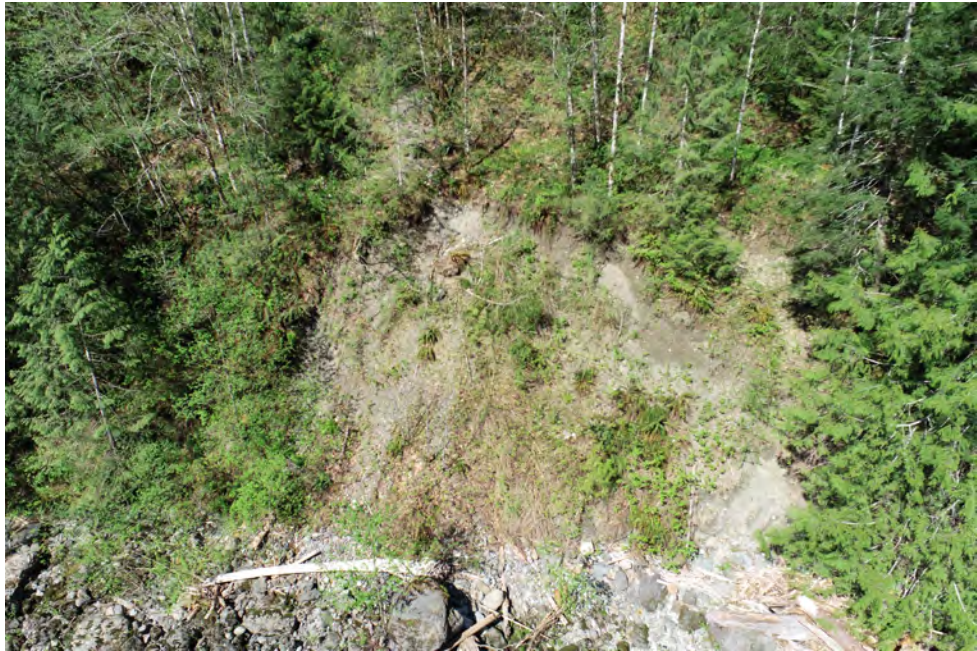
The slide that originates below the pipeline between STA 41+50 and 43+50 showed evidence of significant additional failure between autumn 2025 and spring 2026. The head scarp has receded about 5 feet since our autumn 2025 visit. In 2025, the scarp was about 16 feet below the pipeline alignment at the closest point; the scarp is now about 11 feet from the pipeline alignment. Our monitoring point AMP-04 (STA 41+80) was about 5 feet from the head scarp in autumn of 2025; the monitoring point is now less than 6 inches from the scarp (Figure 4: Photograph 4). In the near-vertical to overhanging head scarp, up to about 8 feet tall, colluvium and tree roots are exposed. The roots of several mature conifers growing at the edge of the scarp are partially exposed and the trees are now susceptible to toppling. Large tree topples can contribute to sudden and significant head scarp recession. Fresh colluvium and toppled vegetation were visible in the debris fan below the scarp (Figure 4: Photograph 3).

In our opinion, the overall hazard to the pipeline has increased at this location. The geology, geomorphology, and relative location of this slide compared to the pipeline and river are all similar to the 2017 landslide that necessitated the slope repair, and this location may warrant a similar repair in the next few years.

**PHOTO 3:** Steep slope below pipeline alignment near STA 42+50. Pipeline is about 11 feet upslope from head scarp. View from UAV to the west.

compared to our hazard assessment from previous site visits. We recommend slope stabilization treatment in this area, similar to the area around STA 37+25 that was stabilized in 2019.

We recommend that consideration be given to the design and construction of an anchored mesh slope stabilization for the area between STA 41+50 and 43+50 where the head scarp has moved several feet closer to the pipeline since our last site visit. Geosyntec plans to complete a supplemental site walk with our geotechnical engineer on the afternoon of May 28, 2026. We understand that as part of the slope stabilization construction contract, the City would like to improve or restore the access path leading out to the spring boxes at STA 56+00 so that they can be more readily accessed with small, motorized gator/side-by-side equipment for maintenance and repair. Our proposal will include evaluation and design of the slope stabilization from 41+50 to 43+50 and trail improvements out to the spring boxes near STA 56+00.

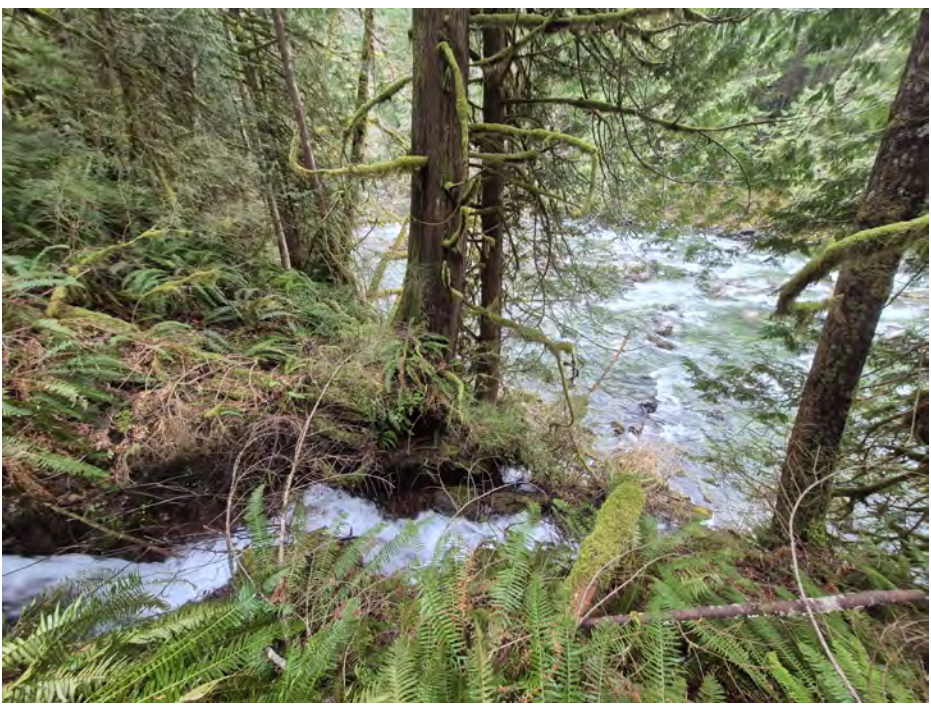
We observed a deep gulley incising into the slope downslope of the access trail near STA 52+00. This gulley is not currently posing a hazard to the pipeline but should be monitored (Figure 4; Photograph 6). The culvert outlet is about 15 feet waterward of the pipeline alignment as of spring 2026. This gulley should be monitored for ongoing erosion downslope of the trail, especially if mature tree roots become exposed or undercut. A second gulley was observed incising into the slope at the culvert outlet below the trail near STA 51+50. The overall hazard to the pipeline through this area is generally low, except in areas where the culvert inlets are blocked.

**PHOTO 6:** Gully incising into slope below trail at culvert outlet near STA 52+00. View downslope and to the southeast.
