PROJECT S 1st and St Helens Intersection Improvements
CONTRACTOR Moore Excavation Inc.
PROJECT WALK-THROUGH May 29th, 2025

PROJECT NO. R-685
DATE May 30th, 2025

PROJECT PUNCH LIST

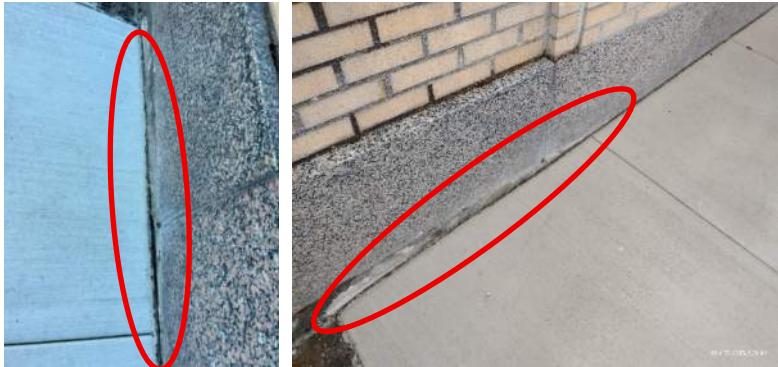
Edge of concrete and wall to Cross Fit Gym needs to be sealed with grout. Sheet 3A-4.

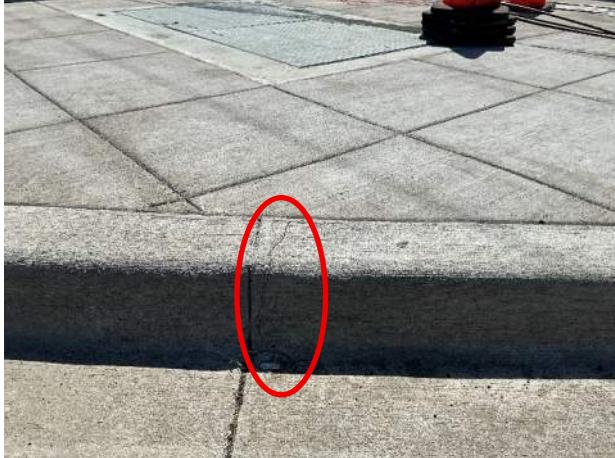
Curb section has a crack in it and needs to be replaced. Sheet 3A-2.

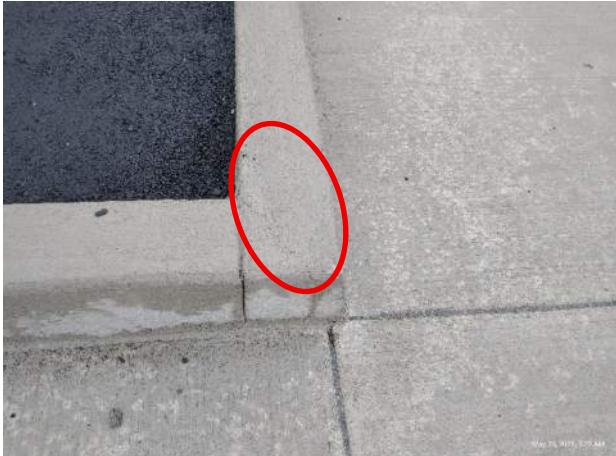
- ❑ Curb section has a crack in it and needs to be replaced. Sheet 3A-3.

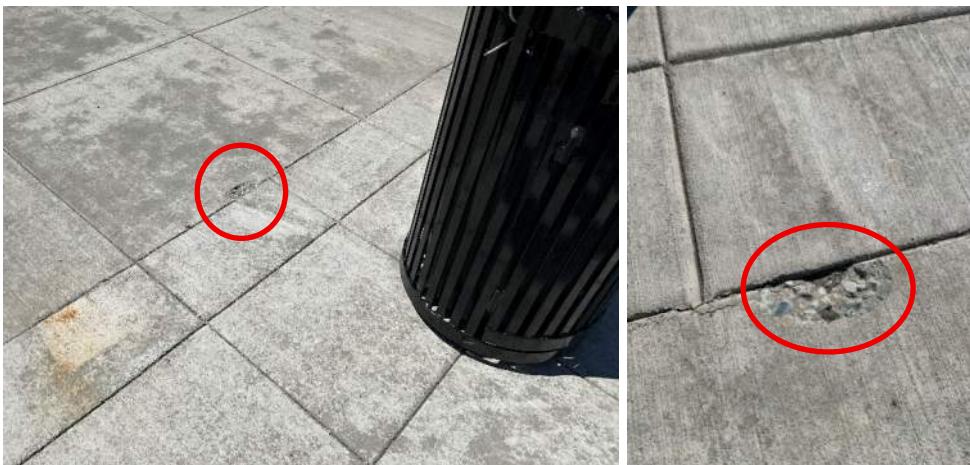
- ❑ Chunk of concrete is missing from this sidewalk section. Panel needs to be repaired with grout. Sheet 3A-2

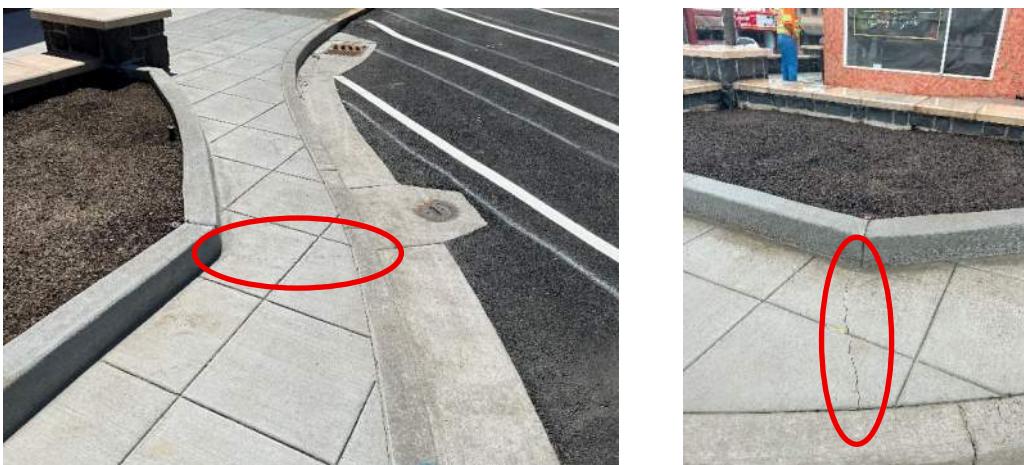
- ❑ Remove and replace concrete panels with crack heading out to curb. Sheet 3A-5.

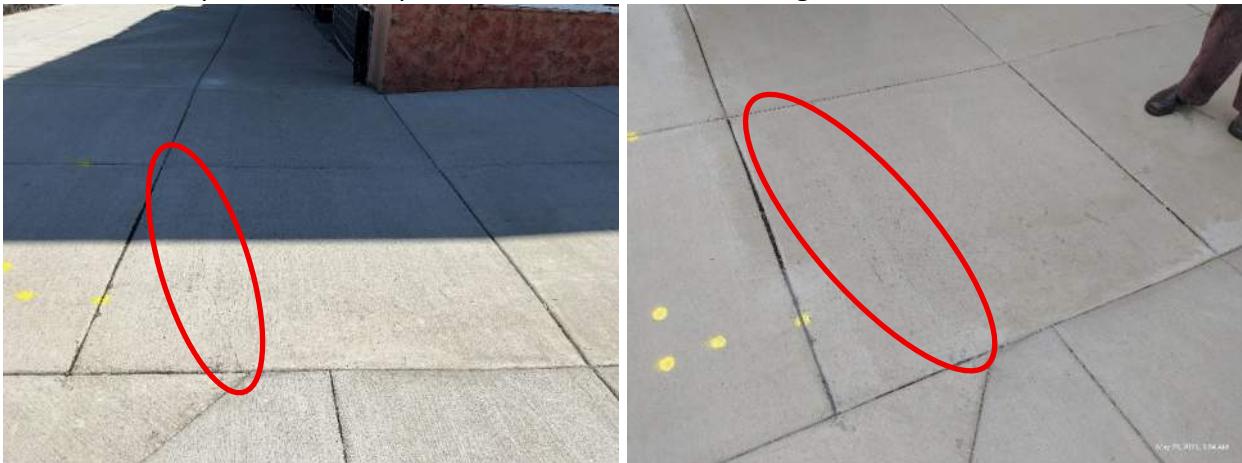
- Remove and replace concrete panels with crack at the landing. Sheet 3A-5.

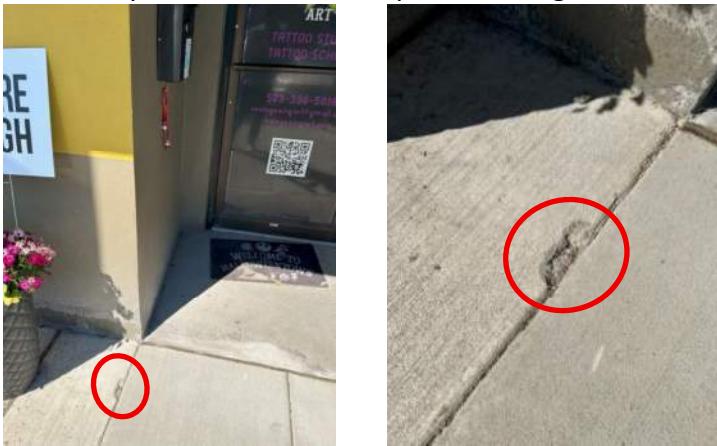
- Concrete panel needs to be repaired with grout near Tattoo Shop entrance. Sheet 3A-5.

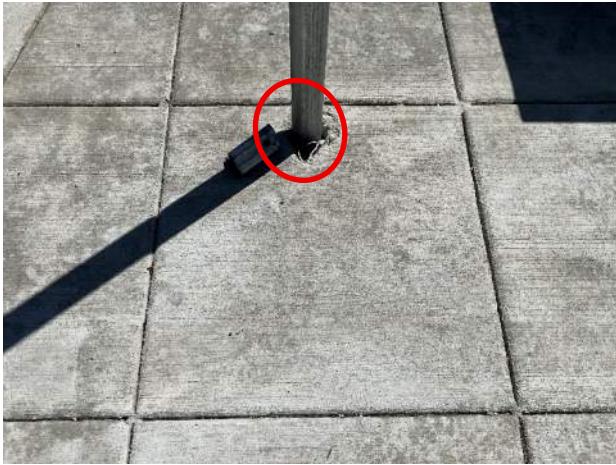
- Concrete around V-lock needs to be grouted and finished. Sheet 3A-2.

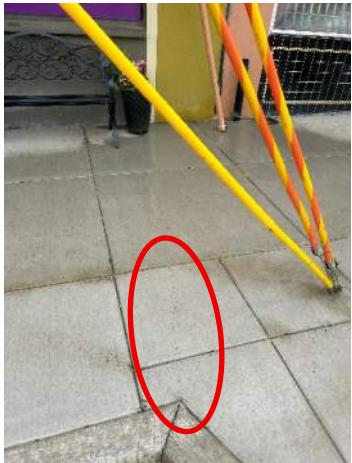
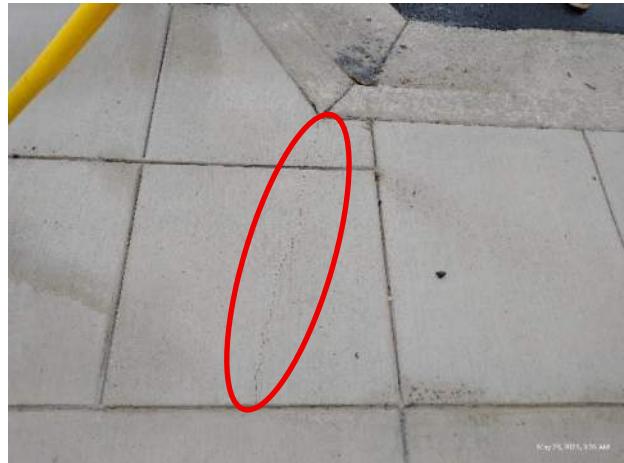
- ❑ Concrete panels with cracks need to be replaced near guywire. Sheet 3A-5.

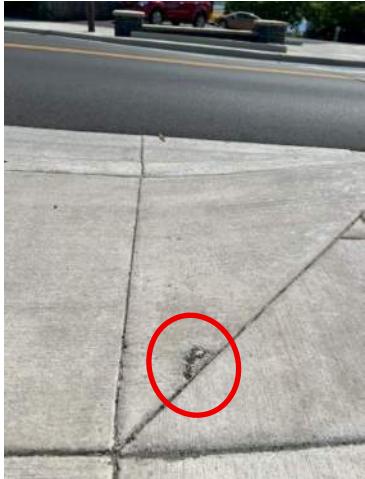
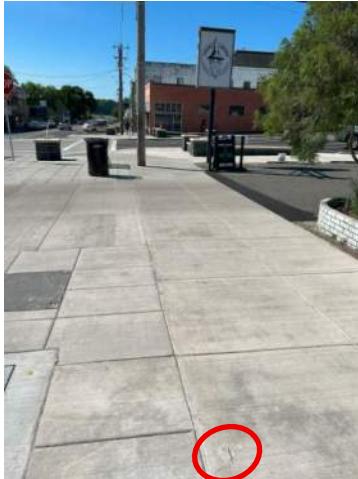
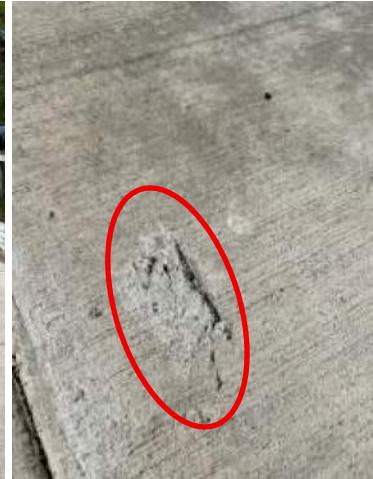
- ❑ Concrete panels needs to be repaired with grout near Gnome Grown driveway. Sheet 3A-2.

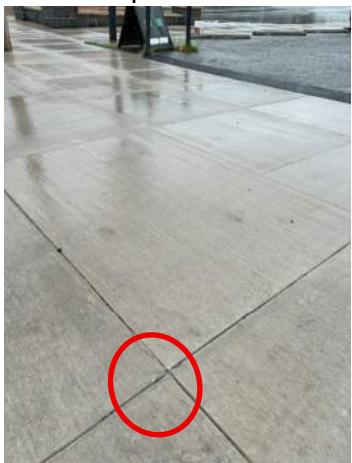
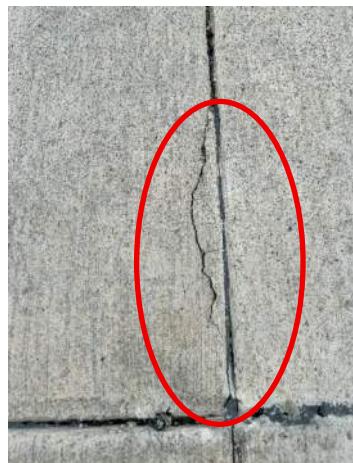
- ❑ Concrete panel needs to be replaced near Gnome Grown driveway. Sheet 3A-2.

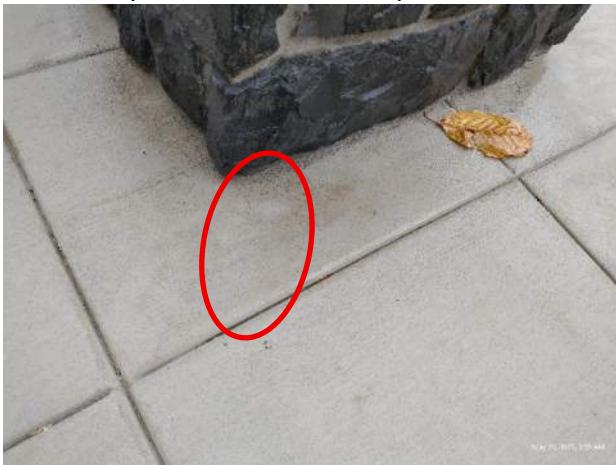
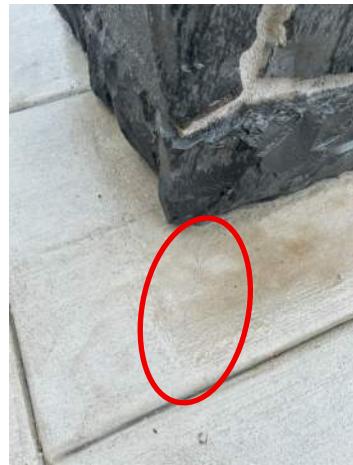
- ❑ Concrete panel needs to be replaced near Planter E south column. Sheet L1.01.

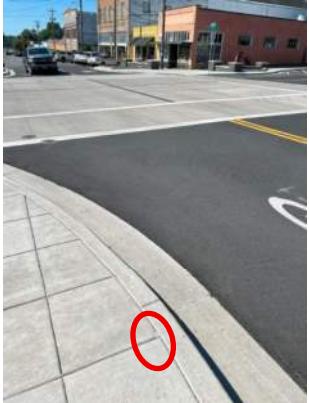
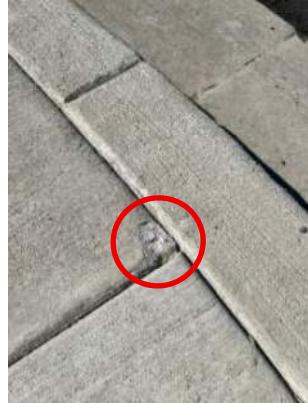
- ❑ Concrete panel needs to be repaired with grout on the Northeast Quadrant. Sheet 3A-3.

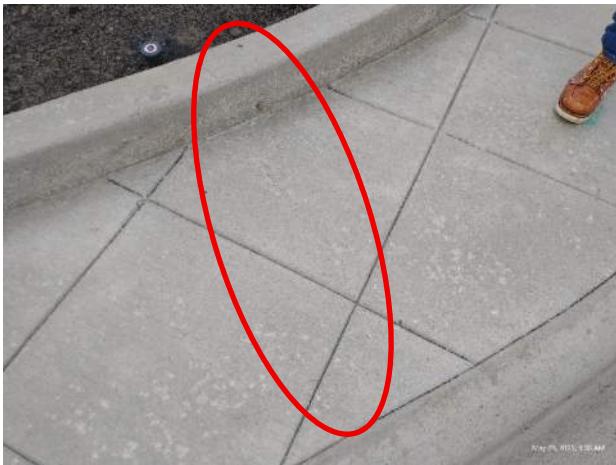
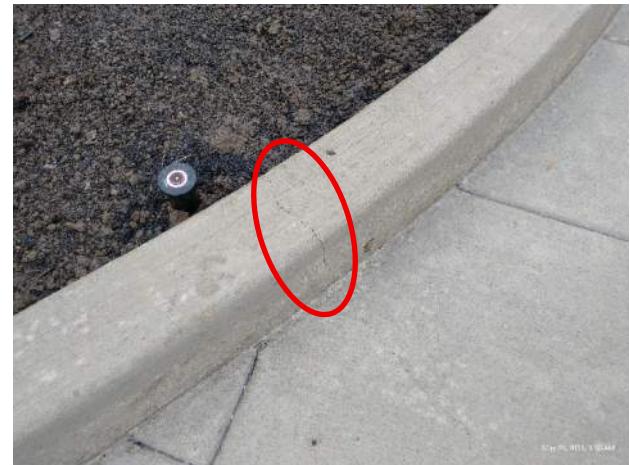
- ❑ Concrete panels and curb with cracks need to be replaced at Planter A. Sheet 3A-3.

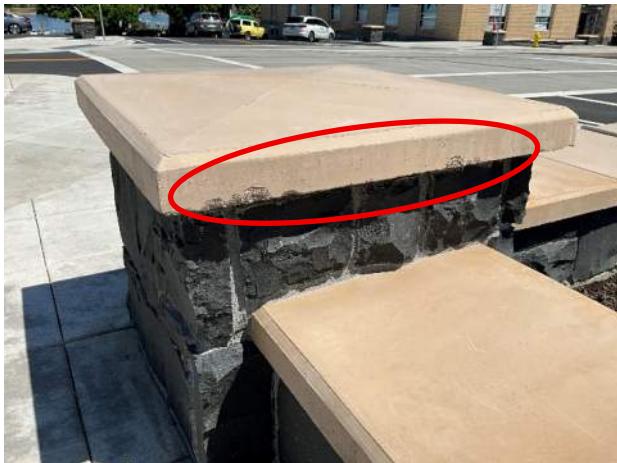
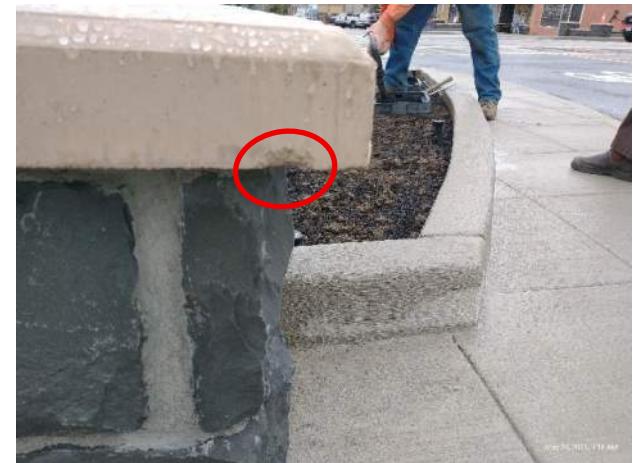
- ❑ Repair damage to precast cap for Planter D and Planter A. Sheet L4.01.

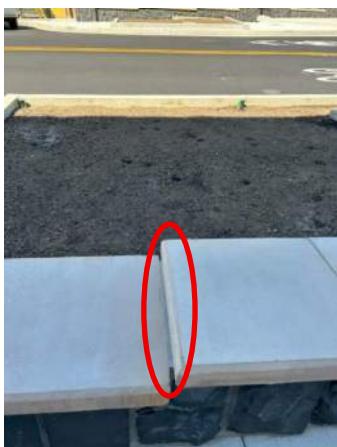
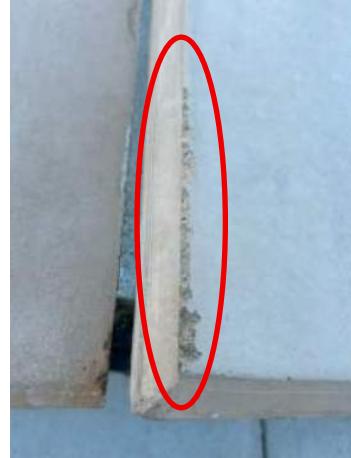
- ❑ Repair damage to precast cap edge for Planter A. Sheet L4.02.

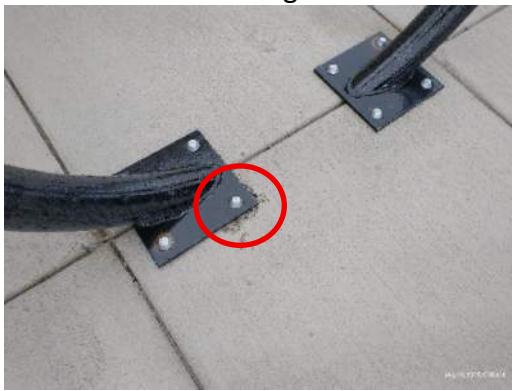
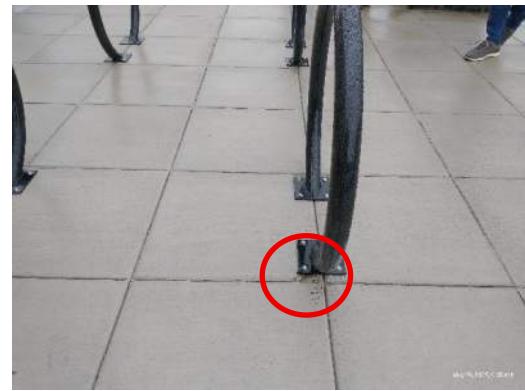
- ❑ Grout concrete damage near the bike racks where the bolts were drilled in. Sheet L1.01.

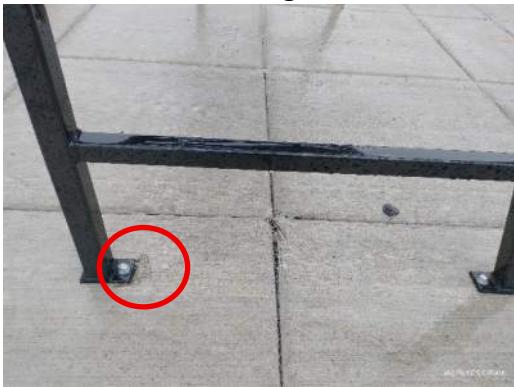
- ❑ Grout concrete damage near the bench where the bolts were drilled in. Sheet L1.01.

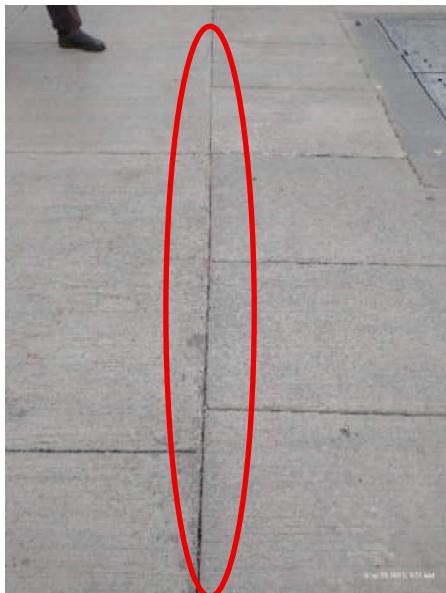
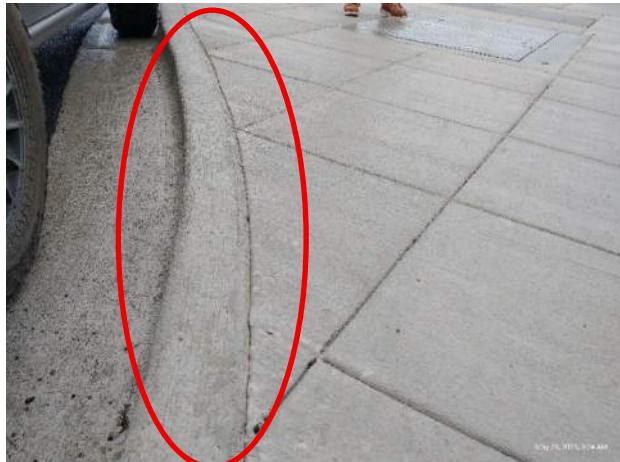
- ❑ Excess concrete between pours has spilled over this joint and along the curb section and needs to be removed and cleaned near the Gnome Grown walkway area. Sheet 3A-2.

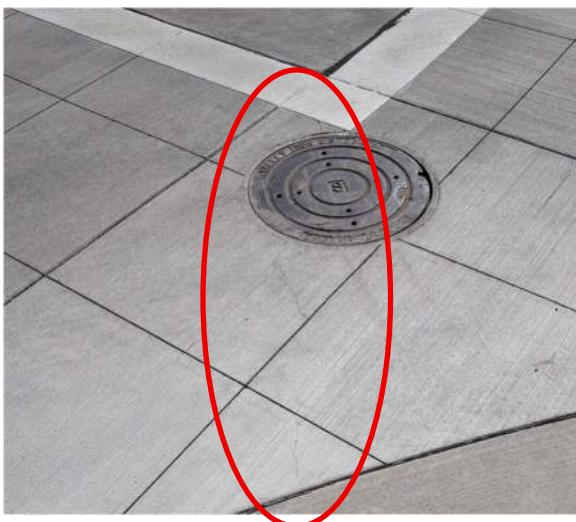
- ❑ Concrete panels with cracks need to be replaced. Sheet 3A-3

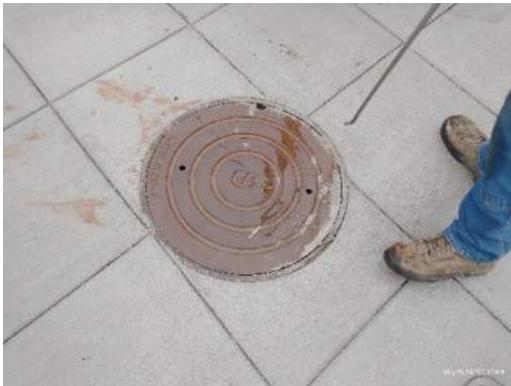
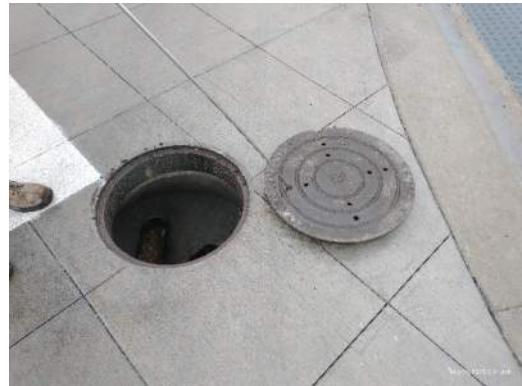
- Swap out sanitary manhole lid for a storm manhole lid with more holes at MH2. Clean up concrete that has spilled onto the lid. Swap storm lid for sewer lid at Keynote 16. Sheet 3.

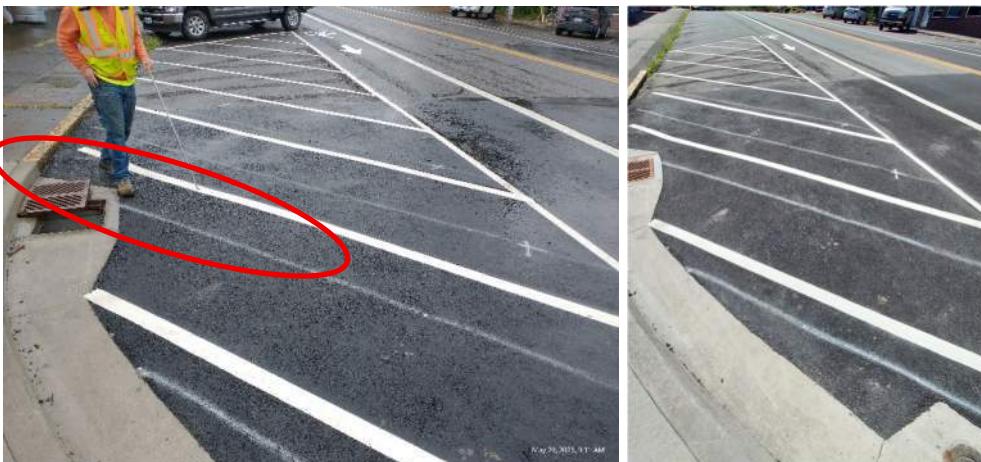
- Remove temporary paint marks on the asphalt used for striping layout.

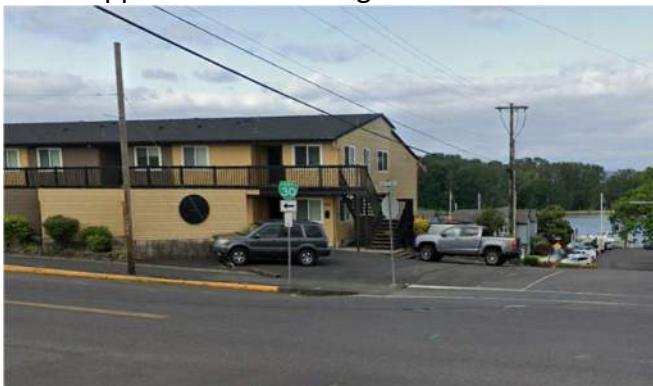
- Reinstall US30 sign at the Northeast Quadrant. See Sheet SS-1. US30 Sign has been installed, but arrow appears to be missing.

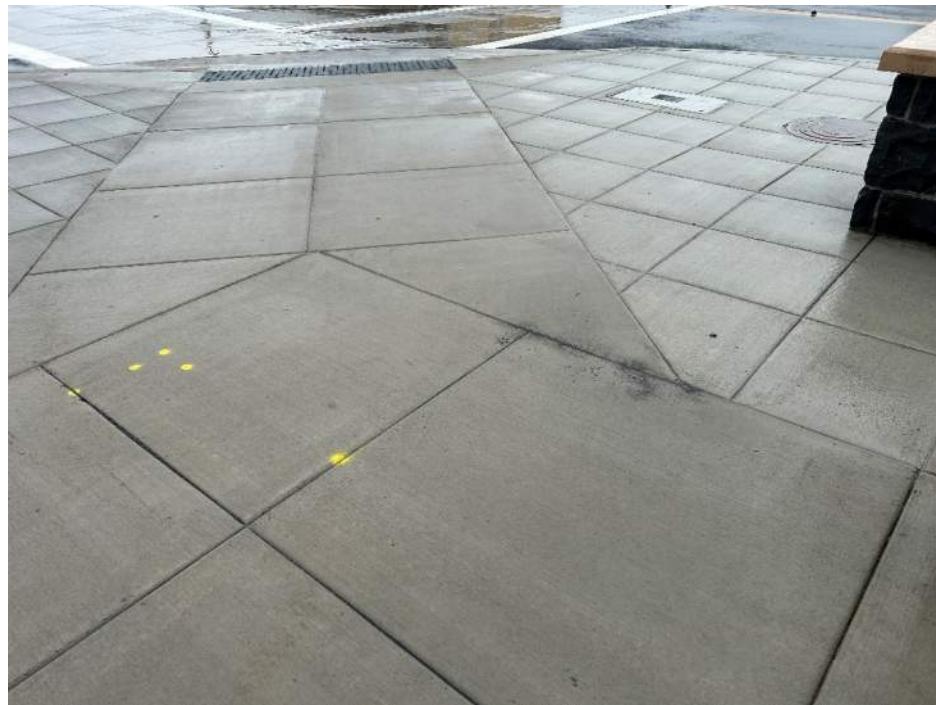
SW corner – Low spot that is collecting ~1/2" of water

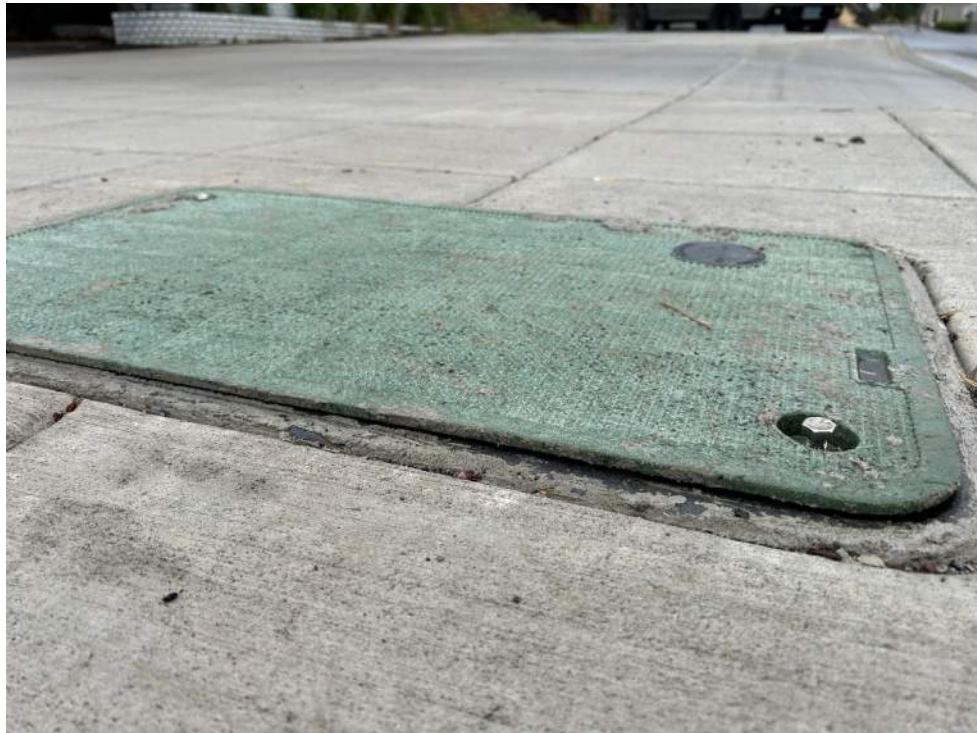
NW Corner – Communication junction box lid has a lip

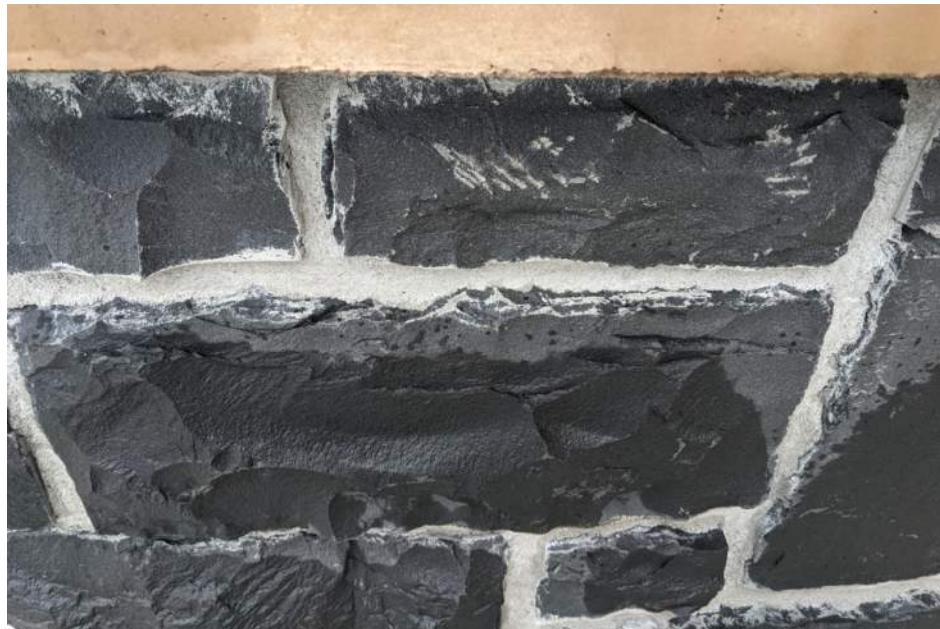
All walls/columns – there is excess grout on most stone veneer that needs to be removed.

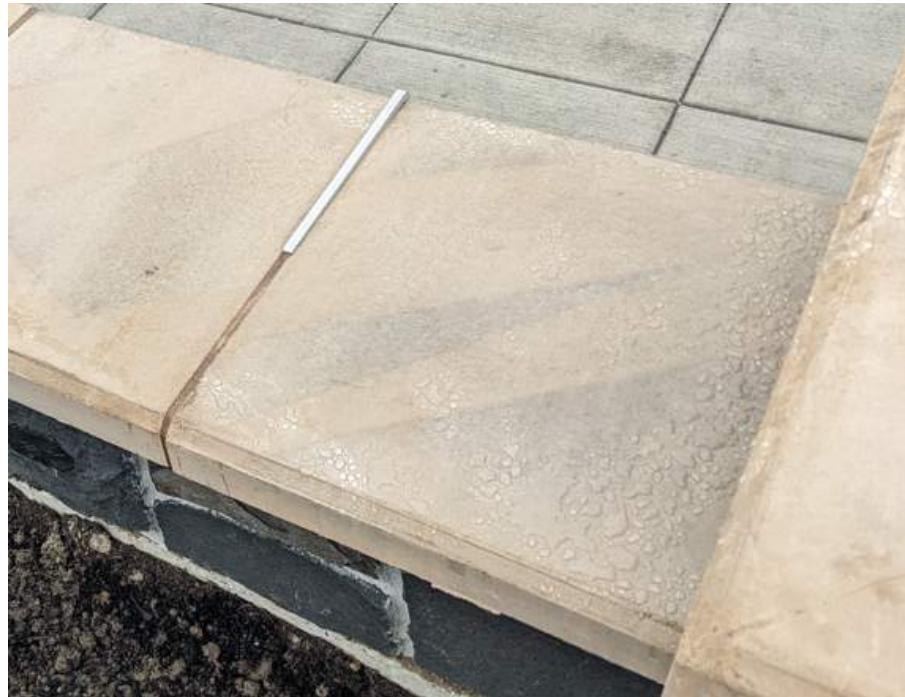
a. Planter D:

All walls/columns - the precast caps have inconsistent color. Some are streaked or otherwise inconsistent within the cap, and some have solid color that varies from the others. Examples (not all instances) are shown below.

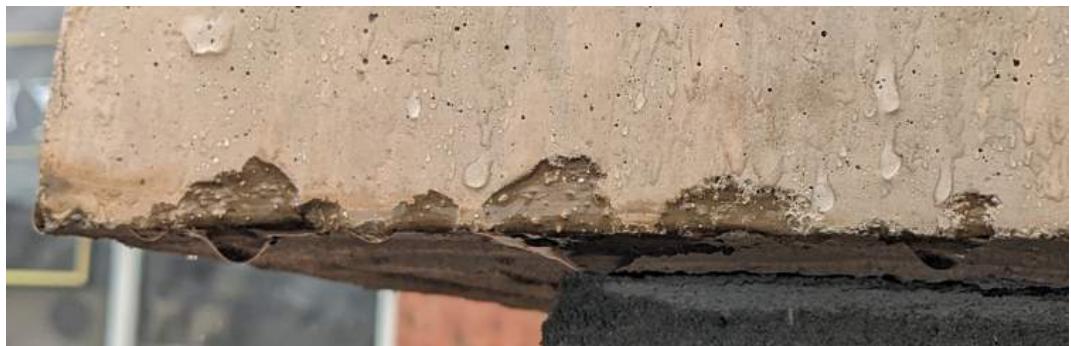
a. Planter C:

All walls/columns – there are discolorations/streaks/smudges on many of the caps which appear to be excess pigment used to color the caps. These discolorations (plus the color variations in item 9) seem to indicate that a surface-applied color stain was used, instead of integral color in the concrete mix as specified in 0596C.17-e. Further, 48 oz. of “dye” was indicated in the precast mix design in Submittal 060.2 (no surface applied stain was submitted). Surface stain would be indicated by a gray interior in the caps broken by light pole installation – ignore surface chips, which may have predated the stain, or been touched up later. If the caps have a surface stain, they should be replaced with integral color caps, or a credit provided to the City for the cost difference. If the caps are not replaced, the discolorations need to be cleaned off. Examples (not all instances) are shown below. [**Cracked caps to be replaced per directive issued 8.28.2025**](#)

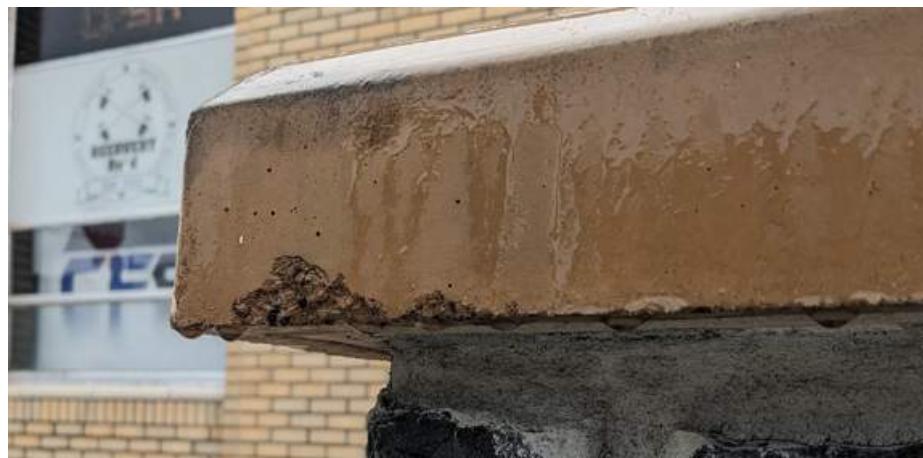
Most walls/columns – there are many chips in the precast caps, that need to be repaired with color-matched mortar. Examples (not all instances) are shown below.

- a. Planter B: [Cracked caps to be replaced per directive issued 8.28.2025](#)

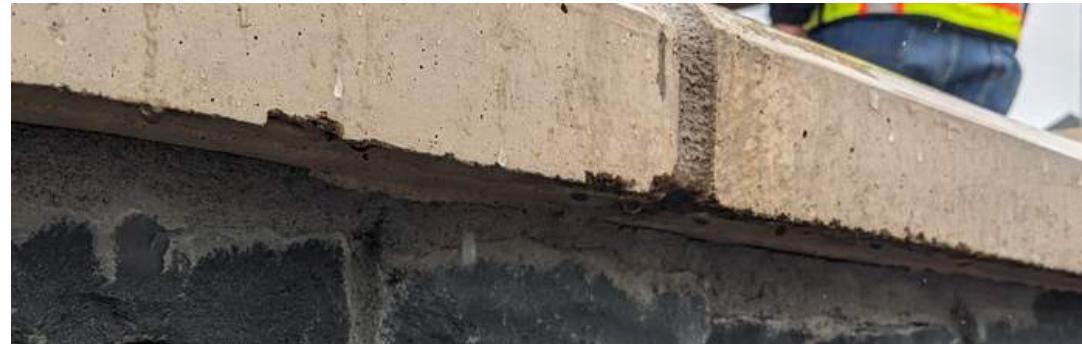
All walls/columns – the precast caps have sharp, rough as-cast lower edges, instead of the 1/8" bottom chamfer called out in detail 3/L4.00 and 0596C.17-F-1. The chamfer would have prevented much of the chipping seen along the lower edges.

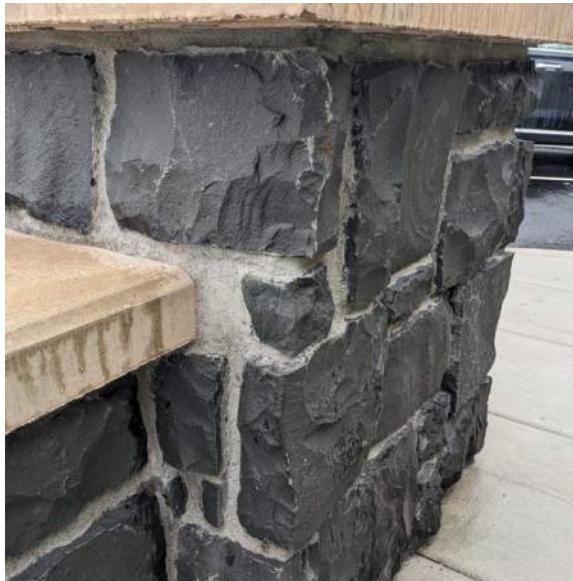
Planter E – the wide grout joint shown below is well outside the specified width range, reference 00596C.44-e.

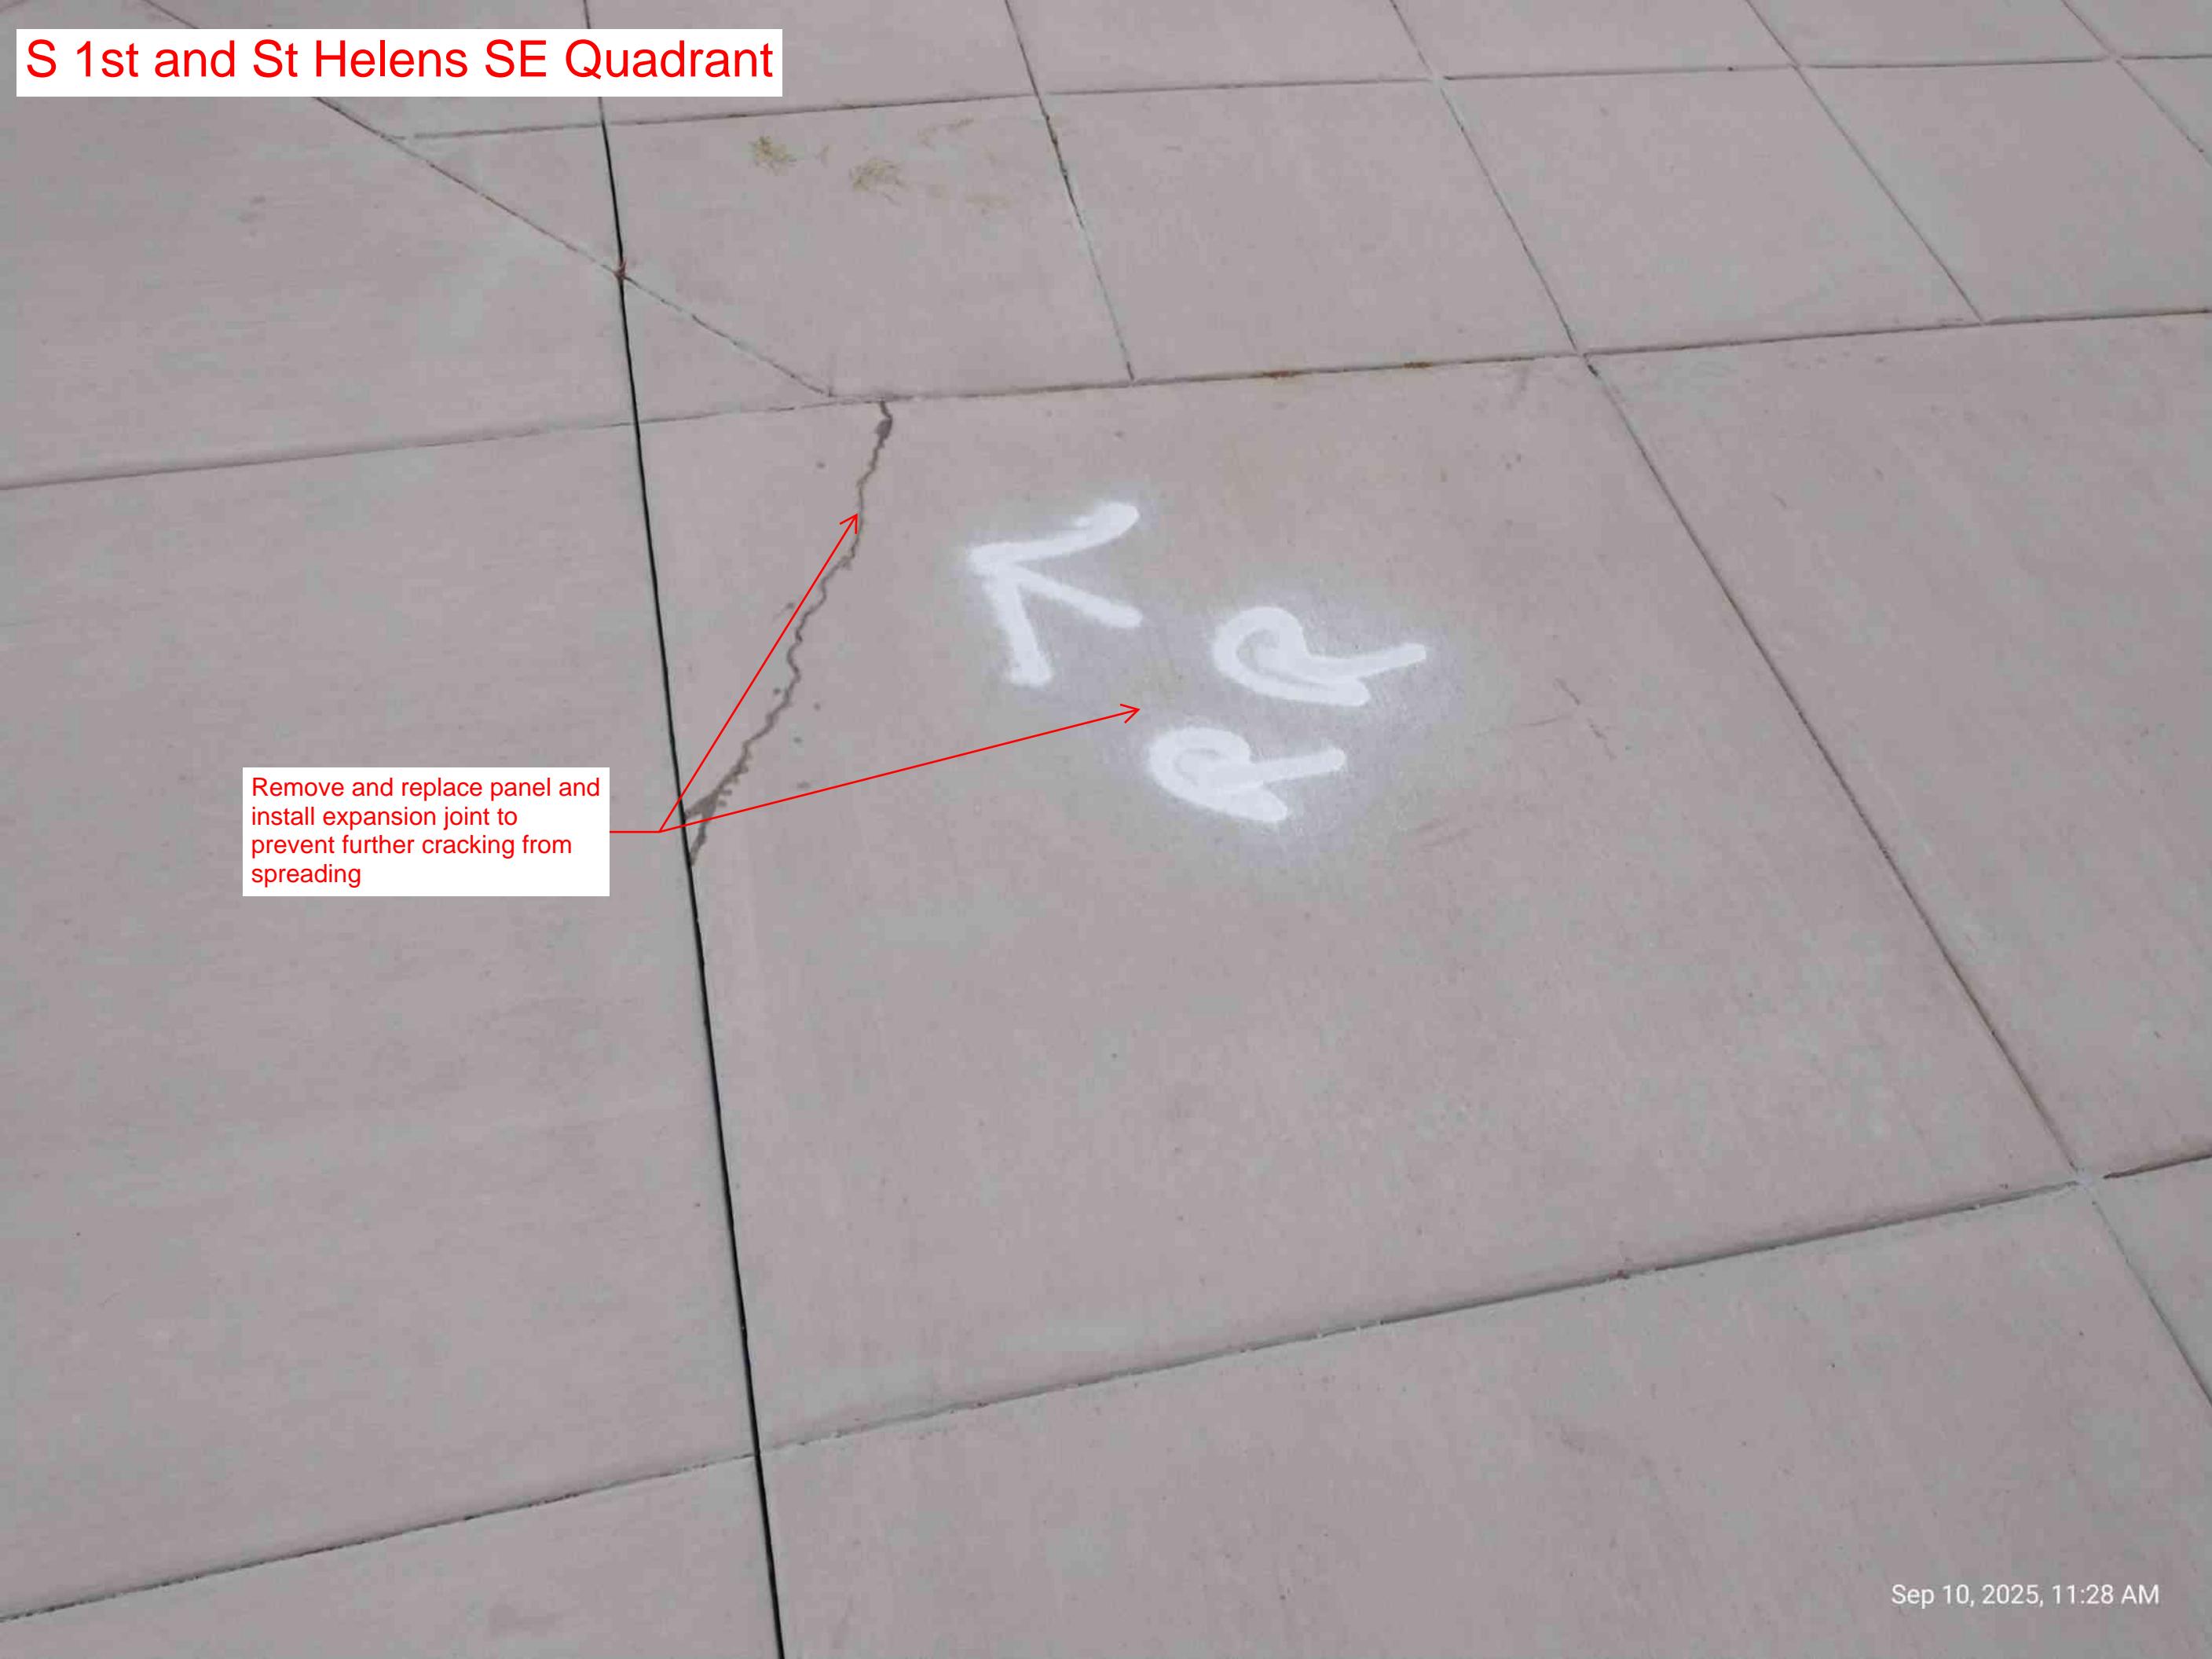
S 1st and St Helens SE Quadrant

Remove and replace panel and
install expansion joint to
prevent further cracking from
spreading

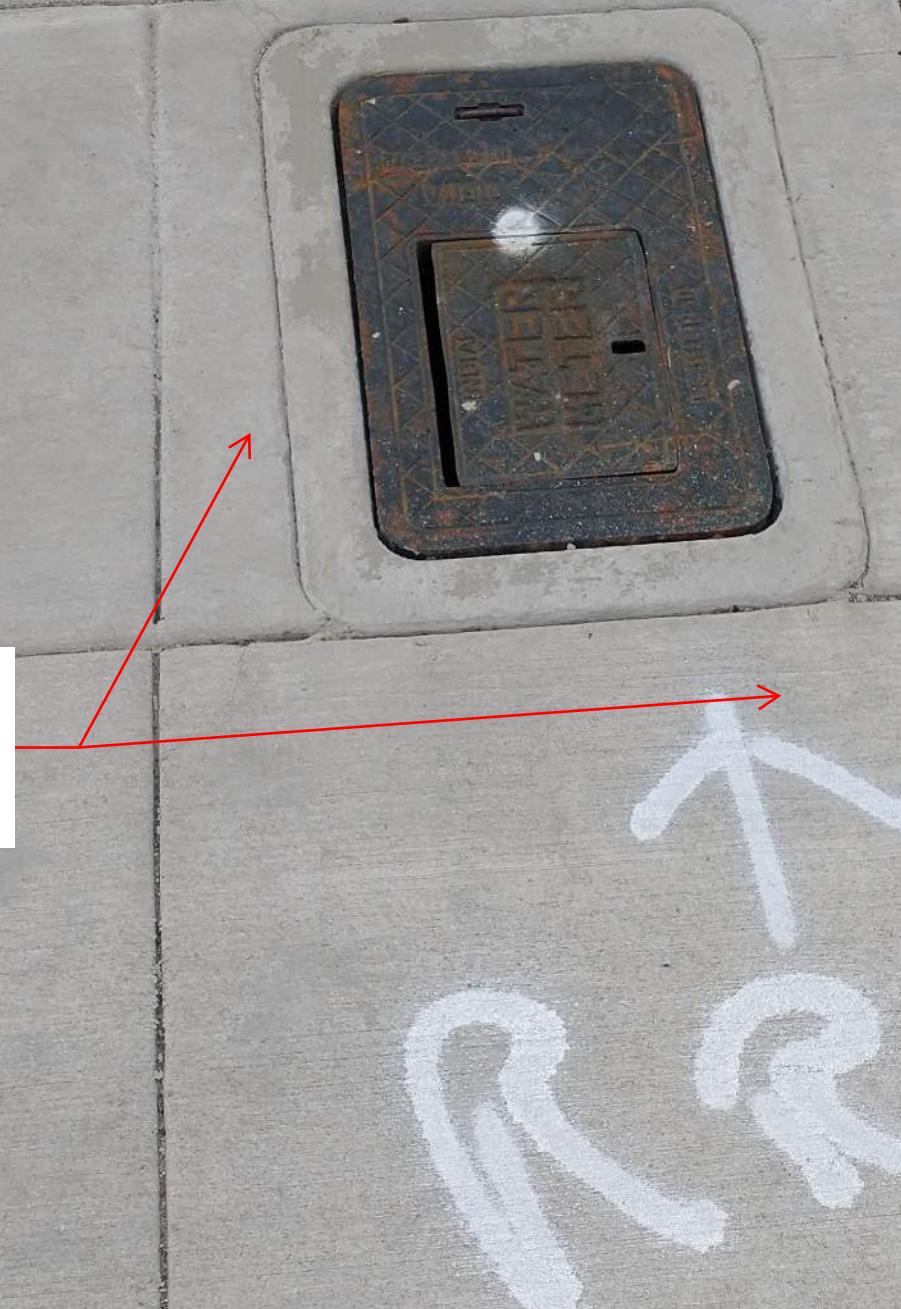
S 1st and St Helens NE Quadrant

Remove and replace panels and install expansion joint around water meter box to prevent further cracking from spreading

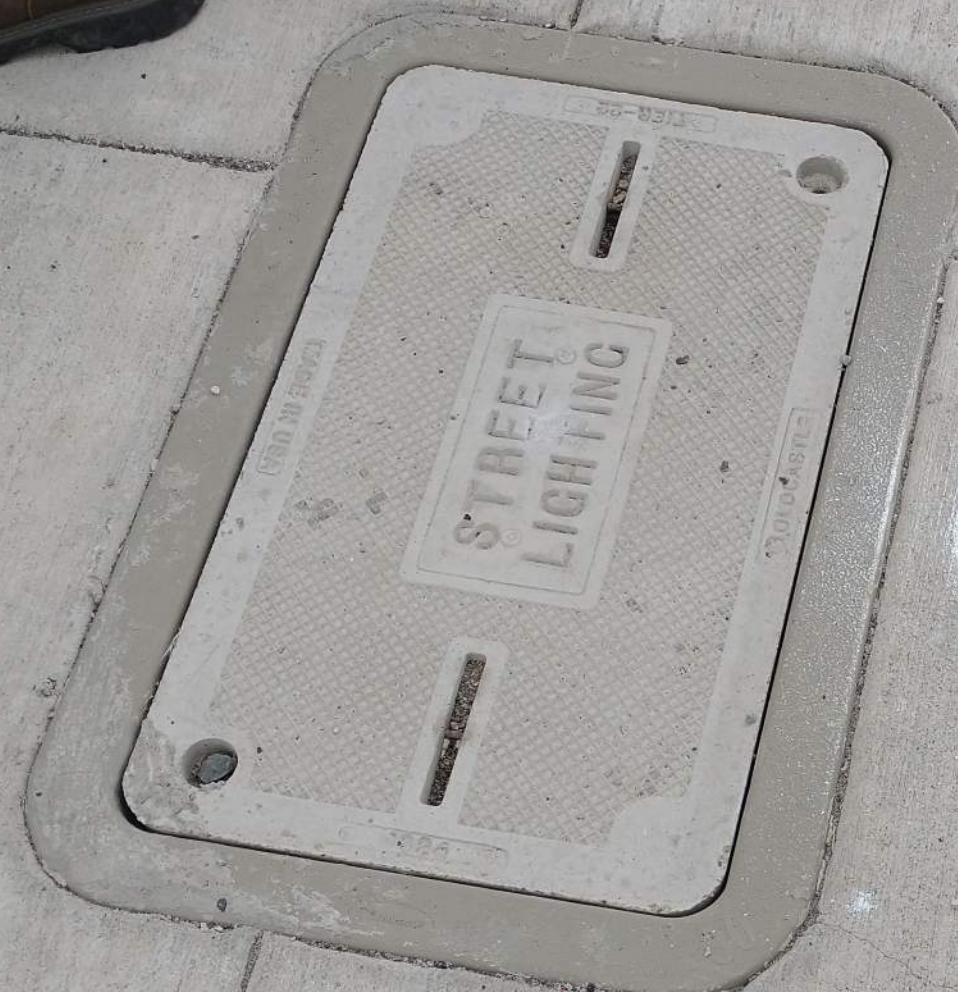
S 1st and St Helens NE Quadrant

Remove and replace panel and
install expansion joint around
street lighting box to prevent
further cracking from spreading

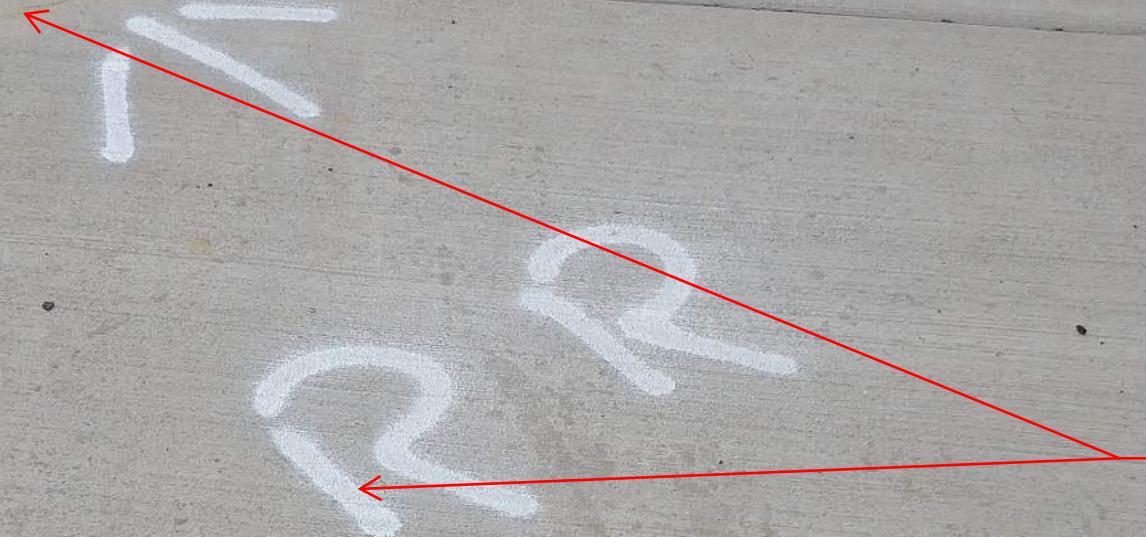
S 1st and St Helens NW Quadrant

Remove and replace panel and
install expansion joint to
prevent further cracking from
spreading
