PROJECT S 1st and St Helens Intersection Improvements
CONTRACTOR Moore Excavation Inc.
PROJECT WALK-THROUGH May 29th, 2025

PROJECT NO. R-685
DATE May 30th, 2025

PROJECT PUNCH LIST

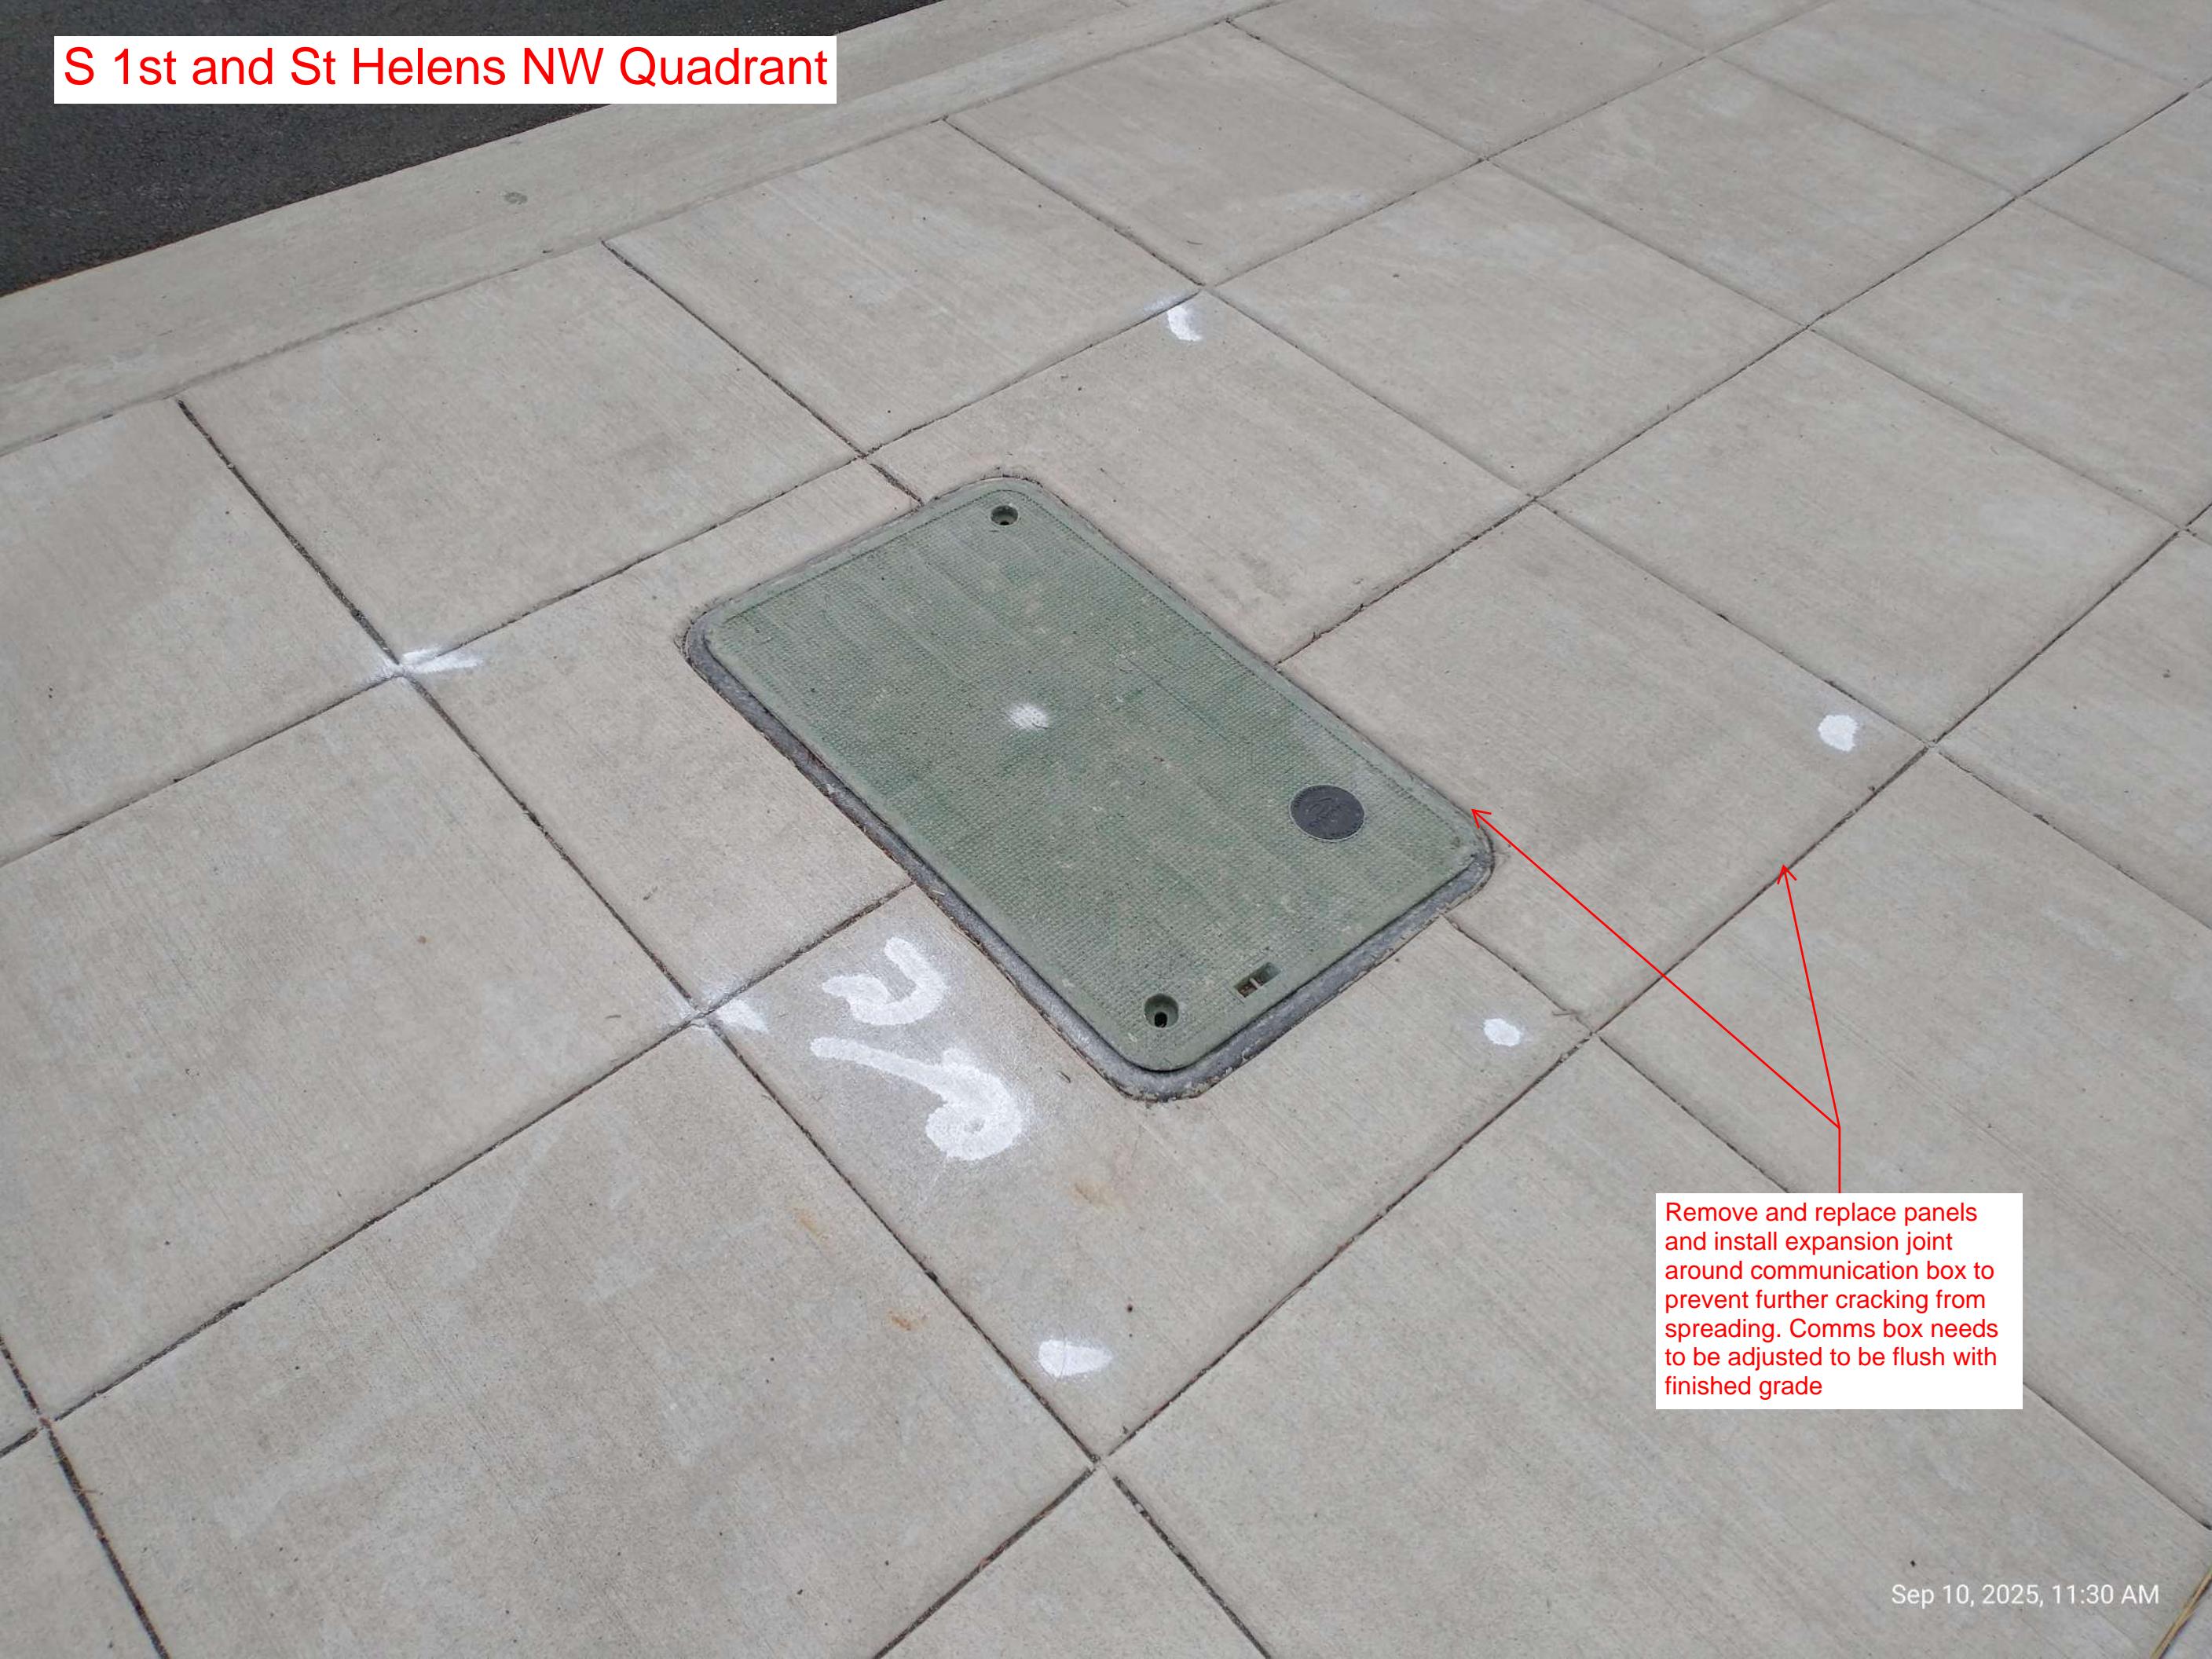
S 1st and St Helens NW Quadrant

Remove and replace panels and install expansion joint around communication box to prevent further cracking from spreading. Comms box needs to be adjusted to be flush with finished grade

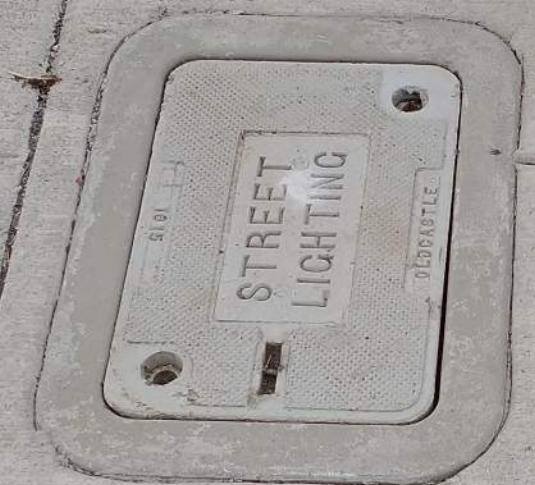
S 1st and St Helens NW Quadrant

Remove and replace panel and
install expansion joint around
street lighting box to prevent
further cracking from spreading

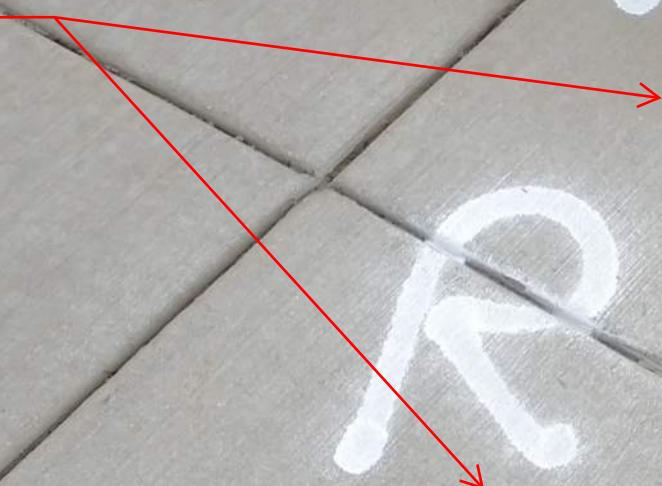
S 1st and St Helens SW Quadrant

Remove and replace existing panels. Install expansion joints to prevent further cracking

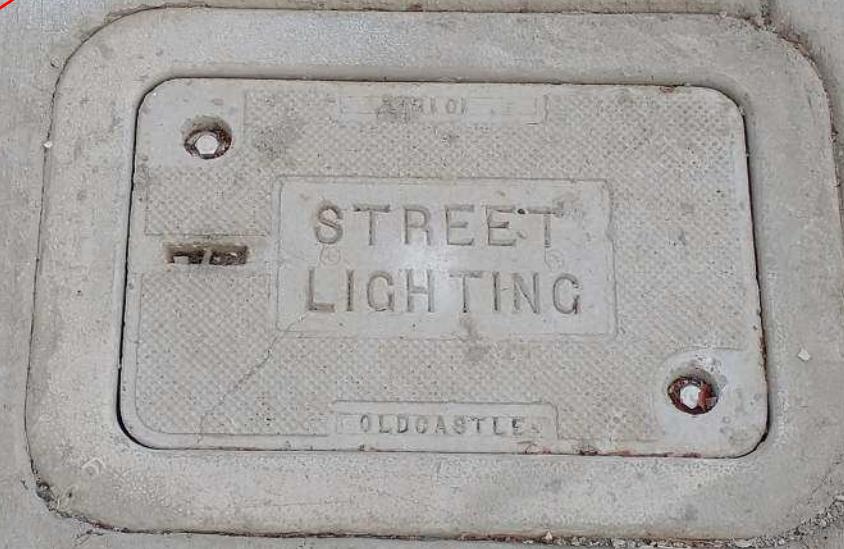
S 1st and St Helens SW Quadrant

Remove and replace panel and install expansion joint around street lighting box to prevent further cracking from spreading
