ADMINISTRATIVE COMMENT

Re: Dove Park Estates Subdivision Extended Warranty Obligation - \$66,616.00 - Letter of Credit #679

Re: Money Hill Plantation Subdivision, Phase 7B-1 Extended Warranty Obligation - \$57,100.00 - Letter of Credit

Re: River Club Subdivision, Phase 2A Extended Warranty Obligation - \$35,900.00 - Letter of Credit #703

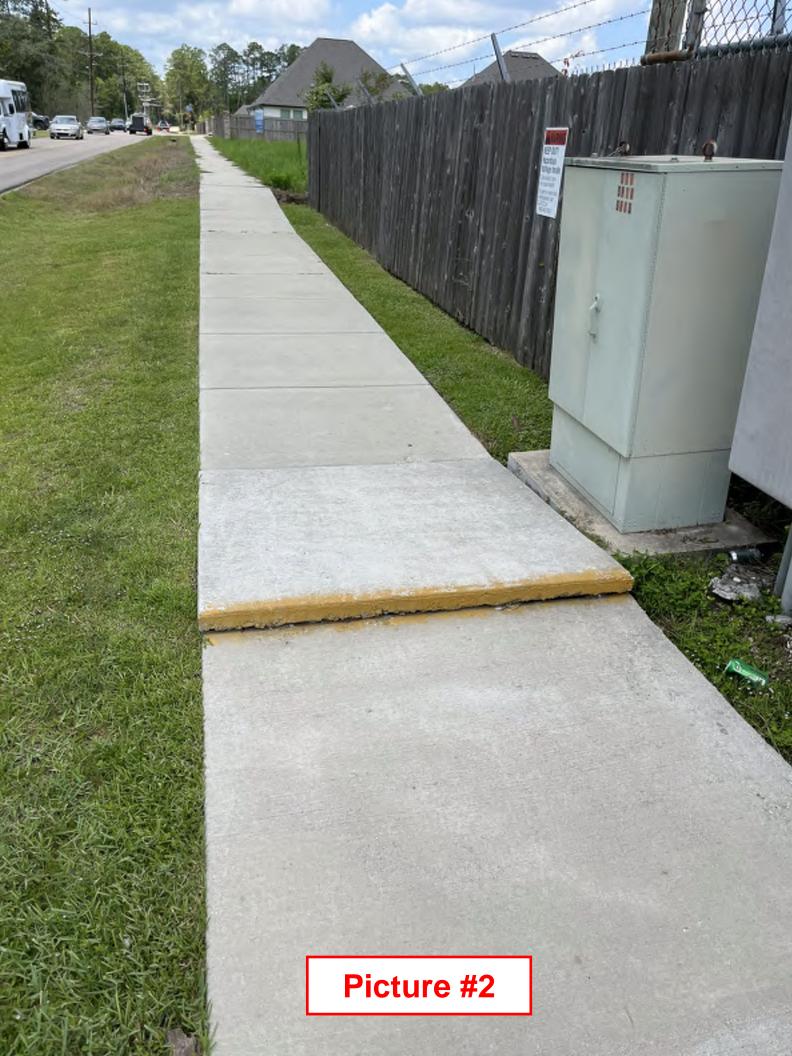
Picture #3

- 1. Replace/Repair all damaged and broken concrete curbing throughout the development (See picture #1 Typical Comment);
- 2. Replace the broken and damaged sidewalk sections within the Dove Park Road Right-of-Way leading to the Tammany Trace (See pictures #2 & #3);

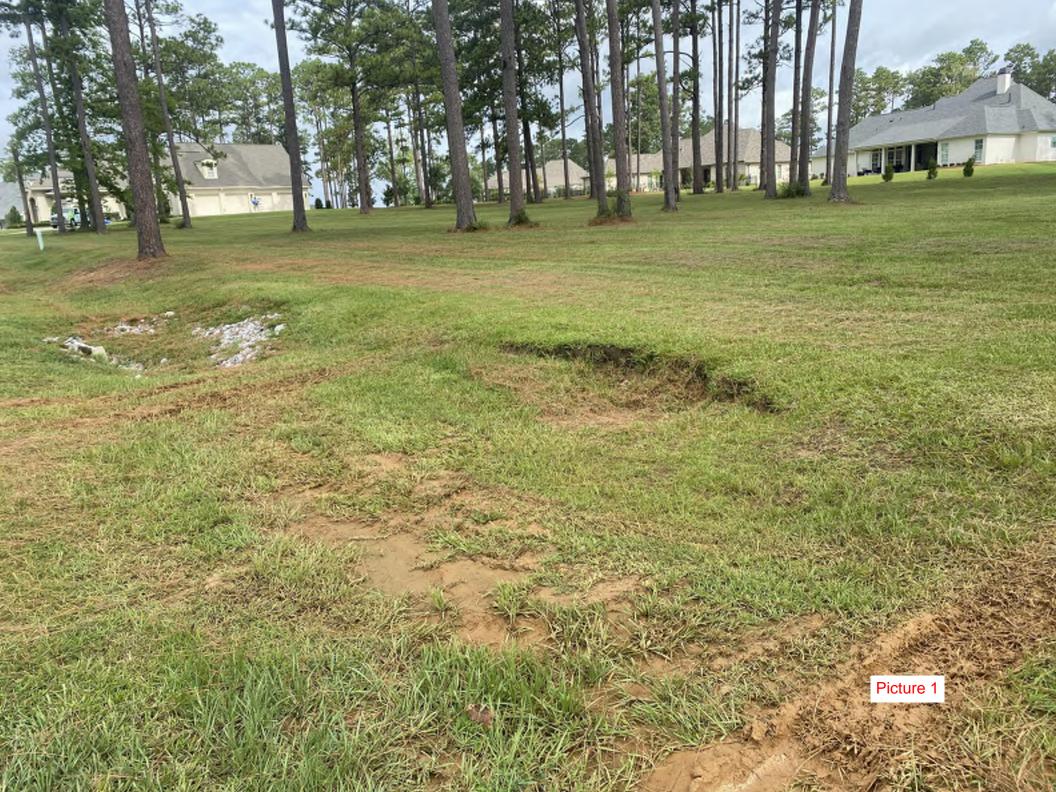
- The roadside ditches located in the vicinity of Lot #423 through #425 are silted in and the side slopes are eroding. Roadside ditches need to be regraded to provide positive flow and should be properly vegetated once regraded and proper erosion control measures installed and maintained until vegetation is established (See pictures #1 - #3);

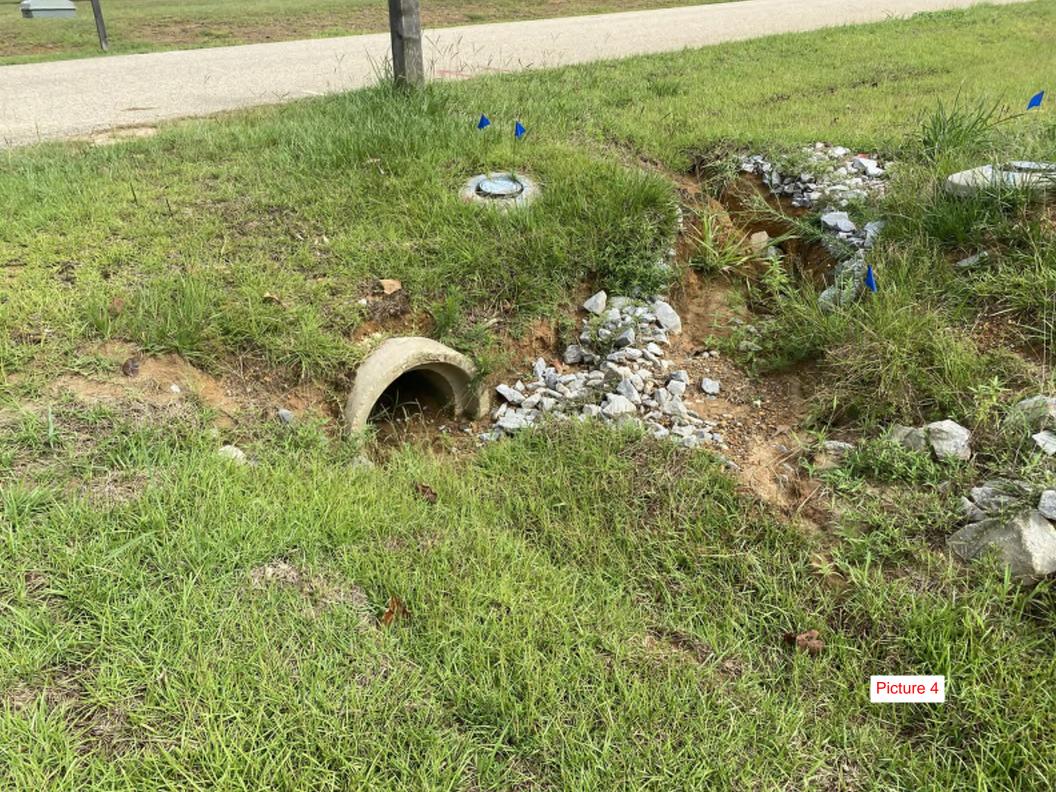
- 2. The cross culvert under Hidden Lake Lane is silted in and needs to be corrected (See picture #4);
- 3. The pond inflow pipe located in the vicinity of Lot #413 is holding water due to erosion and needs regrading and rip rap at the downstream side to provide positive flow and prevent erosion (See pictures #5);

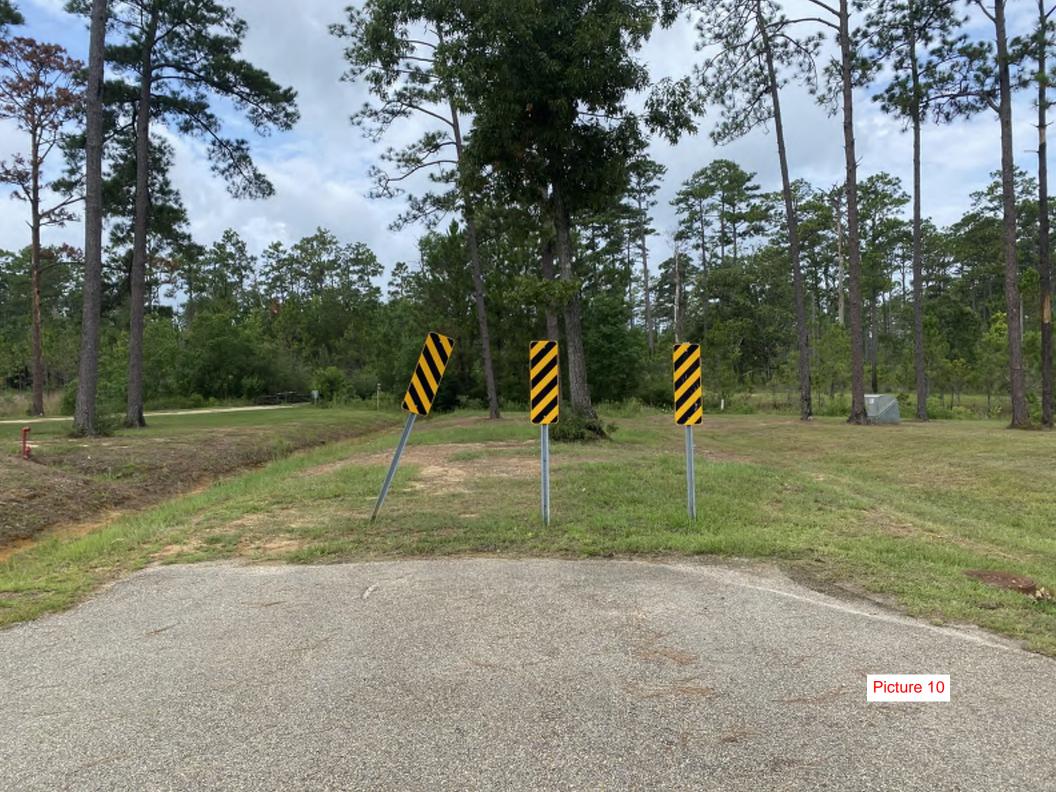
- 5. Replace blue reflectors in the vicinity of fire hydrants where missing (Typical Comment);
- 6. Replace/Repair the end of roadway signage located in the vicinity of Lot #407 (See picture #10);

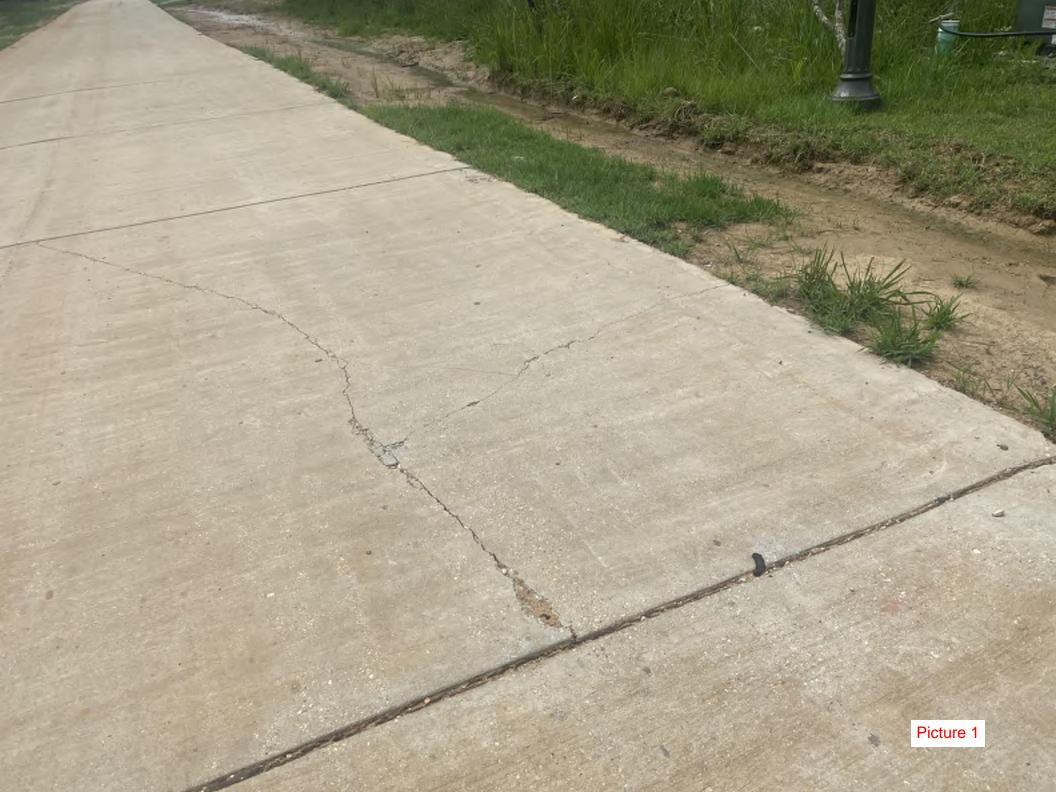
- 1. The concrete panel in front of Lot #180 is broken and needs to be replaced (See picture #1);
- 2. Concrete joints need to be cleaned and repaired throughout this phase of River Club Estates (See picture #2 Typical Comment);

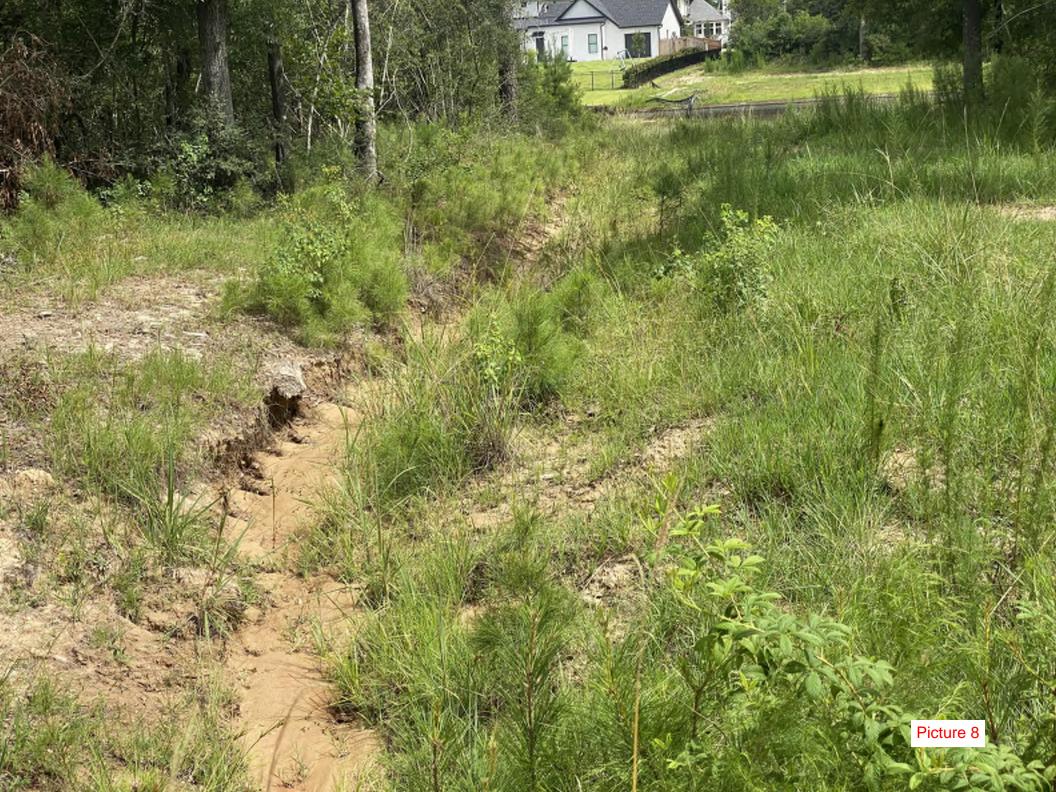
- 6. The temporary ditch located between Lots #123 & #124 should be properly vegetated and proper erosion control measures installed and maintained until vegetation is established (See picture #8);

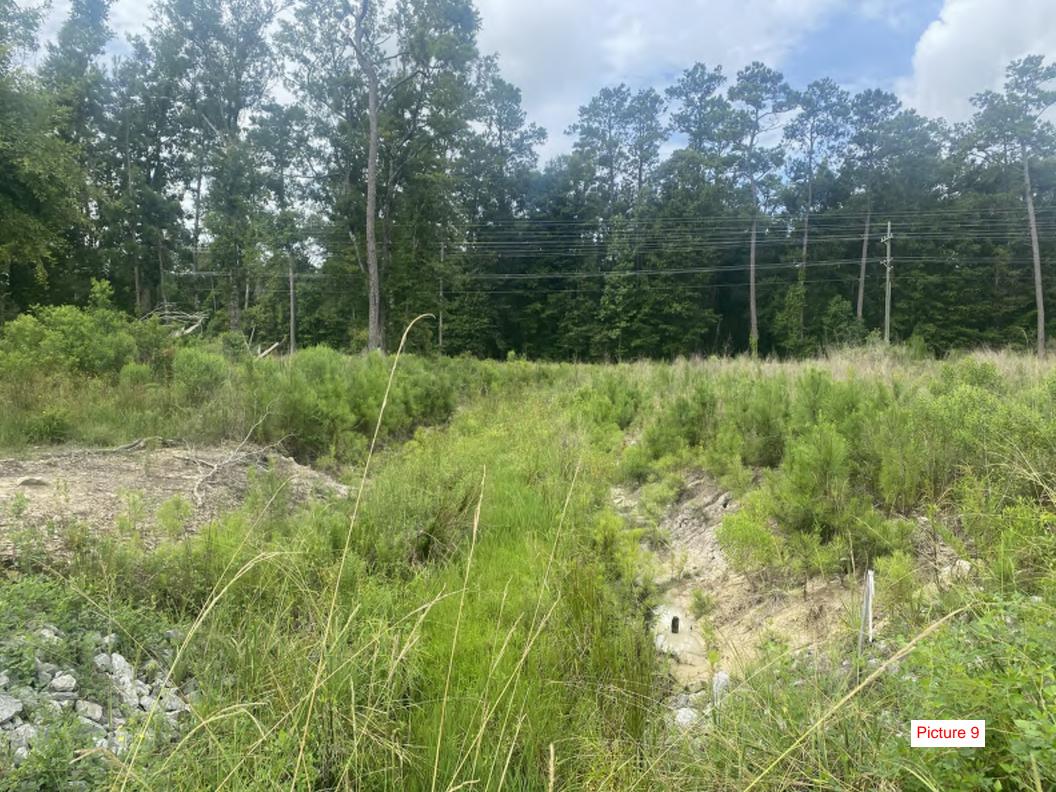
- The side slopes of the ditch located within Parcel B needs to be re-established and should be properly vegetated and proper erosion control measures installed and maintained until vegetation is established. (See picture #9);

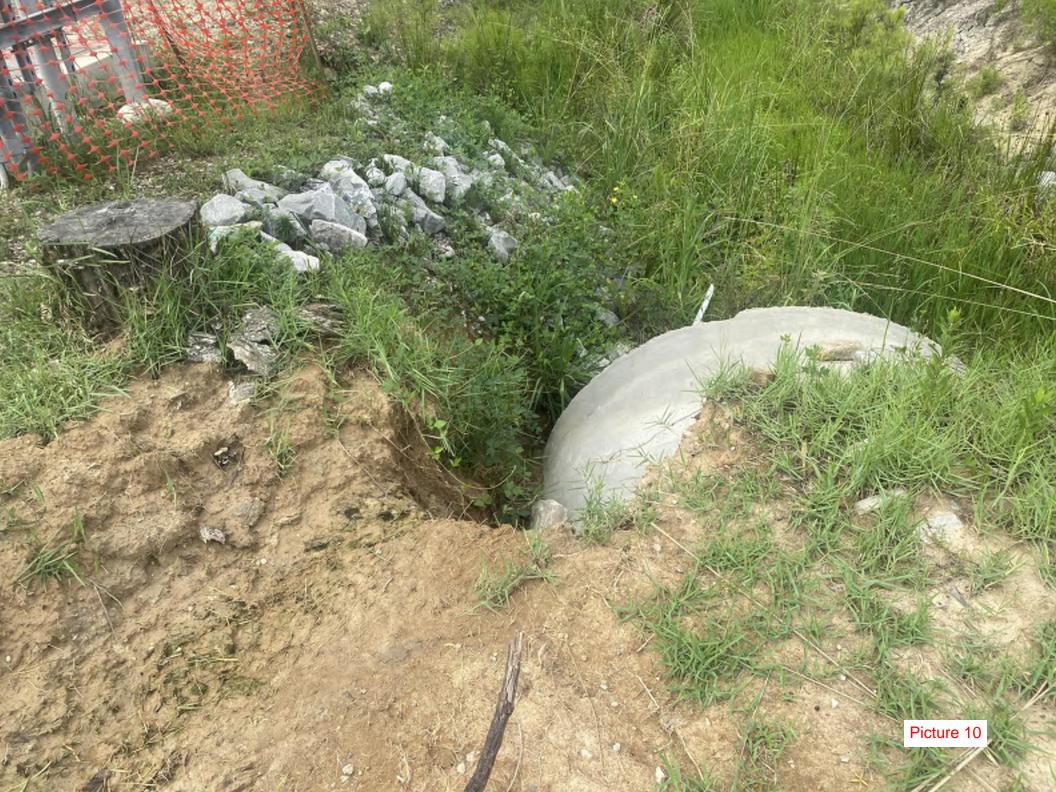
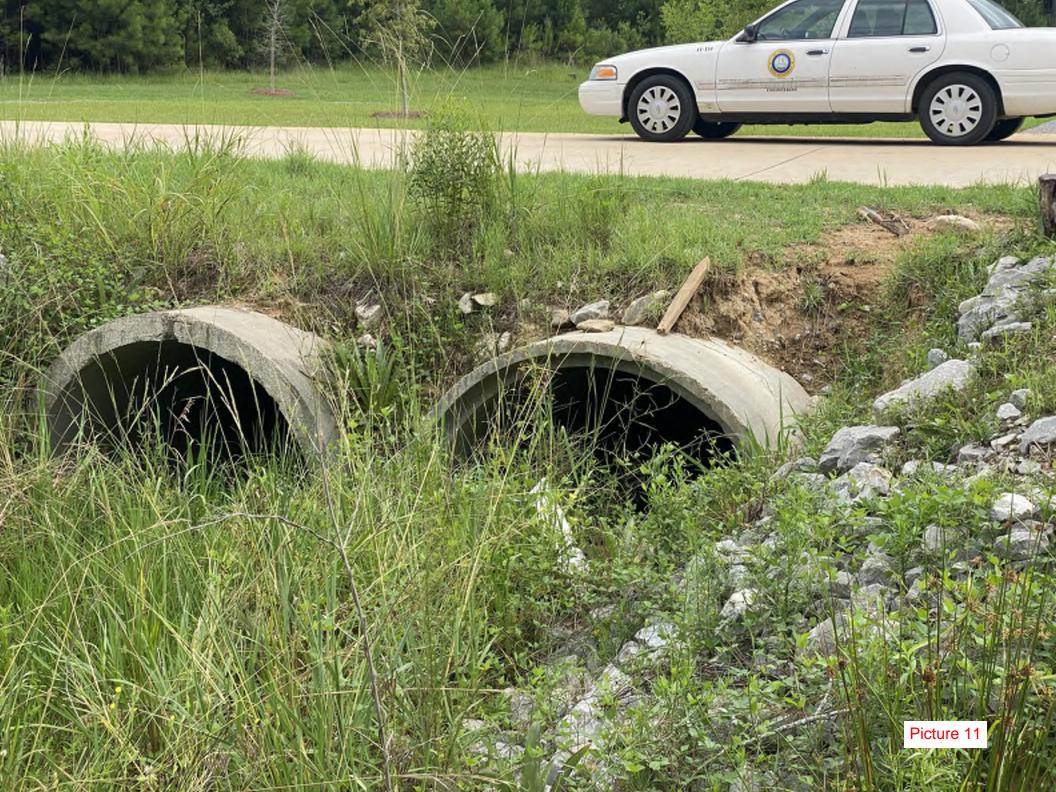
- 8. The soil adjacent to the pipe ends located in the drainage servitude on Parcel B is scouring and needs to be stabilized by installing additional rip rap (See pictures #10 & #11);

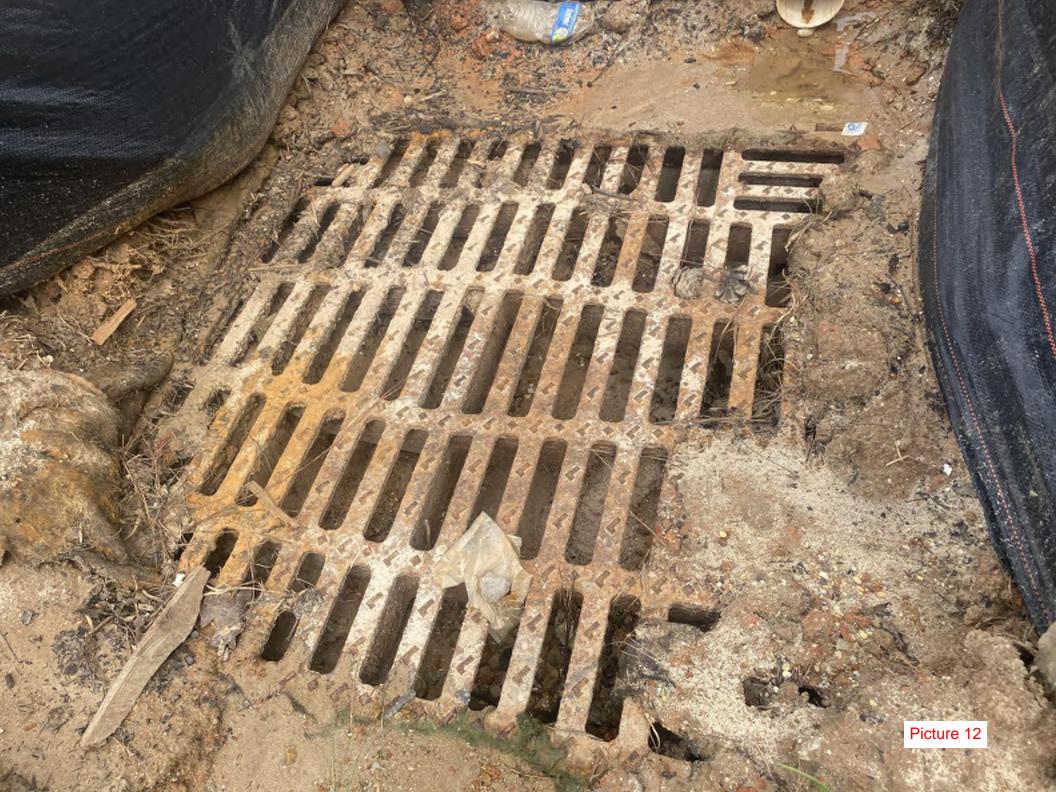
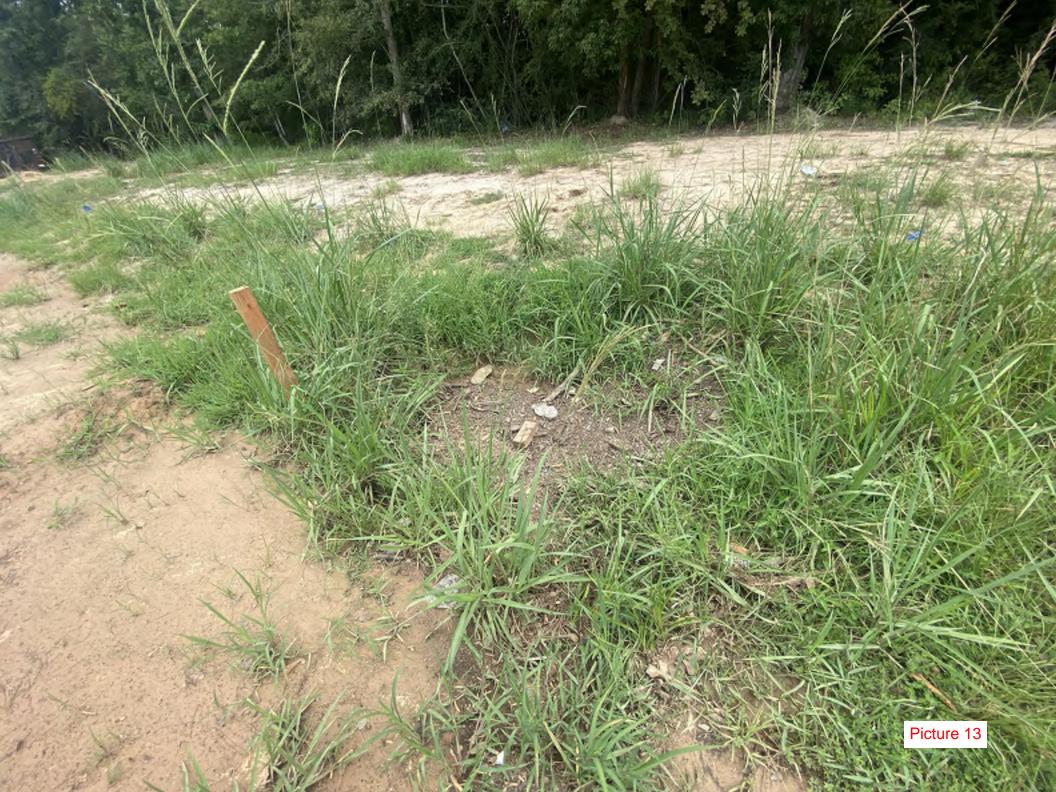
- 9. Drainage catch basins throughout this phase of River Club Estates needs to be cleared and cleaned so a meaningful inspection of the subsurface system can be made (See Picture #12 & #13);
