Amador Regional Sanitation Authority

STAFF REPORT

TO: ARSA BOARD
MEETING DATE: AUGUST 15, 2024
FROM: DAN LAFONTAINE, OPERATIONS
SUBJECT: FRESH WATER DIVERSION UPDATE
TYPE: INFORMATION AND DISCUSSION

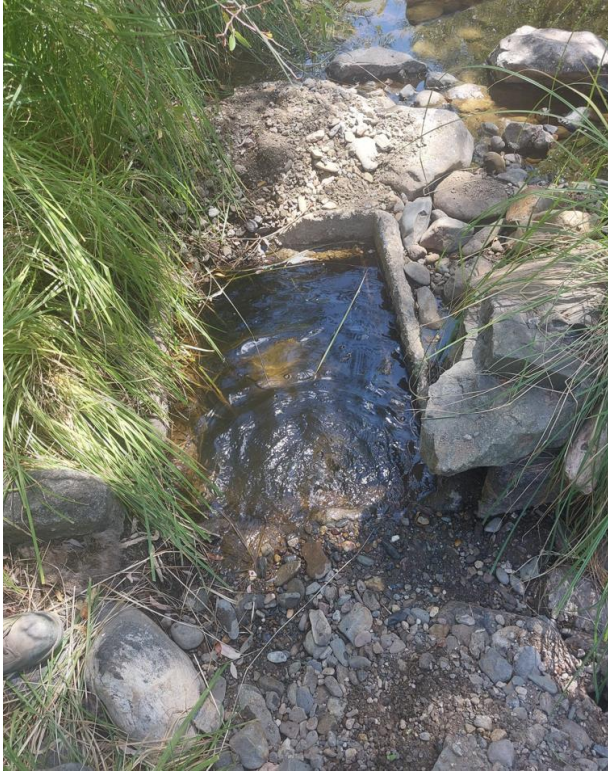
Diversion Box

The diversion box where fresh water from the creek enters the pipeline is made of concrete and has been compromised, about 50% left. The lid to the diversion box has been torn off and is lying next to the creek shore. The pipe from the diversion box to the valve box has debris inside that needs to be removed. The material is packed tight in the pipe and contractors are unsure if it can be freed or the extent of the blockage. The length of the pipe is approximately 20 to 30 feet. The valve box has been unearthed and the box itself seems to be in tack. There is no lid on that box and the location is on the side of the creek not in the creek bed. The existing piping is estimated at 12-inch pipe. The piping entering the valve box has a flanged Y in the box that is bolted to the exit pipes. The valves appear to be butterfly valves and cannot be turned by the wheels in the box. The flanges look to be compromised and need to be replaced. See pictures from the assessment.

Repairs need to be made to the diversion box to keep debris from entering the pipe between the diversion box and the valve box. The line needs to be cleared from the diversion box to the valve box. It is uncertain if this can be done with existing equipment. It may be better to abandon and install a new pipeline. The valve box valves, and piping need to be replaced.
