**City of Sutter Creek  
Design Review Application**

**Project Address:** 40 Gold Dust Trail, Sutter Creek, CA,

Project: Sutter Creek Kingdom Hall Major Renovation  
Address: 40 Gold Dust Trail, Sutter Creek, CA 95685  
Subject: Response to Design Review Committee Questions

An on-site investigation and condition assessment was made on January 21, 2023. The purpose of the site visit was to determine if the URM portion of this Kingdom Hall would meet the Life Safety Structural Performance Level (S-3) of ASCE 41-17, *Seismic Evaluation and Retrofit of Existing Buildings*.

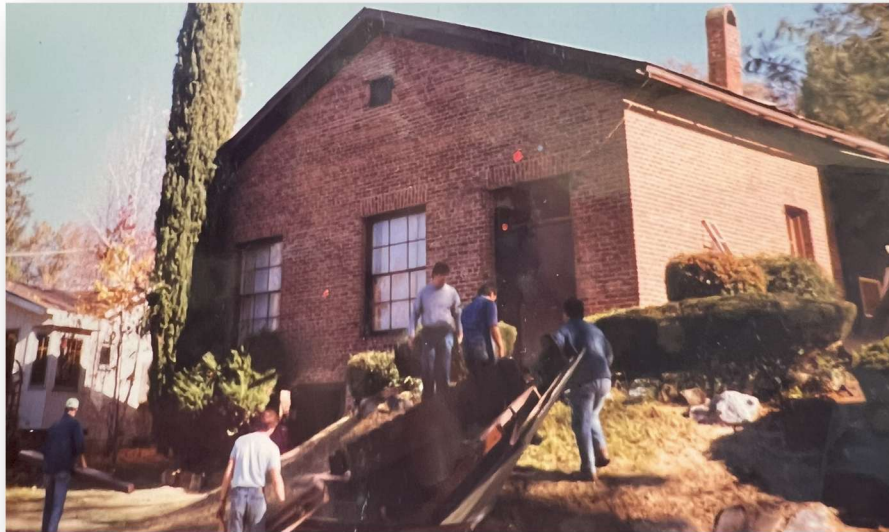
In 1991, the existing openings were closed and replaced with metal shutters (See Figure 5).

Figure 5 – Existing Windows (Source: JWCS Archive Photos)

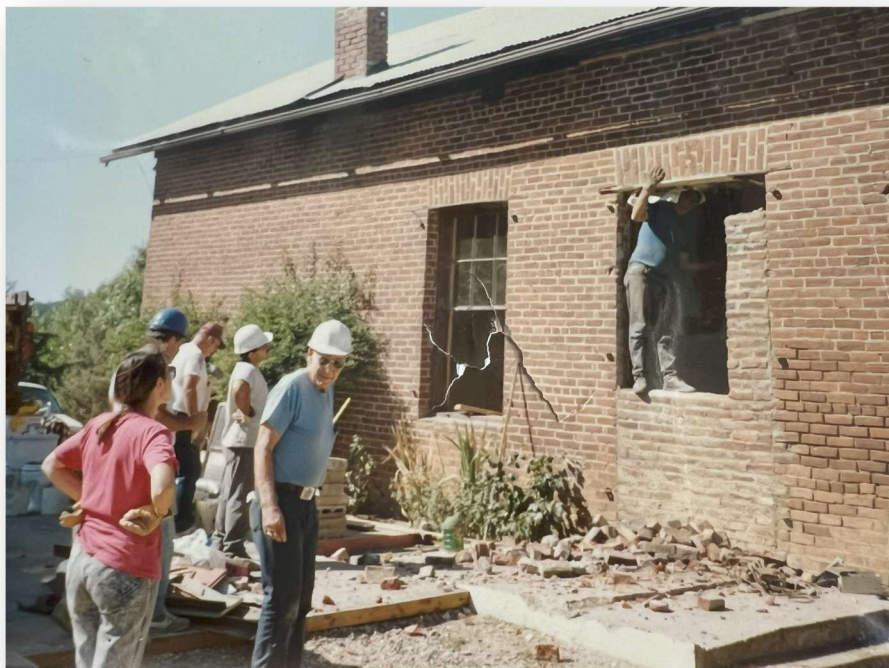
In 1991, photos indicate one opening was filled-in sometime before 1991. During the 1991 renovation, the opening was restored and became the main entry door, see Figure 6.

Figure 6 – 1991 Photo of South Wall (Source: JWCS Archive Photos)

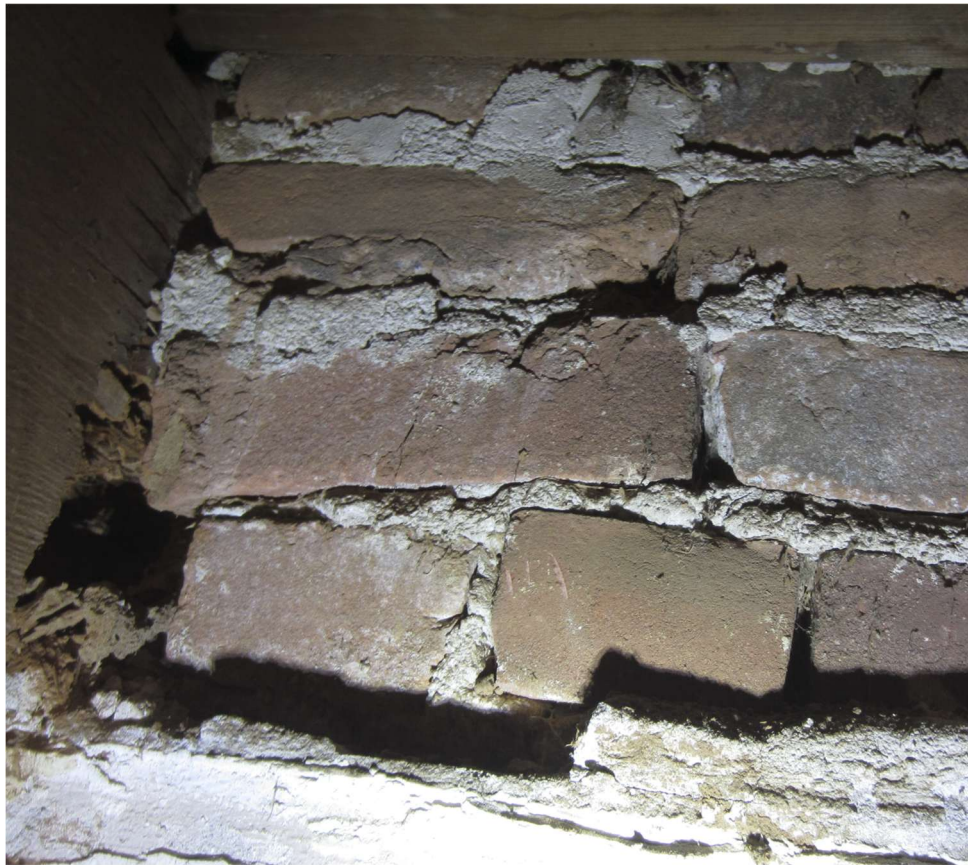
- Roof framing: Dry rot has been observed where the framing connects to the walls.
- Unreinforced Masonry (URM) Walls: Approximately 25% of the mortar on the south, west, and north walls is chalky and can be easily removed.

Figure 10 -Dry rot at embedded beams

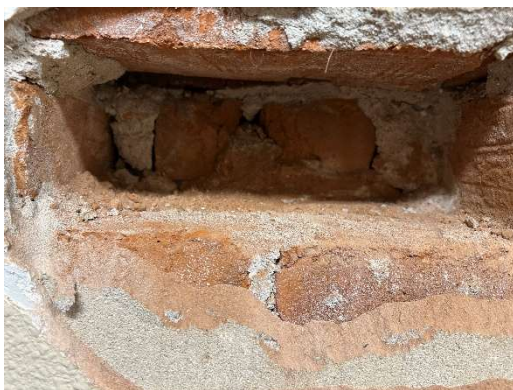
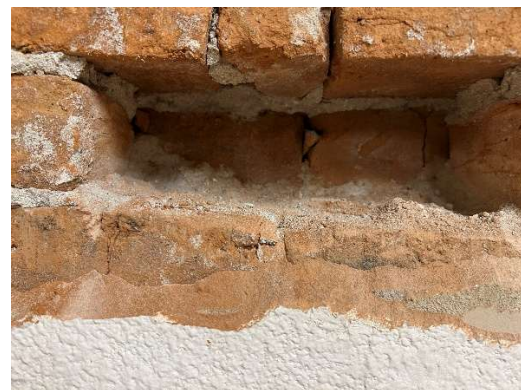
- Mortar quality and workmanship are inconsistent. Variations in lime content have resulted in some mortar being soft to the touch. Additionally, mortar application is uneven, with some bricks exhibiting poor coverage (Figures 9-12).

Figure 11 – Mortar and Brick Review – Interior Brick Condition

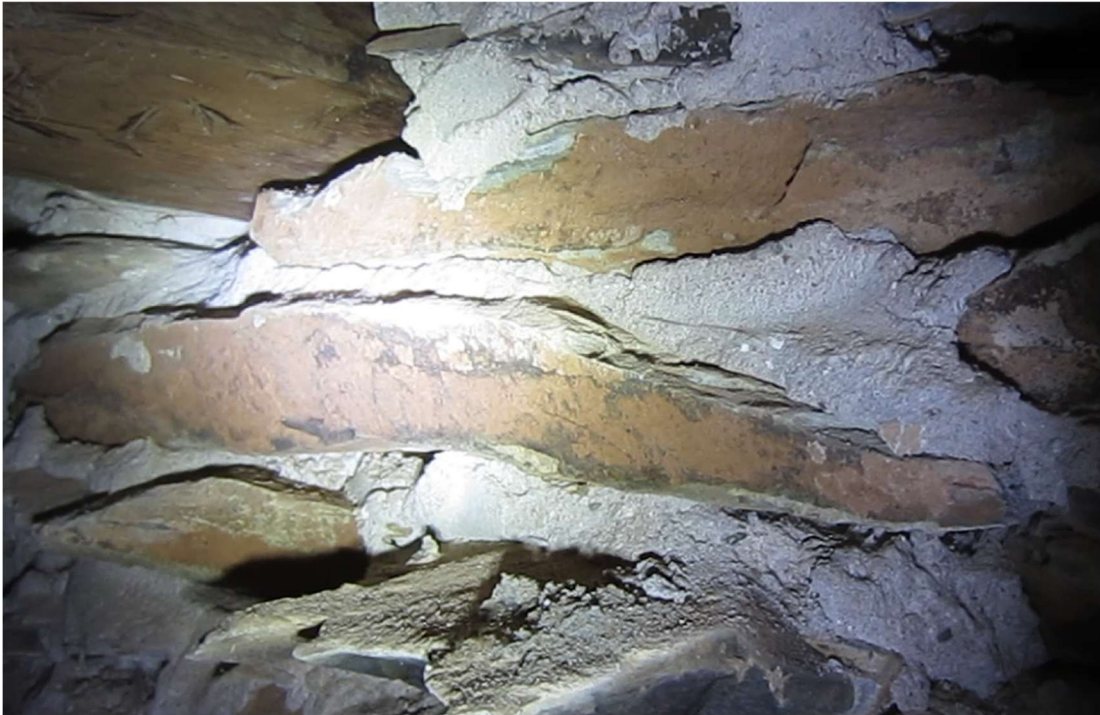
Figure 12 – Foundation Stacked Stone - Moisture affected mortar strength

- e. Foundation- the foundation consists of mortar stacked rock to the floor joist level. The mortar within approximately a foot within the floor level from the surrounding grade level is in poor condition, and in some areas completely eroded.

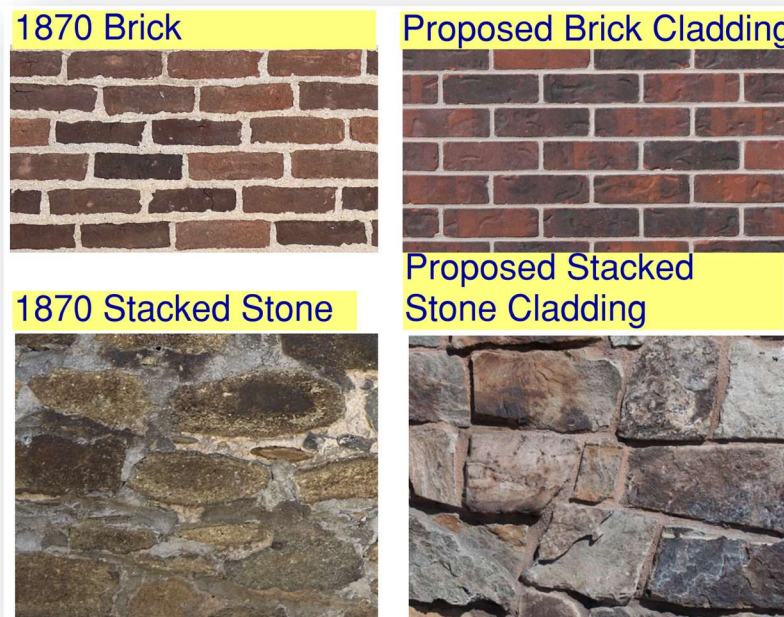
Figure 13 – Exterior Wall Finish

- **Roof Structure.** The existing roof structure is proposed to be replaced with an engineered truss system. The roof pitch will match the auditorium roof pitch (which is about 7:12).
- **Roof Covering.** The roof covering will consist of a metal roof. The metal roof is proposed to be either reused or removed and replaced with a metal roof that is consistent with the adjoining structure.
- **Exterior Wall.** The existing brick wall is proposed to be removed and replaced with wood framed construction. The wall covering is proposed to consist of brick cladding and stacked stone cladding which is similar to the existing exterior look.

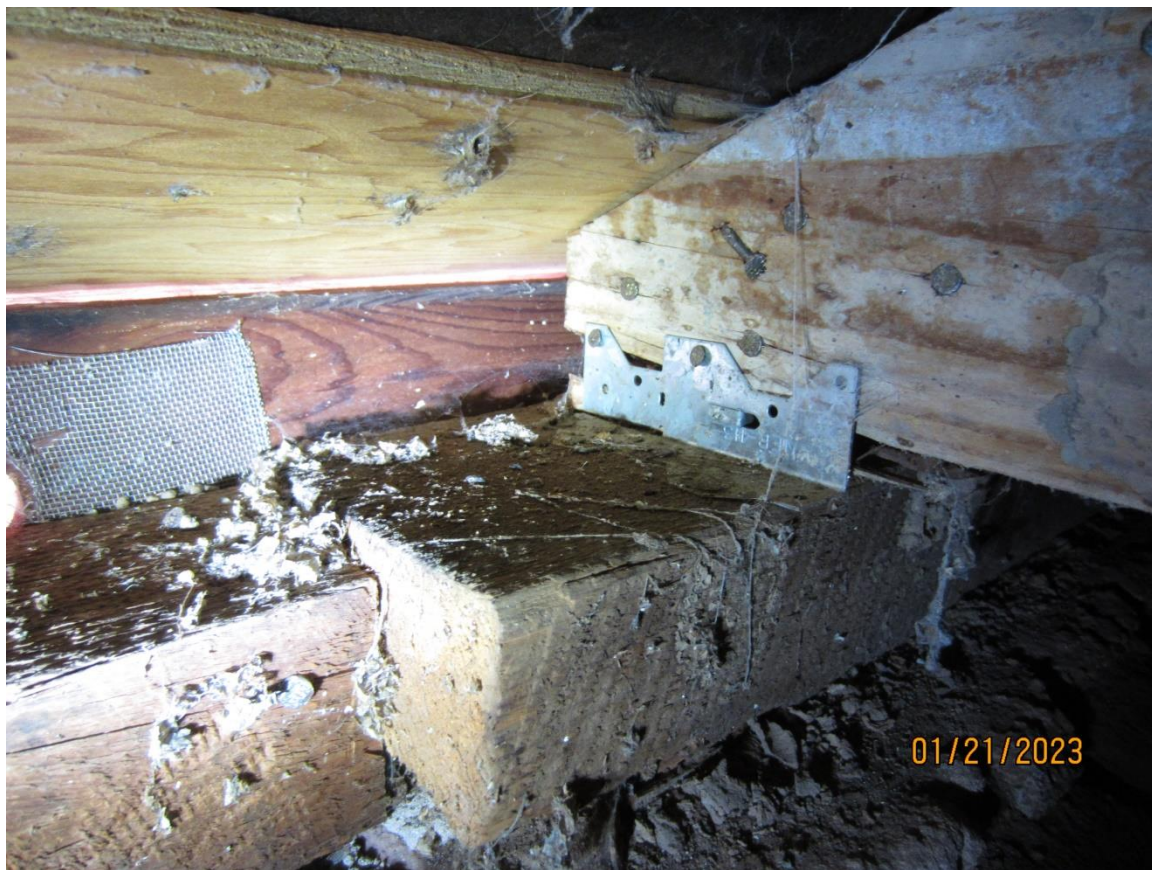
The existing roof framing system is composed of 2"x5" rafters @24"cc with collar ties at varying elevations. (See Pics 3 and 4). Representative top of wall conditions at Gridline 2 are shown in Pics 5, 6, and 7. Very minimal connection to the top of wall sill plates was present. No anchor bolts were observed between the top of wall sill plates and the URM walls below. The bearing ends of the rafters are unblocked so shear transfer from the spaced sheathing roof diaphragm is questionable.

Pic 5 – Roof rafters at top of wall at Gridline 2.

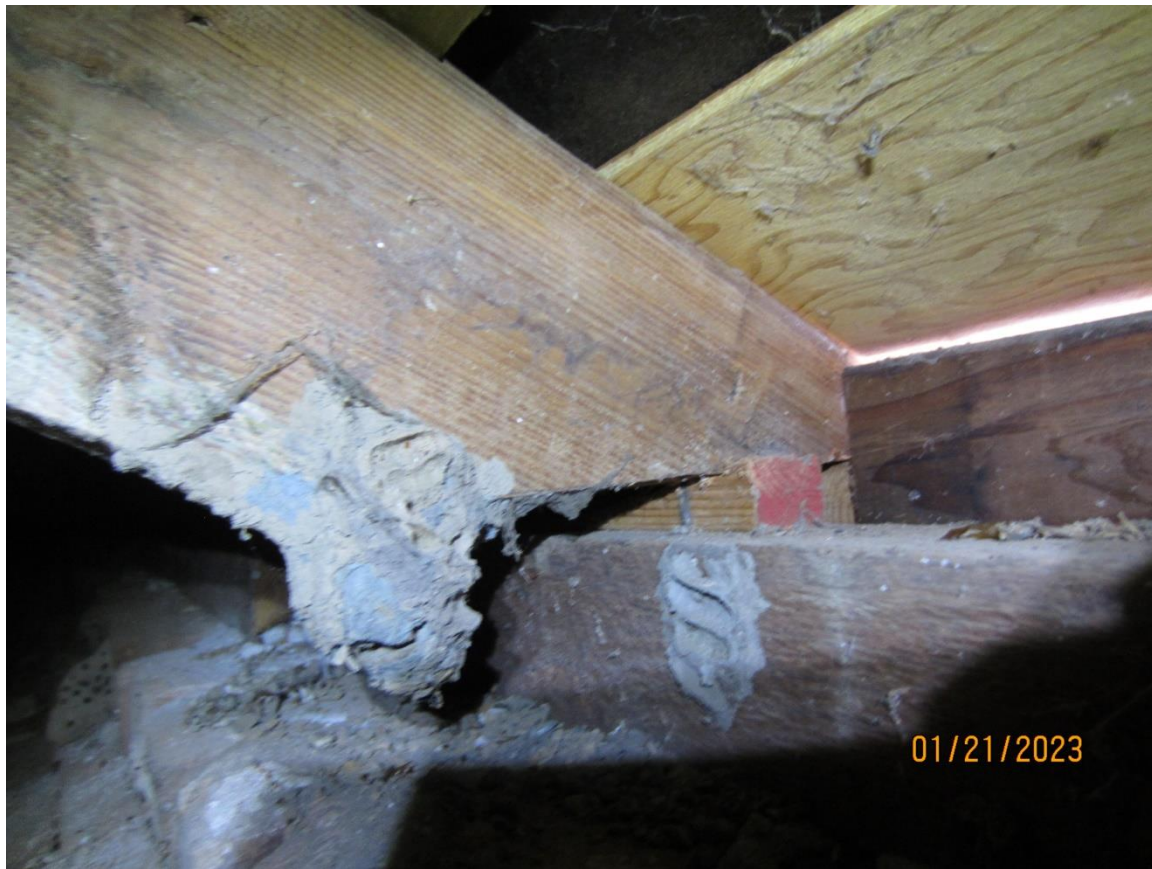
Pic 6 – Roof rafter with low collar tie and Simpson A35 to sill plate at top of wall

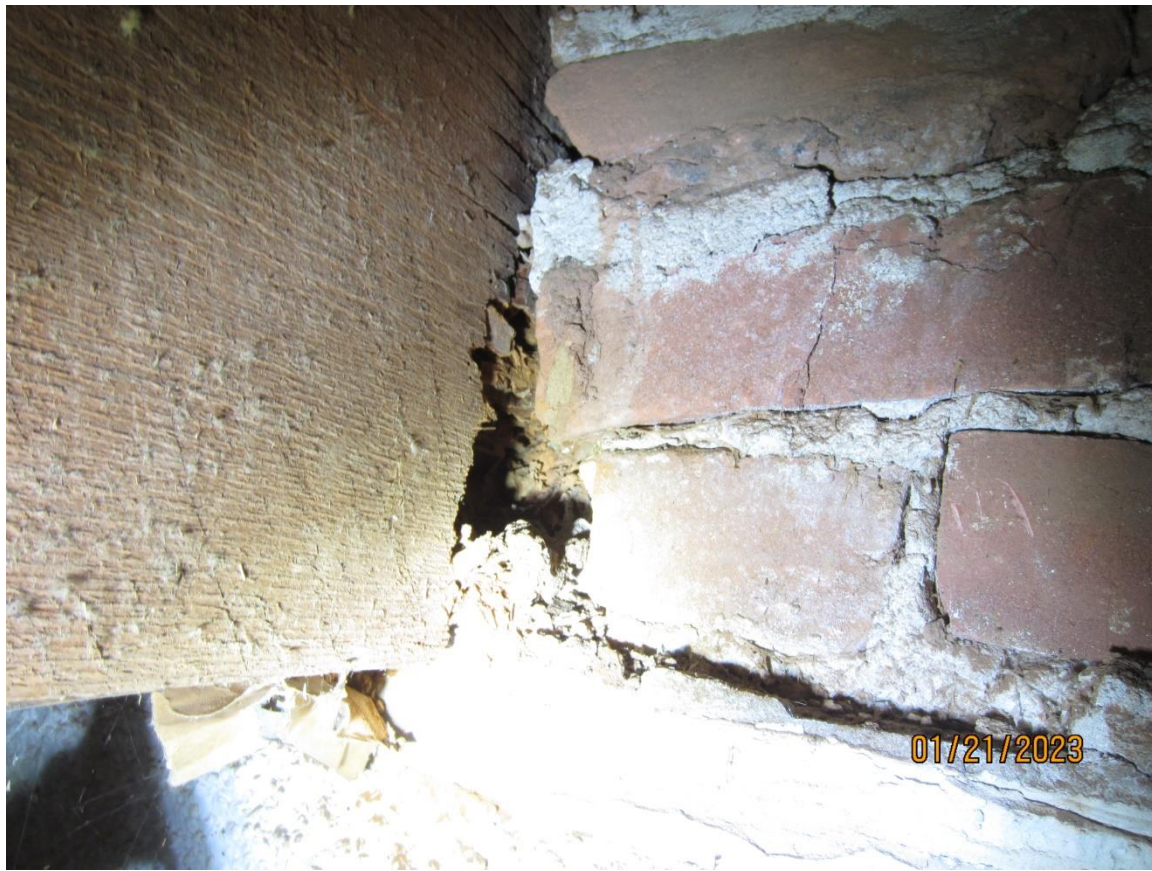
The attic floor joists (See Pic 10) are built into the URM masonry walls with no positive anchorage or moisture protection. Many of the joist ends have dry-rot (Pics 11, 12, 13). Very weak mortar and bricks were observed at various attic floor joists (Pics 13, 14, 15, 16). The mortar was weak or loose. The bricks would crumble from probing by a screwdriver. Mortared brick could be loosened and removed by hand without mechanical assistance. More than a few attic joist ends were repaired with plywood scabs (Pic 13, 14, 15).

Pic 10 – Attic floor joists built into masonry wall with 1x floor boards removed. Roof rafters on top of wall

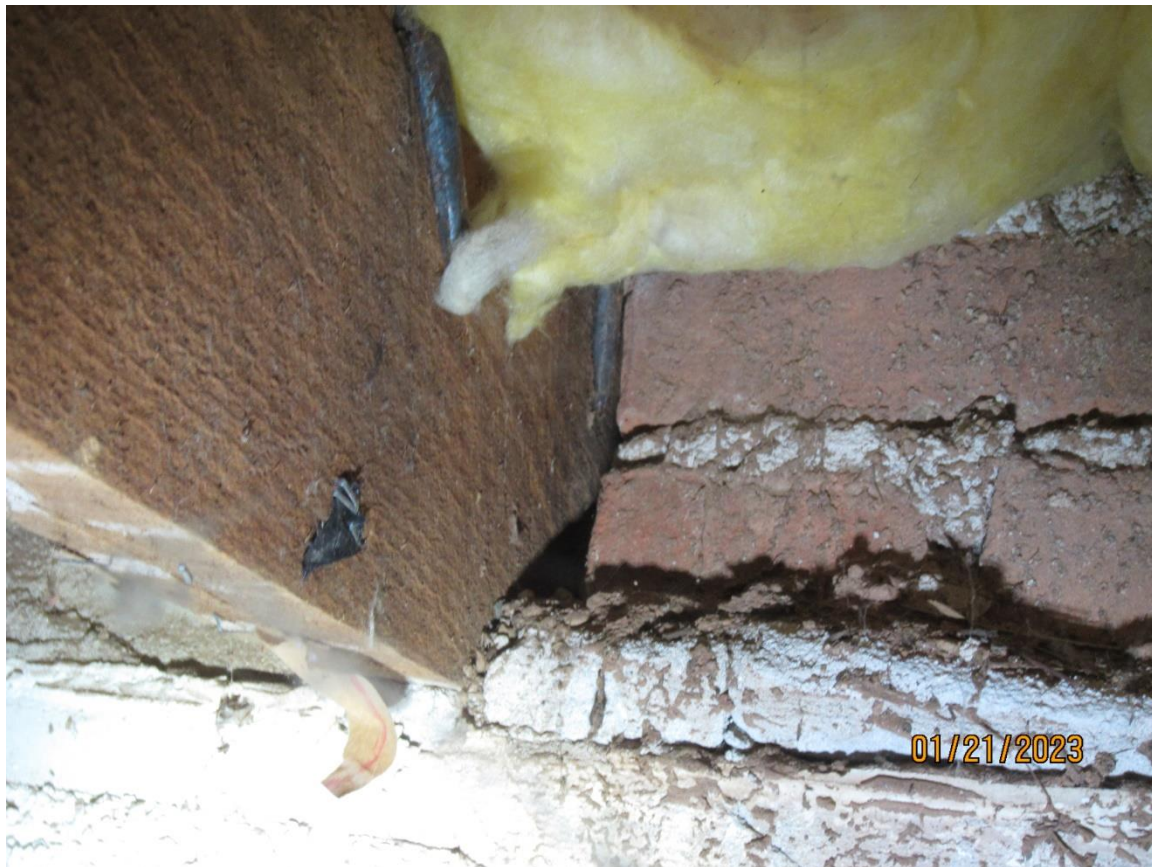
Pic 11 – Dry rot at embedded 2"x11.25" attic floor joists

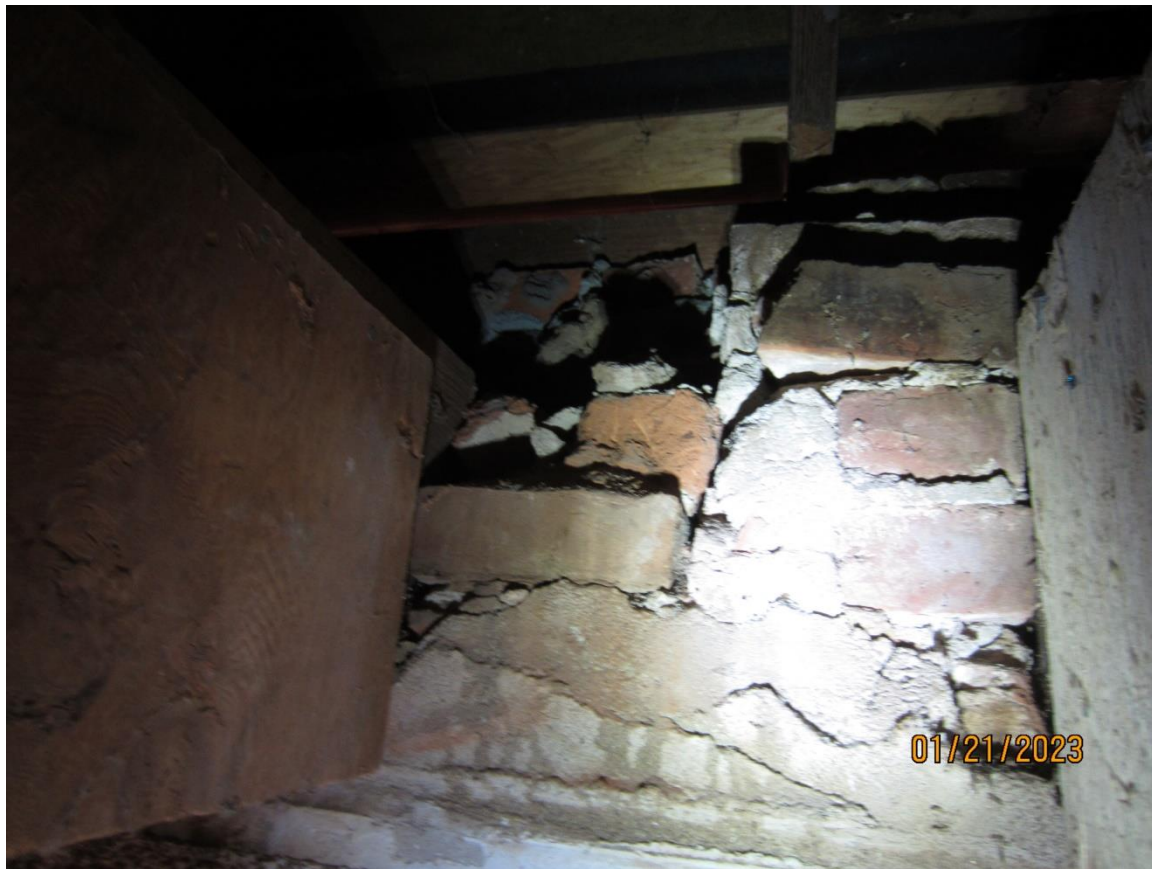
Pic 14 – Weak mortar and loose bricks at attic ceiling joist repair locations.

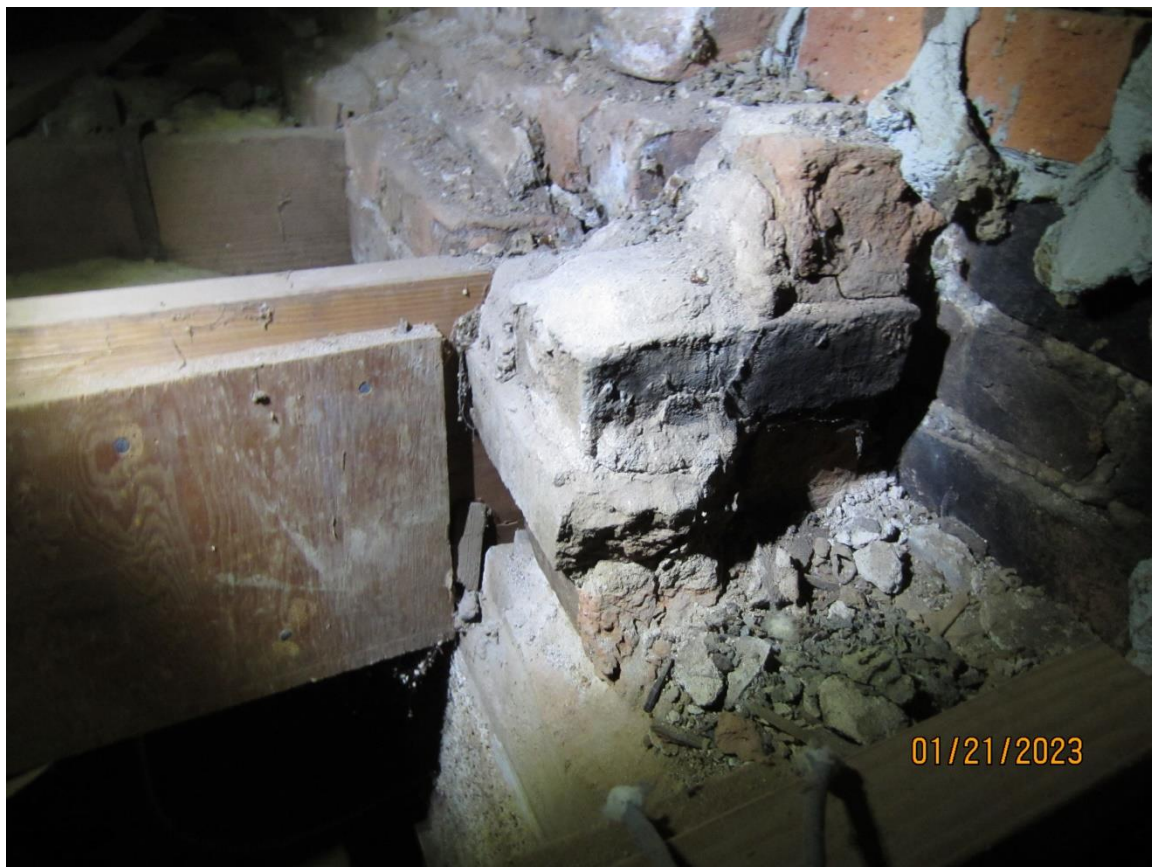
Pic 15 – Loose bricks and weak mortar at attic floor joist repair location

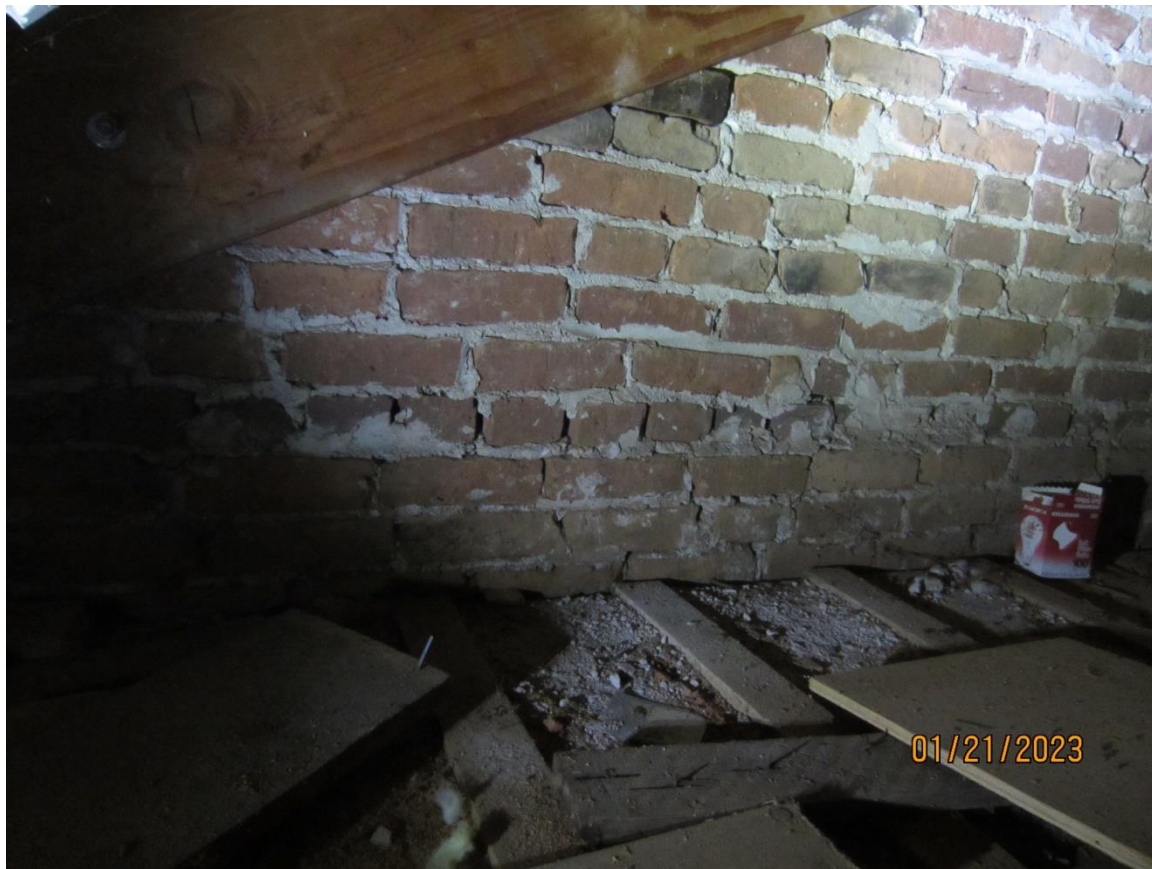
Pic 16 - Loose and missing bricks. Exposed brick head for interior two wythes of wall.

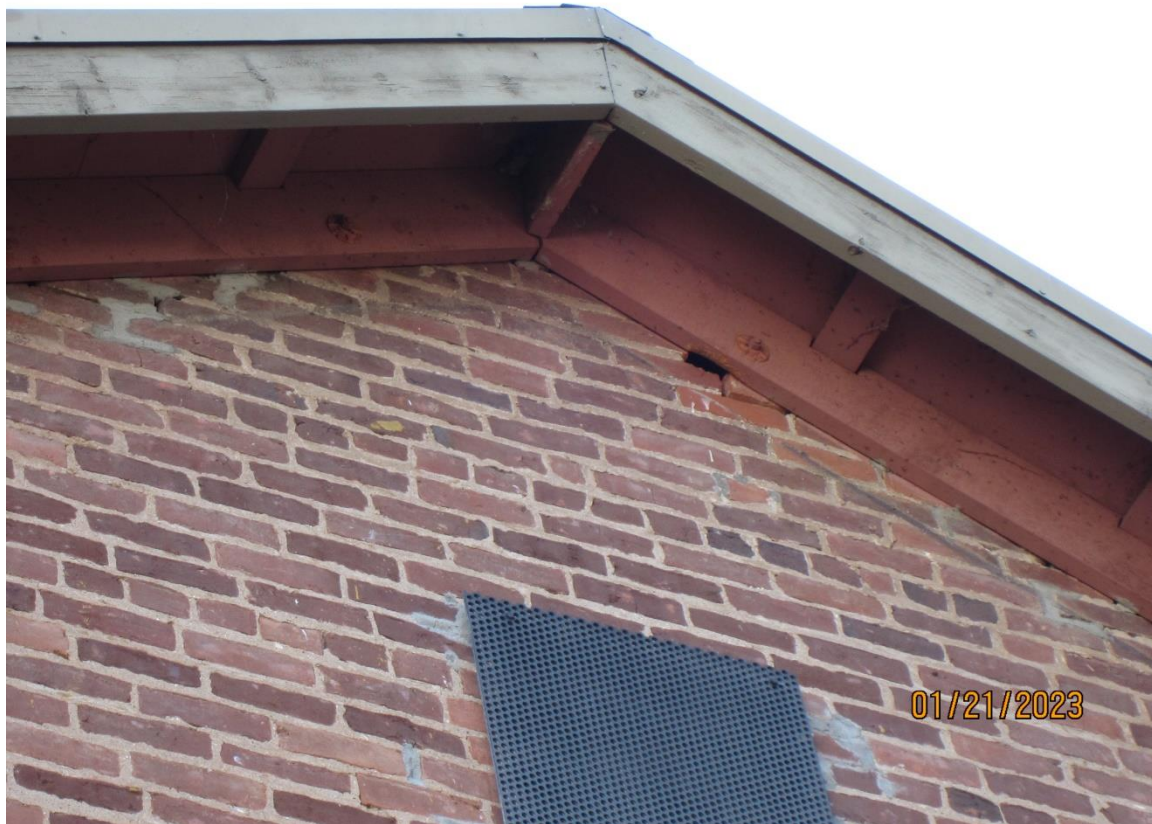
At gable end walls at Lines A and B no wall anchorage was observed at the attic level (See Pics 1, 17).

The masonry at the top of gable end walls is loose at various locations (See Pics 17, 18, 19)

Pic 17 - No wall anchorage at Line B (East Wall) at attic floor level. Attic floor boards removed.

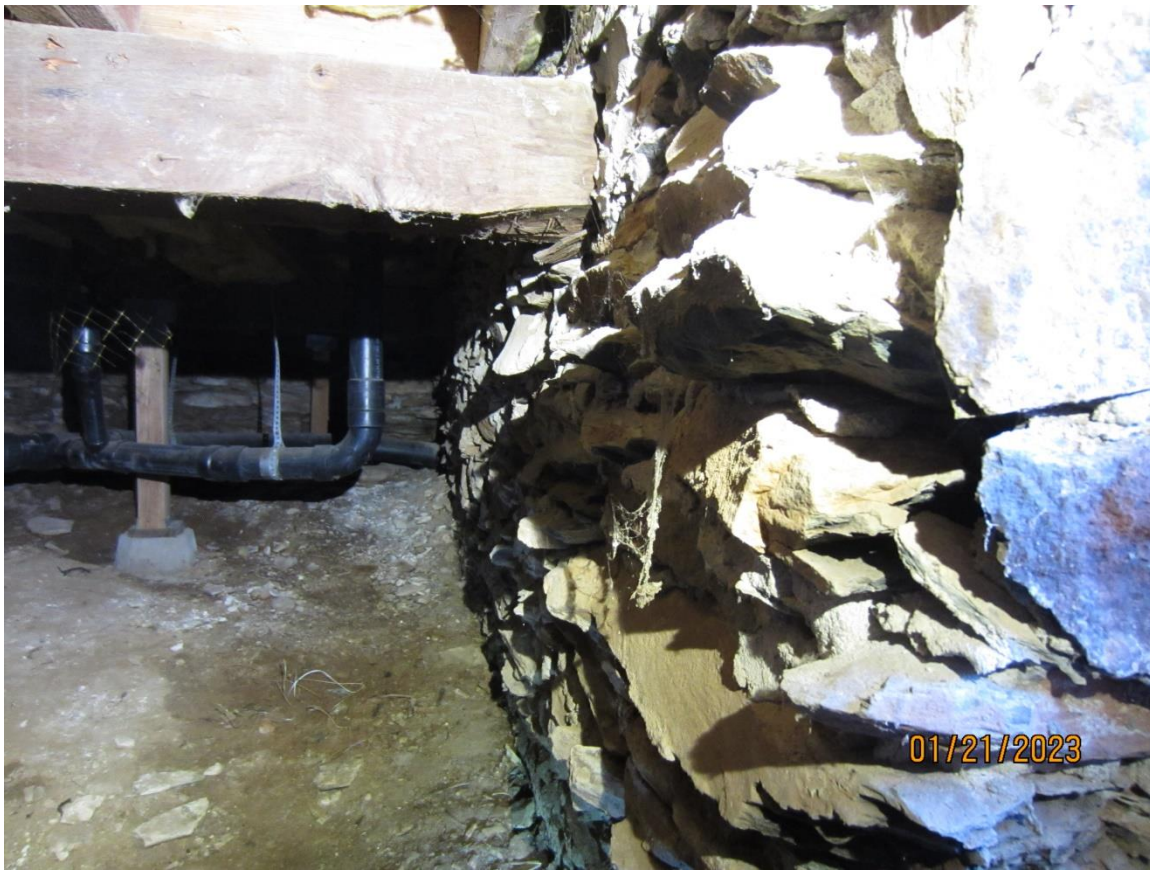
The foundation walls supporting the URM walls are composed of stacked pieces of mortared shale (See Pics 21, 22, 23, 24). The mortar was weak under probing with a screwdriver in some locations.

Pic 22 – Stacked shale foundation wall at floor girder at Gridline A

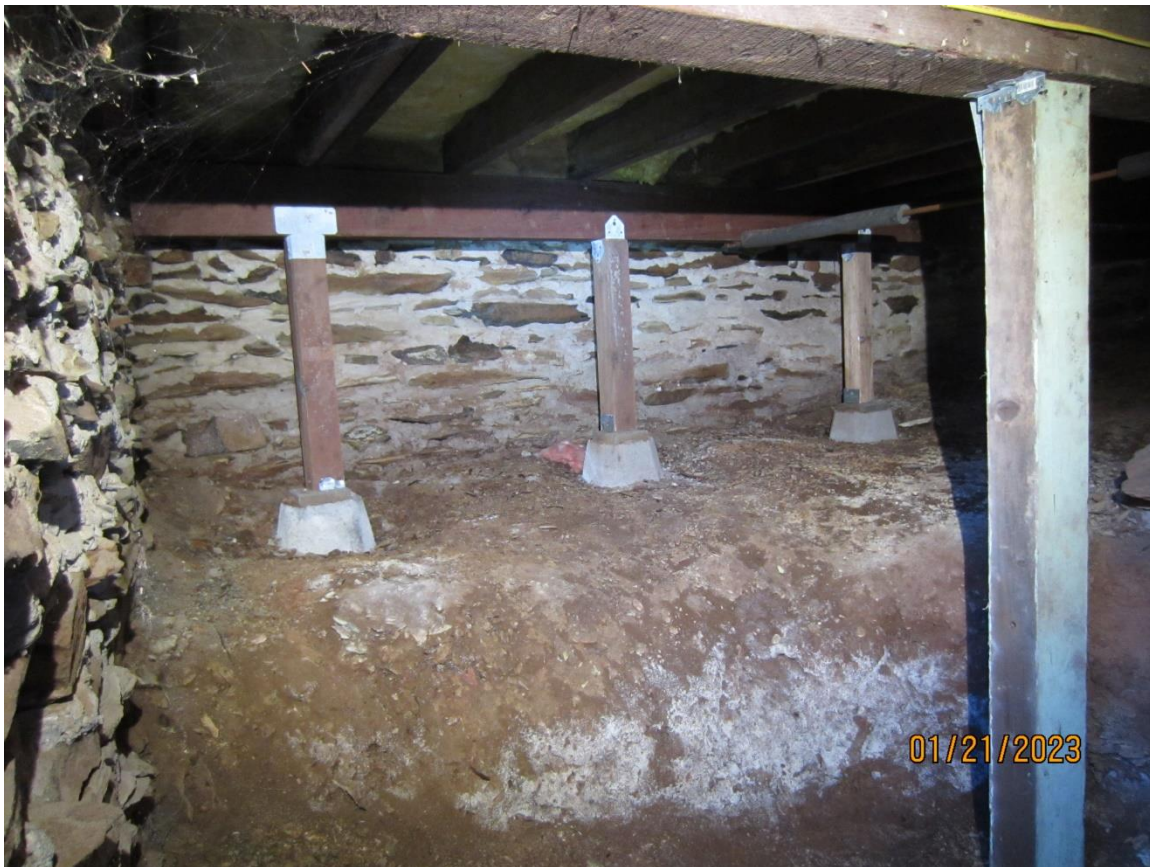
Pic 23 – Stacked shale foundation wall at Gridline A.

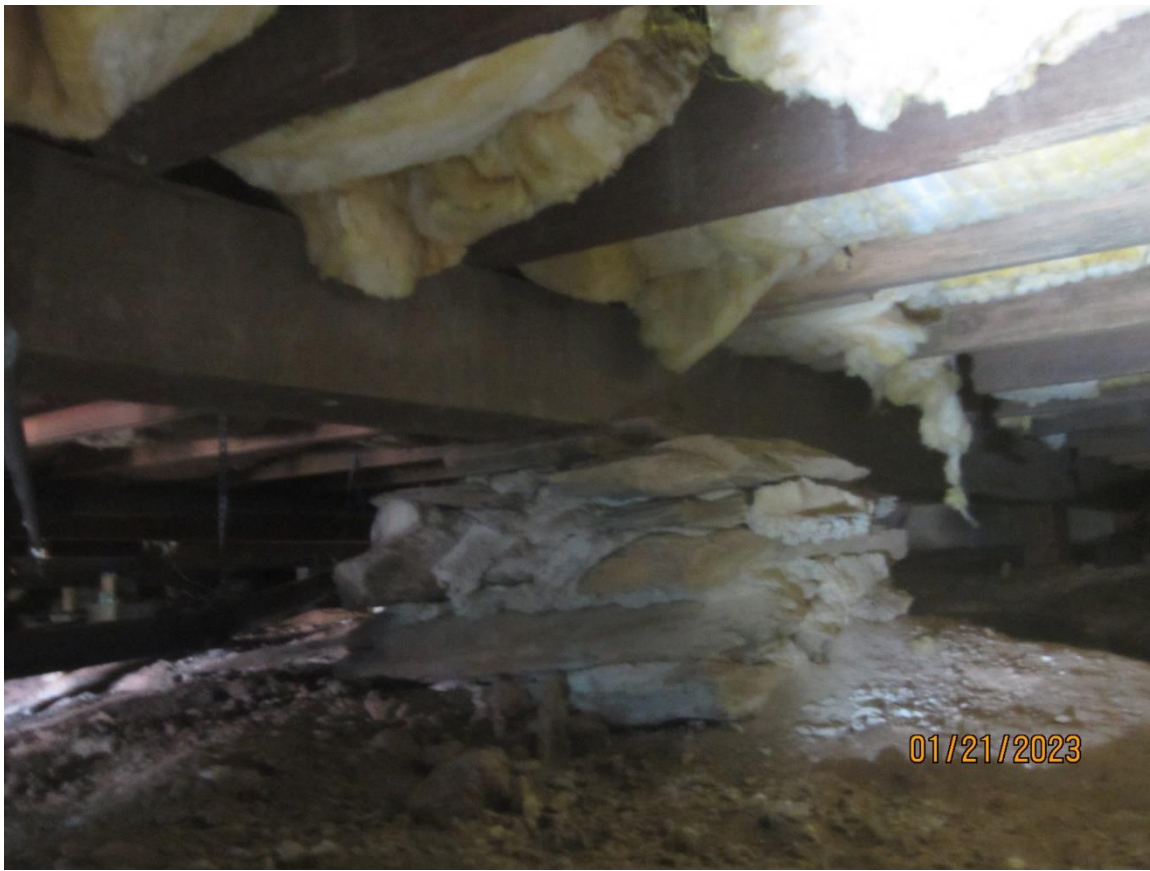
Pic 24 – Stacked shale foundation wall at southwest corner of crawl space.

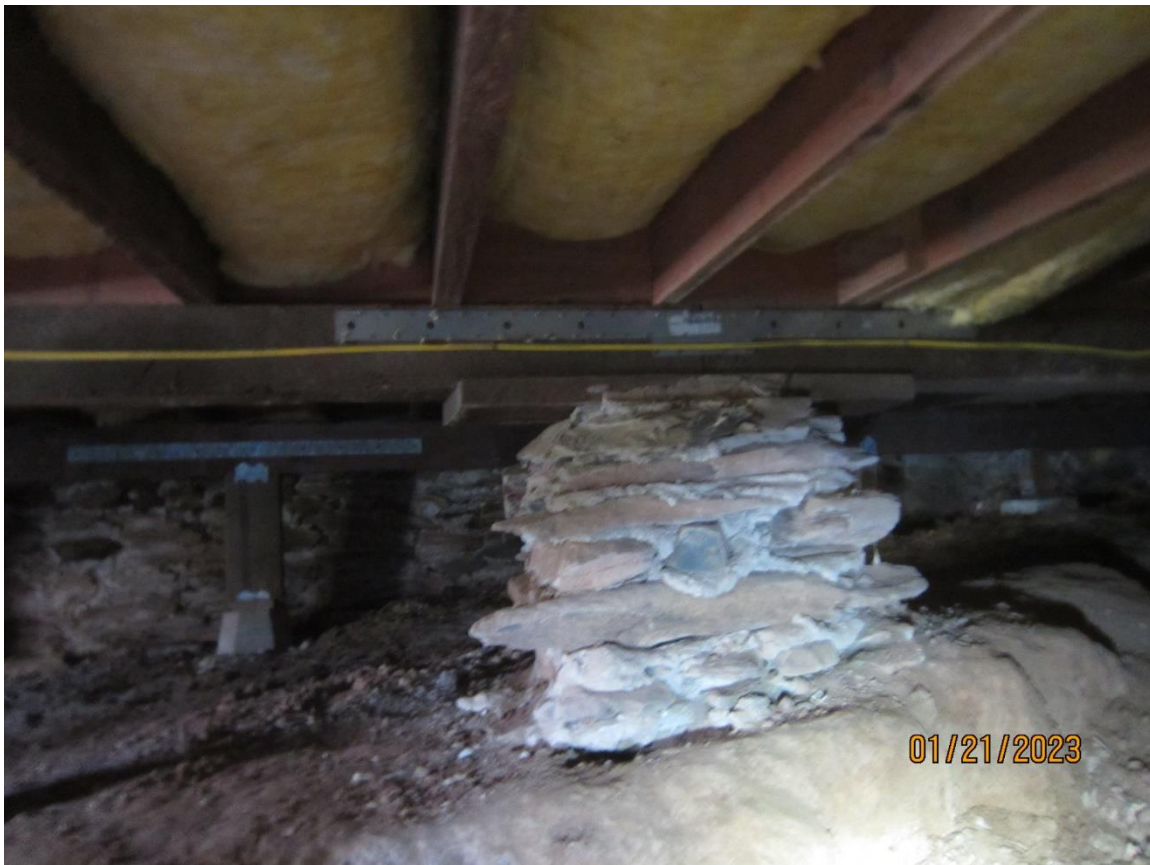
Pic 25 - Floor beam supported on stacked shale pier

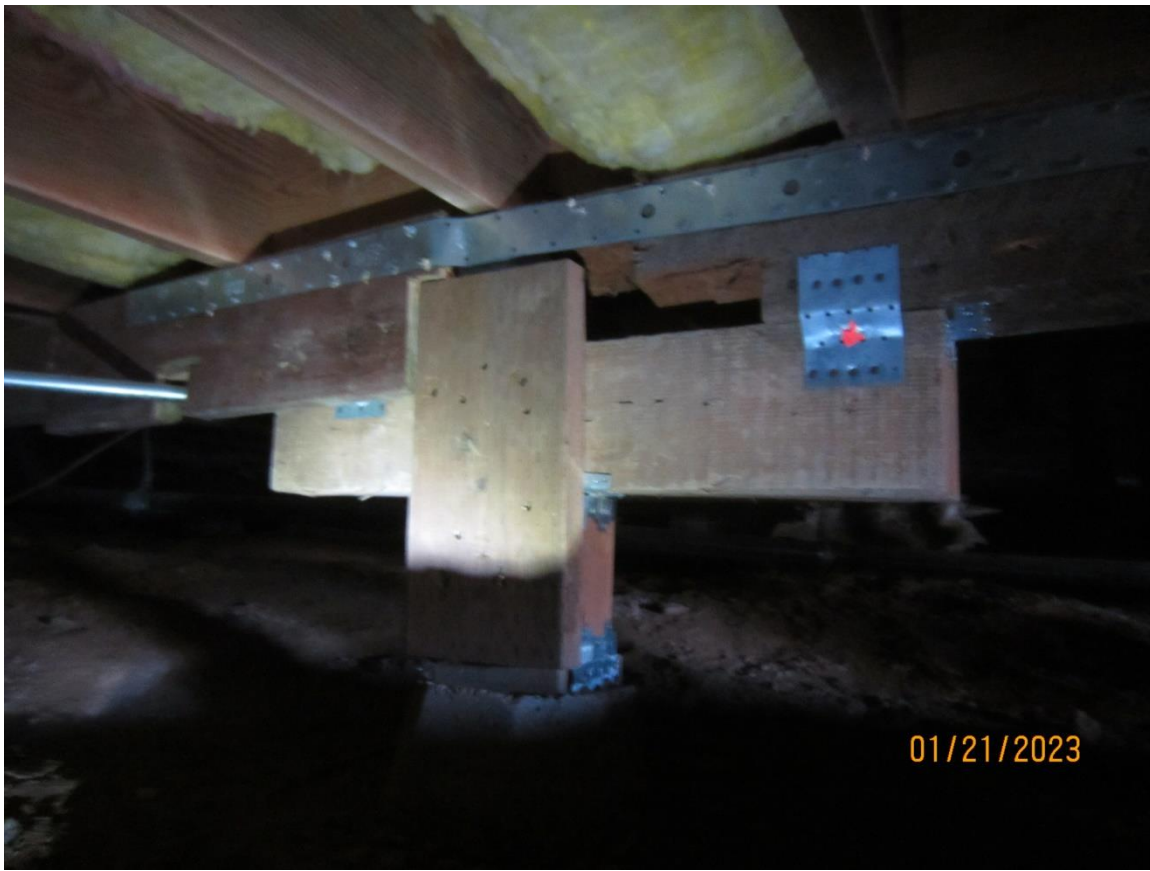
Pic 26 - Beam splice over shim at built-up shale pier
