*Town of Swansboro Public Works Department*

*Civil Engineering Assessment  
Swansgate Subdivision  
Roads, Sidewalks and Drainage Areas  
Swansboro, NC*

*May 24, 2023*

*Submitted by: Larion PLLC, P-1146*

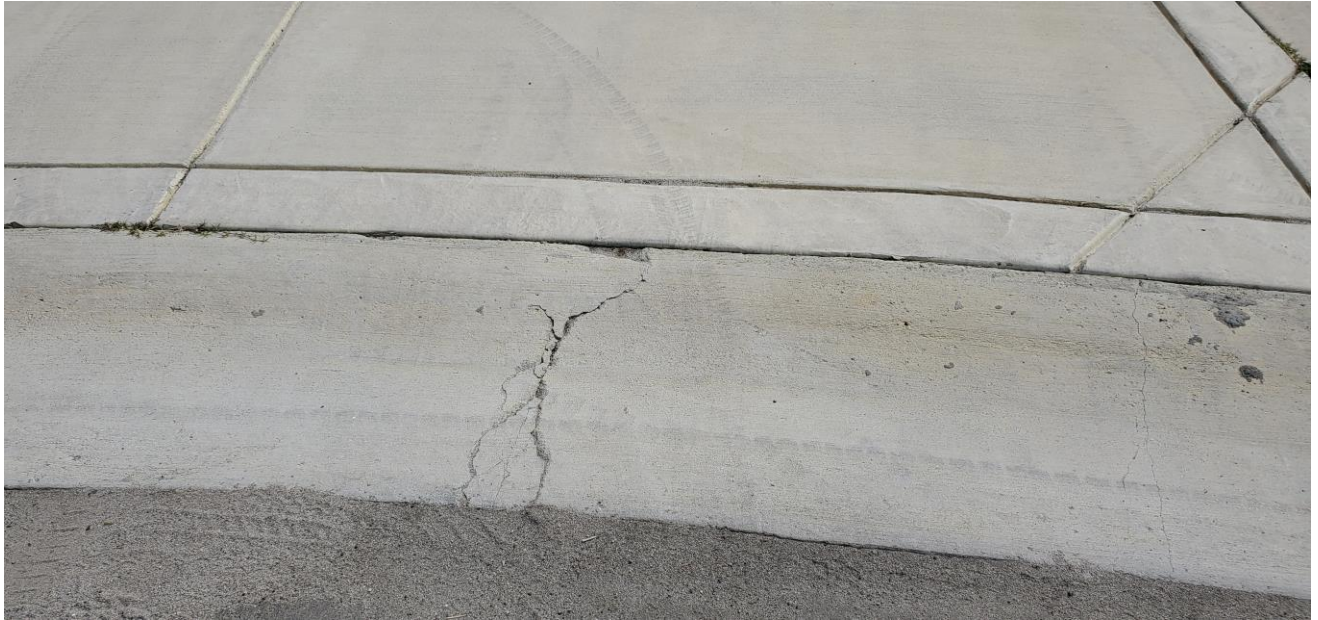
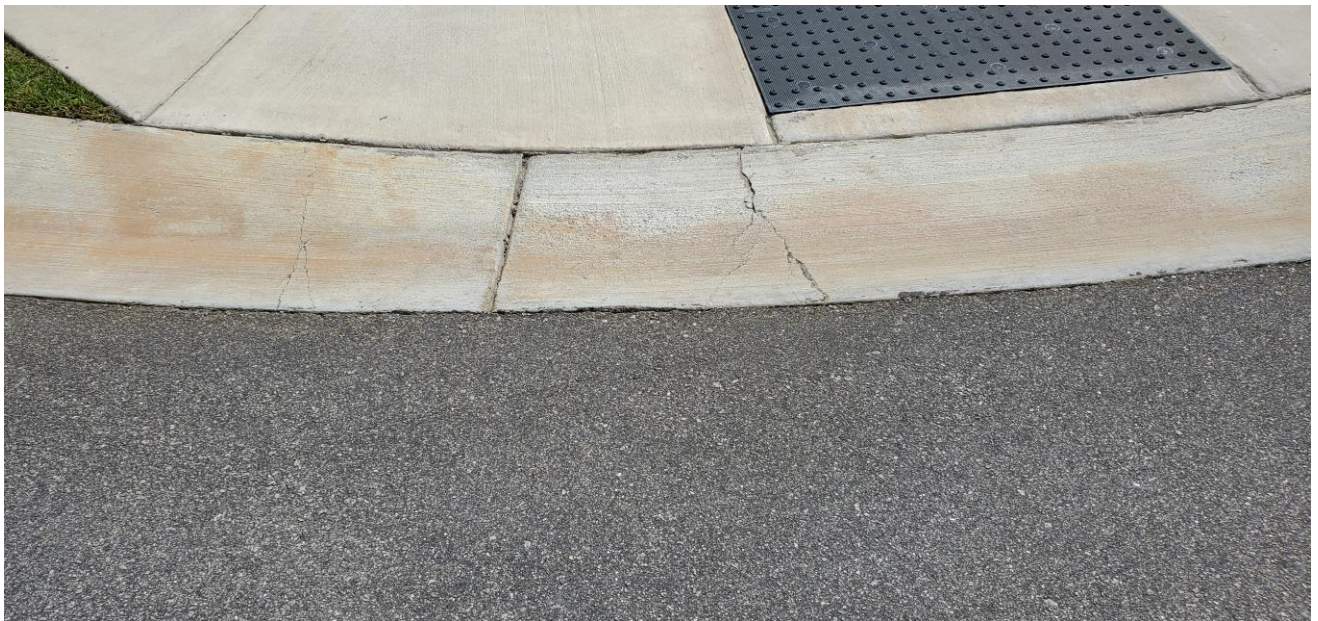
**Photos 1 and 2**

There are multiple locations where the curb and gutter are cracked (photos 1 and 2).

- It is recommended that each crack be saw cut and filled with NP 1 polyurethane sealant.

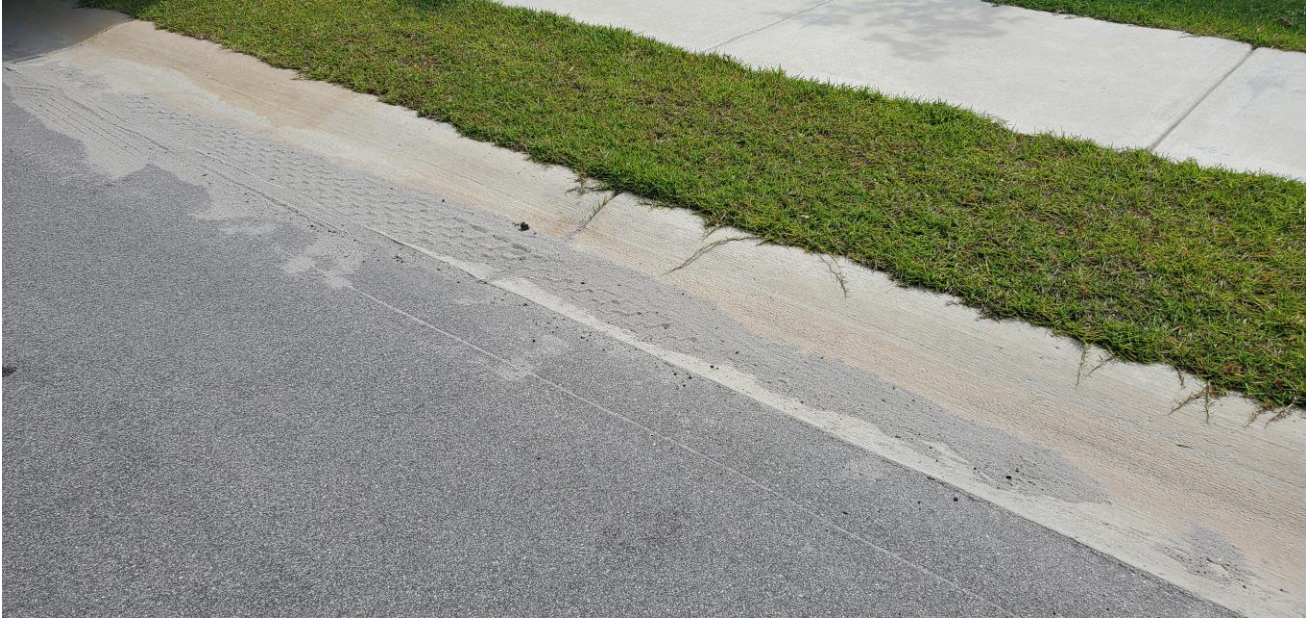
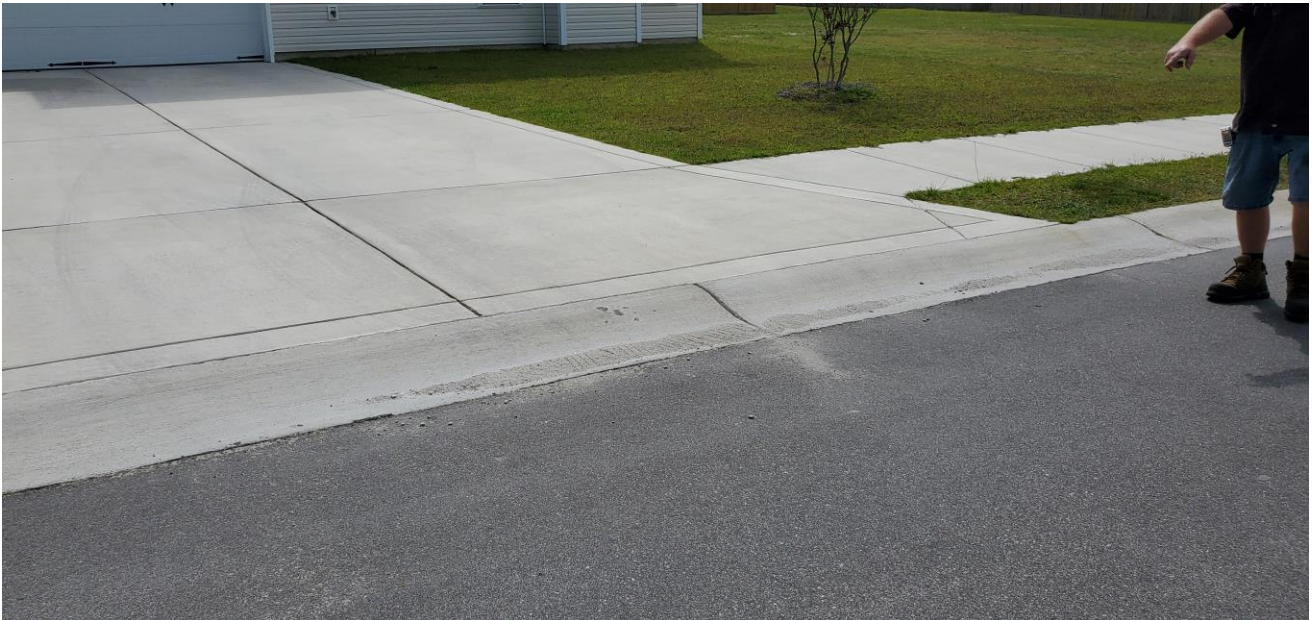
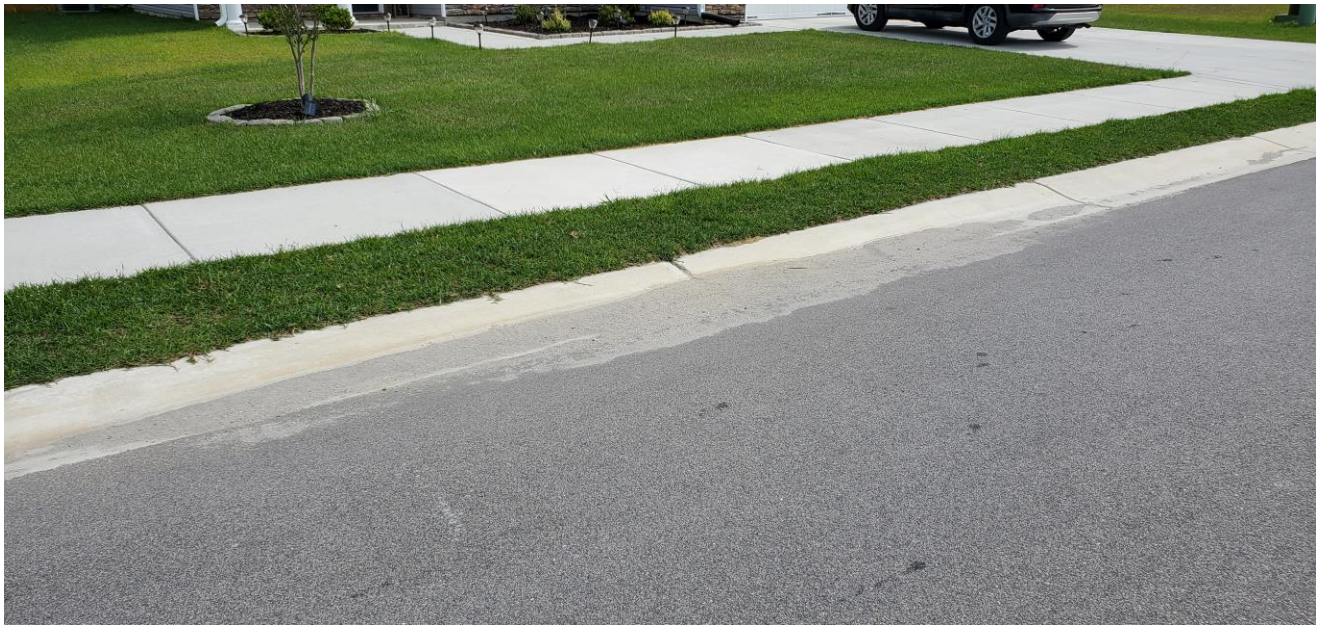
**Photos 3, 4 and 5**

There are areas where the curb and gutter were not installed to provide positive drainage and are ponding water during rain events (photos 3, 4 and 5).

- It is recommended that these areas of curb and gutter be removed and reinstalled to correct elevation for positive drainage.

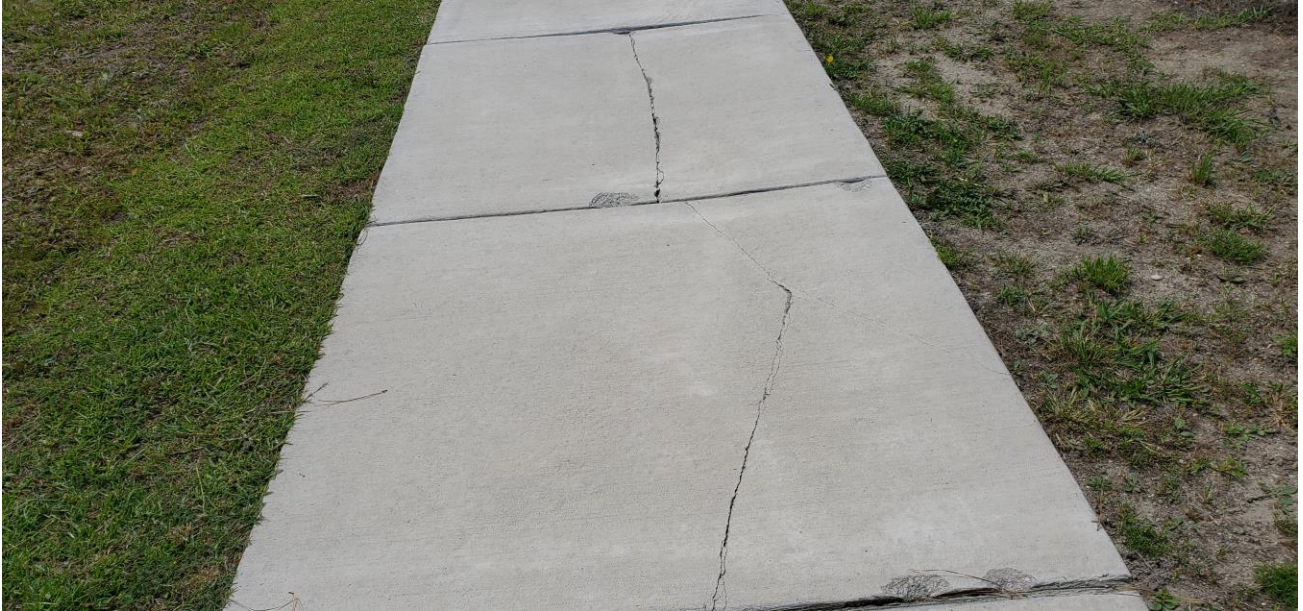
**Photo 6**

There is a section of sidewalk along Swansboro Loop Road that is damaged and cracked (photo 6).

- Recommend replacement of this section of sidewalk.

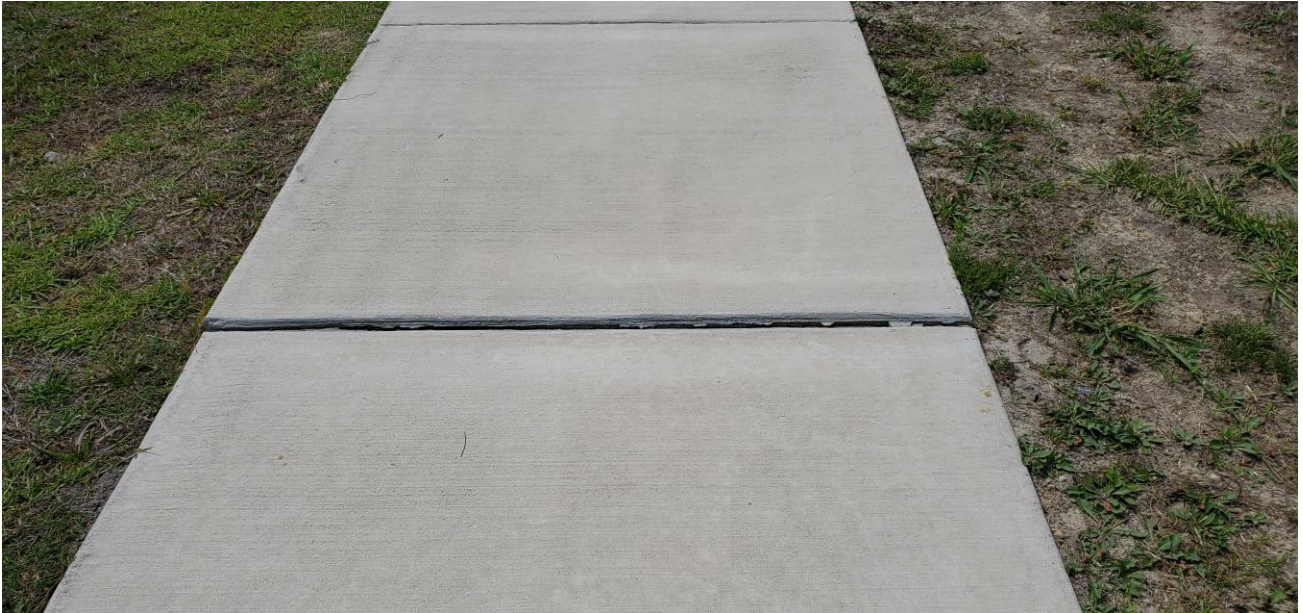
**Photo 7**

The sidewalk along Swansboro Loop Road has joints that are uneven/elevated with adjoining sidewalk sections at construction/control joints, multiple locations (photo 7).

- Recommend to grind sidewalks joints flush with adjoining section.

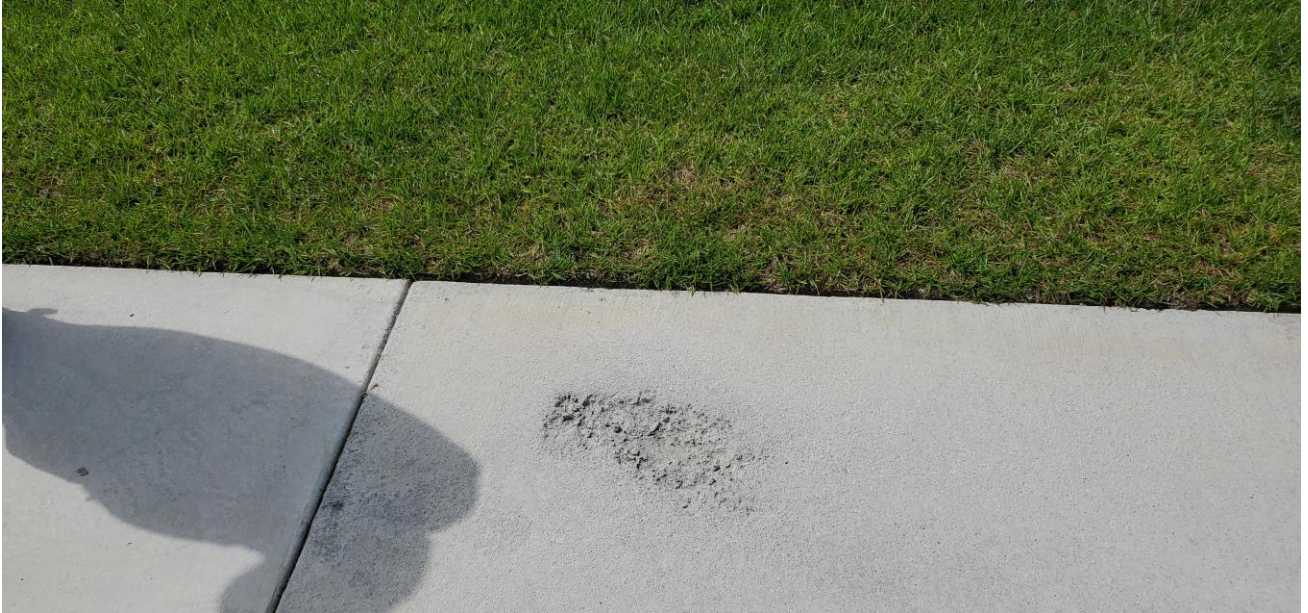
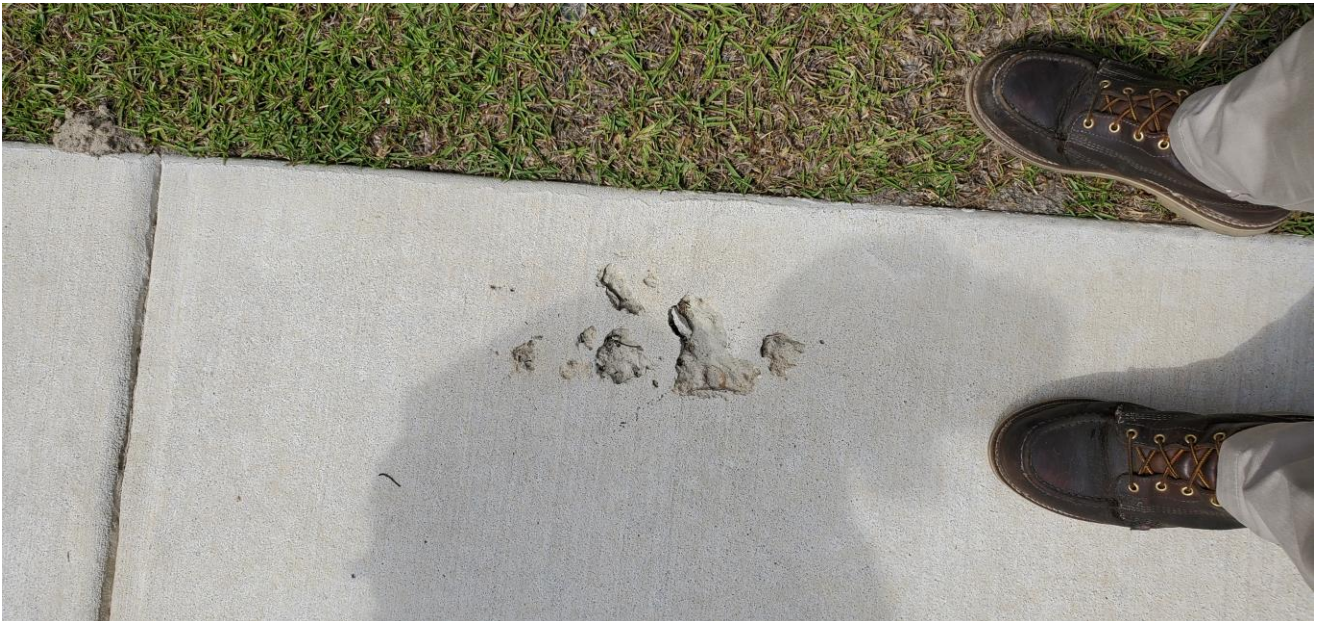
Photo 8 and 9

There are areas of spalling of the sidewalks surface (photos 8 and 9).

- Recommend that areas of spalling be repaired with an epoxy concrete product.

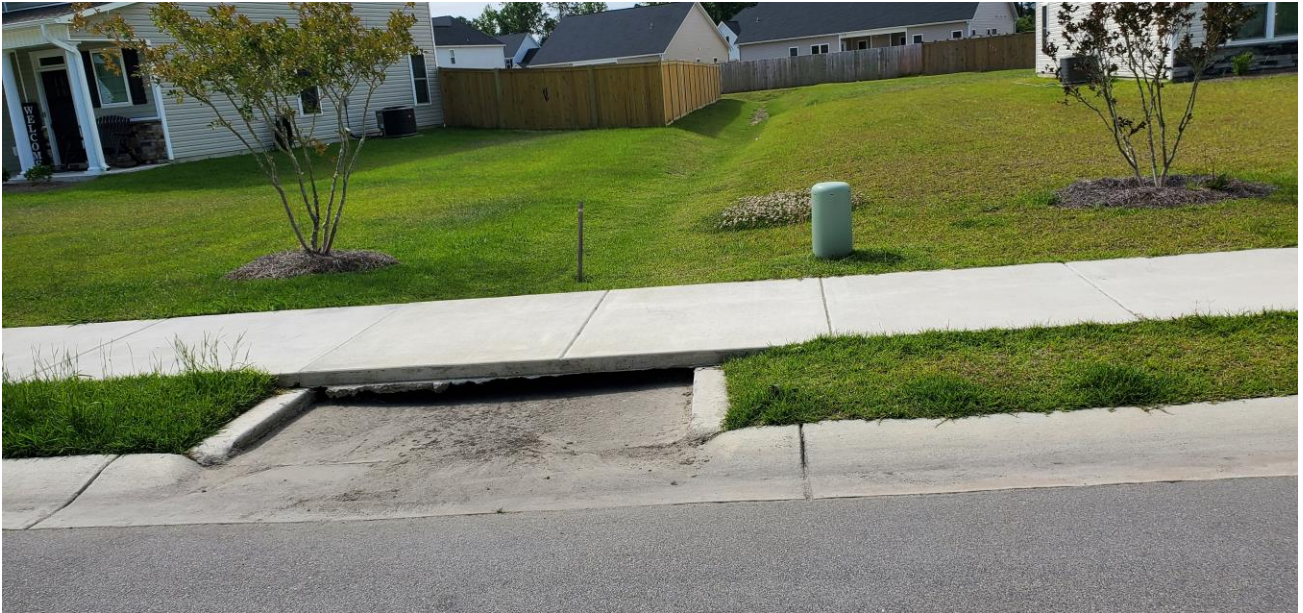
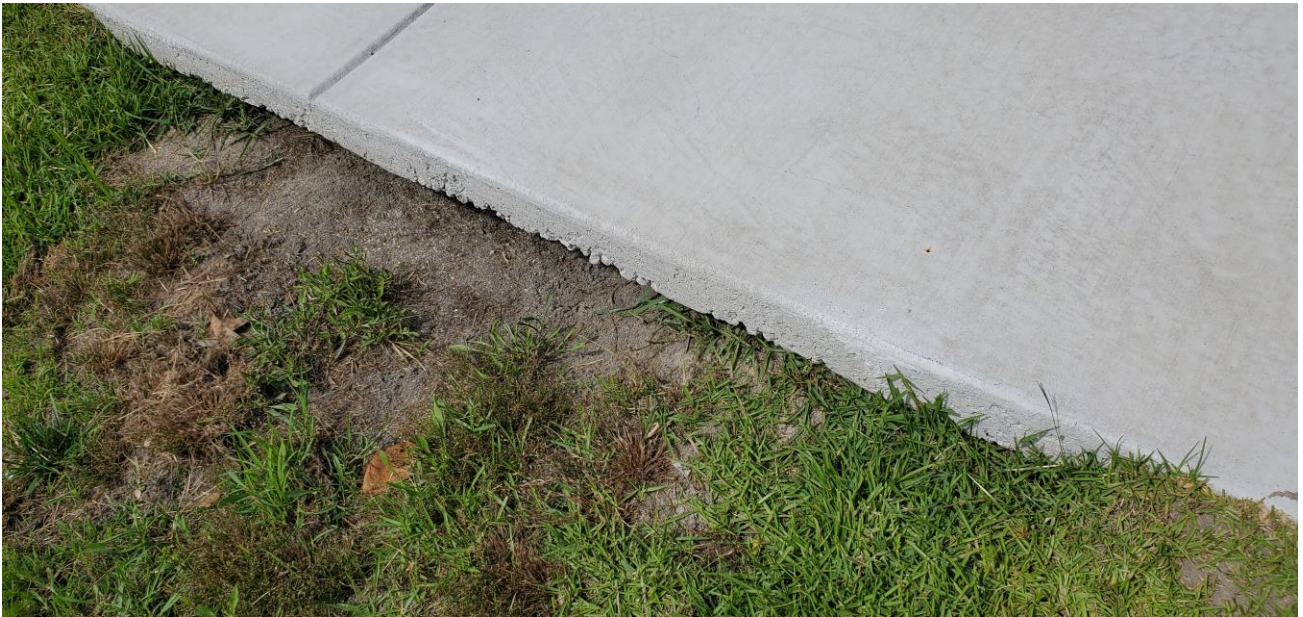
**Photo 10 and 11**

The sidewalks that are installed over the curb inlet areas do not have finished edges, honeycomb and form burrs were not corrected (photos 10 and 11).

- Recommend grinding the burrs and grouting the honeycomb to repair the sidewalks at these locations.

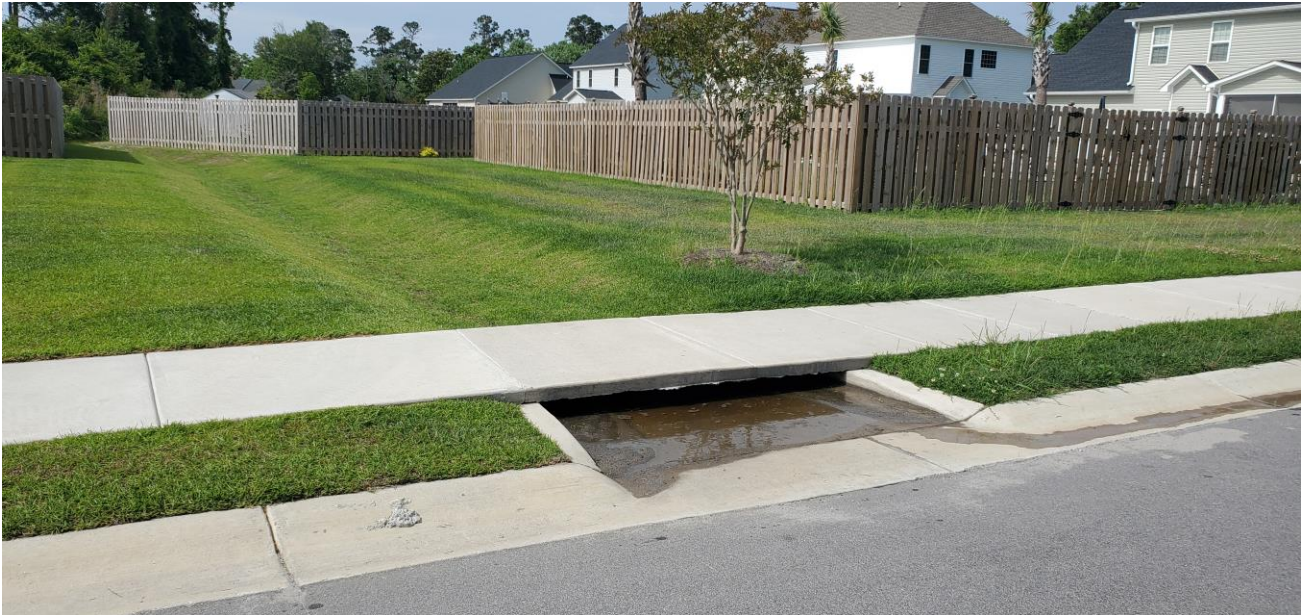
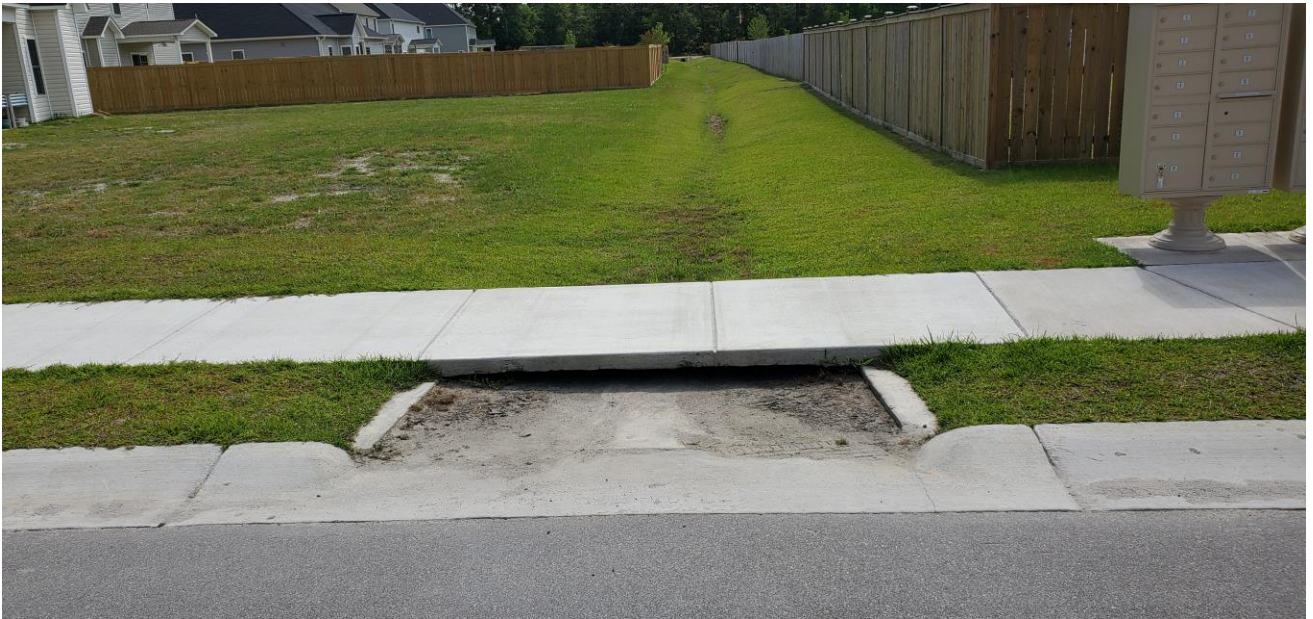
Photos 12 and 13

The drainage swales are not graded to provide positive drainage. The swales trap and pond water during and after rain events.

The drainage swales are not at the correct elevation at each of the curb inlets. There is no positive drainage from the roads/curbs through the curb inlets to the swales (photos 12 and 13).

- Recommend that all the swales be regraded to provide positive drainage and sodded after grading.

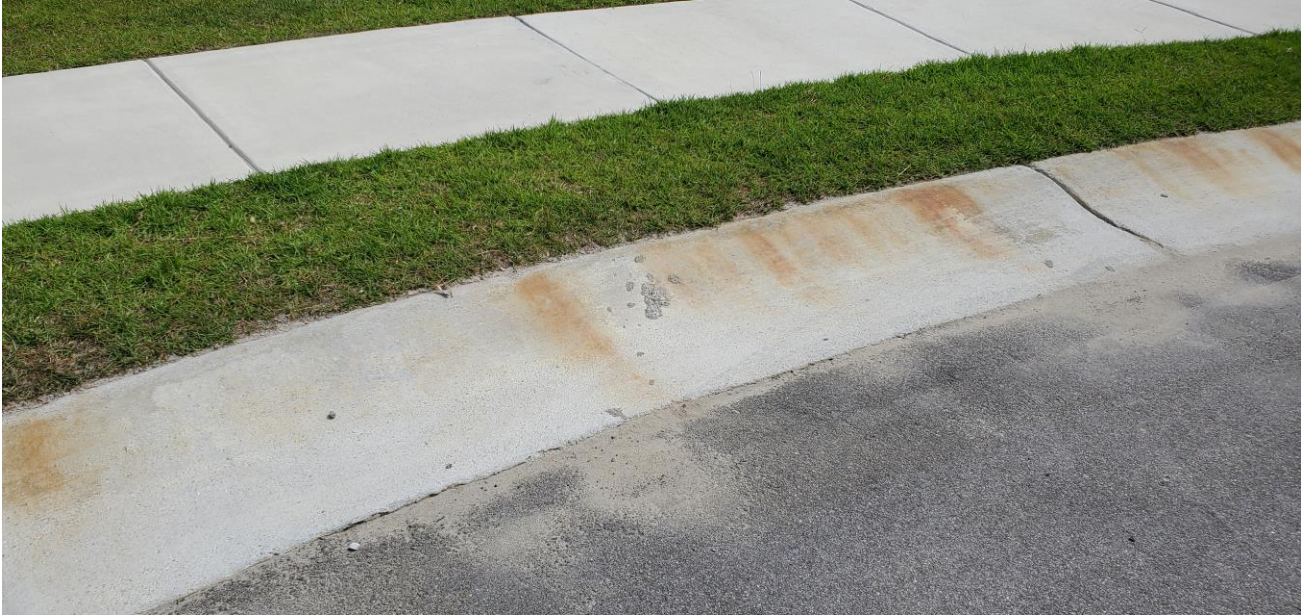
**Photo 14**

There is concrete spillage and dropping on the finished surfaces of the curb/gutter and the sidewalks throughout the subdivision that should be removed (photo 14).

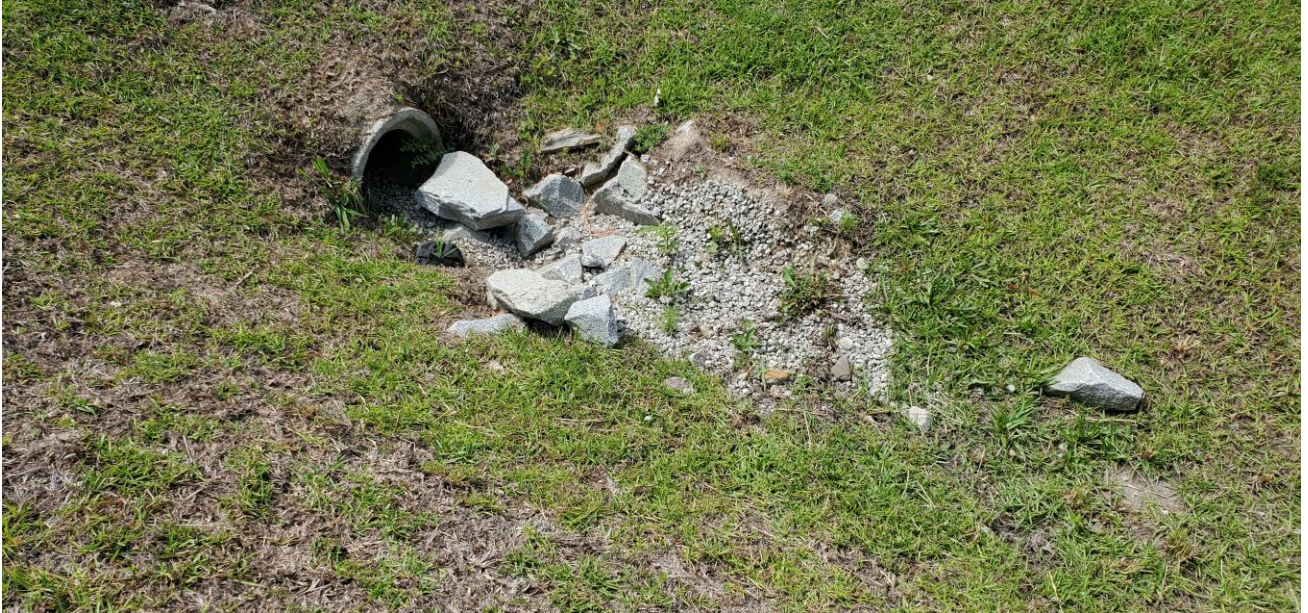
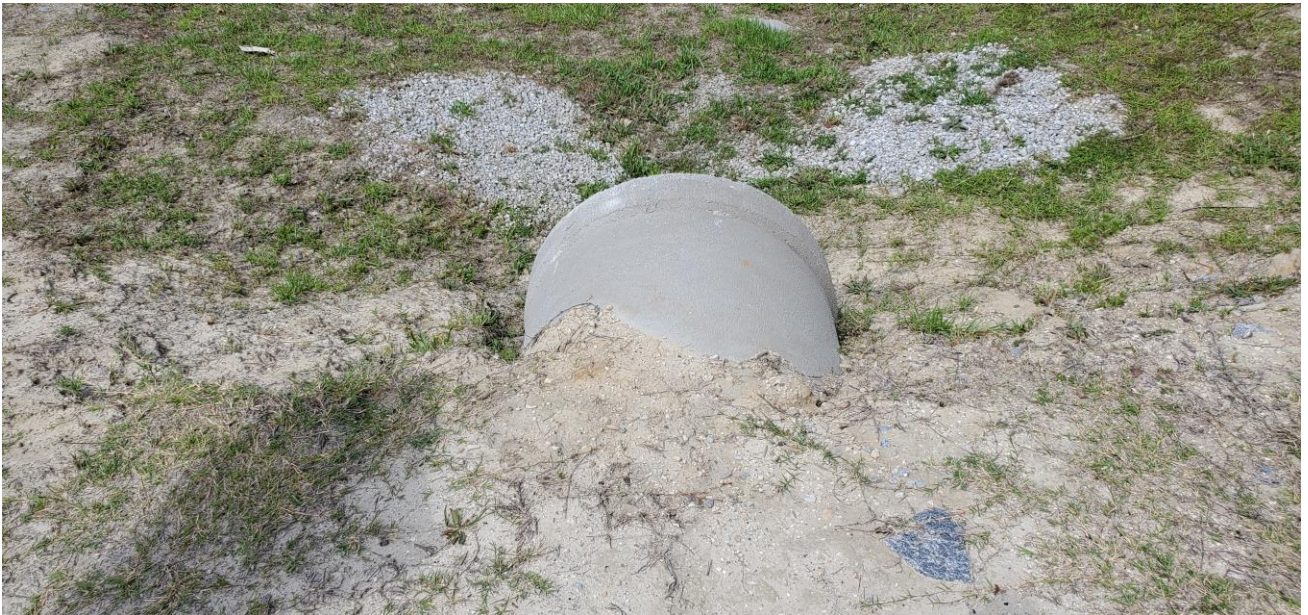
**Photo 15 and 16**

Remove the remaining riprap and stone that was used to form check dams during construction (photos 15 and 16).

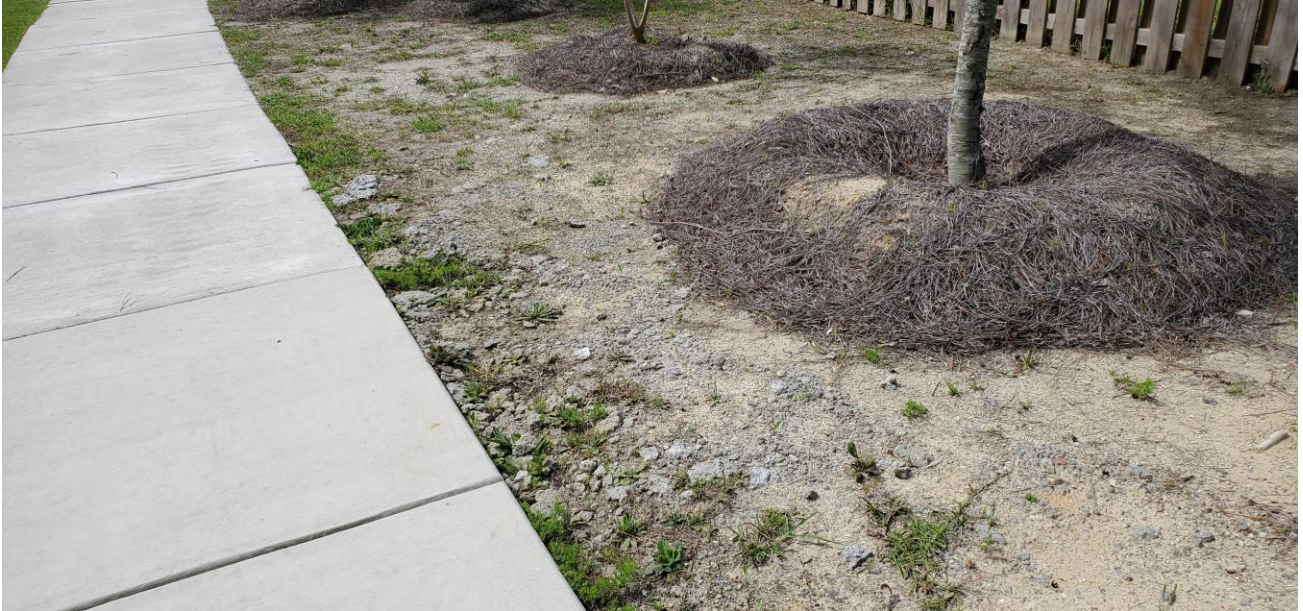
**Photo 17**

Remove concrete debris along the sidewalk on Swansboro Loop Road (photo 17).

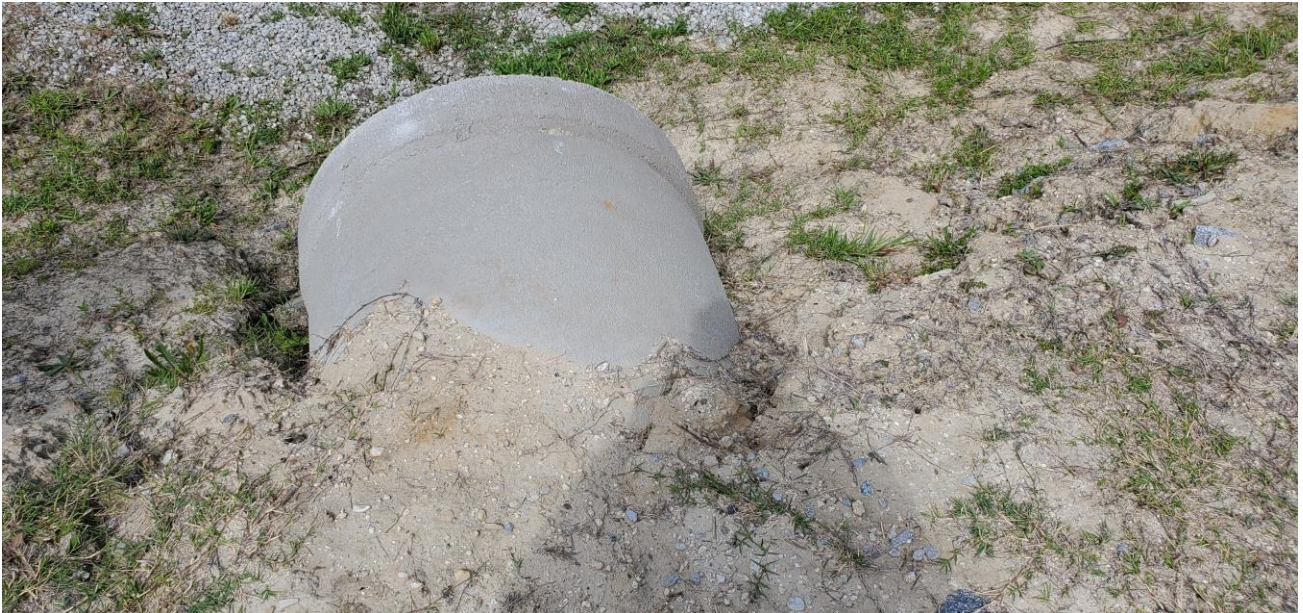
**Photo 18**

Grade and sod the culvert inlets that have eroded (photo 18).
