*Town of Swansboro Public Works Department*

*Civil Engineering Assessment  
Swansgate Subdivision  
Roads, Sidewalks and Drainage Areas  
Swansboro, NC*

*April 6, 2026*

*Submitted by: Larion PLLC, P-1146*

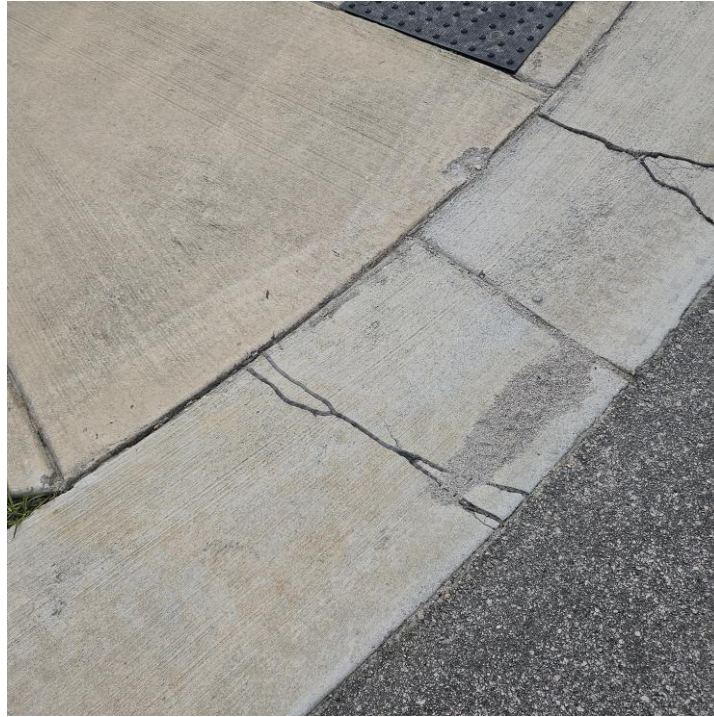
**Photo 1**

There are multiple locations where the curb and gutter are cracked (photos 1).

- The cracks have been filled with NP 1 polyurethane sealant.

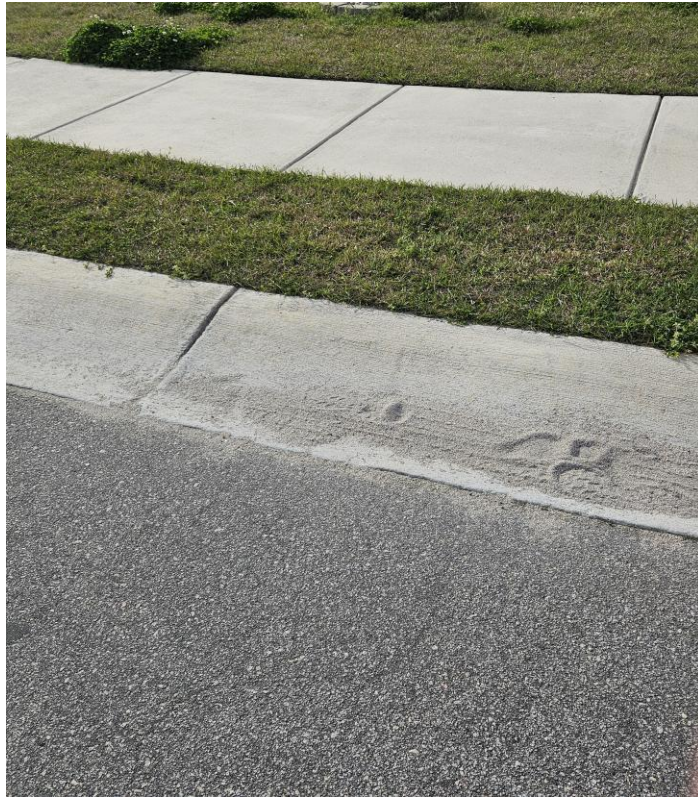
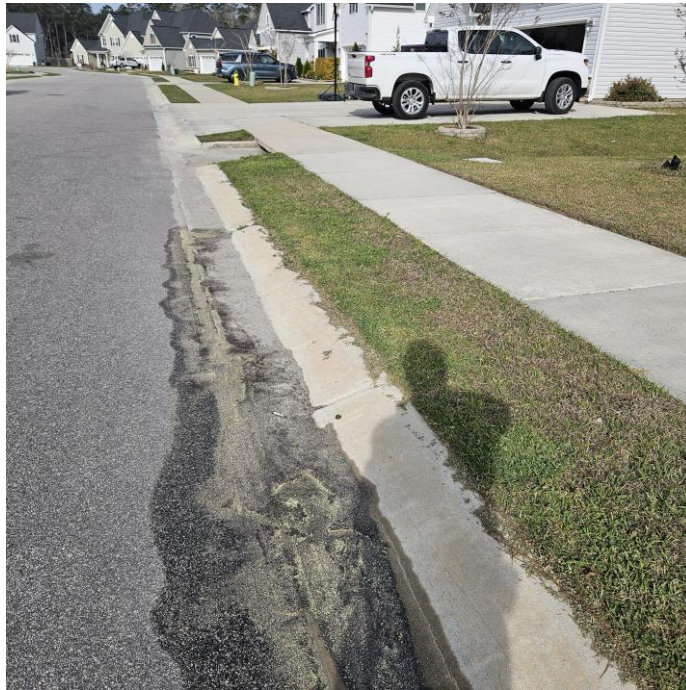
There are areas where the curb and gutter were not installed to provide positive drainage and are ponding water during rain events (photos 2 and 3). *This item has not been corrected.*

- It is recommended that these areas of curb and gutter be removed and reinstalled to correct elevation for positive drainage.

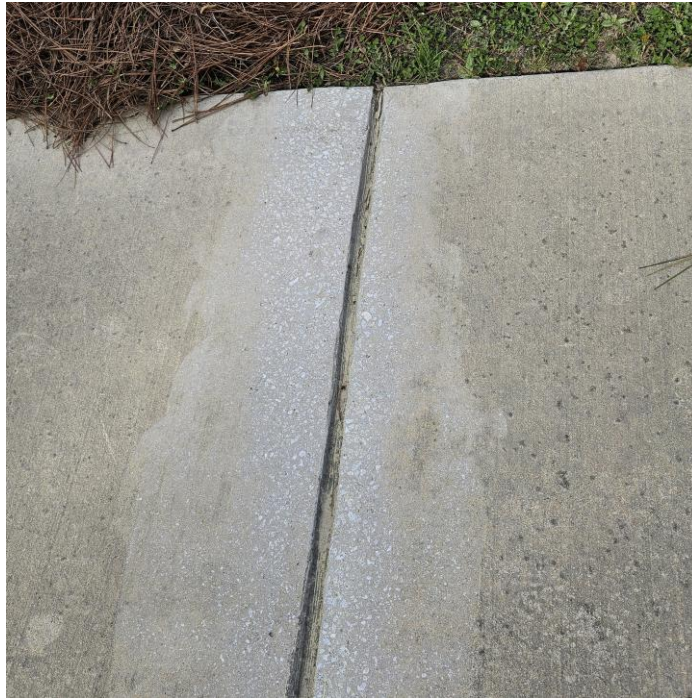
**Photo 4**

The sidewalk along Swansboro Loop Road has joints that are uneven/elevated with adjoining sidewalk sections at construction/control joints, multiple locations (photo 4).

- The joints in the sidewalks have been made flush with adjoining section.

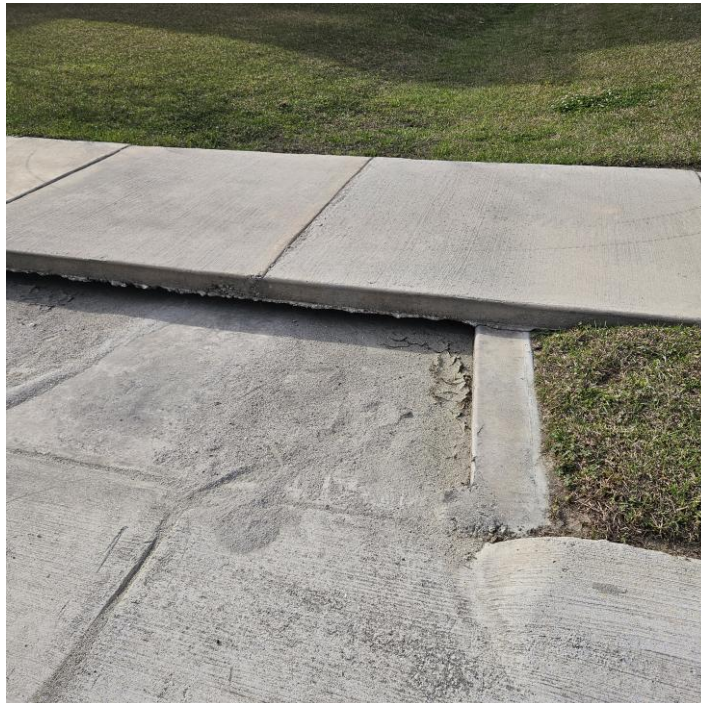
**Photo 5**

The sidewalks that are installed over the curb inlet areas do not have finished edges, honeycomb and form burrs were not corrected (photo 5).

- Recommend grinding the burrs and grouting the honeycomb to repair the sidewalks at these locations. *This item has not been corrected.*

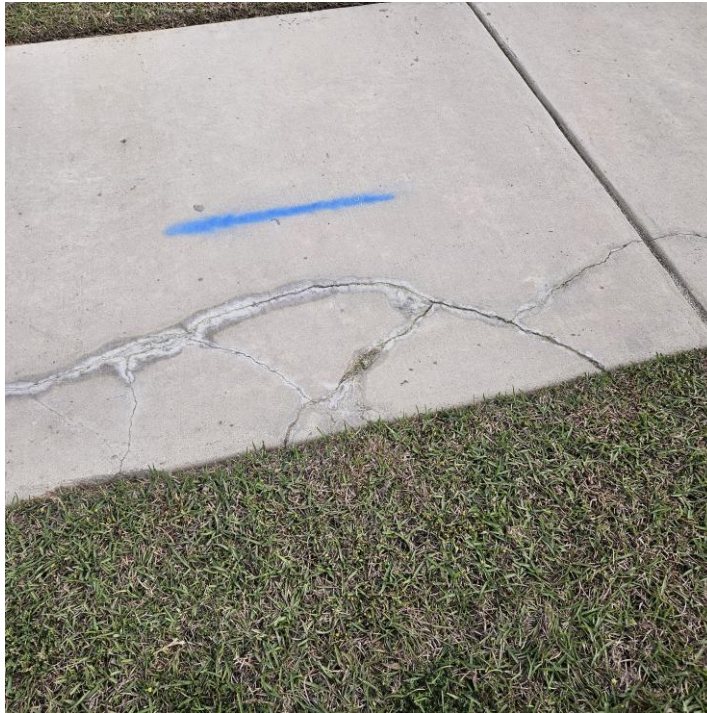
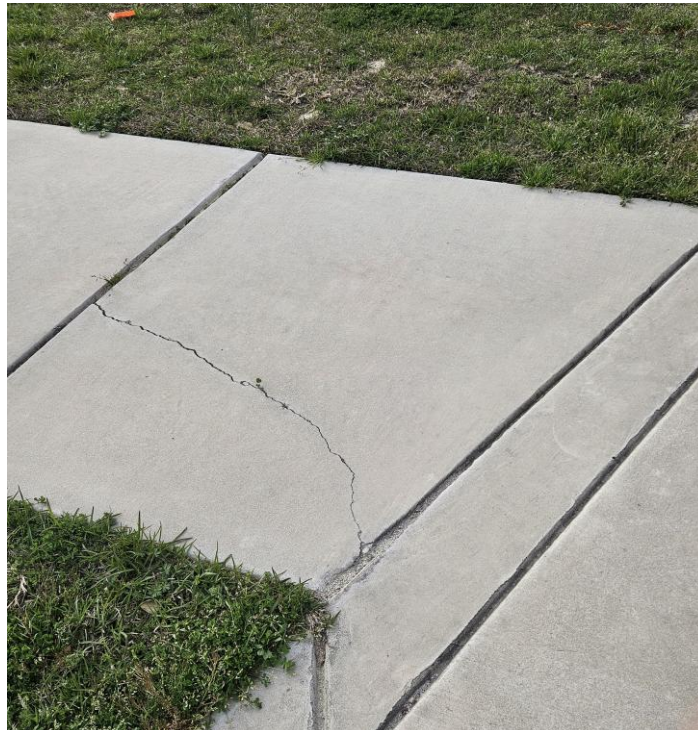
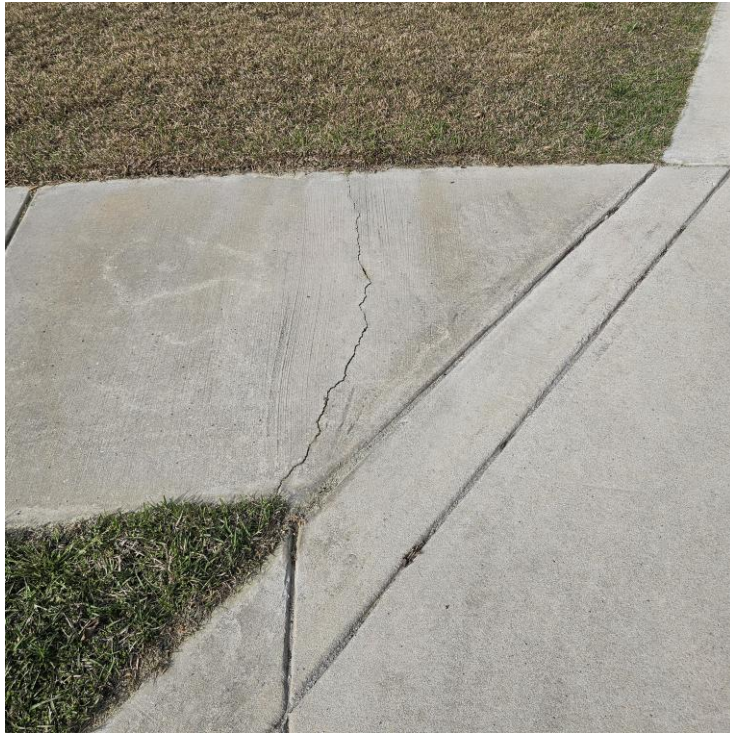
There are sections of sidewalk noted during this evaluation at the homes listed below that are damaged and cracked.

- This section of sidewalk at home 204 Tundra Trail should be replaced (photo 6).
- This section of sidewalk at home 205 Tundra Trail should be replaced (photo 7).
- This section of sidewalk at home 115 Tundra Trail should be replaced (photo 8).

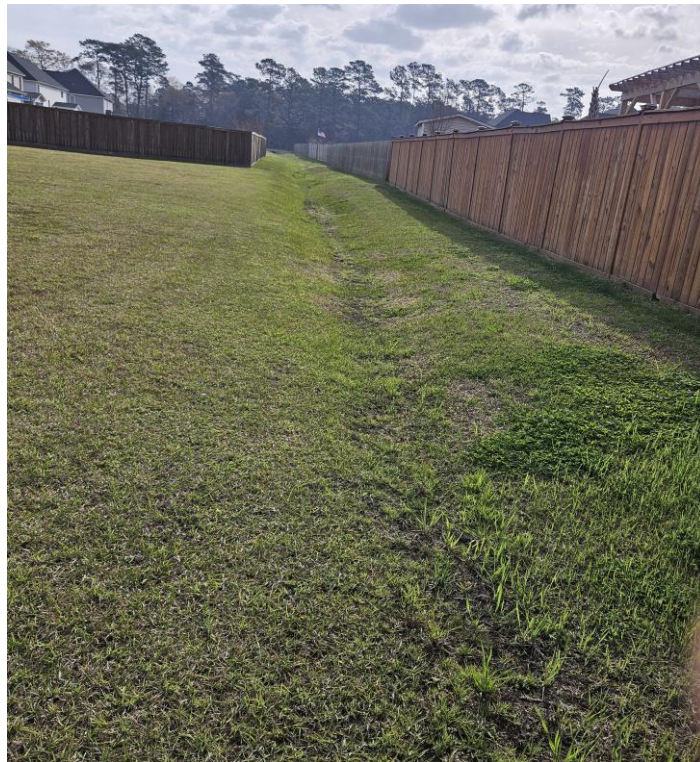
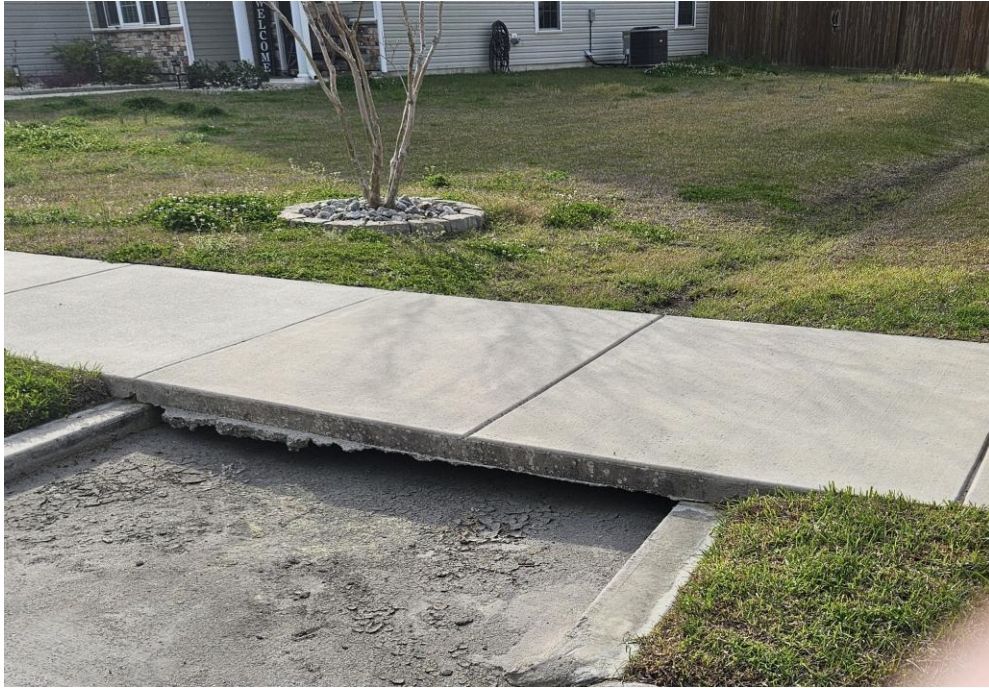
The drainage swales are not graded to provide positive drainage. The swales trap and pond water during and after rain events.

The drainage swales are not at the correct elevation at each of the curb inlets. There is no positive drainage from the roads/curbs through the curb inlets to the swales (photos 9 and 10).

- Recommend that all the swales be regraded to provide positive drainage and sodded after grading. This item has not been corrected.

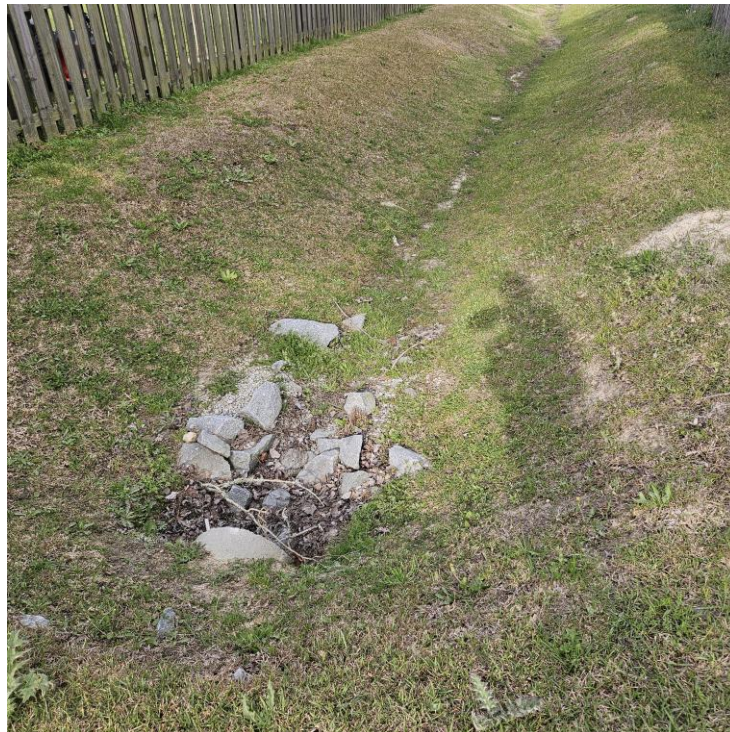
**Photo 11**

Remove the remaining riprap and stone that was used to form check dams during construction (photo 11). This item has not been corrected.

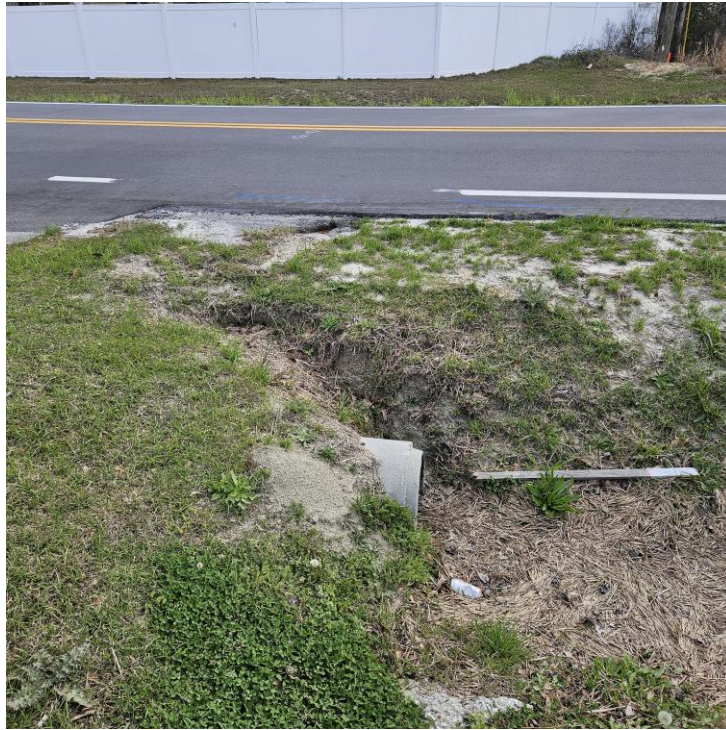
**Photo 12**

Grade and sod the culvert inlets that have eroded (photo 12). This item has not been corrected.

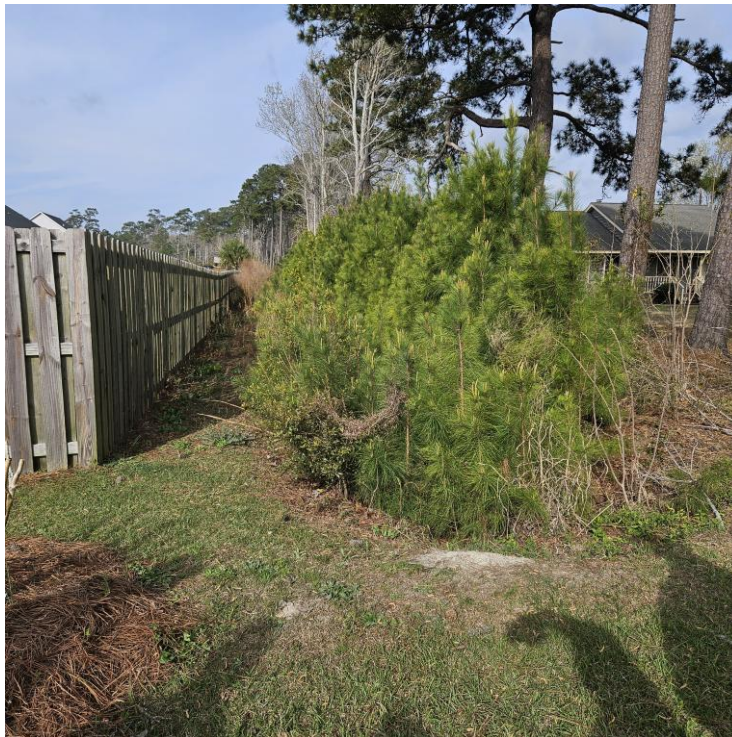
**Photo 13**

The drainage easement located along the back of the home on the north side of the development has not been maintained/mowed. The easement is now overgrown with small pine trees. This easement should be clear, graded and have turf established so that it can be easily maintained (photo 13)

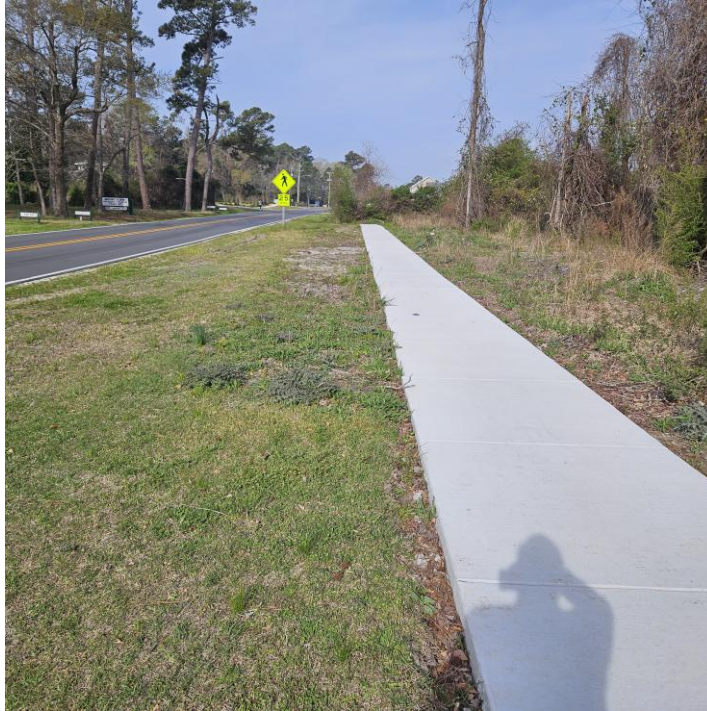
**Photo 14**

The new sidewalk installed along Main Street Extension needs to have the surrounding grade leveled to the top of the sidewalk, construction debris removed and turf established. (photo 14).
