INSPECTION REPORT

For the Property at:
203 CHURCH STREET
SWANSBORO, NC 28584

Prepared for: TANK BATES
Inspection Date: Tuesday, October 15, 2024
Prepared by: Kelly Honeycutt, 4741

Report No. 1846

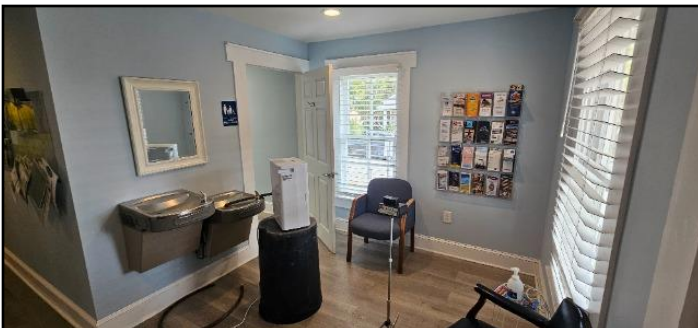
1. Front room - Dehumidifier installed

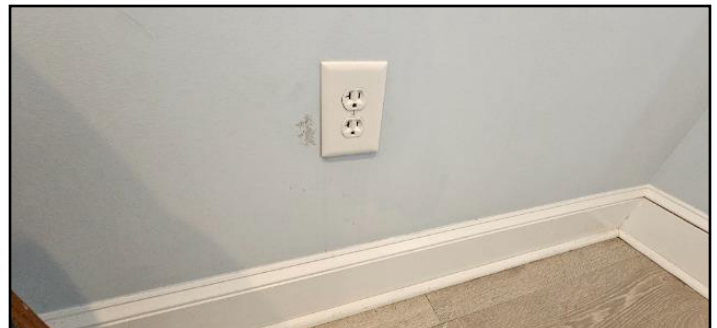
2. Condition: • Areas of air infiltration and visible growth were noted in the left side office areas. The rear wall built around the HVAC plenum was saturated. This is most likely due to condensation and this plenum may not be properly insulated. Condensation from the plenum has wet the drywall. This drywall should be removed so that the HVAC plenum can be evaluated by a licensed mechanical (HVAC) contractor and repaired. Any areas of visible mold growth in the wall cavity should be addressed by removing any wet drywall or drywall showing visible mold growth. As motioned previously, the infiltration of air around the perimeter of the exterior walls should be evaluated by a licensed general contractor. I recommend removing all of the drywall from the exterior walls to inspect the seal around the windows as well. Visible growth and air infiltration were noted at electrical outlets and above and below windows and above baseboards. The concern is that the visible evidence is a sign of more extensive mold growth or moisture issues in the wall cavities. I recommend removing all wet drywall, removing the baseboards, removing drywall and insulation 2 feet up from the floor and removing trim and drywall from around the window casings. If visible mold is discovered, continue to remove drywall and insulation 2 feet past visible mold growth. HEPA vacuum and clean the stud walls with an antimicrobial agent and dry the building materials to industry standards. An areas of air infiltration should be addressed while the wall cavity is open and corrected before remediation begins. If the source of moisture is not corrected, remediation practices and drying may need to be repeated.

2. Visible growth at wall outlet

Task: Tear our drywall and insulation as described above, correct the sources of moisture, remediated the wall cavities and dry the structure

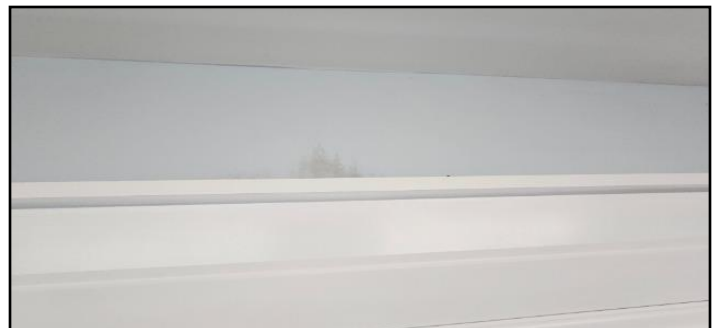
4. Visible growth or infiltration above window

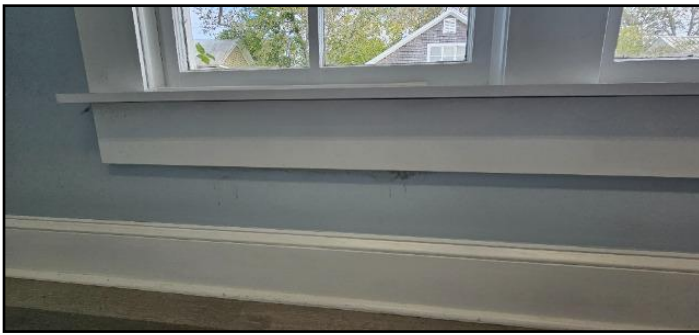
5. Visible growth or infiltration below window

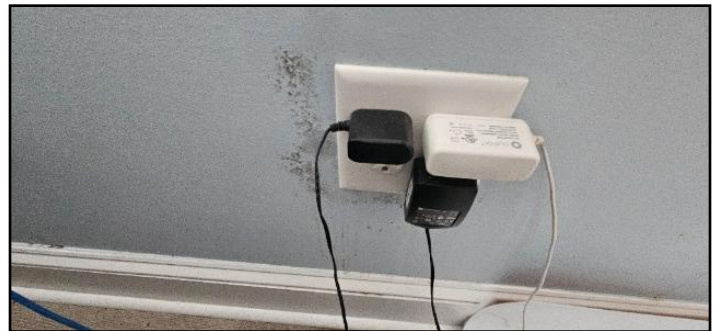
8. Visible growth around outlet

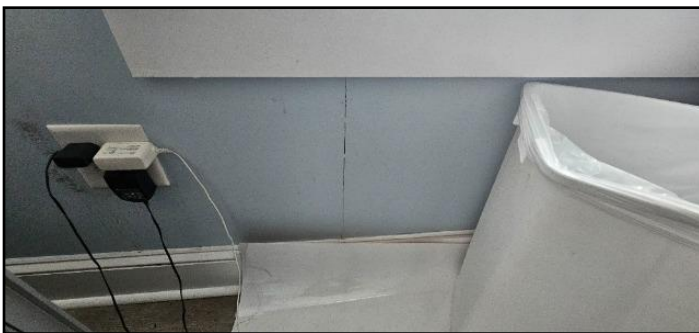
9. Visible growth at baseboard

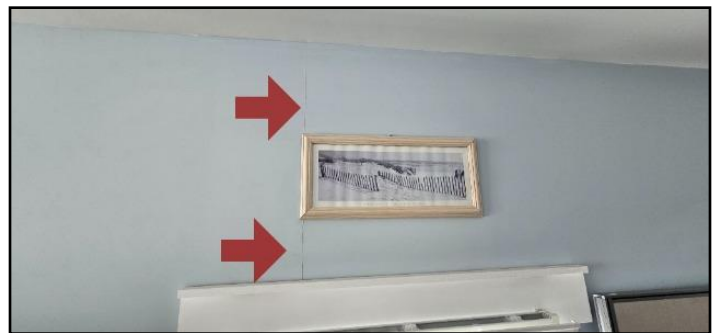
10. Crack in drywall

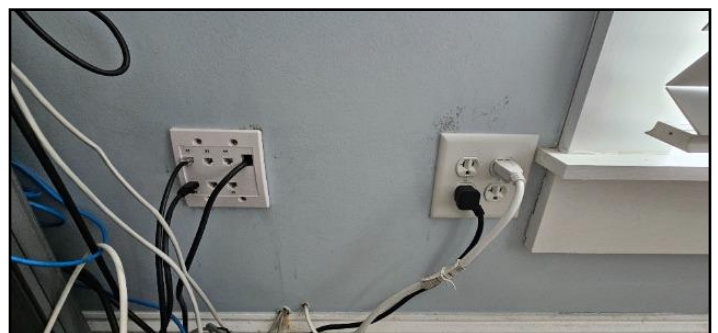
12. Visible growth around outlets

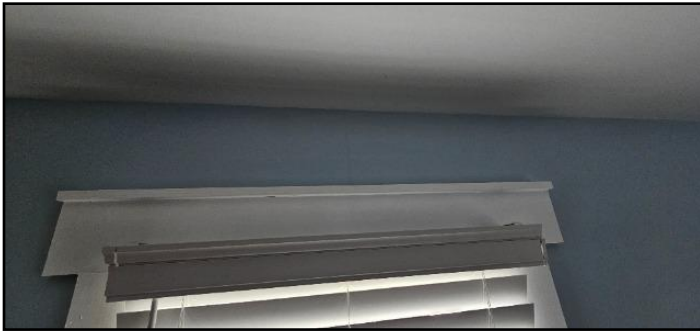
13. Visible growth above window

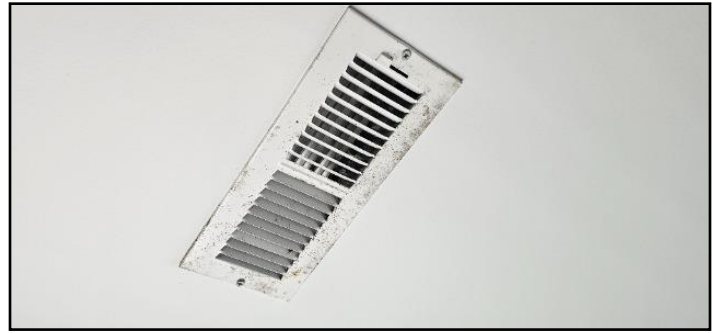
14. Visible growth around return

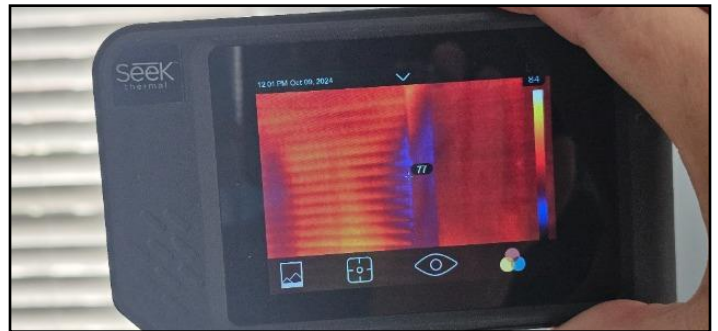
16. Moisture noted around window

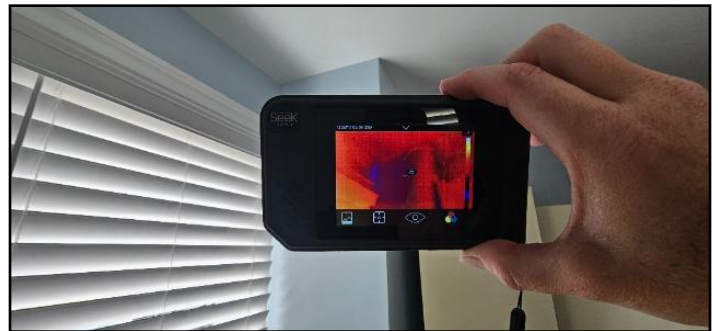
18. Moisture noted at drywall around plenum

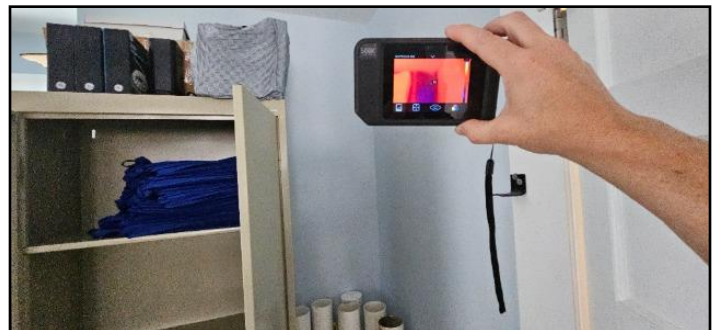
20. Moisture noted at drywall around plenum

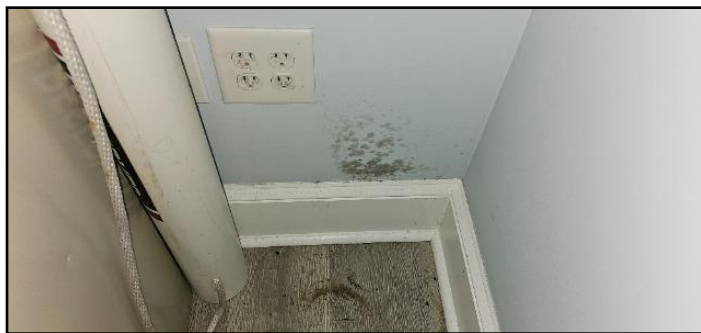
22. Visible growth on drywall near plenum

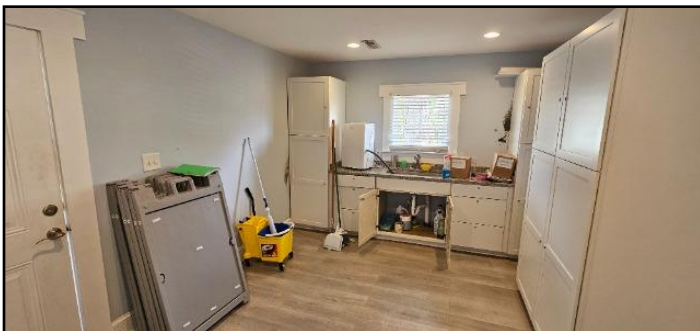
23. Kitchen

3. Condition: • Visible growth was noted on the wall behind the cabinets in the kitchen. There was also visible mold inside the cabinets. Moisture was detected in the wall cavity behind the cabinets indicating there may be infiltration coming from air leaks at the base of the wall. No water leaks were detected under the sink and no water leaks were noted in the crawlspace however, the plumbing lines under the house were contained above a sheet of vapor barrier that has been stapled to the joists. It is my hypothesis that air is infiltrating the wall cavity through unsealed areas under the home. This would cause moisture to be trapped in the wall behind the cabinets and, unlike other areas of the property, the cabinets area preventing the drywall from drying out and the trapped moisture behind the cabinets is causing heavy mold growth on the drywall. HVAC registers had visible signs of mold growth. Areas of moisture were detected around windows and above baseboards. An area of missing insulation was noted around the exhaust fan in the bathroom. I recommend further evaluation of the base of the wall cavity to see if there are open areas where air is able to infiltrate the wall. The vapor barrier that is stapled up under the plumbing for the kitchen should be removed and the plumbing lines and subfloor in this area should be evaluated. I recommend tearing out drywall 2 feet up from the floors and around windows and doors. The seal around windows and doors should be evaluated and corrected if necessary. Any drywall with visible mold growth should be torn out along with the insulation behind the drywall. The wall cavities should be HEPA vacuumed and cleaned with an antimicrobial agent and dried. Air scrubbers should be run during remediation practices. Again, the source of moisture and/or air filtration into the wall cavities should be corrected to prevent reoccurrence of the mold growth.

Task: Correct areas of air infiltration and moisture intrusion and remediate the property as necessary

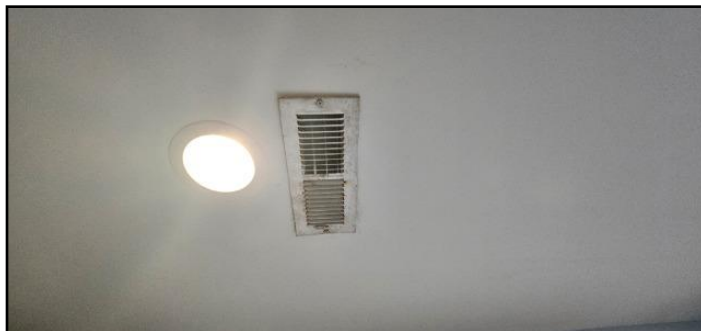
24. Visible growth on register

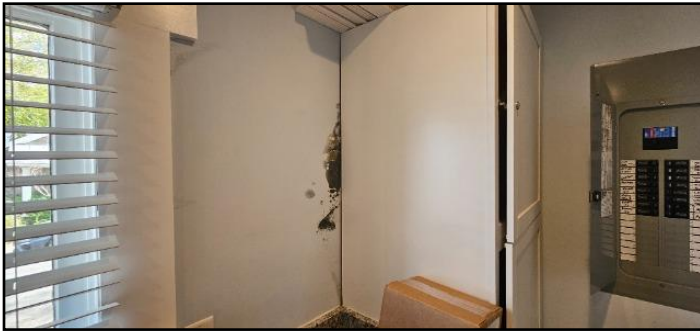
25. Visible growth on wall behind cabinet

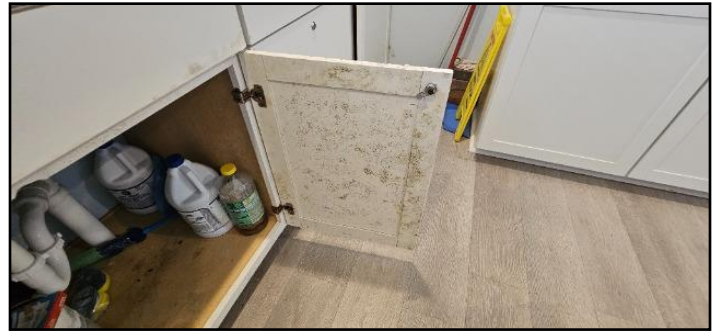
26. Visible growth on cabinets

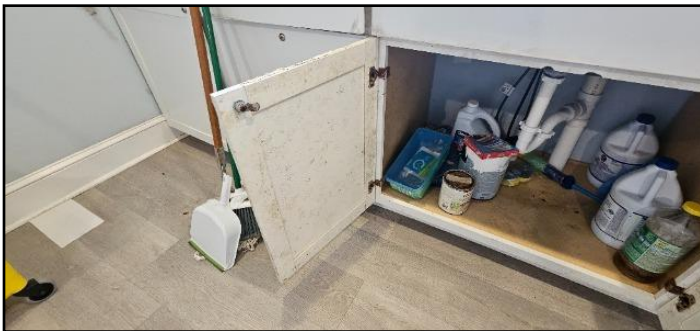
27. Visible growth on cabinets

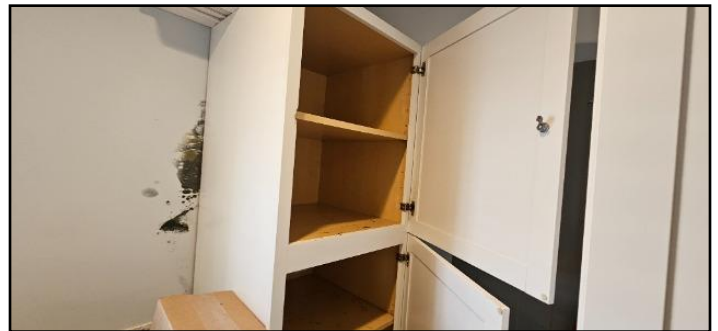
28. Visible growth on cabinets

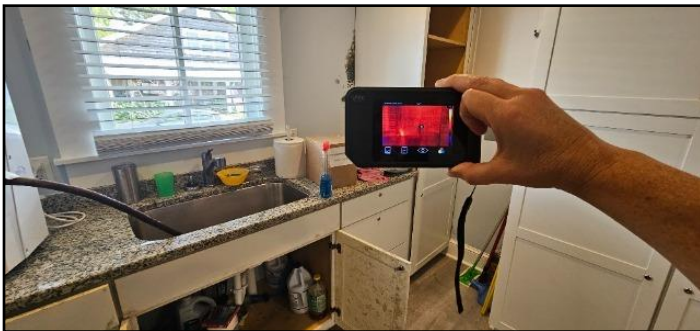
29. Moistuer behind wall

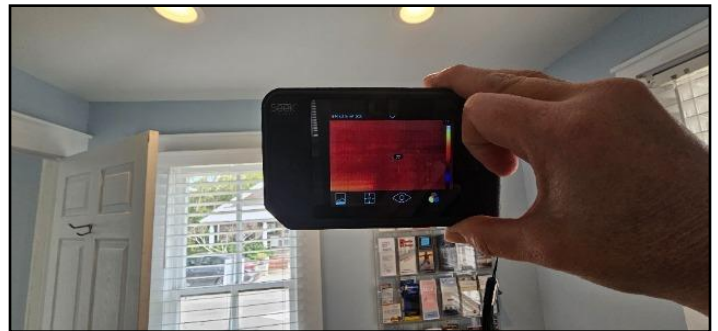
30. Moisture above window

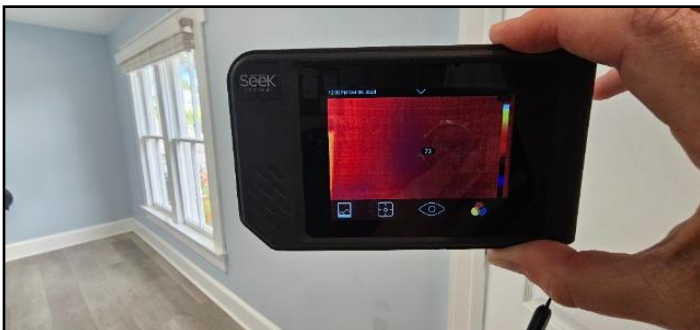
31. Moistuer in wall beside window

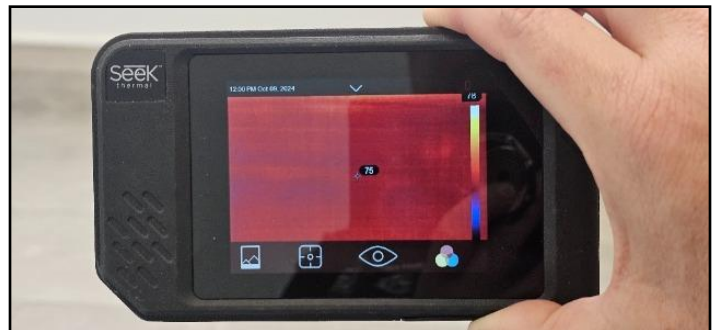
32. Moisture in wall above baseboards

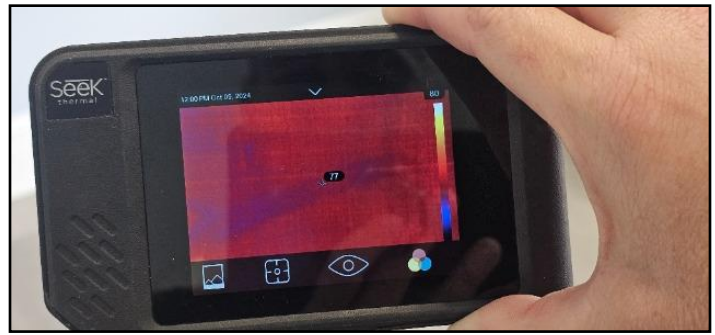
34. Moisture at baseboards

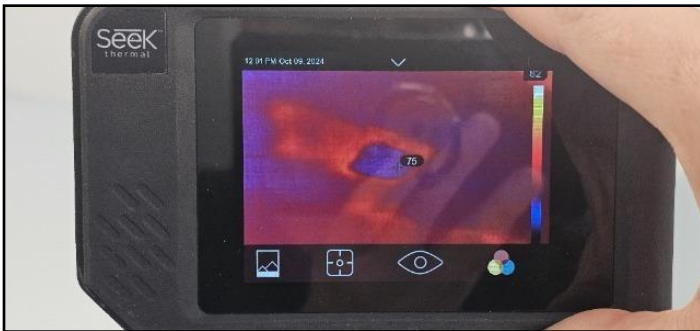
35. Missing insulation around exhaust fan

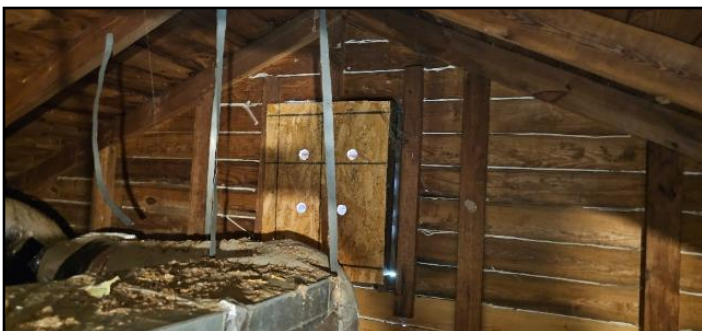
4. Condition: • The attic space was inspected as part of the investigation. Plywood boards had been installed over the gable vents. Holes were drilled into the plywood, however, the ventilation in the attic is inadequate. The drilled holes area not enough to properly ventilate the attic. The gable vents should be opened back up for proper ventilation. You can install screening behind the vents to prevent pest entry. There were also gaps noted between the siding boards and daylight was visible in the attic space. No sheathing is installed behind the wood siding. This may be an area where water can enter into the property. The ridge vent was open and appeared to be properly installed. The exhaust vent for the bathroom was not vented to the exterior and insulation around the vent was compressed. The exhaust fan should terminate to the exterior of the property to prevent high humidity in the bathroom. Duct tape (not proper mechanical grade duct tape) was installed on various ducts in the attic indicating there may have been some air leaks that were attempted to be repaired; however, black duct tape is not the correct material for this repair. When the tape gets hot, the glue can melt, and the tape can detach from the ducts. There may be air leaks from the duct lines that are leaking into the attic resulting in loss of heating and cooling, risk of high utility costs and risk of condensation formation in the attic that can raise the humidity of the air being pumped into the conditioned space. The water heater is installed in the attic and a hole has been drilled in the side of the pan, however, the drain line is capped. This does not allow water to drain out of the pan. I recommend installing a drain line from the line at the water heater pan that terminates to the exterior to prevent water damage in the property if the water heater fails. The edge of the top of the drywall from the exterior and interior walls was visible in the attic and mold growth was noted on the drywall. This is not typical building practice and should be evaluated by a general contractor. Once the damaged drywall in the property is removed, new drywall should be installed according to industry practices. I recommend further evaluation of the ventilation in the attic space and correction as necessary, installing a duct line from the bathroom exhaust fan that terminates to the exterior and replacing the compressed insulation around the exhaust fan, and having the ductwork in the attic further evaluated by a mechanical (HVAC) contractor and repaired as necessary to prevent air leaks into the attic space. The gaps in the wood siding should be addressed. There is no sheathing installed behind the siding. I recommend further evaluation by a general contractor and correction as necessary to prevent water entry into the attic from the siding. I also recommend further evaluation of the siding once the exterior walls from the interior of the property have been removed to see if there

37. Gable vent covered with plywood

Task: Further evaluation of the attic space, including inspection of the ductwork, installation of siding, amount of ventilation, termination of the exhaust fan and exposed edges of drywall that had visible mold growth on the edges

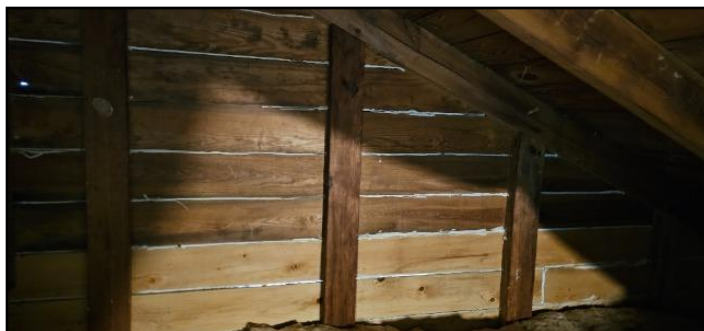
38. Gaps between wood siding

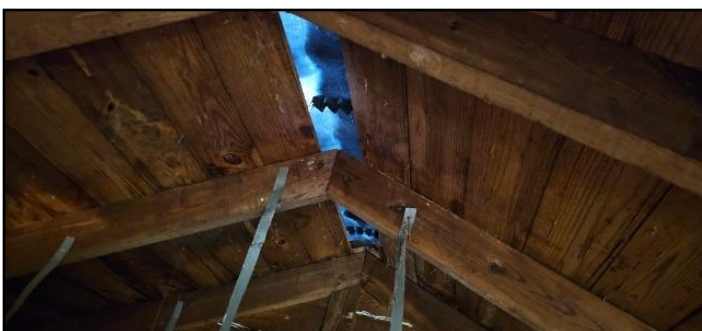
39. Ridge vent looks adequate

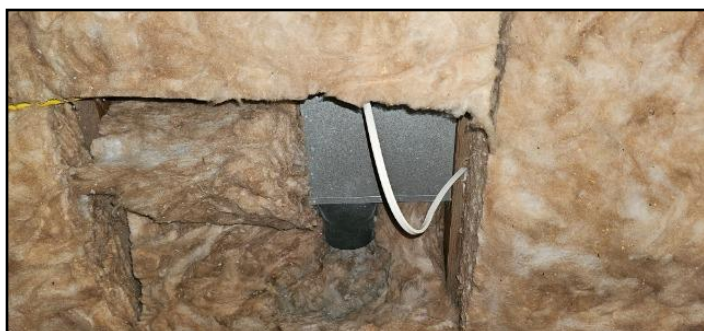
40. Exhaust fan not exhausted to exterior

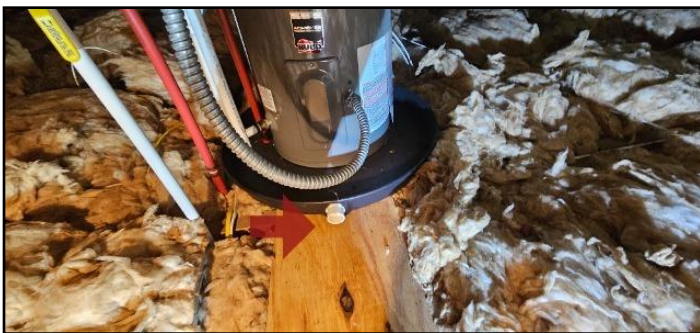
43. Drain line capped - improper

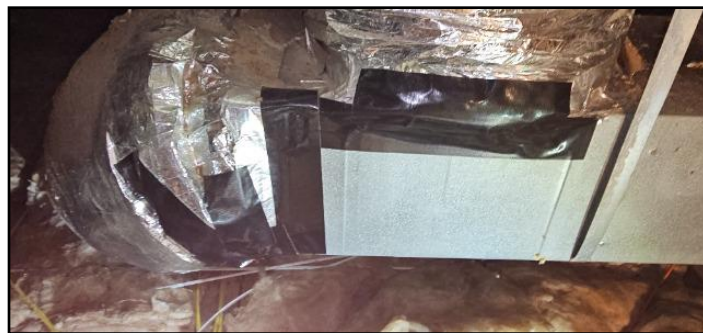
44. Ductwork repaired with improper duct tape

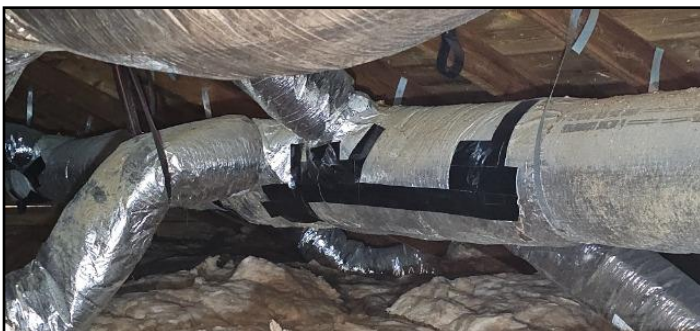
45. Ductwork repaired with improper duct tape

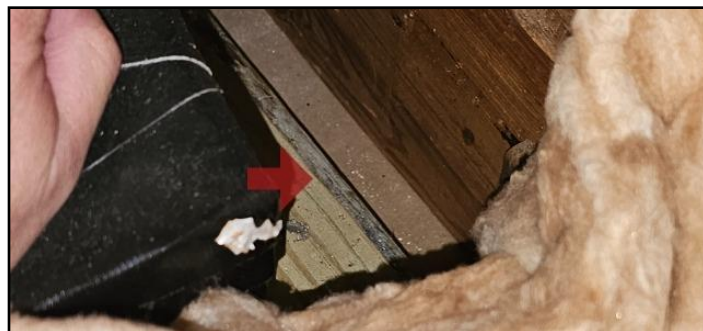
46. Edge of drywall visible from the attic

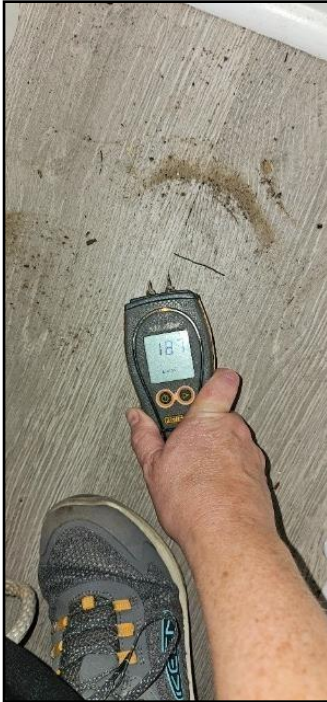
The floors throughout the property had moderate to high moisture readings. Due to the wet subfloor noted in the crawlspace and the moisture issue noted throughout the property, I recommend removing the floor covering as part of the remediation process. Once the floor covering has been removed, the subfloor should be evaluated. Any areas of deteriorated or rotted subfloor should be replaced and remaining subfloor in the property should be HEAP vacuumed, cleaned with an antimicrobial agent and dried to industry standards.

47. Water damage

Task: Remove floor covering and follow remediation practices as listed above

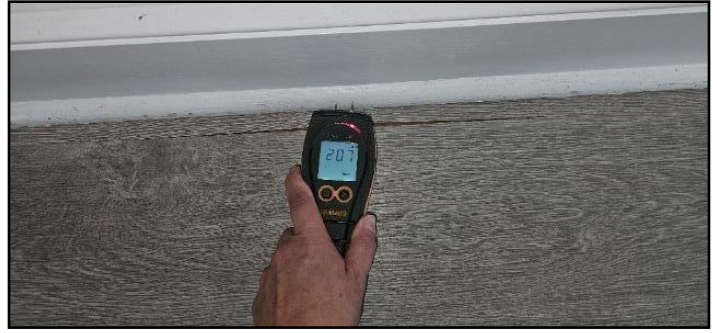
48. Water damage

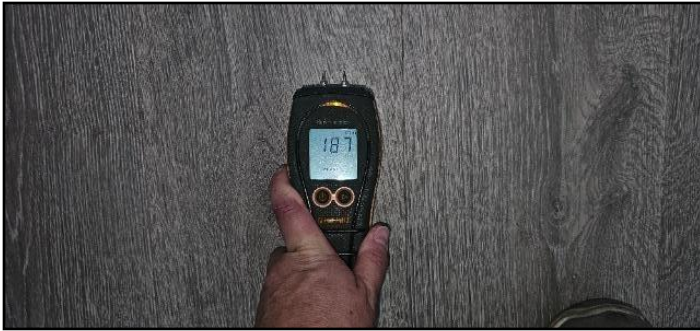
49. Water damage

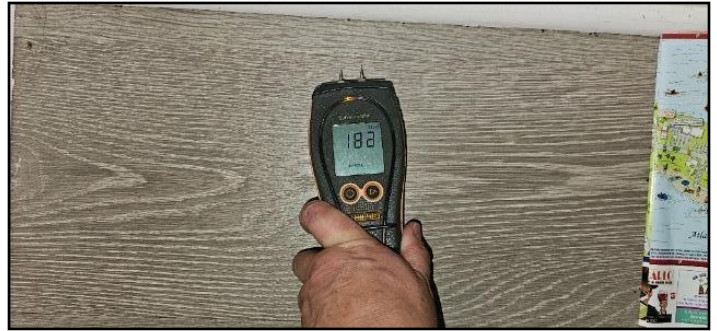
50. Water damage

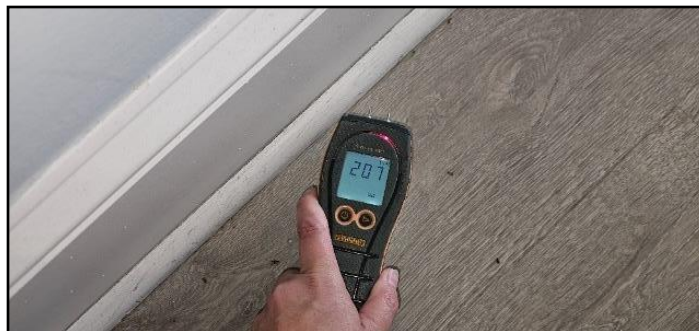
51. Water damage

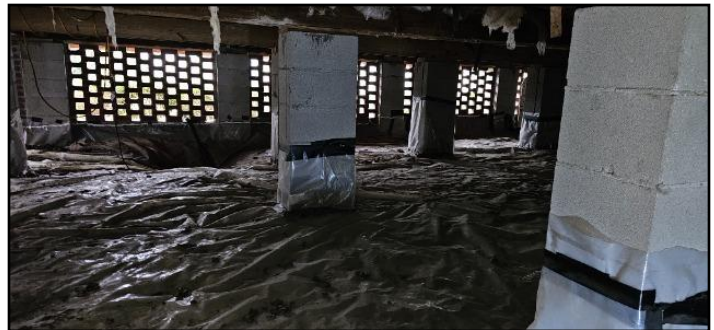
6. Condition: • The crawlspace was inspected as part of the investigation. The crawlspace is partially below grade and plastic vapor barrier has been "taped" up around the perimeter of the crawlspace wall to prey to prevent ground water from entering and standing on top of the vapor barrier. The crawlspace is well ventilated but the staggered bricks that allow for ventilation also allow water to enter the crawlspace and sit on top of the vapor barrier. This can cause high humidity in the crawlspace. Two main issues were noted in the crawlspace that are contributing to the mold growth in the property. The drywall from the middle wall was visible in the crawlspace. There is a gap in the subfloor down the middle of the crawlspace that allows the drywall to be exposed and air from the crawlspace to infiltrate into the wall cavity. There was also an area of saturated subfloor at the rear of the crawlspace near the HVAC plenum. This subfloor was saturated and may need to be replaced. Mold growth was noted on the subfloor in this area and in other areas of the crawlspace. Fifty percent of the insulation was missing in the crawlspace. There are several ways to correct the issues in the crawlspace. A vapor barrier can be installed under the floor joists instead of on the floor of the crawlspace. This would be more effective as the crawlspace is below grade and the brick is very open allowing water to sit on top of a vapor barrier that has been installed on the ground. This type of vapor barrier installation is very similar to how belly paper is installed under a mobile home but would be a suitable option in this instance due to the construction of the property. The exposed drywall, missing subfloor, saturated subfloor in the rear of the building and the visible mold growth on the subfloor and joists should all be addressed before making corrections to the installation of the new vapor barrier. I am available to discuss options for correct the moisture issues in the crawlspace if you decide to move forward with the remediation of the property.

53. Vapor barrier on crawlspace floor

Task: Repair issues with HVAC system, remove insulation from under the floor, evaluate and replace areas of deteriorated or rotted subfloor, clean joists and subfloor throughout the crawlspace, dry the structure and install an effective vapor barrier

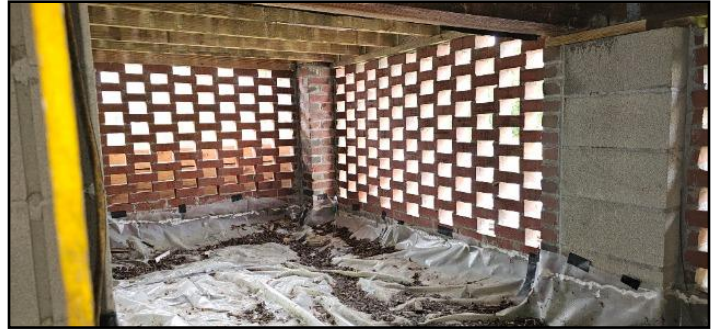
55. *Crawlspace below grade*

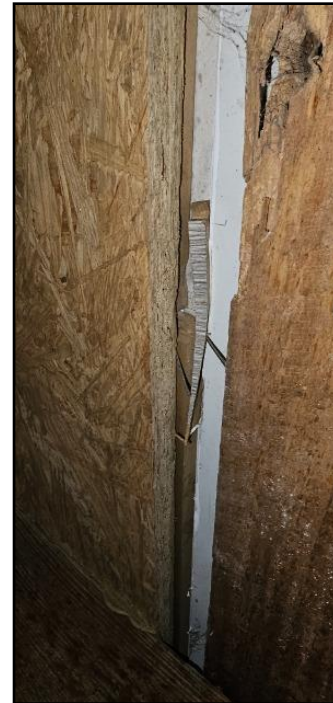
The subfloor is not complete down the middle of the property and the drywall from the middle interior wall is exposed to the unconditioned crawlspace. It is not recommended to have drywall exposed to the exterior in any area. I recommend removing the drywall on the middle wall, inspecting the stud wall for signs of moisture damage and mold growth, and removing the wall in order to install subfloor under the wall. This may require some temporary supports be built to support the structure if this middle wall is structural. That should be determined by a licensed general contractor before removing the stud wall.

57. *Subfloor missing*

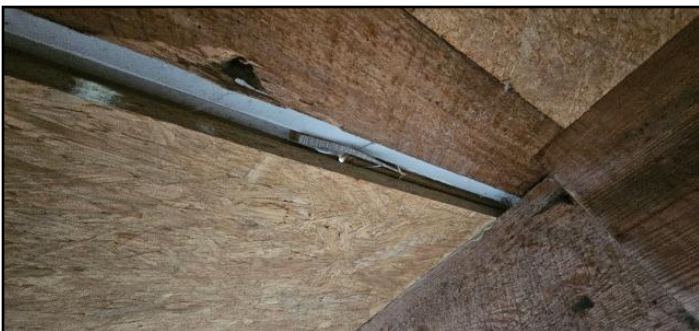
58. *Exposed drywall in crawl*

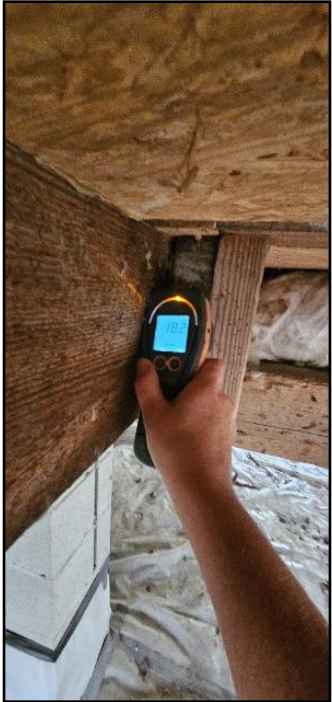
62. Wet drywall exposed in crawlspace

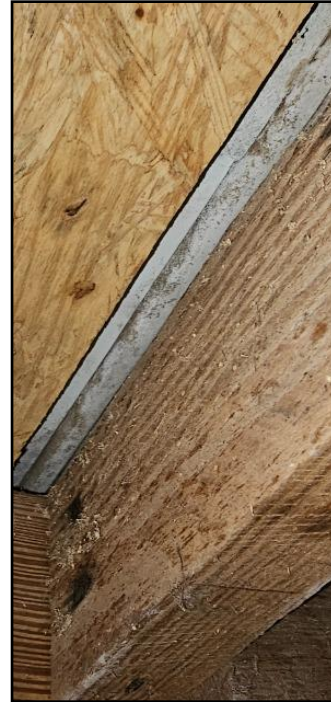
63. Microbial growth on drywall

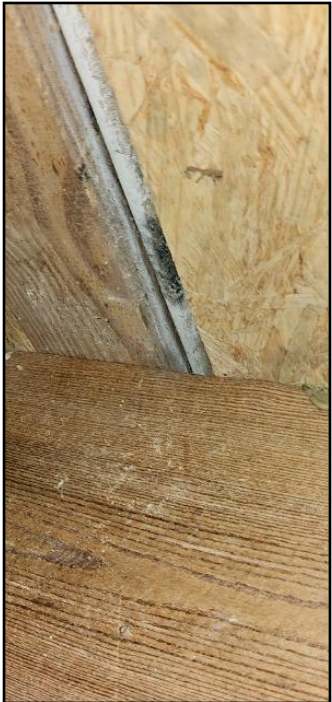
64. Microbial growth on drywall

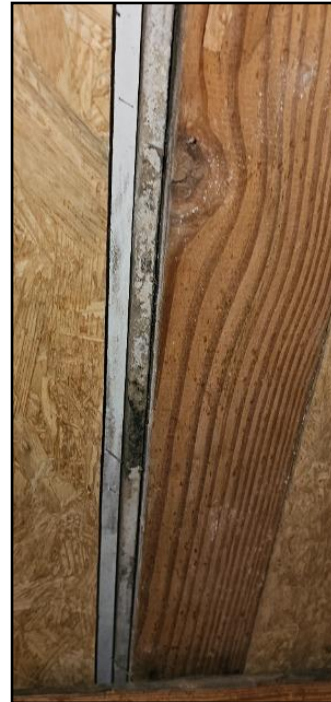
65. Microbial growth on drywall

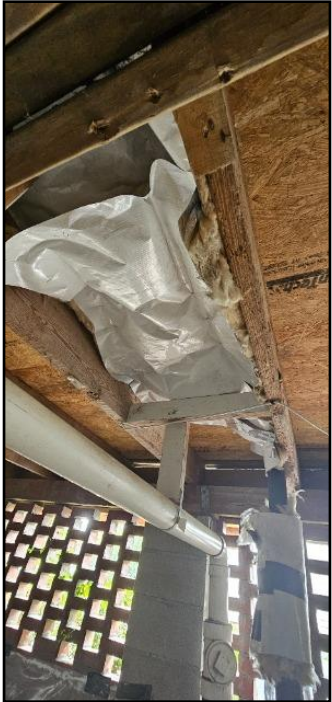
66. Plumbing access limited due to plastic

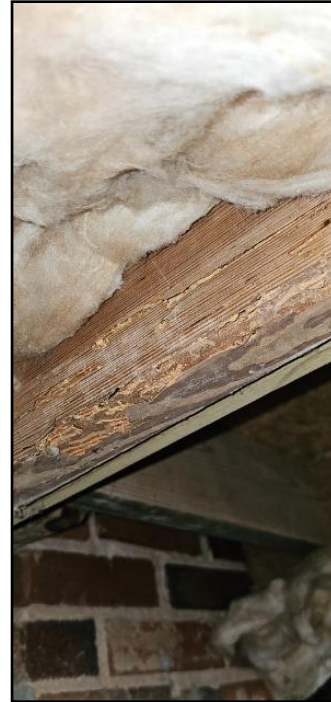
67. Visible growth on floor joists

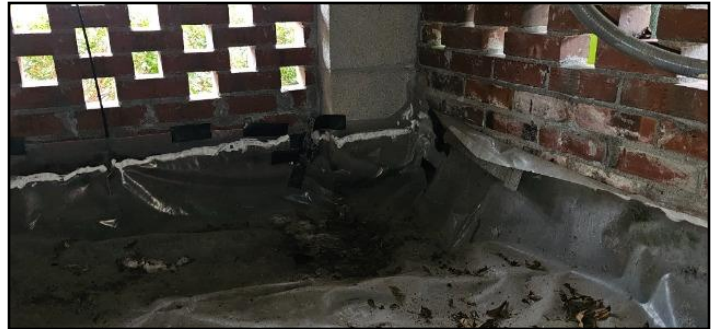
69. Crawlspace below grade

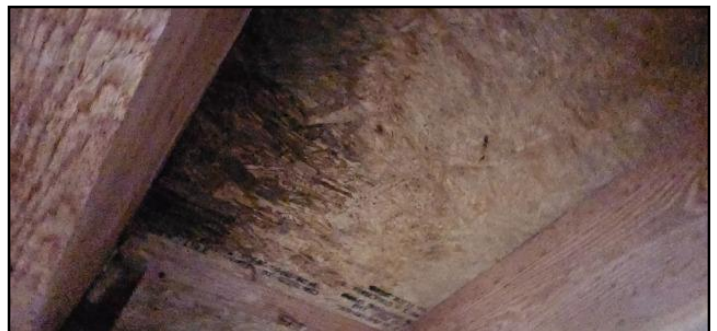
Implication(s): Visible mold growth in the crawlspace and an area of saturated subfloor at the rear of the crawlspace from the condensation coming from the plenum that is installed at the back of the property.

71. Wet subfloor near HVAC plenum

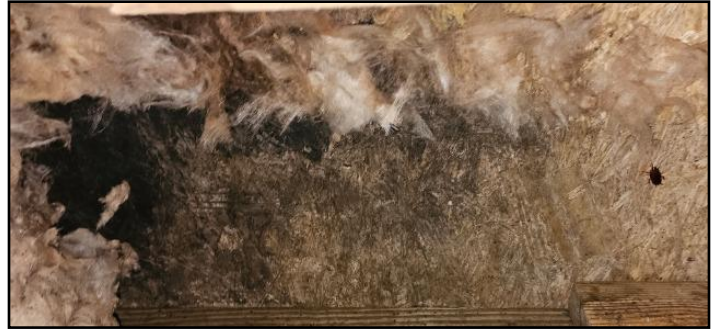
73. Visible mold growth

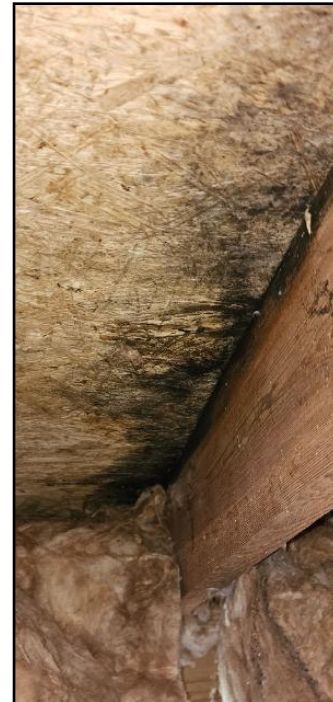
77. Wet subfloor near HVAC plenum

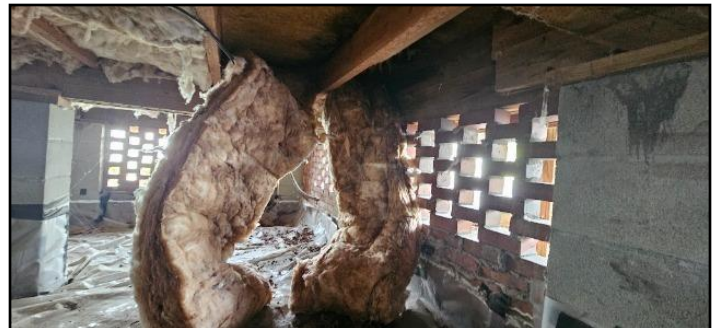
79. Area of wet subfloor due to condensation HVAC

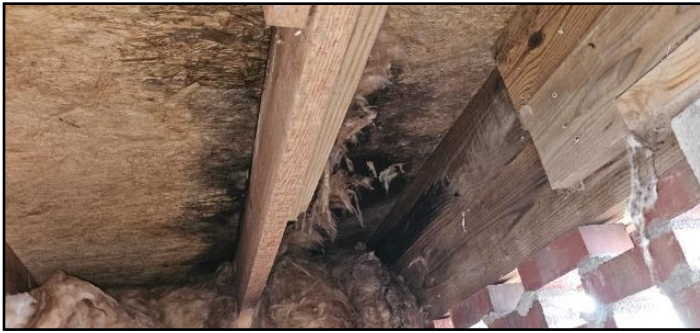
80. *Water damaged subfloor*

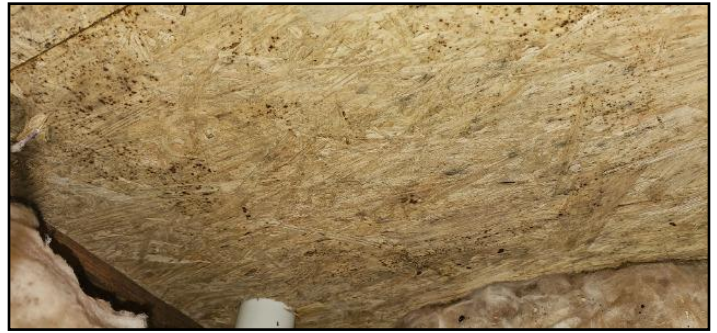
81. *Visible growth on subfloor*
