IAQ Environmental

Client Name: The City of Sweeny

Location Address: 111 W Third St Sweeny, TX 77480

Date: 04/25/2023

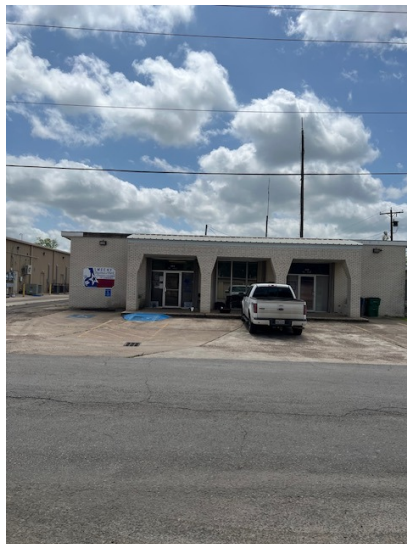
There appears to be water intrusion located at the front door (see photo)
