Hydrant Testing Plan Memorandum

SUBJECT: Hydrant Testing Plan – City of Sweet Home Water Master Plan

Technical Memorandum	
To: Sandrine Ganry West Yost	Project: Sweet Home Water Master Plan
From: Wolfe Lang, PE Delve Underground	cc:
Prepared by: Luke Ferguson, PE Delve Underground	Job No.: 6342.0
Date: May 31, 2023	
Subject: Seismic Hazards Evaluation - FINAL

STRUCTURAL TECHNICAL MEMORANDUM

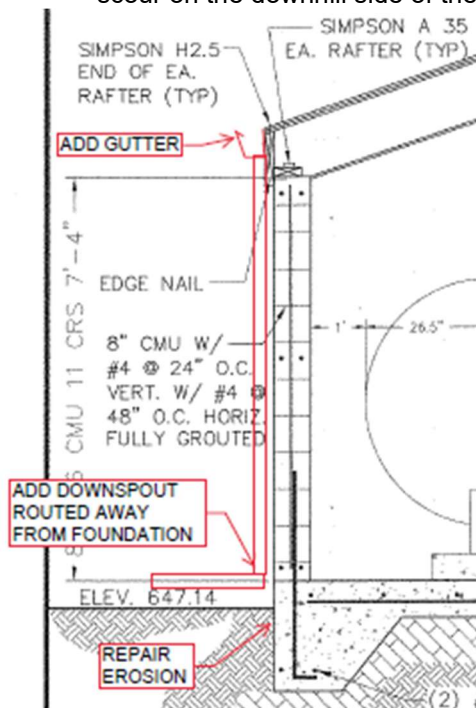
Figure 6.1 Raw Water Intake

The Raw Water Intake structure is considered a Reinforced Masonry Bearing Walls with Flexible Diaphragm (RM1) structure. No deficiencies were found in the checklists for the Raw Water Intake structure. The only non-structural deficiency found during the site observation is:

- Lack of rain gutter on the back side of the roof contributing to some minor exposure or scour on the downhill side of the building.

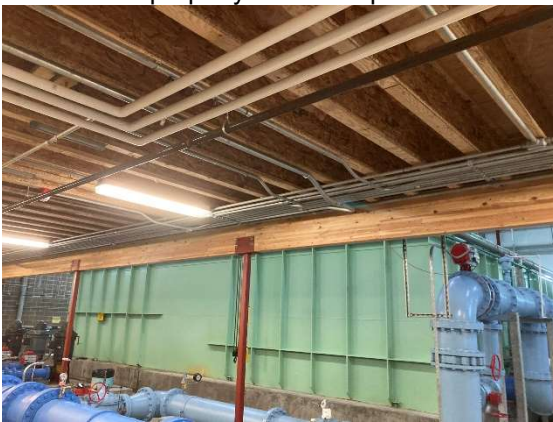
Fig 6.3.1 Open Mezzanine Lacks Redundancy

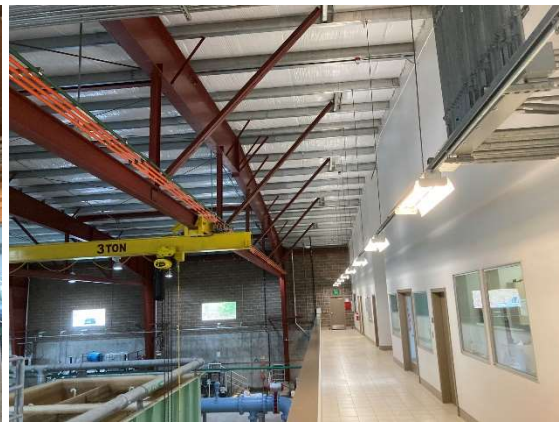
Figure 6.3.2 Lights & Conduits at Egress

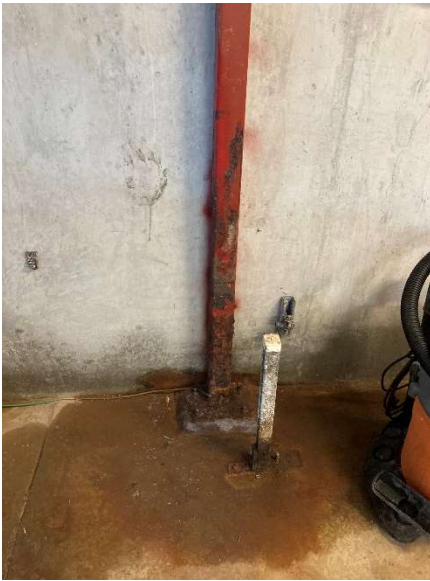
The structure was built in 2008 and is in good condition despite some issues. Steven pointed out some insulation that became saturated when condensation building up on the underside of the metal roof. Rust and corrosion was observed near the base of most of the steel columns.

Figure 6.3.3 Corrosion at Steel Columns

- The condensation buildup above the insulation should be addressed to prevent further failure of the insulation.
- The rust and corrosion around the base of the steel columns should be treated, repaired and properly coated to prevent further deterioration.

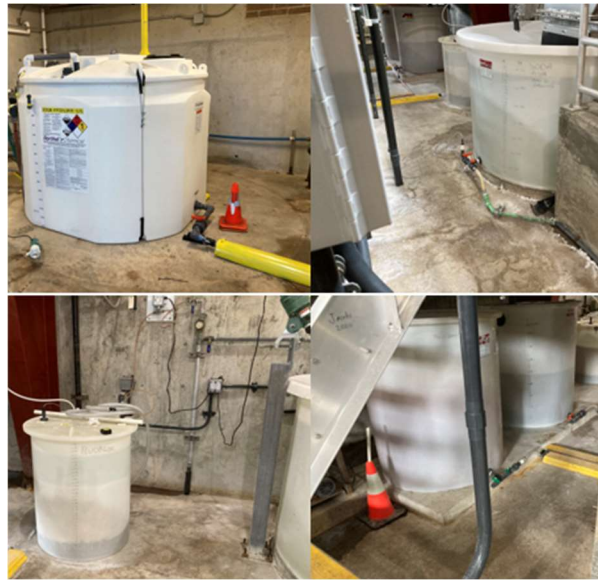
Figure 6.3.4 Tanks without Restraints

- **TALL NARROW EQUIPMENT:** There are several pieces of equipment more than 6 feet tall that should be anchored to the floor or adjacent walls.
- **CONDUIT COUPLINGS:** Conduit greater than 2.5 inches should have flexible couplings.

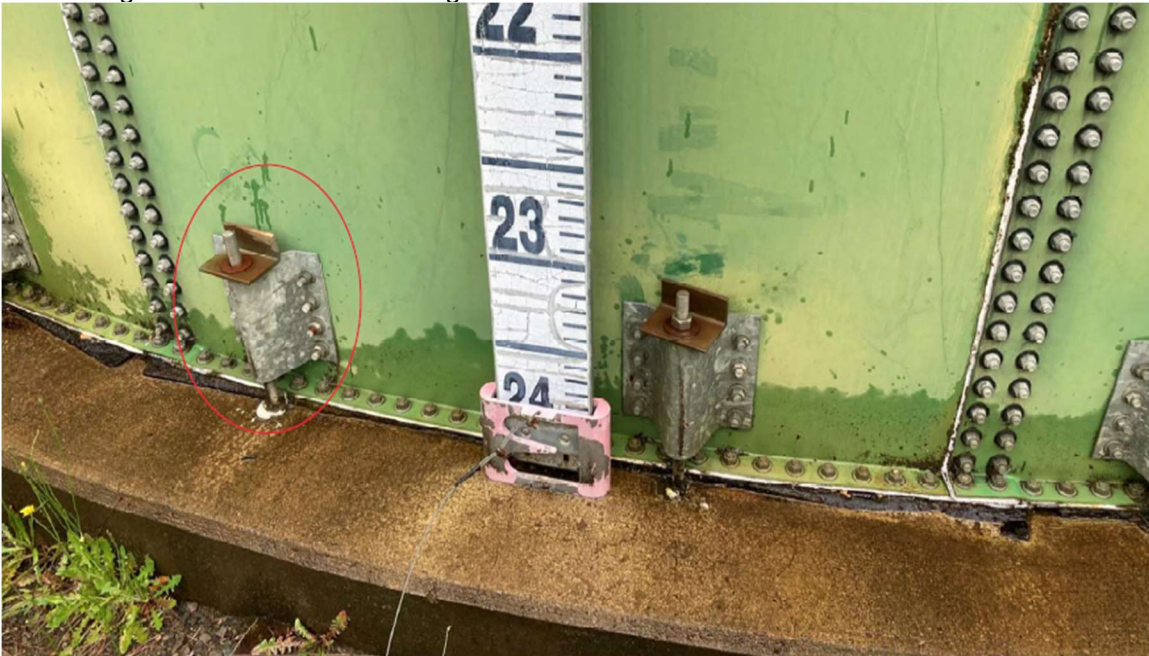
Figure 6.7 Strawberry Reservoir Anchor Bolts

The Strawberry Reservoir is considered a Steel Plate Shear Wall (S6) structure. No deficiencies were found in the checklists, document review. The only item to be addressed from the site observation is:

- Tighten the nuts of the existing anchor bolts.

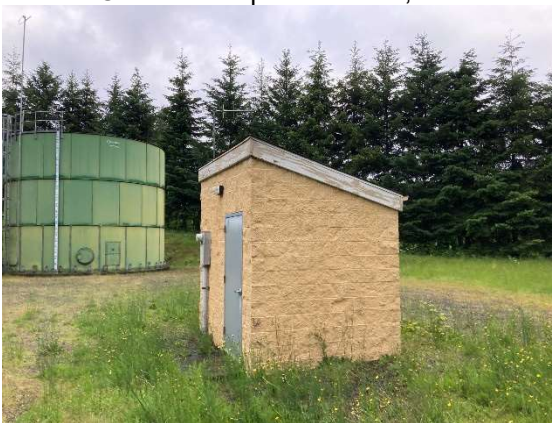
Figure 6.8.1 Strawberry Vault

The Strawberry Reservoir is considered a Reinforced Masonry Bearing Walls with Flexible Diaphragm (RM1) structure. No deficiencies were found in the checklists, document review. The items to be addressed from the site observation include:

- Repair the fan or provide adequate ventilation to prevent future build up of mold, rust and corrosion
- Clean and repair the mold, rust and corrosion to original condition.

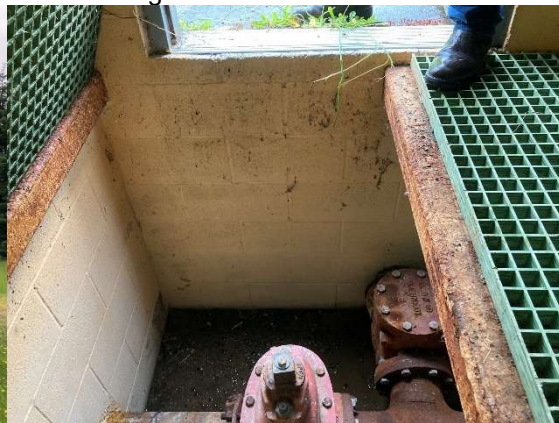
Figure 6.8.2 Strawberry Vault Corrosion

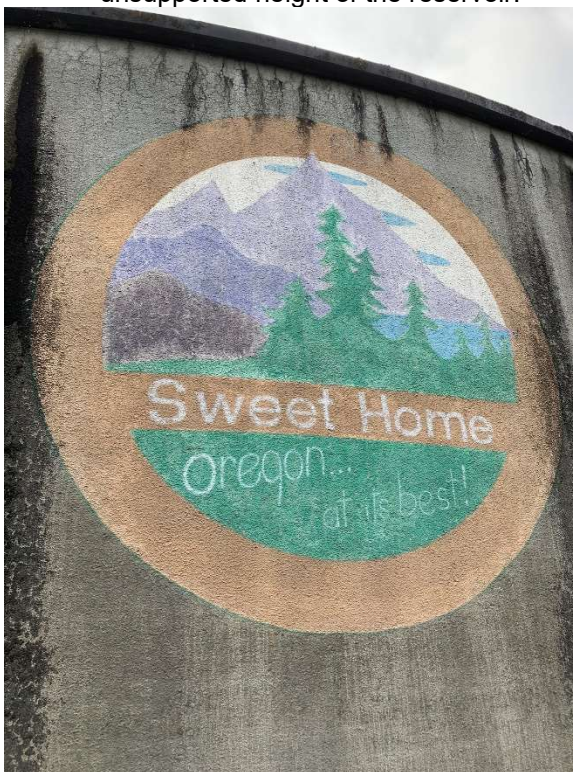
The 2.0M gallon reservoir at 49th Avenue is considered a Concrete Shear Wall (C2) structure. The only noncompliant item discovered in the checklists and site observation include:

- **WALL THICKNESS:** The perimeter wall thickness exceeds the recommended limit for the unsupported height of the reservoir.

Figure 6.12 49th Avenue Reservoir 2.0M Wall
