Weddle Covered Bridge (Sweet Home, OR)

JANUARY 31, 2023

Oregon Transportation Professionals, LLC

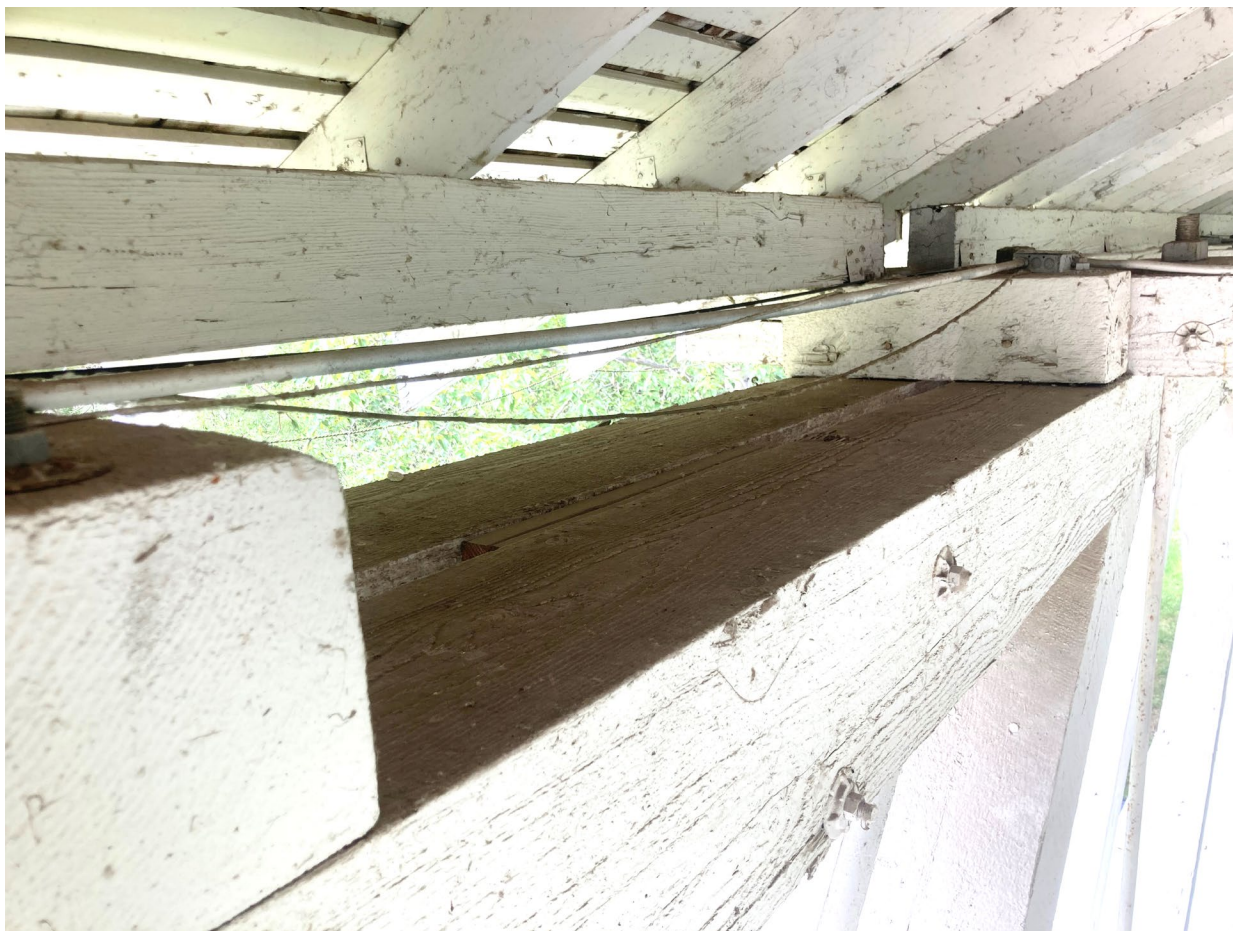
Fortunately, the roof is still effective, and no leaks were observed at the time of the inspection. The top chord is in good shape without signs of advancing decay. While the roof is the primary moisture barrier, the secondary preservation system is a good coat of paint.

Figure 3 - Unpainted top chord

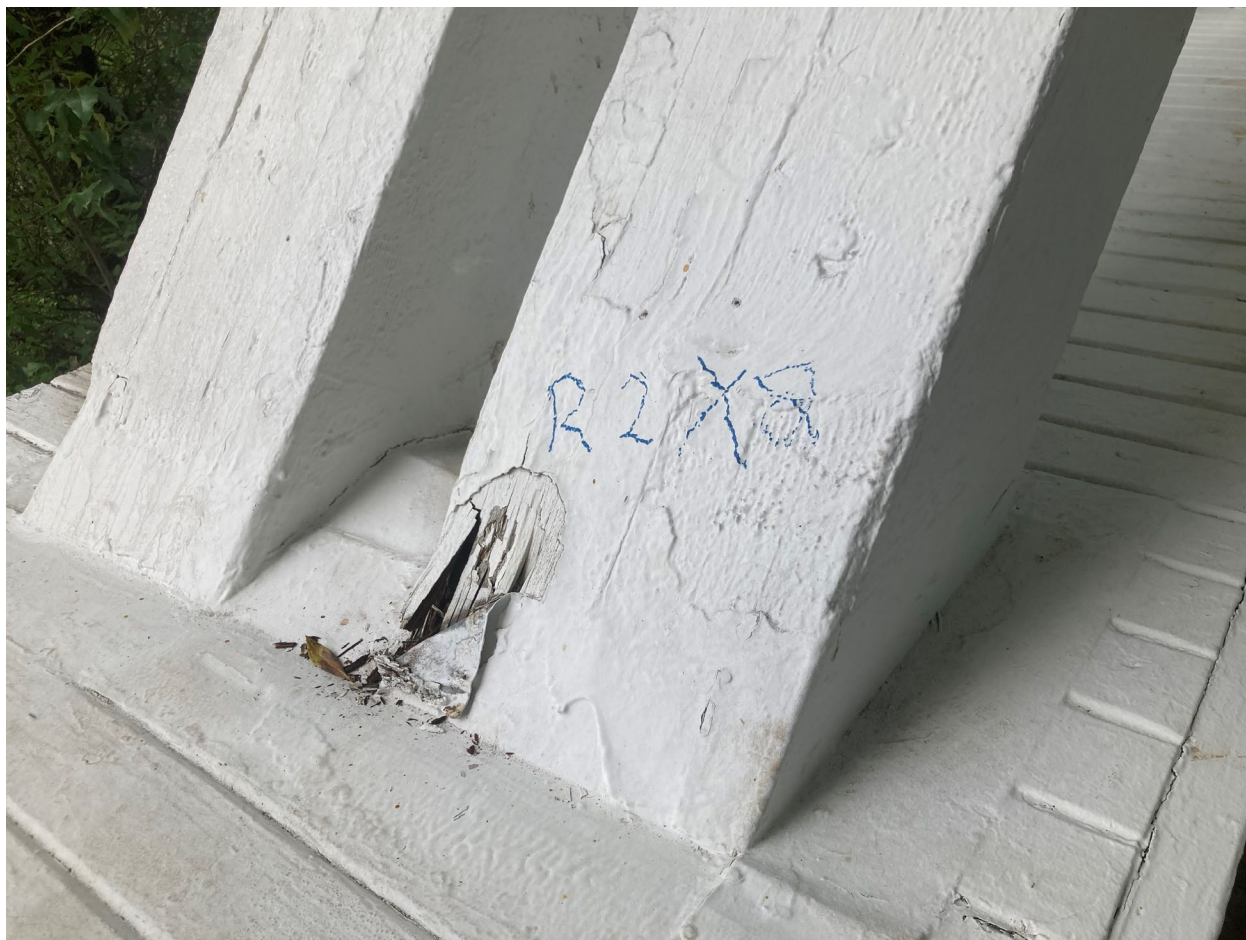
The downstream diagonals have areas of moderate to heavy decay present. L3U4 (Right) a 10"x10" downstream diagonal has minor decay in right member which should be monitored in the future if the decay spreads. The Left member has major decay (9") localized at the brace. While not designed as a tension or compression member, the bracing serves to provide rigidity against buckling.

Figure 5 – Downstream L3U4 (right) 2" of minor decay

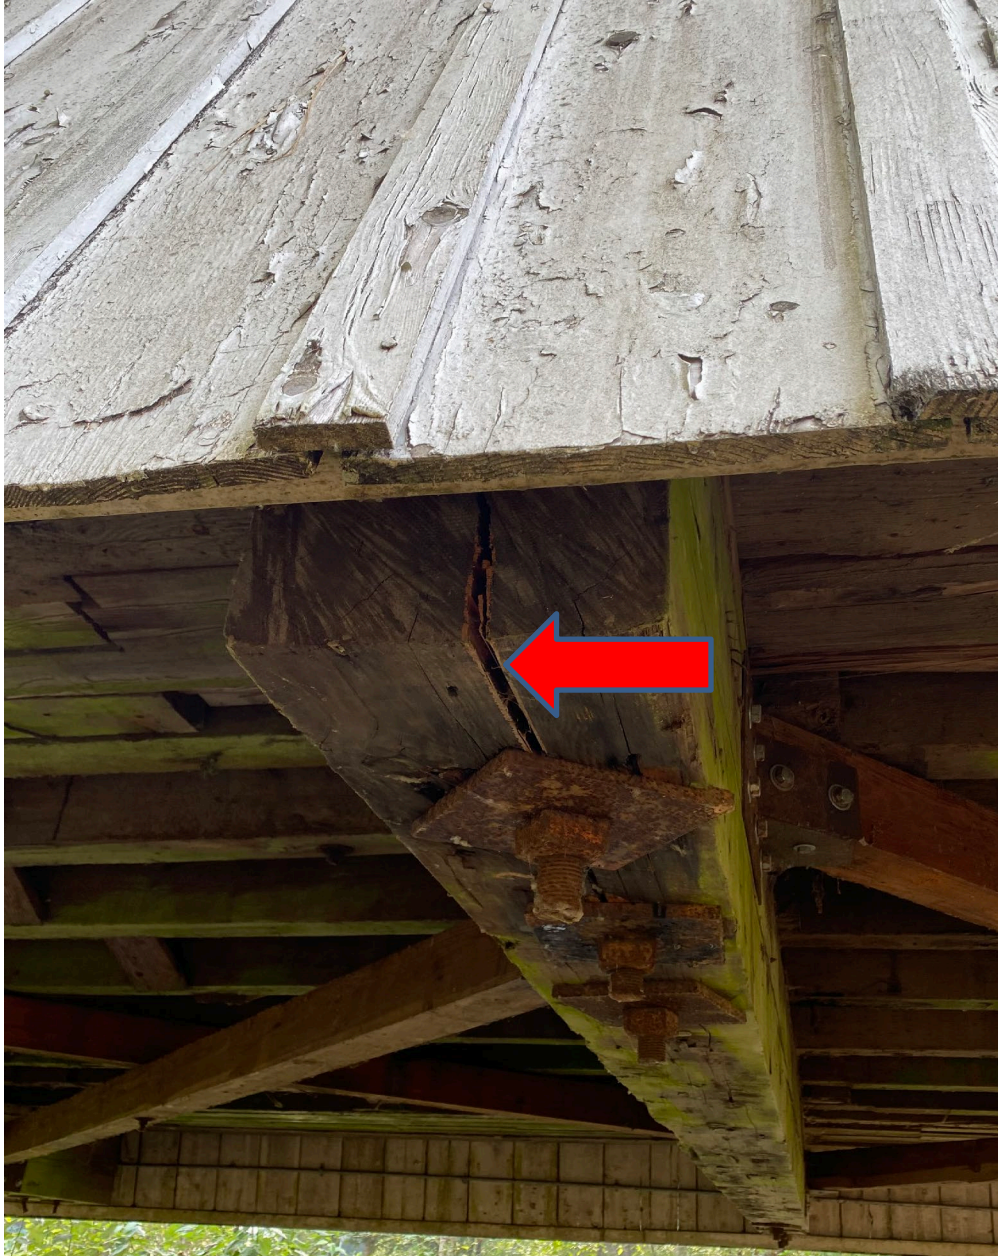
Figure 8 – Split at end of Floor Beam 3

Floor beam 3 has a split at both ends that will need to be monitored. We recommend repair with a fish plate to stabilize the split.

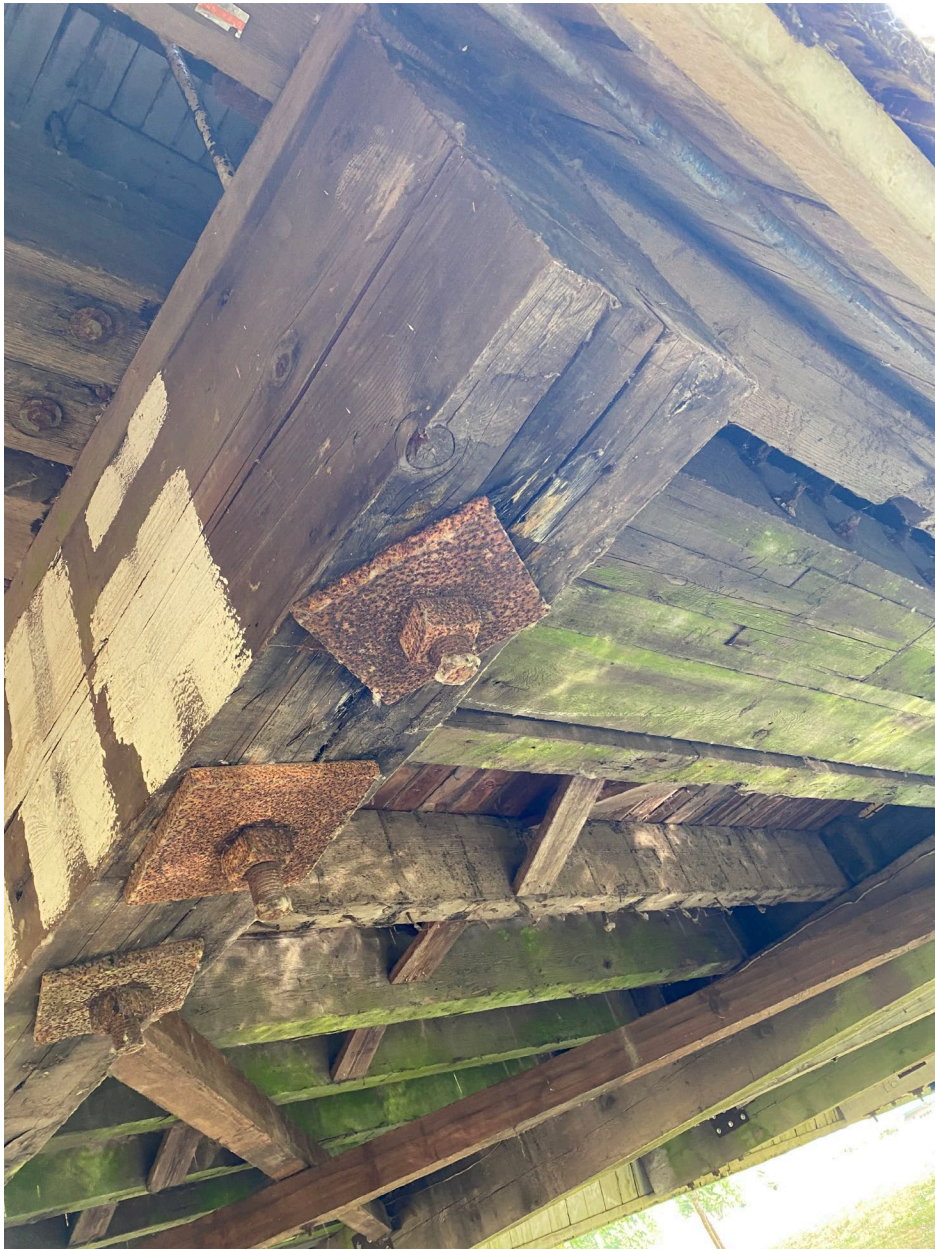
The steel rods and anchor plates have mild surface corrosion and pitting. They need to be painted to prevent future section loss. The section loss is within tolerable limits.

Figure 9 – Pitting on tie rod anchors

Recommendation #7 – Clean and paint pitted plates at bottom connection of steel cables. Maintenance Priority = Routine Schedule (next 2-3 years), est. \$2,000.

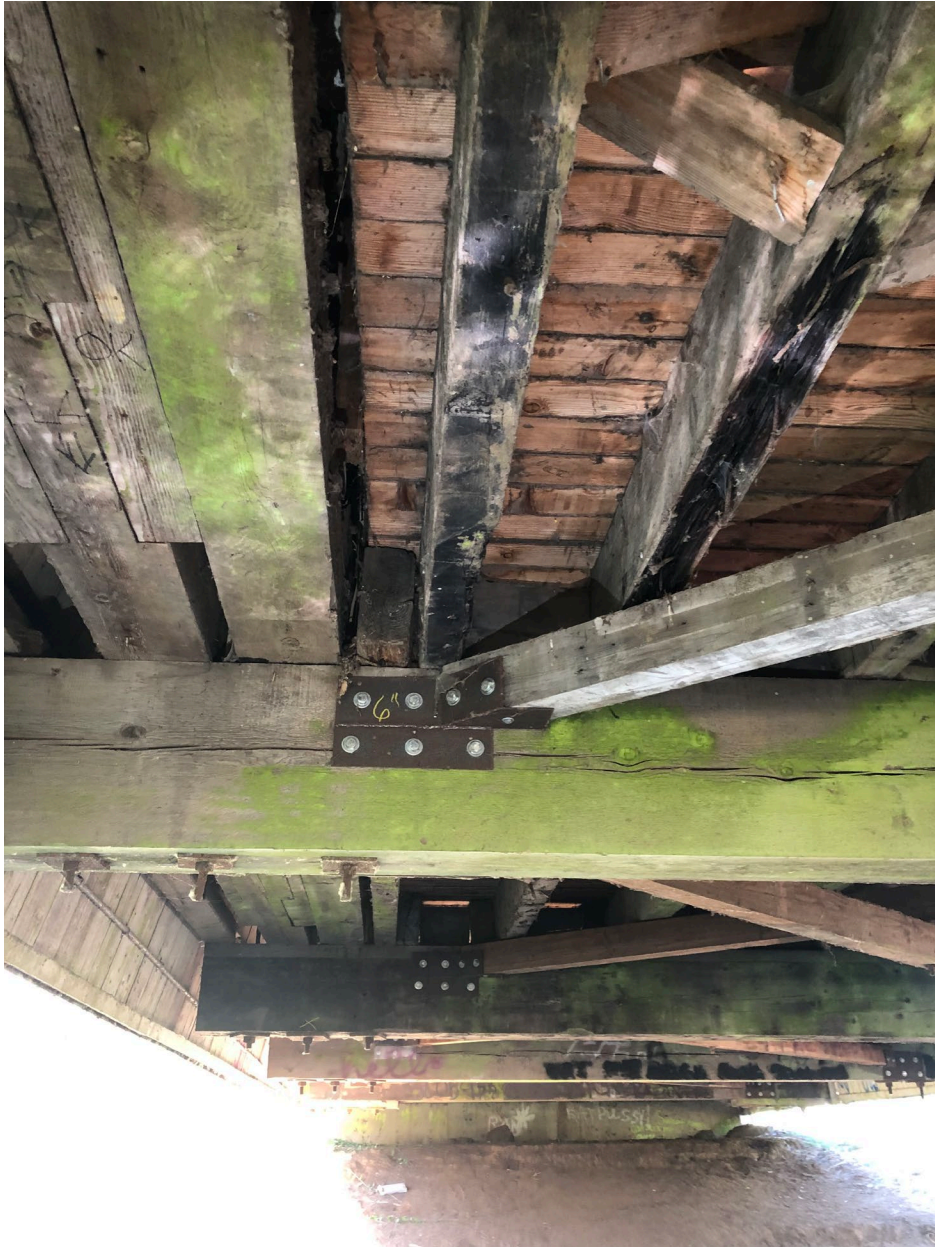
Figure 11 - Surface decay and fire damage to Bay 5 Stringers 7 & 8

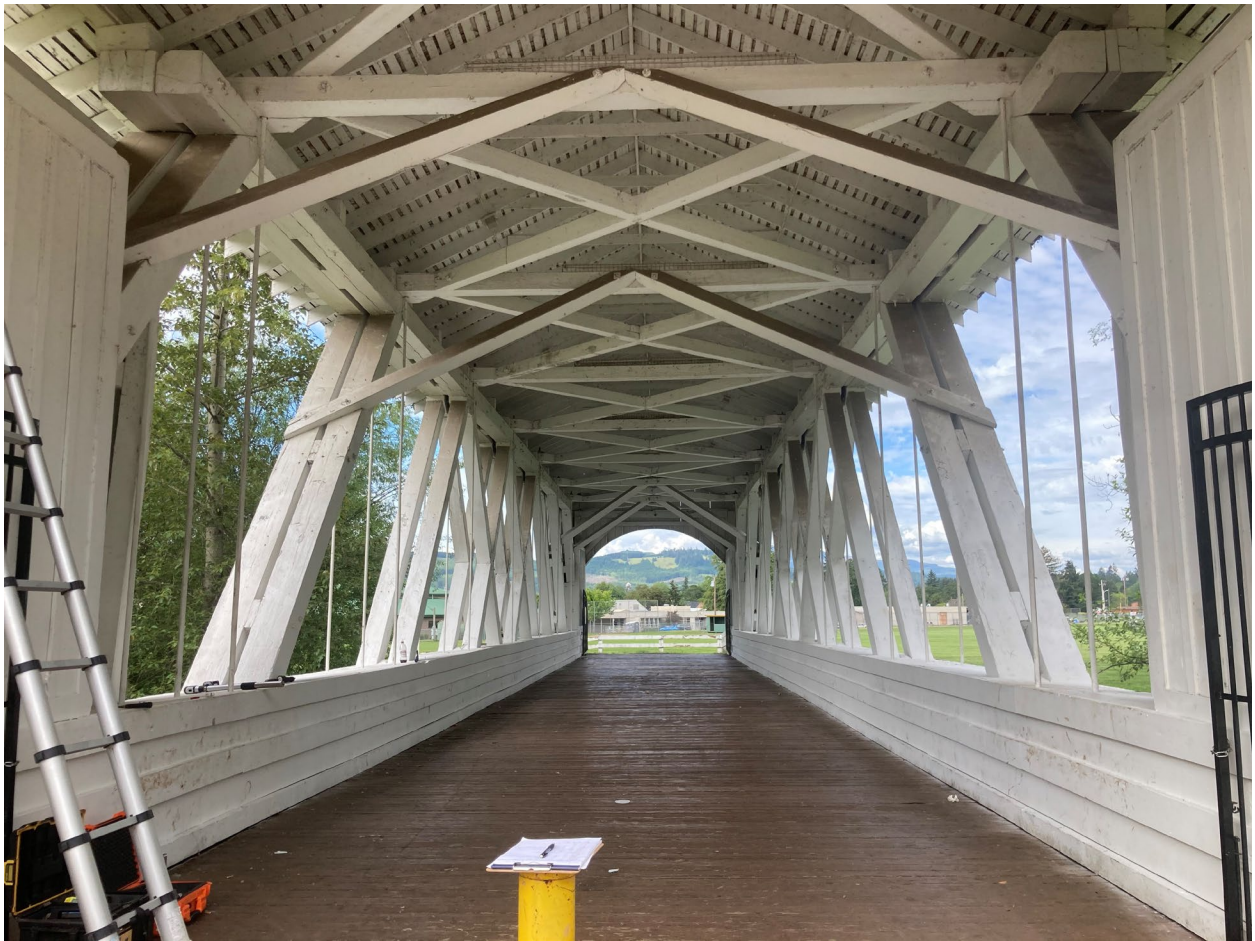
The painting system on the outside of the house is approaching the end of its useful life. Repainting of the bridge within the next five years will extend the life of the exterior siding and more importantly protect the interior truss members. As a protective system, paint repels damaging moisture that leads to timber decay. The inside portion has some life left but the top of the top chord is unpainted.

Figure 16 – Inside Paint condition
