July 22, 2019

Job#: 19-0275

**RE: Structural review of bandstand at Sankey park, 877 14<sup>th</sup> Ave, Sweet Home, Oregon**

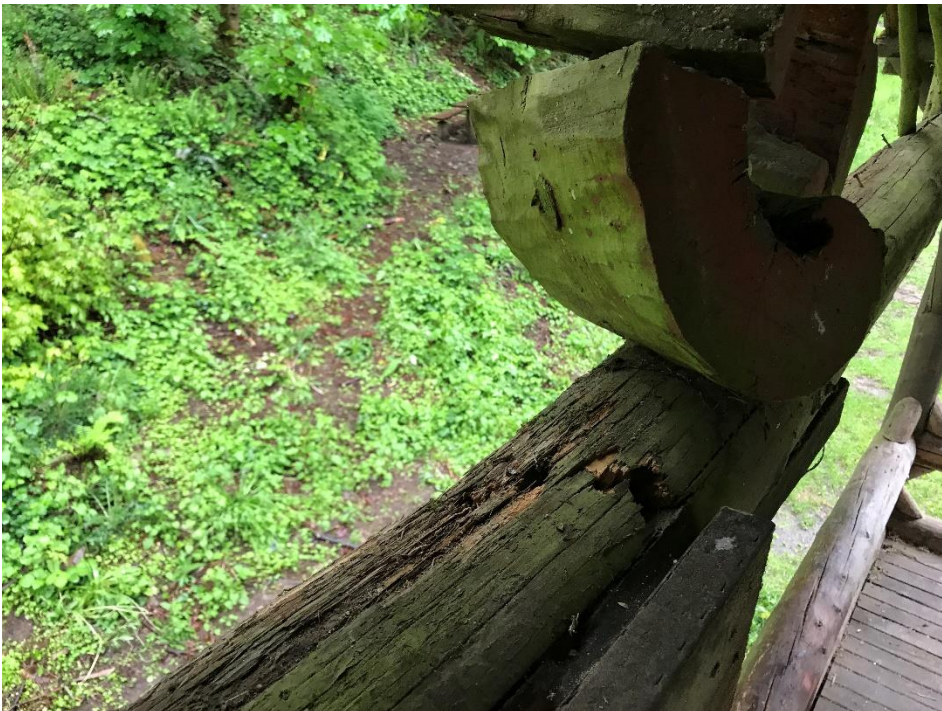
A tree fell on the south side damaging the roof and one of the main structural members. (pictures 2,3,4). At the time of the inspection temporary shoring was in place to support the broken beam. (picture 5)

Picture 3- tree damage

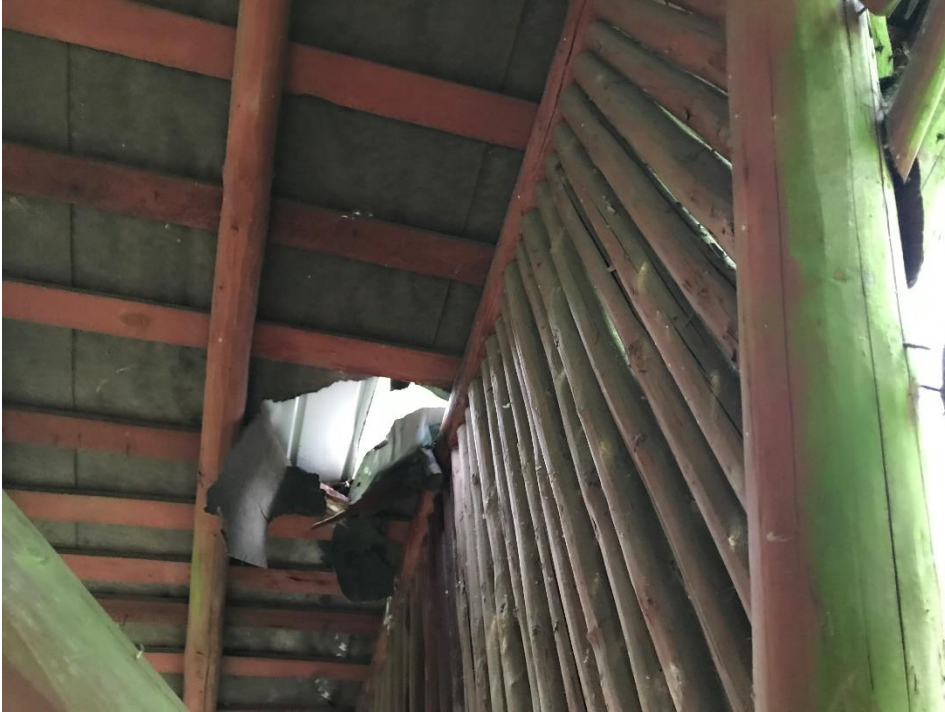
Picture 4 – tree damage

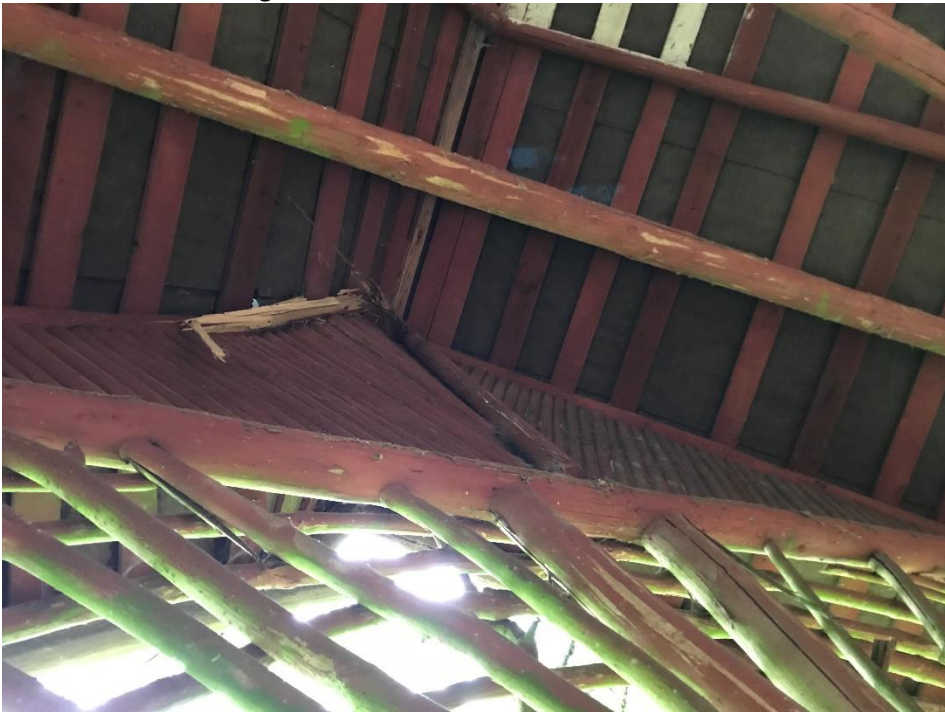
Picture 5 -south side tree damage and shoring

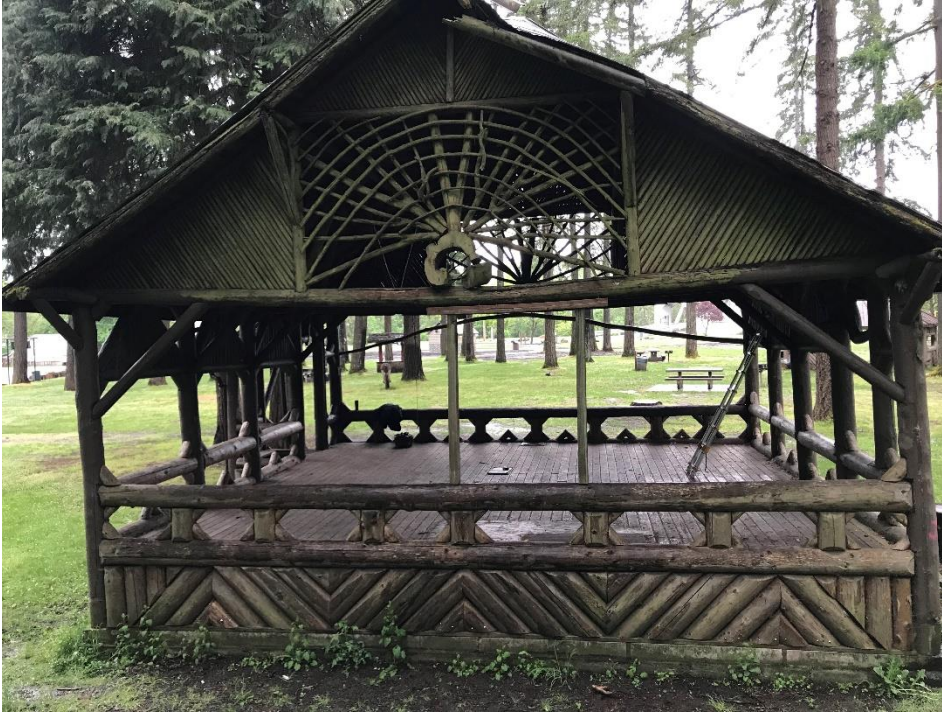
We noted several areas of dry rot damage at the outside edges of the roof members. (pictures 6,7,8)

Picture 6 – dry rot damage

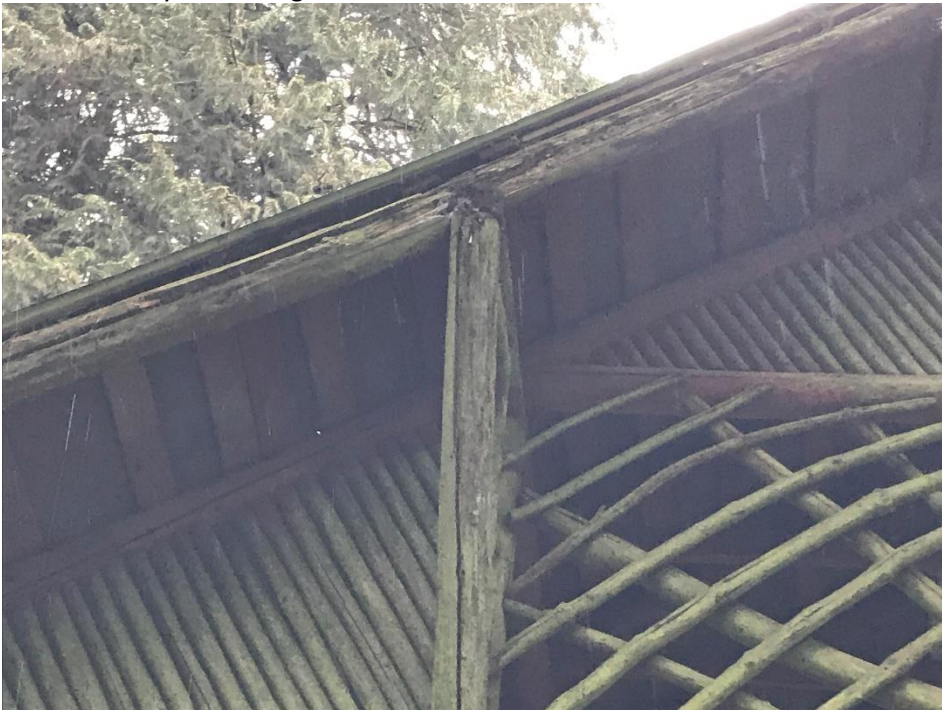
Picture 7 – dry rot damage

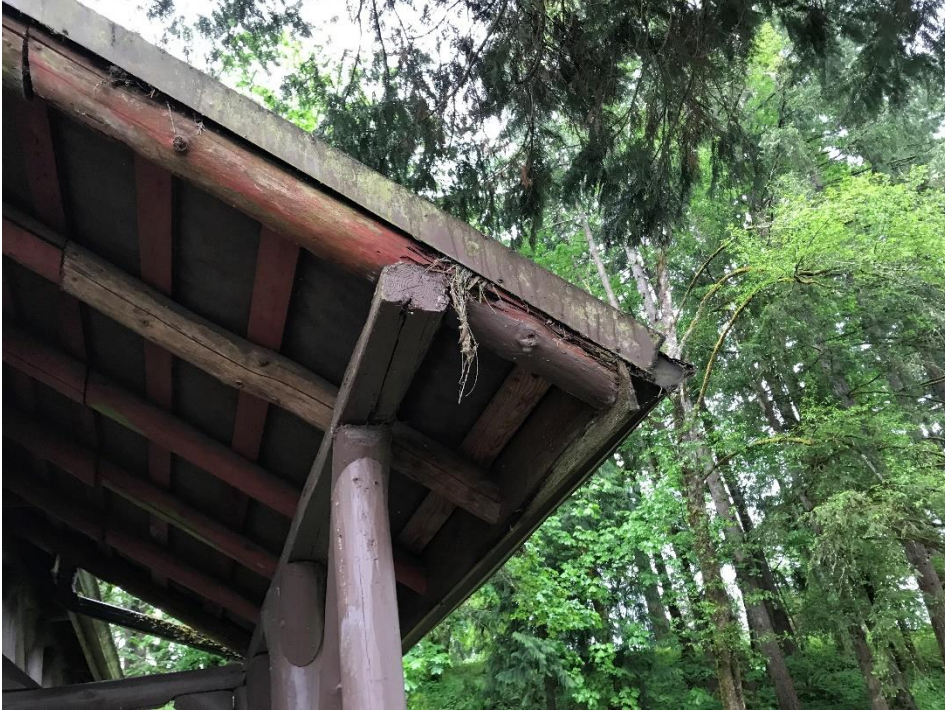
Picture 8 – dry rot damage

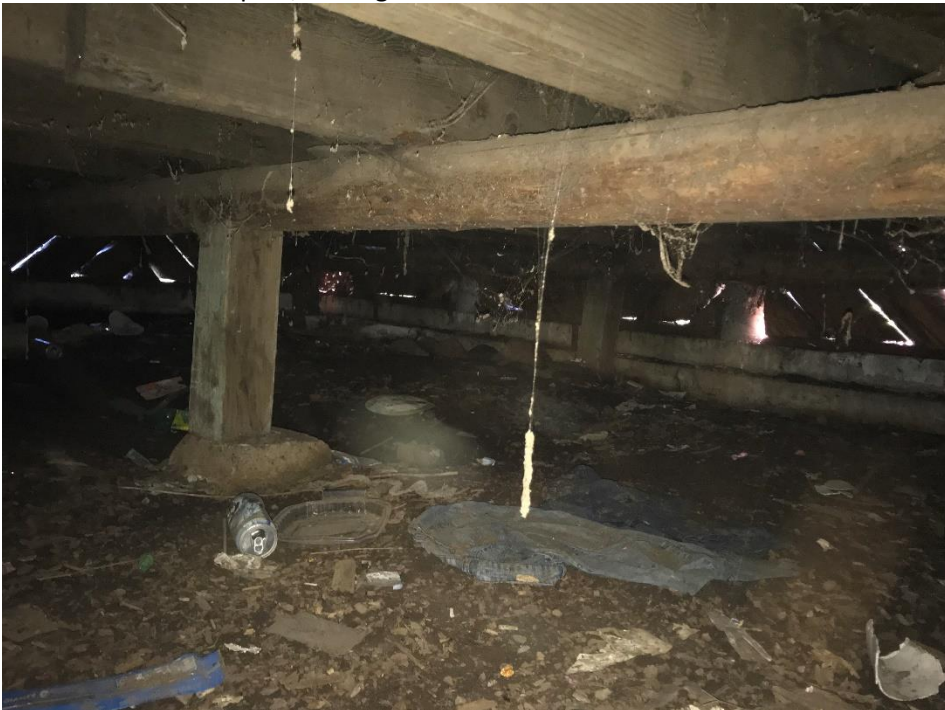
We did enter the crawlspace and found footings that had settled and shifted over time. (picture 13, 14). The foundation appears to have been replaced or repaired relatively recently (in relation to the age of the structure). The posts are dimensional lumber instead of the round members use for the rest of the structure, we also noted pressure treated lumber used for the sill plate on the continuous footing.

Picture 14 – shifted footings
