mwa architects

Architectural Report

Project: Tenino City Hall Renovation
Project No: 201906.00

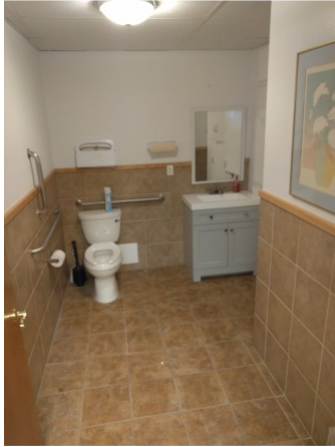
Image 1

Both women's and men's restroom located in the addition have been upgraded to accessibility standards. The men's restroom has had a lavatory replacement that is not code compliant. The base cabinet does not allow for the required knee space.

Some bathroom accessories may need to be relocated to comply with reach restrictions. Finishes are in good order.

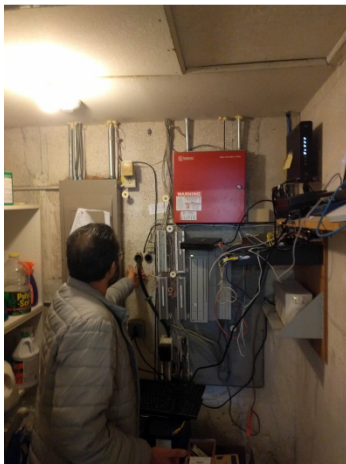
Image 2

The electrical/server/telephone room is small but there is enough room to upgrade the servers.

There is very little CAT 5 cabling in the building and the network needs to be upgraded. Existing cables are routed behind the suspended ceilings. It may not be difficult to route new cables.

It has been reported that the cameras in the visual security system don't communicate with the recording device. This system needs to be upgraded.

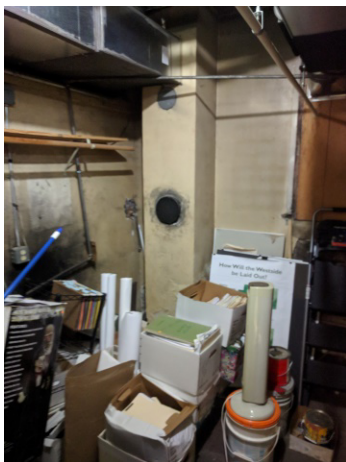
Image 3

The existing mechanical room has been converted to storage. Patching and painting are required. Storage shelves should be added if this room remains as a storage room.

The air intakes at the heat exchanger need to be sealed better at the existing window infill. The existing HVAC system was converted to a variable refrigerant flow (VRF) system. The system is undersized and needs to run continuously to maintain comfort levels.

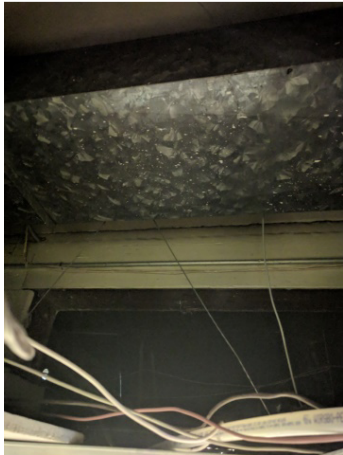
Image 4

Existing ducts, telephone lines, and some power are routed above the suspended ceiling. Codes should be reviewed to verify if conductors can be routed without conduit. The suspended ceilings are not seismically braced.

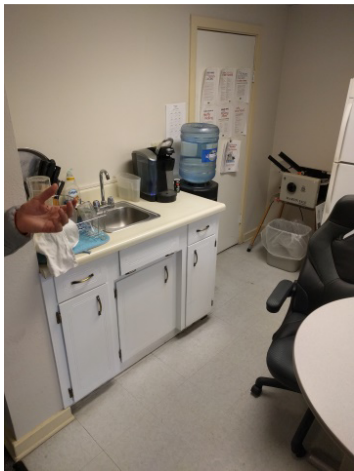
Image 5

The break area counter needs to be ADA accessible. Painting and floor replacement could be done as part of the ADA upgrade.

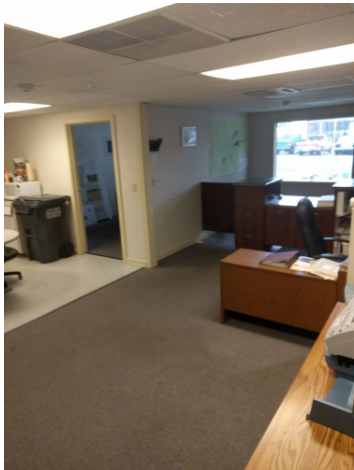
Image 6

The reception area outside of the Mayor's office is not used. A conference room does not exist in the City Hall and the existing reception area could easily be converted to a conference room. The upstairs Council Chambers can be used for meeting but it is not convenient for small group use. All carpets located on the first floor will need to be replaced soon.

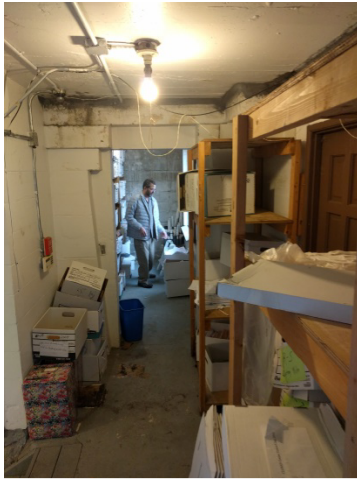
Image 7

The existing storage areas that are under the second floor have had water intrusion problems. The entry deck above has been coated with an elastomeric coating which has helped.

The existing door to the exterior is unusable due to an electrical conduit was routed at the bottom of the door (see image #24). A travel distance analysis should be conducted to verify that egress isn't in code violation.

Patching, painting and shelving additions should be considered.

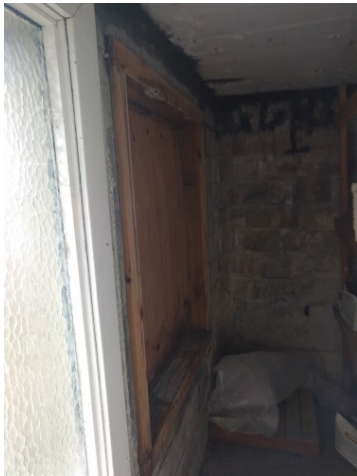
Image 8

The existing storage areas have had window openings simply filled in. The exterior walls lack insulation.

Window openings could be insulated with an interior gypsum board finish applied.

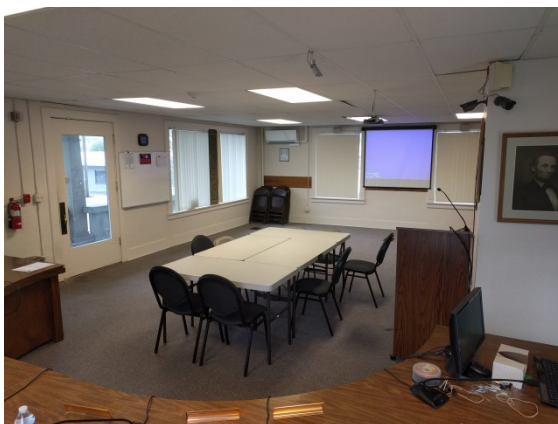
Image 9

Second Floor Council Chambers:

There is only one ductless HVAC unit for the whole floor and it is not adequate for comfort.

Carpet, painting, and suspended ceilings should be upgraded.

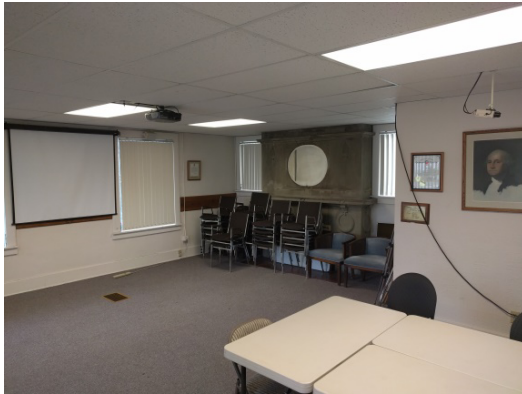
Image 10

Second Floor Council Chambers:

One of the few features of the original building is the fireplace which is not used.

This image also shows a computer projector and intrusion protection cameras. As noted previously, the cabling in the building needs to be upgraded. CAT 6 cabling is the industry standard.

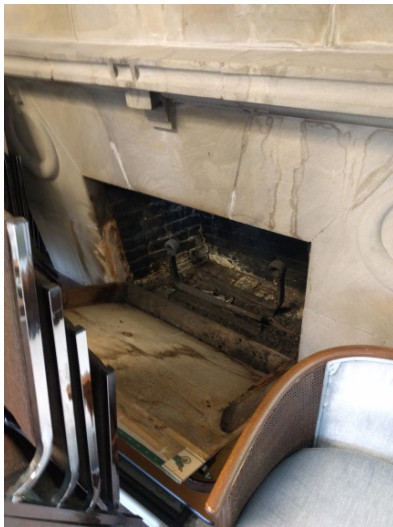
Image 11

The original fireplace has been stained over the years from water intrusion. If it can't be used the flue should be capped to prevent heat escaping and water intrusion from the interior of the chimney. The new roof installation has stopped the water intrusion from the exterior of the chimney.

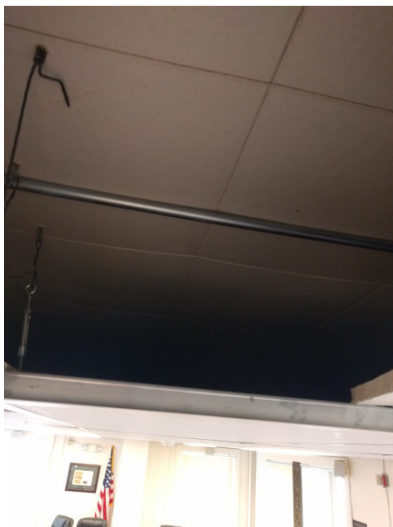
Image 12

The suspended ceiling has been installed just below the existing ceiling. The suspended ceiling has not been seismically braced. It also conceals newer power and cabling runs. It may also conceal an attic access but further investigation is required to verify.

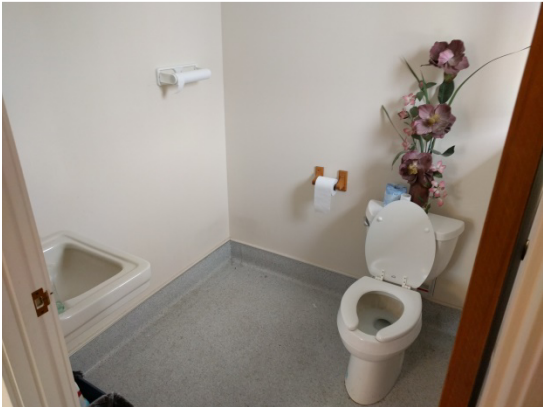
Image 13

The existing restroom adjacent to the Council Chambers is not ADA accessible. A review of the accessibility code would help to determine if this needs to be accessible. To enlarge this restroom it would remove more of the character of the original building. There are three restrooms in the building and two have been upgraded.

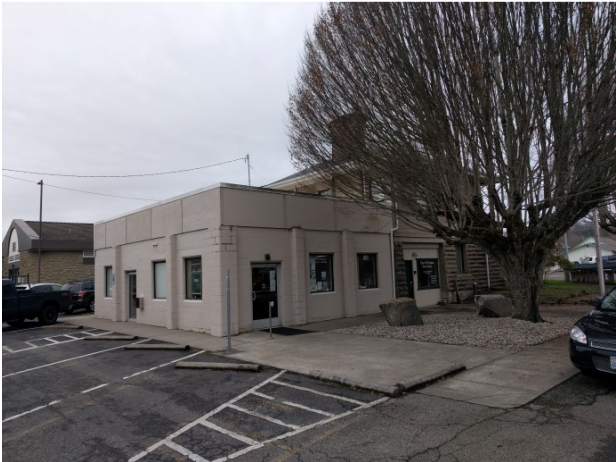
Image 14

The parapet wall is simple plywood and has a great deal of algae under the tree.

Due to the date that this addition was added it is assumed that it is of minimal or non-reinforced CMU construction.

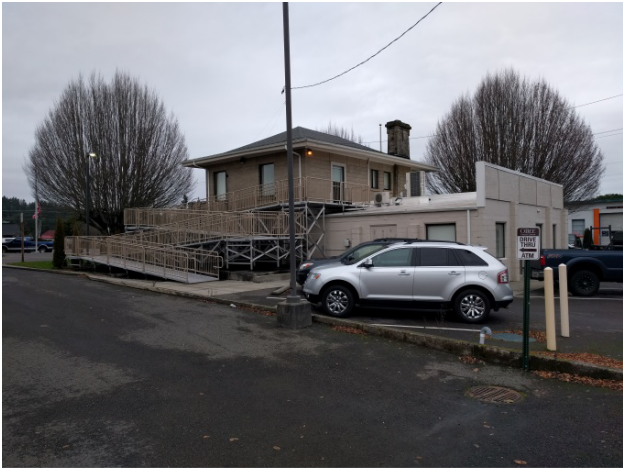
Image 16

This image was taken from the west. It shows the handicapped ramp to the second floor. Budget should be looked at to remove the ramp and replace it with a more compact ADA lift. This would free up area for future expansion or alternate use.

The roof at the addition appears to be newer and it is probably not the original which required the plywood parapet walls.

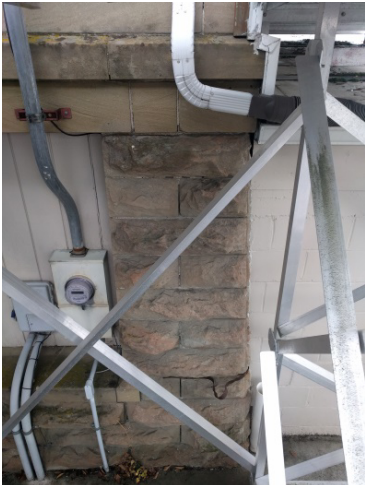
Image 17

The existing ADA ramp could hinder needed upgrades to the electrical system, the HVAC system, and repointing the sandstone joints

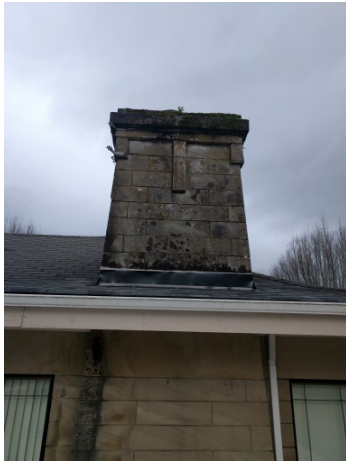
Image 19

The existing sandstone chimney has vegetation growing from the top. Since the fireplace is not being used it would be advisable to cap the chimney.

The roof hip behind the chimney has a visible sag. Although unable to look into the attic this has been reported to the City as a rotting hip beam. The fact that this structure was a library proves that the floor loading can handle short term loads for the shoring to replace the hip beam.

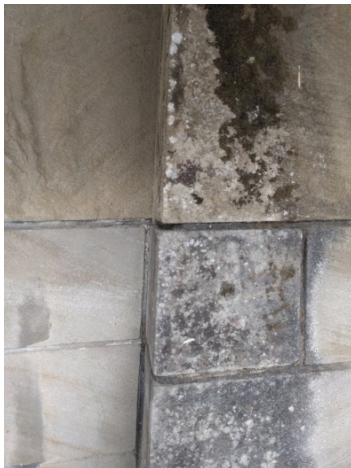
Image 20

Grout between the sandstone blocks is in various conditions depending on the amount of moisture that is consistently present.

It appears as if some of the grout has been repointed previously. A thorough inspection of all conditions is strongly advised.

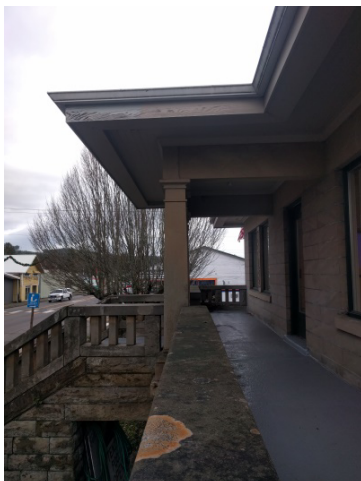
Image 21

The entry walkway has been coated in an elastomeric product. This seems to have reduced the water infiltration to the storage below.

Further investigation is warranted to verify that water is not being directed towards the building and is being directed away. There are methods to "float" this walkway surface for proper drainage.

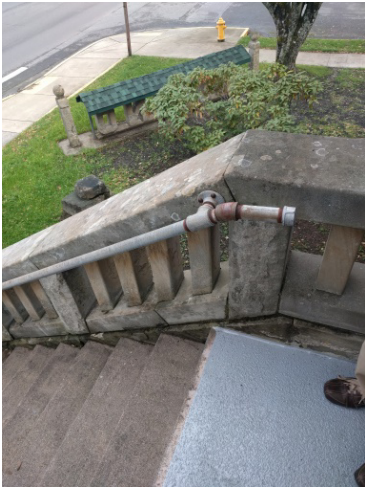
Image 22

The handrails on the stairs are not code compliant. The height is only 29 ½” above the stair nosing (34” to 38” required). A new railing connection can be designed to fit where the existing connections are present.

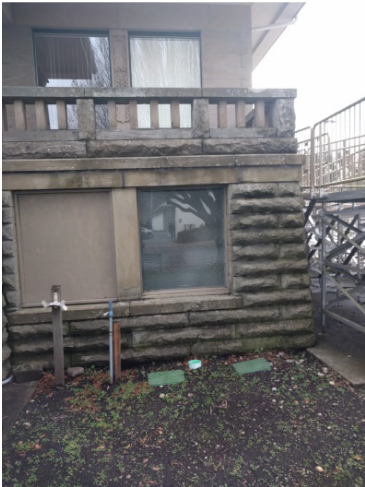
Image 23

Image taken of the northwest side of the building. Image documents the condition of the sandstone blocks and the plywood window infill.

As reported, all sandstone joints need to be examined for failing mortar.

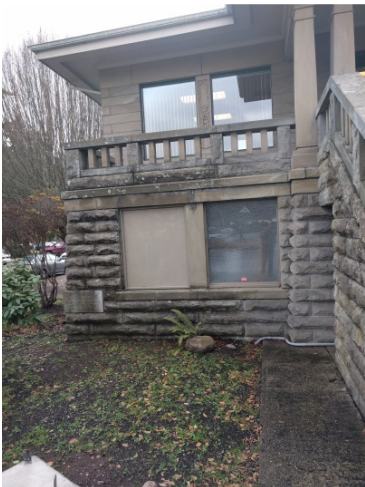
Image 24

Image taken of the northeast side of the building. Image documents the condition of the sandstone blocks and the plywood window infill.

As reported, all sandstone joints need to be examined for failing mortar.

This view documents the difference between the dry block area and the wet block area.

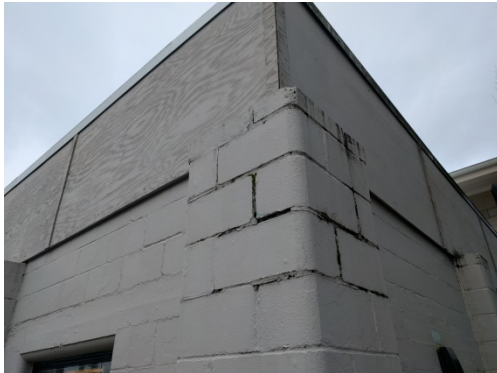
Image 25

The CMU building addition needs to be repointed. It is assumed that the block is minimally reinforced. It is recommended to verify the reinforcing with a metal detector and to verify if a seismic strengthening process can be accomplished.

Rain water is likely collecting on top of the pilasters after running off of the face of the plywood parapet.

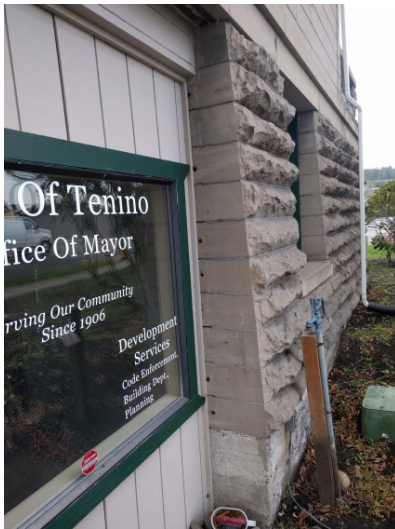
Image 26

At some time in the past the sandstone has been removed for the entry to the Mayor's office and reception.

It is advised that the sealant be removed and replaced at the sandstone. Sandstone "holes" should be grouted full to prevent freeze/thaw degradation.

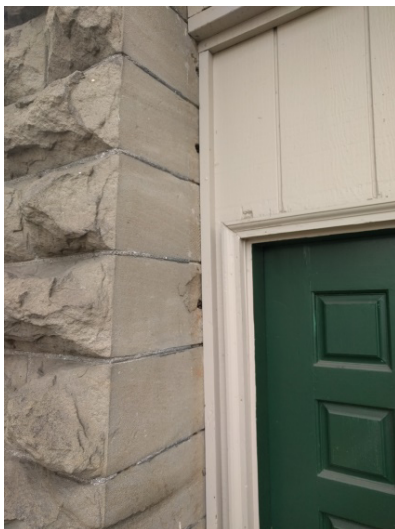
Image 27

Please see image #26 for identical comments.

If the reception area is converted to a conference room then the door could be removed. A study of the egress distance would be required to verify the removal of the door.
