### HAZARDOUS MATERIALS SURVEY

### ASBESTOS LEAD-BASED PAINT

Residential Structure 220 W. 1st Ave. Toppenish, WA 98948

Project #A2024/1004

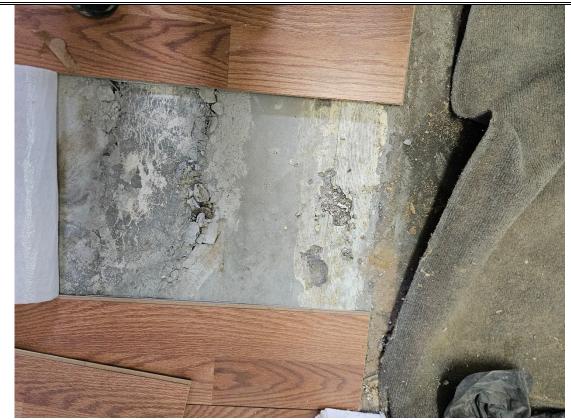
Photo 1: Sample 400 Lab Data: Non-Detect

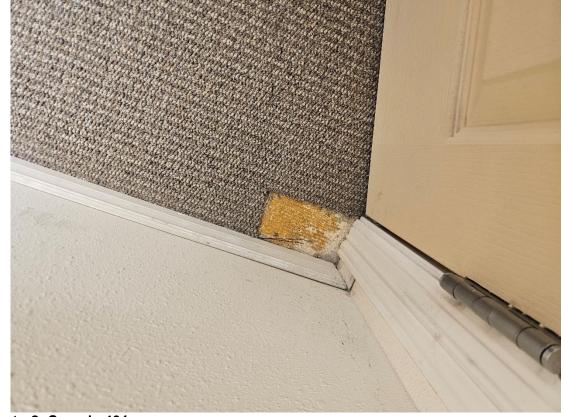
Photo 2: Sample 401 Lab Data: Non-Detect

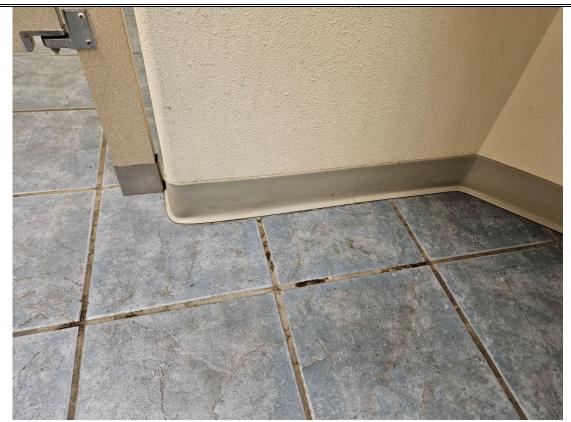
Photo 5: Sample 502 Lab Data: Non-Detect

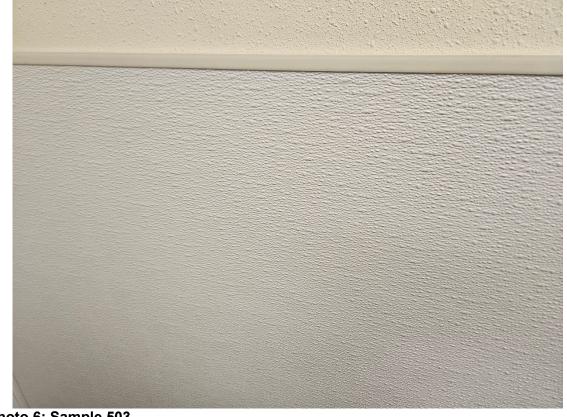
Photo 6: Sample 503 Lab Data: Non-Detect

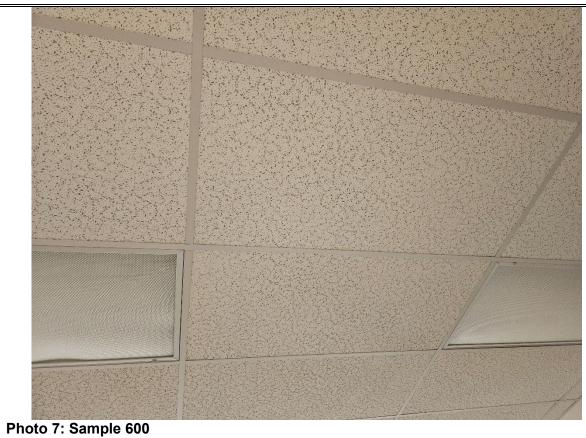
Photo 7: Sample 600 Lab Data: Non-Detect

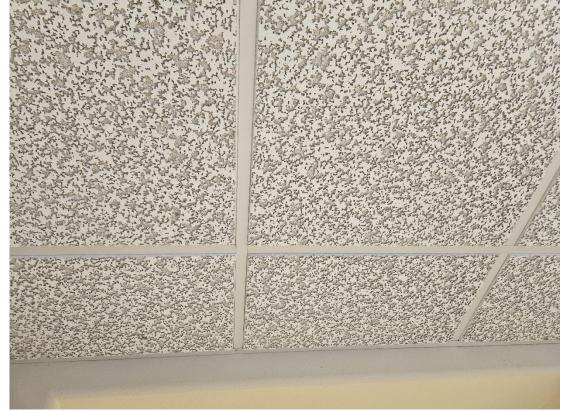
Photo 8: Sample 601 Lab Data: Non-Detect

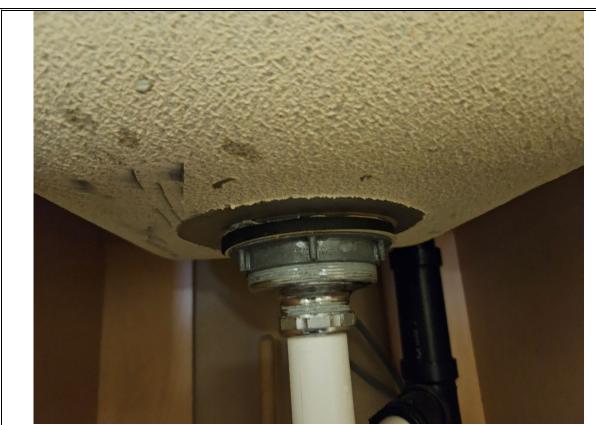
Photo 9: Sample 900 Lab Data: Non-Detect

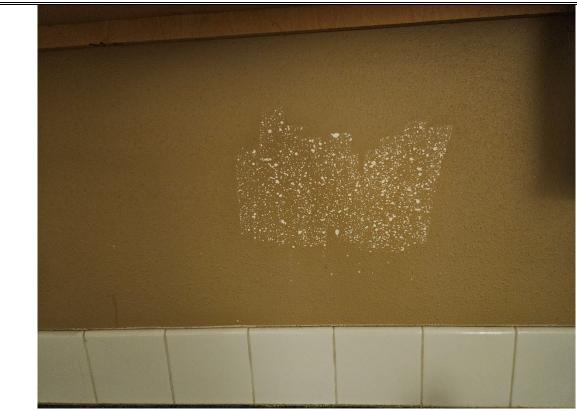
Photo 3: Sample Pb-3 Lab Data: BRL

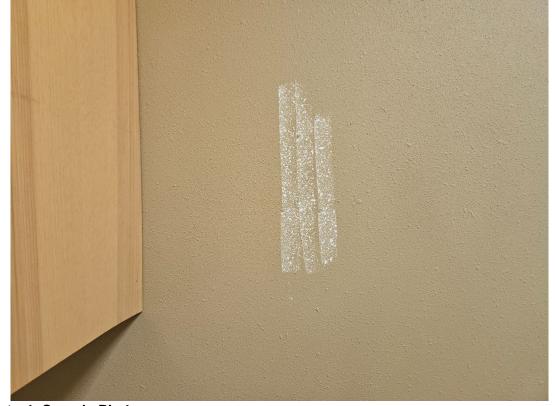
Photo 4: Sample Pb-4 Lab Data: BRL

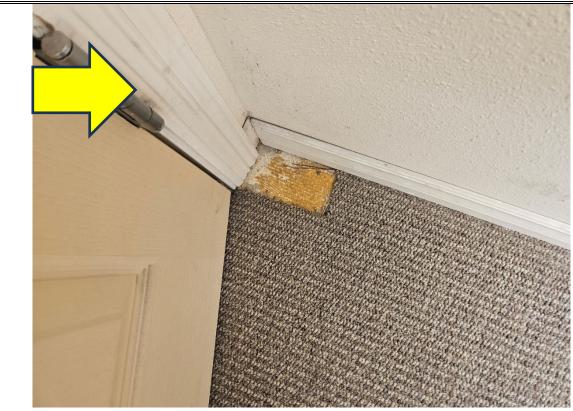
Photo 5: Sample Pb-5 Lab Data: BRL

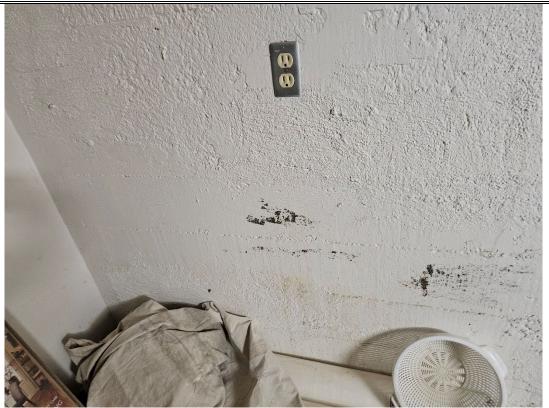
Material Sample #	Color Substrate Component	Location Sample Collected	Analysis Results (PPM)
Pb-1	Yellow-GWB-Wall	Interior	BRL
Pb-2	Yellow-GWB-Wall	Interior	BRL
Pb-3	Brown-GWB-Wall	Interior	BRL
Pb-4	Brown-GWB-Wall	Interior	BRL
Pb-5	White-Wood-Door Casing	Interior	BRL
Pb-6 See Photo#6	White-Concrete-Wall	Interior	5350

The Washington State Department of Labor and Industries (L&I) Lead in Construction Standard (WAC 296-155-1760) applies to demolition-related tasks that impact materials with detectable level of lead. One of six samples collected for lead have detectable levels of lead, specifically the white concrete exterior wall located in the former "apartment".

Photo 6: Sample Pb-6 Lab Data: 5350ppm

Demolition Contractor(s) must be notified by the Owner, prior to the start of demolition activities that detectable levels of lead were identified in some of the painted surfaces sampled, and that all work must be completed in accordance with the United States, Occupational Safety and Health Administration's (OSHA) Lead Standard for the Construction Industry, Title 29 Code of Federal Regulations 1926.62, as amended on March 26, 2012, and Washington State Department of Labor and Industries, Division of Occupational Safety and Health WAC 296-62-07521.
