# Proposed Police Department

## 220 West 1st Street, Toppenish, Washington

PROJECT PURPOSE	LOCATION	DATE OF SITE VISIT
Building Condition Assessment	220 W. 1 <sup>st</sup> Street	10/17/2024
OVERVIEW		
<p>CKJT evaluated this facility to determine current building conditions and suitability as a semi-permanent replacement facility to house the City of Toppenish Police Department. Overall, the facility is in fairly good condition with the roof having been replaced in the last 5 years and some remodeling performed for the prior tenant. Facility deficiencies are identified herein.</p> <p>The existing layout is largely suitable for the police department with some modification and would meet most basic separation and security needs. A more robust remodel would result in meeting all current staffing needs, replacing the current number of private offices. Both Preliminary programming plan options (sheets A2 &amp; A3) include a reduction in the size of private office spaces and most programmed spaces when compared to the current facility.</p>

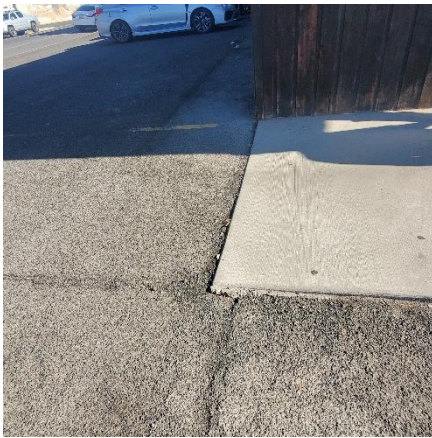
Additional evaluation of the public entrances may be required for accessibility depending on which existing entry is used for public access. The Northwest entry (the former tenant's main public entrance) landing is slightly irregular, and variations in elevation may require leveling to prevent potential trip hazards. There is significant deterioration of the landing outside the North entry that should be leveled to prevent potential trip hazards.

*NW Entry Material/Grade Change*

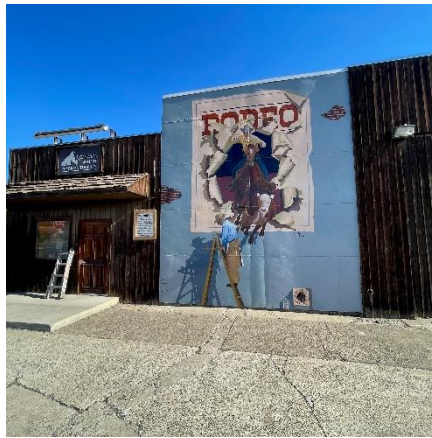
*Grade Change West Facade*

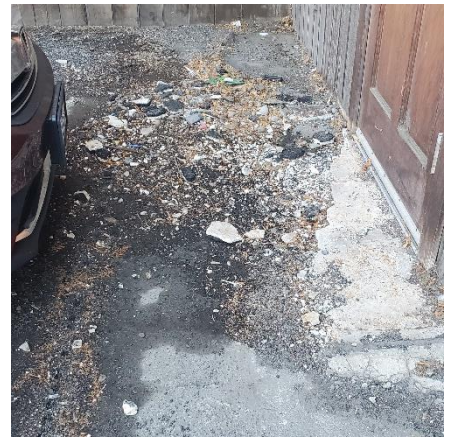
*Degradation of North Entry Pavement*

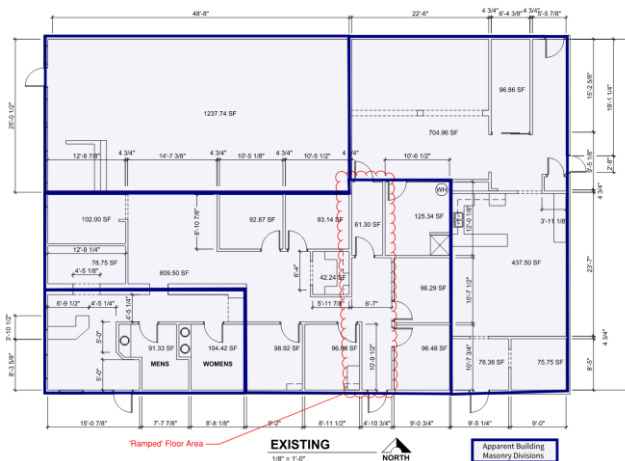
The facility is slab on grade with most of the site paved in concrete and some asphalt that adjoins directly to visible foundation. As previously stated the building is made up of what appears to be four building units joined over time; there is an elevation change between the two units to the North and the two units to the South. The elevation difference is most obvious where it appears two articulating garage doors were infilled, and a hallway connection was made to the rear units.

*Building Units and Ramped Floor*

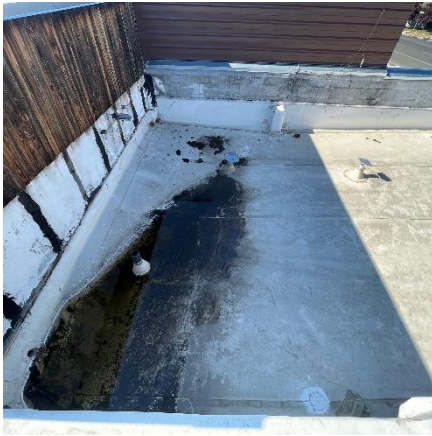
*Roof Ponding and Clogged Drain*

- There is ponding occurring on the roof in the Northwest corner and along the elevation change between roof sections. The ponding area on the Northwest corner appears to have a drain; however, the closest drain/outlet at grade is visibly clogged and filled with expanding foam. Immediate further investigation is recommended.

- Roof Membrane shows signs of ponding and sagging. Flashing and roof penetrations will require further investigation for modifications and verification of roof drainage and overflows.

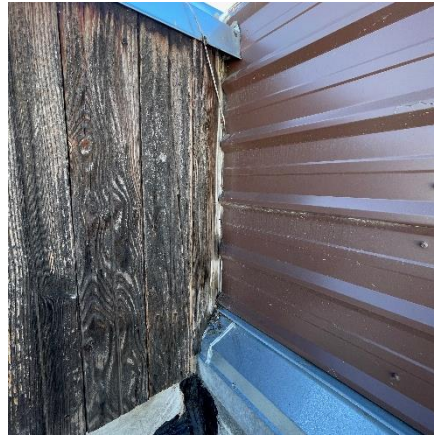
*Improper Sealing/Flashings*

- There are few overflow downspouts and flashing penetrations, and where present most appear clogged or sealed over.
- Existing sheet metal vents and flashing need reworked to seal properly.

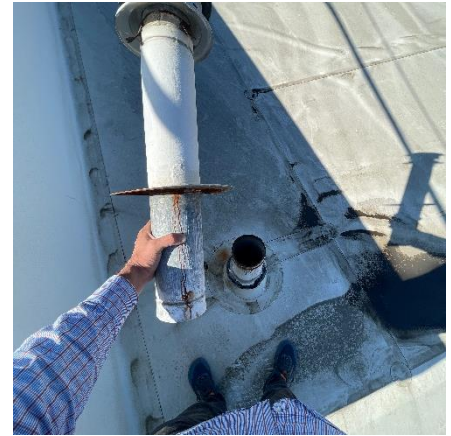
*Detached HVAC Vent Assembly*

- Existing chimney venting the hot water heater is not securely attached and needs to be reassembled to prevent pushing exhaust back into the buildings habitable spaces.

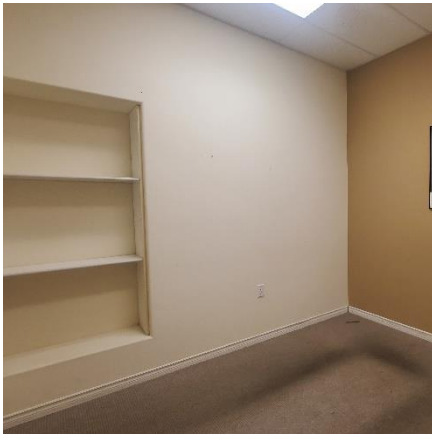
*Typical 'Exam Room' w/ Built in Shelving*

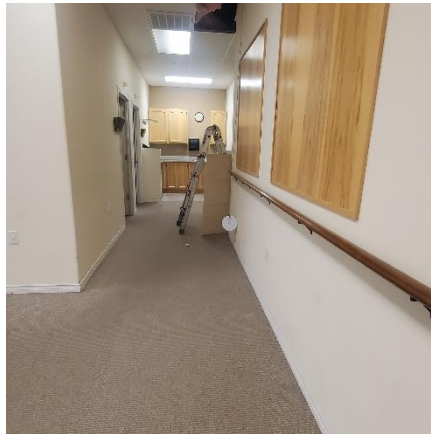
*Corridor b/t Training Area and Offices*

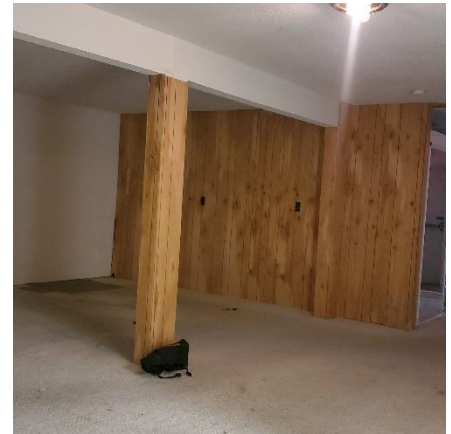
*Former Living Area w/ Wood Veneer*

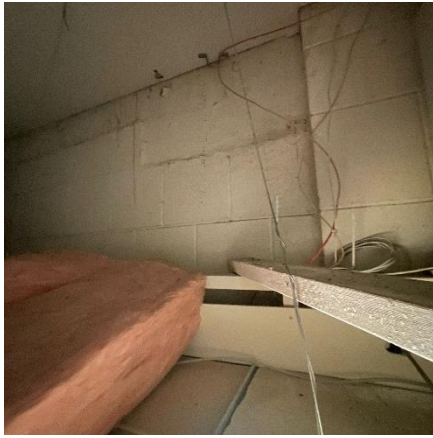
*2x4 Stud Wall Adjacent to CMU Block  
Stud Walls Joined Above Drop Ceiling*

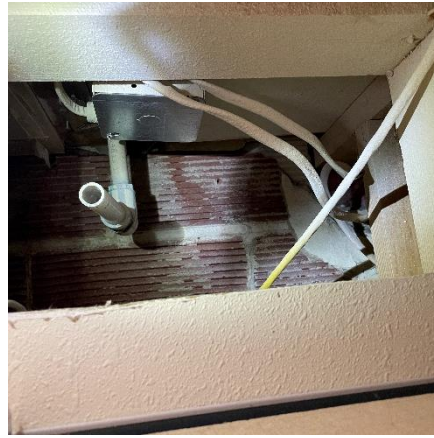
*PVC Pipe Termination Near Restroom  
Undetermined Use*

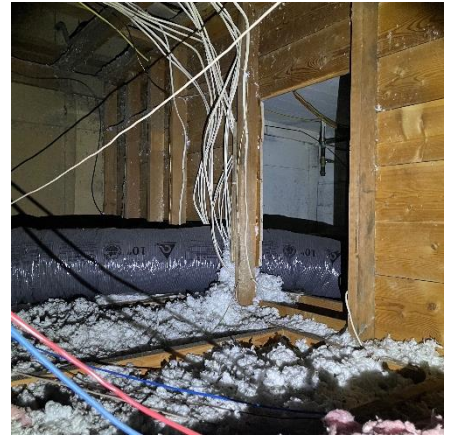
*Attic Space Above Southern  
Portion of Building*

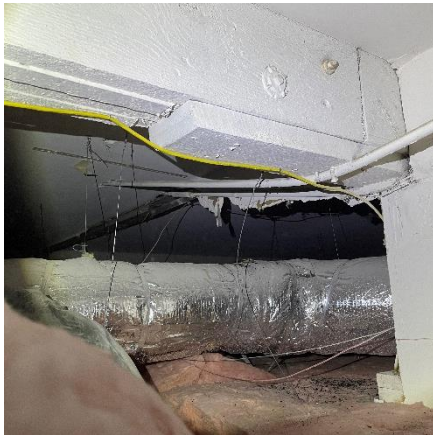
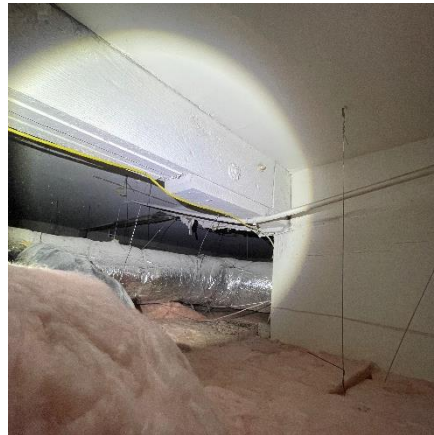
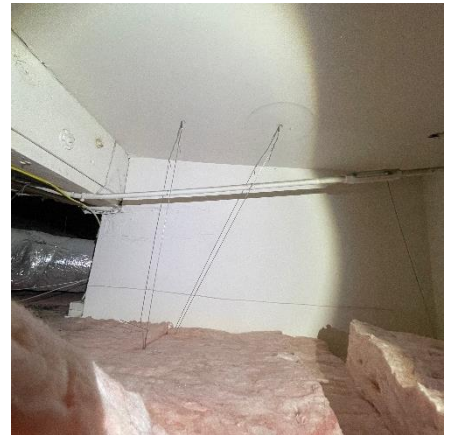
No attempt has been made to verify the structural systems. One unknown condition was observed that we recommend structural evaluation of. (sheet A1)
