State of California - The Resources Agency
DEPARTMENT OF PARKS AND RECREATION
PRIMARY RECORD

*Resource Name or #: THRI - 40 (1998: KEC-134-T-3)

c. Address 10236 Donner Pass Road

*P11. Report Citation: Christensen et al. 2004.
Town of Truckee: Historic Resources and
Architectural Inventory. Kautz Environmental
Consultants, Inc., Reno, Nevada.

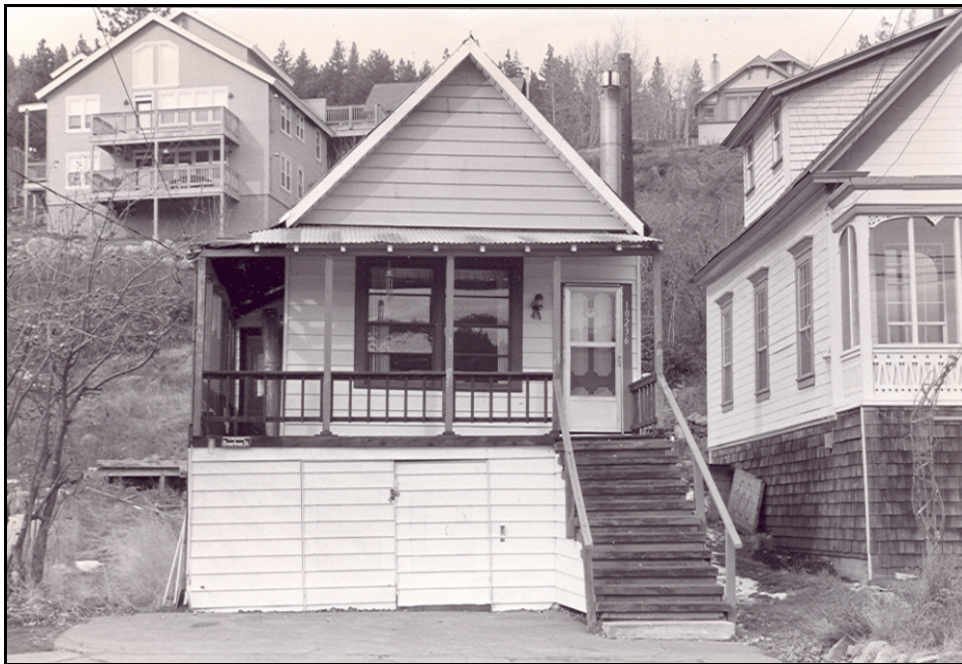
This is a one story, vernacular, gable-front building that is narrow and rectangular in plan. The wood-frame building sets on a raised, wood pier foundation and is covered with c. 1970s horizontal aluminum siding and horizontal wood planks. The steep pitched gable-front roof is covered in corrugated metal sheeting. It has a narrow eave with enclosed rafters on both the gable-front and porch. The east elevation appears to have a closed eave with only a roofing sheet metal overhang. An external metal pipe extends from the east elevation. The primary elevation faces south and has a beveled, arched, four-panel door offset to the east. Centered to the west of the door are paired, vertical, two-over-two, double-hung windows. The south gable is covered with a full-width, dropped, shed roof porch that wraps around the west elevation for 3/4 of its length. The western portion of the porch is partially enclosed with fixed windows in the upper half of the balustrade and aluminum siding in the lower half. The balustrade on the south elevation is built of simple stick design with plain, square support posts. There is another porch addition in the rear of the building. Windows include tall, rectangular, vertical, two-over-two, double-hung, six-over-one, wood-framed, double-hung, one-over-one replacement metal, metal framed full-light vertical, and metal framed full-light horizontal types.

*P5. Description of Photo: (View, date, etc.) South elevation; north view; 11/20/98; Acc. #134-10-7.

- Remove aluminum siding and restore original cladding if present beneath
- Replace metal-frame windows with appropriate historic restoration forms
- Remove porch on the rear; restore enclosed section of front porch (stick balustrade and square post supports)
-
-

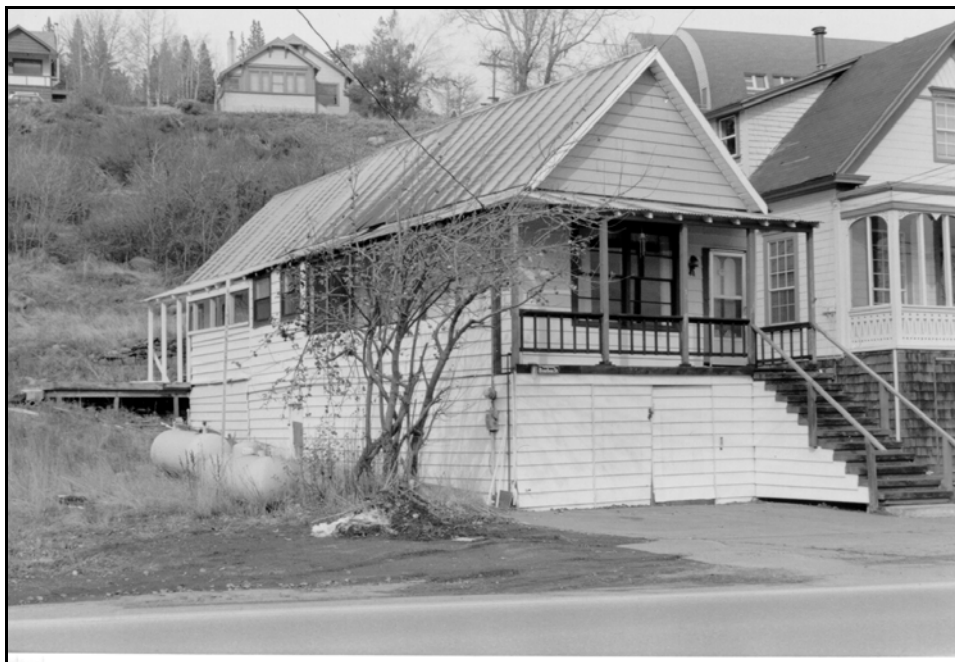
West and south elevations; northeast view; 11/20/98; Acc. #134-10-8.
