## ATTACHMENT A - EXISTING CONDITIONS

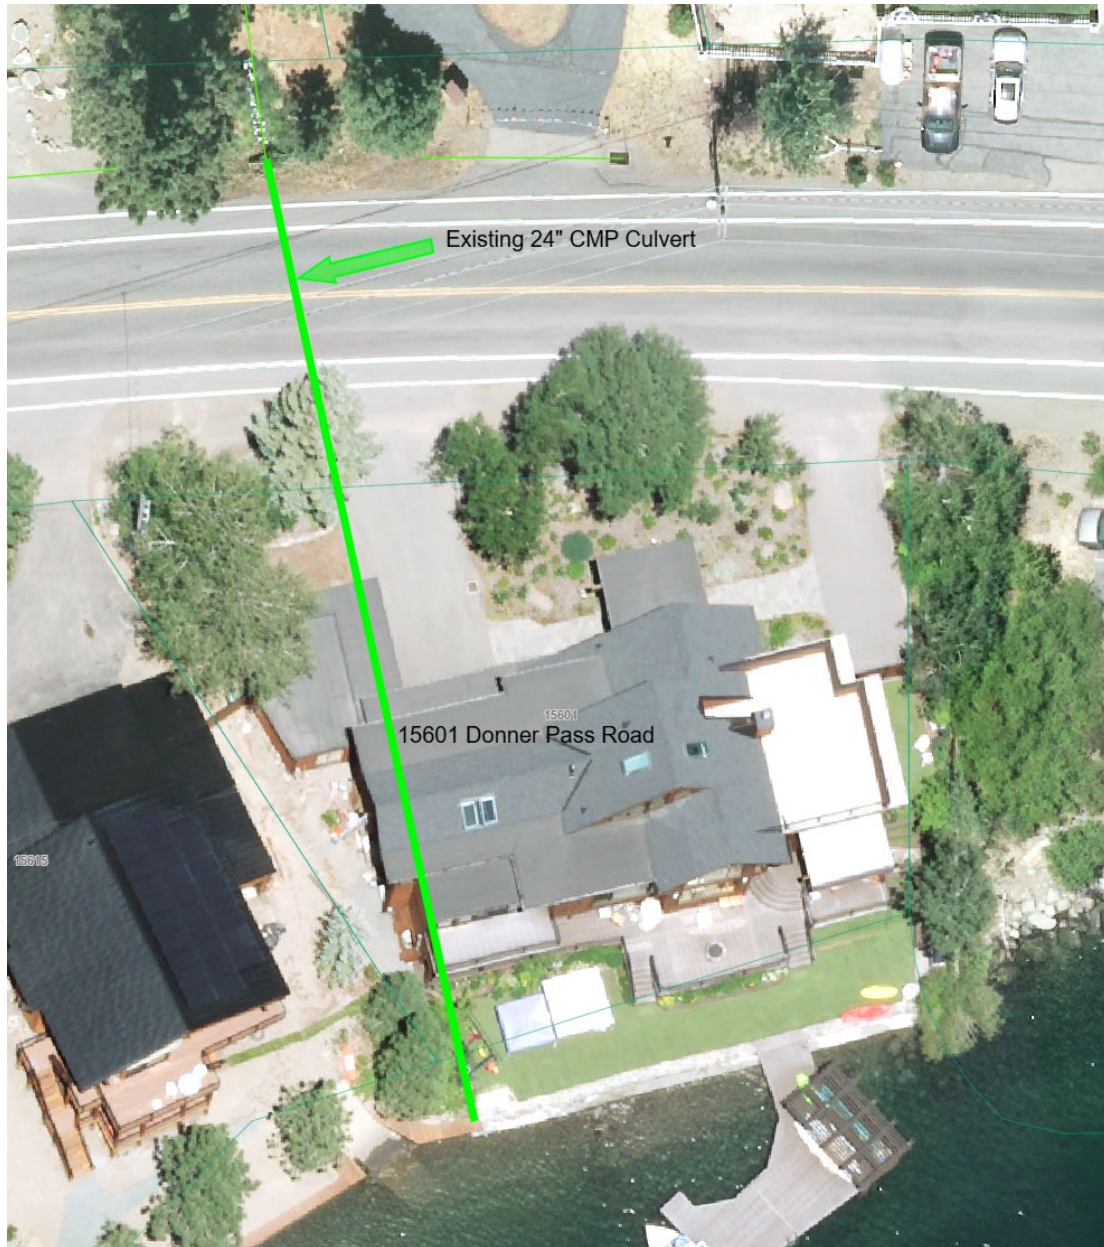
Figure 1

*Existing 24" corrugated metal pipe culvert at 15601 Donner Pass Road. The culvert, depicted by the green line, has an inlet basin on the north side of the road and an outfall into Donner Lake.*

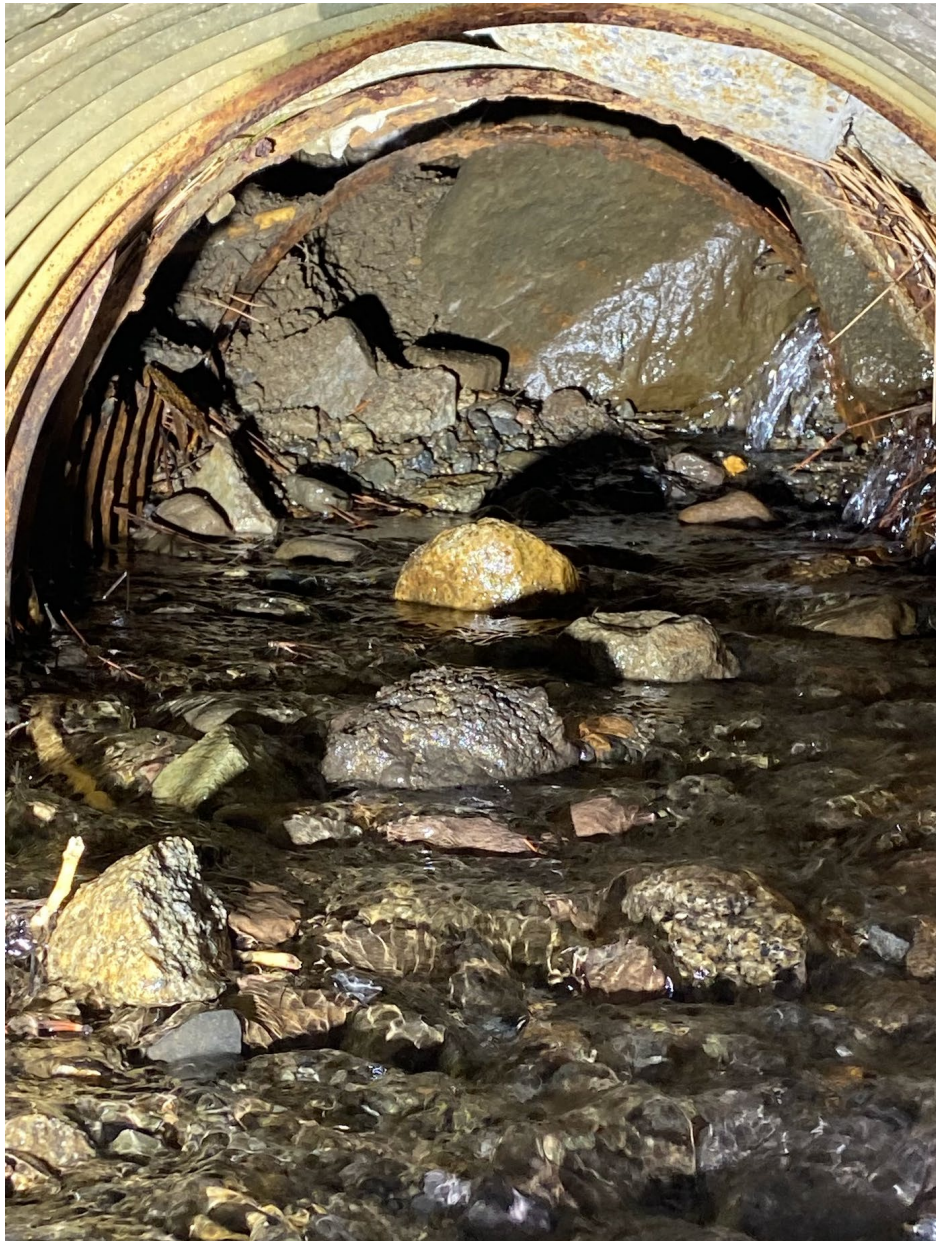
Figure 2

*This image was taken during a camera inspection of the culvert in October 2024. The obstruction depicted is located somewhere underneath the residential structure.*
