# CROSBY HOUSE

## STRUCTURAL OBSERVATION & ASSESSMENT

For: City of Tumwater

Observation Dates:  
Feb. 9<sup>th</sup>, 2021 & July 7<sup>th</sup>, 2021

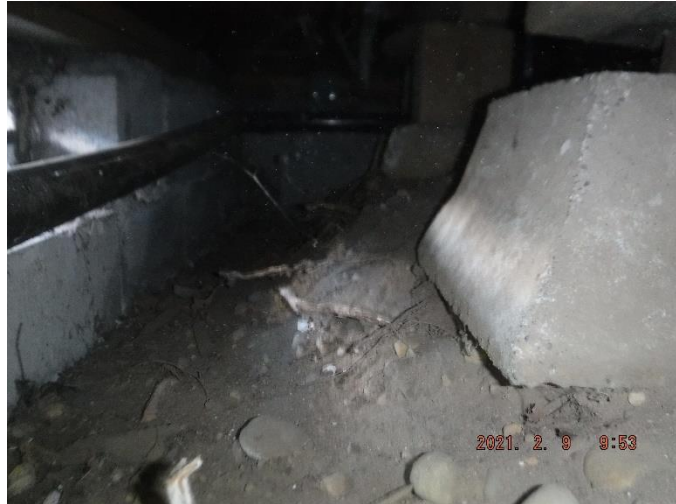
Several of the intermediate support blocks are buried to the point that the bottom of the untreated timber post is several inches below ground. Along the western most perimeter wall below the kitchen, the excavation that was done when the perimeter foundation was installed left a few interior post footings nearly undercut (see photo to right).

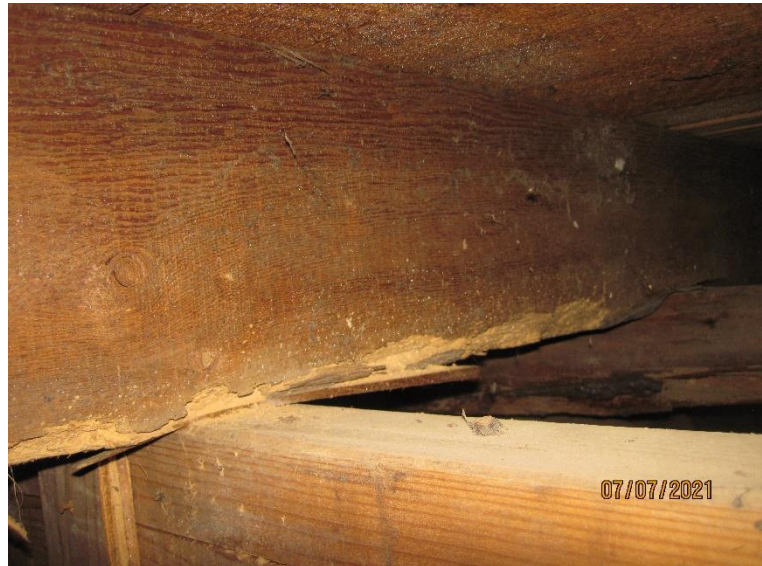
The follow-up observation of the crawl space found no noticeable changes to the structure. The floor joists are still peppered with holes and in generally poor condition (see photo to right). The bottom 1/3 of multiple floor joists have severe deterioration such that you can squeeze and crush the wood with your hand. This is most noticeable along the south wall below the stairs. It's evident that a pest specialist had been in the crawl space since the initial visit with the presence of rodent traps and vent screen repairs.

Any attempt to make this house level would likely cause more damage and issues than it would solve. On that same note, allowing it to continue to settle at this rate is even worse for the structure. The highest priority for repair recommendations is to stop the insect activity as much as possible within the framing of the house and have a more in-depth inspection of the wood members of the house. After that is complete, we recommend the house be monitored every 6 months, including ongoing elevation measurements, until a plan to strengthen the compromised floor framing and foundations is implemented. The next set of elevation measurements should include a mapping of all interior posts and beams and special care taken to get measurements directly above supporting element. This will allow for a better understanding of what elements are causing the most movement.

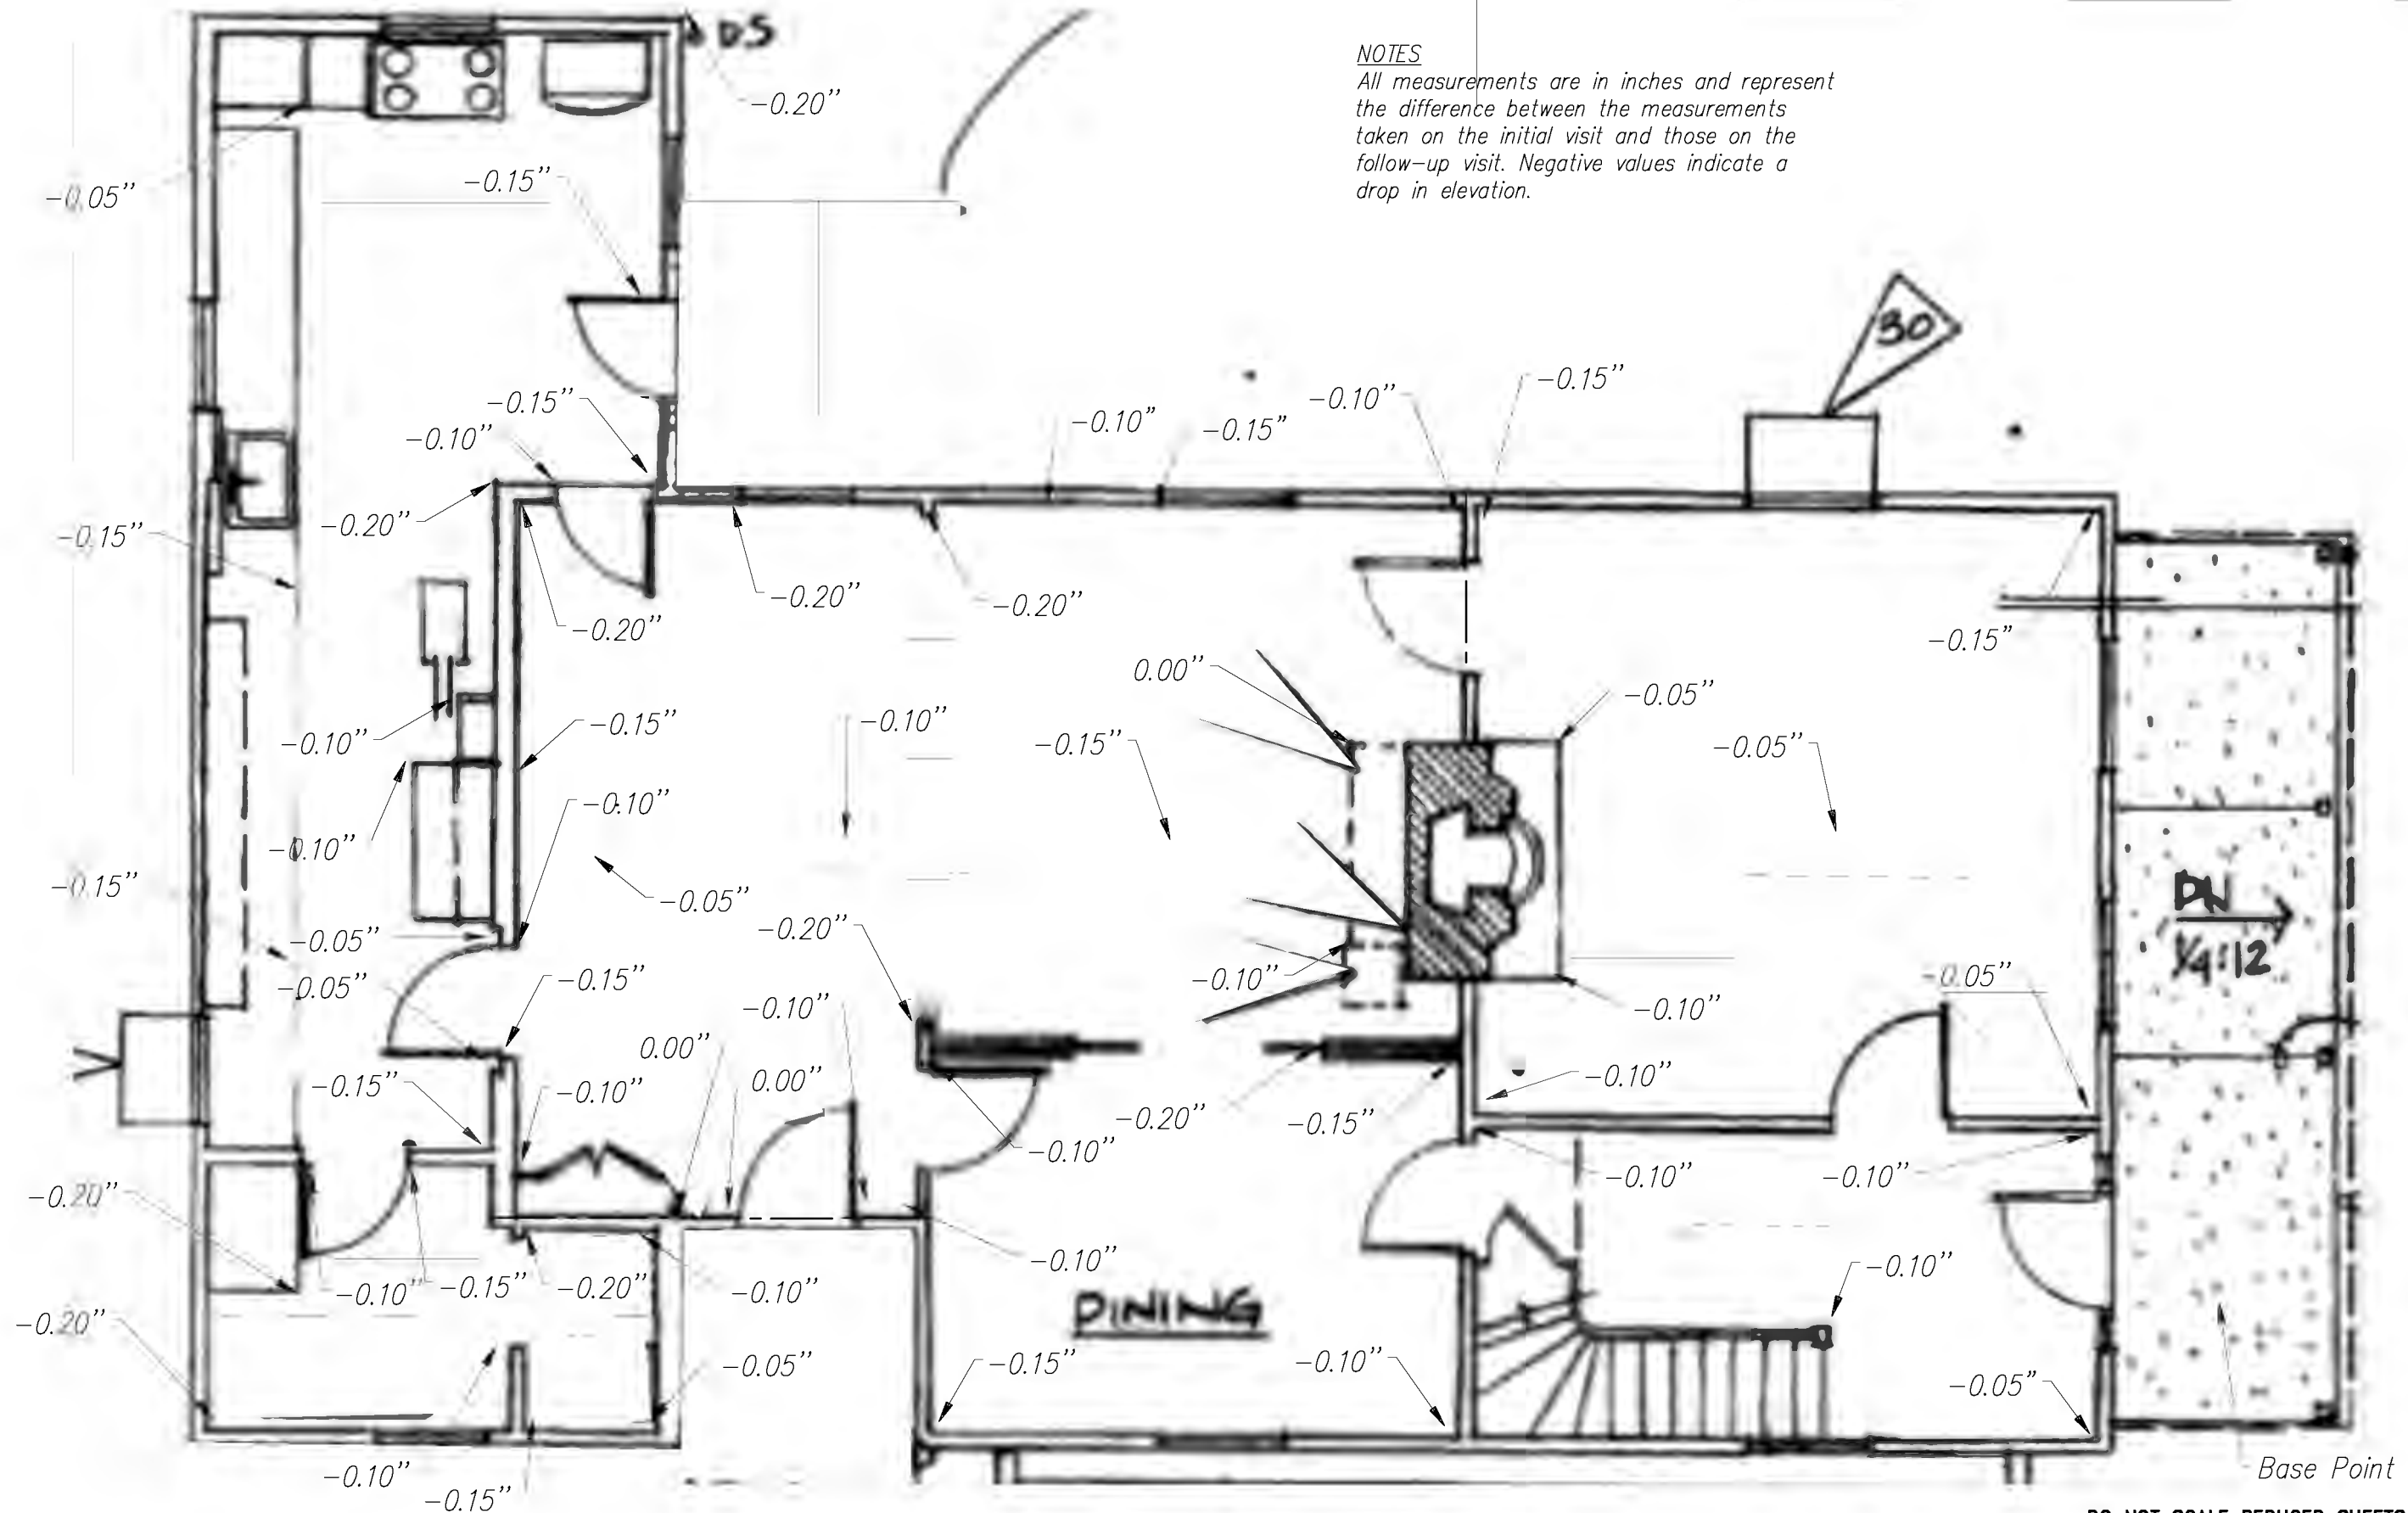
FIRST FLOOR COMPARISON

After comparing the relative elevation measurements from the first visit to the second, it appears that there is significant active settlement occurring (see Appendix). The first floor has areas that settled as much as 0.20" with most areas settling an average of 0.11".

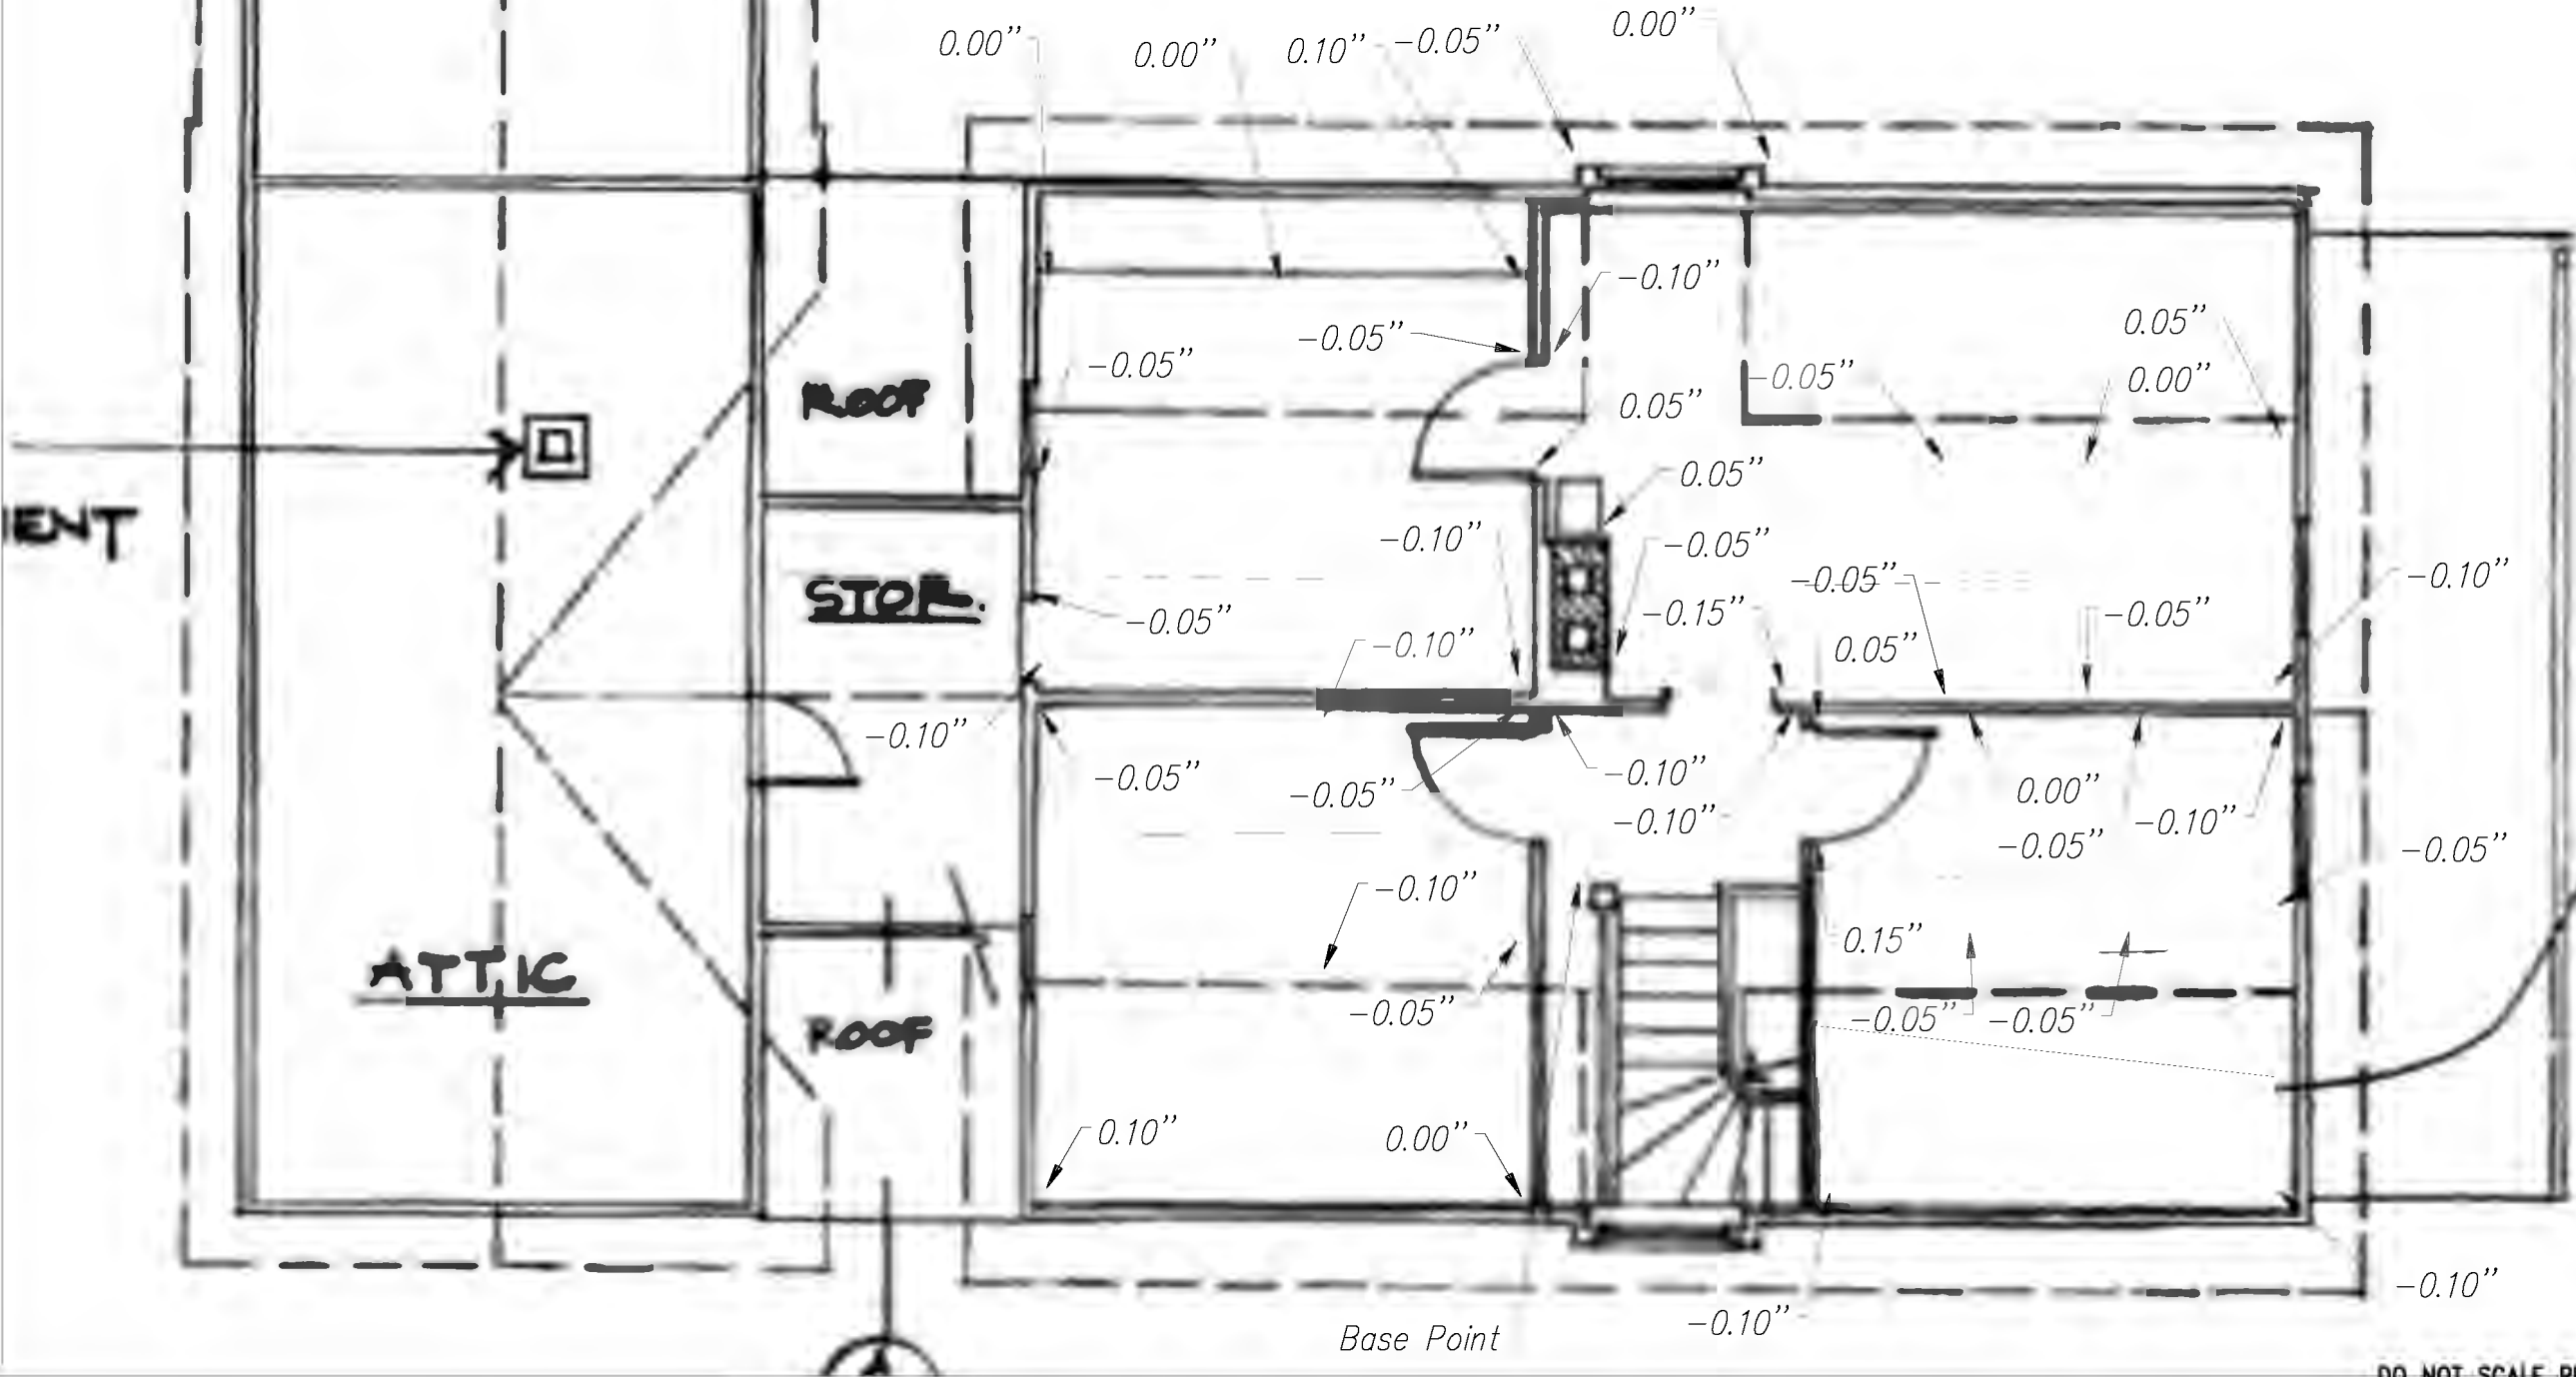
SECOND FLOOR COMPARISON

The location of the base unit for measuring the second floor (at the top of the stairs) is likely to have settled at least 0.10", looking at the amount of settlement directly below it on the first floor. This makes comparing the measurements of the second floor unlikely to give us an accurate picture of where the movement is occurring.
