Todd Prager & Associates
LLC

Tree Risk Assessment for the Davis-Meeker Oak

Date: February 7, 2025

Site Address: 7525 Old Highway 99 SE
Tumwater, Washington 98501

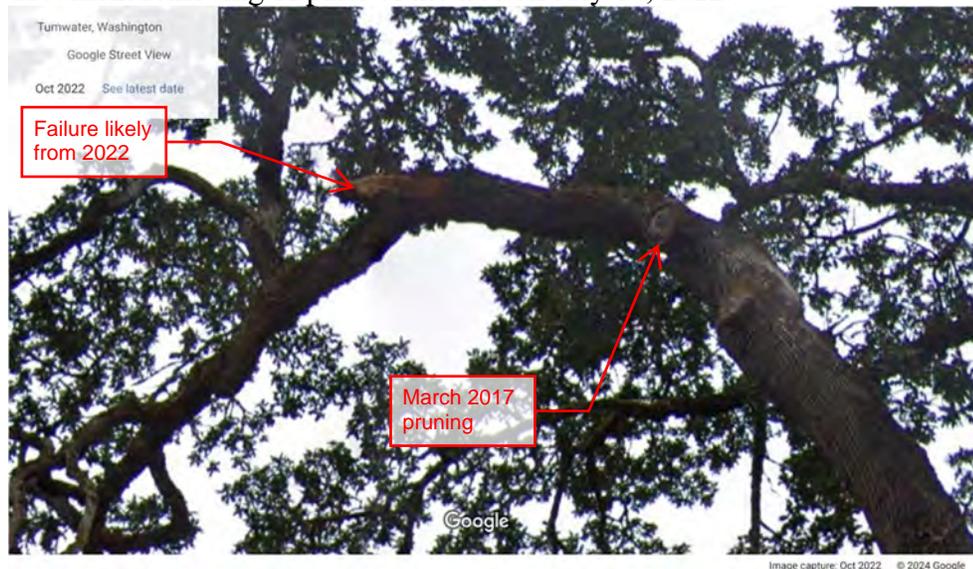
Figure 4 October 2022 view of branch over Old Highway 99.

- There is a relatively recent branch failure, likely from 2022. Google street view shows the torn branch first appearing in October 2022. City of Tumwater records document removing of parts of the tree on July 16, 2022.

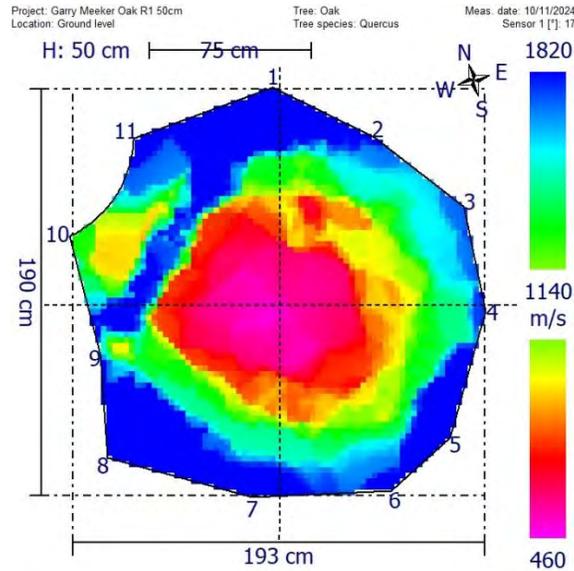
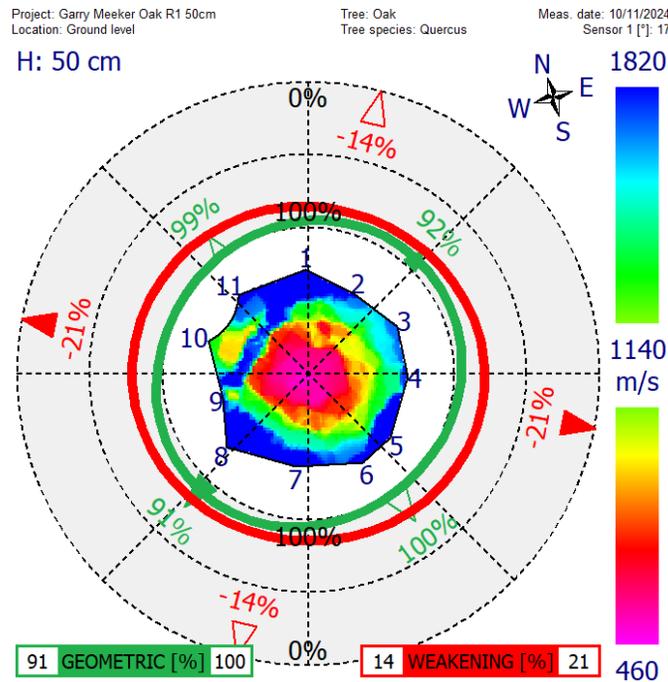
At this level there is significant compromised wood throughout the stem. The wood decay fungi that is affecting this tree has created a significant amount of compromised wood.

At this level there is between 14% and 21% strength loss depending on direction.

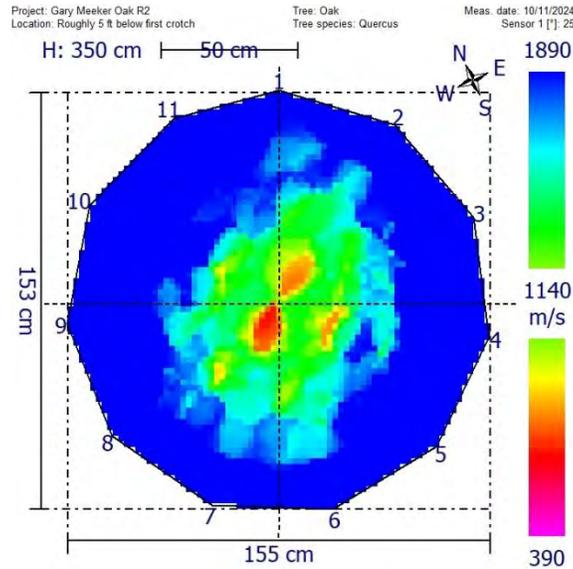
At this level there is a small amount of compromised wood in the center of the stem. The green indicates where the co-dominant inclusion is causing a weak attachment point.

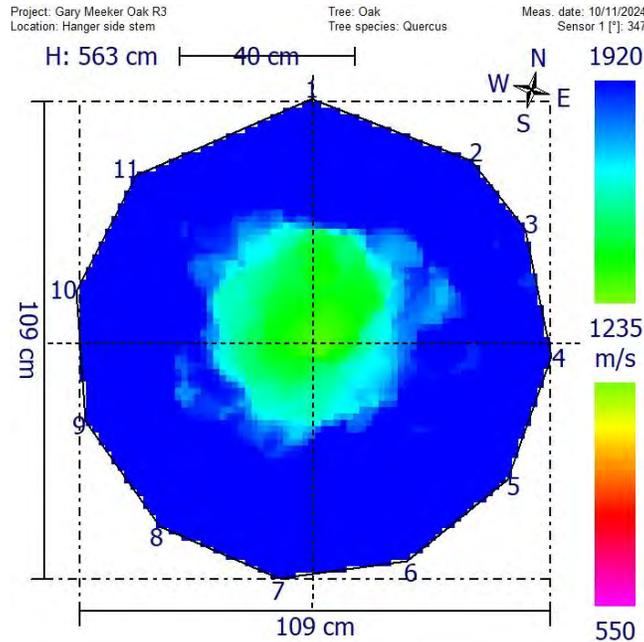
At this level there is no sign of compromised wood.

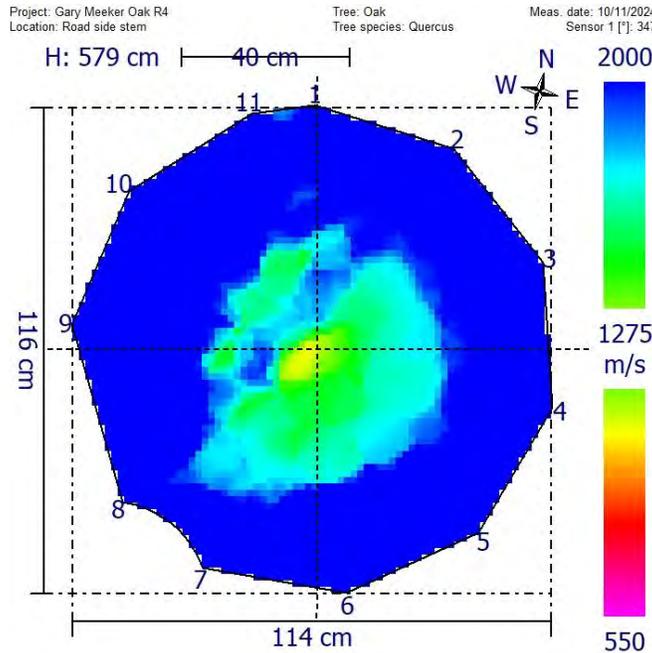
At this level there is no sign of compromised wood.

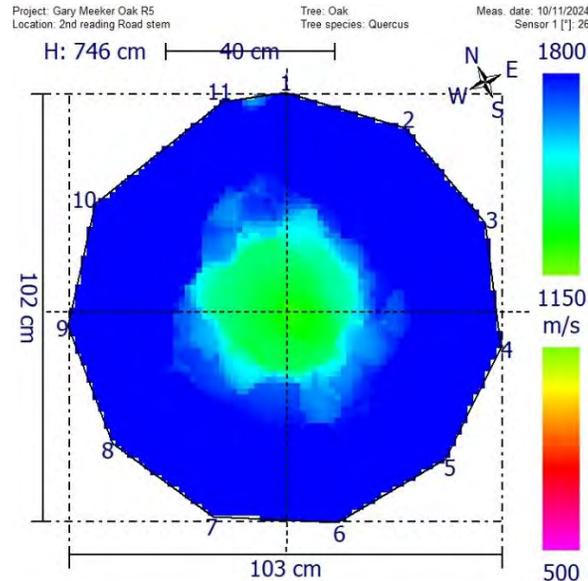
At this level there are no signs of compromised wood.

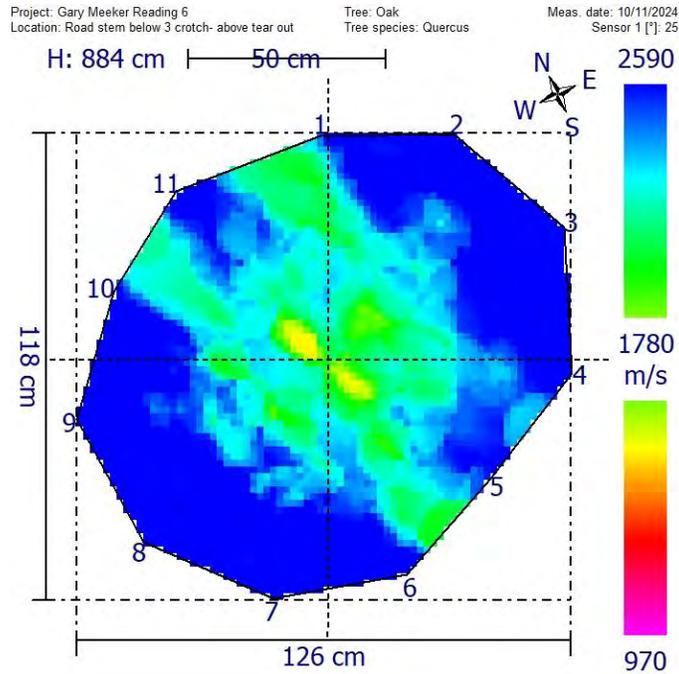
At this level there is included bark throughout the center of the stem, where the three stems connect.

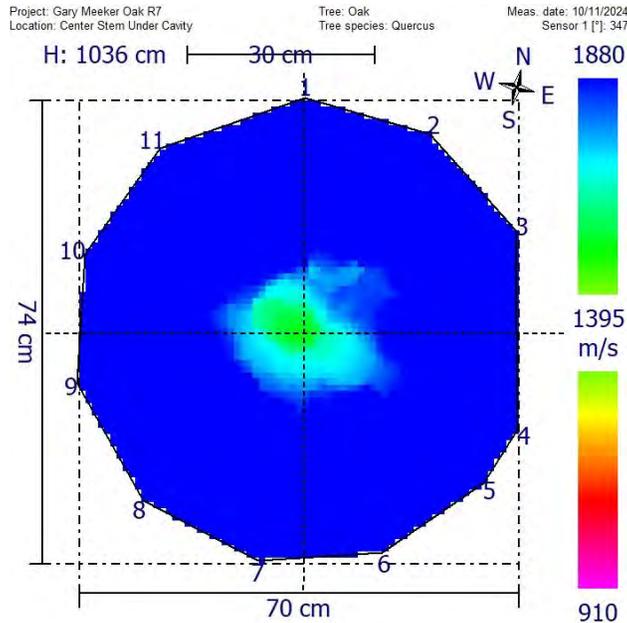
At this level there is no sign of compromised wood.

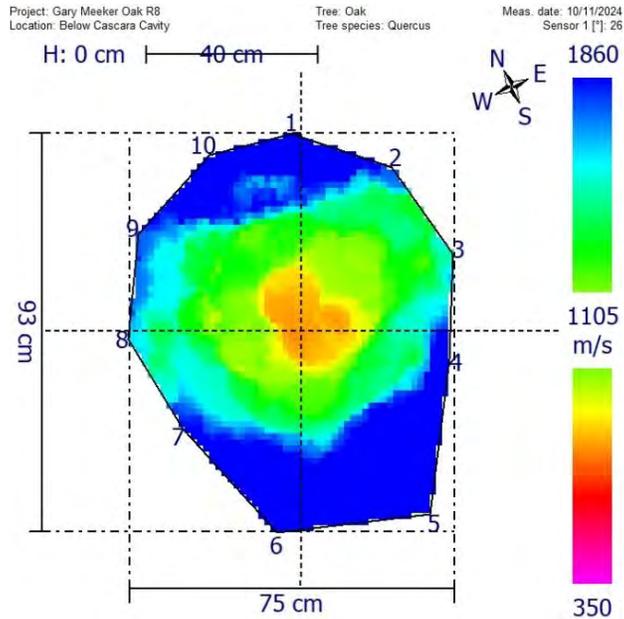
At this level there is less dense wood in the center of the stem. The center yellow spot indicates where the cavity above extends too.

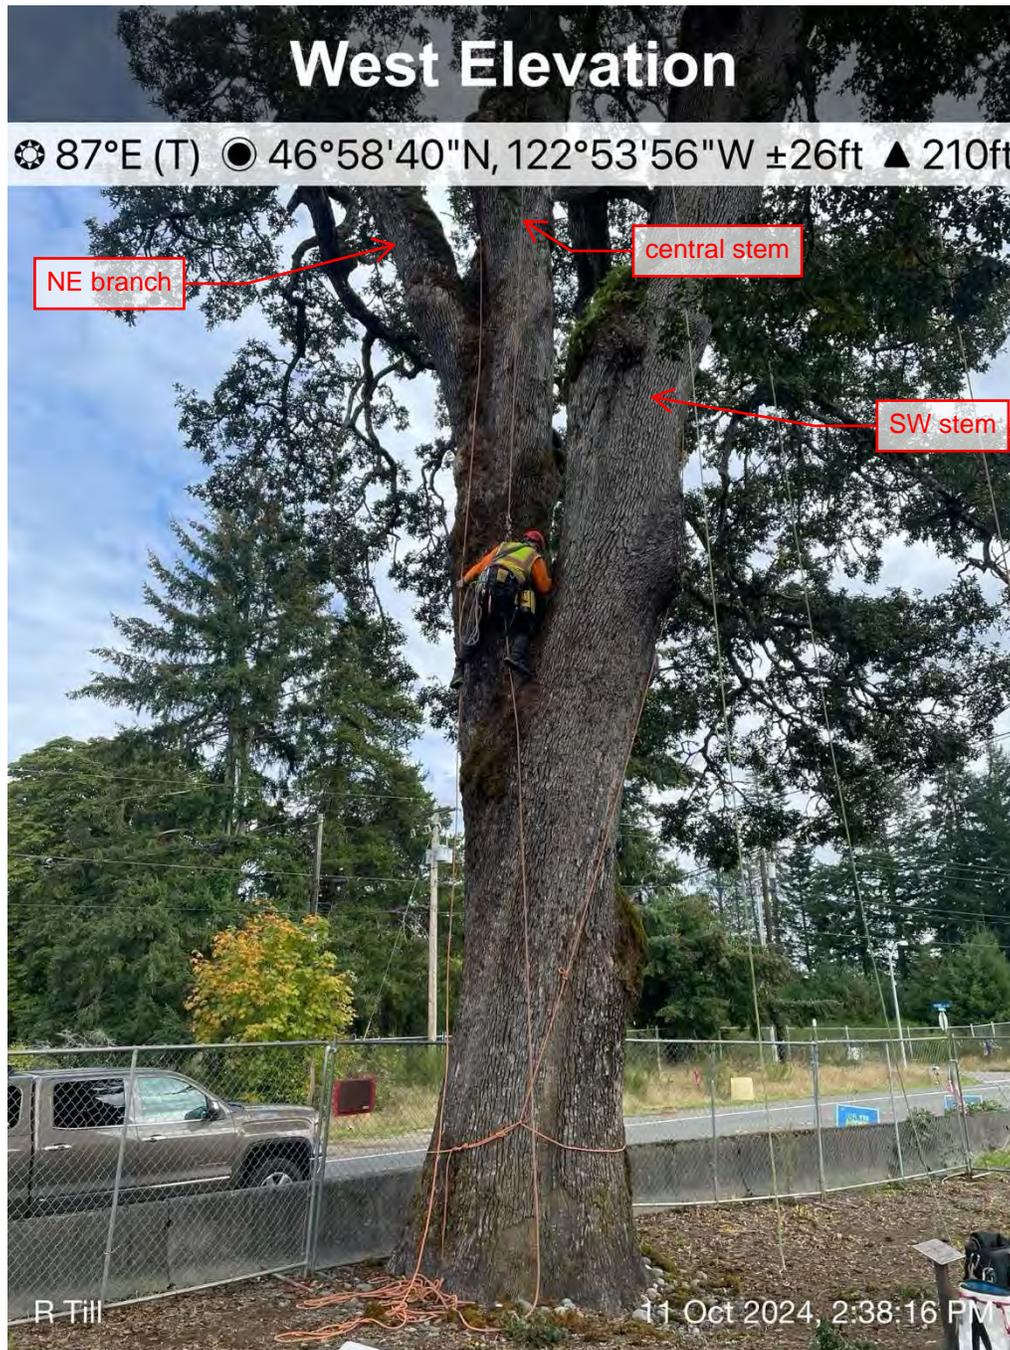
Figure 1 Inspection of first codominant union. A ¼ inch steel probe was inserted between stems and encountered solid resistance below historic debris collecting between the stems.

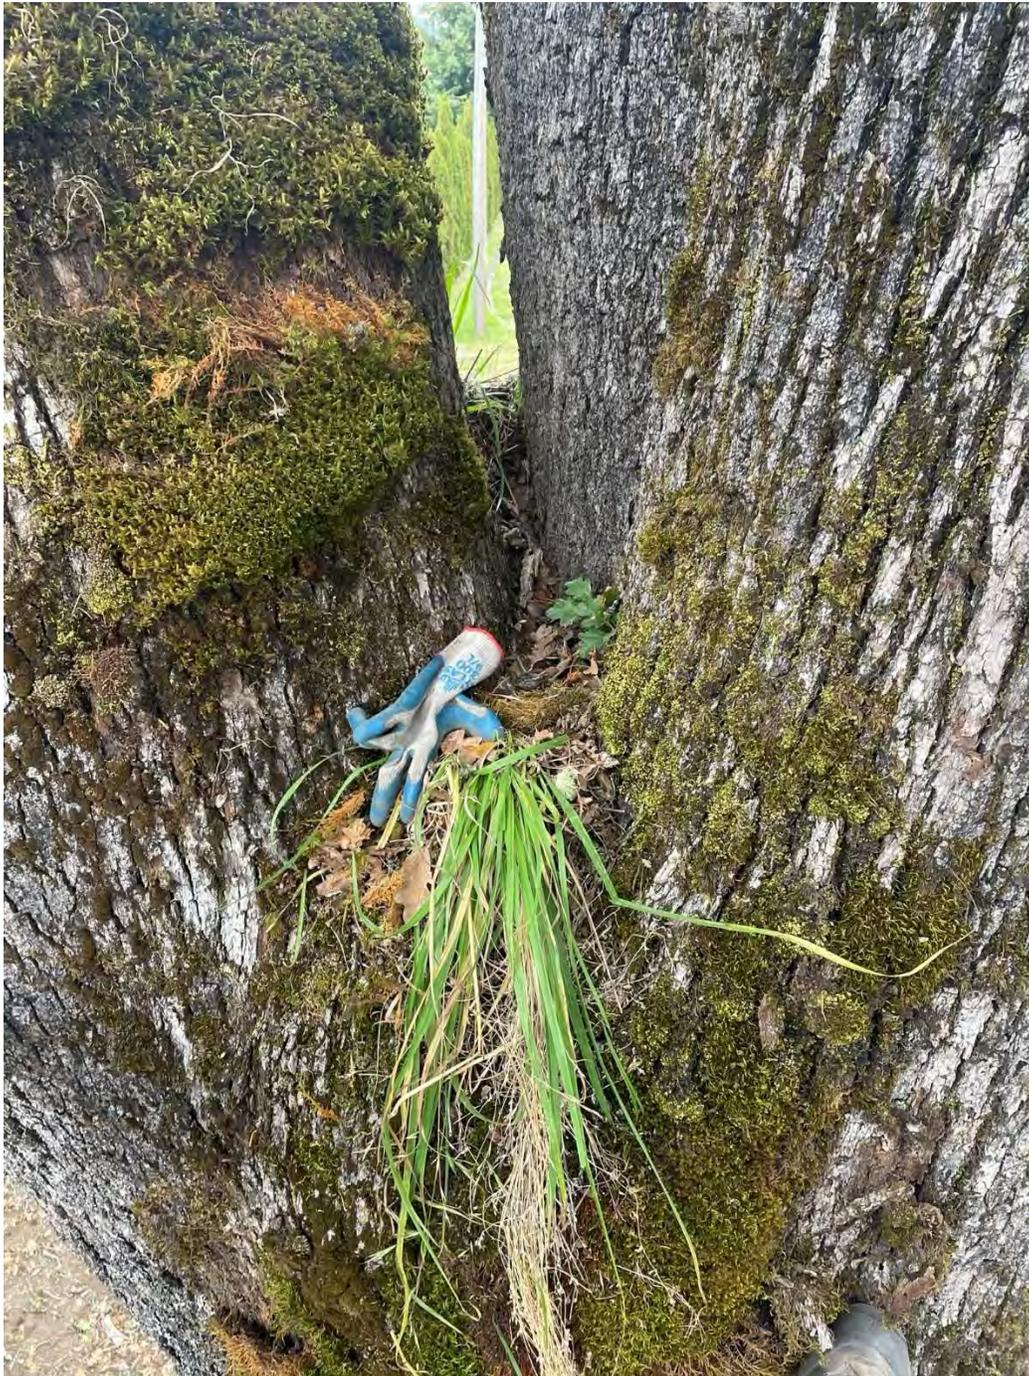
Figure 2 Debris accumulation and plant growth between codominant stems.

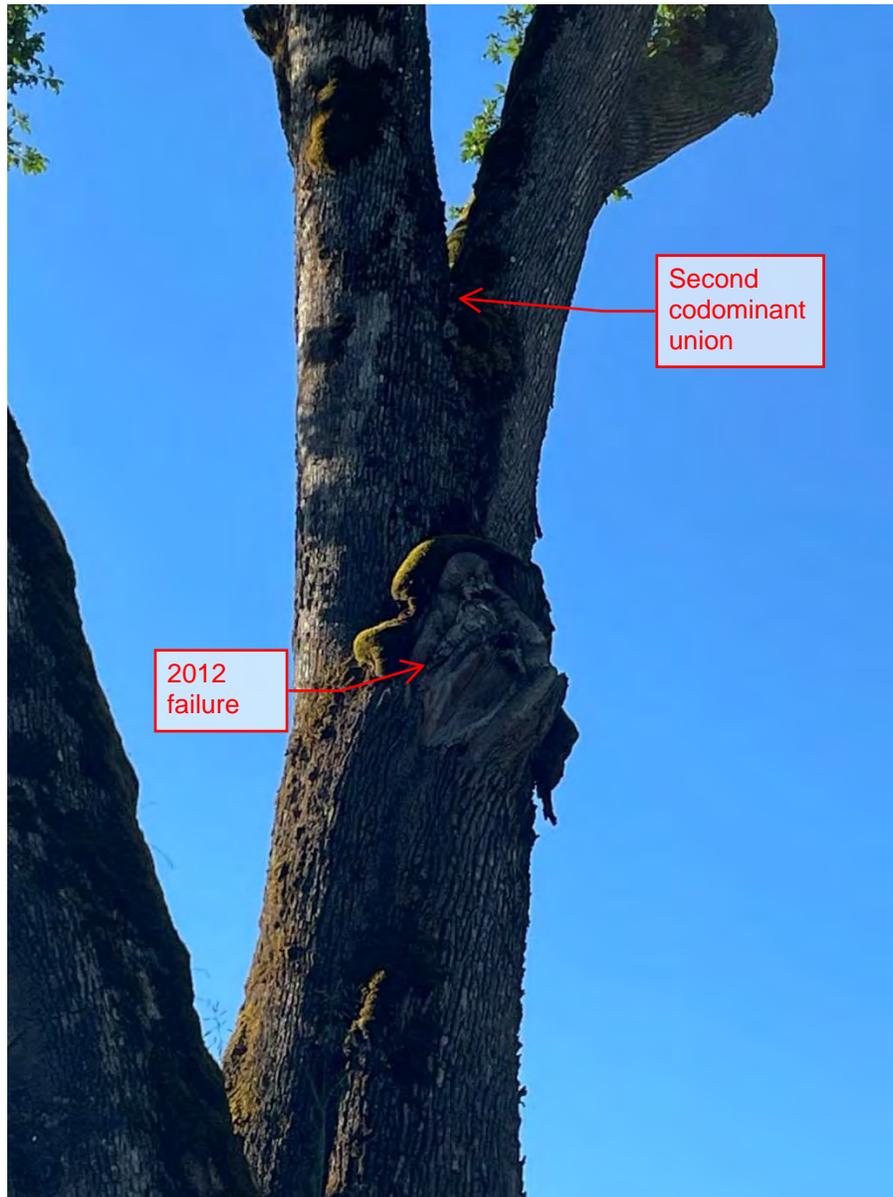
Figure 3 2012 failure and the second codominant union related to the following series of photos.

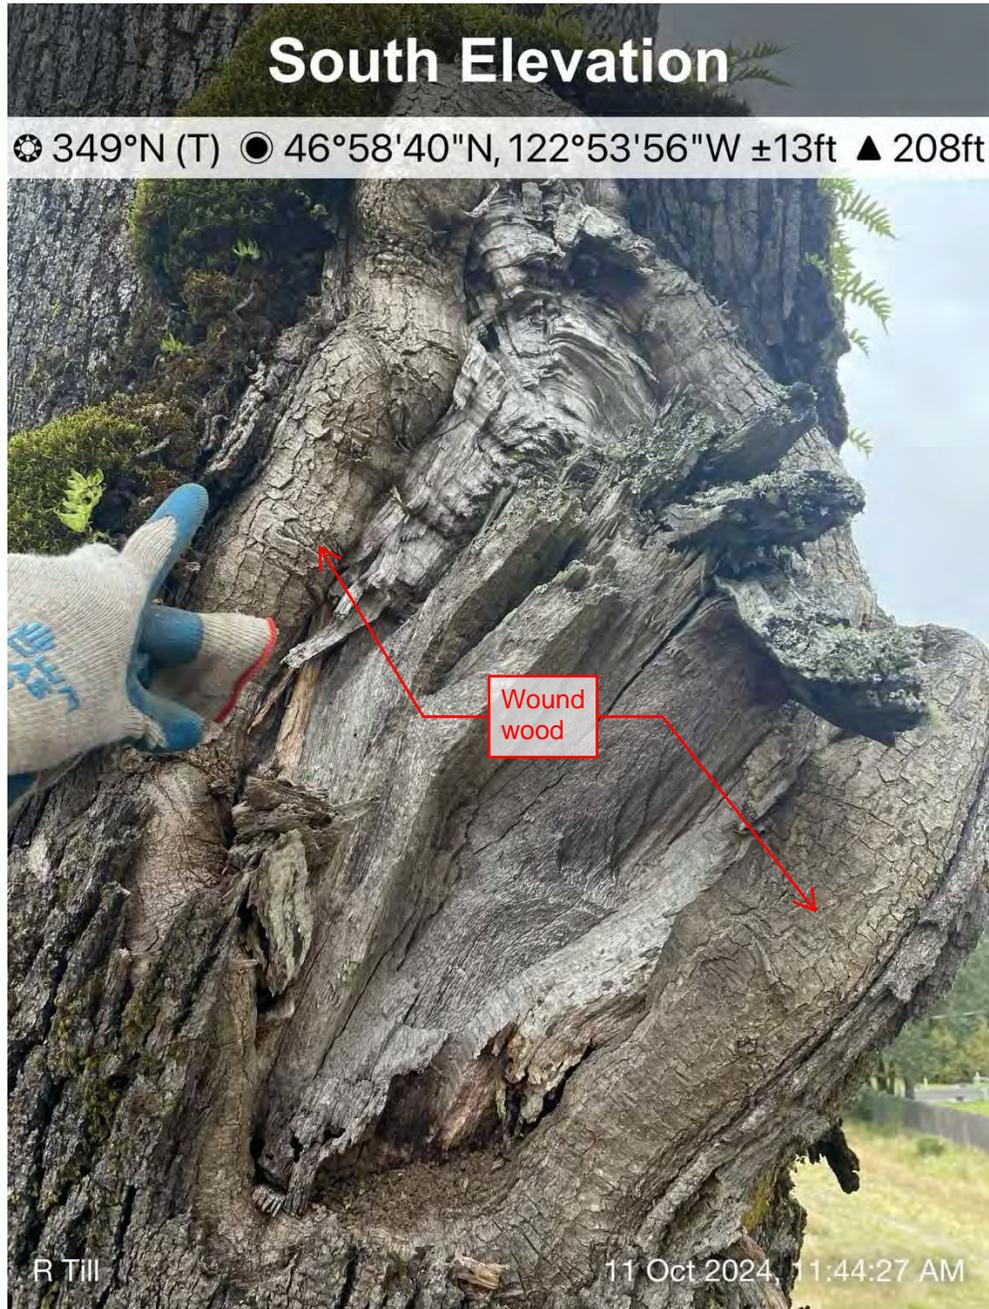
Figure 4 Failure on southeast side of central stem at 26 feet.

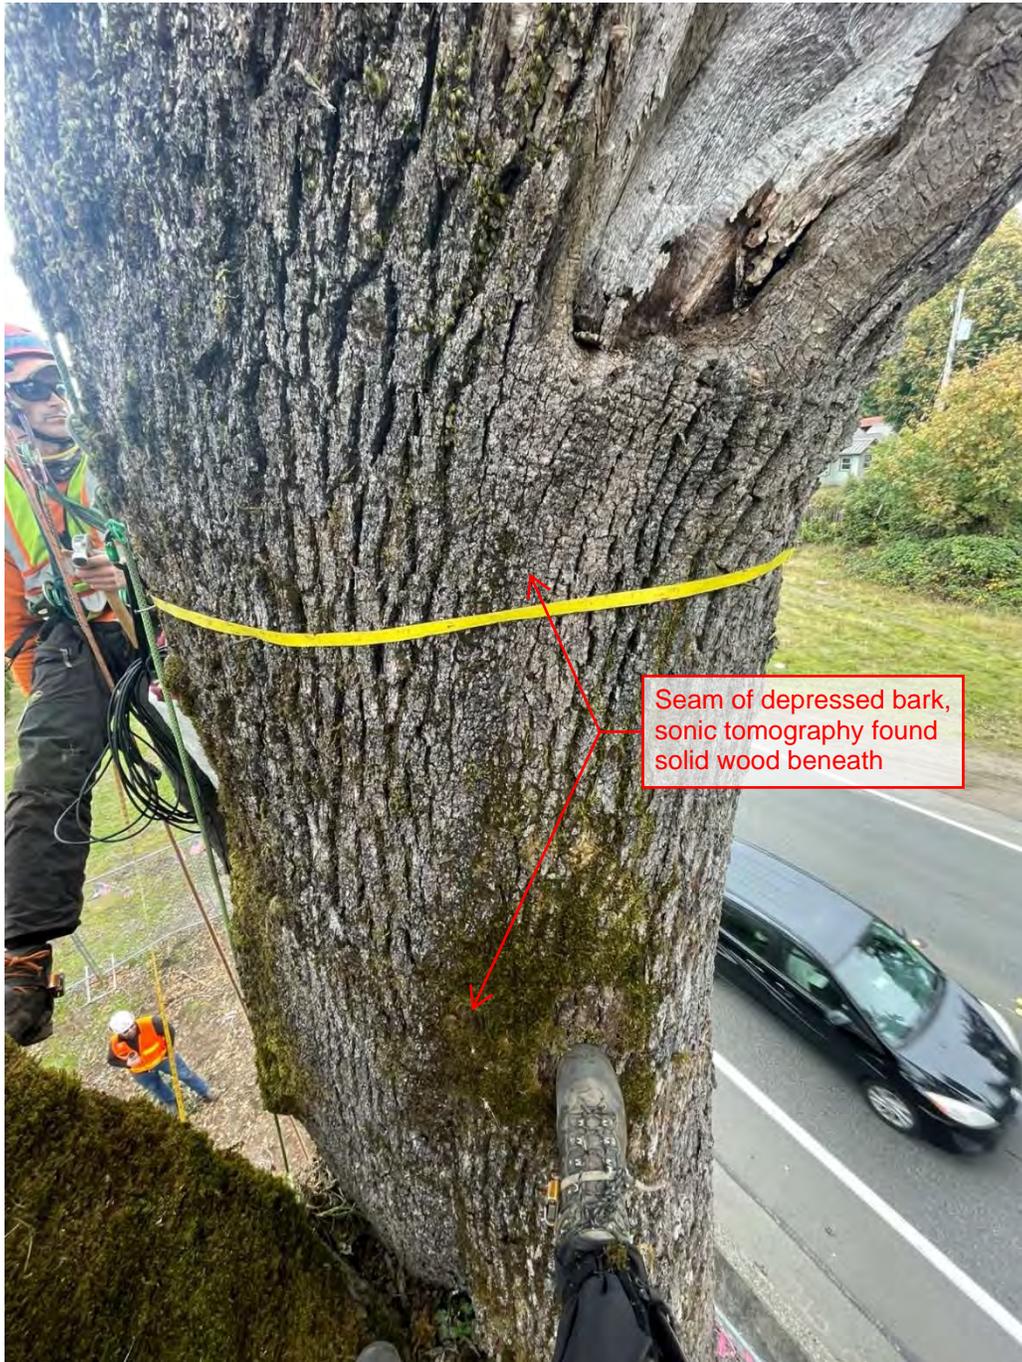
Figure 5 Seam below 2012 failure. Sonic tomography found solid wood down into codominant union.

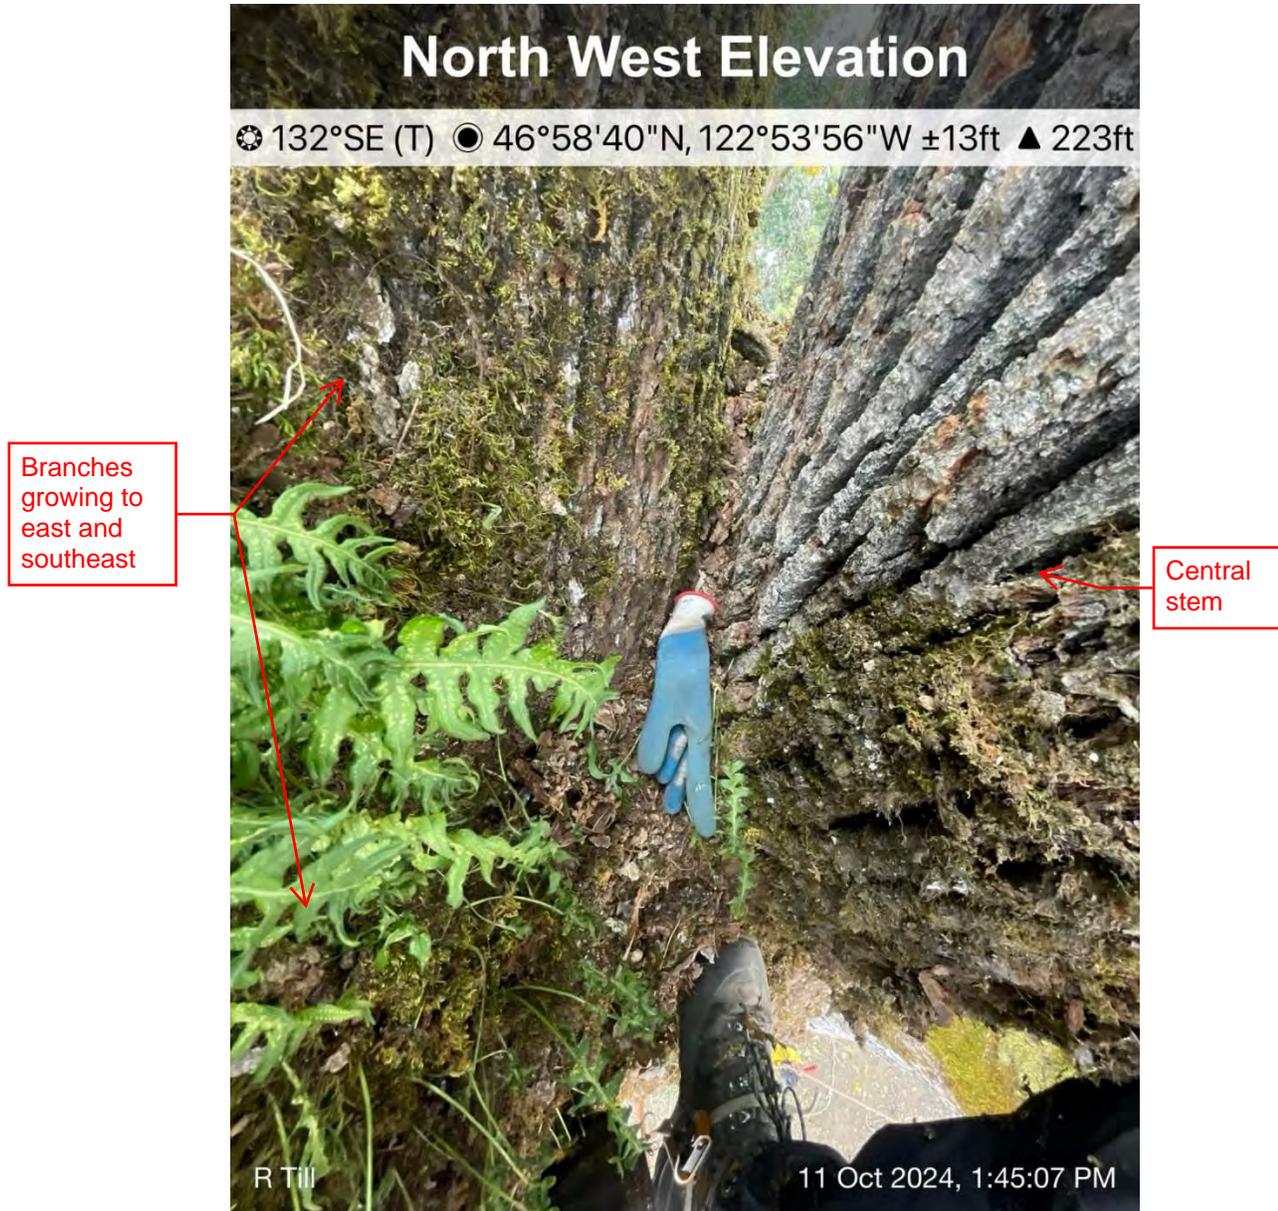
Figure 6 View directly down into second codominant union. Two stems over the road are on the left and central stem to the right. Union has included bark. Probing did encounter solid resistance beneath debris.

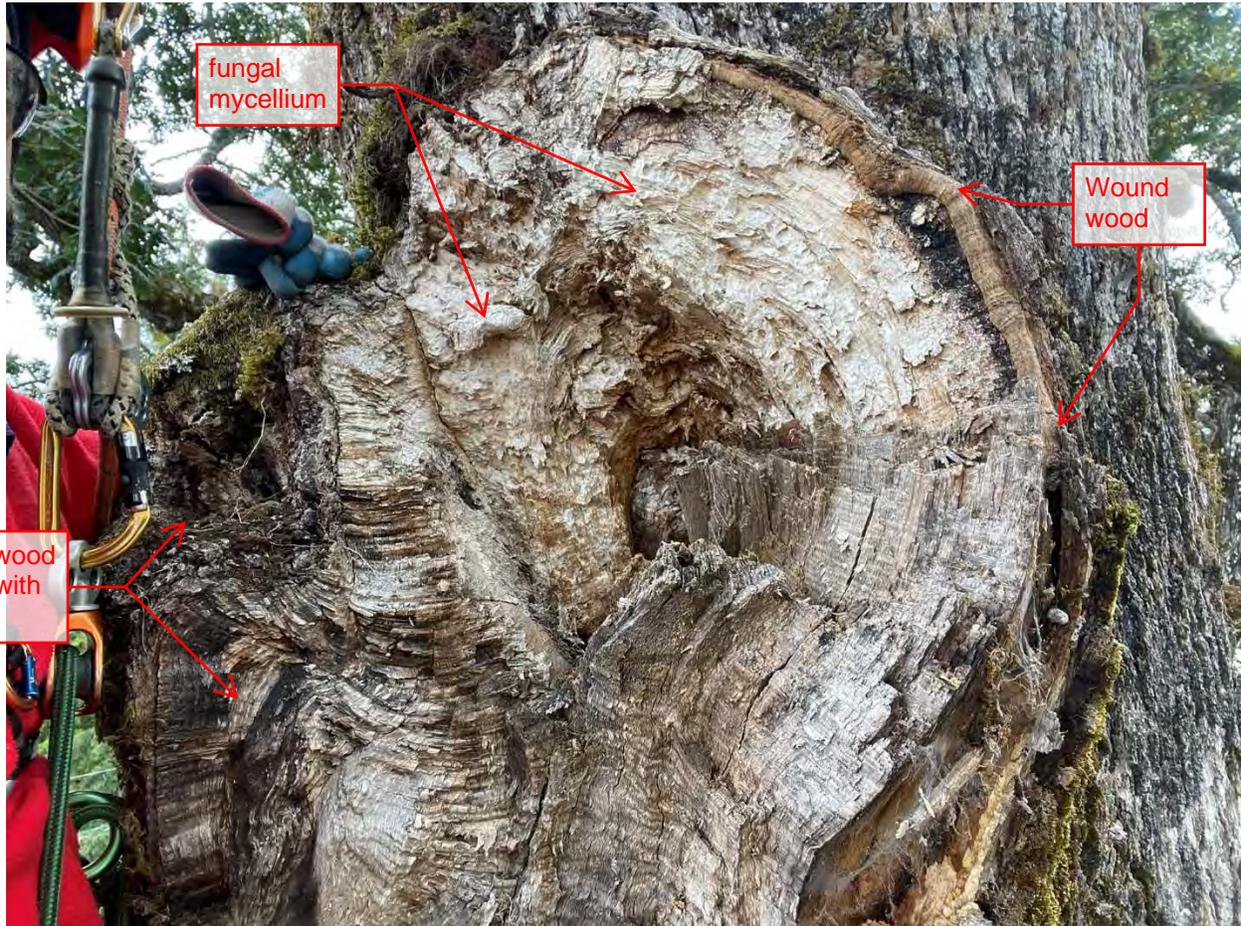
Figure 11 Wound wood on the top-right margin is positive response from tree. The fungal mycelium sampled from this location was identified as a Stereum species, which primarily consumes dead sap wood.

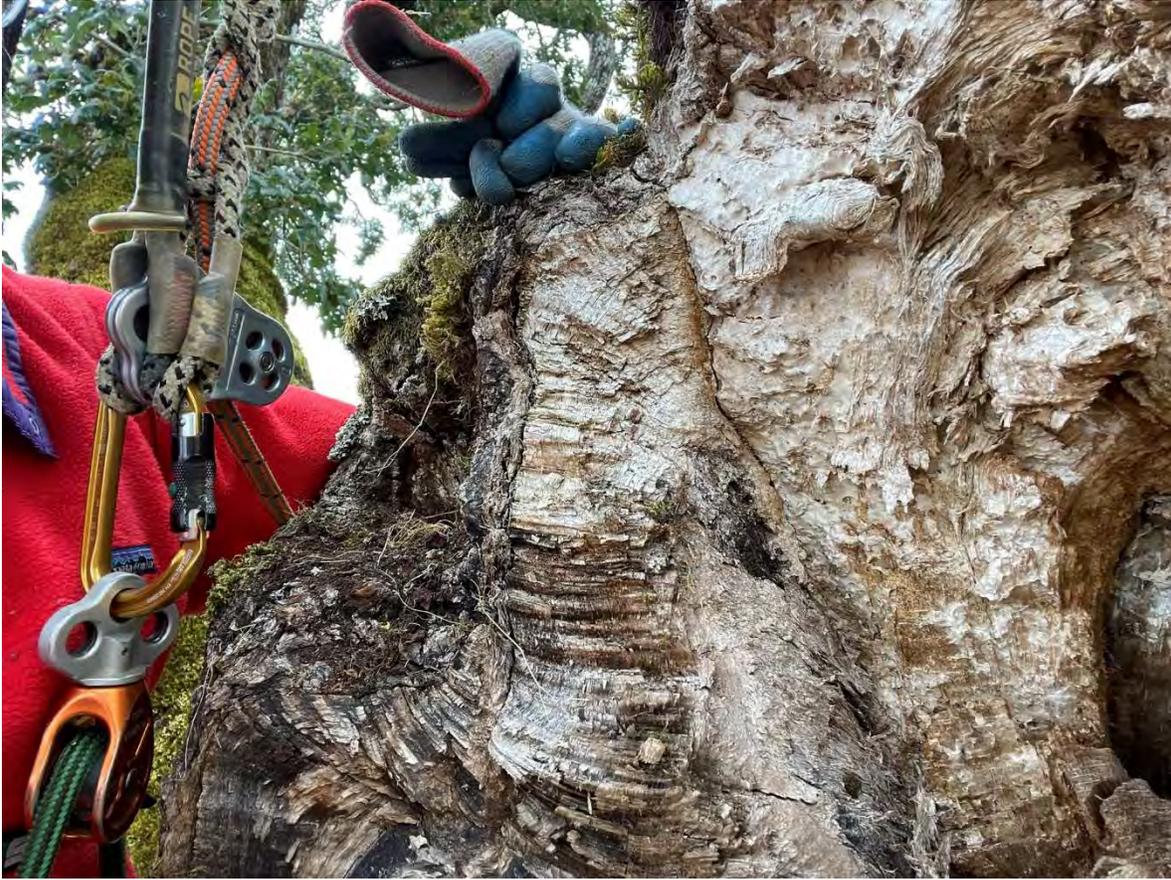
Figure 12 Left margin of 2023 failure and adjacent historic wound.

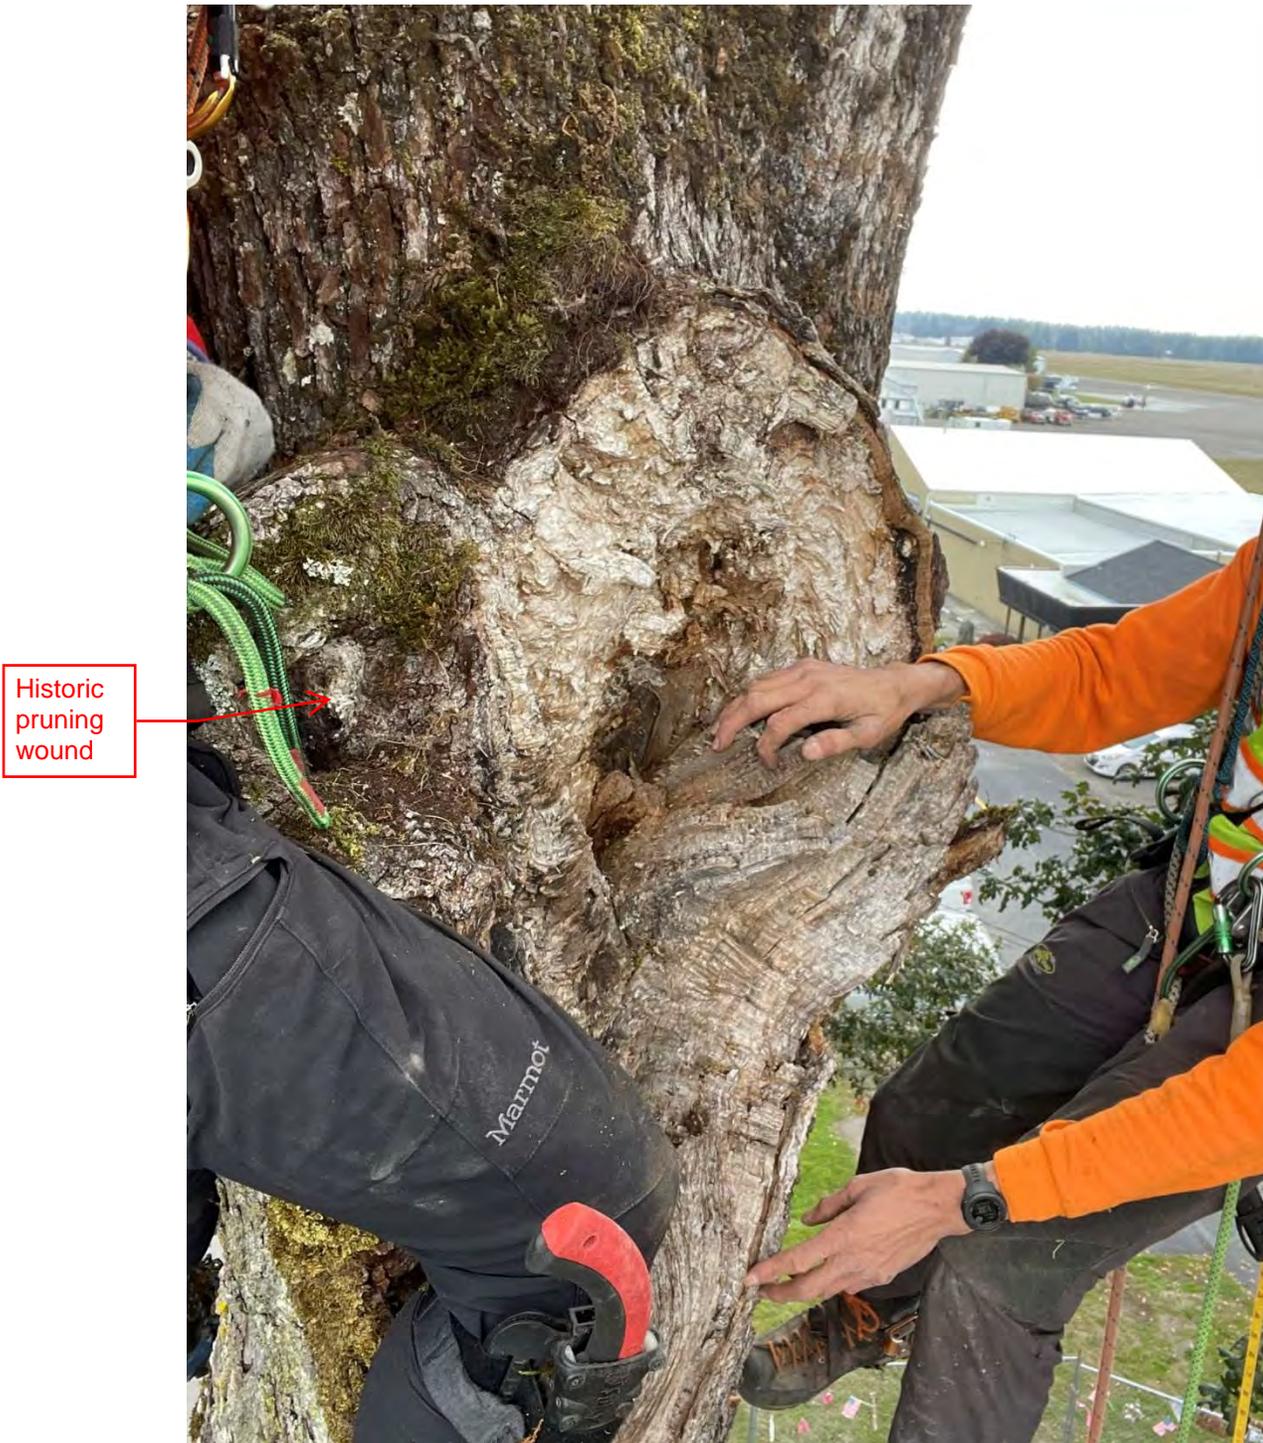
Figure 13 Additional view of 2023 failure and historic pruning wound.

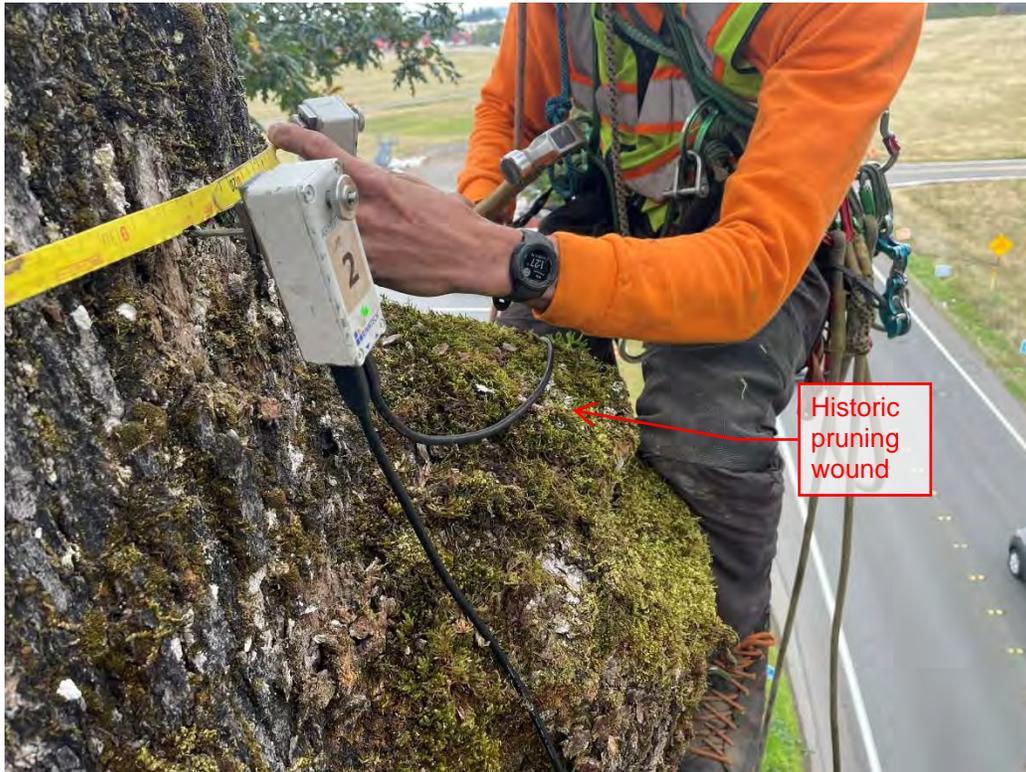
Figure 14 Historic pruning wound (covered in moss directly below watch) approximately 1 foot above the 2023 failure and below the Kestrel cavity.

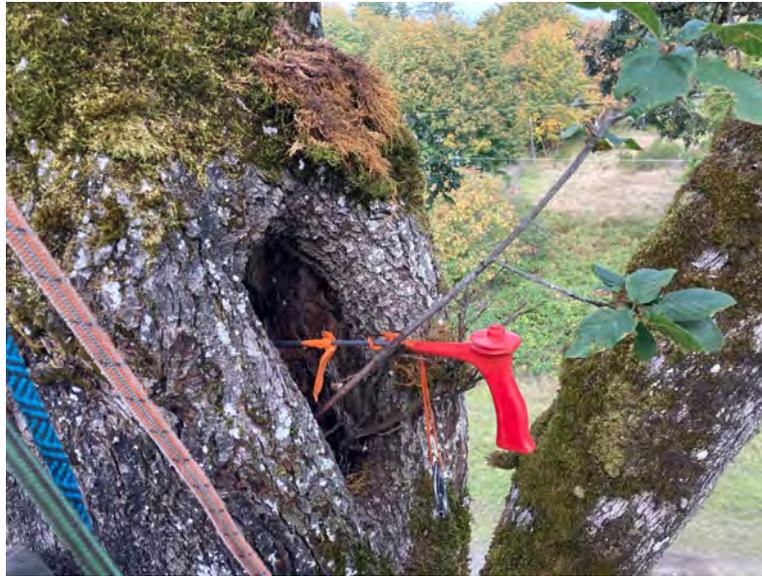
Figure 15 Photo depicting depth of cavity and cascara (*Frangula purshiana*) growing from cavity.

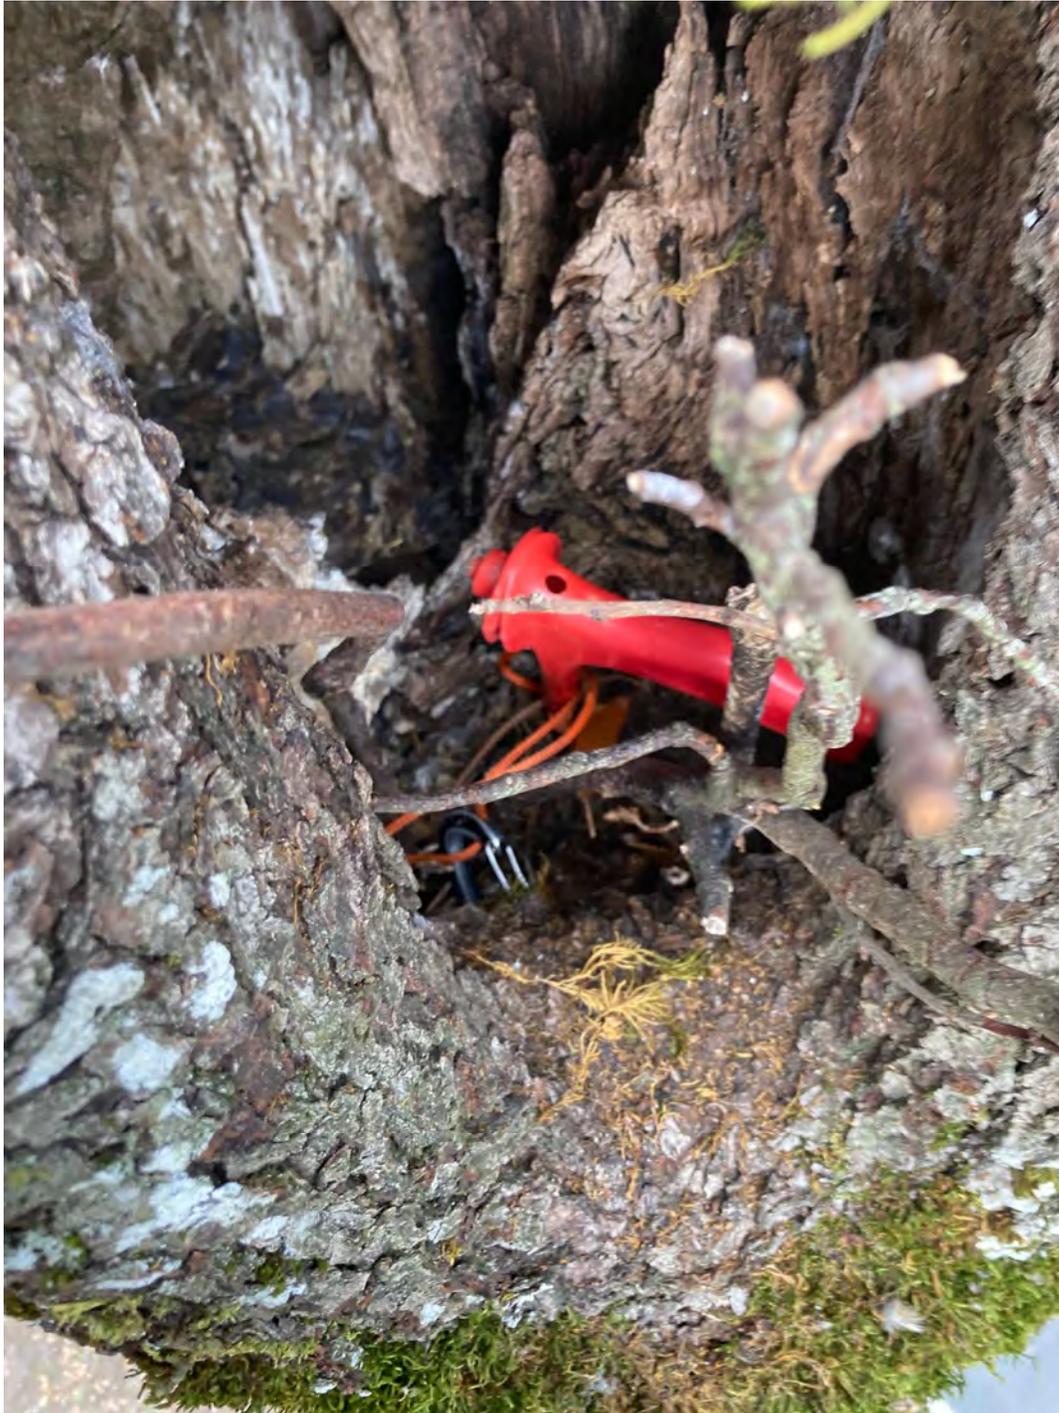
Figure 23 Probe inserted down into cavity in a central column of decay.

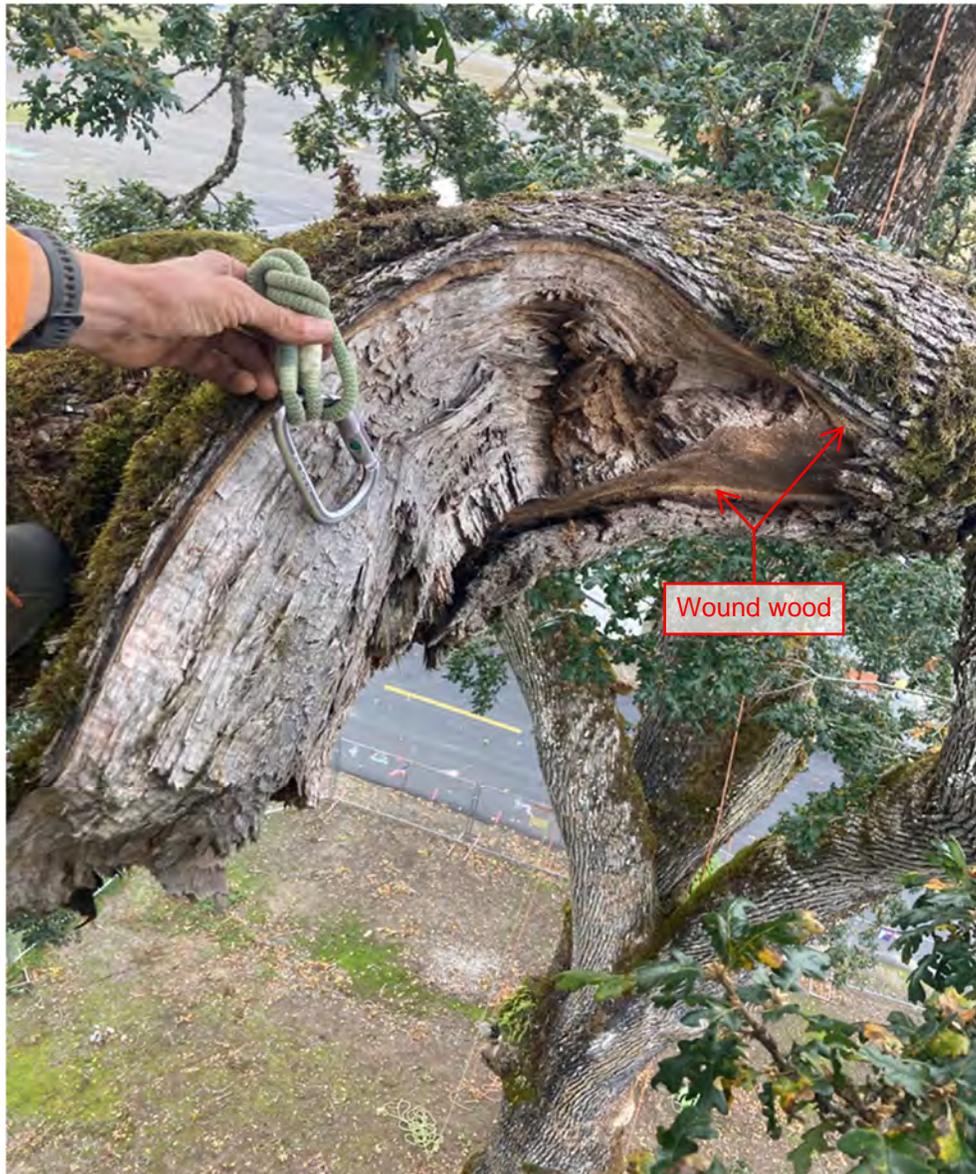
Figure 25 Carabiner used for scale. Note two to three years of wound wood growth around margin of injury.

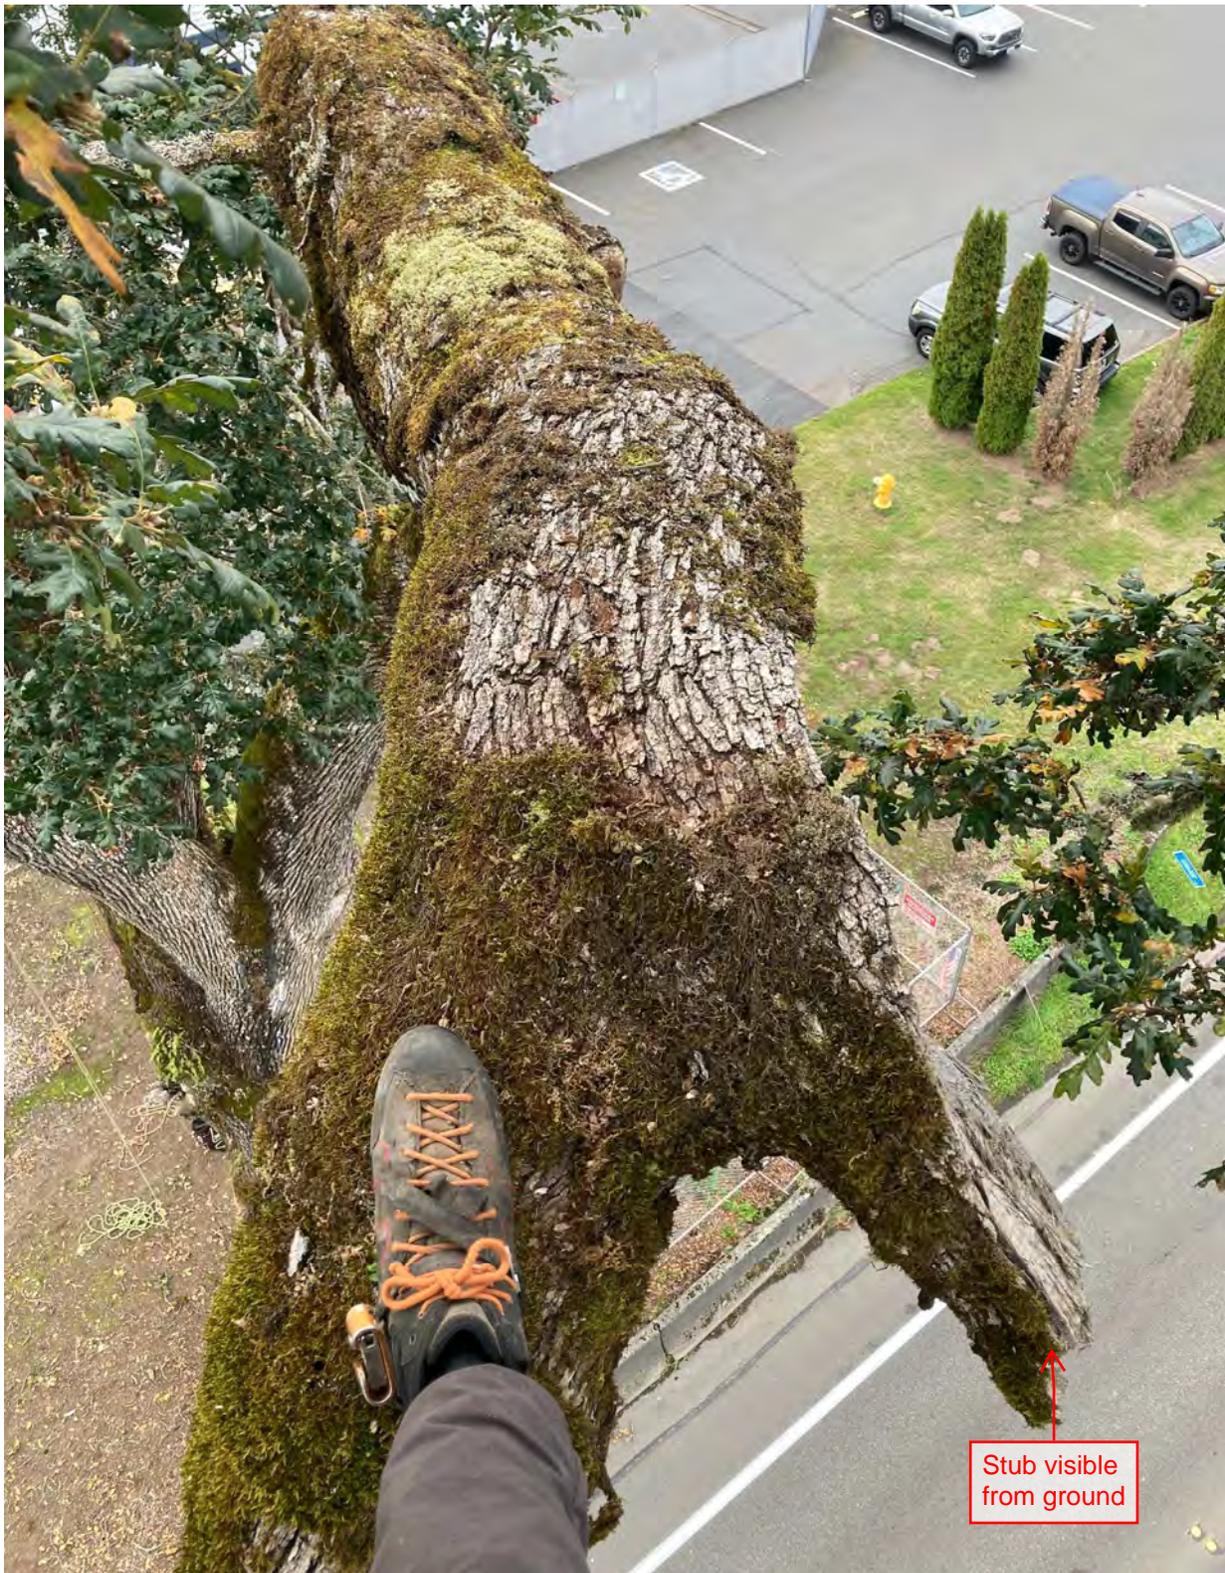
Figure 26 View from above failure showing extent of sound wood supporting remaining stem.
