Todd Prager & Associates
LLC

Tree Risk Assessment for the Davis-Meeker Oak

Date: February 7, 2025

Site Address: 7525 Old Highway 99 SE
Tumwater, Washington 98501

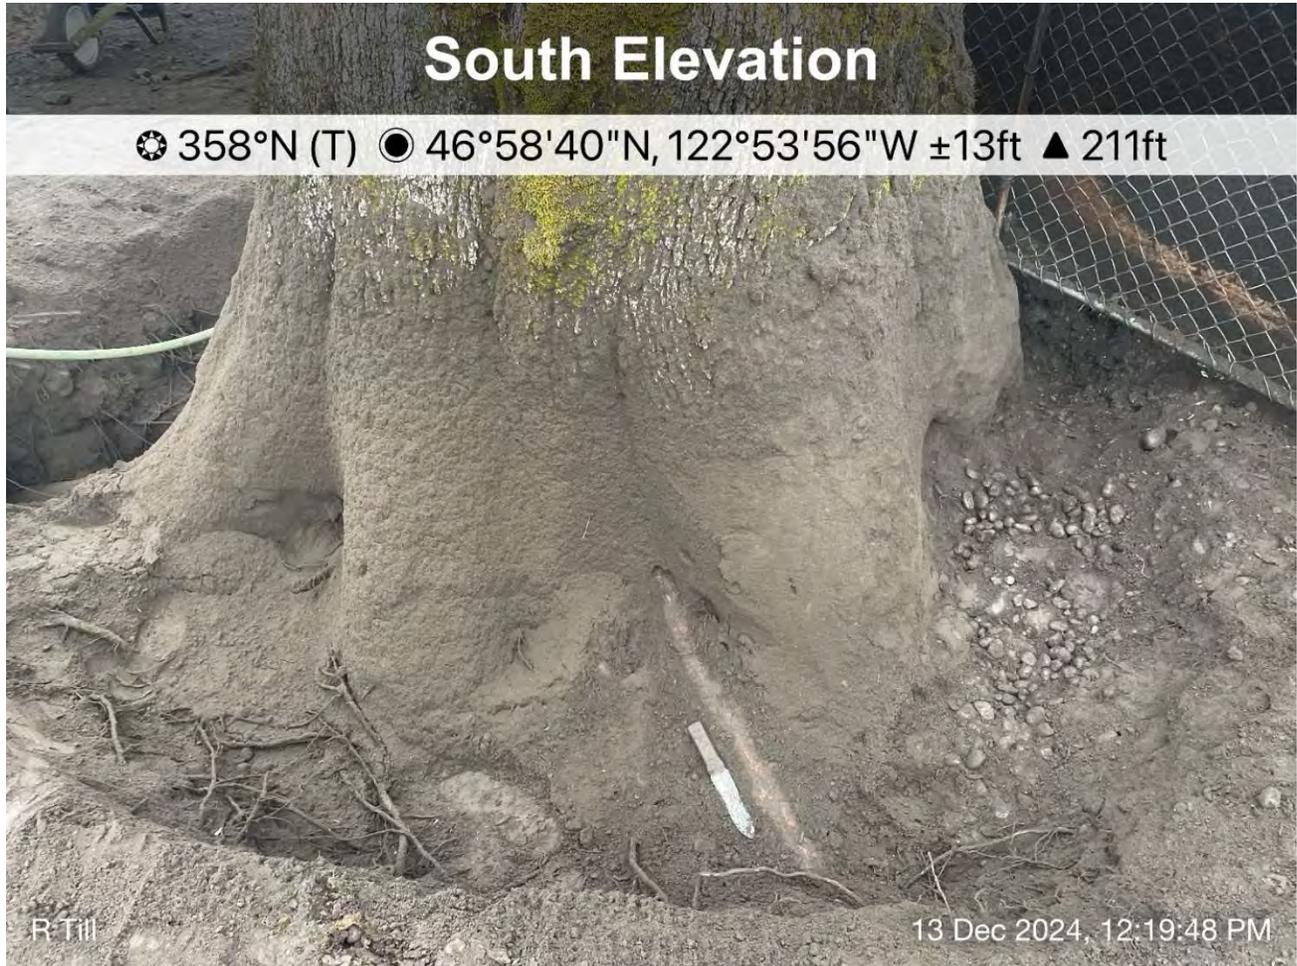
Figure 2 Southeast side excavated to significant lateral root. Performed additional probing to locate solid buttress roots and solid integrity of wood between buttress roots.

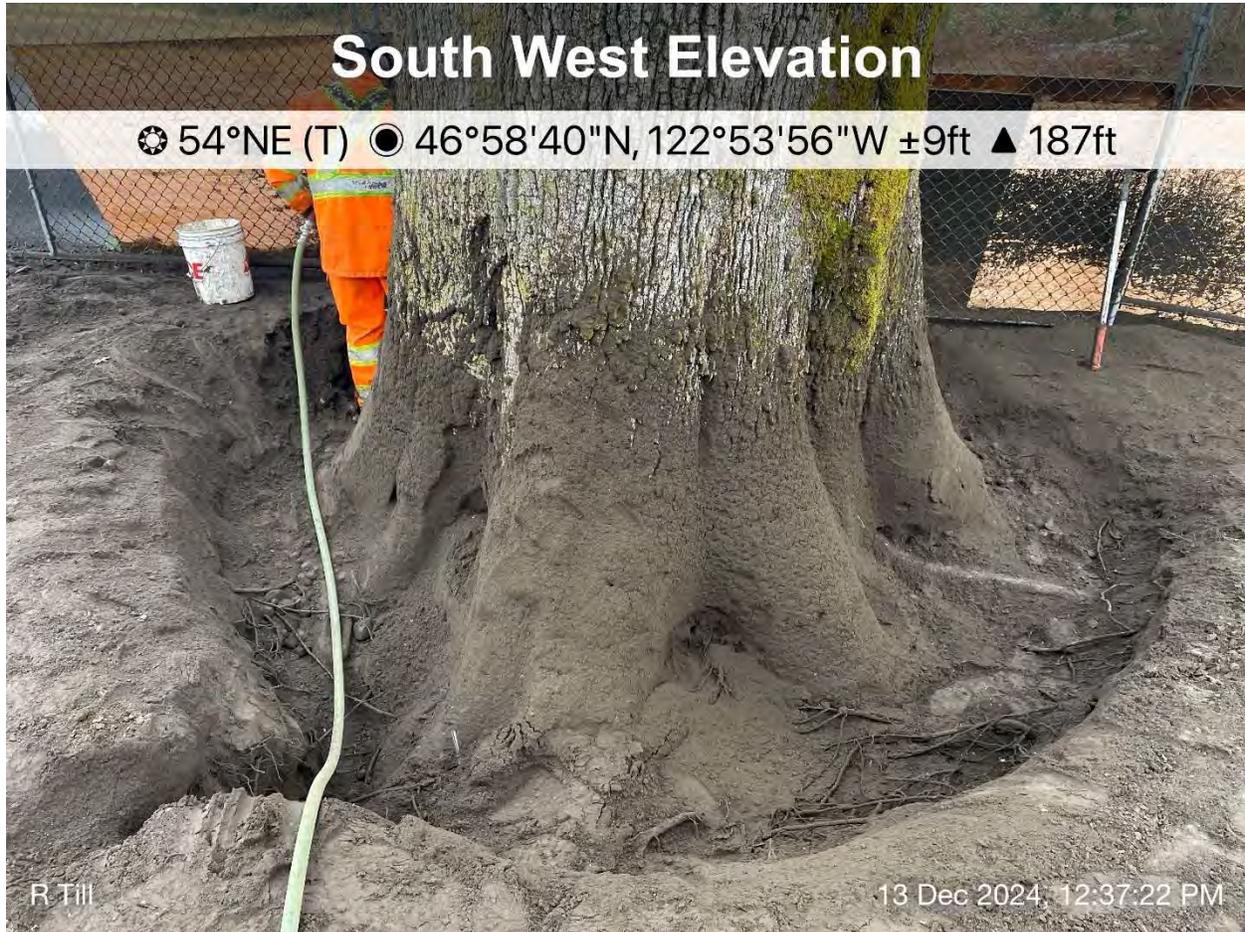
Figure 3 Full view of excavation from southwest. All visible portions were inspected and no indicators of decay identified.

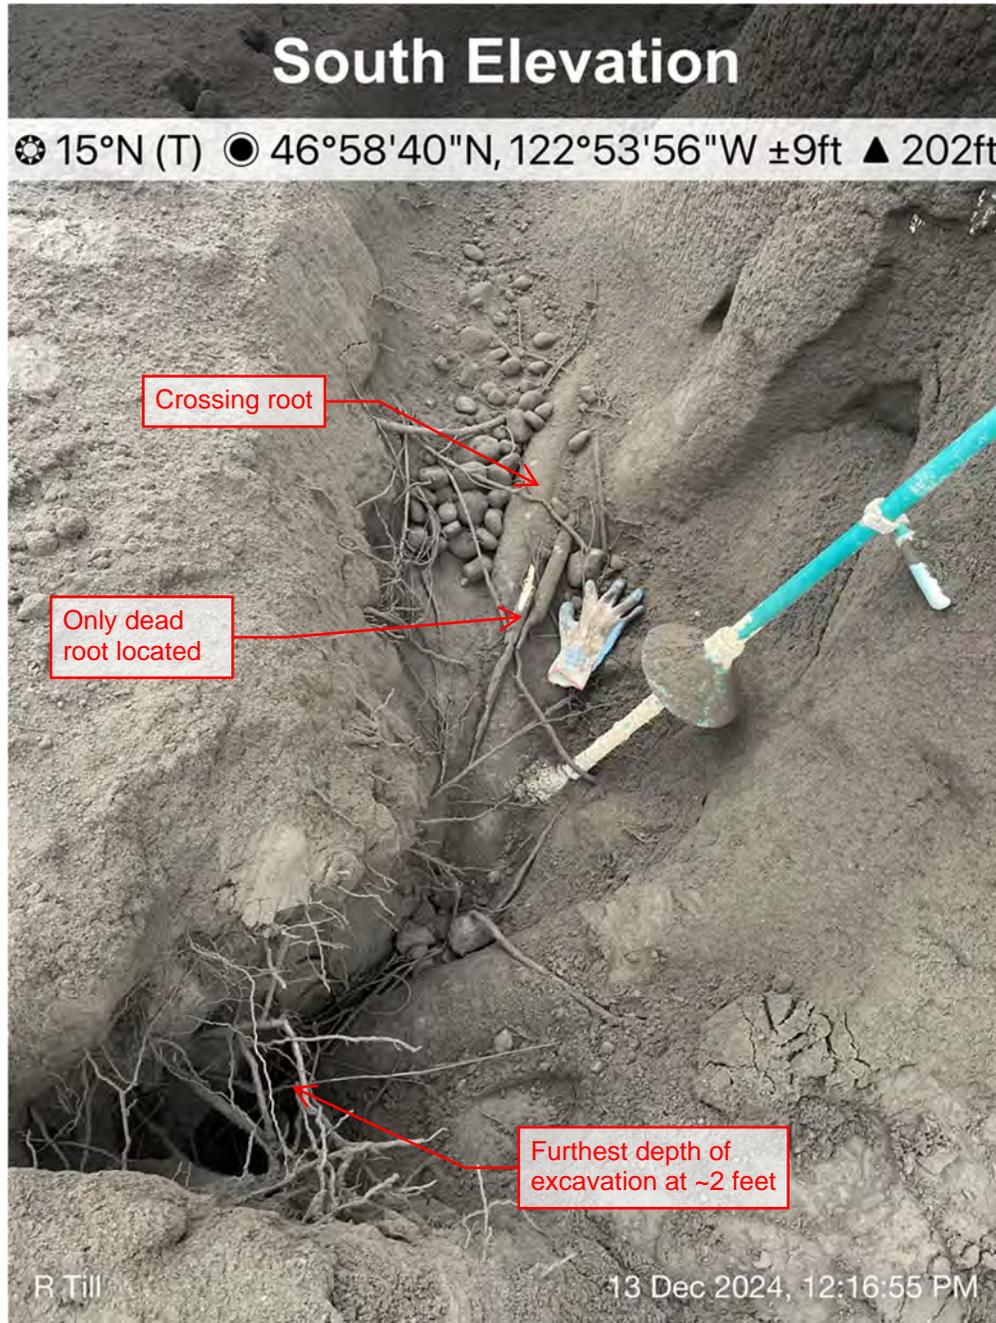
Figure 4 Traced one buttress root and did not locate any signs of concern. One, ~1-inch diameter dead root was located (visible to the left of the glove). One ~4-inch root crosses a primary buttress root, which could limit buttress root expansion.

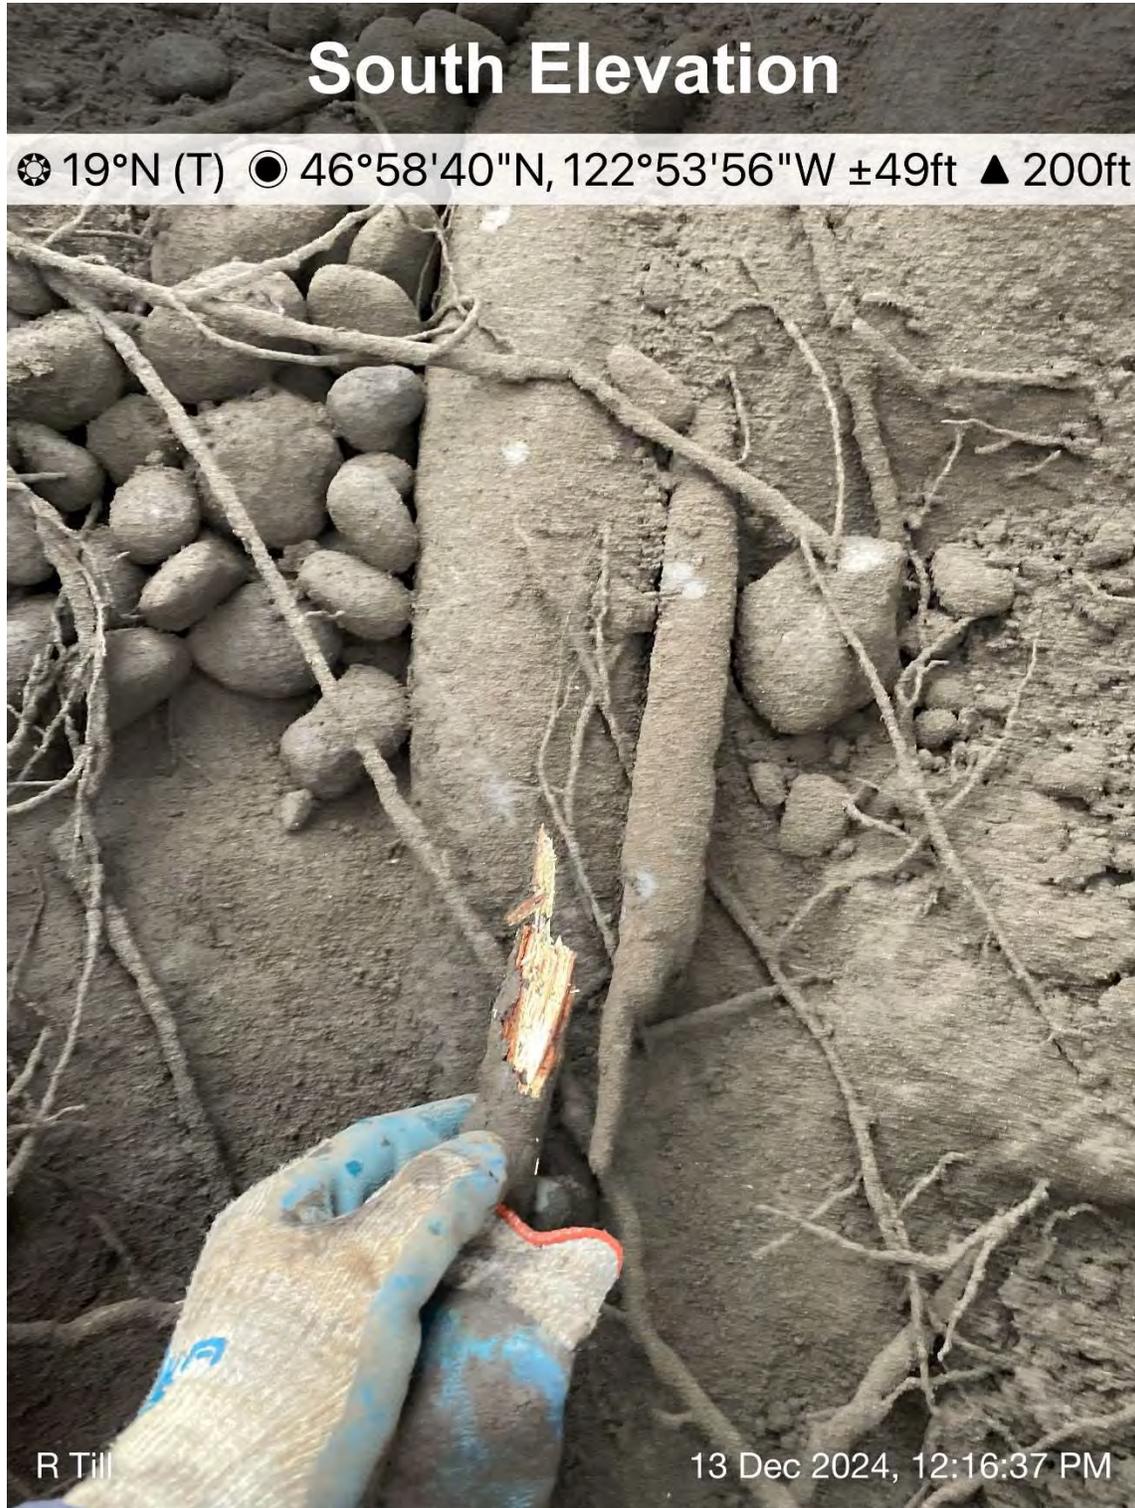
Figure 5 Dead root and crossing root.

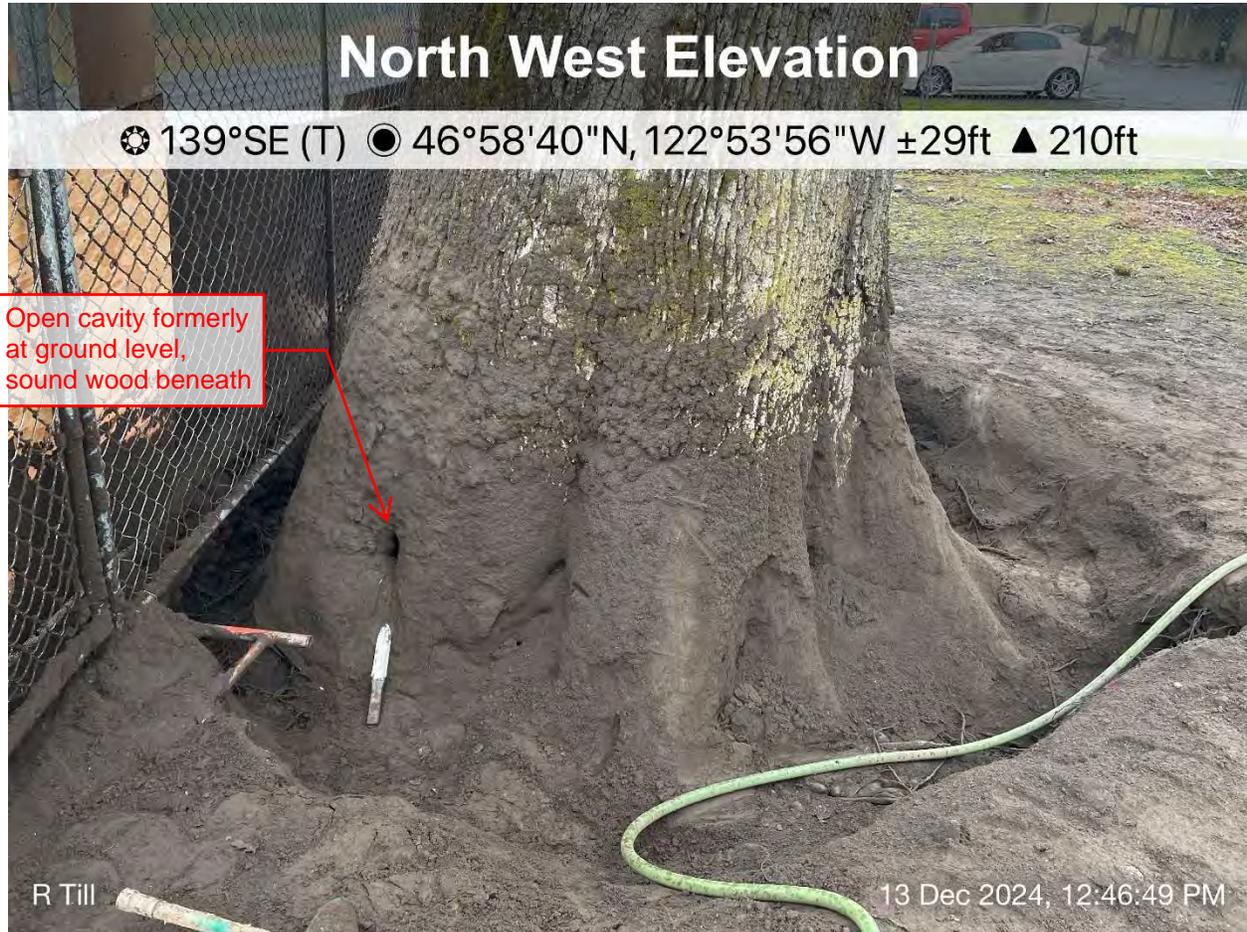
Figure 6 View from northwest. Wood below the cavity is sound. Hand inspected cavity and substantial wood present. Probes creases/sinuses between buttress lobes and did not identify signs of decay.

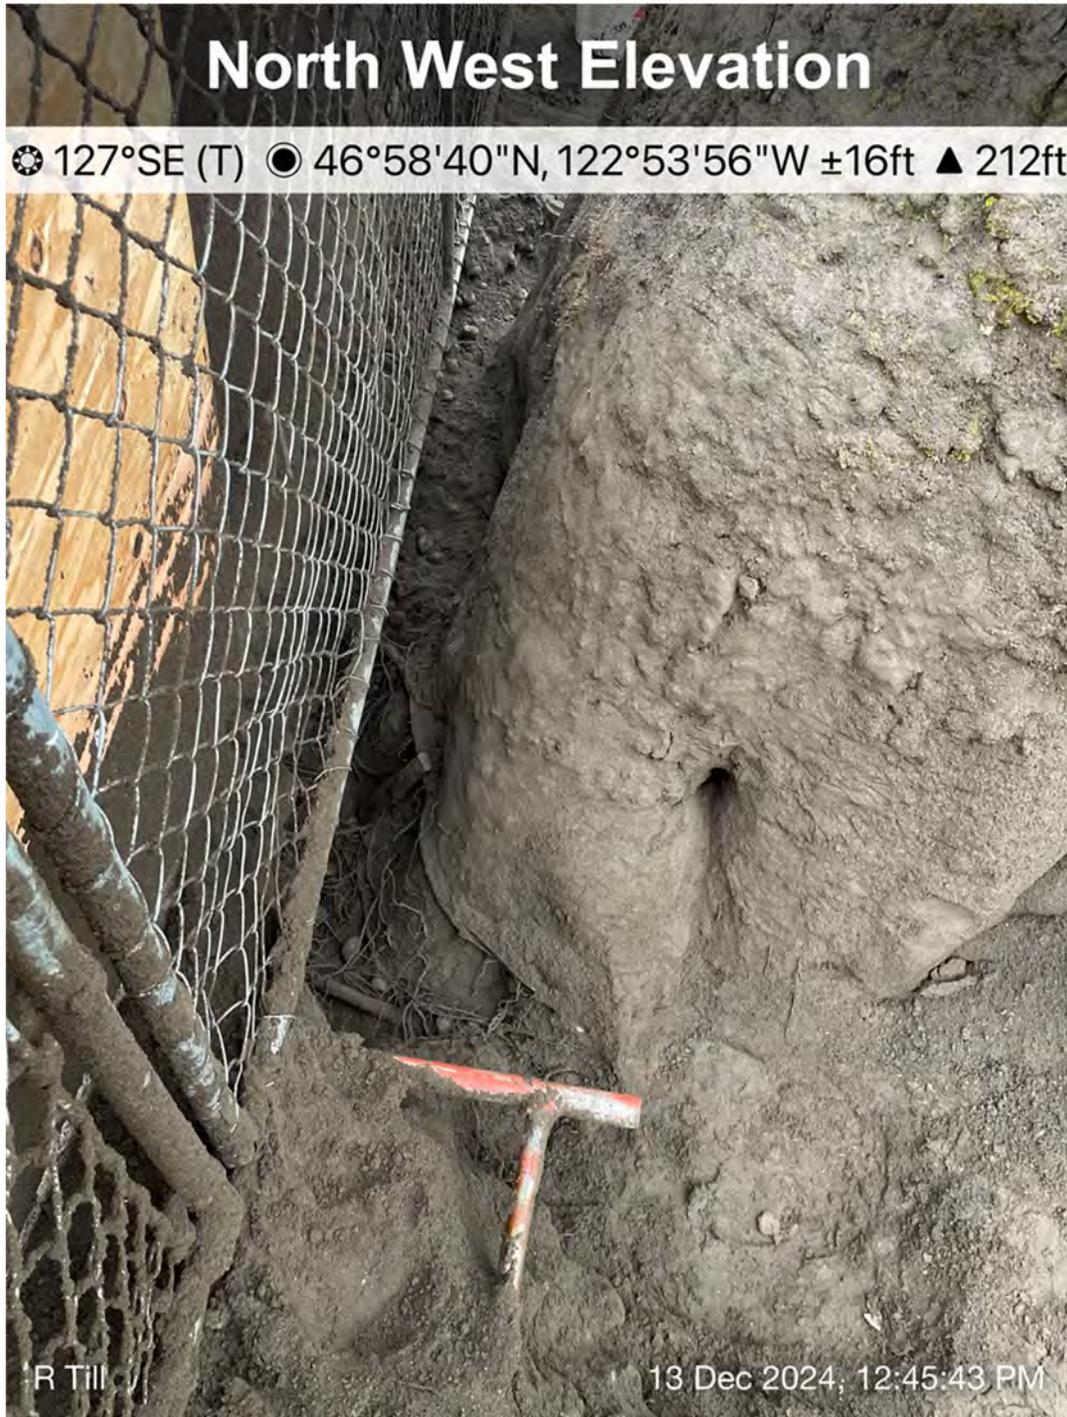
Figure 7 Street side excavation uncovered sound wood and adventitious roots. Buttress flare was not as pronounced, but otherwise no concerning signs. Depth of excavation was hindered by fence.
