SOUND URBAN FORESTRY, LLC

RE: Proposed Heritage Trees – Mills & Mills Funeral Home and Memorial Park Chestnut Trees

Upon the request of the City of Tumwater, I have conducted an assessment of two chestnut trees located within the Mills & Mills Funeral Home and Memorial Park property at 5725 Littlerock Road SW, as part of the City's Heritage Tree nomination process. I visited the site on November 22, 2022.

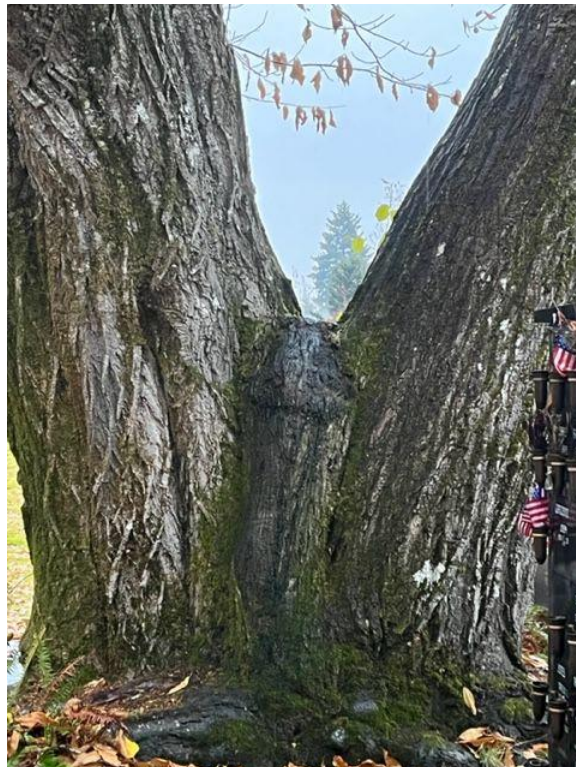
Tree #1: American chestnut, (*Castanea dentata*), 79" DBH. Approximate height of 100'. Overall condition is fair. The main stem splits at 5' into co-dominants. There is some bulging at the inclusion between the stems on the north side of the tree. No signs of active separation. Previously topped at 45-50'. Fungal fruiting bodies associated with Brown Cubical Rot (*Laetiporus sulphurrus*) are found at the site of a past large diameter scaffold branch cut on the north side. Decay is present within the main and co-dominant stems. Root flare is growing into the cement base of the memorial.

Bulging Inclusion on North Side of Tree #1

Due to the structures and amount of decay, both of the assessed trees would benefit from pruning to clean the crowns of dead/damaged branches and reduce stress load. I would also recommend the cement at the base of the trees be cut to accommodate the expanding root flares.

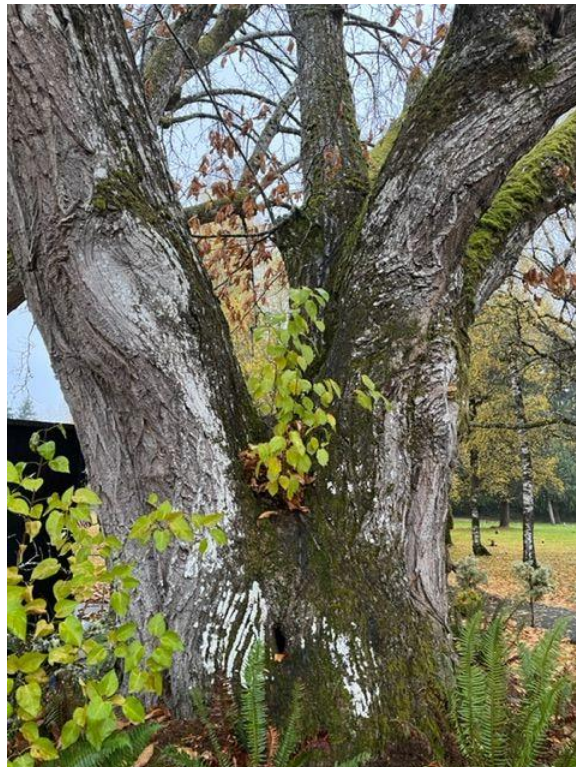
Tree #2: American chestnut, 79" DBH. Approximate height of 115'. Overall condition is fair. Open cavity is found on the north side of the tree, at the location of a past co-dominant stem failure. Decay is present at the site of a large wound from a past scaffold branch failure on the south side at 22' above grade. Previously topped at 45-50'.

Open Cavity on Tree #2
