Todd Prager & Associates
LLC

Tree Risk Assessment for the Davis-Meeker Oak

Date: February 7, 2025

Site Address: 7525 Old Highway 99 SE
Tumwater, Washington 98501

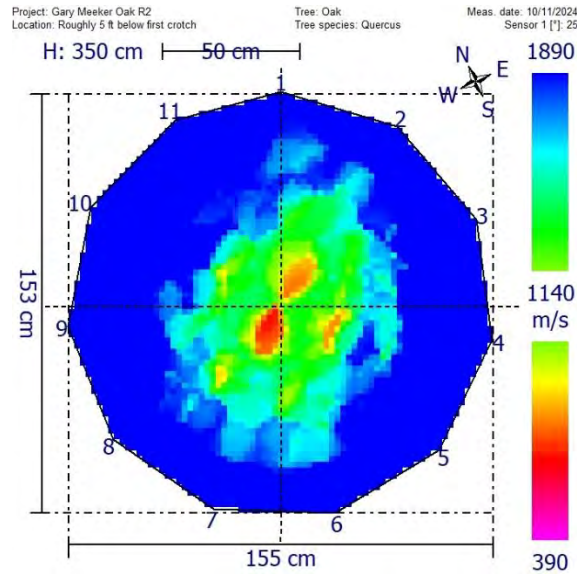
At this level there is a small amount of compromised wood in the center of the stem. The green indicates where the co-dominant inclusion is causing a weak attachment point.

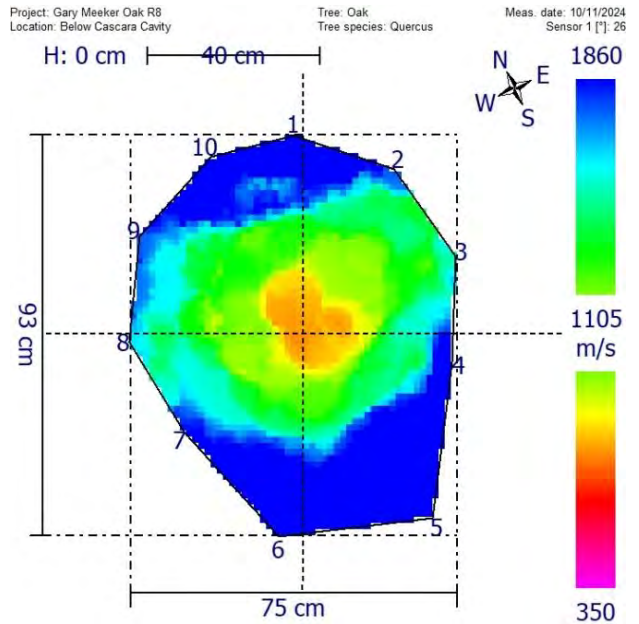
At this level there is less dense wood in the center of the stem. The center yellow spot indicates where the cavity above extends too.

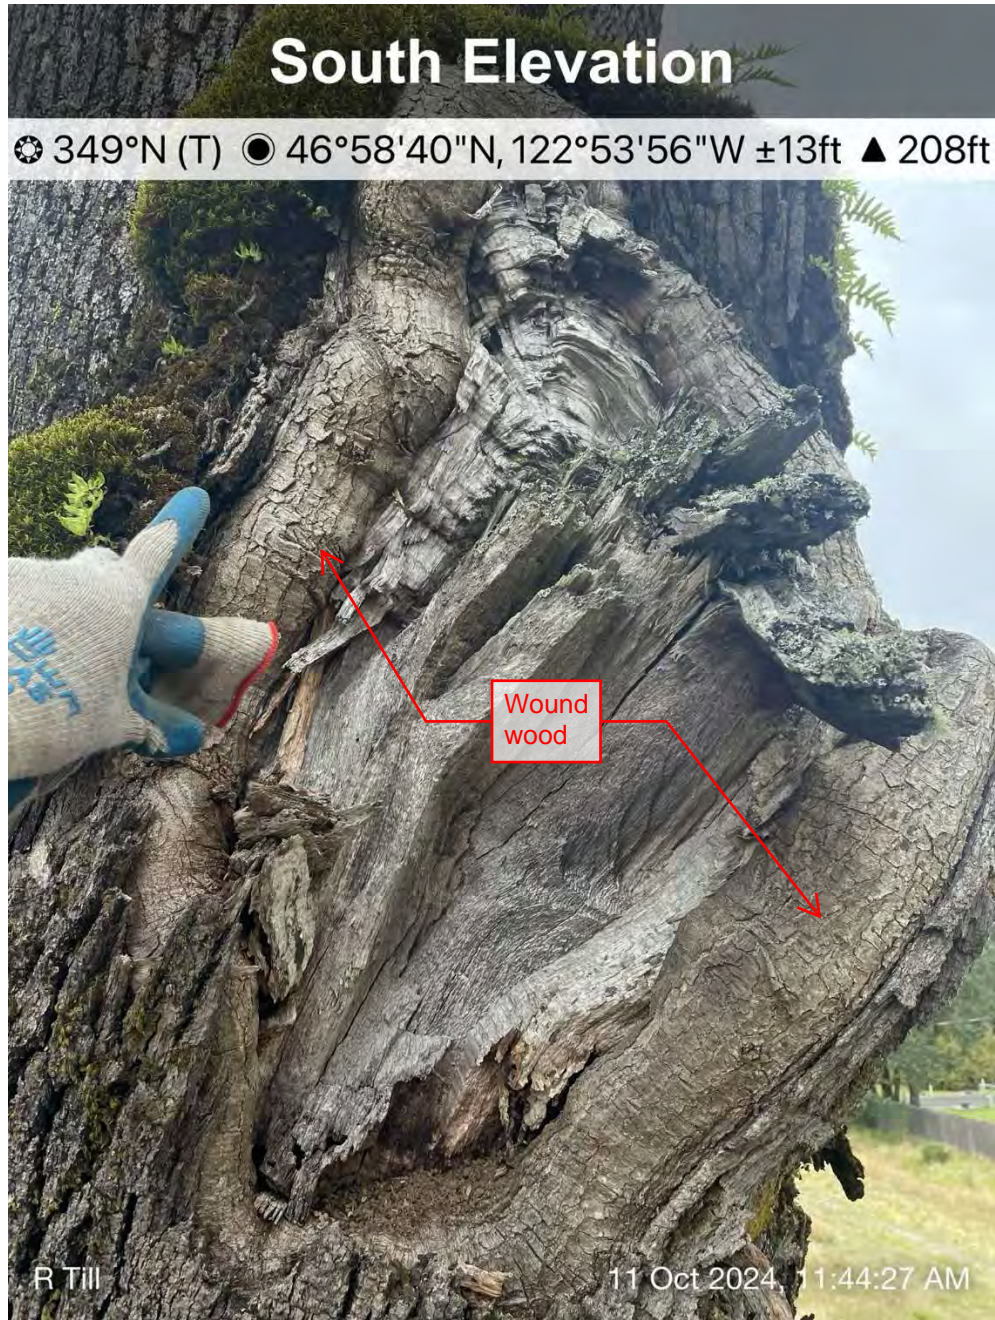
Figure 4 Failure on southeast side of central stem at 26 feet.

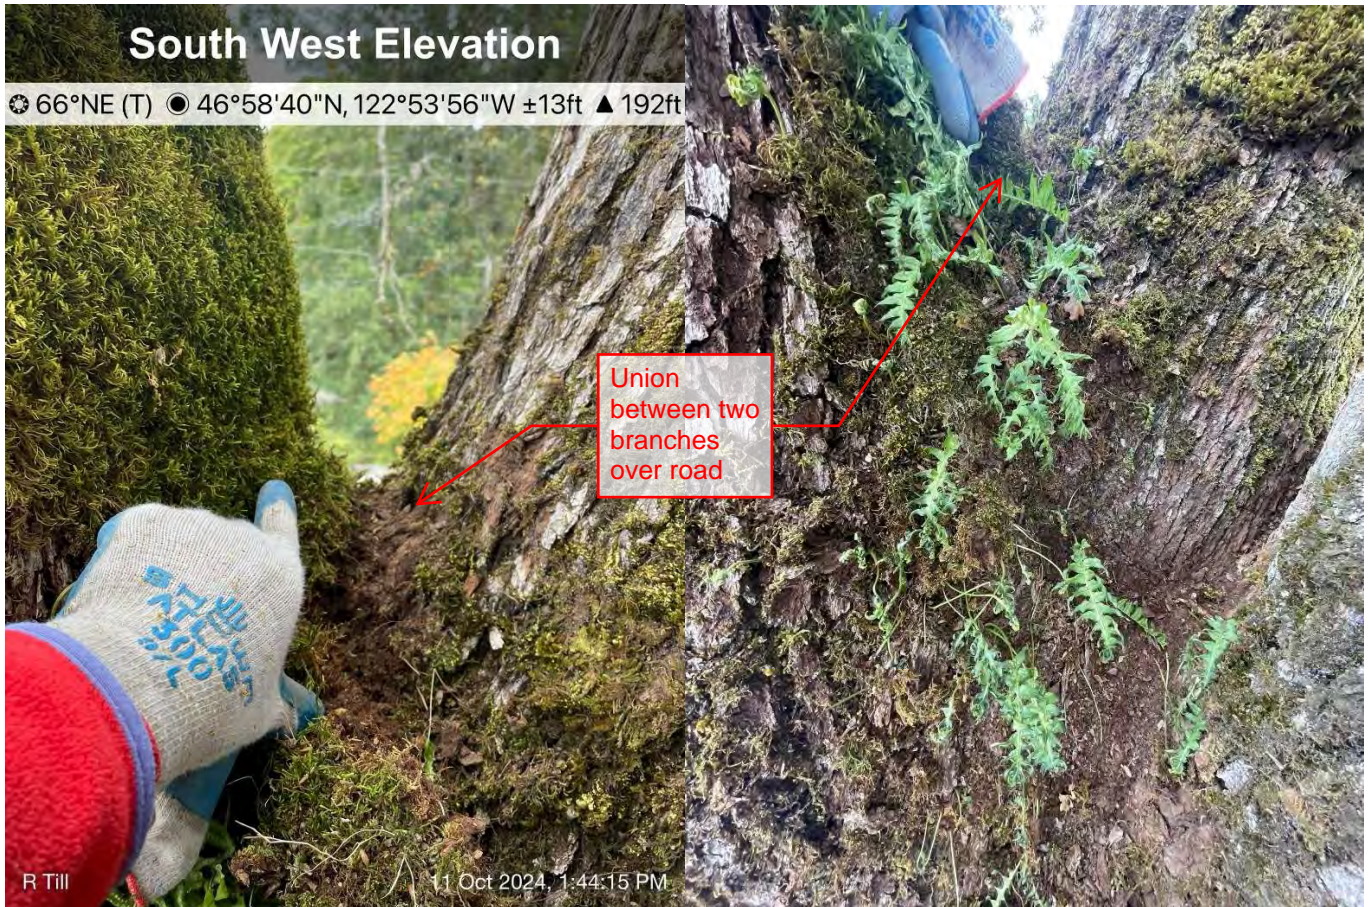
Figures 7 and 8 Southwest view of attachment between two secondary stems extending over the road. Exterior signs indicate a sound union.

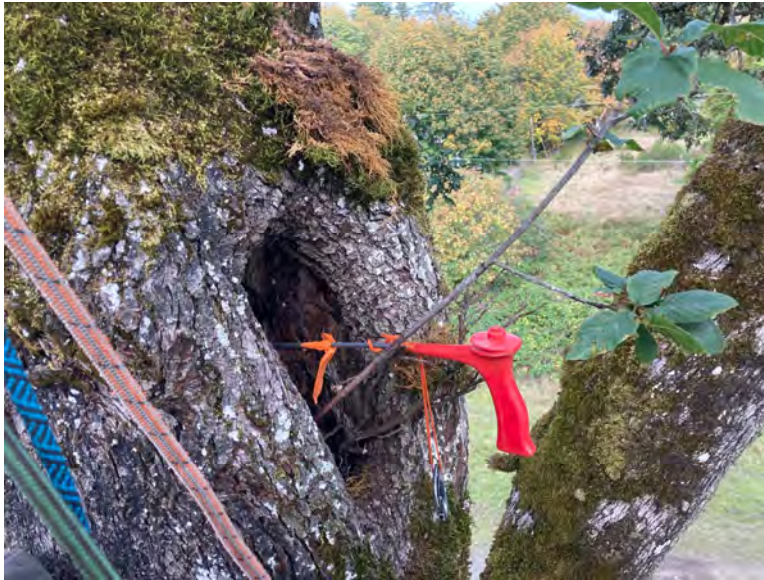
Figure 15 Photo depicting depth of cavity and cascara (*Frangula purshiana*) growing from cavity.

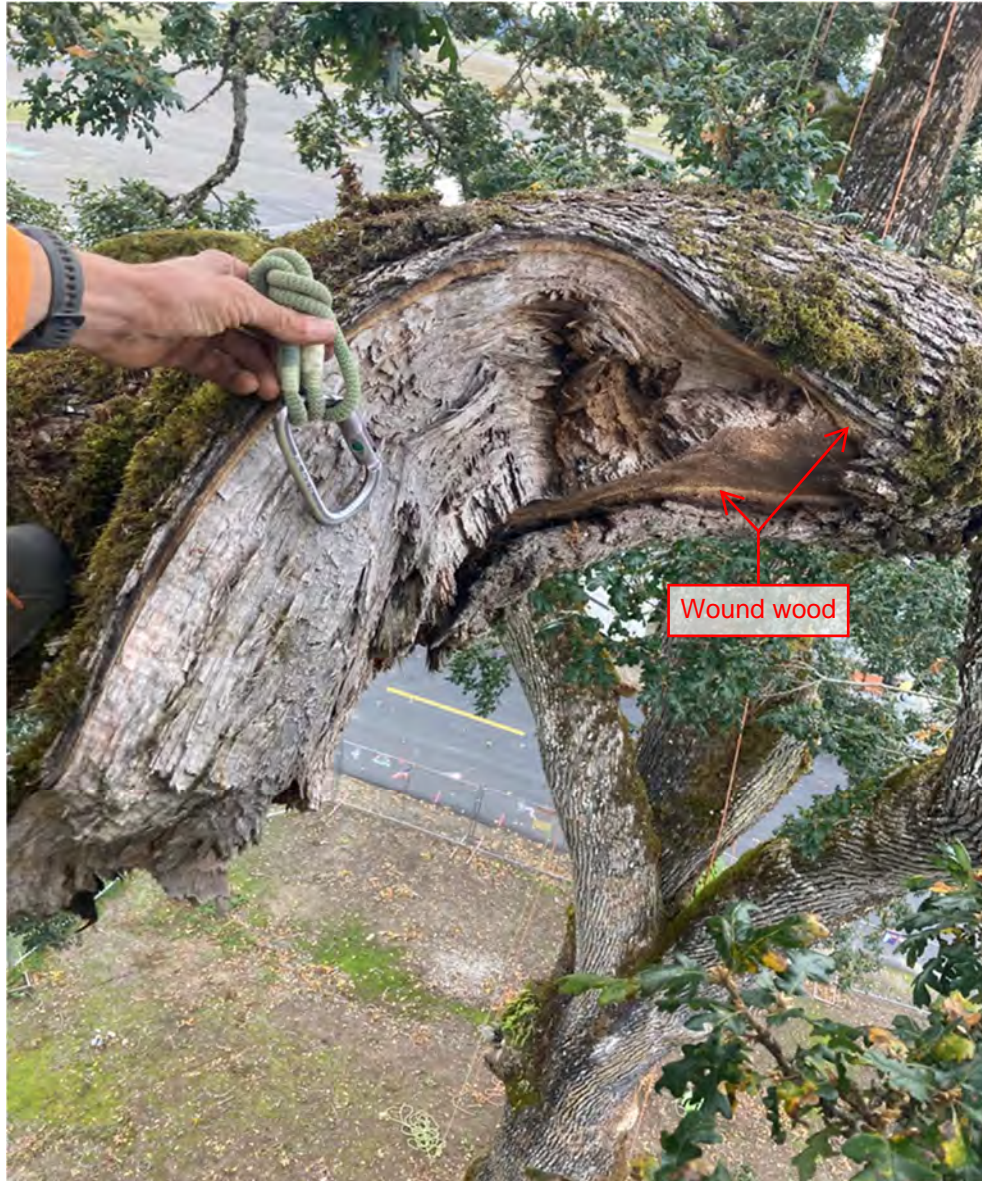
Figure 25 Carabiner used for scale. Note two to three years of wound wood growth around margin of injury.

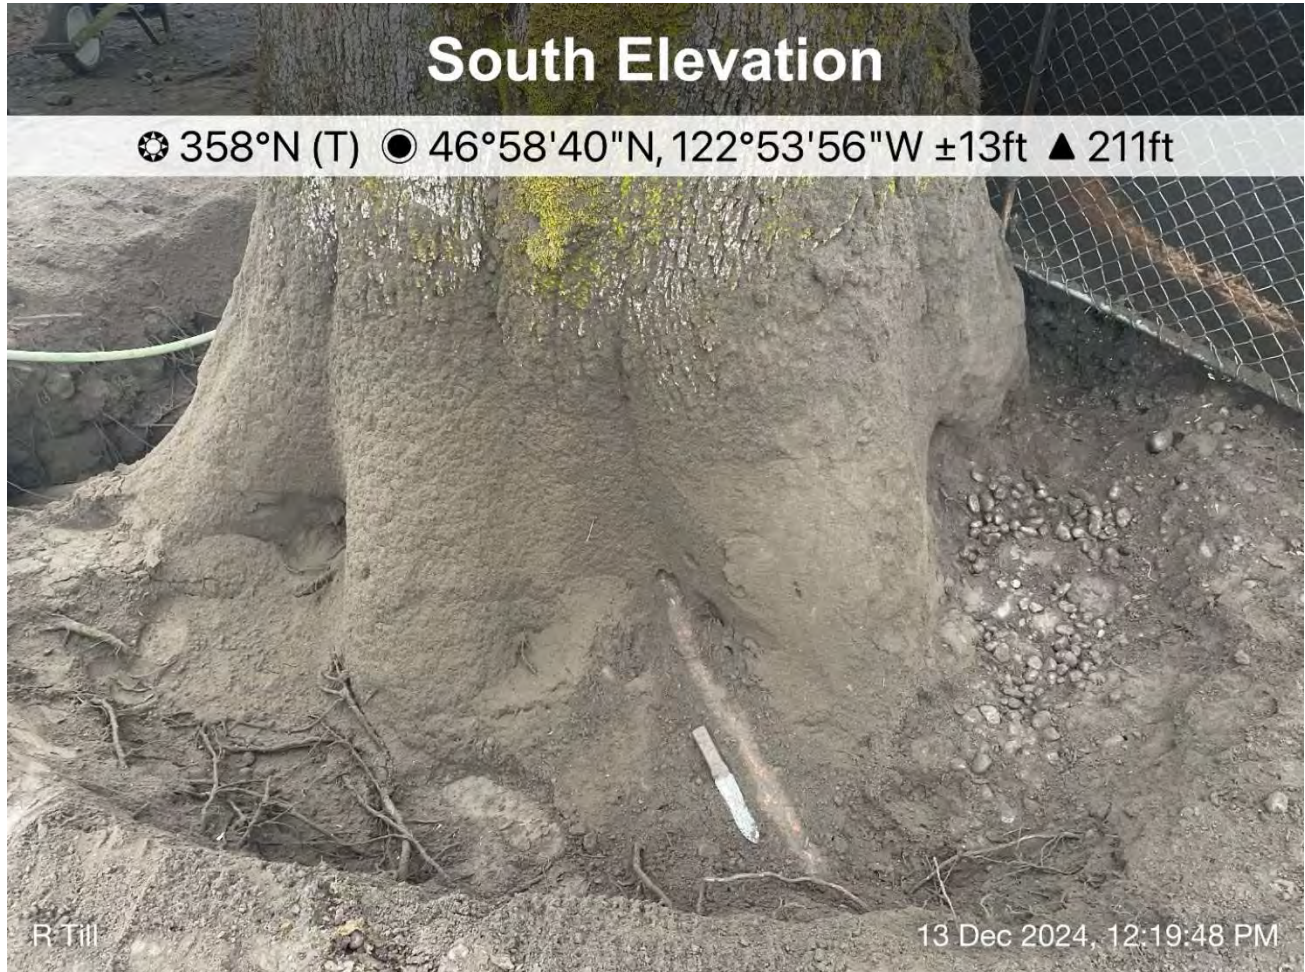
Figure 2 Southeast side excavated to significant lateral root. Performed additional probing to locate solid buttress roots and solid integrity of wood between buttress roots.

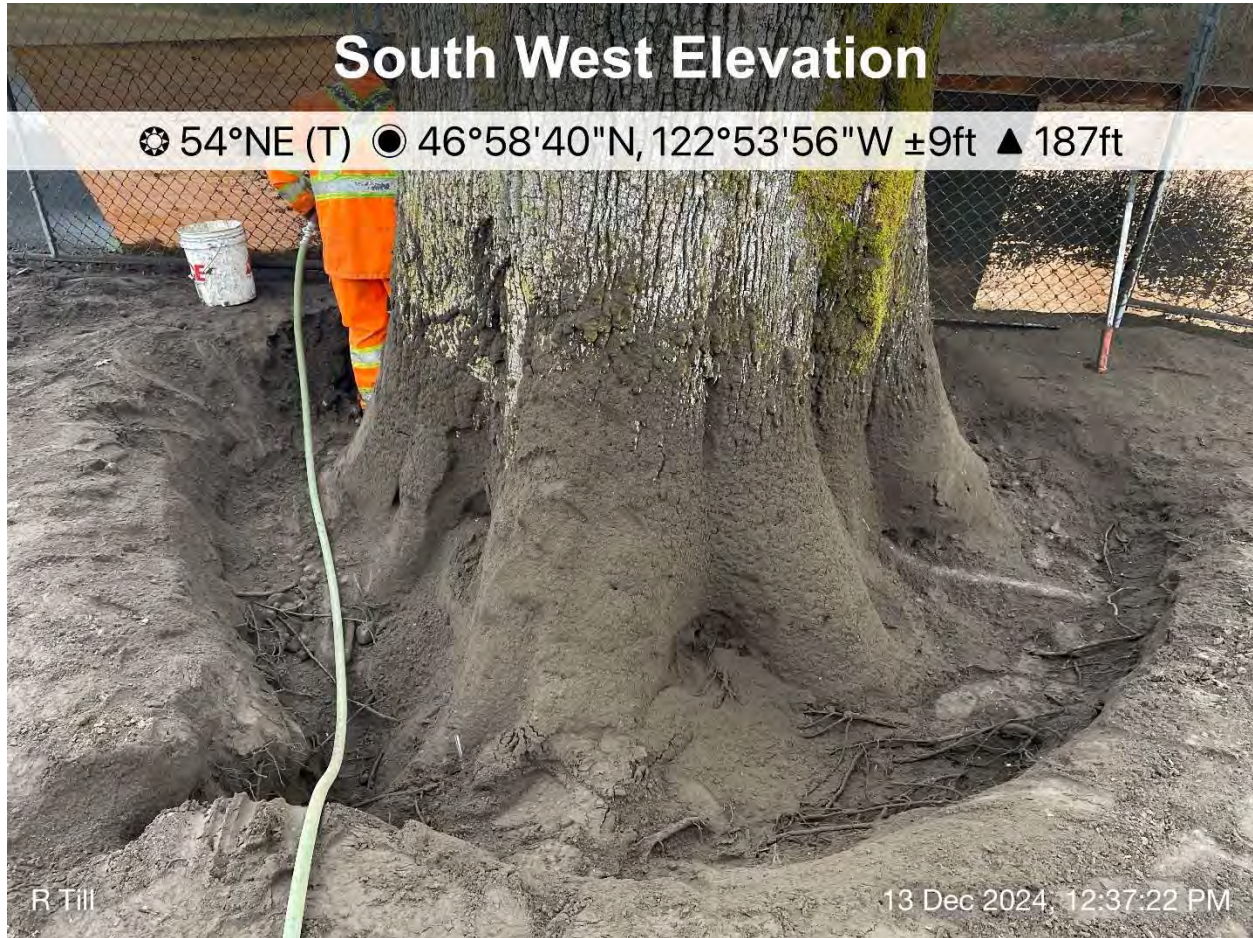
Figure 3 Full view of excavation from southwest. All visible portions were inspected and no indicators of decay identified.
