SOUND URBAN FORESTRY, LLC

10/10/2023

RE: Meeker Oak Risk Assessment

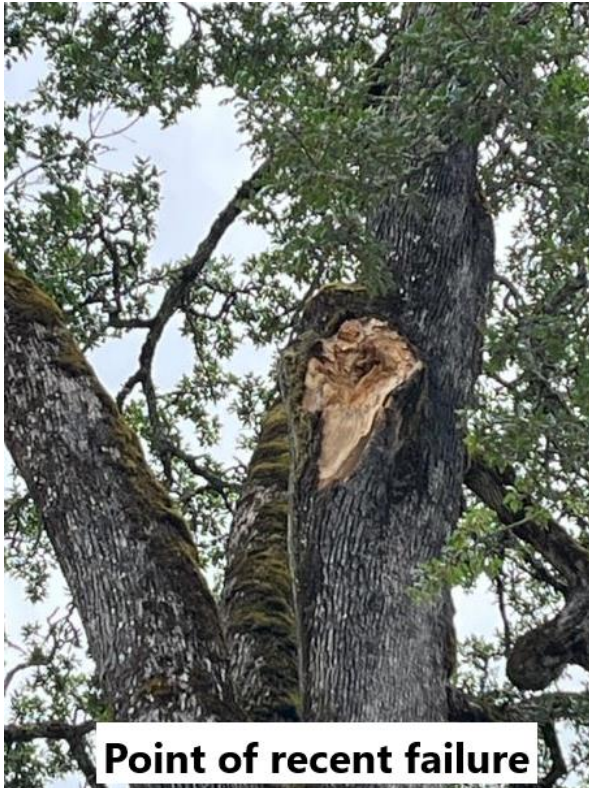
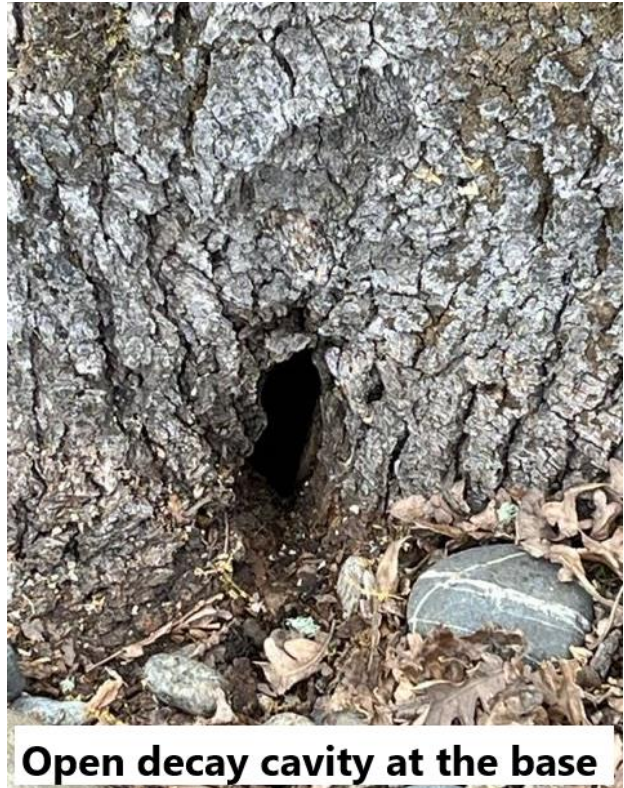
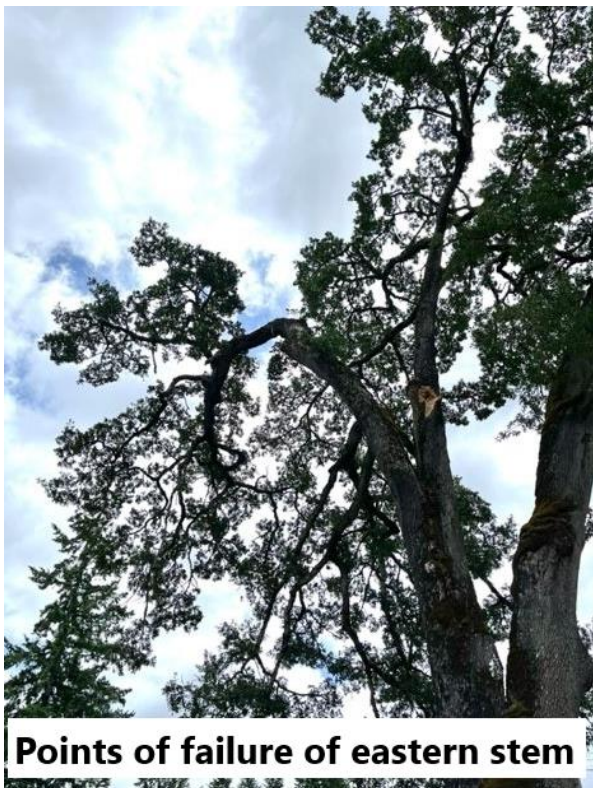
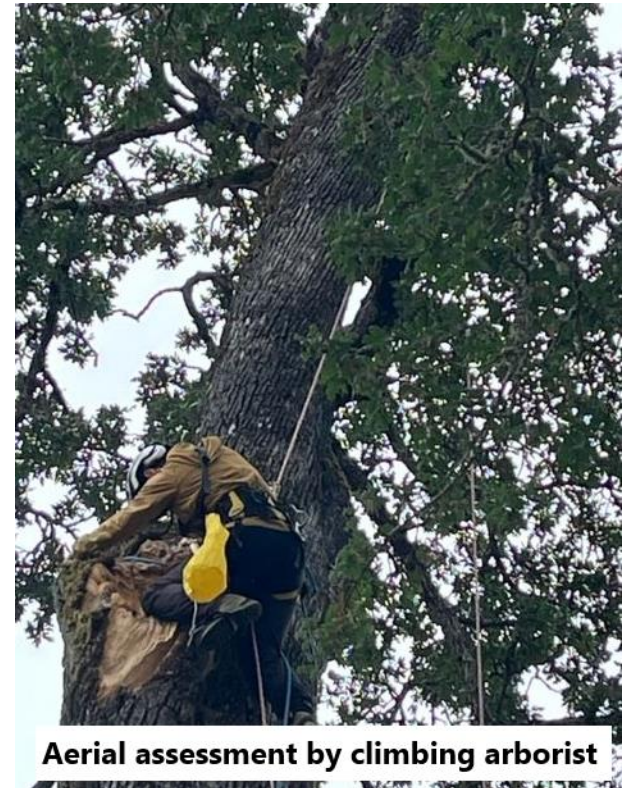
Photos

An aerial assessment was conducted by Amanda Hancock (ISA Certified Arborist TX4155AU & TRAQ) with Waxwing Tree Specialists on June 29, 2023. This inspection found extensive white rot decay within the large scaffold that recently experienced failure at the union (see photo). Further examination determined that the main stem's decay column continues upward into the eastern co-dominant stem and large diameter scaffold branches (see attached diagram). The west facing co-dominant stem contains solid healthy interior wood upward into the large scaffold branches overhanging the drive and aircraft hangar.

Based on my findings and information I have been provided, I am recommending removal.

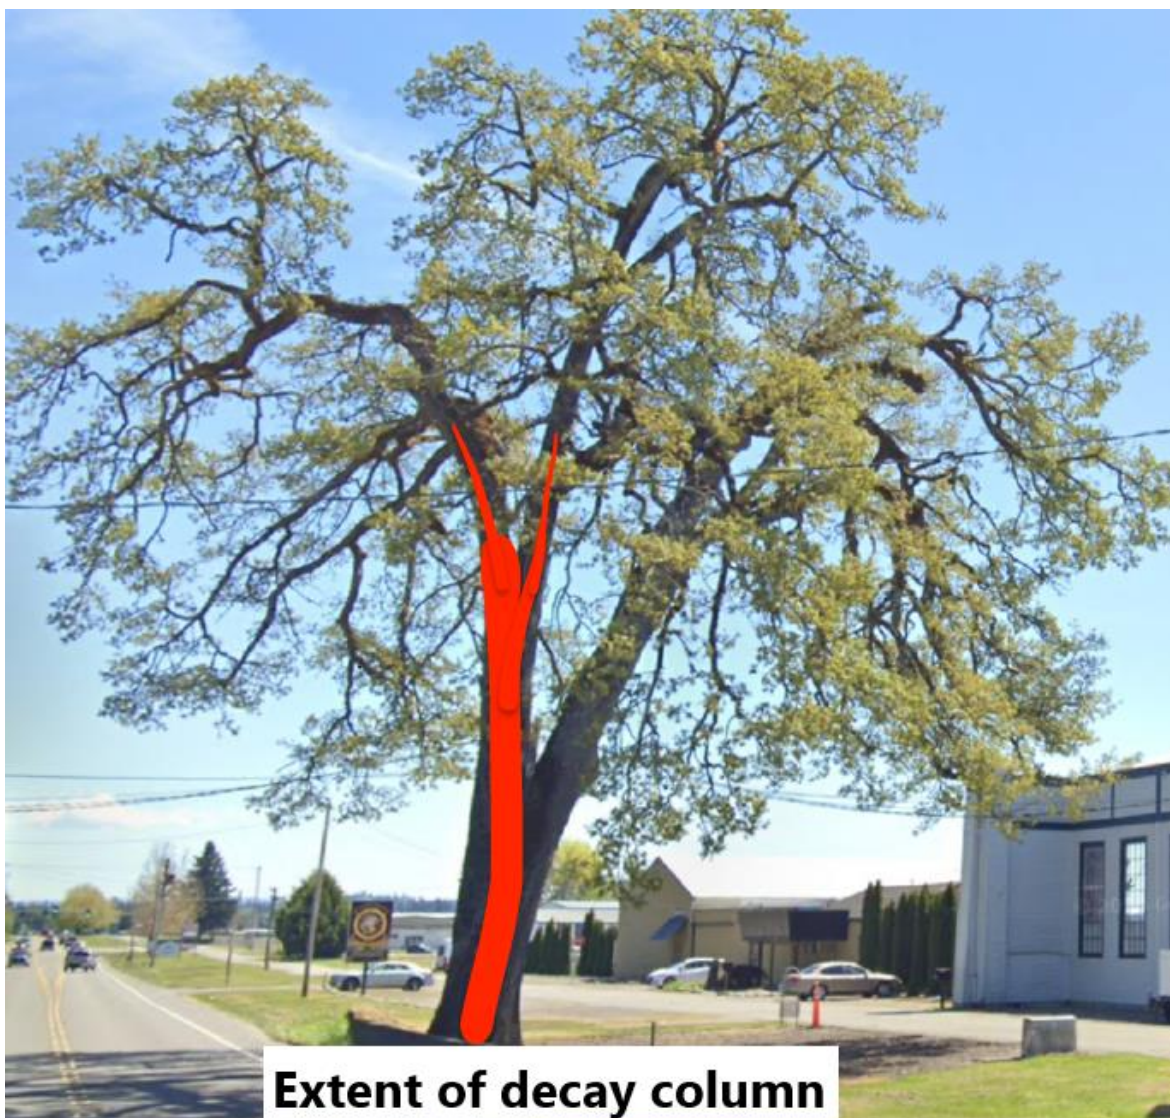
With the exception of the recent large branch failures, the Meeker Oak appears to be in very good health. The crown density, leaf color, leaf size and internode growth all indicate a vigorous tree. However, there are structural concerns associated with the significant decay found in the stem base, lower main stem, east facing co-dominant stem and large scaffold branches. Probable future failures include large diameter scaffold branches from the east facing co-dominant stem and the entire west facing co-dominant stem at the union. The associated inclusions and stress loads will contribute to future failures. Structural support systems in conjunction with pruning were considered but the extent of decay in the main stem and upper east side of the canopy removes that as a mitigation option in my opinion.

Extent of decay column

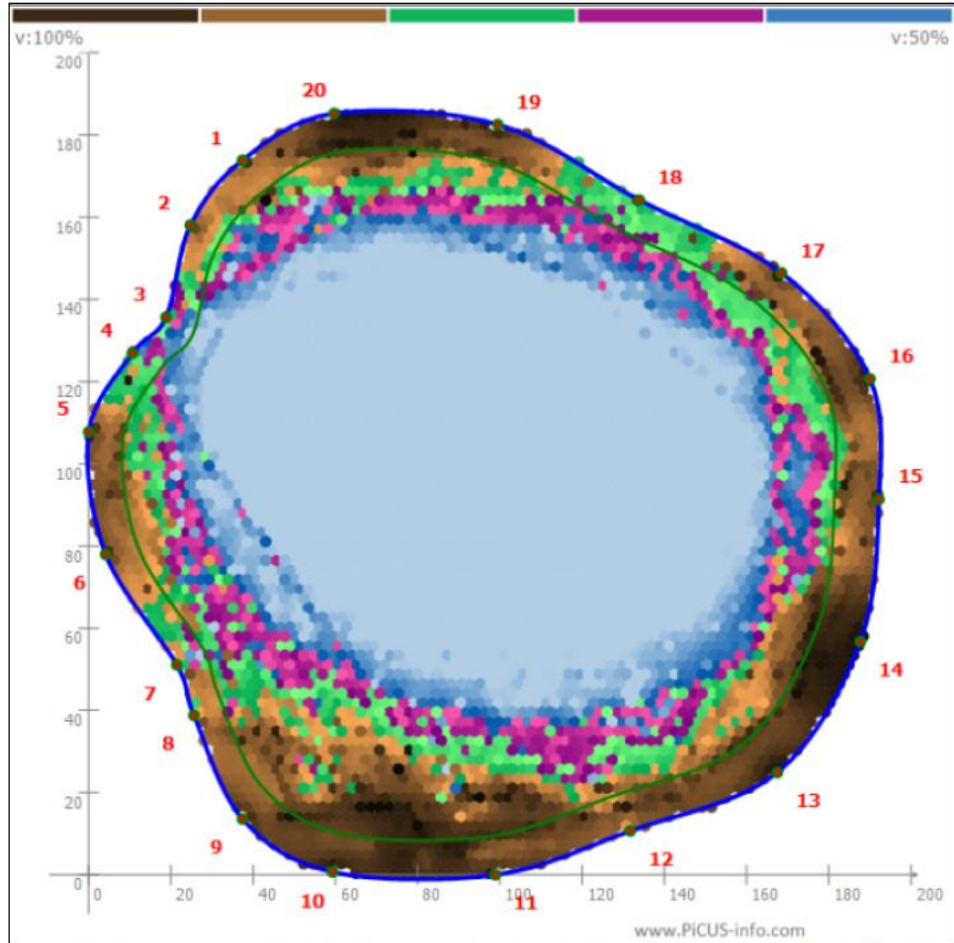
I used a PiCUS sonic tomograph to obtain a tomogram 50 centimeters above the tree base. I selected this height based on soundings of the trunk which indicated the most extensive decay was located low in the trunk. I used the PiCUS Q74 program to analyze the data and obtain a rough estimate of the remaining sound wood shell wall required to maintain tree stability, indicated by the green line in Figure 1 in Appendix A.

The tomogram indicates there is slightly more sound wood than is required to support the tree. However, due to the extent of the decay and thin shell wall around measuring points 3, 4, and 18 it is my opinion that this tree should be managed as a veteran tree and have retrenchment pruning performed to reduce the tree height and spread by approximately 15 feet. Reducing the tree height and spread will result in lowered wind loads acting on the trunk and branch unions resulting in a lower likelihood of failure.

Figure 1. Sonic tomogram of the subject tree. North is located at measuring point 1, and the side of the tree towards the highway is along measuring points 17, 18, and 19. The blue areas indicate decay or a decay cavity, and the brown areas indicate sound wood. The purple and green areas indicate early or spreading decay. The green line is the calculated shell wall of sound wood required for the tree to remain stable.

If this tree is retained, it should be reassessed with sonic tomography in five years to determine if the decay is continuing to spread and what the remaining shell wall is at that time. Additionally, 4 to 6 inches of wood chip mulch should be added within the dripline of the tree to improve soil conditions. The wood chip mulch should be kept 12 inches from the base of the tree.

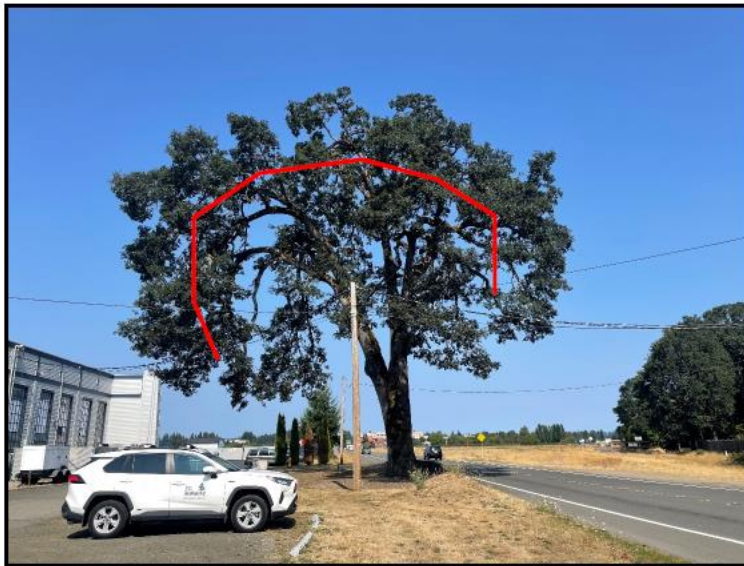
Photograph 2. The crown of the subject tree viewed from the southeast. The red line indicates approximately 15 feet of crown reduction.
