SOUND URBAN FORESTRY, LLC

10/10/2023

RE: Meeker Oak Risk Assessment

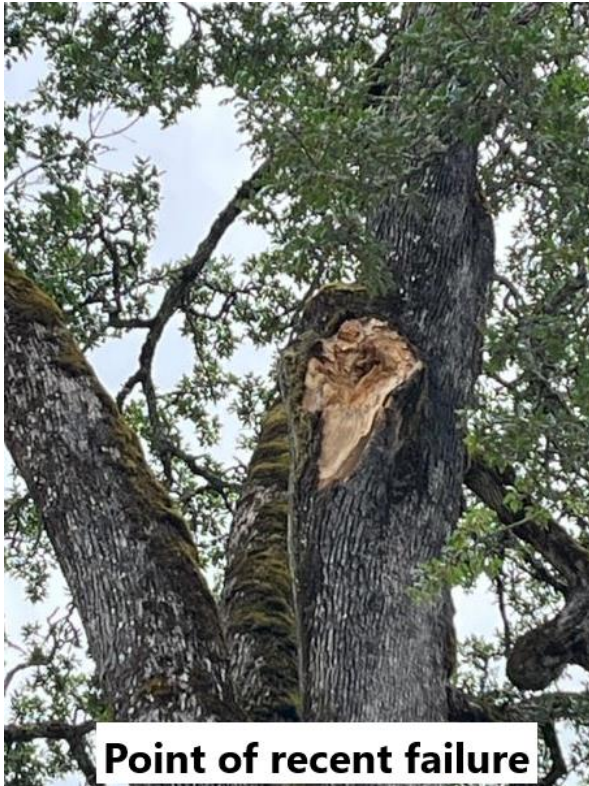
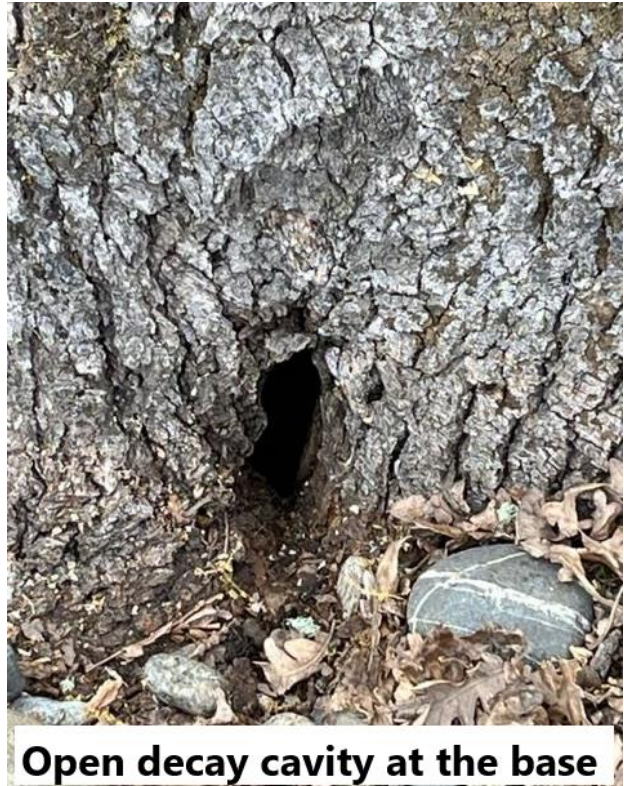
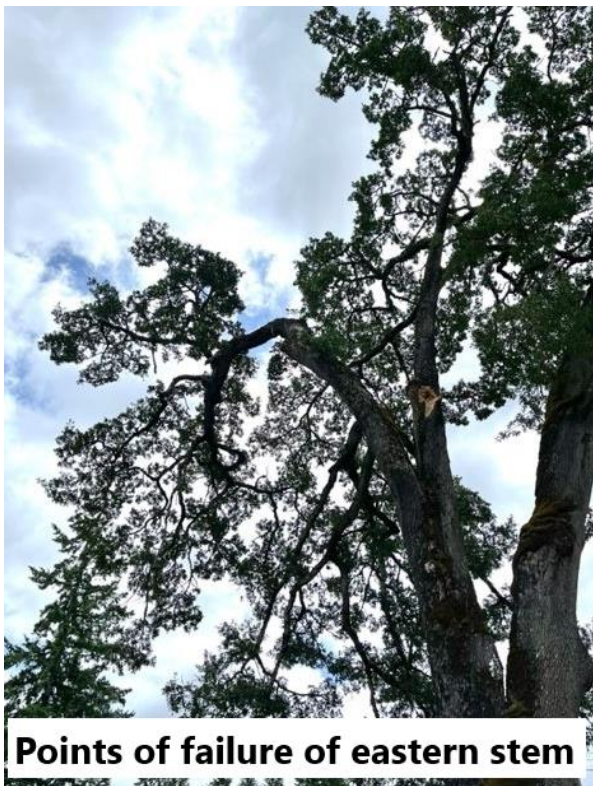
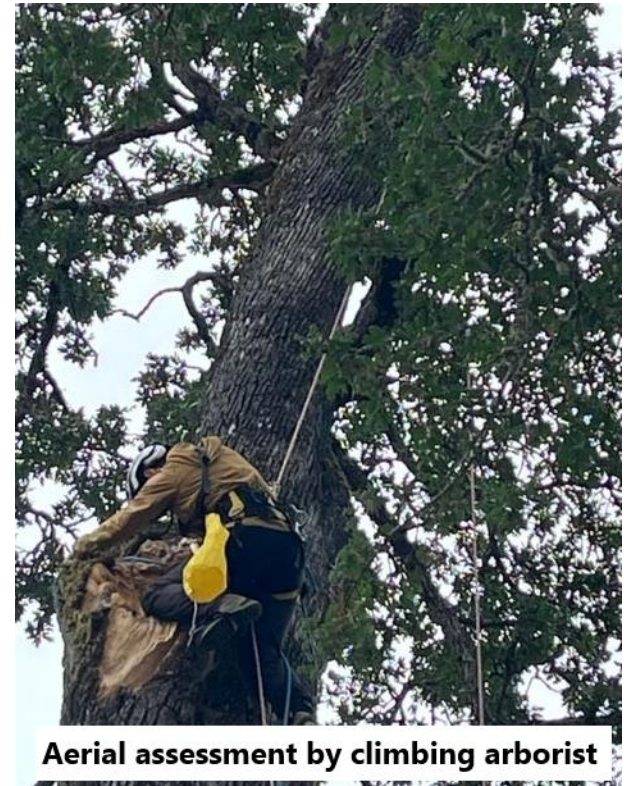
Photos

An aerial assessment was conducted by Amanda Hancock (ISA Certified Arborist TX4155AU & TRAQ) with Waxwing Tree Specialists on June 29, 2023. This inspection found extensive white rot decay within the large scaffold that recently experienced failure at the union (see photo). Further examination determined that the main stem's decay column continues upward into the eastern co-dominant stem and large diameter scaffold branches (see attached diagram). The west facing co-dominant stem contains solid healthy interior wood upward into the large scaffold branches overhanging the drive and aircraft hangar.

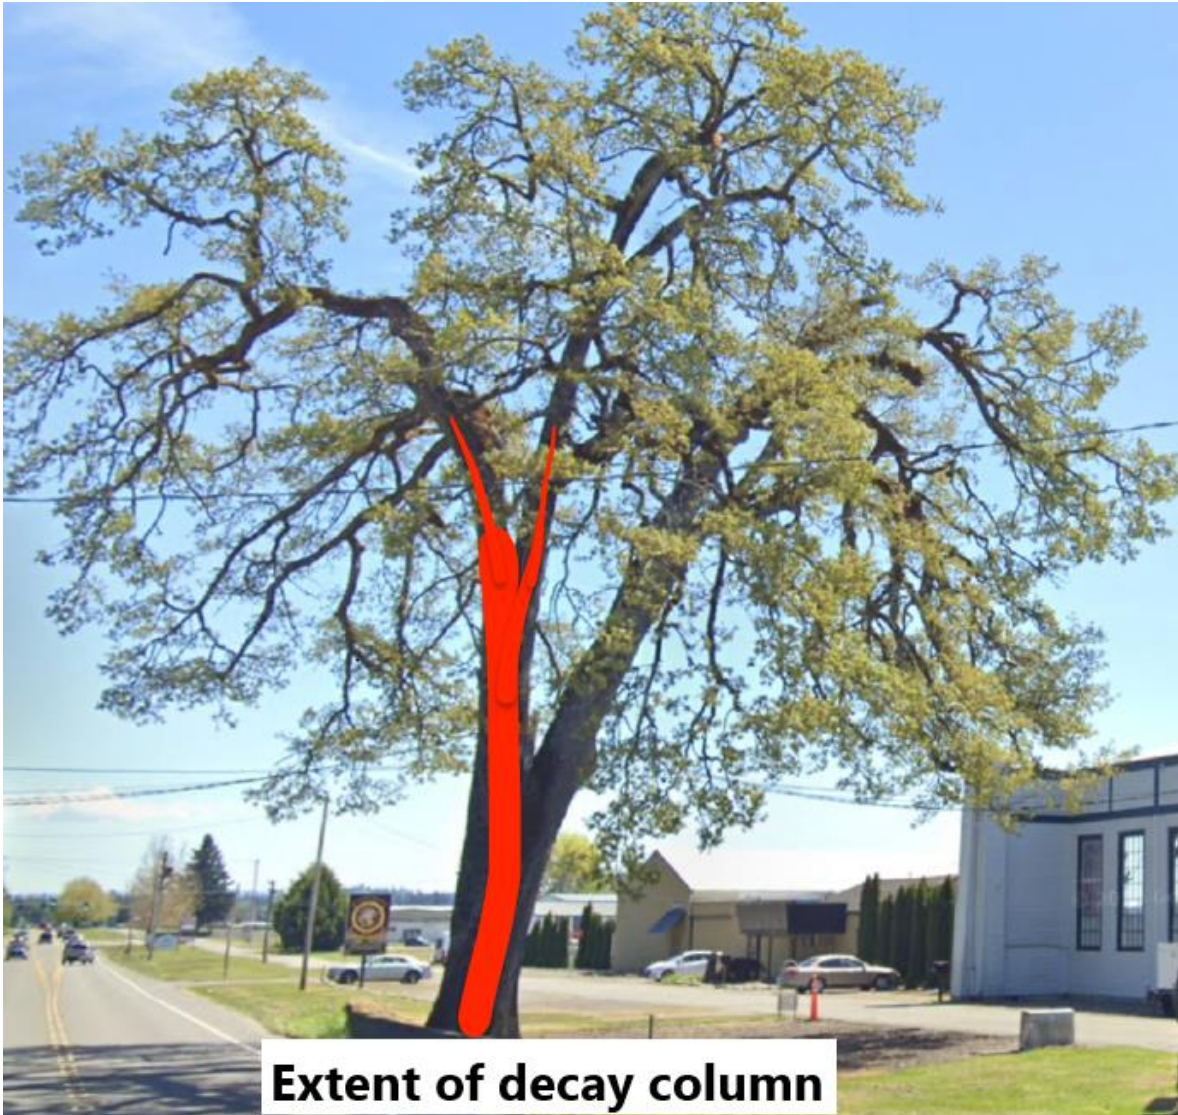
Extent of decay column

Based on my findings and information I have been provided, I am recommending removal.

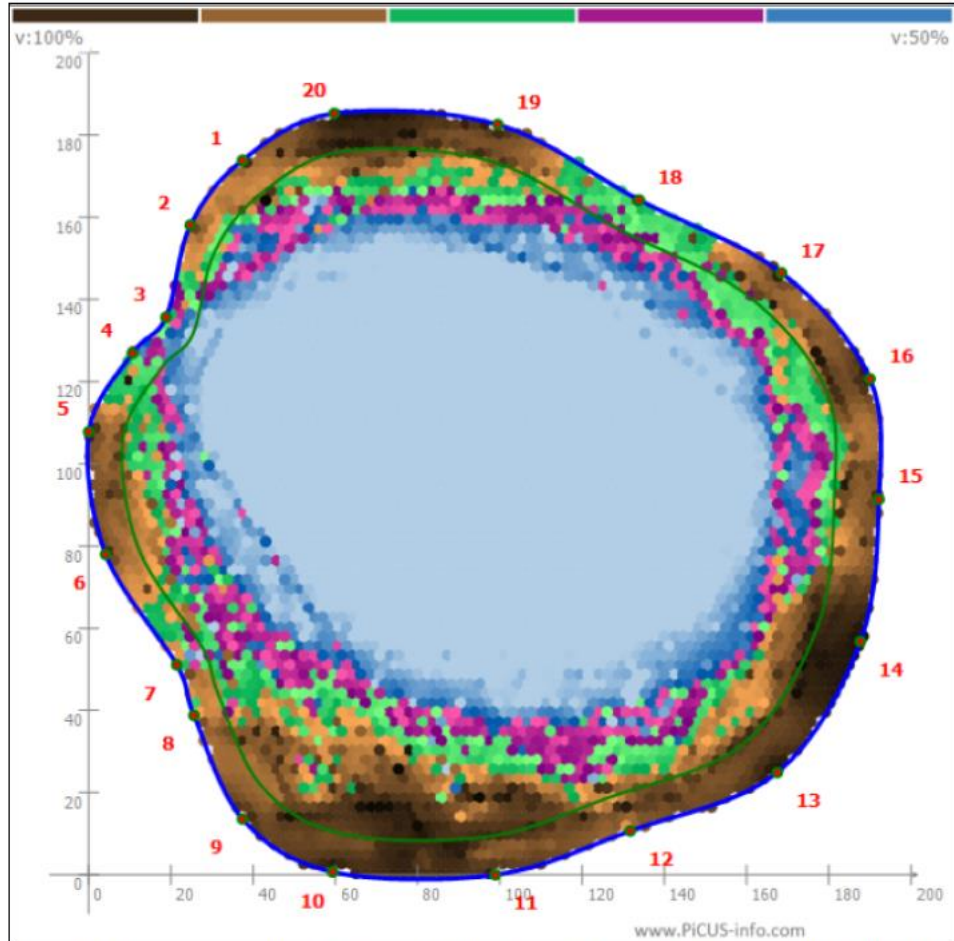
I used a PiCUS sonic tomograph to obtain a tomogram 50 centimeters above the tree base. I selected this height based on soundings of the trunk which indicated the most extensive decay was located low in the trunk. I used the PiCUS Q74 program to analyze the data and obtain a rough estimate of the remaining sound wood shell wall required to maintain tree stability, indicated by the green line in Figure 1 in Appendix A.

The tomogram indicates there is slightly more sound wood than is required to support the tree. However, due to the extent of the decay and thin shell wall around measuring points 3, 4, and 18 it is my opinion that this tree should be managed as a veteran tree and have retrenchment pruning performed to reduce the tree height and spread by approximately 15 feet. Reducing the tree height and spread will result in lowered wind loads acting on the trunk and branch unions resulting in a lower likelihood of failure.

Figure 1. Sonic tomogram of the subject tree. North is located at measuring point 1, and the side of the tree towards the highway is along measuring points 17, 18, and 19. The blue areas indicate decay or a decay cavity, and the brown areas indicate sound wood. The purple and green areas indicate early or spreading decay. The green line is the calculated shell wall of sound wood required for the tree to remain stable.

If this tree is retained, it should be reassessed with sonic tomography in five years to determine if the decay is continuing to spread and what the remaining shell wall is at that time. Additionally, 4 to 6 inches of wood chip mulch should be added within the dripline of the tree to improve soil conditions. The wood chip mulch should be kept 12 inches from the base of the tree.

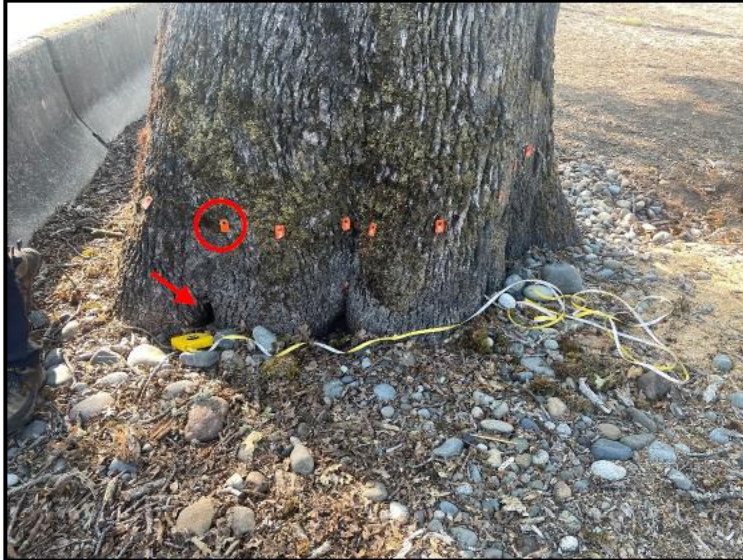
Photograph 1. Measuring point 1 is circled in red. An opening into the decay cavity is indicated by the red arrow.

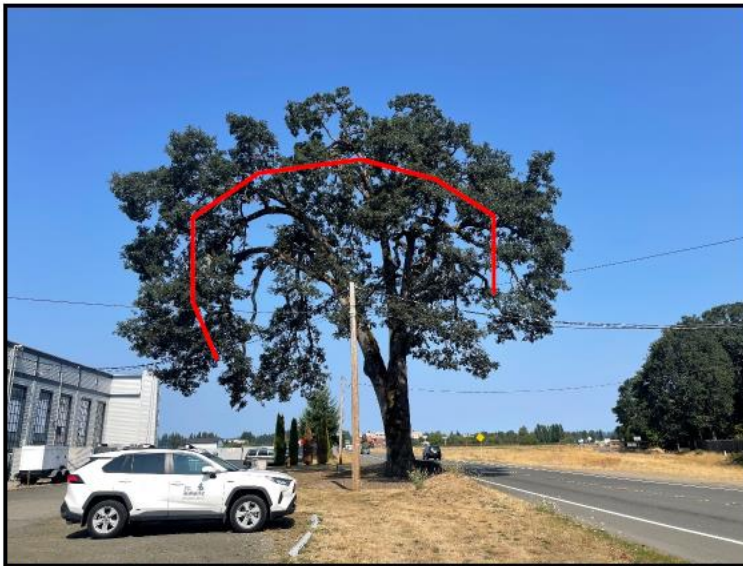
Photograph 2. The crown of the subject tree viewed from the southeast. The red line indicates approximately 15 feet of crown reduction.
