Todd Prager & Associates
LLC

Tree Risk Assessment for the Davis-Meeker Oak

Date: February 7, 2025

Site Address: 7525 Old Highway 99 SE
Tumwater, Washington 98501

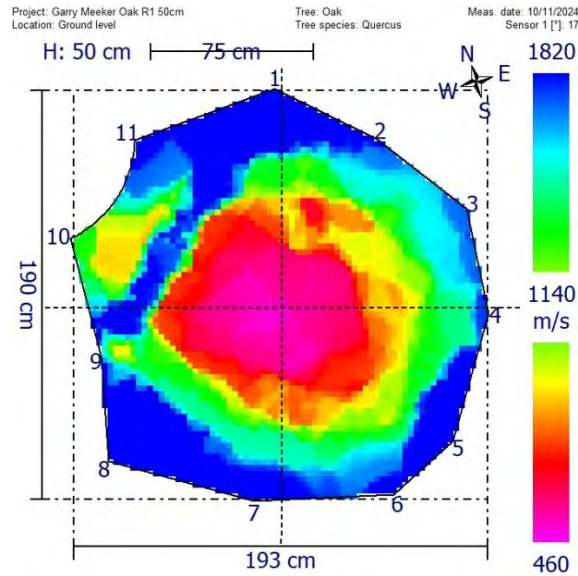
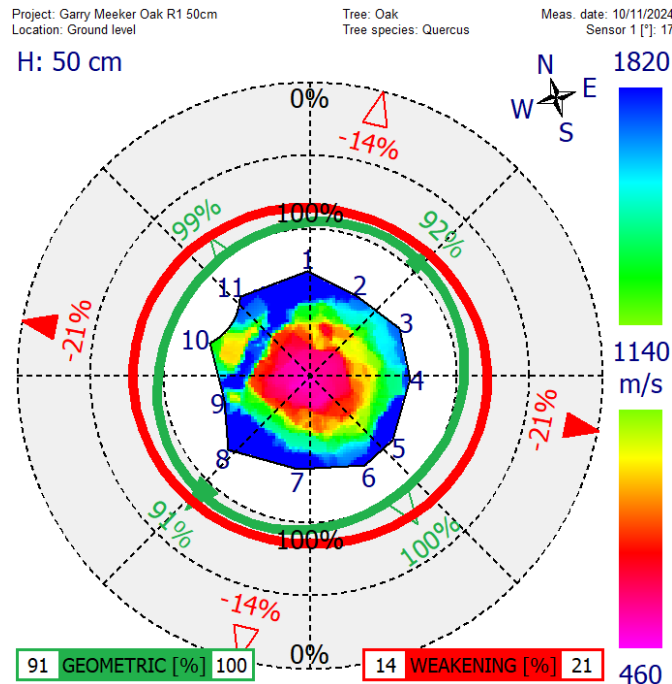
At this level there is significant compromised wood throughout the stem. The wood decay fungi that is affecting this tree has created a significant amount of compromised wood.

At this level there is between 14% and 21% strength loss depending on direction.

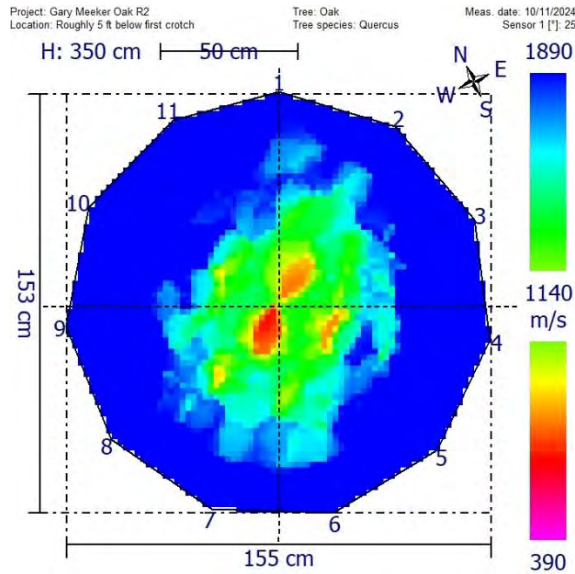
At this level there is a small amount of compromised wood in the center of the stem. The green indicates where the co-dominant inclusion is causing a weak attachment point.

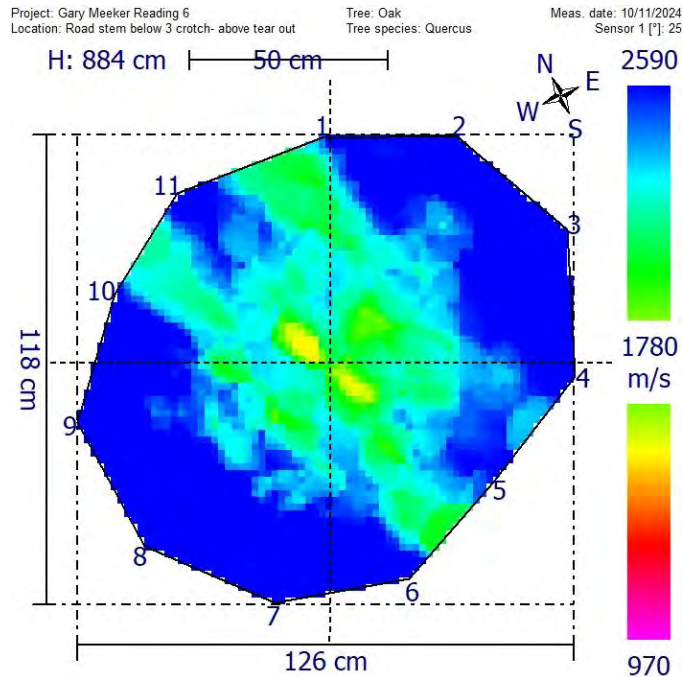
At this level there is included bark throughout the center of the stem, where the three stems connect.

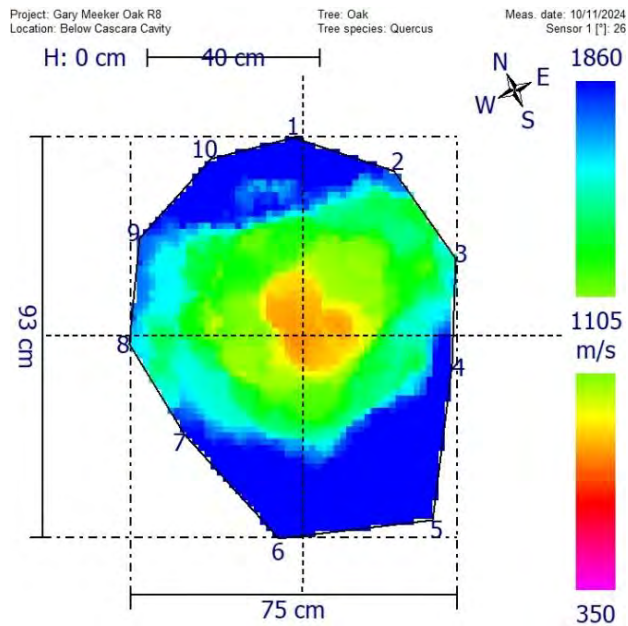
At this level there is less dense wood in the center of the stem. The center yellow spot indicates where the cavity above extends too.

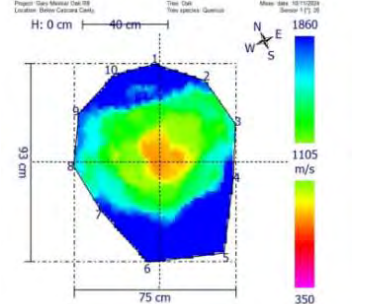
<p>At this level there is less dense wood in the center of the stem. The center yellow spot indicates where the cavity above extends too.</p> <p>At this level there is between 6% and 19% strength loss. This is minimal strength loss.</p>
7	1036 cm/ 33 ft	Stem 1, above 2 nd codominant stem.

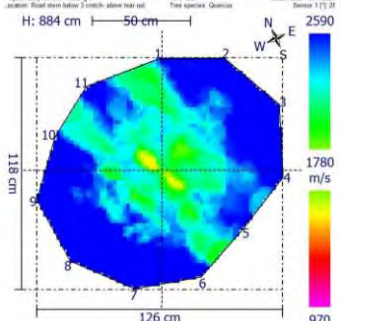
<p>At this level there is likely included bark within the center of the stem, where the codominant stems connect.</p> <p>At this level there is between 2% and 8% strength loss. This is minimal strength loss.</p>

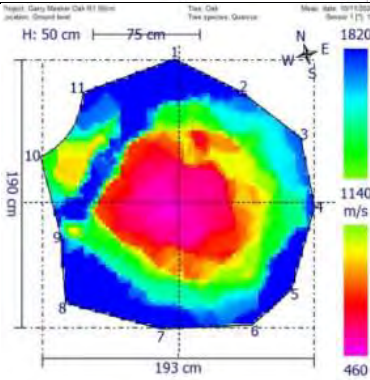
<p>At this level there is significant compromised wood throughout the stem. A wood decay fungi has created a significant amount of compromised wood and hollow trunk.</p> <p>At this level there is between 14% and 21% strength loss depending on direction.</p>
<p>1</p> <p>50 cm/ 1.6 ft</p>	<p>Main stem near ground level.</p>

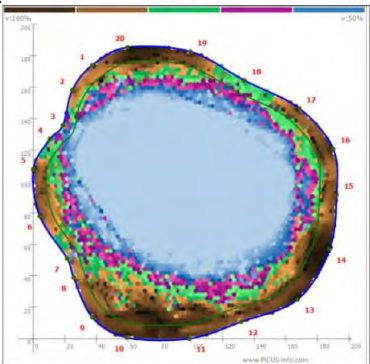
<p>Tree Solutions sonic tomography reading. Conclusion was that there is sufficient wood to support existing tree. The sonic tomography strength limit appears to have been set at approximately 80 percent hollow, or approximately 4-inches (10 cm) of sound wood based on the tree's diameter at the measurement point.</p>

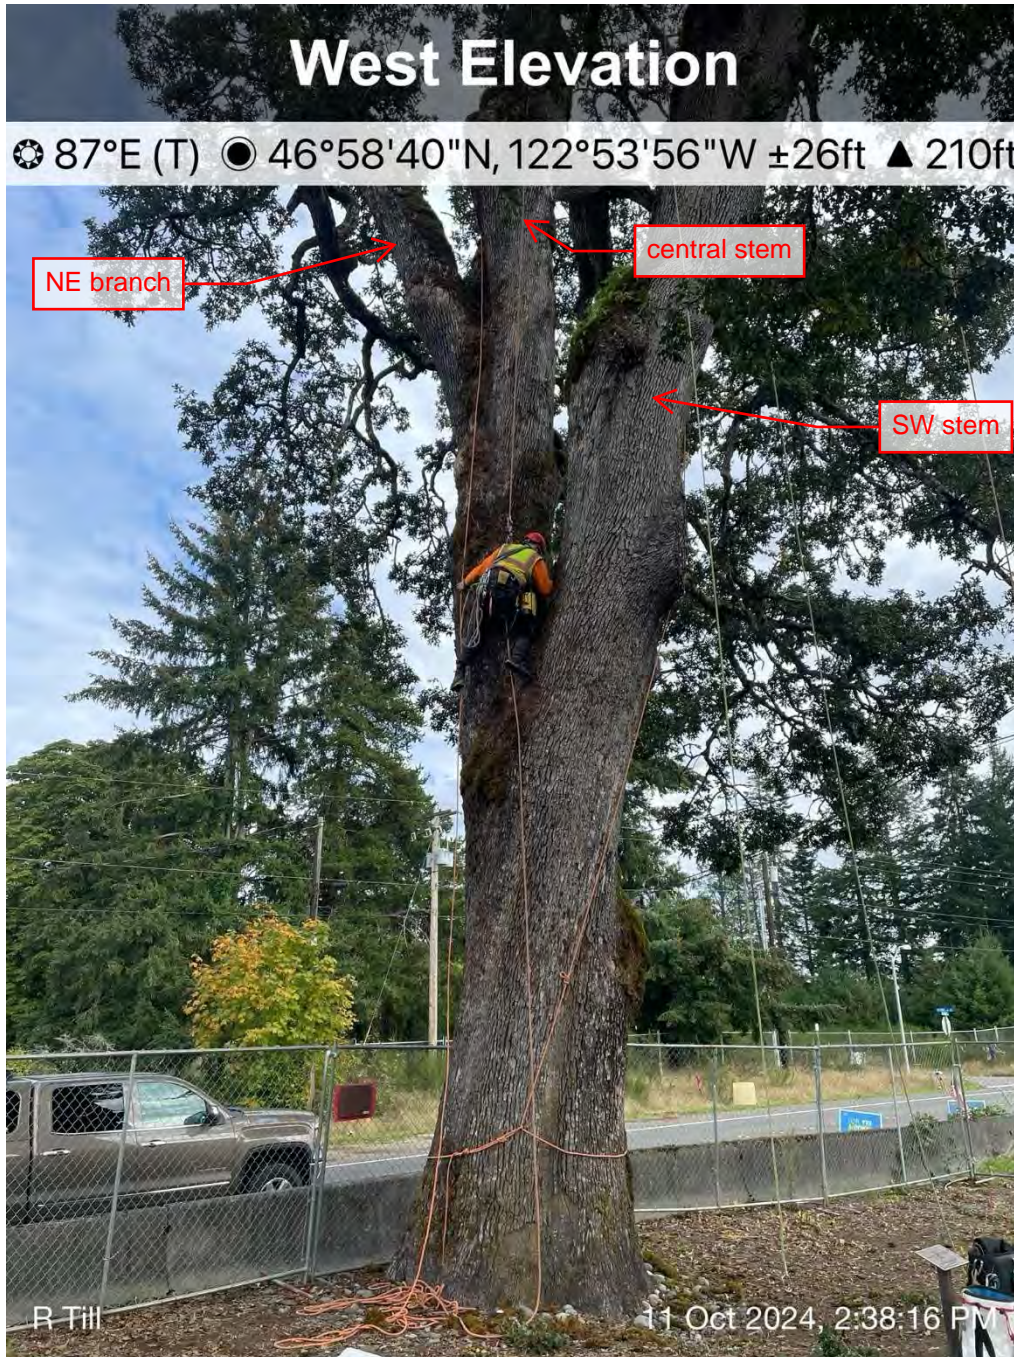
Figure 1 Inspection of first codominant union. A ¼ inch steel probe was inserted between stems and encountered solid resistance below historic debris collecting between the stems.

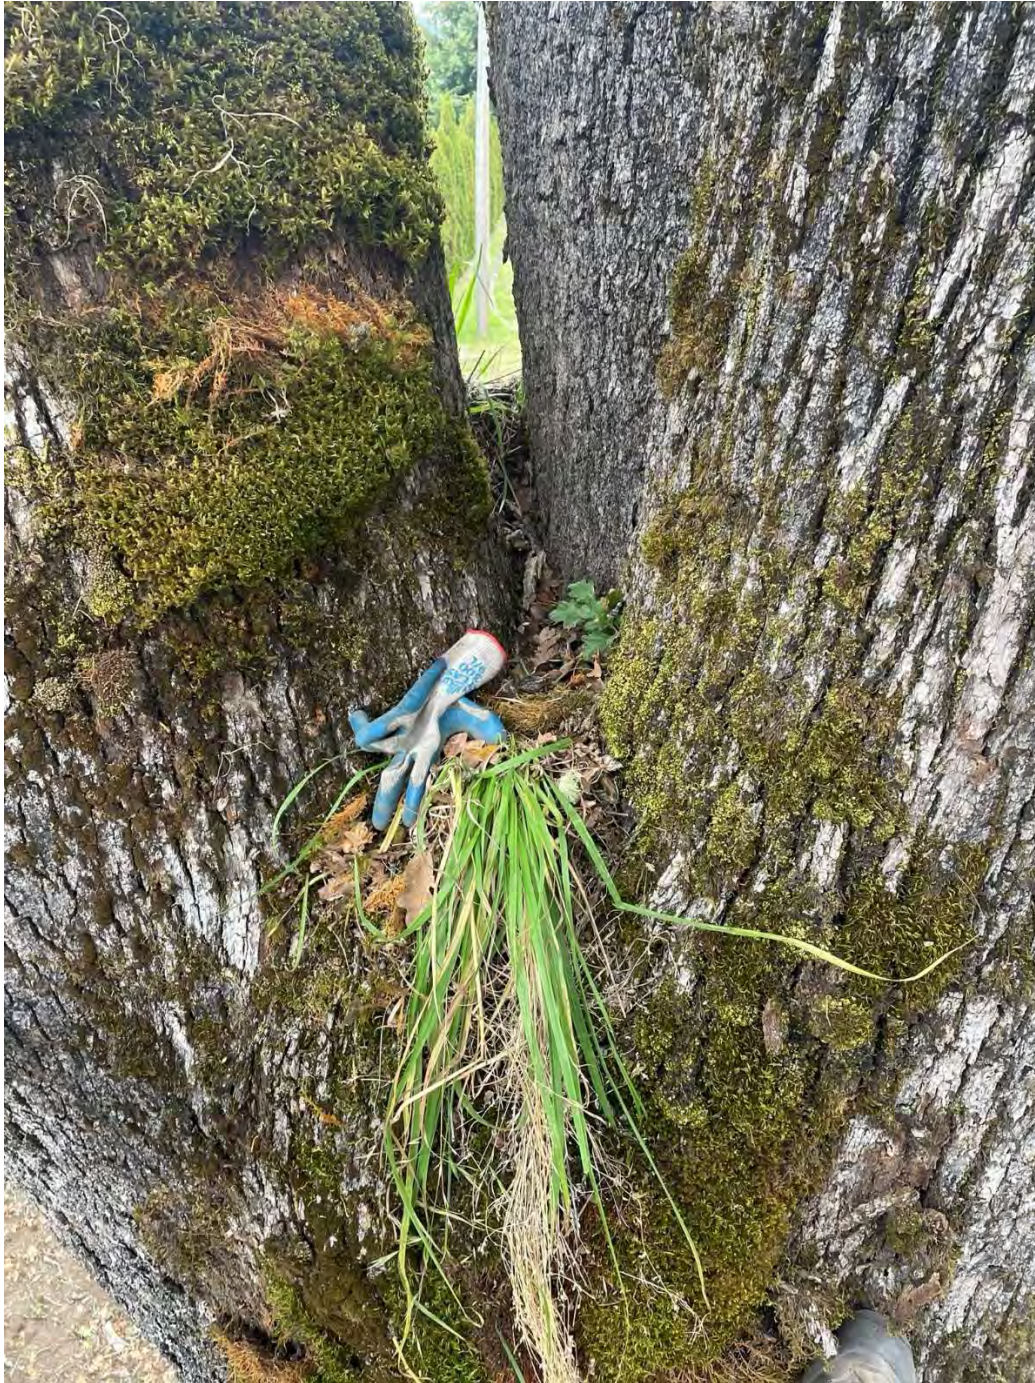
Figure 2 Debris accumulation and plant growth between codominant stems.

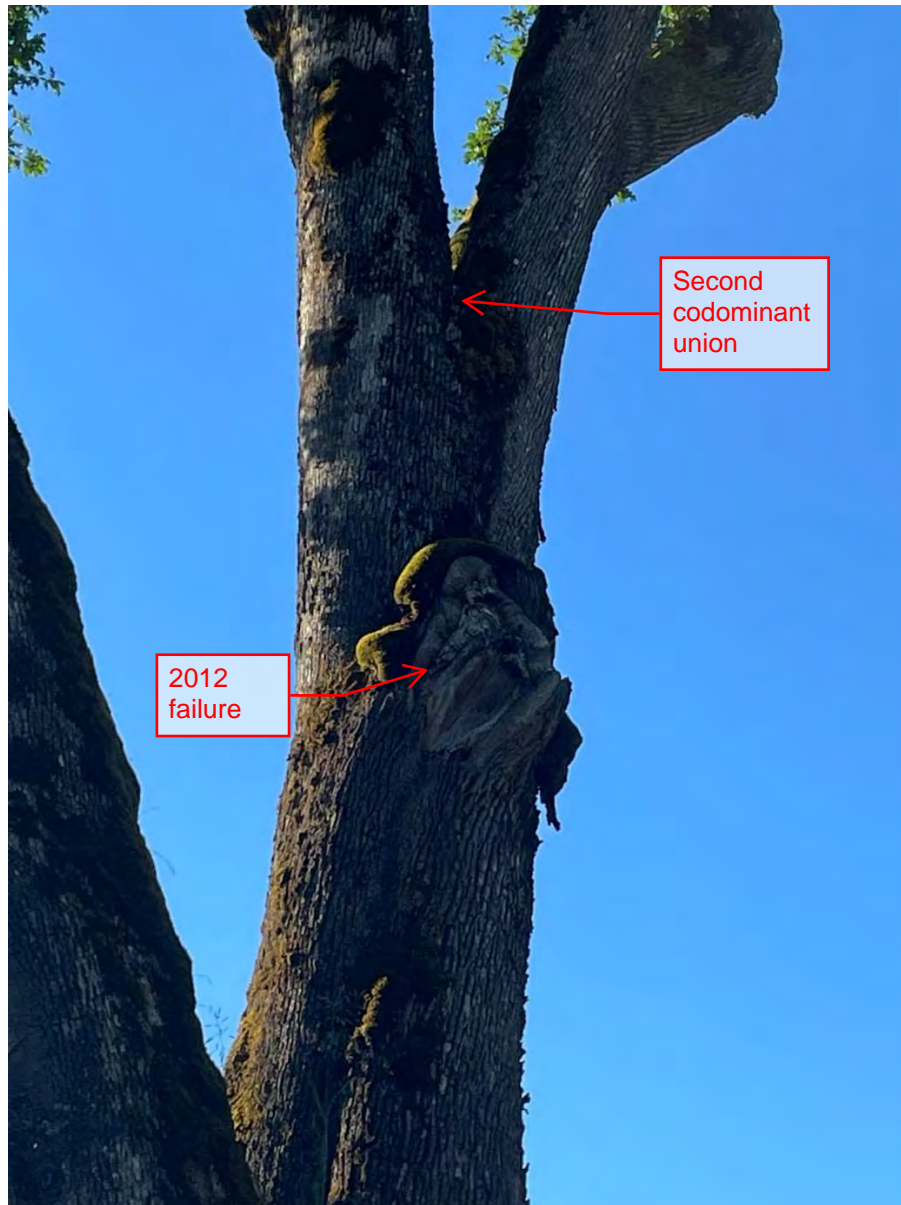
Figure 3 2012 failure and the second codominant union related to the following series of photos.

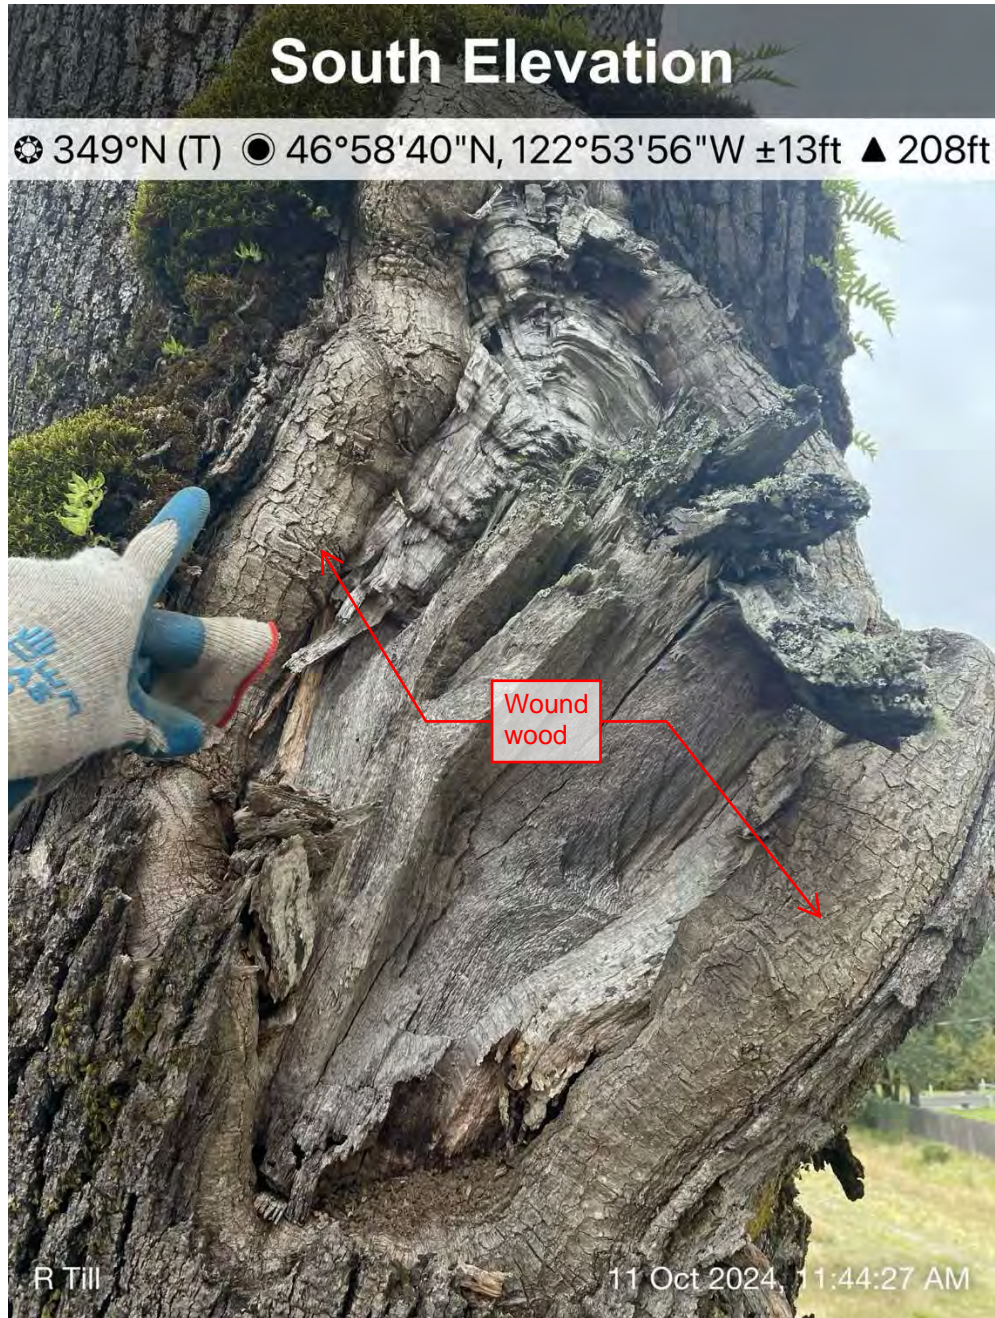
Figure 4 Failure on southeast side of central stem at 26 feet.

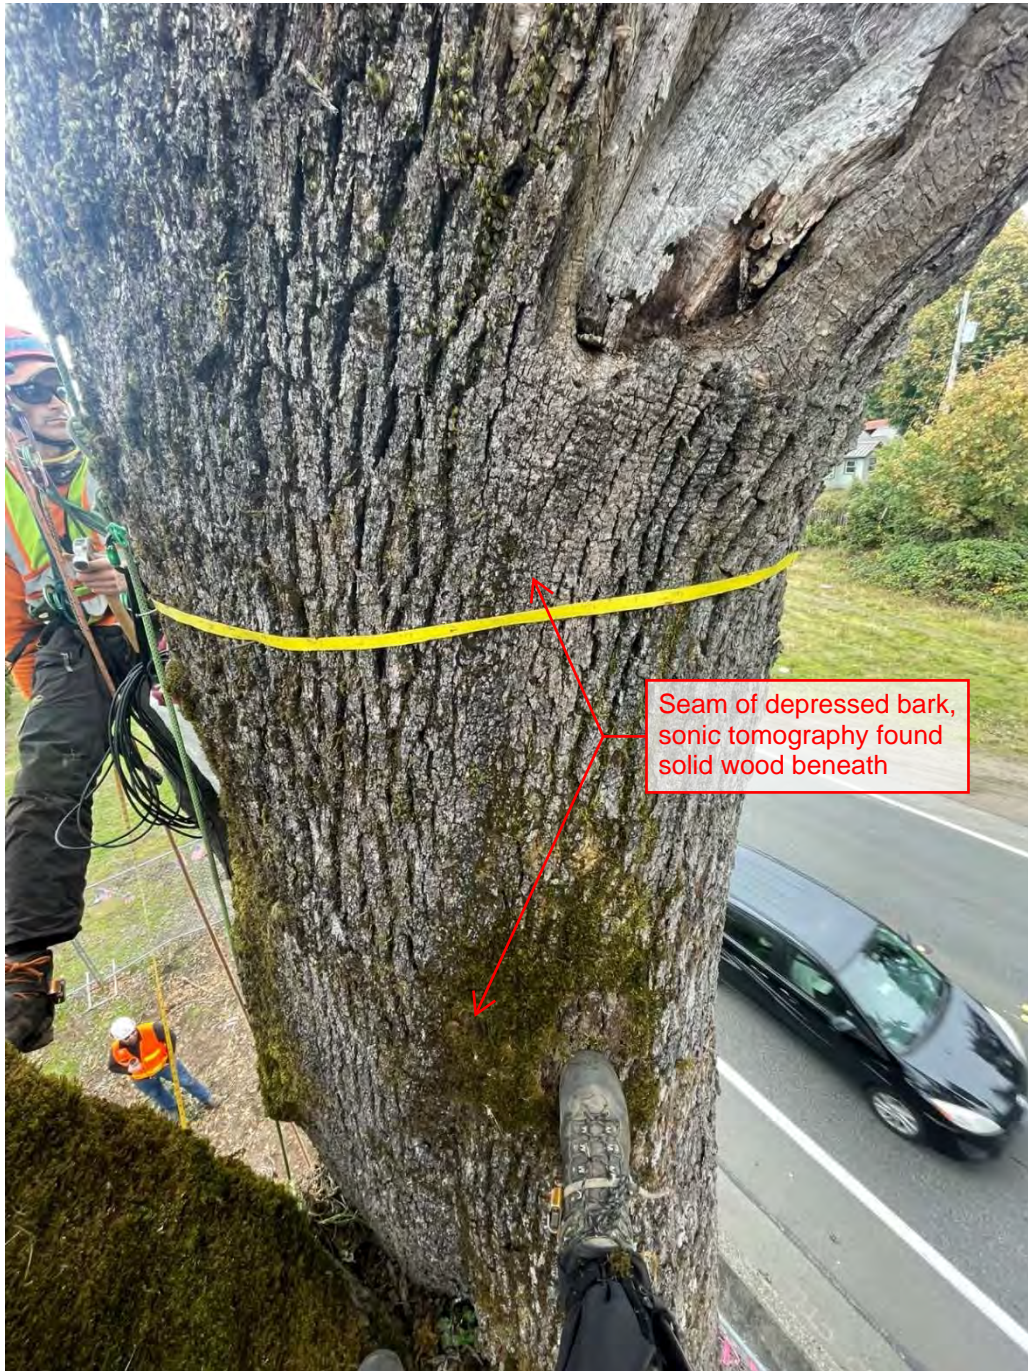
Figure 5 Seam below 2012 failure. Sonic tomography found solid wood down into codominant union.

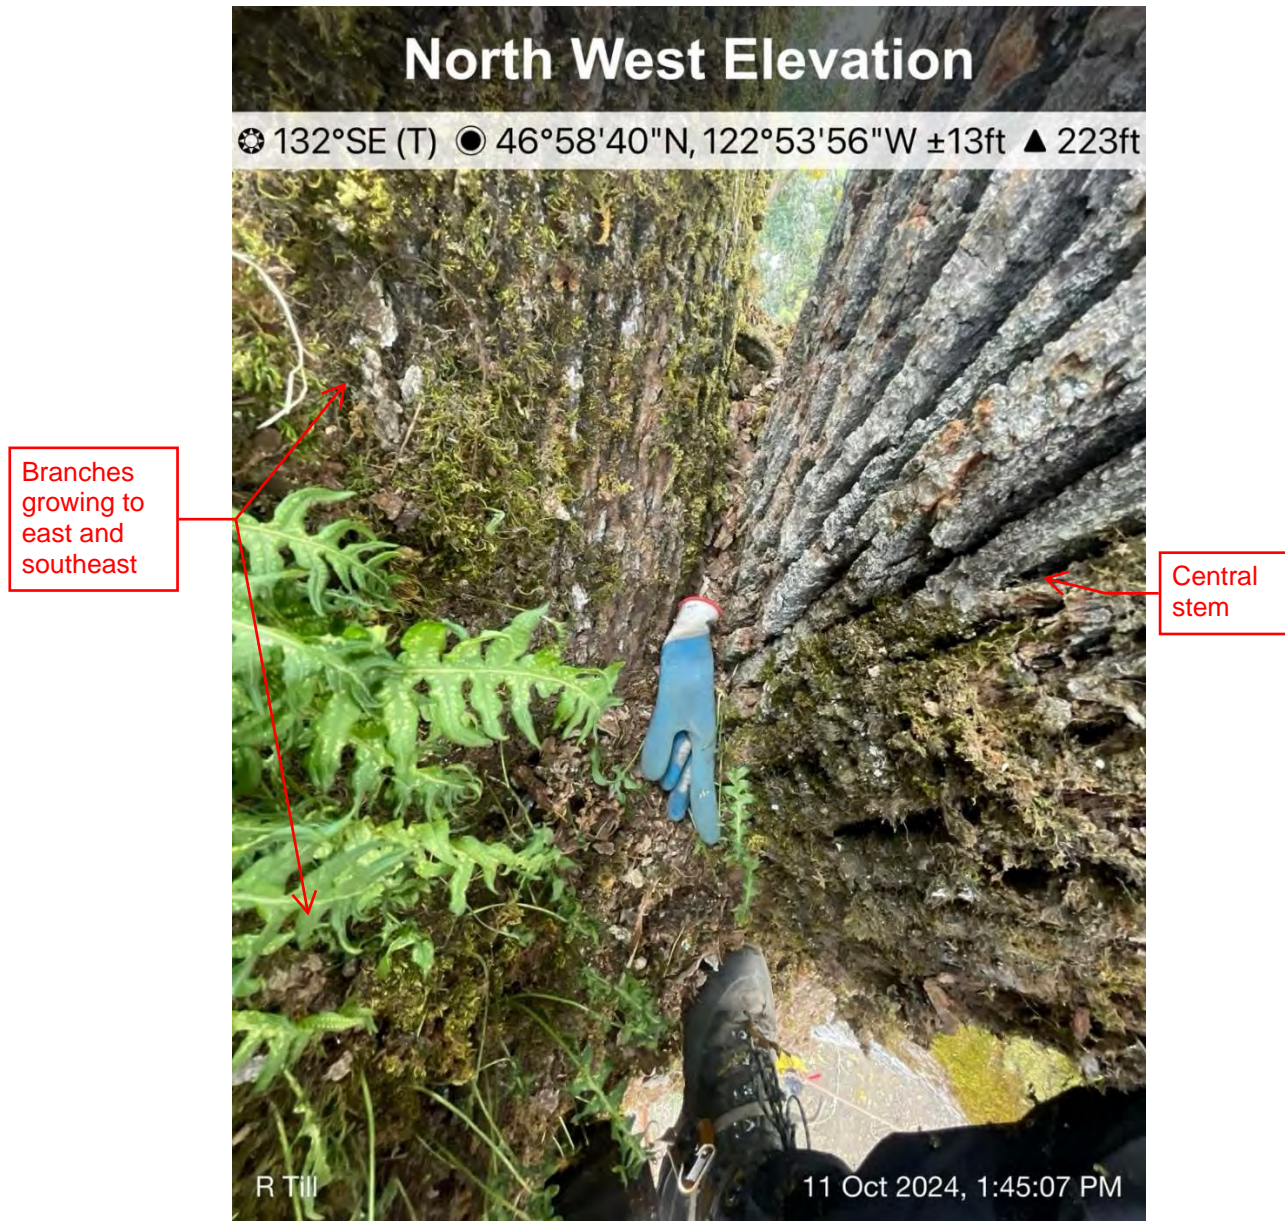
Figure 6 View directly down into second codominant union. Two stems over the road are on the left and central stem to the right. Union has included bark. Probing did encounter solid resistance beneath debris.

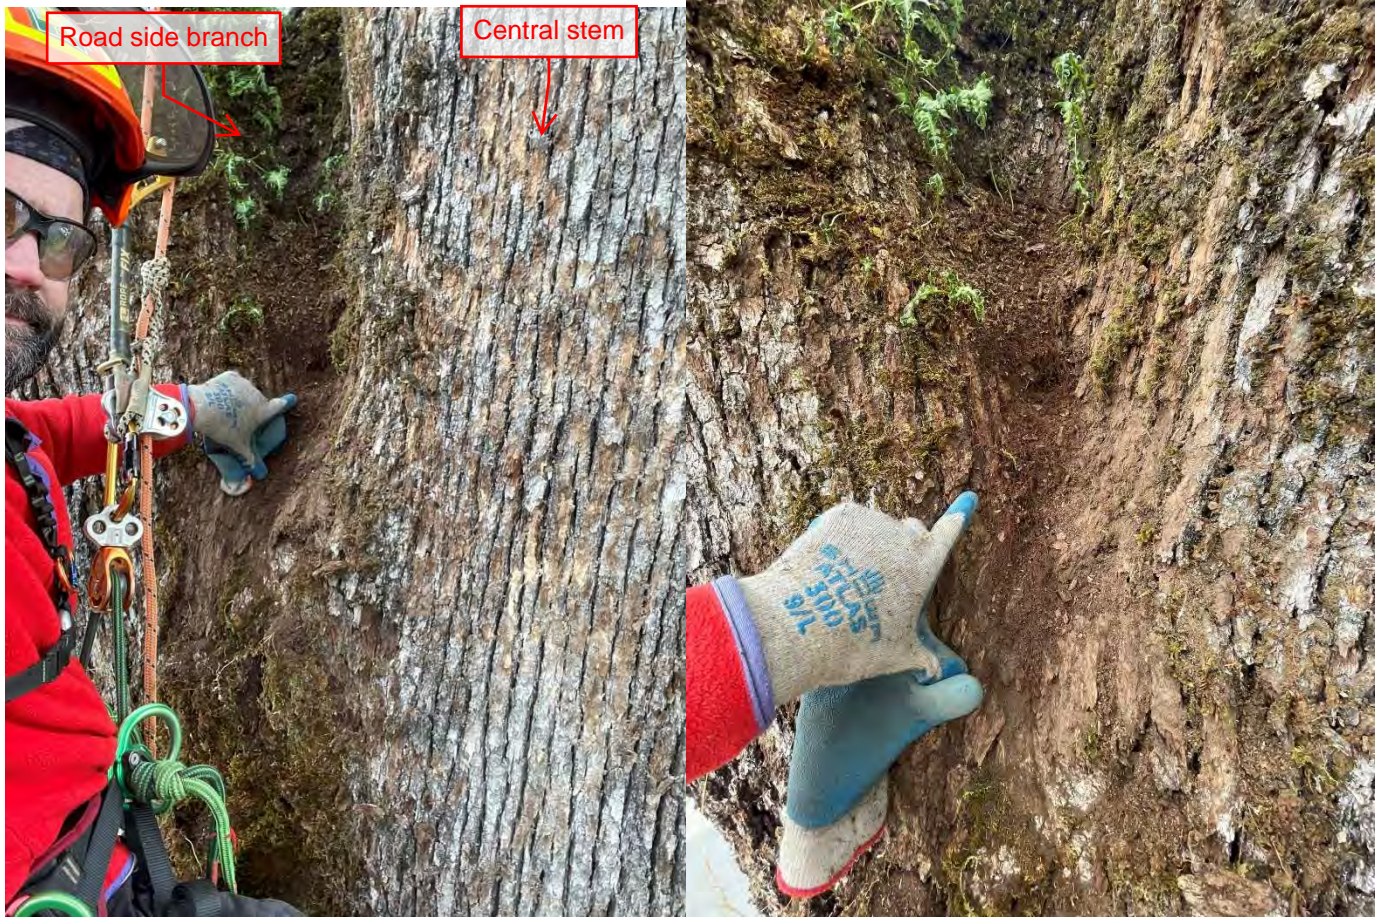
Figures 9 and 10 Northwest view of second codominant union. Included bark transitions into sound wood attachment.

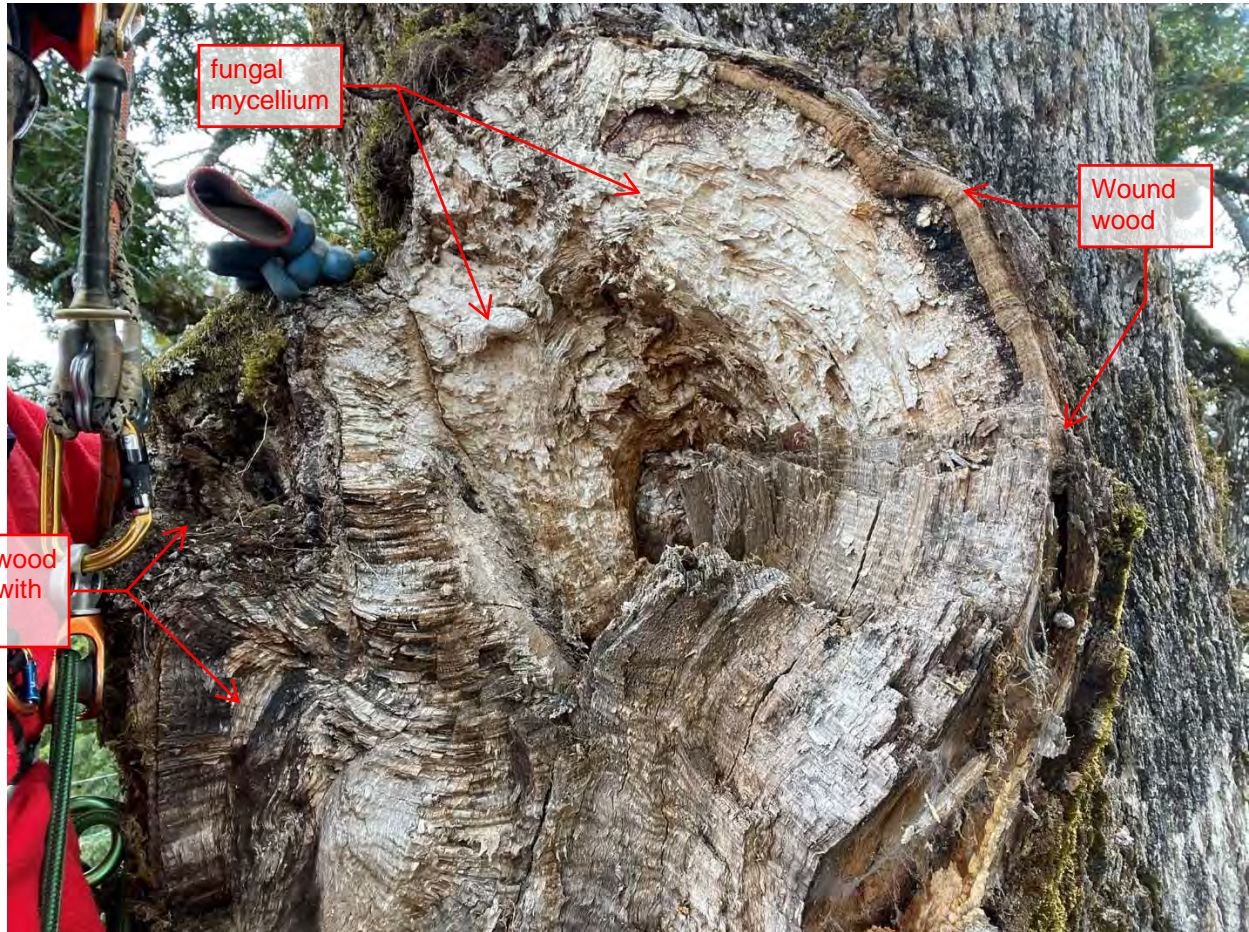
Figure 11 Wound wood on the top-right margin is positive response from tree. The fungal mycelium sampled from this location was identified as a Stereum species, which primarily consumes dead sap wood.

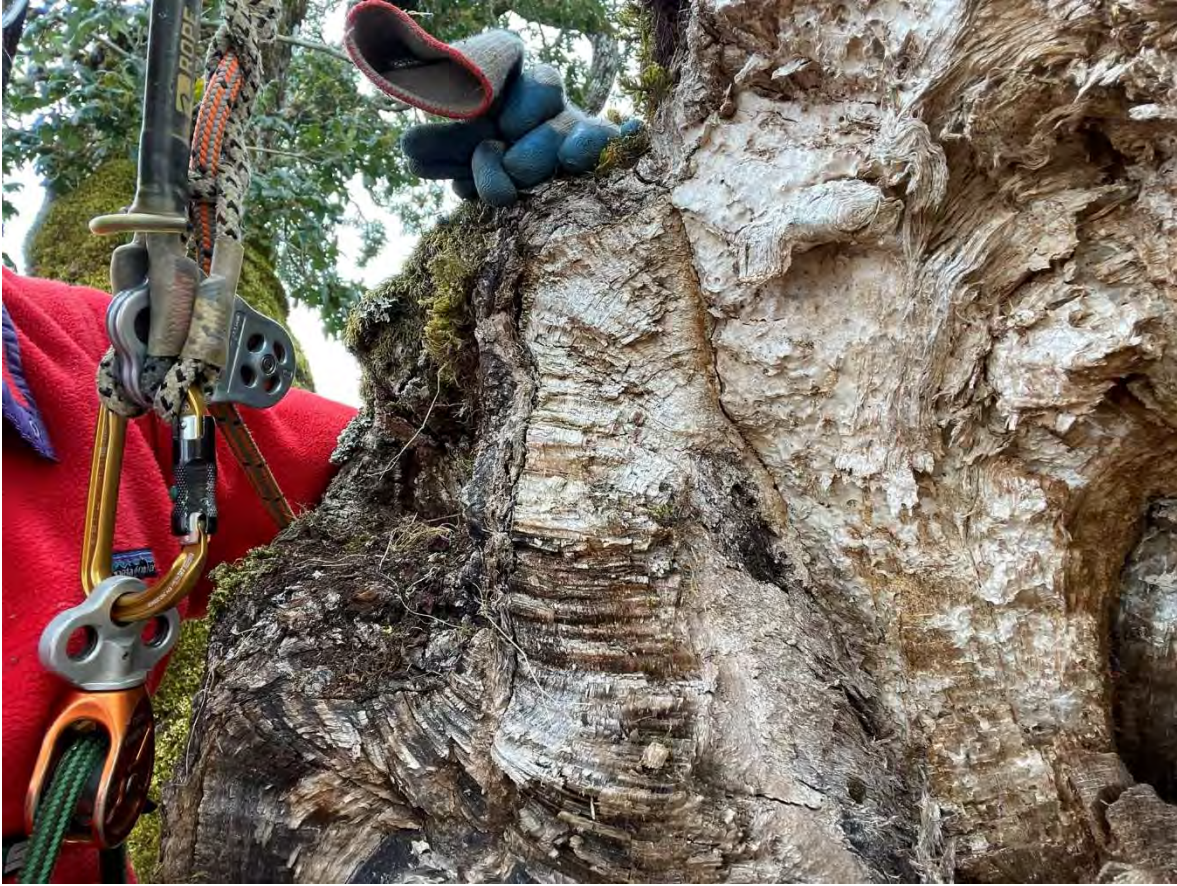
Figure 12 Left margin of 2023 failure and adjacent historic wound.

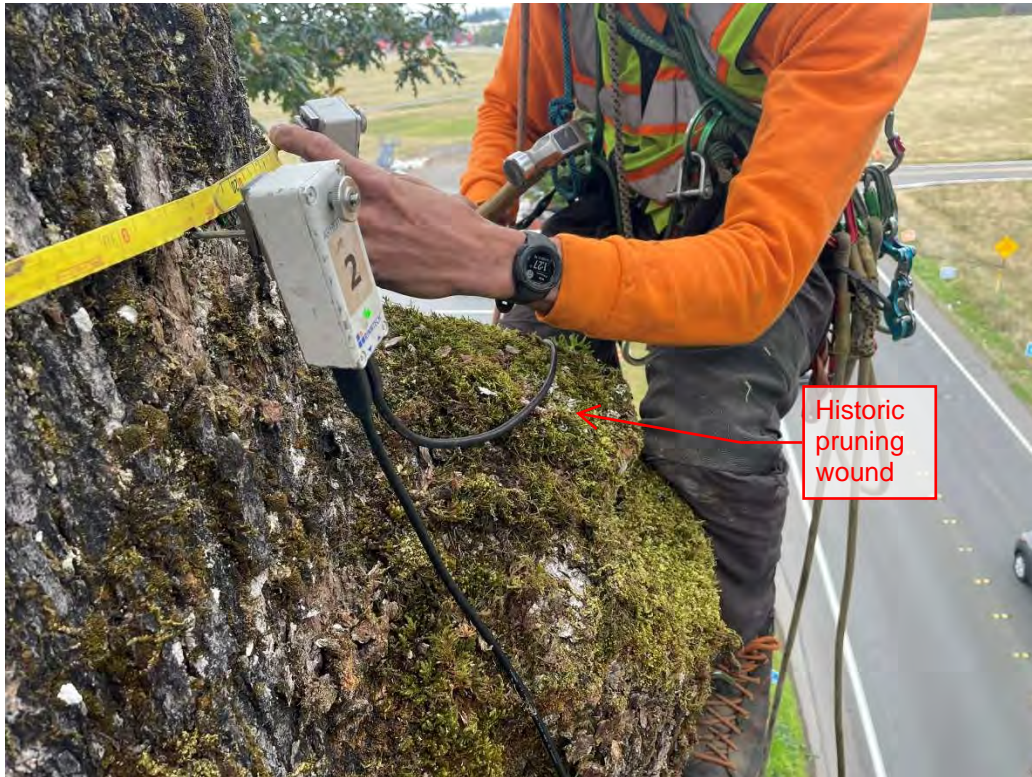
Figure 14 Historic pruning wound (covered in moss directly below watch) approximately 1 foot above the 2023 failure and below the Kestrel cavity.

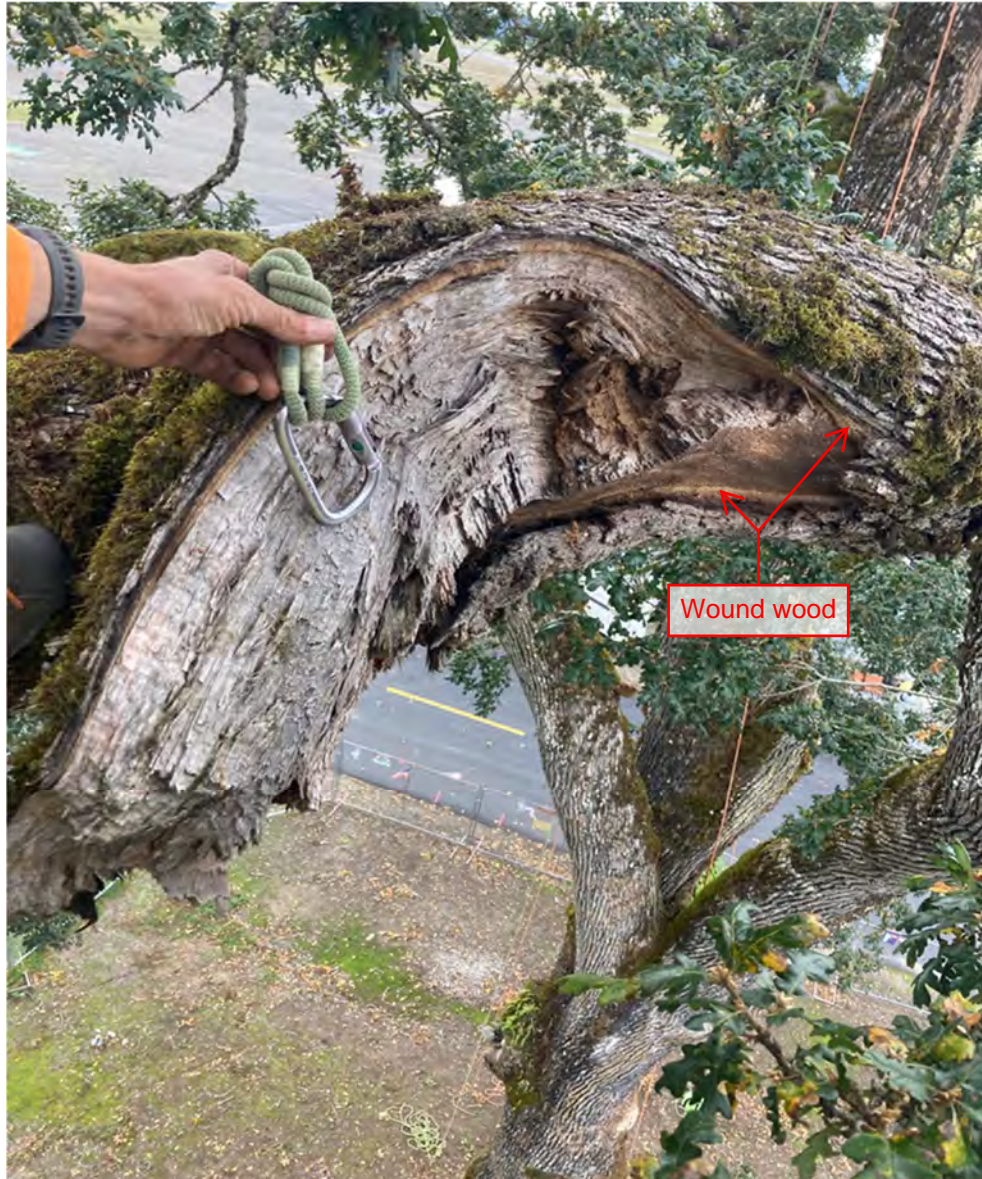
Figure 25 Carabiner used for scale. Note two to three years of wound wood growth around margin of injury.

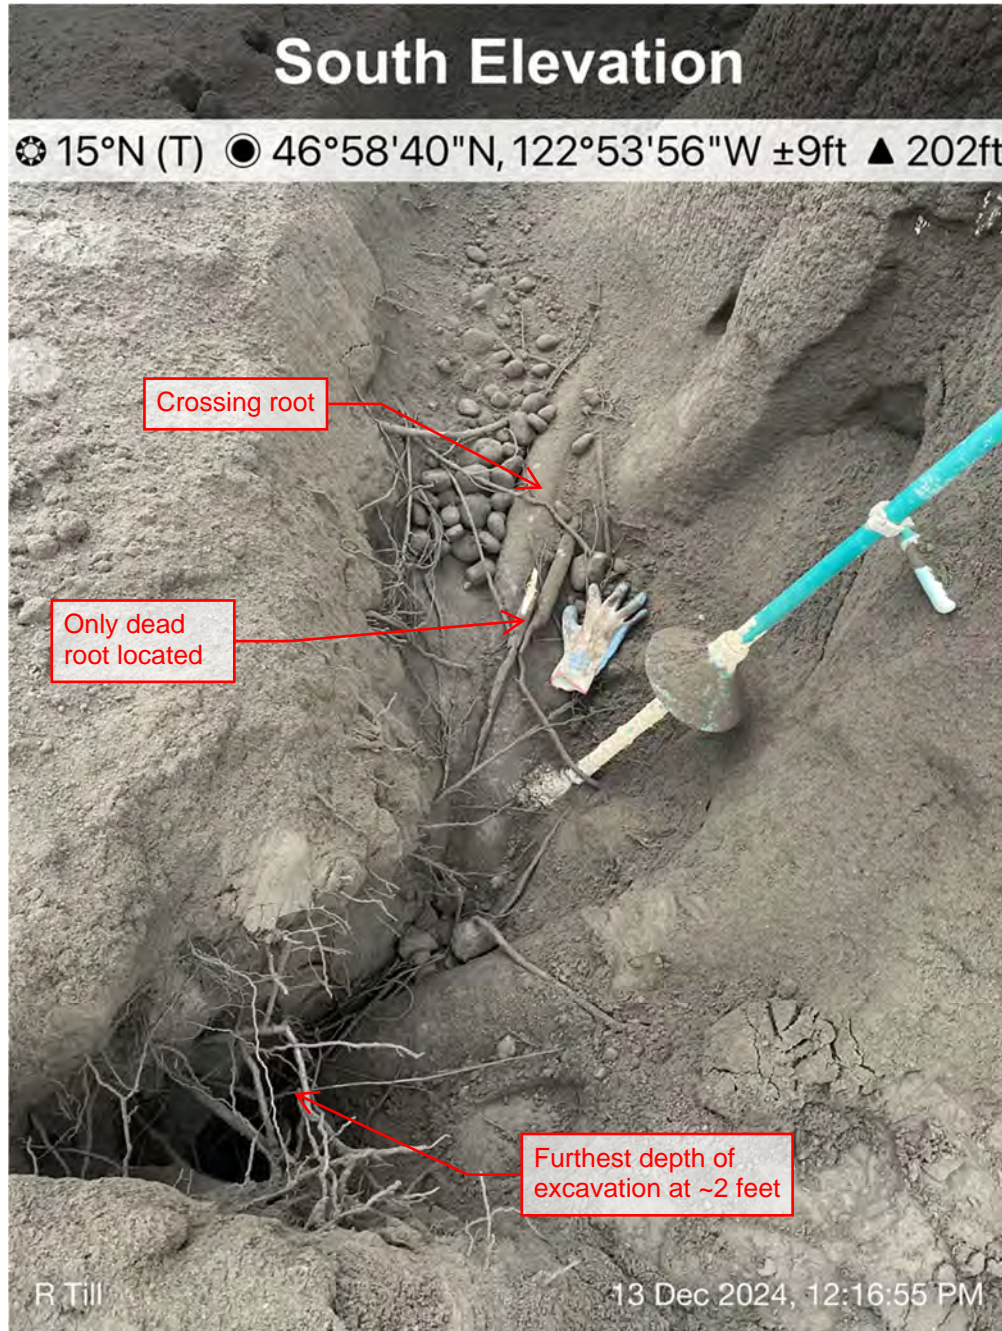
Figure 4 Traced one buttress root and did not locate any signs of concern. One, ~1-inch diameter dead root was located (visible to the left of the glove). One ~4-inch root crosses a primary buttress root, which could limit buttress root expansion.

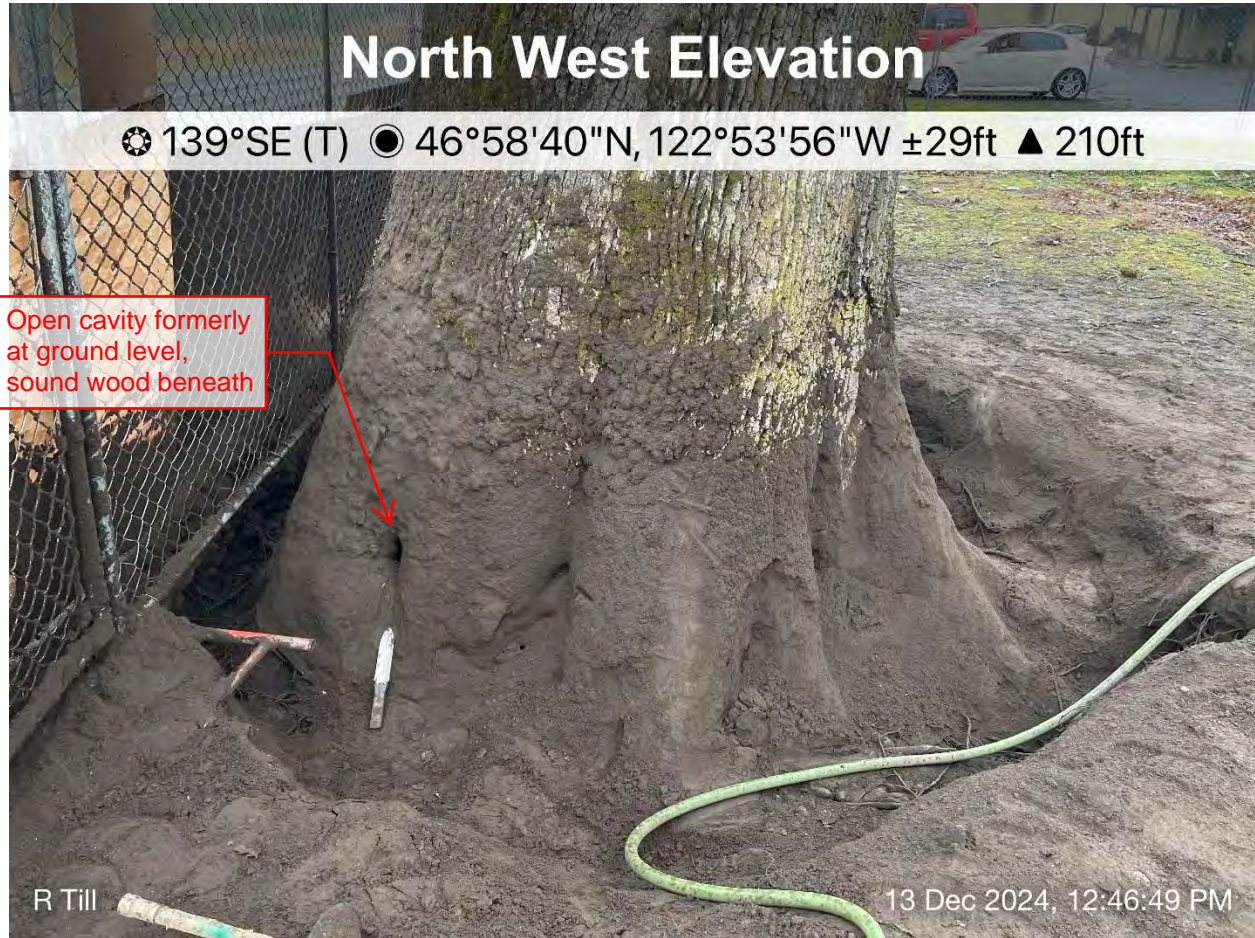
Figure 6 View from northwest. Wood below the cavity is sound. Hand inspected cavity and substantial wood present. Probes creases/sinuses between buttress lobes and did not identify signs of decay.

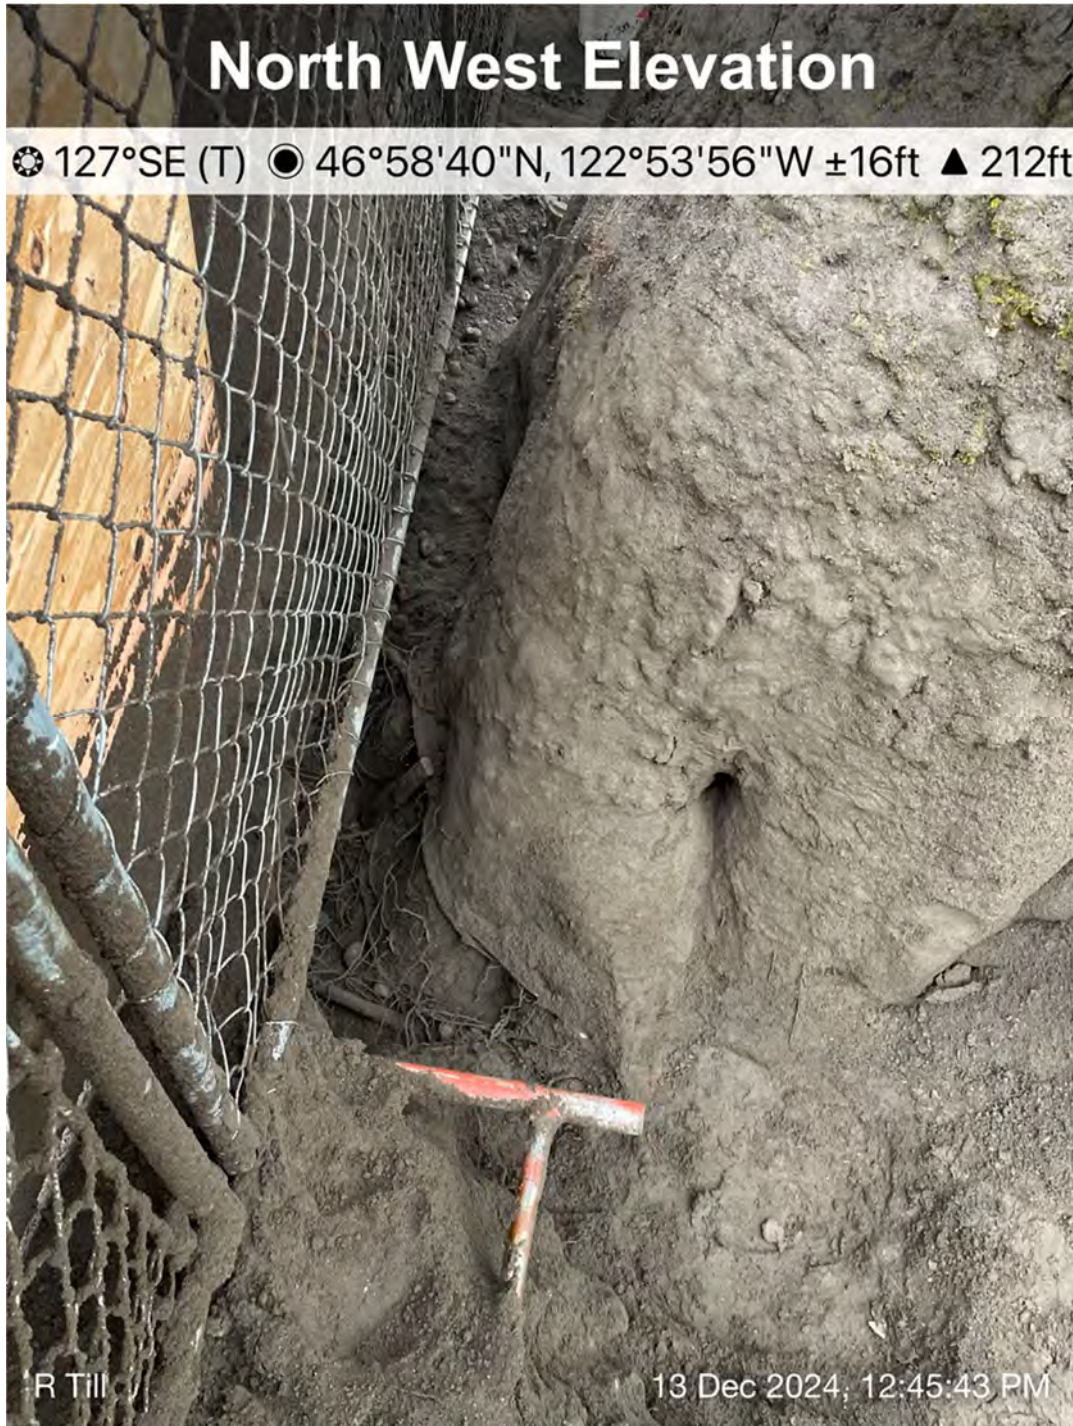
Figure 7 Street side excavation uncovered sound wood and adventitious roots. Buttress flare was not as pronounced, but otherwise no concerning signs. Depth of excavation was hindered by fence.
