STATE OF MISSISSIPPI
TATE REEVES
GOVERNOR
MISSISSIPPI DEPARTMENT OF ENVIRONMENTAL QUALITY
CHRIS WELLS, EXECUTIVE DIRECTOR

Re: Dam Inspection – Proposed Butler Park Phase II
Tupelo, Lee County, Mississippi

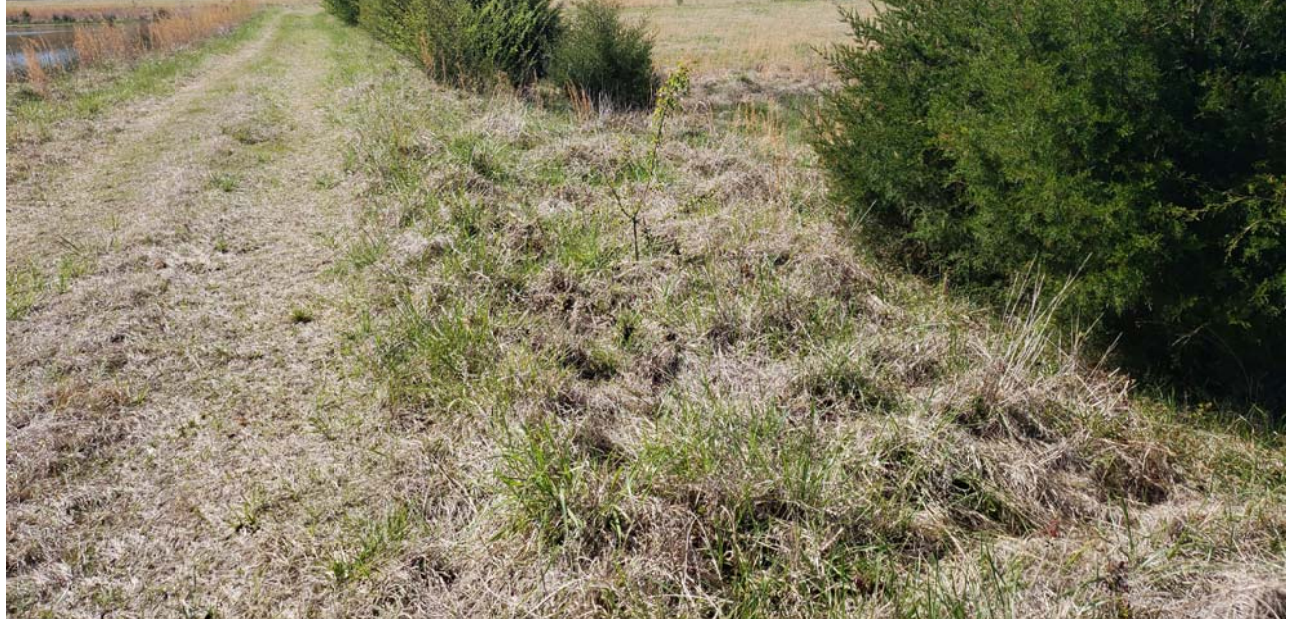
Butler Phase II - Tupelo, MS
April 10, 2022 10:39:27 AM
lat/long: 34.274, -88.780
Altitude: 83.0
Azimuth: -172.4 deg(S)

Saplings and brush growth on
downstream slope.

- Trees and shrubs are growing on the upstream and downstream slope of the dam. Their roots are damaging to the structure. The dam should be cleared of all woody vegetation.
- The front face of the dam has suffered minor wave wash erosion. This area should be regraded and thought given to placing erosion protection on the front face to prevent further erosion.
- The dam structure has a single spillway channel that appears degraded. MDEQ recommends the spillway channel be modified to ensure that the primary spillway structure that controls the water level in the dam be constructed of an erosion resistant material.
- Consideration should be made to ensure that any construction in proposed Lot 5 be elevated to ensure any construction would be above the resulting flood in the event of dam failure.

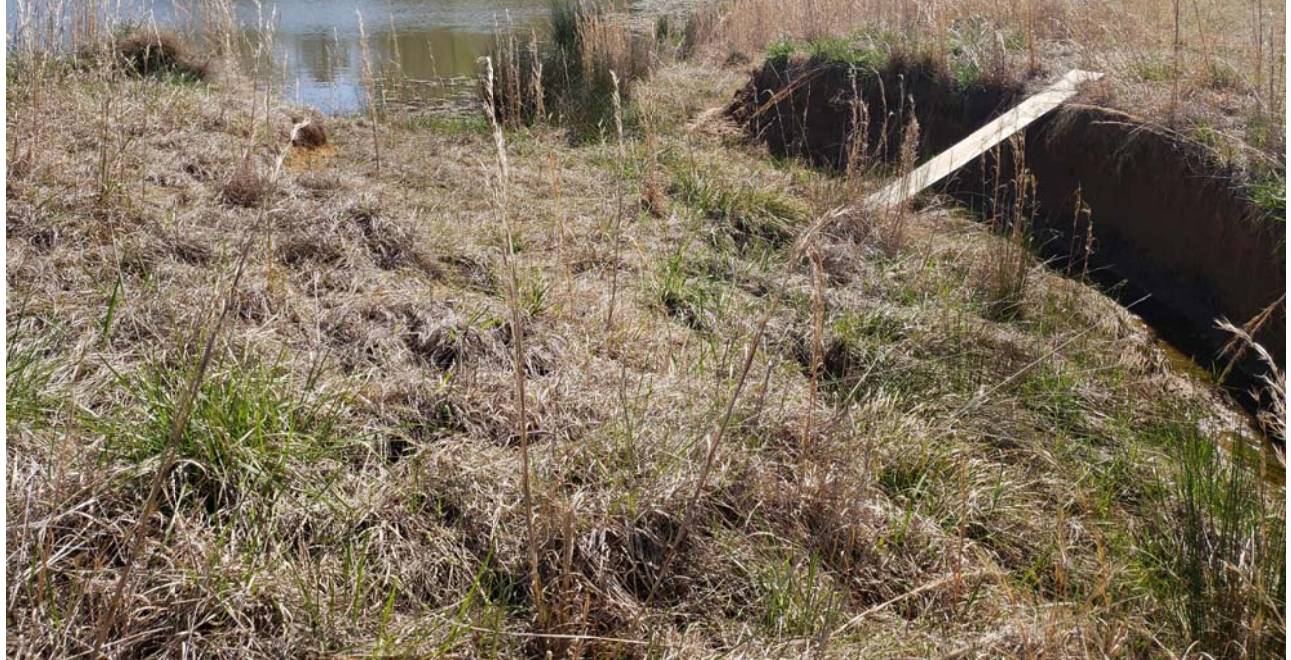
Butler Phase II - Tupelo, MS
April 10, 2022 10:43:20 AM
lat/long: 34.274, -88.780
Altitude: 84.3
Azimuth: 96.9 deg(ENE)

Poorly defined and degraded spillway.
