September 27, 2021

Re: Narrowsburg Garage-Rooftop Café' Seating Addition
Review summary/comment letter

File: 1341.013.001

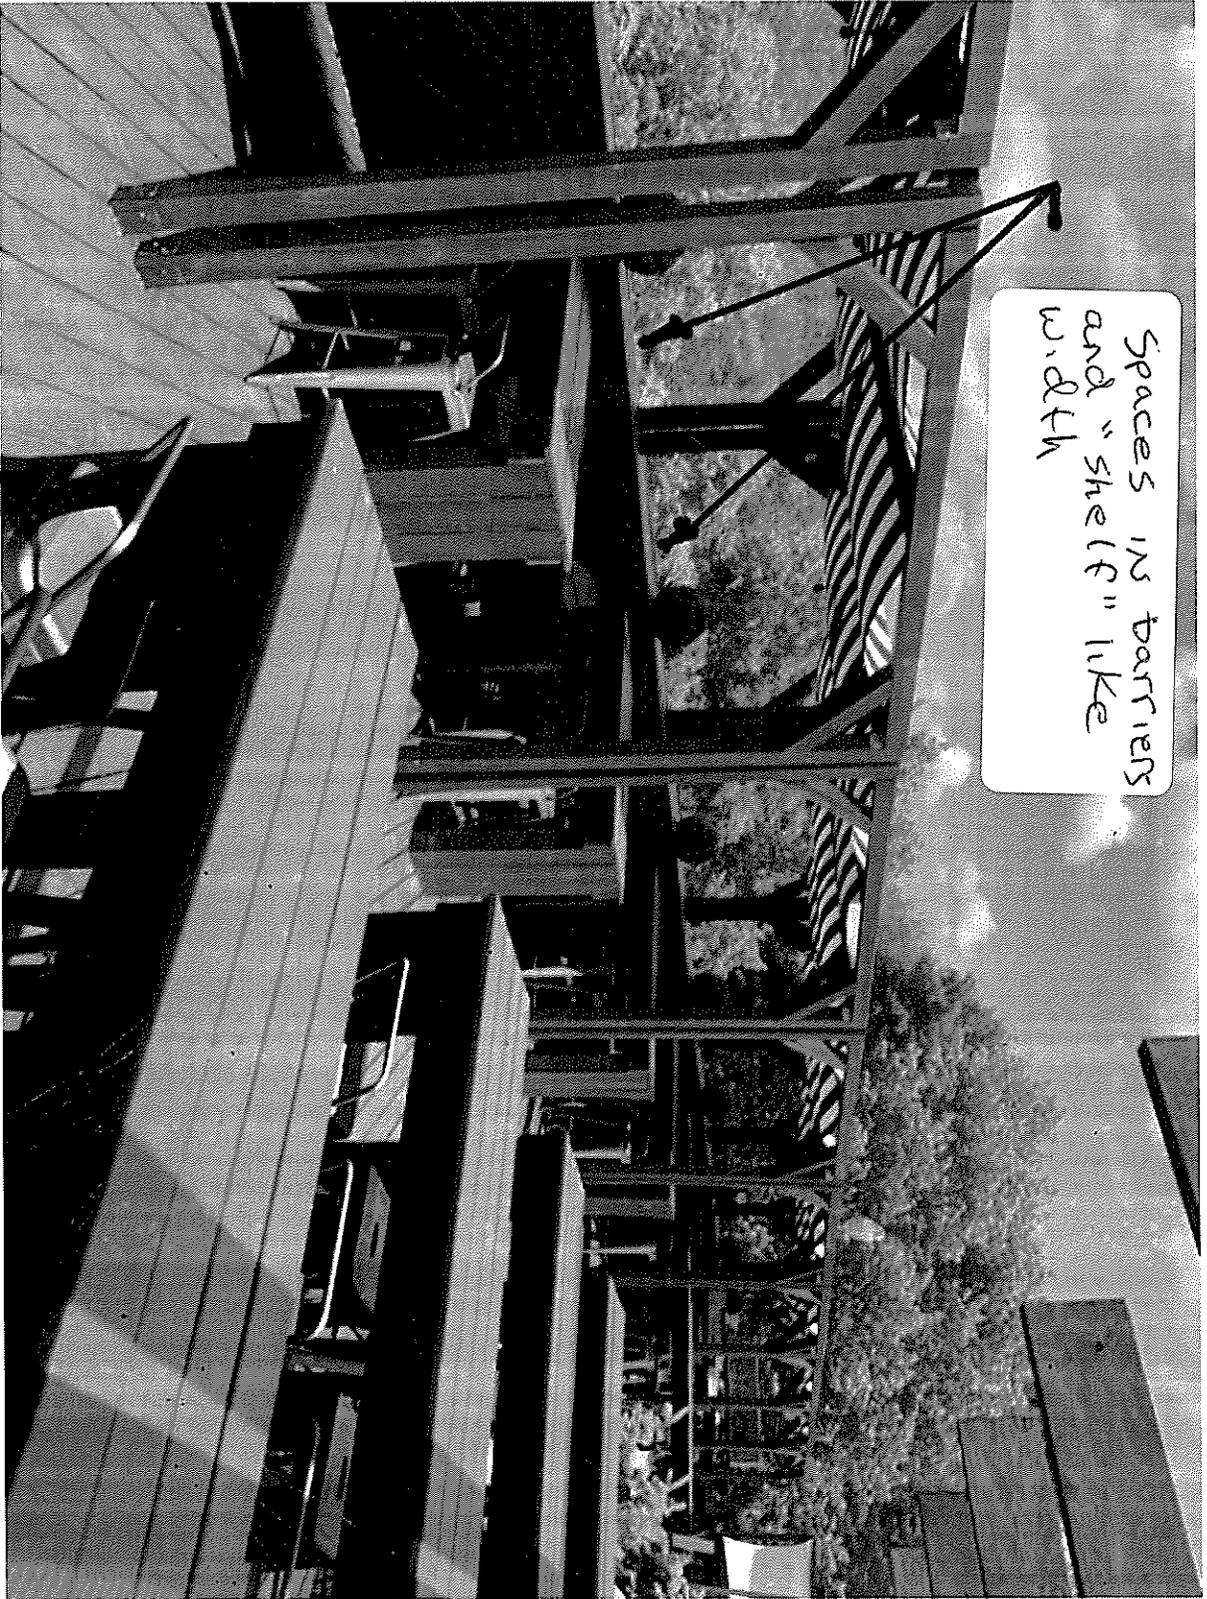
3. What are normal hours of operation?
4. A fairly wide "shelf" is adjacent to some of the tables that could be easily sat on and accessed from elevated high-top chairs and tabletops with no barrier to a fall from the roof. Small planters define the part of the space but not all of it. Signage warning of danger or a simple

barrier such as a cable to discourage sitting on it or placing drinks or other items that could be knocked off and fall on persons or property below. See picture enclosed of areas of concern.

Spaces in barriers
and "shelf" like
width

11. Are stairs and framing designed for 100 psf per IBC Table 1607.1 (35)?
12. Architect's walk through should include verification of railing and barrier system at roof edge are spaced according to code and will not pass a 4-inch sphere.
13. Has the applicant filed a building application form and paid any applicable fees? Perhaps some procedural items have already been addressed.
14. We recommend the project record and files include record plans labeled as As Built plans after the Architect visits the site and verify that the railings for the stairs, railings and barrier systems were constructed as designed, code compliant and appropriately fastened. The architect should submit correspondence with the plans attesting to floor and structural design, stairs, railing systems and safety systems/barriers for rooftop café.

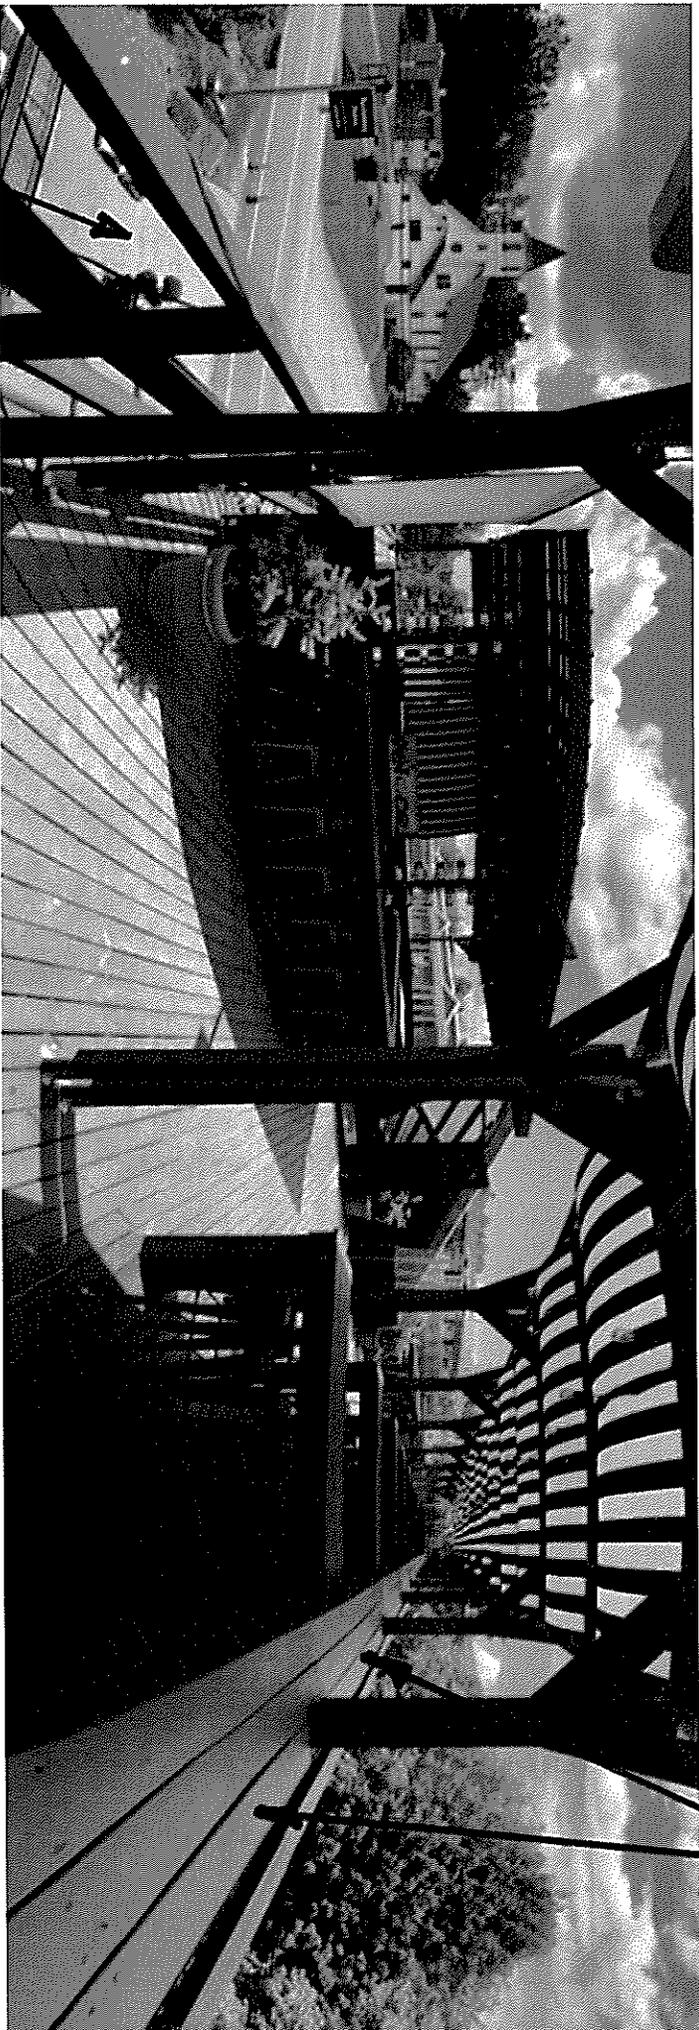
wide spaces in railing system

"shelf" like width, concern for lack of barrier
