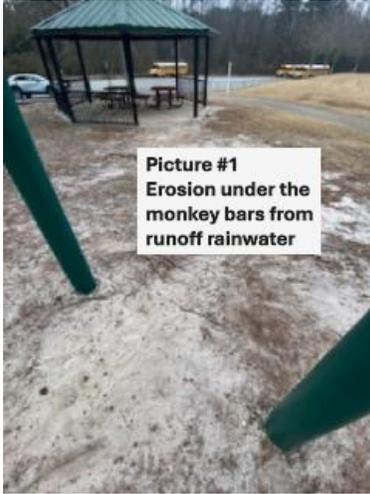
Picture #1  
Erosion under the  
monkey bars from  
runoff rainwater

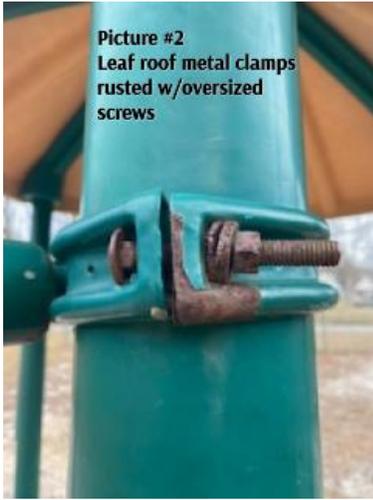
Picture #2  
Leaf roof metal clamps  
rusted w/oversized  
screws

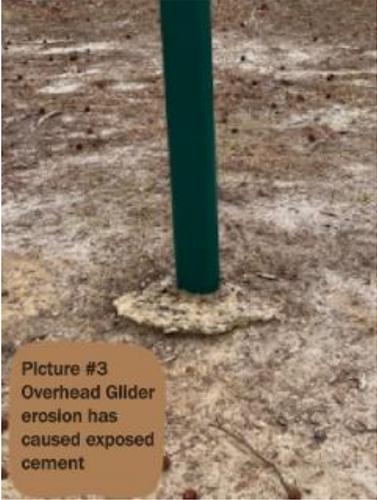
Picture #3  
Overhead Gilder  
erosion has  
caused exposed  
cement

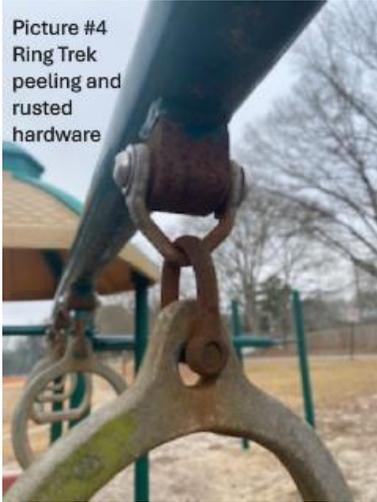
Picture #4  
Ring Trek  
peeling and  
rusted  
hardware

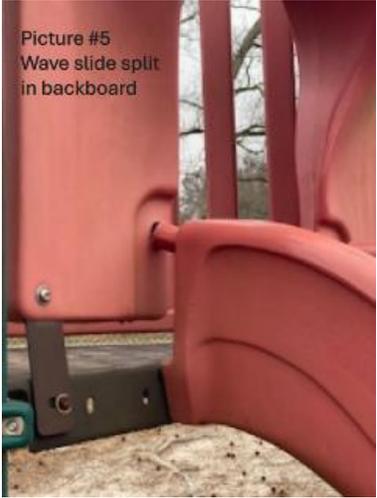
Picture #5  
Wave slide split  
in backboard
