REQUEST/SOLUTION

RE: 3 Hotel Street
Warraton, VA
Street Drainage Concerns
CV # 20221005

**3 HOTEL STREET WARRENTON VA
PROJECT PHOTOS
SITE VISIT JANUARY 23, 2022**

NOTICE OF VIOLATION – INQY 2020-1

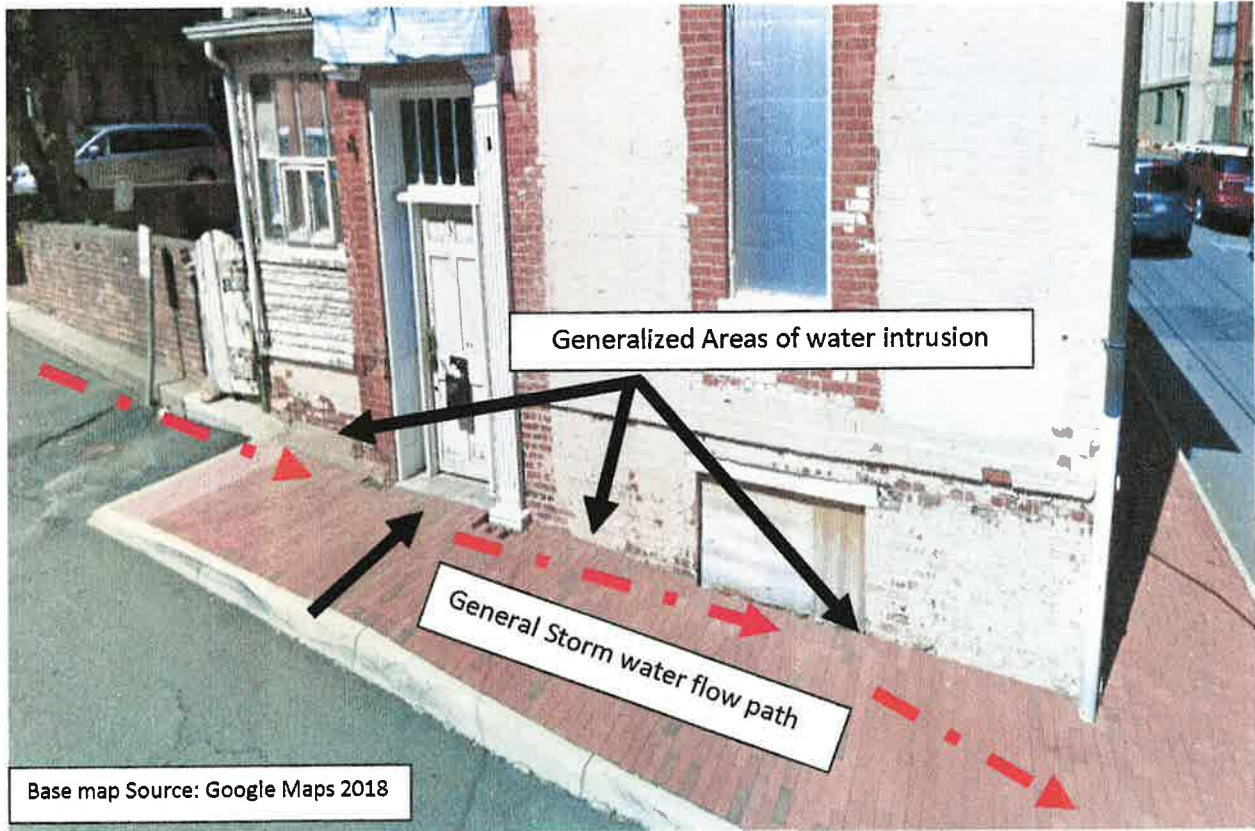
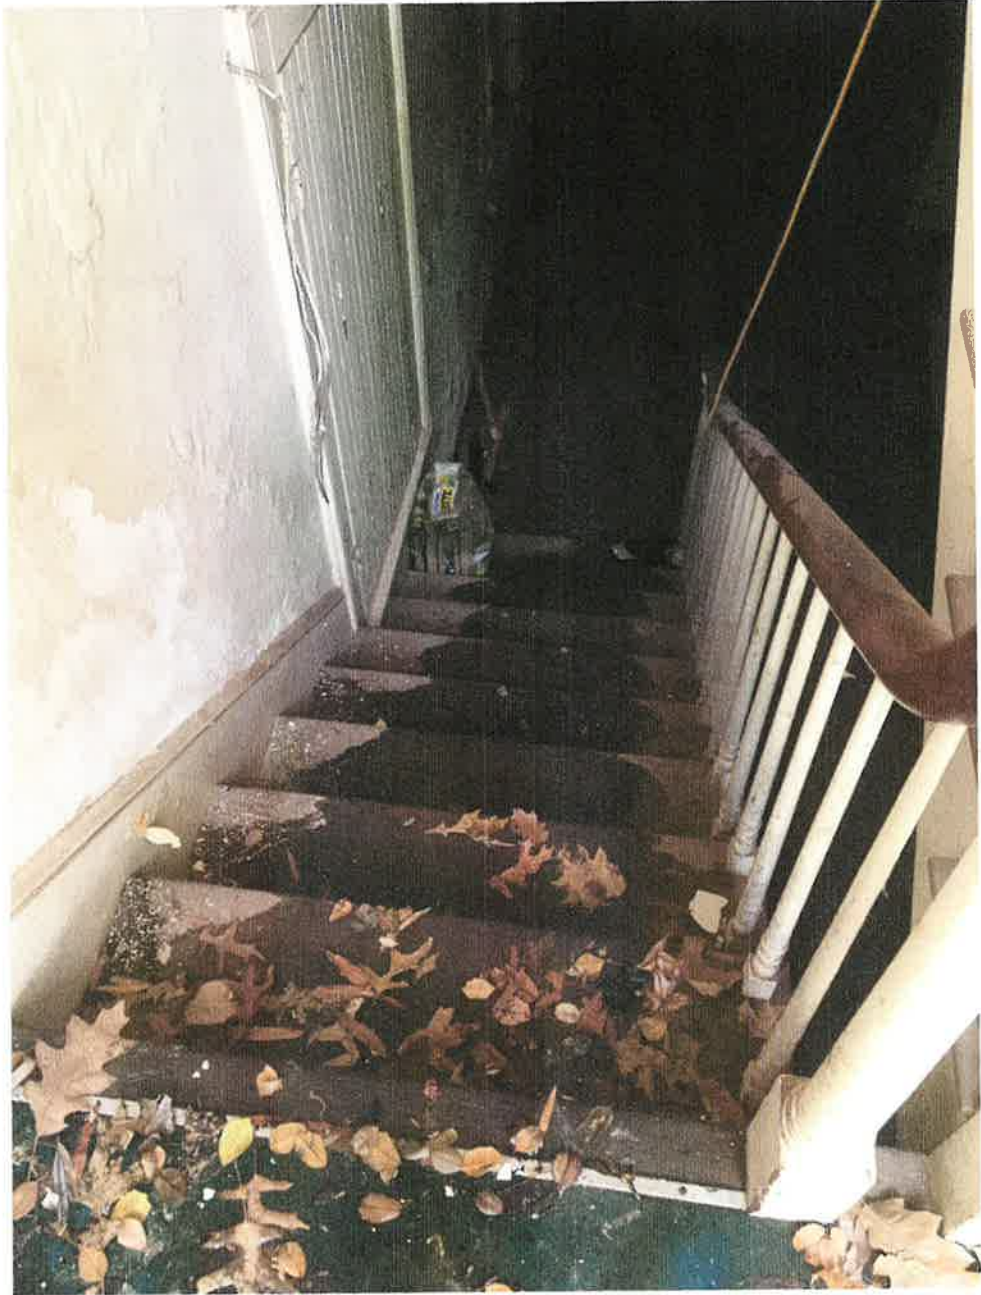
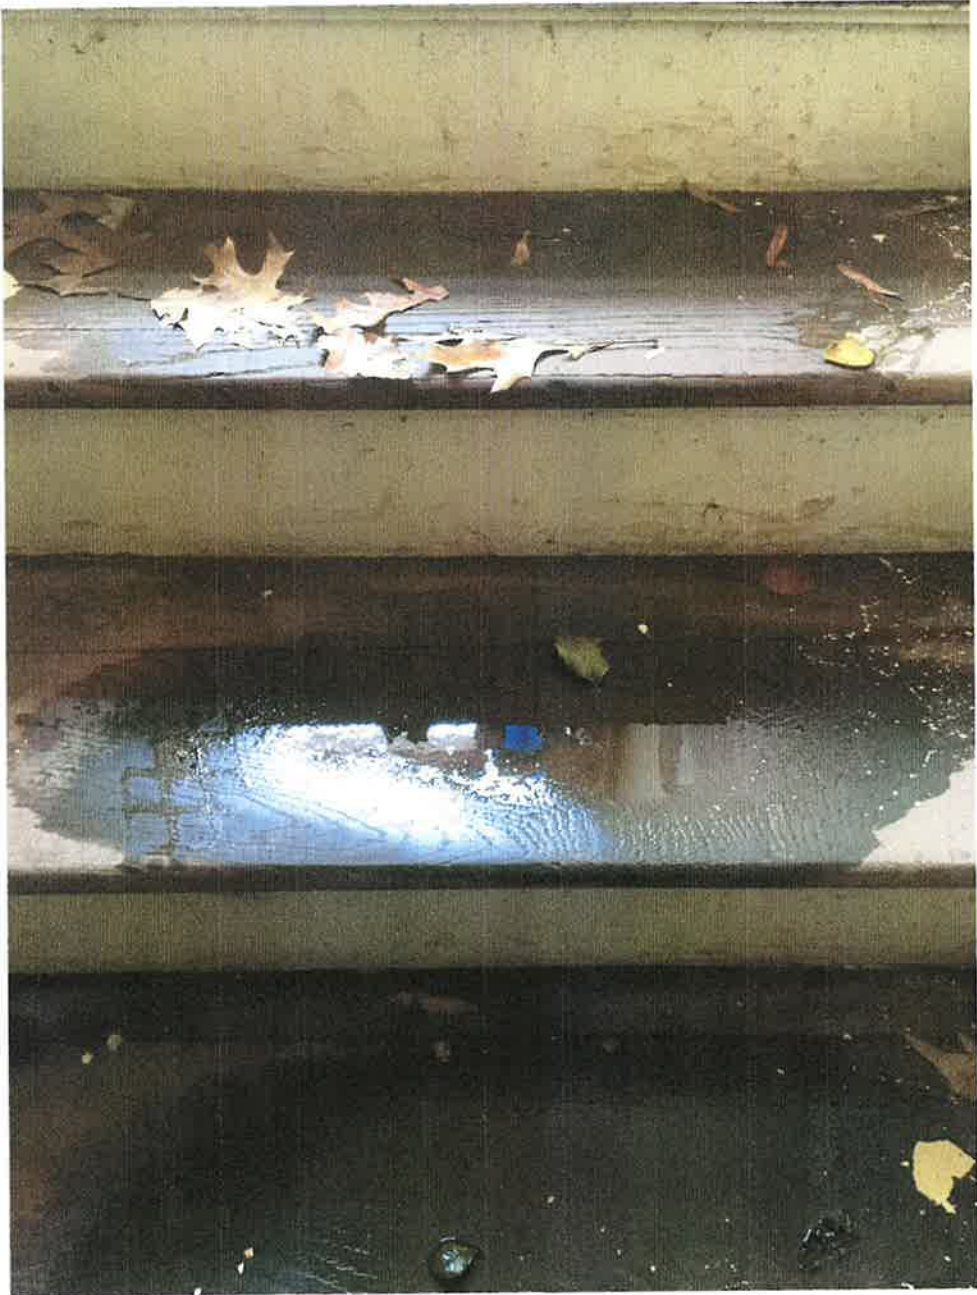
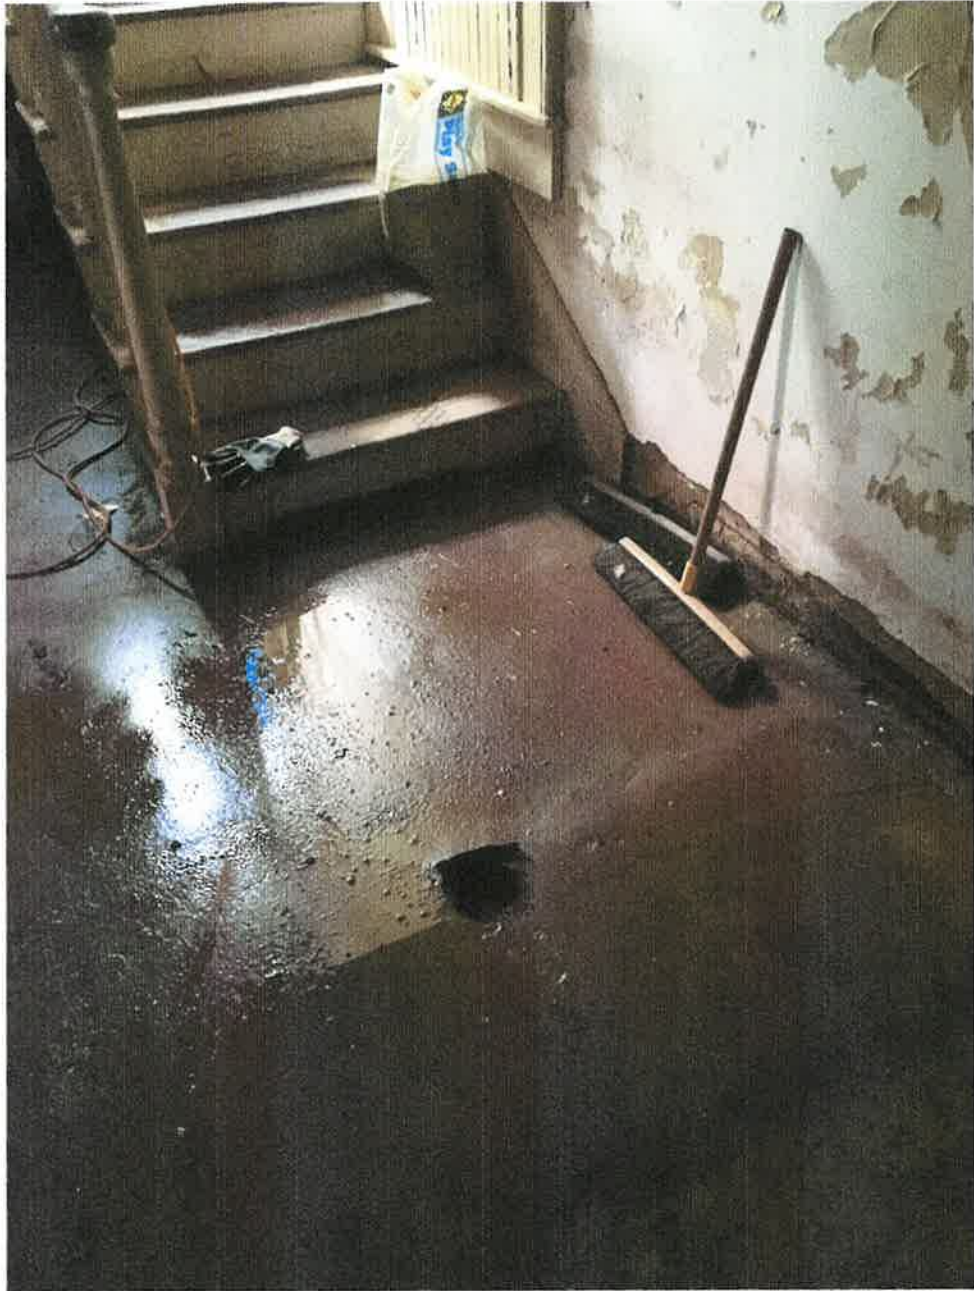
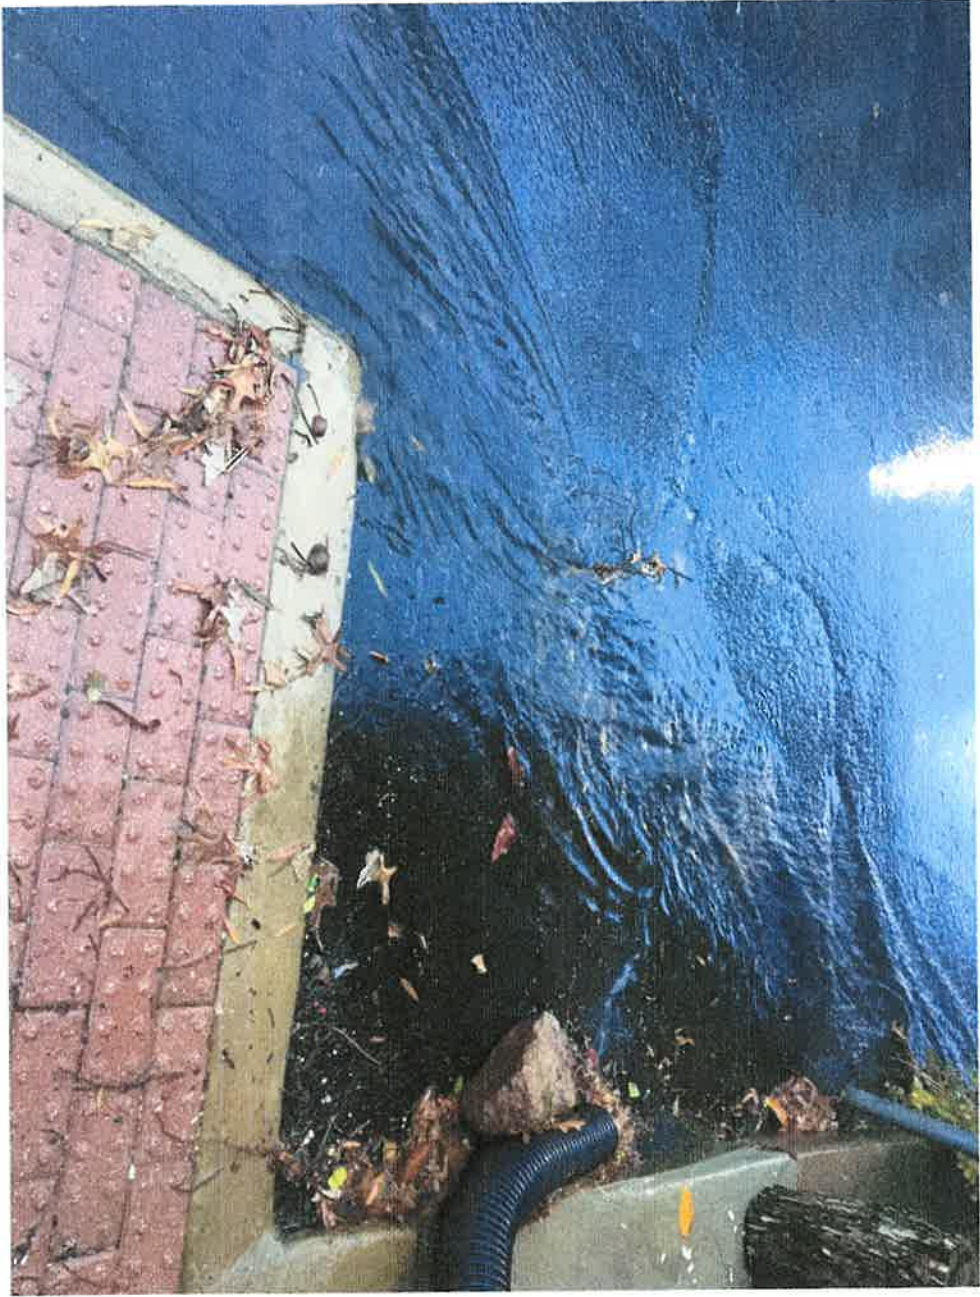
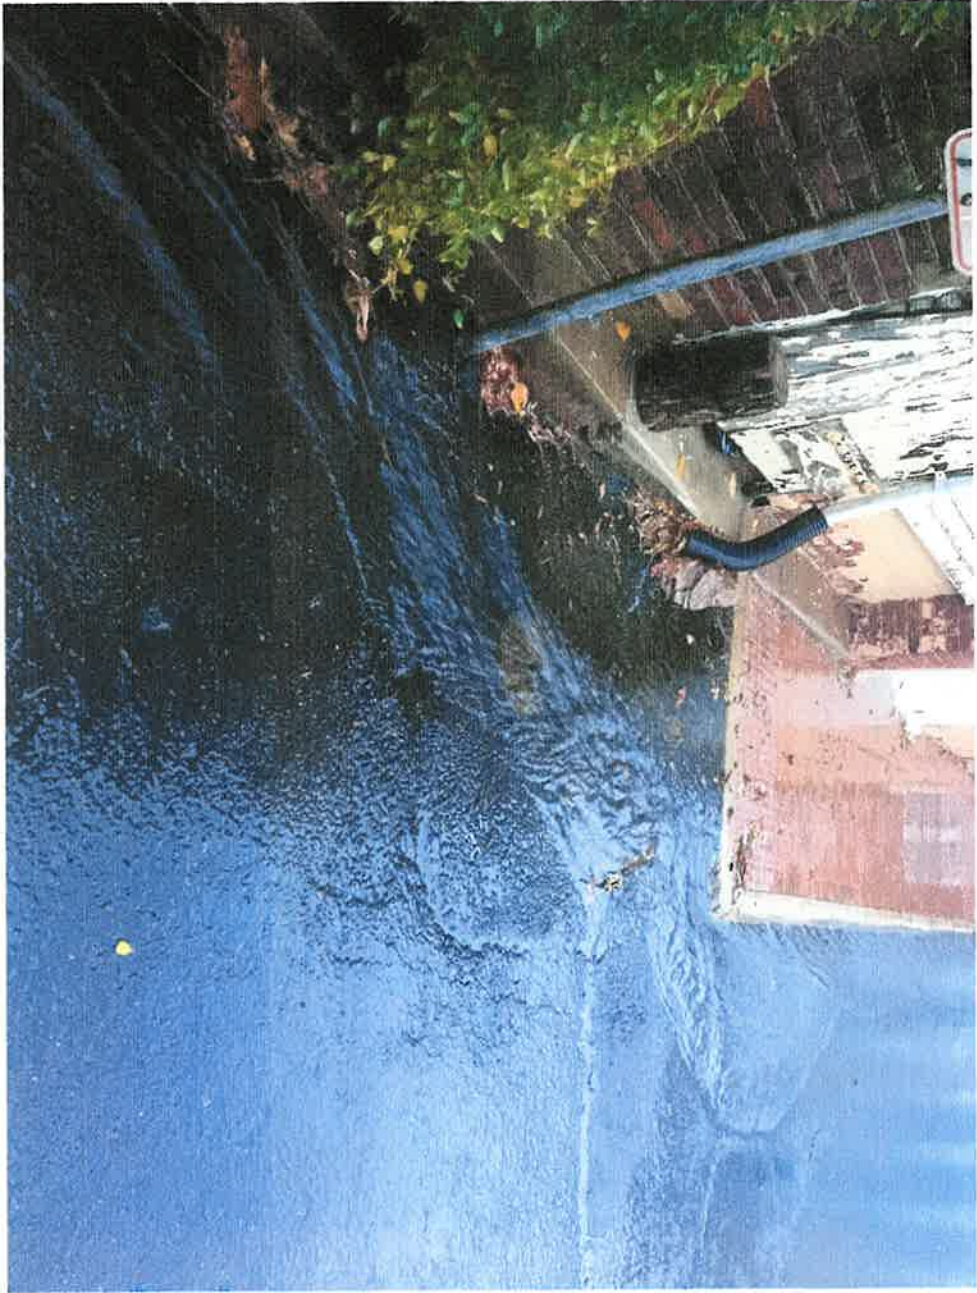
Stormwater does enter 3 Hotel Street in three generally locations; the at-grade stoop, the English (basement) window and at through various points along the building/ sidewalk's grade interface (see attached photos).

There are significant concerns that the continuous water intrusion is having a deleterious structural effect on the basement walls, adjacent wooden beams/joists and, the construction of the sidewalk may have accelerated the rate of inflow.

Diverting the storm water around the brick sidewalk is critical. This may be accomplished with the removal of the existing curb and ramp and installing a higher concrete curb. The installed curb should tie back to the existing curb in the vicinity of the brick wall at the wood fence.

The brick sidewalk abutting the building should be lowered approximately 4" and sloped toward the street to decrease the volume of water flowing against the building. The reinstated sidewalks should be constructed with the maximum cross slope permitted by ADA regulations. The new section should include, at a minimum the installation of a flexible expansive material between the walk and the building to allow for expansion and contraction of the dissimilar materials while providing a 'gasketed' joint at their interface.

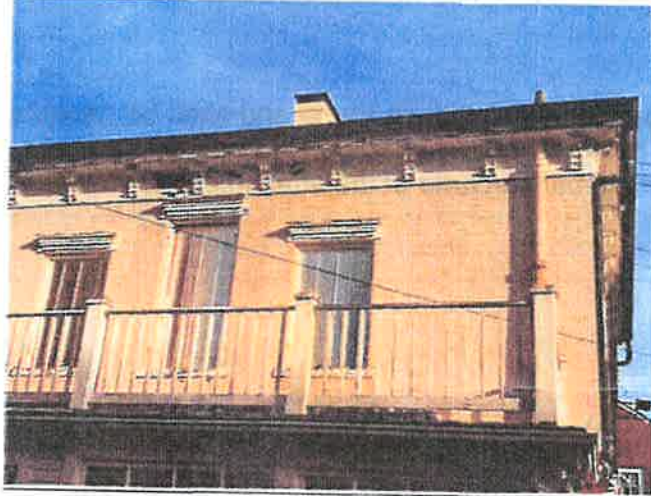
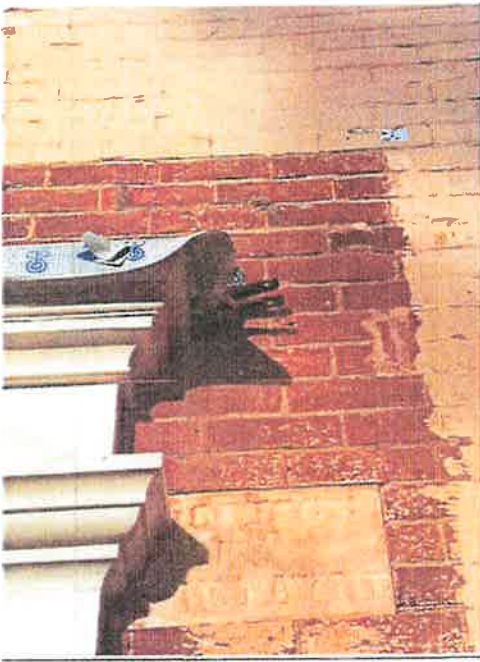
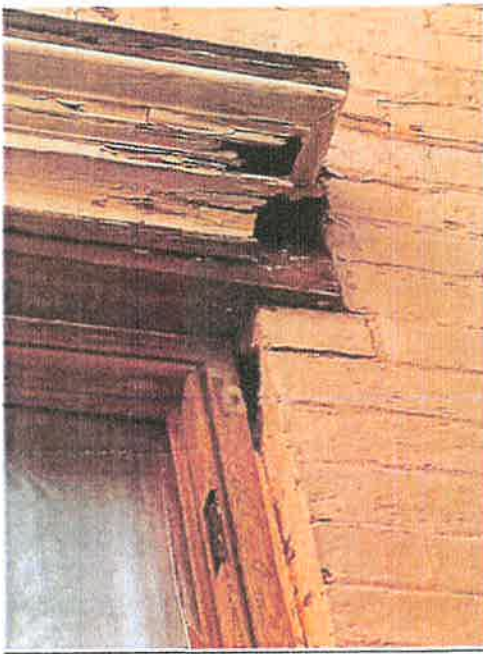
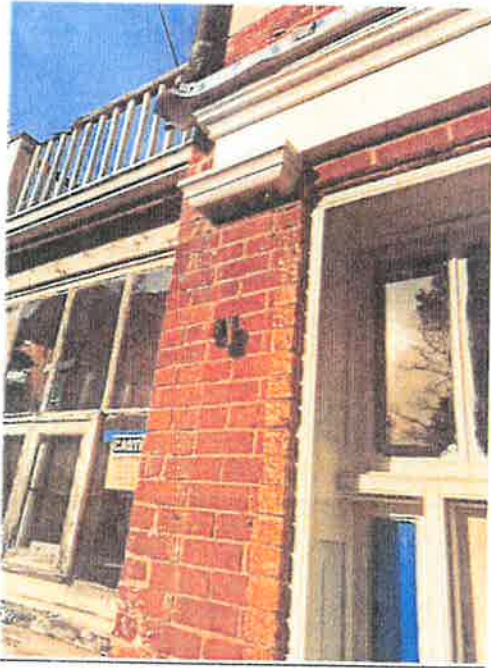
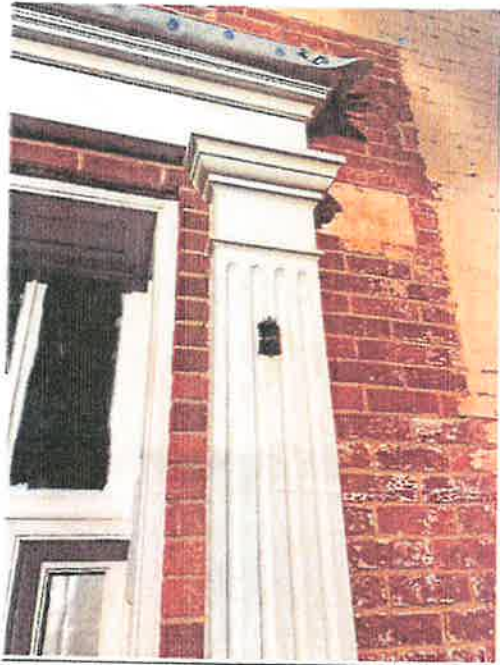
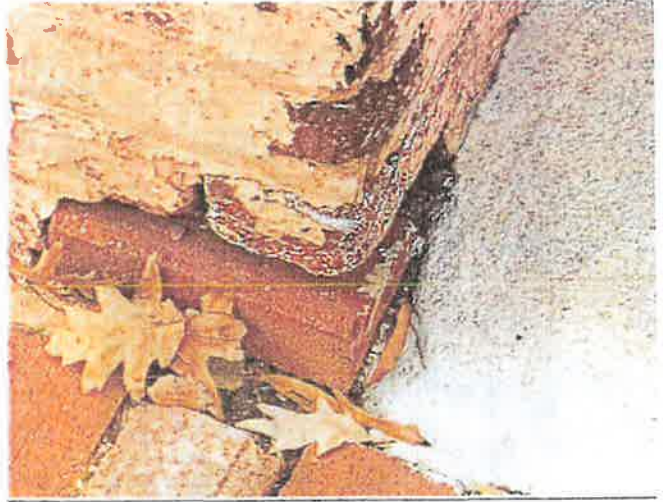
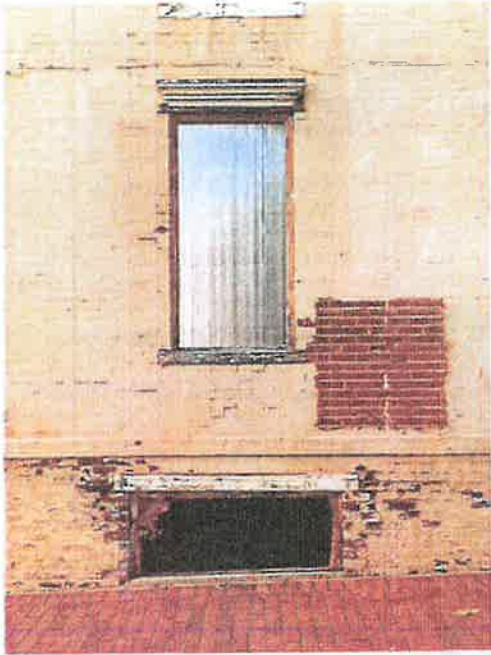
Main Exterior:

1. The exterior of the entire structure on the property shows extensive signs of water damage, exposure to elements, and wood rot. The entire exterior of the structure has peeling paint and spalling of brick and mortar; rooting wood, exposed structural elements including siding; missing broken windows and glazing; decorative features deteriorating. There is spalling along all the walls, exposed and/or missing electrical outlets and fixtures, and exposure to the elements. The overall condition of this property constitutes a nuisance condition.

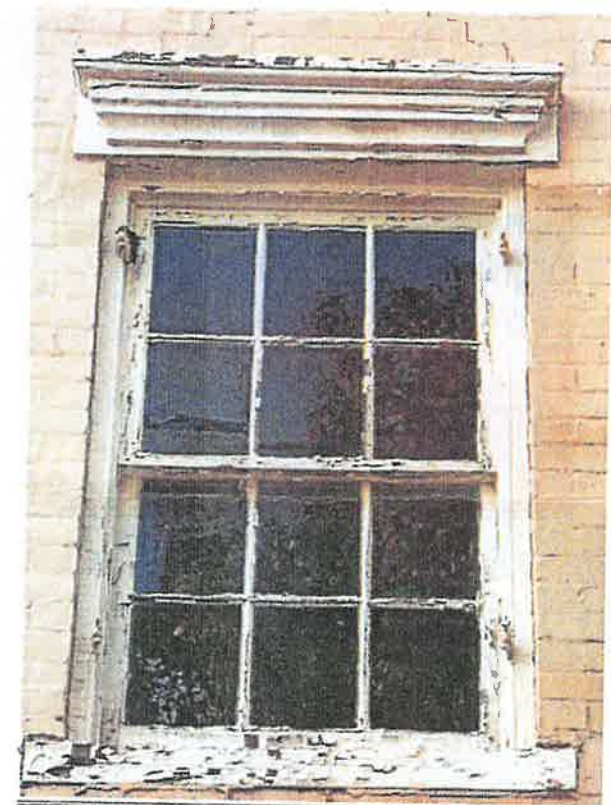
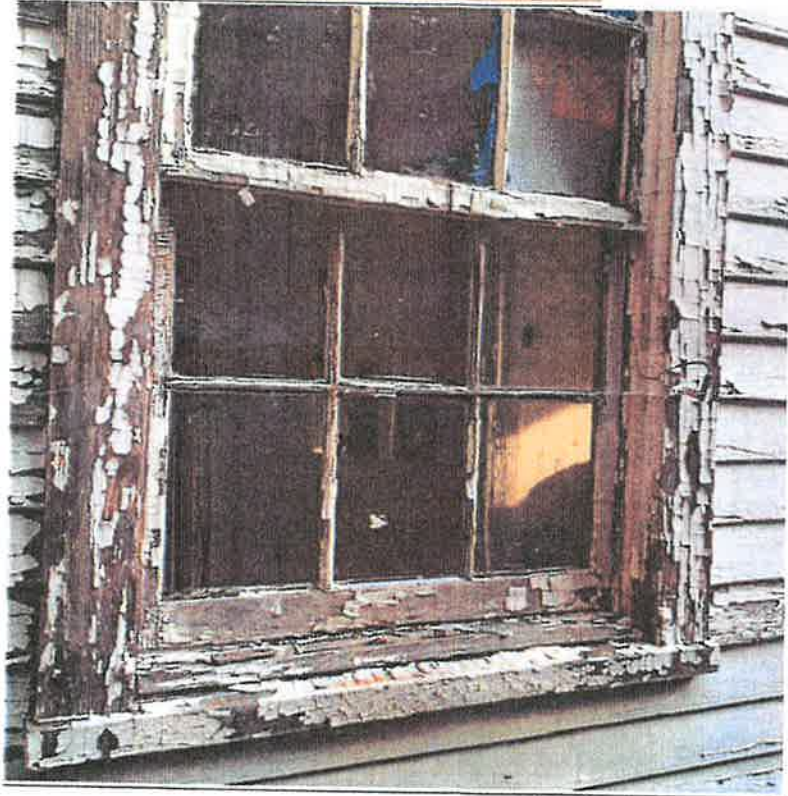
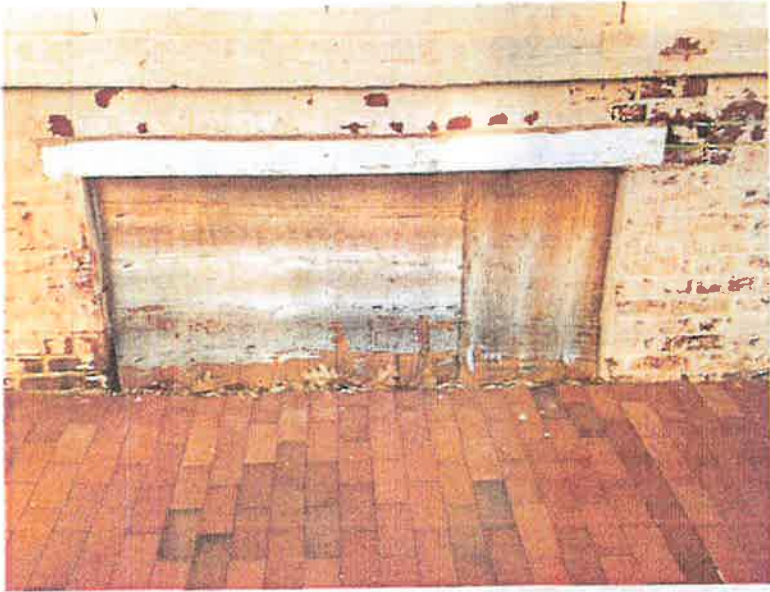
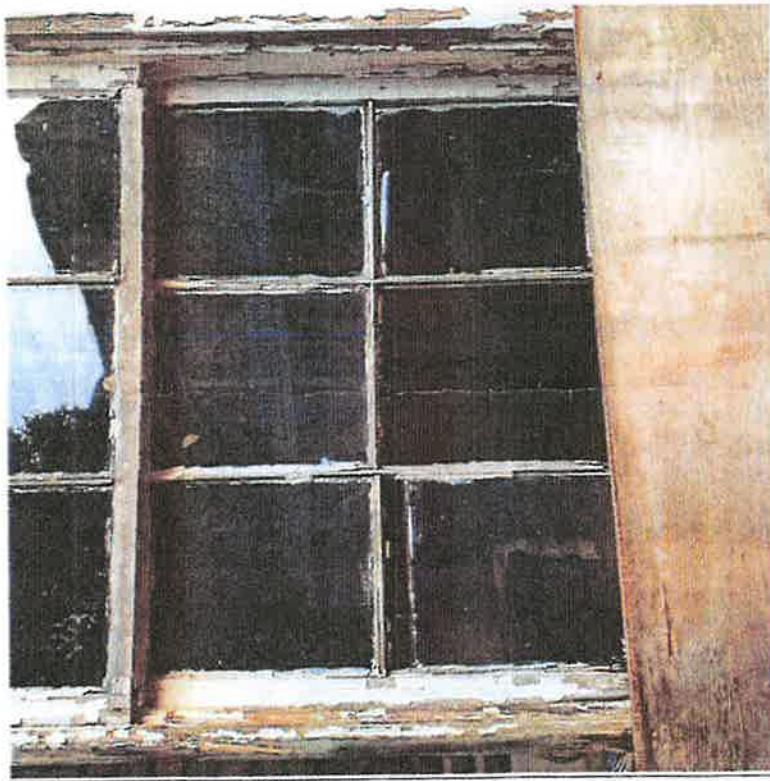
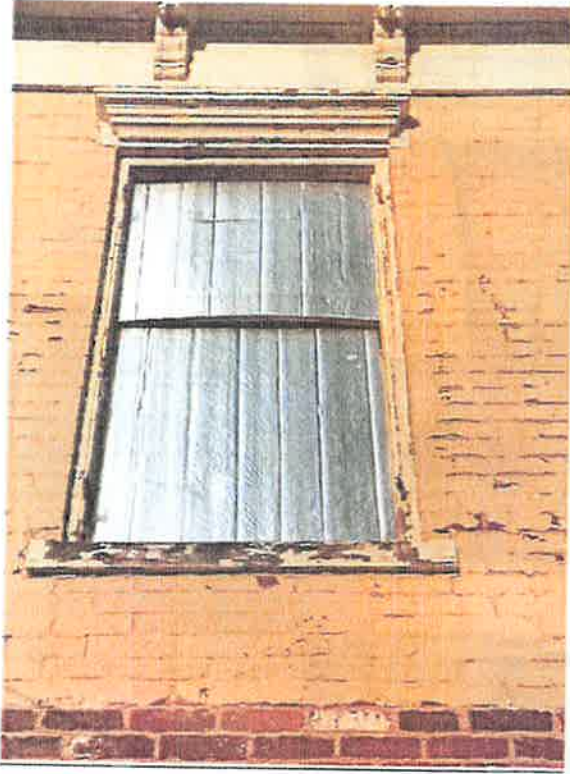
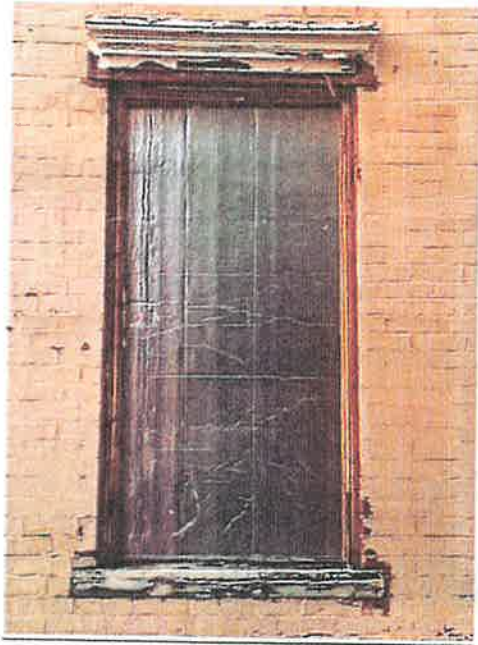
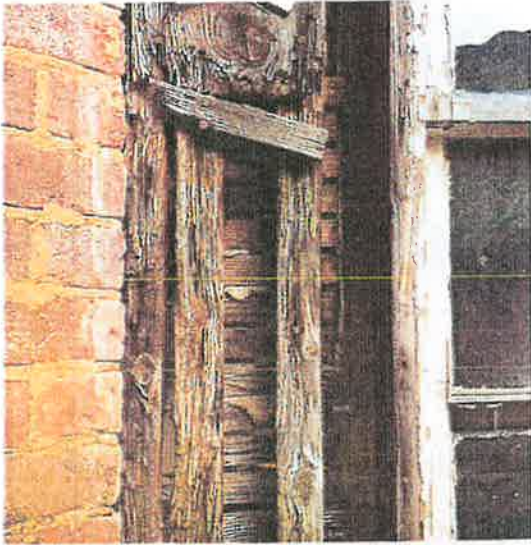
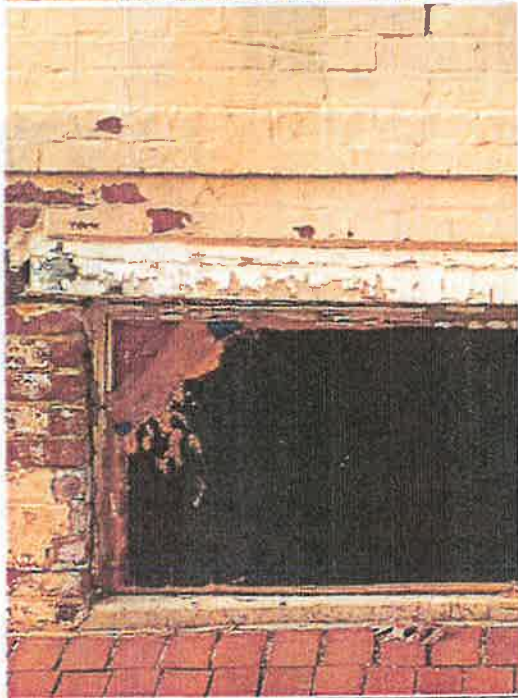
Windows and Doors:

2. Windows and doors are broken, in disrepair and/or have inadequate covers on them which are deteriorating. Broken windows allow access into the structure. Broken lower level/basement windows allow access for rodents and/or other vermin and provide a harborage. Window and door frames have exposed wood showing signs of rot and signs of weakening to the point of failing to support proper loads as designed.

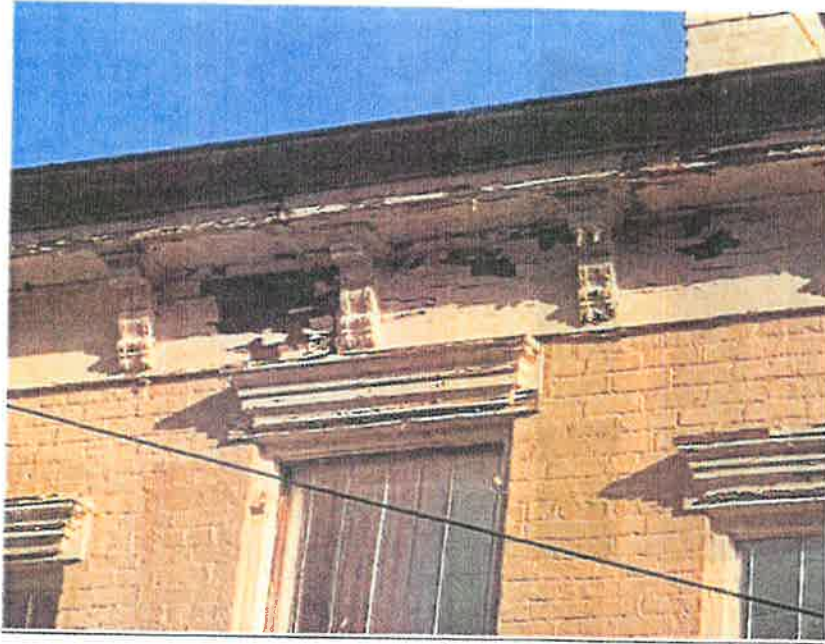
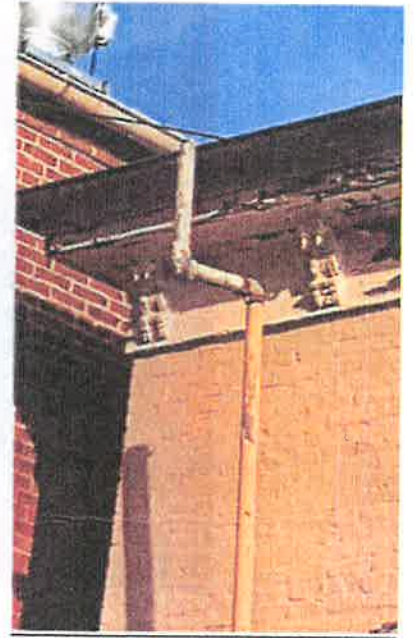
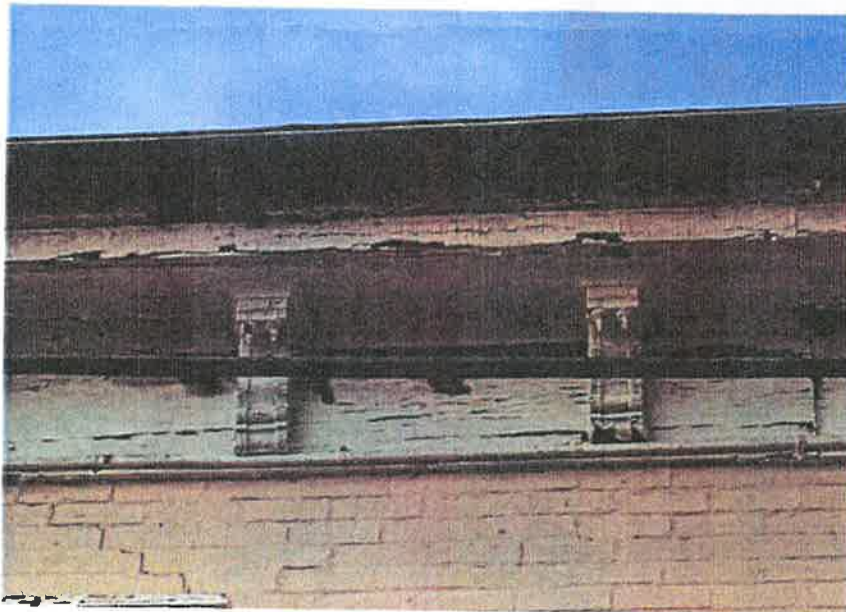
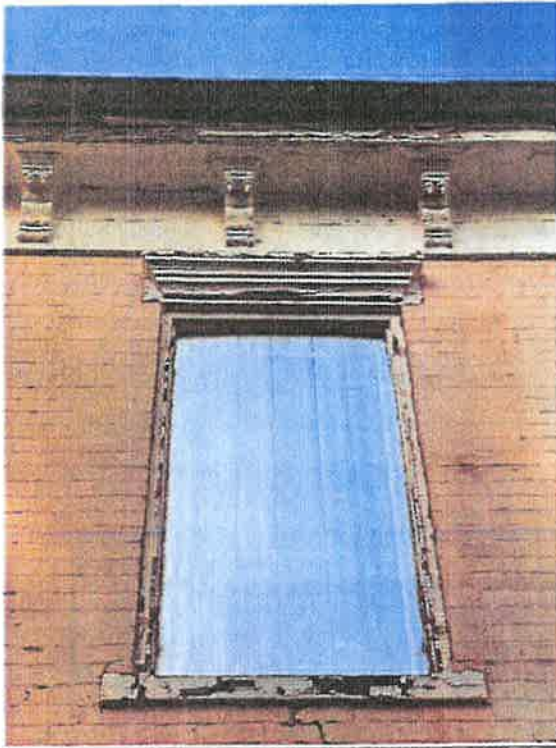
Roof Assembly- Fascia and Soffit:

3. The roof structure is in disrepair from exposed underlayment being improperly installed and/or attached by improper methods like clamps to the entire fascia and soffit assembly in disrepair with rotted wood, water damage from intrusion, peeling paint and failure.

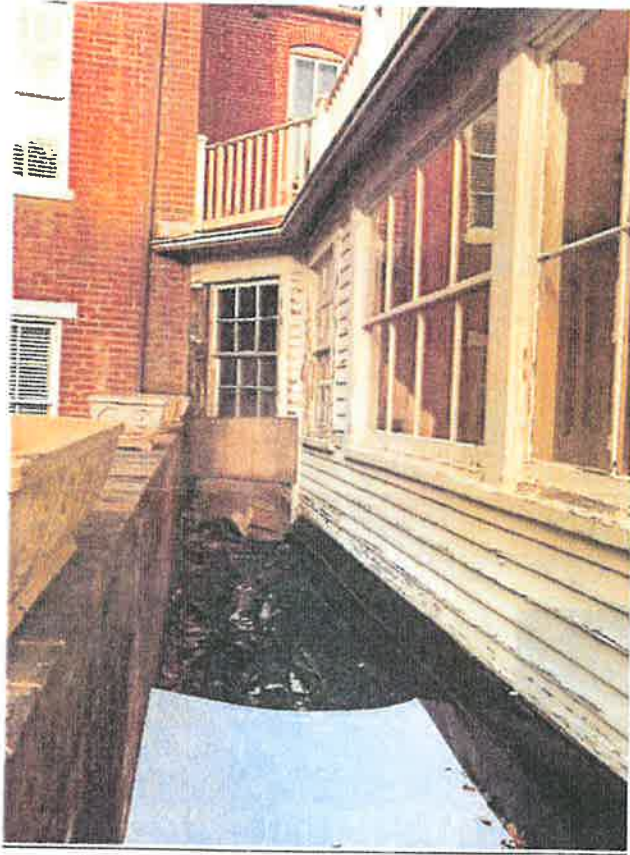
Main Entry Way:

5. The main entrance ground level walk way to the structure from Hotel Street is covered by a tarp. The access way contains debris and materials creating a nuisance. The walls are in disrepair with peeling paint and exposed wood siding and rot. The main door is inoperable and is semi-boarded with exposed plywood. The door is in disrepair. The window is broken and allows a view into the structure.
6. The limited view of the interior shows extensive water intrusion, peeling paint; walls in disrepair and inhabitable spaces.

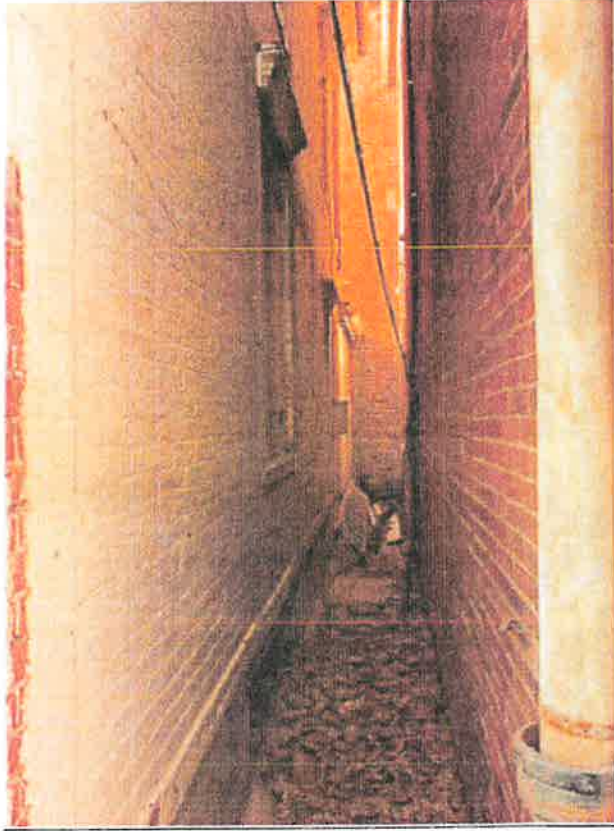
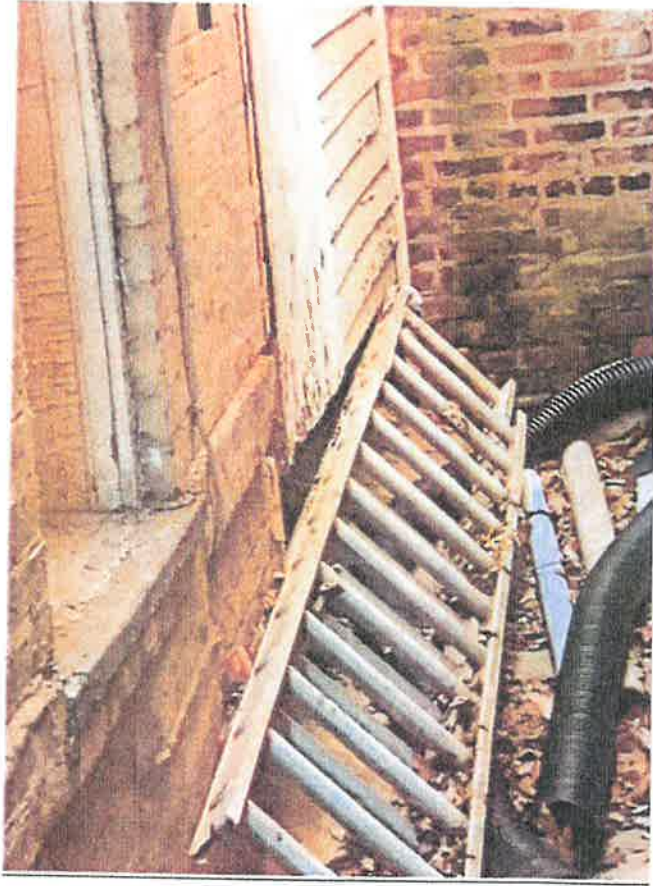
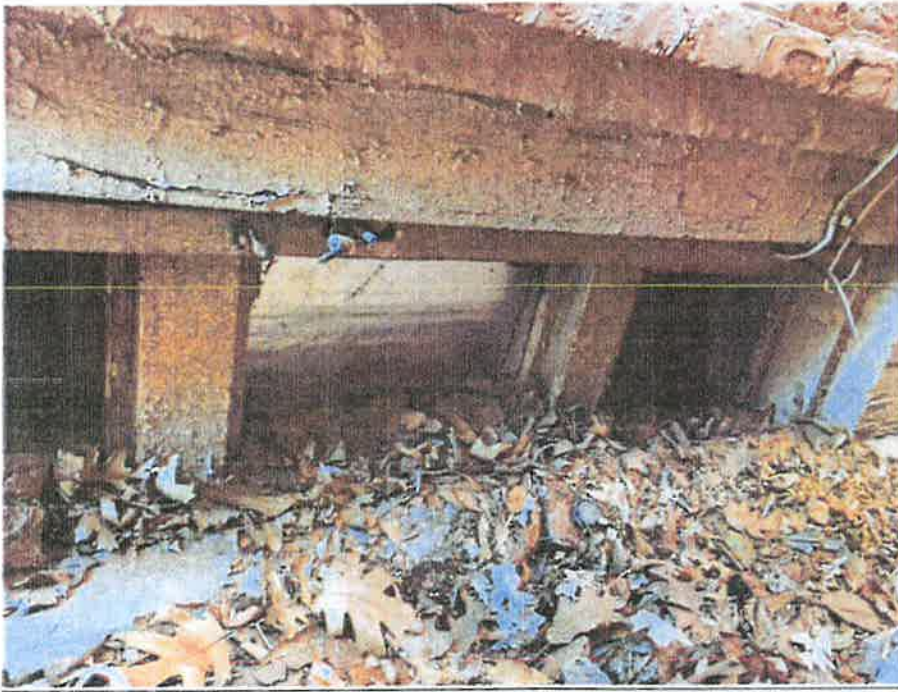
Space Between Buildings on Culpeper Street:

4. The area between structures on Culpeper is not being maintained. This area contains trash and debris. The windows along this area are in disrepair and open allowing harborage and entrance into the structure. The exterior walls along this area are consistent with the other exterior walls showing extensive paint peeling and other deterioration of wood and brick.
