Warrenton Horse Show Observations

WHITMAN, REQUARDT AND ASSOCIATES

MONDAY, 3/20/2023

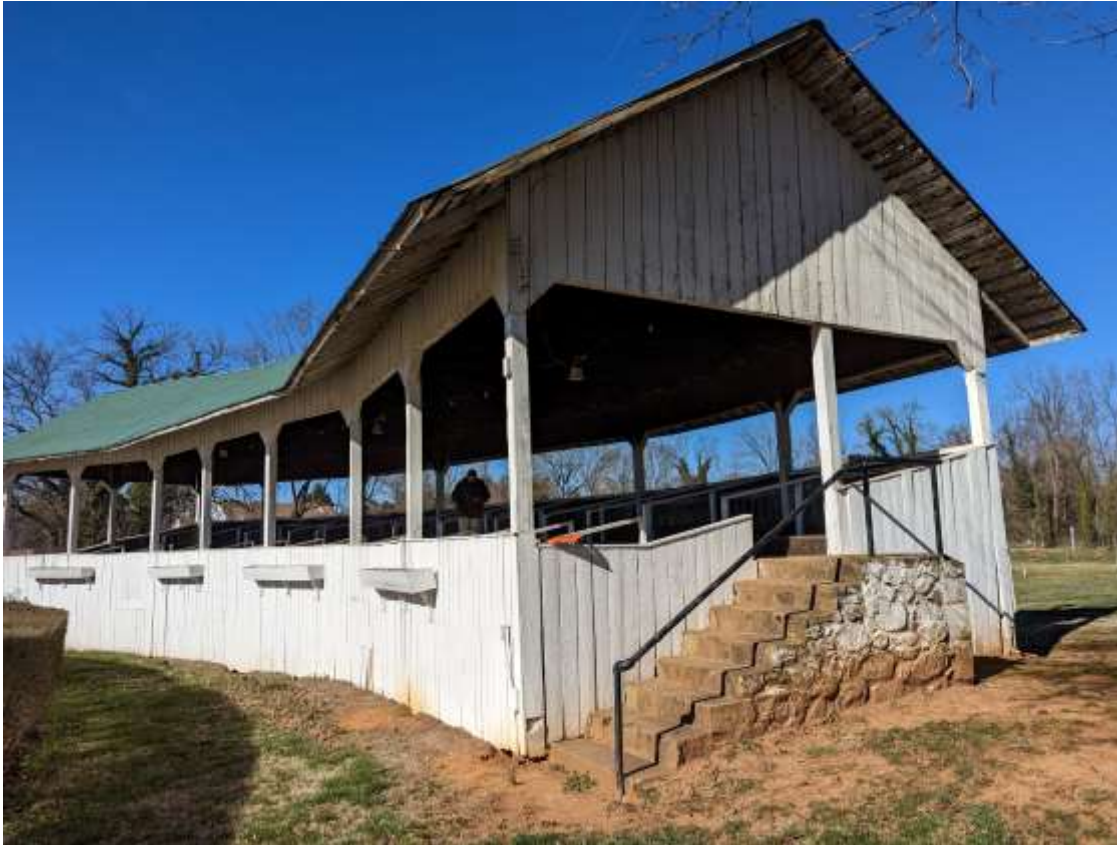
- Grandstand wood structure appears to be in fair condition based on initial observations.
- Significant issues observed at concrete piers.
- Existing wooden structure with metal roof and stone staircase.
- One point of egress on north side of structure.
- Uneven walking surface for seating area.

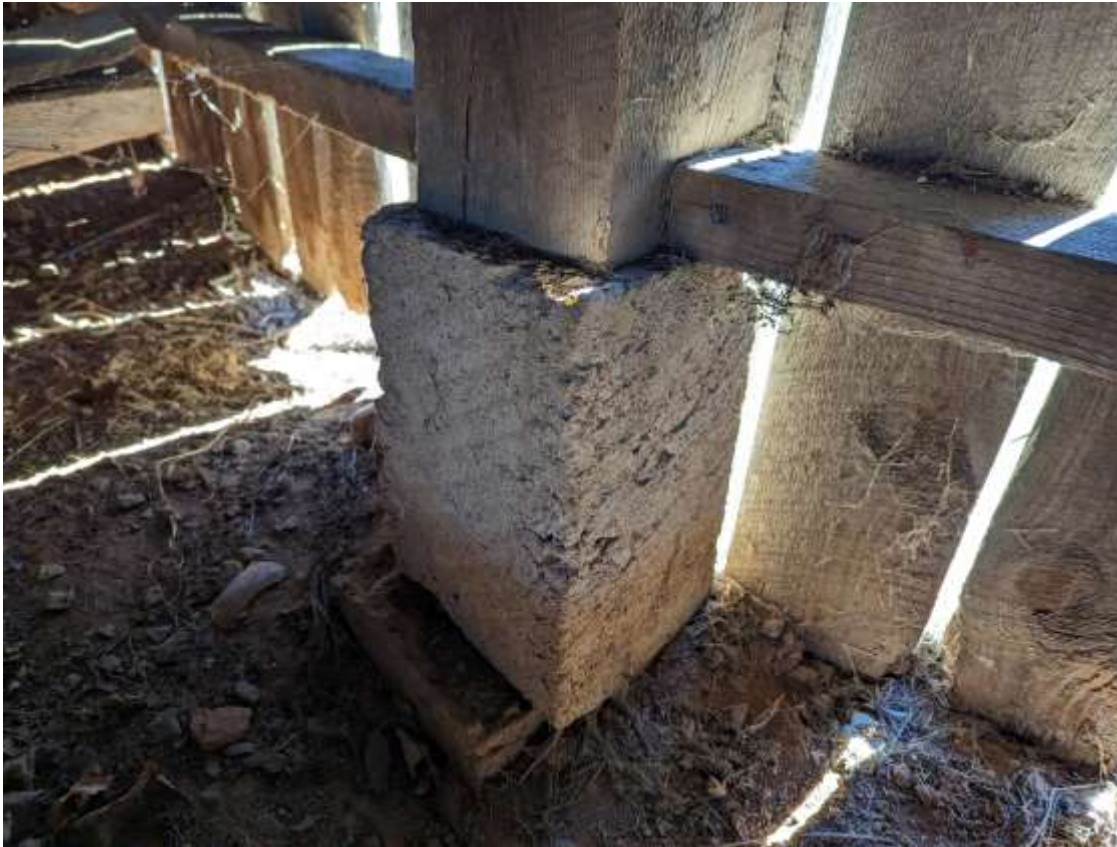
Pier Issues

- Complete shear failure observed at one pier
- Load carrying capacity is significantly impacted.
- Steel reinforcement most likely not used in construction.
- Quality of concrete is questionable due to smooth aggregate used in mix. Structural concrete uses angular aggregate.
- Not evident how some wood posts are connected to the pier.

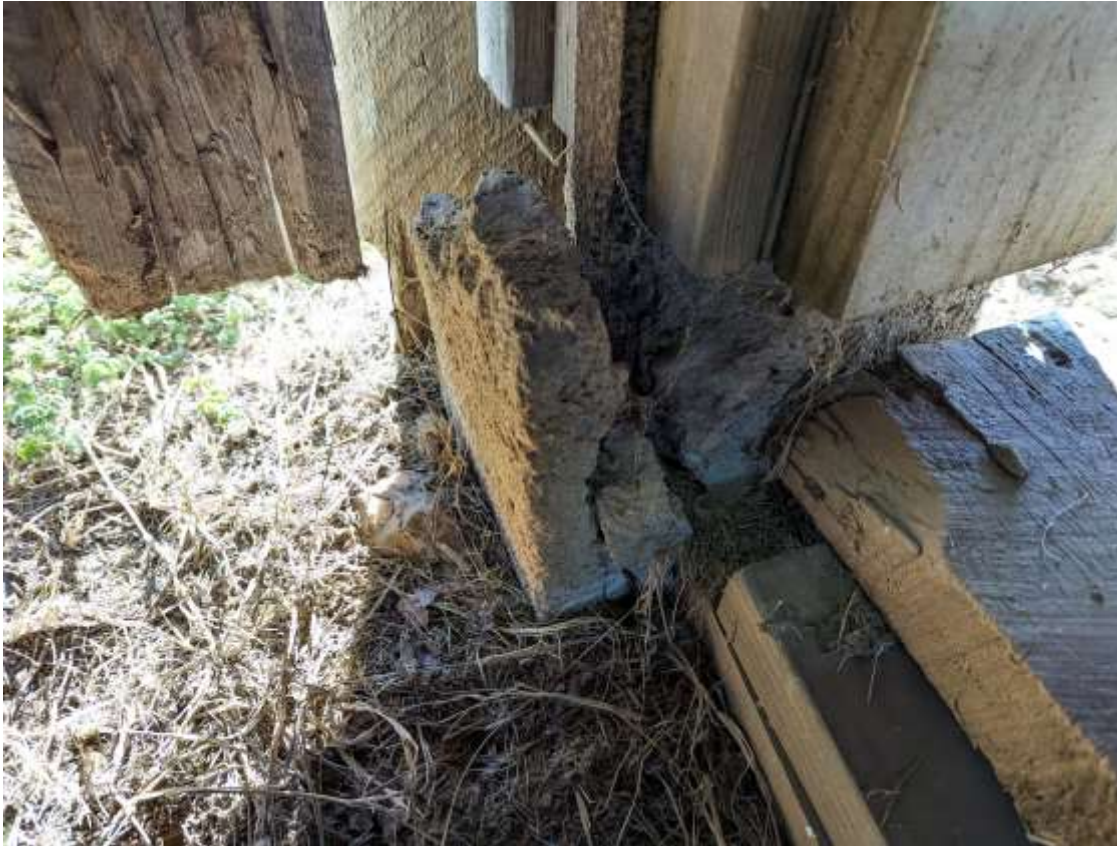
Pier Issues

- Wood post connected to pier with metal plate
- The metal has rusted over time and cause expansion.
- The expansion has caused the pier to spall.

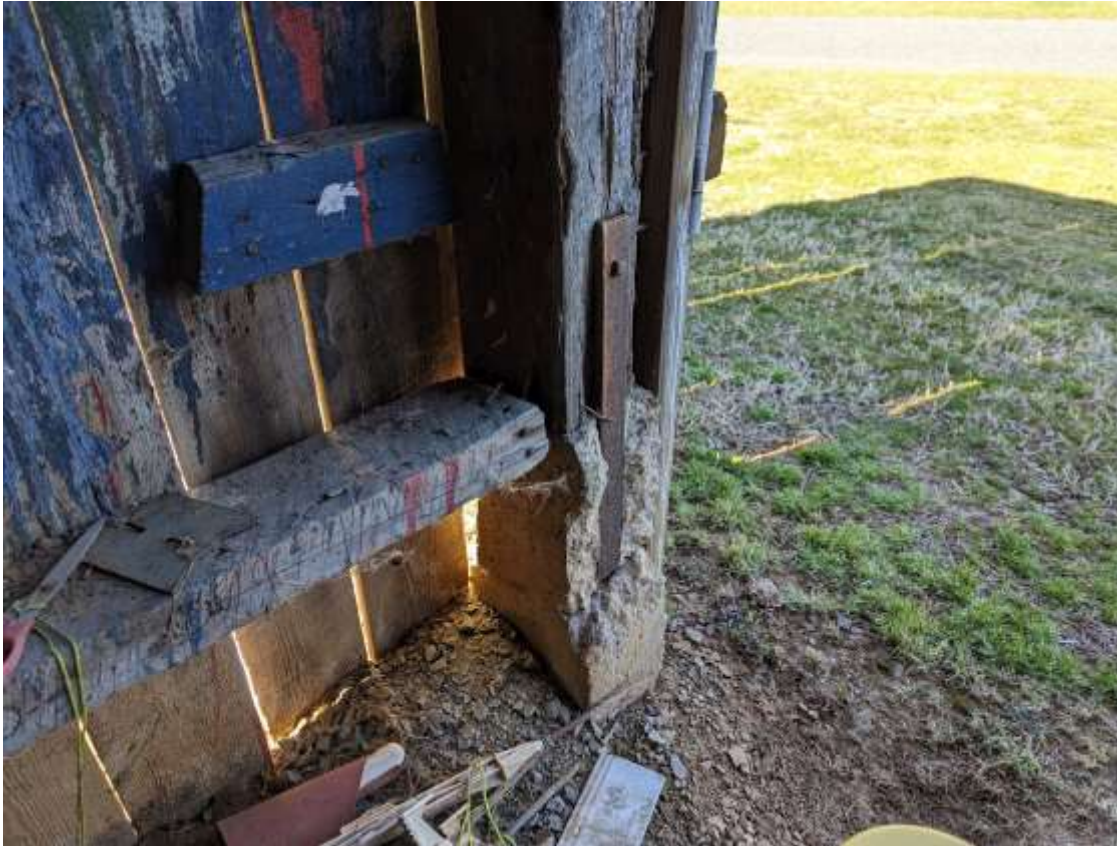
Pier Issues

- Metal strap connecting to wood post
- Spalls where the plate was embedded in pier

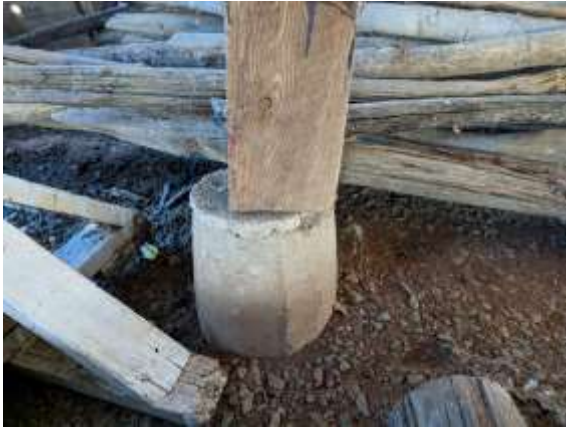
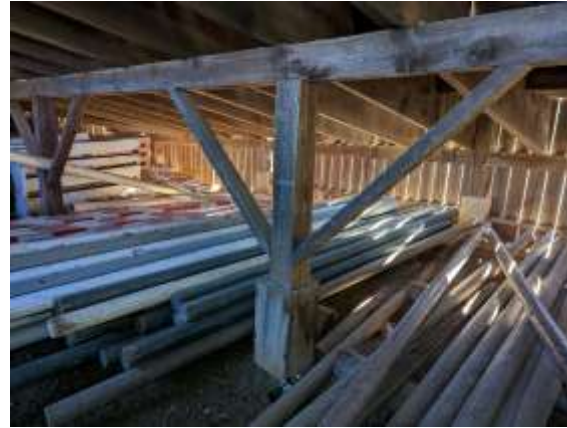
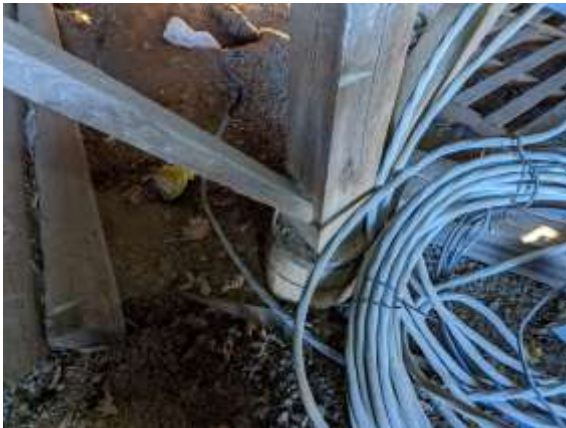
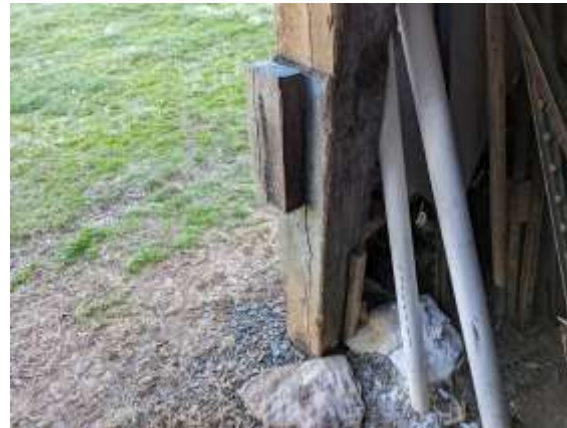
Pier Issues

- Various pier types
- Posts off center of piers
- Unknown shape and size below grade.
- Connection to pier unknown.
- Further investigation needed:
 - Test pits after storage area has been cleared out.
 - Geotechnical report to establish soil conditions.
 - Recommendations for pier repairs or replacement and construction cost estimate.

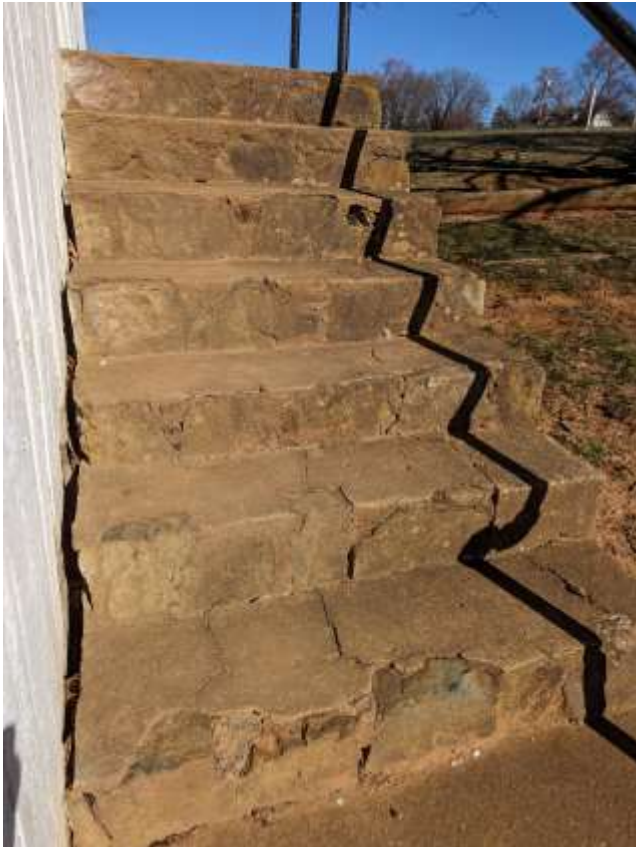
Existing Stair

- Existing stair needs to be replaced based on condition and code requirements.
- Stair consists of stone with a concrete parge coat.
- Riser height is too high and is inconsistent.
- The parge coat on the riser surfaces has signs of wear.
- The railing is not up to code. There are not enough vertical posts and there is no mid-height rail.
- Second stair would most likely be required for egress.

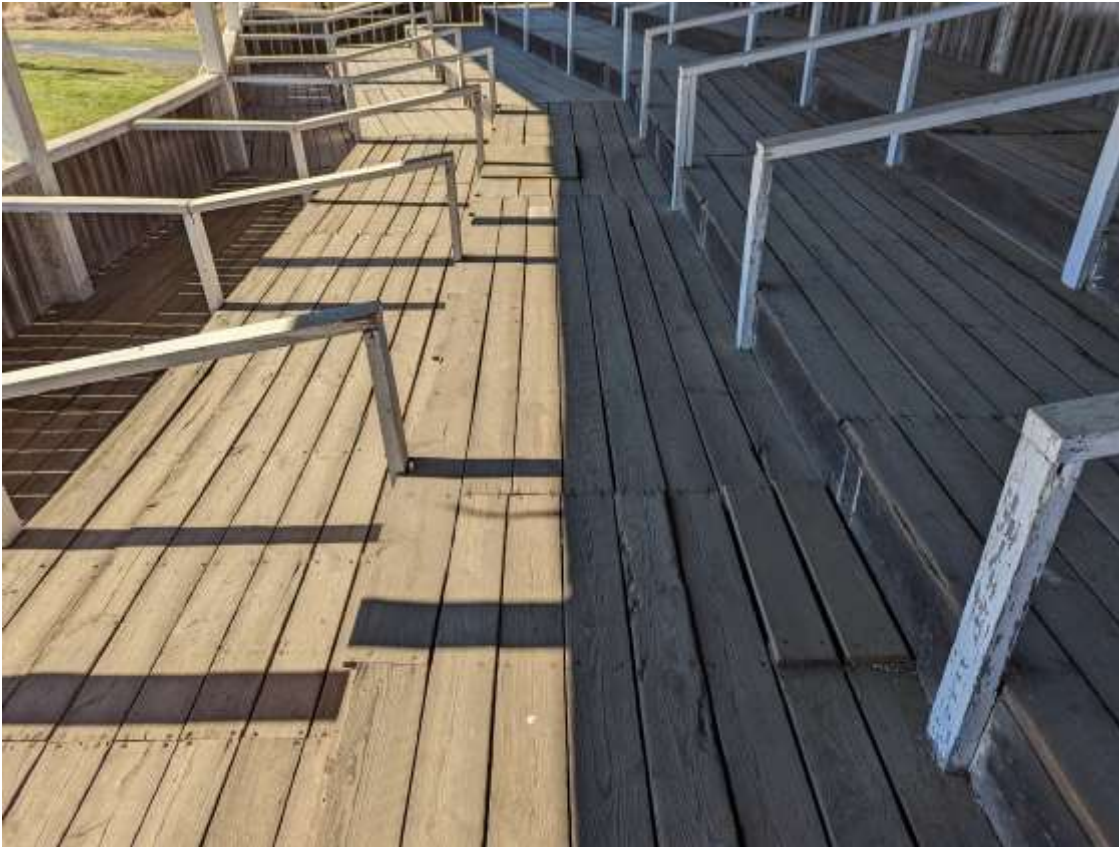
Seating Area

- Uneven walking surface.
- Boards and plywood installed as temporary repairs. These protrude and are a tripping hazard.

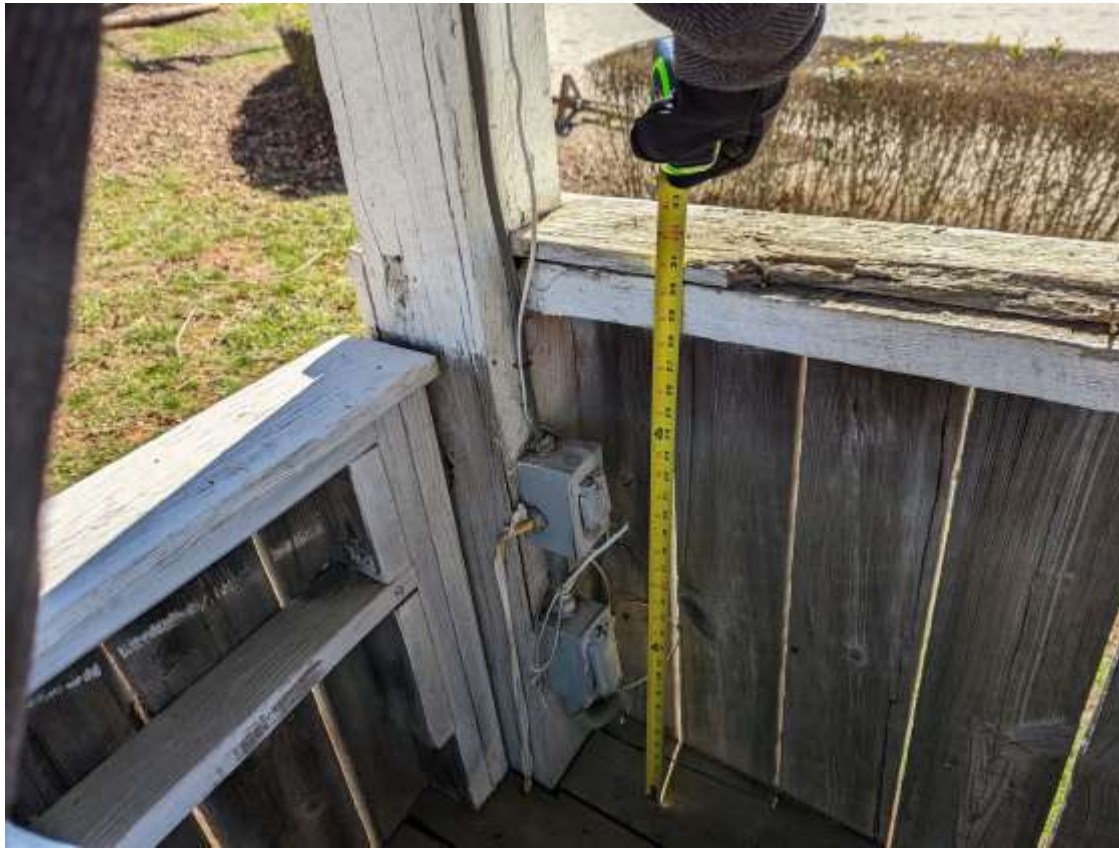
Seating Area Perimeter Barrier

- Need barrier at perimeter of seating area to be 42" for fall prevention
- Existing barriers are approximately 31" and would need to be extended.

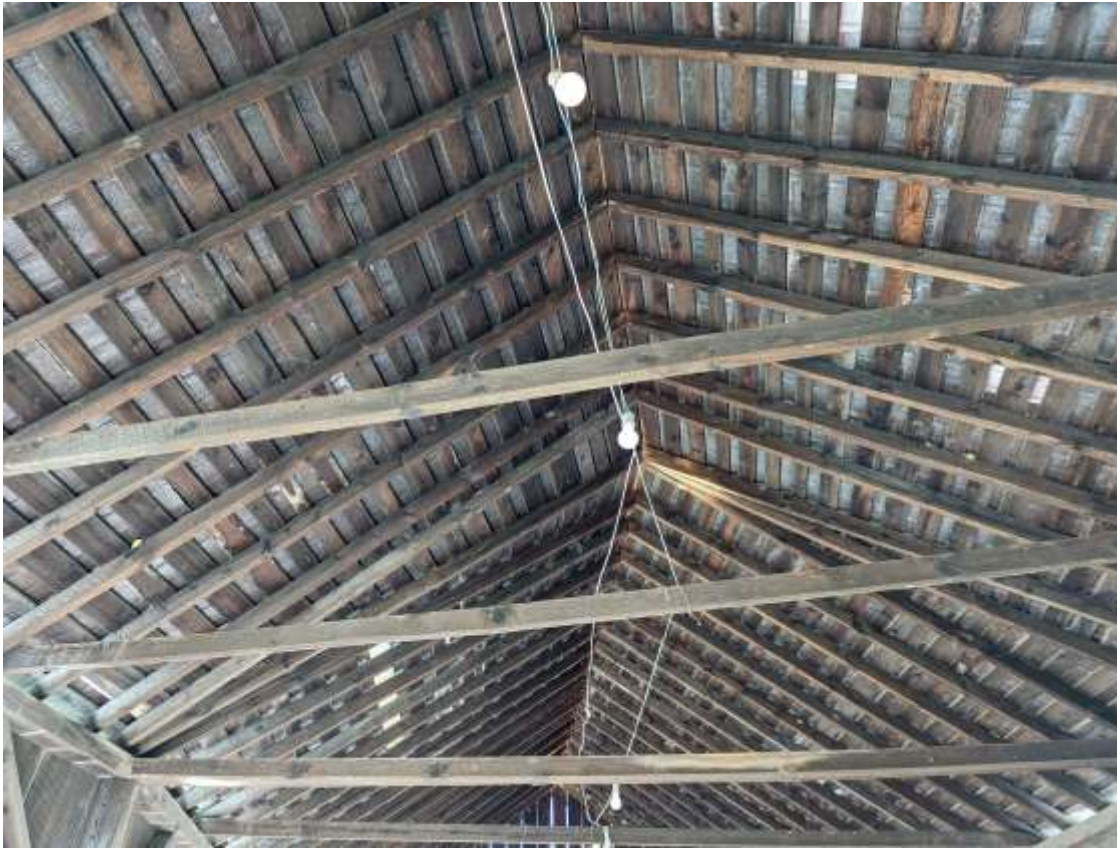
Roof Framing

- Metal roof needs further investigation.
- Lighting may need to be upgraded for egress requirements.
- Modern connections at rafters would be beneficial.

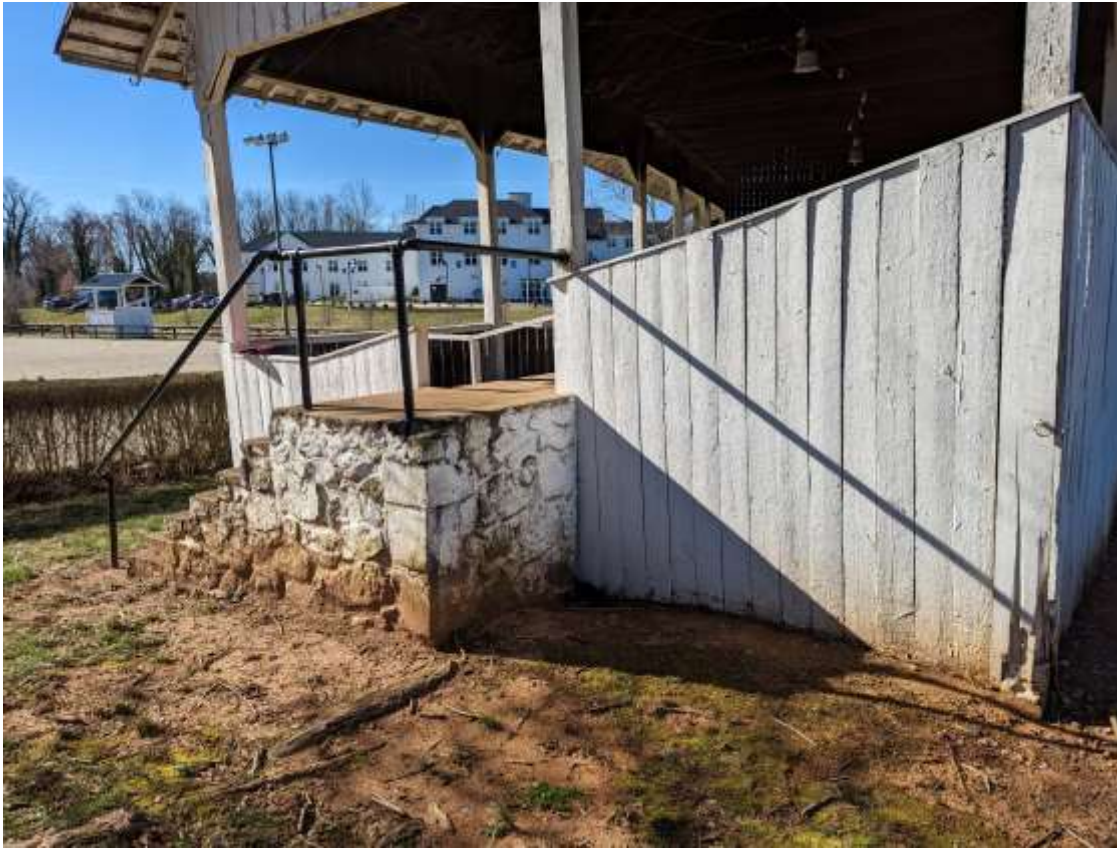
ADA Access

- Based on existing landing height, new ramp would be approximately 55' in length.
- A sidewalk and handicap parking area leading to ramp would be required per ADA requirements.
- As an alternative, a new ADA seating structure could be provided.

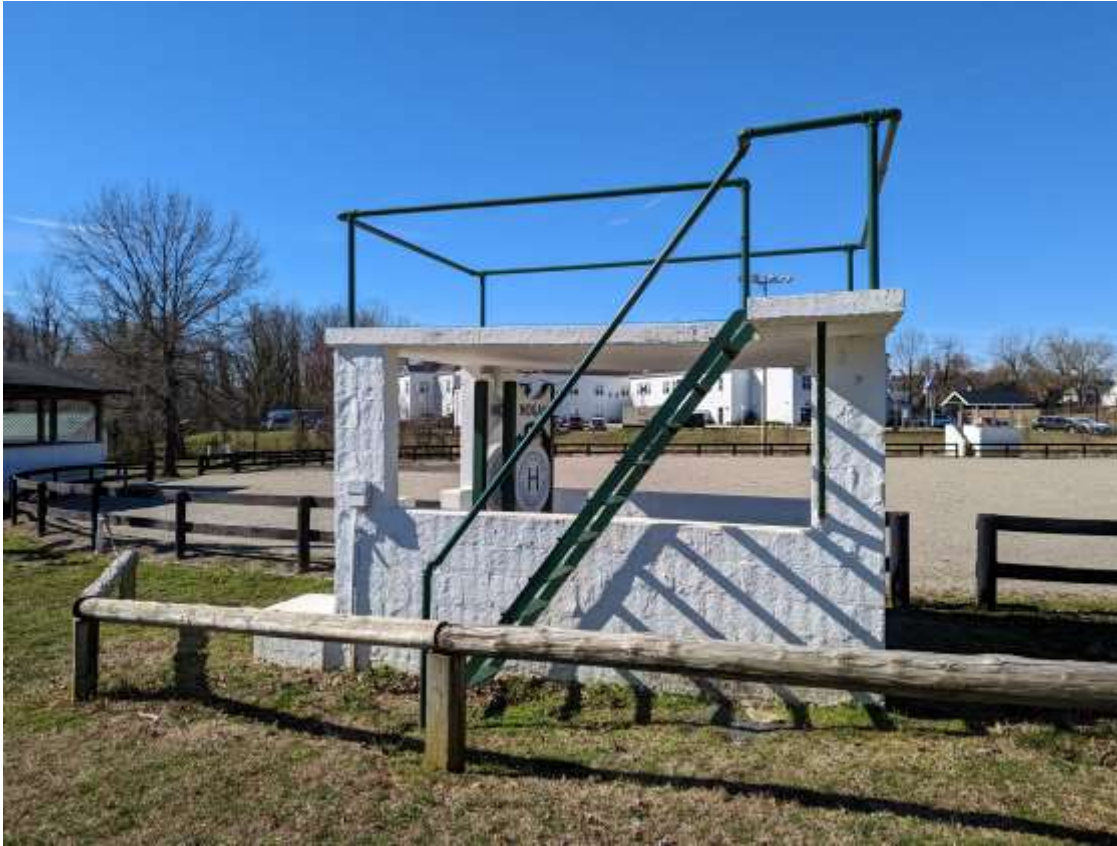
Patsy Cline Memorial Pavilion

- Existing structure appears to be in fair condition based on initial observations.
- Current condition of roof slab does not pose any immediate concern as long as roof is not occupied.
- Existing stair and railing do not meet code.
- If desired, roof slab replacement can be performed.
- If stair is to remain in place, a new barrier is recommended for the back of the structure to prevent access to the stair.
