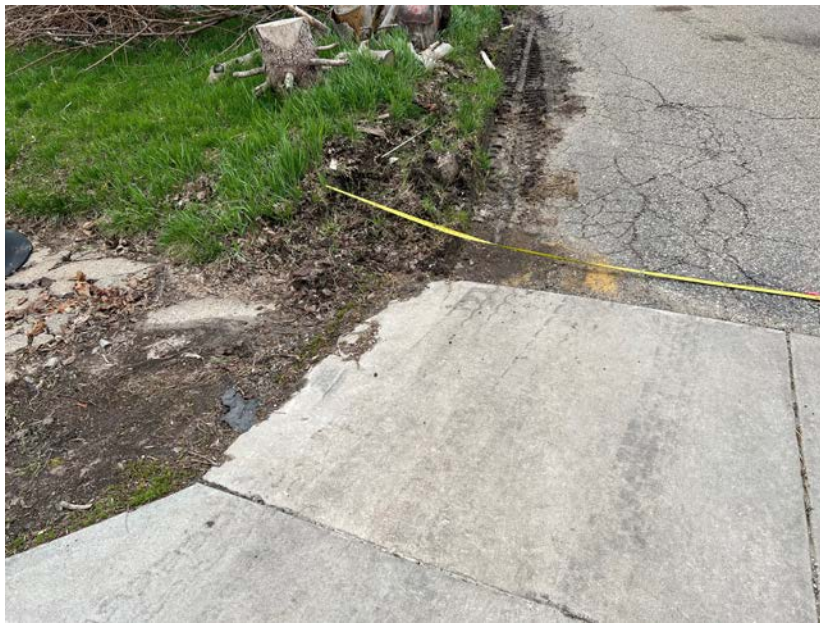
Alley entrance from Ruth Street. Iron placed by Professional Land Surveyor on right side of photo

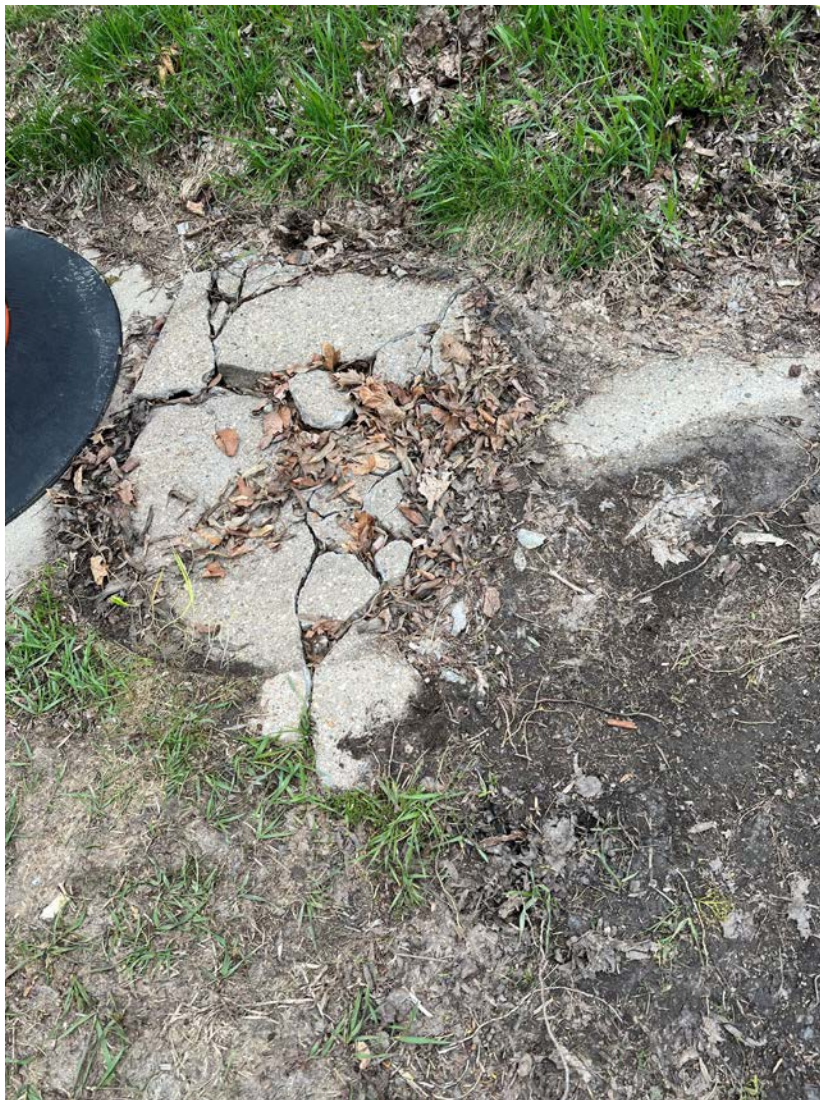
Broken concrete north of Alley entrance

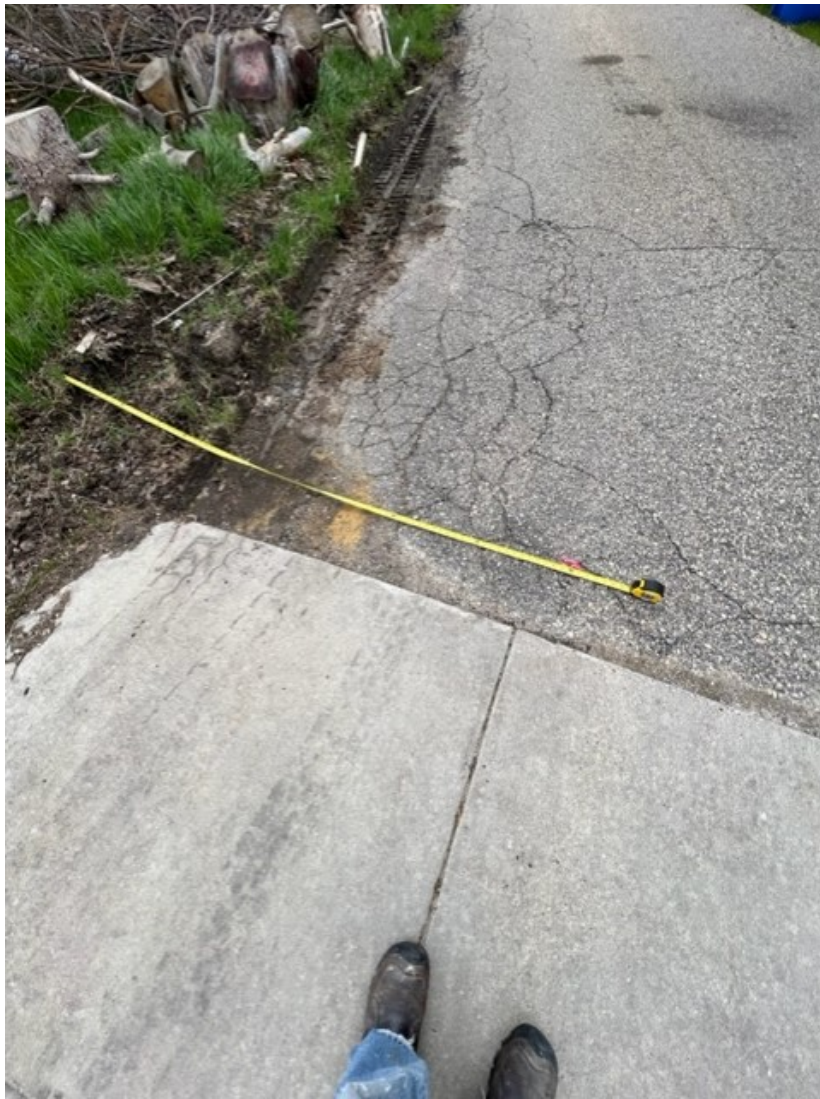
Suspected alley
encroachment, rutting
