# **Watertown Rock River Seawall**

## **Wall Condition Assessment and Feasibility Study**

**City of Watertown  
Watertown, Wisconsin**

**July 2026**

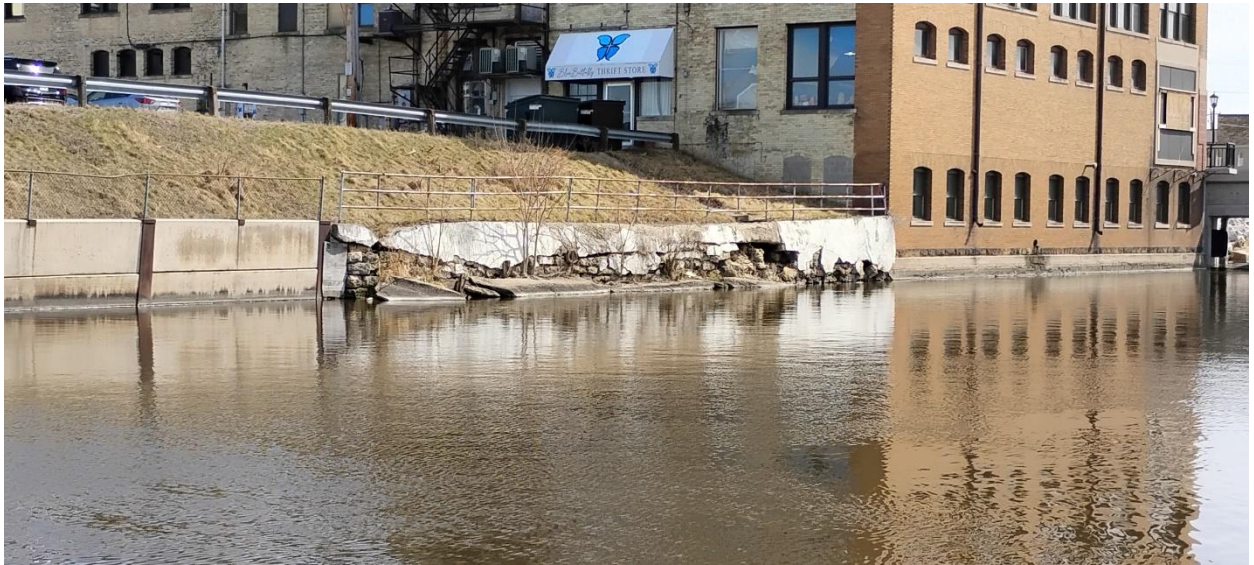
**Figure 2. View of Section A looking southeast.**

Section A is comprised of a limestone masonry gravity wall with a concrete cap (see Figure 2) approximately 77 feet long and 8.5 feet tall. The retained fill is sloped (3.1H:1.0V) up to the adjacent parking lot. A plaster overlay of sorts was applied on the exposed face of the wall at some point, though most of it has failed, thereby exposing the original masonry. Almost no mortar exists between joints, and a significant void, measuring approximately 4 feet high by 8 feet wide and 5 feet deep, has formed below the concrete cap where the surface drain extends from the adjacent parking lot, as shown in Figure 3. City personnel stated that water was observed actively seeping from the void, most likely coming from an abandoned water main that terminated behind the wall. Since addressing the leaking watermain, the seepage has ceased, but this most likely explains the cause for the size of the void.

Additionally, the drainage from the parking lot meant to be carried by the surface drain may be finding its way to the backside of the wall, also attributing to the loss of material and the large void.

The concrete cap along the top of the wall is approximately 18 inches wide by 12 inches thick. Spalling exists along most of the riverward edge and exposed face, but no exposed rebar was observed here. The railing along the top of the wall has failed with only a few posts still embedded in concrete. This poses a significant hazard to anyone traversing near the wall.

Overall, Section A is in a critical condition. Given its proximity to the adjacent building and parking lot and given the impact to these structures should the wall completely fail, this section is considered the highest risk compared to other sections of the wall.

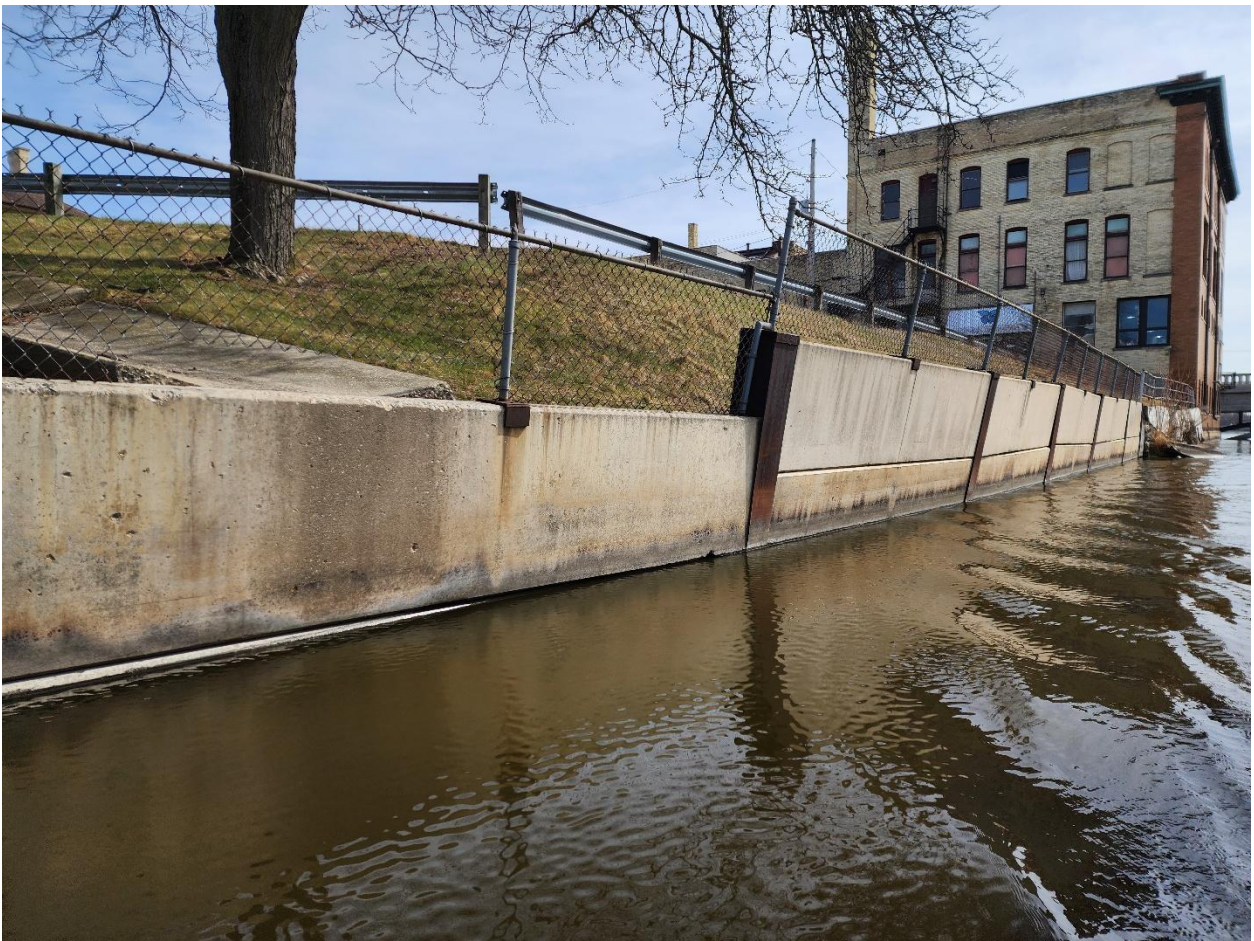
**Figure 4. View of extreme deflection in Section B.**

The top of the Section B wall has deflected approximately 24 inches towards the river, leaving several voids between the soil and wall and areas of very loose soil. Figure 4 demonstrates the extent of deflection in Section B. Although plans or design computations for this section are not available, it is assumed the excessive deflection is due to insufficient embedment into competent subgrade and/or bedrock.

Overall, the structural elements of Section B are in fair condition, but due to the deflection of the wall, the condition of the wall is considered poor-to-critical.

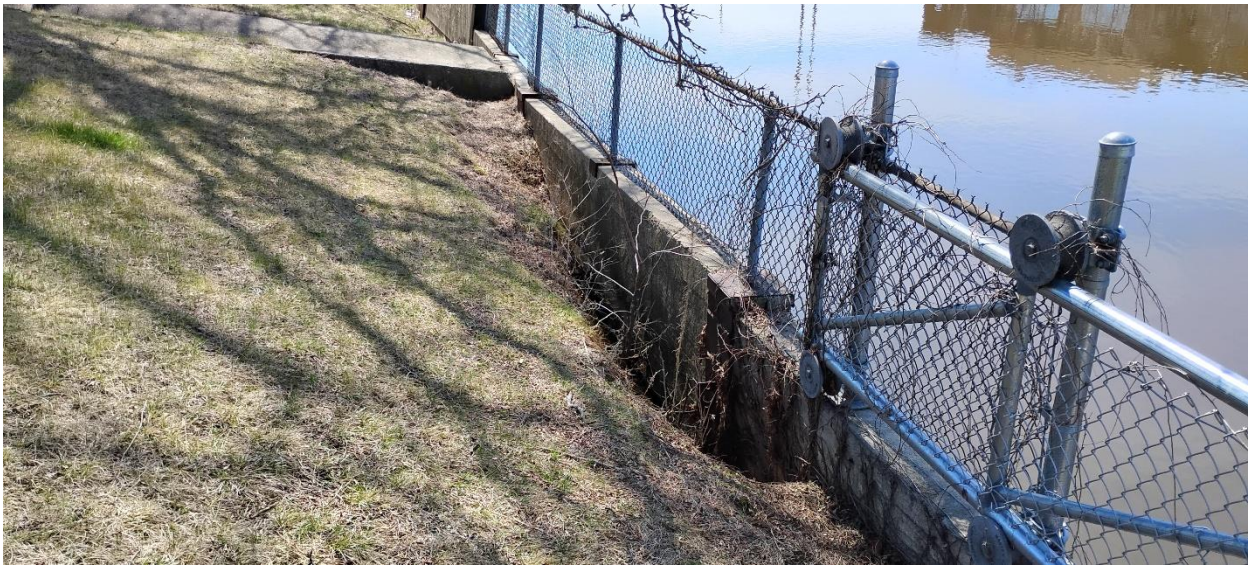
**Figure 5. Lost fill in Section C. Surface drain from parking lot seen near top of photo.**

Section C experienced similar deflection as Section B, with large voids between the backfill and wall as seen in Figure 5. As mentioned in Section A, runoff that spills over the surface drain into the retained fill may be contributing to the loss of material behind the wall. The inspection also did not note any presence of geotextile on the backside of the precast panels; geotextile would help prevent the migration of soils through the panel joints.

Similar to Section B, the structural elements of Section C are in fair condition, but overall, the wall is in poor-to-critical condition due to the deflection and the loss of soils behind the wall.

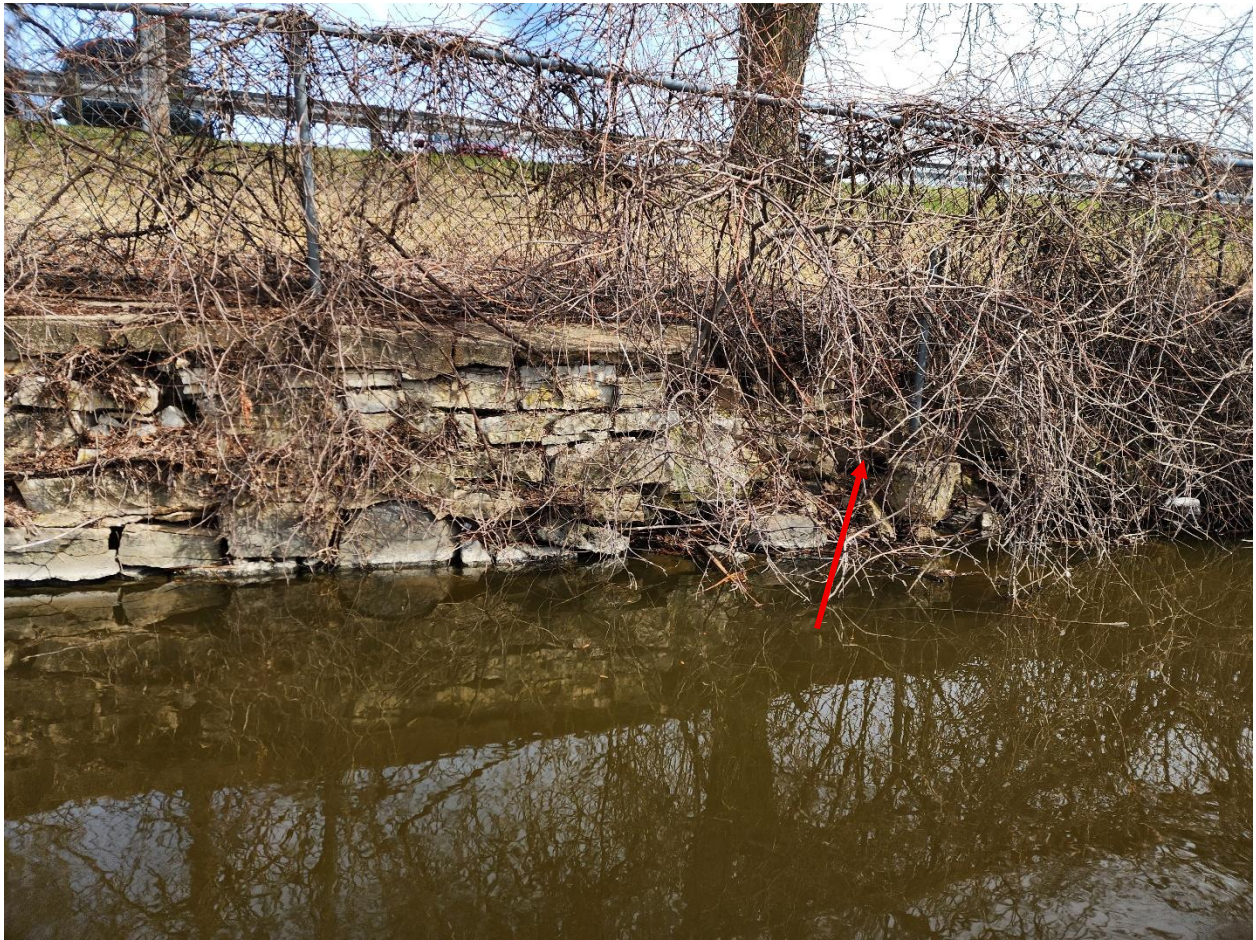
**Figure 6. Failed portion of Section D.**

Most of Section D is covered in vegetation, which makes monitoring the condition of this section difficult from land. However, several sections of Section D were noted to have masonry completely absent and retained fill exposed. Overall, Section D is in poor-to-critical condition.

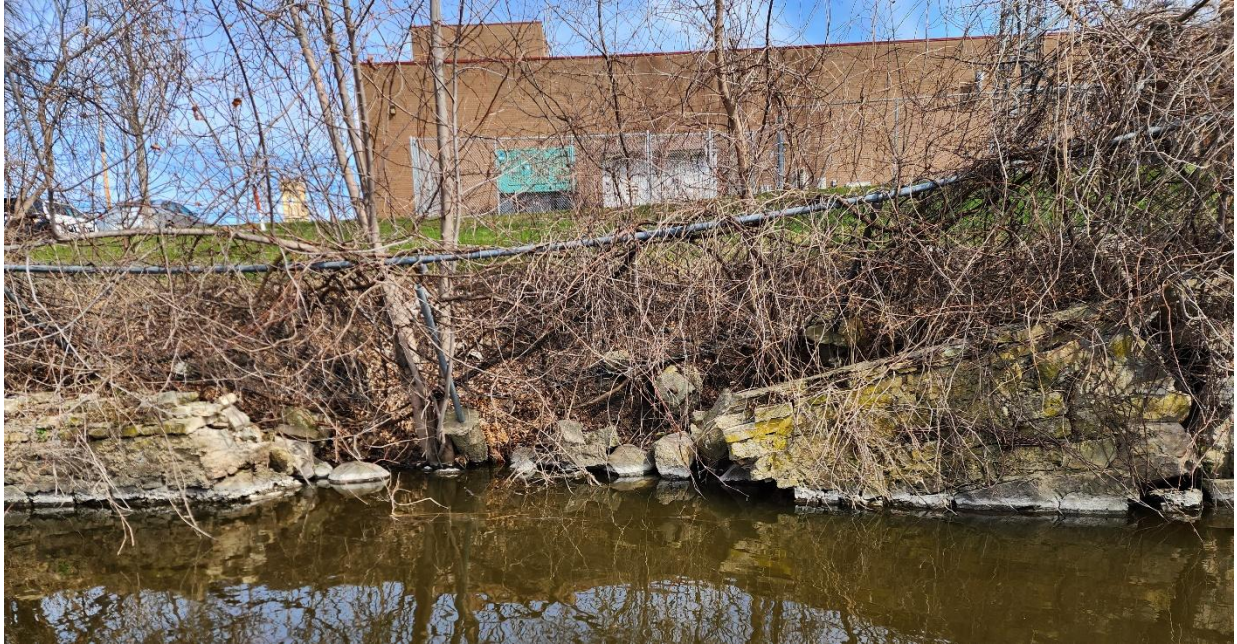
**Figure 7. Failed segment of wall along Section E.**

Section E extends from the north end of Section D to the Cady St bridge. It consists of an identical composition as Section D (irregular, angular fieldstone with concrete cap and chain-link fence). Like Section D, no mortar is visible between the joints, and several portions of fieldstone have completely failed as shown in Figure 7.

Overall, Section E is in poor-to-critical condition.

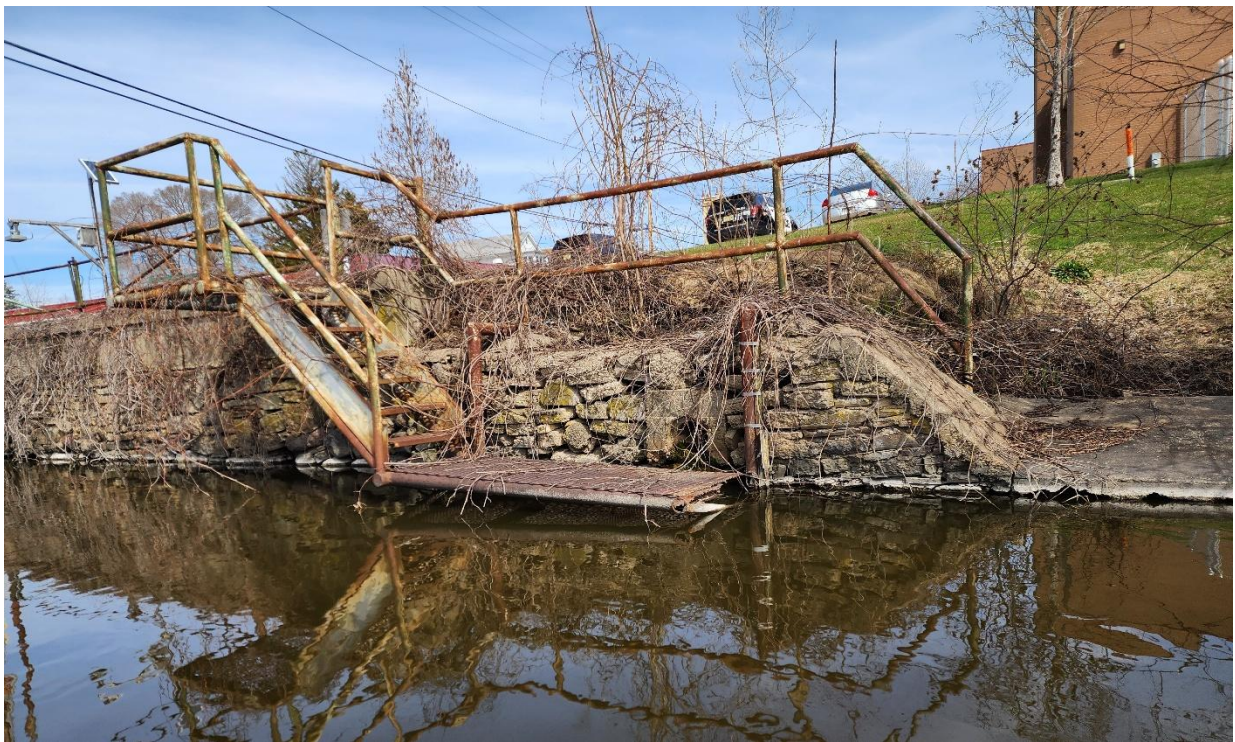
**Figure 8. Old boat launch along Section E.**

What appears to be an old boat launch is located near the north end of Section E (see Figure 8). If no longer in use, the steel platform and stairs should be removed for safety concerns.
