## Invitation to Bid Wheatland Corporation Yard Sinkhole Repair Project

# City of Wheatland - Corp Yard Sinkhole Repair

Blackburn Consulting (Blackburn) appreciates the opportunity to provide geotechnical consultation services for the void that has formed below the City of Wheatland (City) Water Department Operations Building at 208 4<sup>th</sup> Street in Wheatland, California. Blackburn prepared a letter dated April 17, 2024, presenting preliminary conclusions, and recommendations. Below is a summary of site observations, review of available information, conclusions, recommendations for filling the void, and limitations. The recommendations in this updated letter supersede recommendations presented previously.

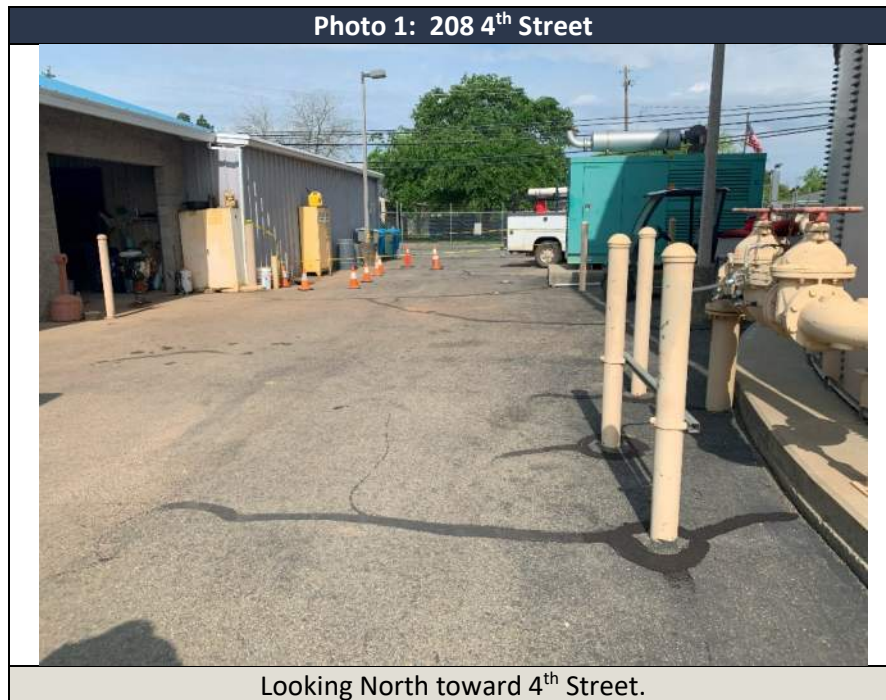
Photo 1 shows the conditions near the shop/warehouse.

We understand City employees found a hole in the pavement near the southeast corner of the shop/warehouse building (coned area in Photo 1) on Thursday April 11, 2024, while moving a fuel storage cabinet (yellow cabinet on east side of shop/warehouse in Photo 1). The City contacted Coastland Engineering who requested Blackburn visit the site to observe the conditions, provide a professional opinion regarding likely cause(s) of the void, and preliminary recommendations to mitigate/ fill the void. We prepared this memo to summarize our observations, conclusions, and preliminary recommendations.

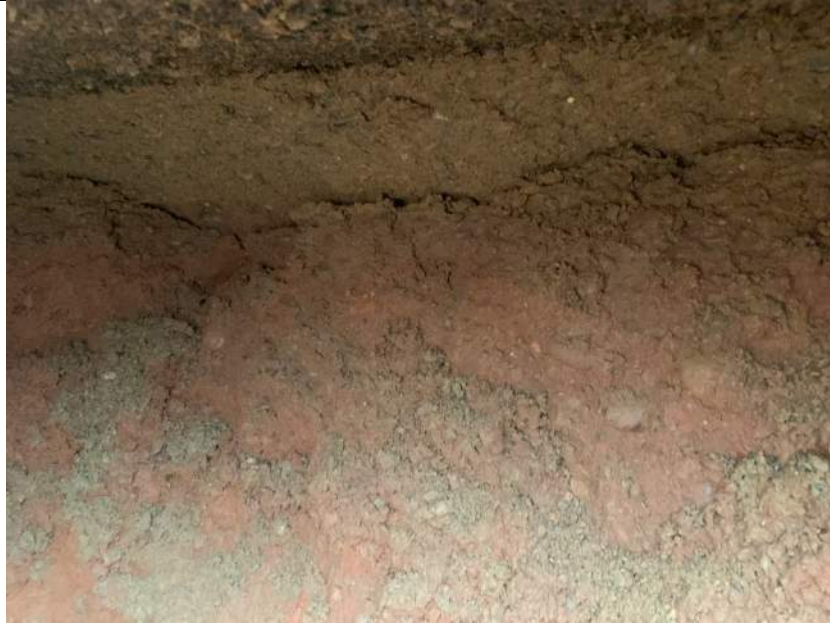
Photo 2: 208 4<sup>th</sup> Street

Undermined asphalt pavement at east edge of void. Bottom of AC is observed at top of photo.

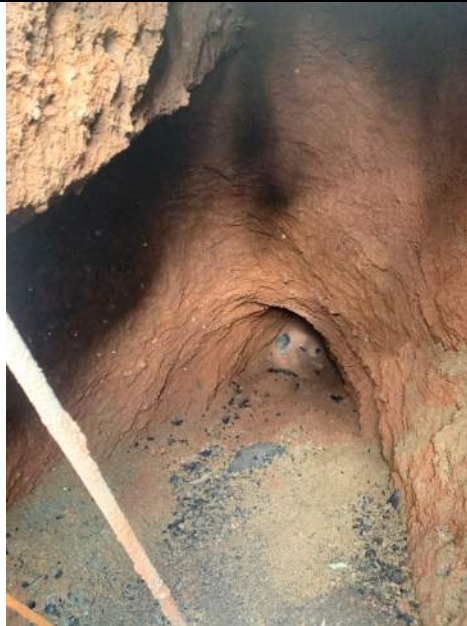
Photo 3: 208 4<sup>th</sup> Street

- A brick structure was observed at the northern end of the void (Photo 3).
- The base of the void is covered with loose soil, Aggregate Base, and debris (AC pieces, leaves, etc.).

Looking North down void toward 4<sup>th</sup> Street. Eastern perimeter footing is visible at top left corner of photo, and Brick structure is observed at end of void.

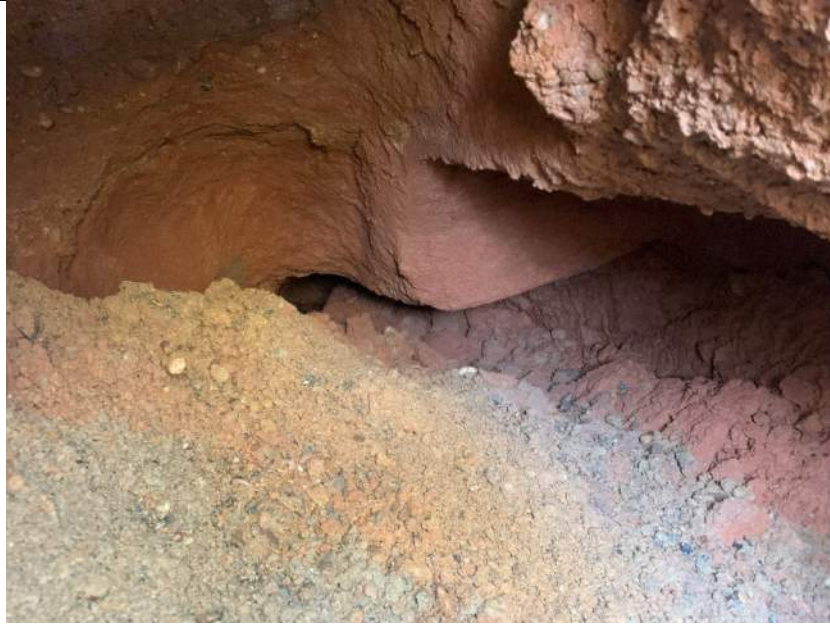
Photo 4: 208 4<sup>th</sup> Street

Looking Southwest below southeast corner of shop/warehouse building. Corner and eastern perimeter footing are visible.

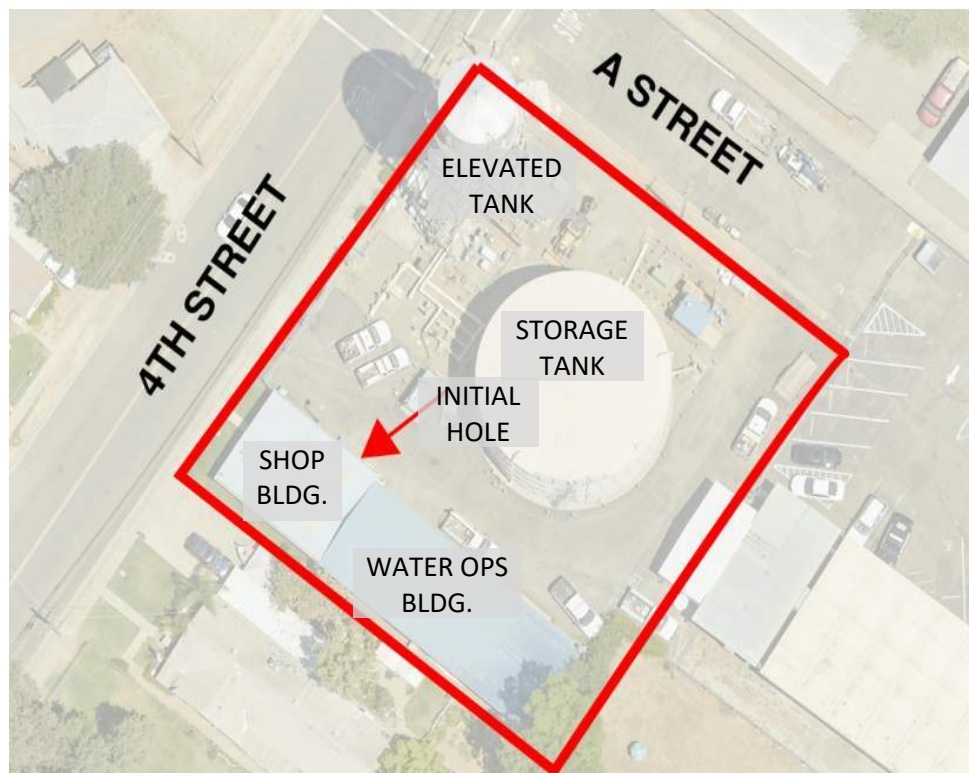
*Photo 1: Aerial View of Wheatland's Corp Yard*

On the afternoon of April 11, 2024, the City's Public Works staff was working at the City's Corporation Yard ("Site") and discovered a hole in the pavement just outside of a shop building located at the northwest corner of the Site (see Photo 1) that revealed a large underground void.

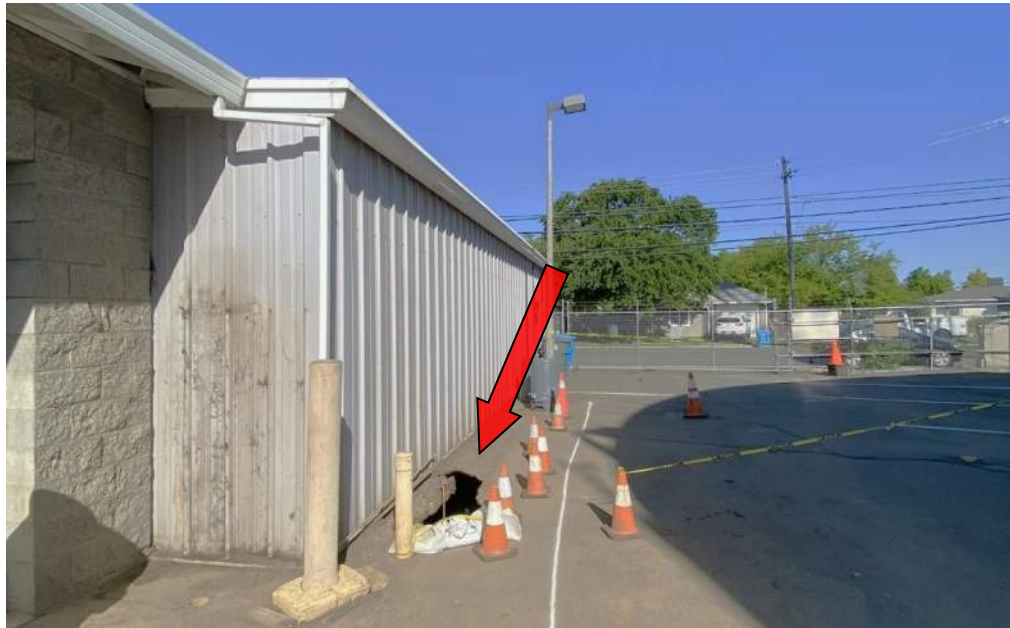
After discovering the hole and void, Staff carefully removed a 3-ft x 5-ft area asphalt paving around the original hole which revealed a very large and deep void with tunnels extending in two directions: beneath the shop building foundation and slab; and extending under the asphalt road into the yard. Photo 2 shows the location of the hole in the asphalt. The white line on the pavement in Photo 2 shows the approximate limit of the void beyond the building.

*Photo 2: Location of Hole in Pavement (facing northwest towards 4<sup>th</sup> Street)*

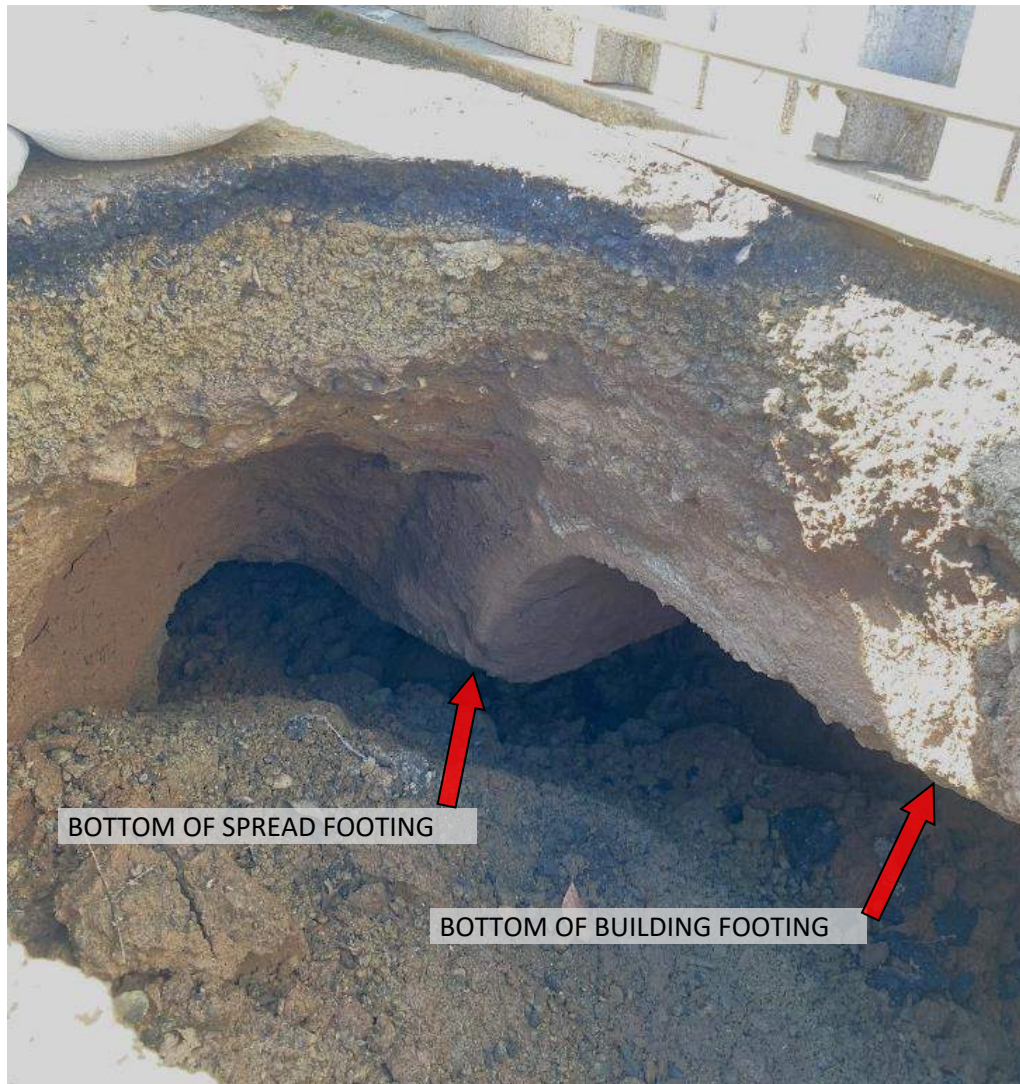
Initial estimates indicate that building foundation has been undercut by the void leaving at much as 25-ft of the east side of the building foundation and slab unsupported. Photo 3 shows the exposed void and the unsupported spread footing.

*Photo 3: Exposed Foundation and Spread Footing, Tunnel to the Southeast of the Hole*

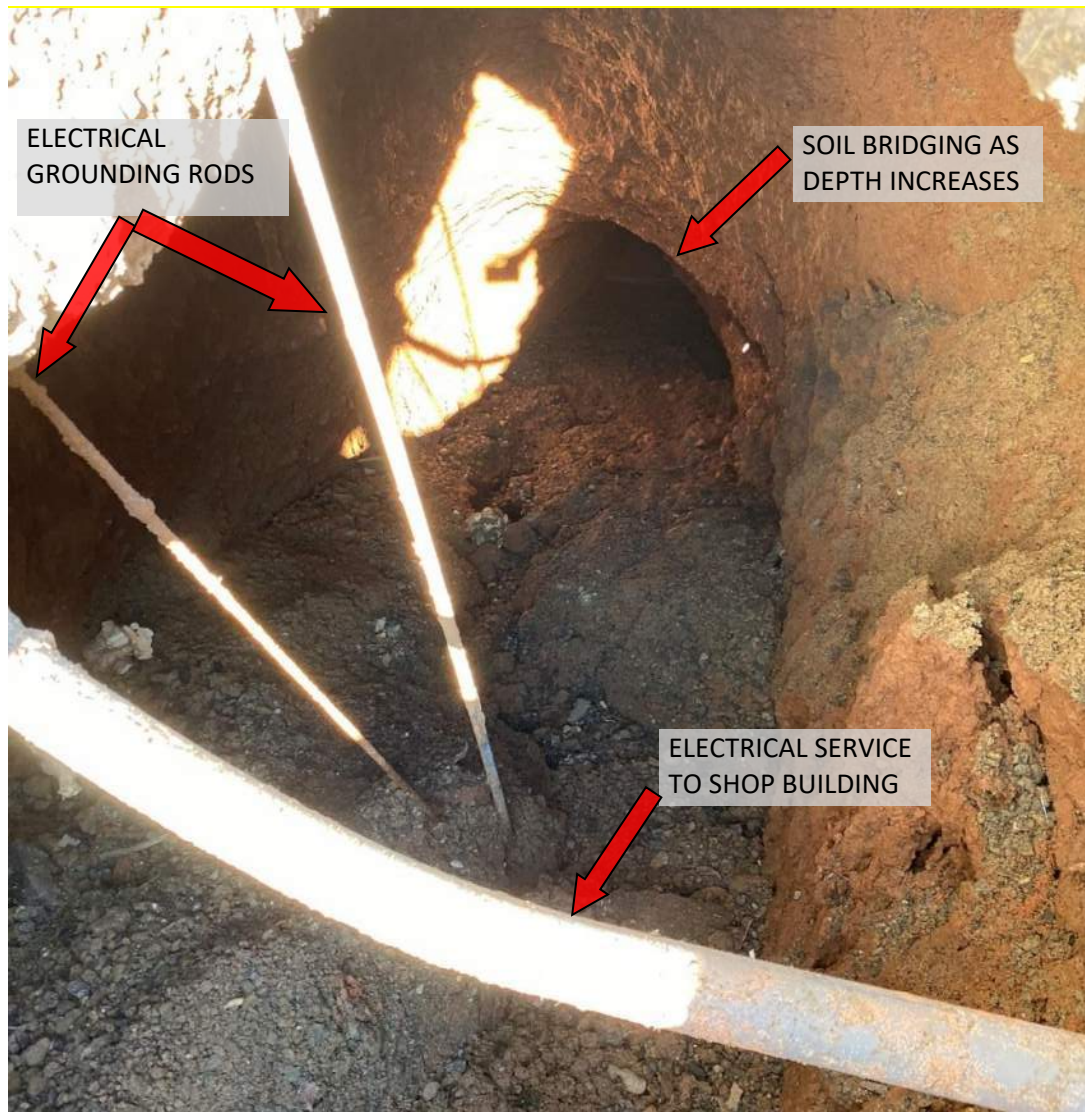
In the following week, Public Works Staff further explored the void using underground utility cameras which revealed the smaller void is a tunnel that extends to the southeast of the surface hole and is 1- to 3-ft in diameter and approximately 20-ft in length (see Exhibits A and B). The larger void extends along the easterly edge of the shop building and angles to the northwest for approximately 25-feet to a depth of approximately 25-ft and ranges from 3- to 6-ft in diameter. Approximately 15-feet from the opening in the asphalt, the void turns into a tunnel with approximately 6'-8' of material bridging over the void (see Photo 4).

*Photo 4: Tunnel Facing Northwest of the Hole*

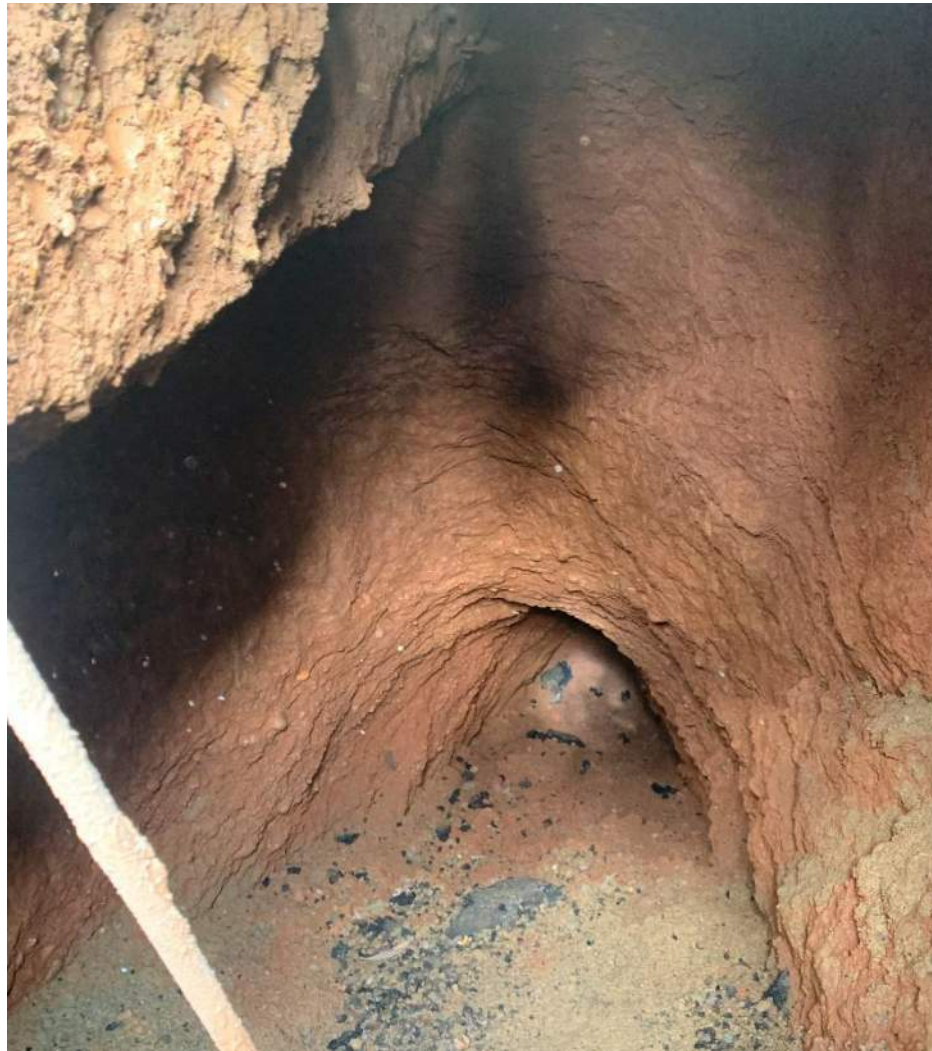
At the farthest/deepest part of the large void a brick structure is barely visible and appears to be arranged in a convex configuration such as the outside edge of a cylindrical structure (see Photo 5).

*Photo 5: Brick Exposed at End of Tunnel*

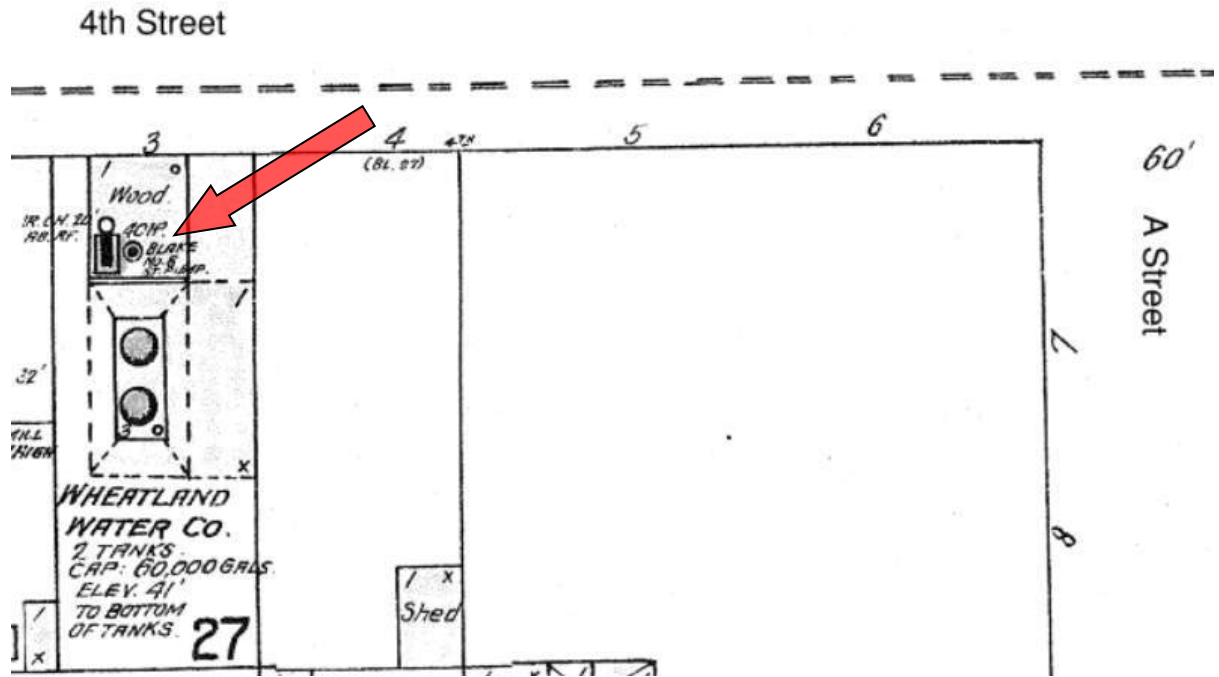
A 1899 Sandborn Map (Figure 1 and Exhibit C) indicates that a well was present near the turn of the century along with two storage tanks. Apparently, the well was abandoned in-place but the means and extent of the abandonment cannot be ascertained at this time. It is known from recent work in the area that ground water that would be available for municipal use is available at depths of 30- to 40-feet below ground surface. Therefore, it is estimated that the abandoned well is at least 30-feet in depth.

Figure 1: Portion of 1899 Sandborn Map at Corp Yard site with well indicated by arrow

The Shop Building appears to have been built over of a portion of the historic well. The brick that is visible from looking into the void is expected to be the outside of the well casing. If the brick structure is indeed the old well, it would likely be approximately 4-6 feet in diameter and it is expected that it would have been at least 30-feet in depth to reach groundwater and supply the 40-horse power pump shown on the map.

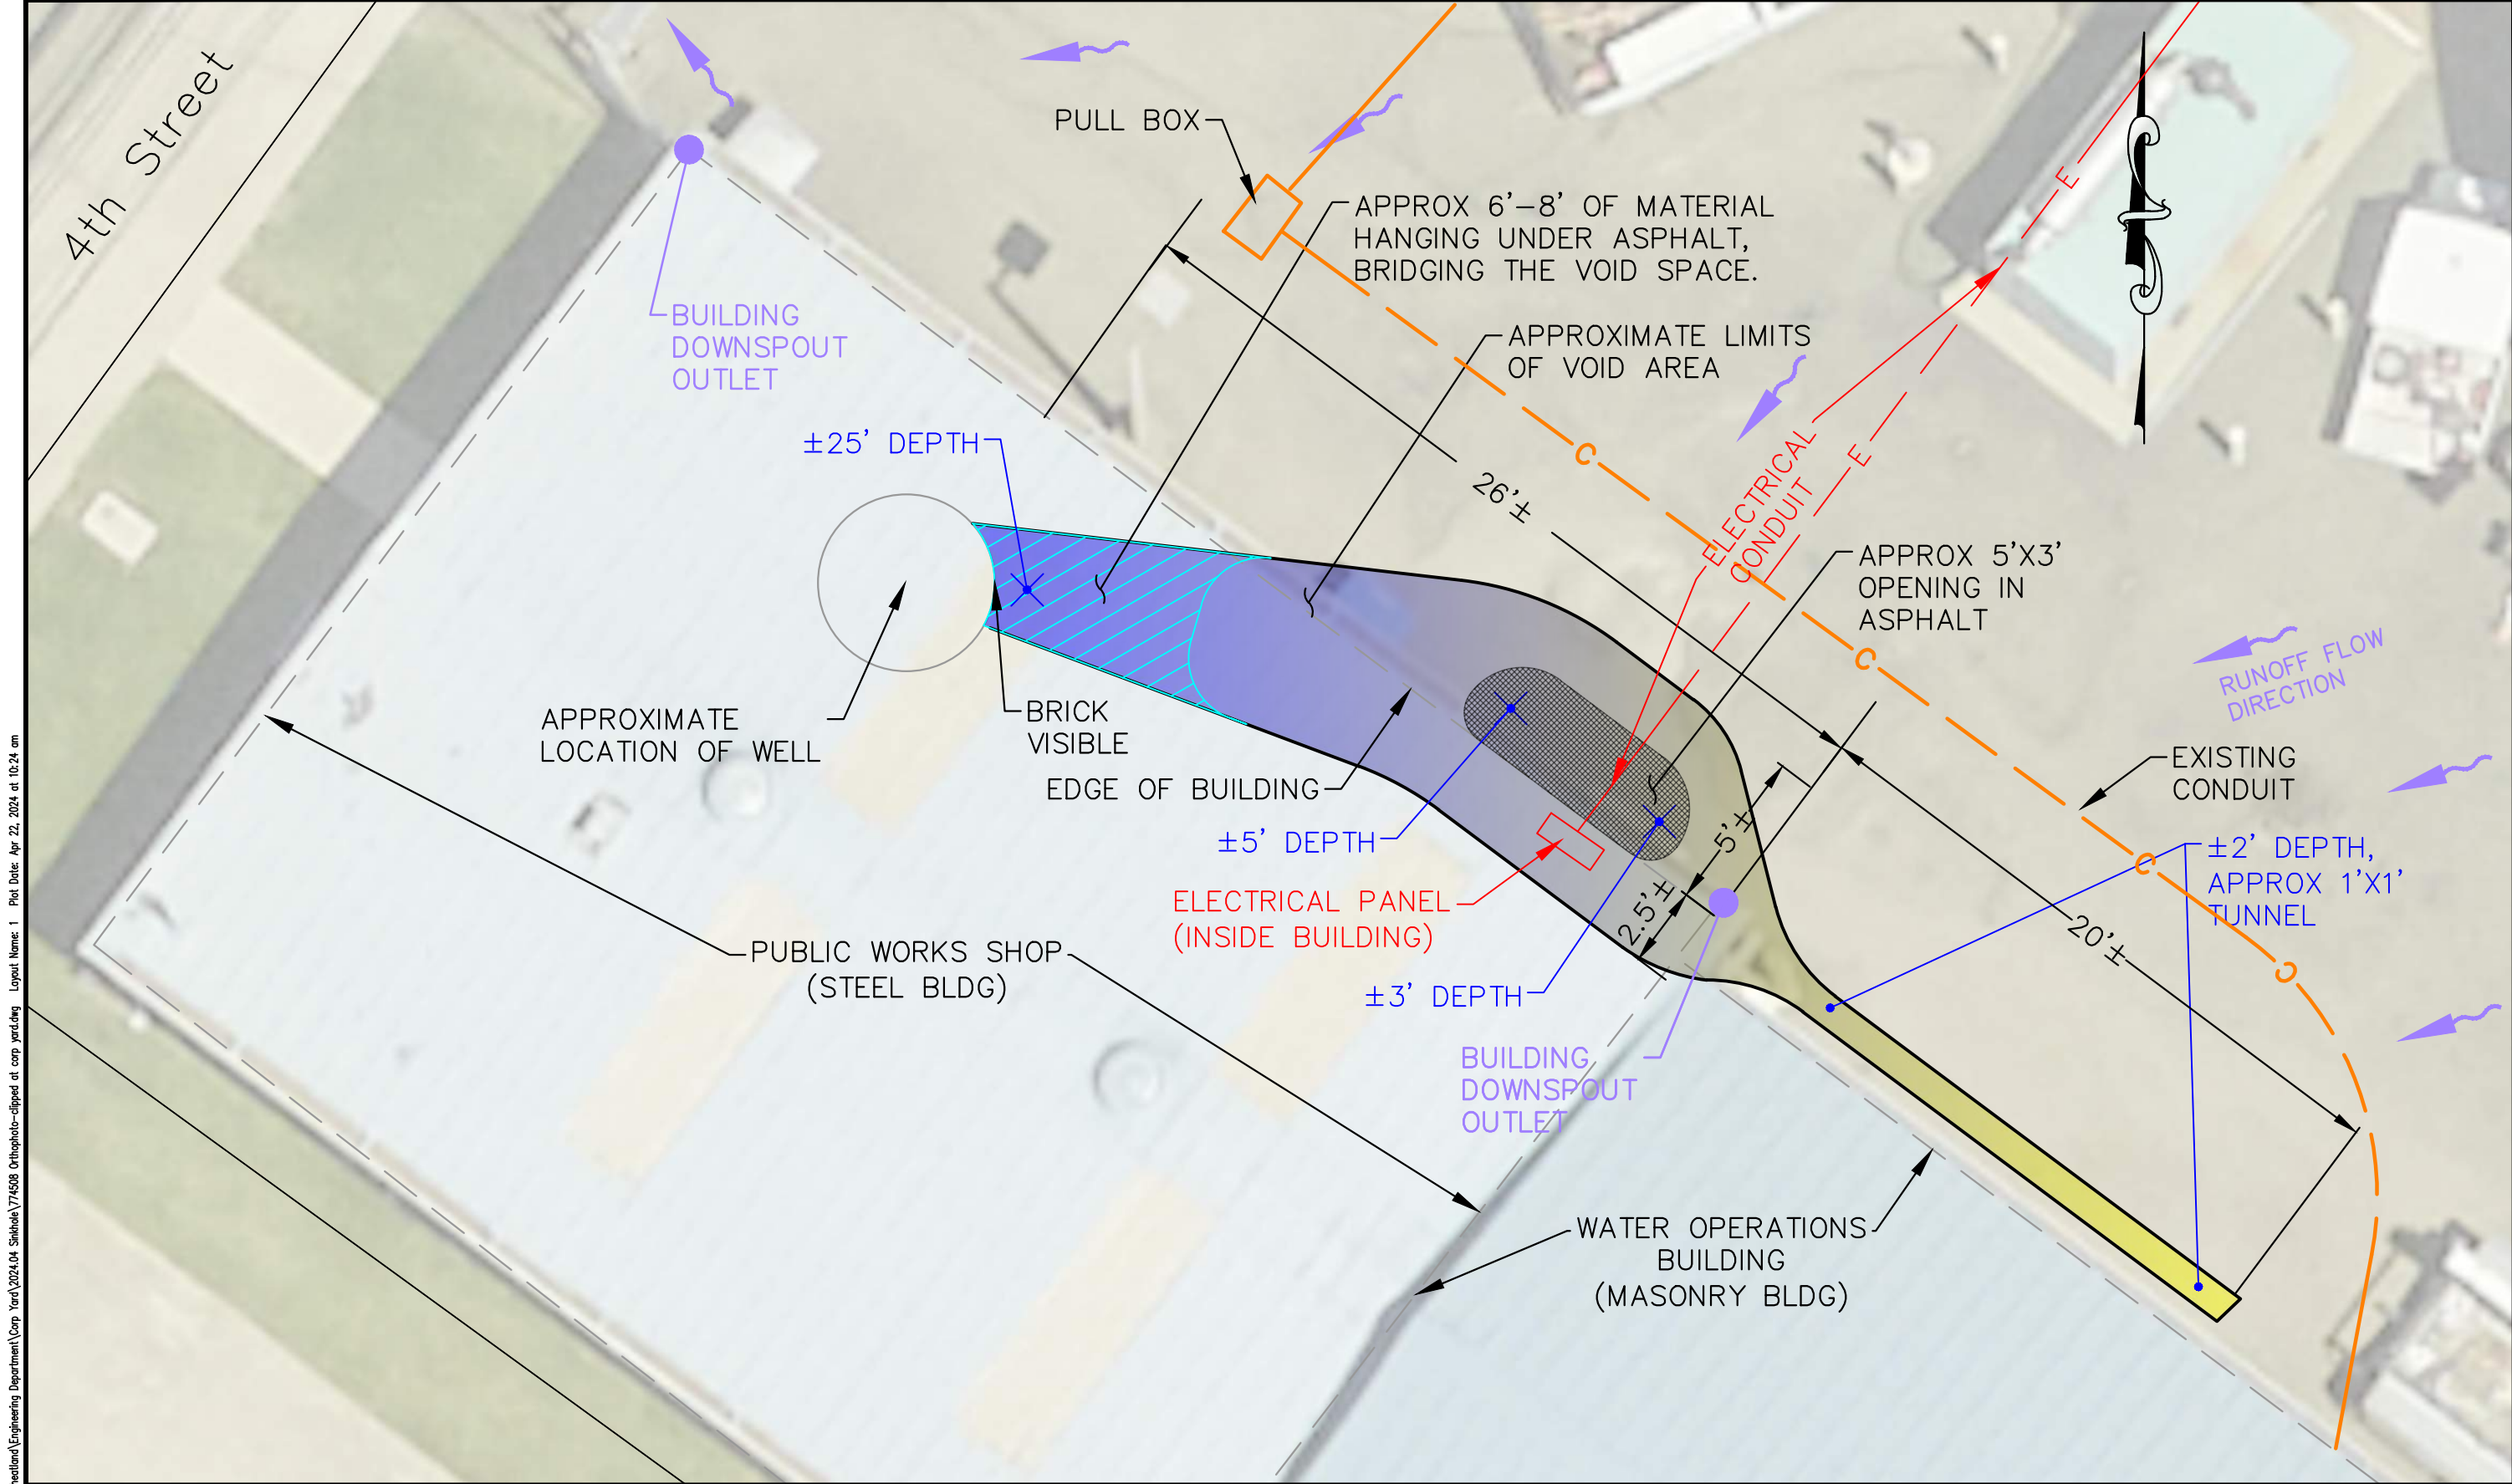
# EXHIBIT A

CITY OF WHEATLAND CORP YARD SINKHOLE LIMITS APRIL 22, 2024 REVISION 1
--

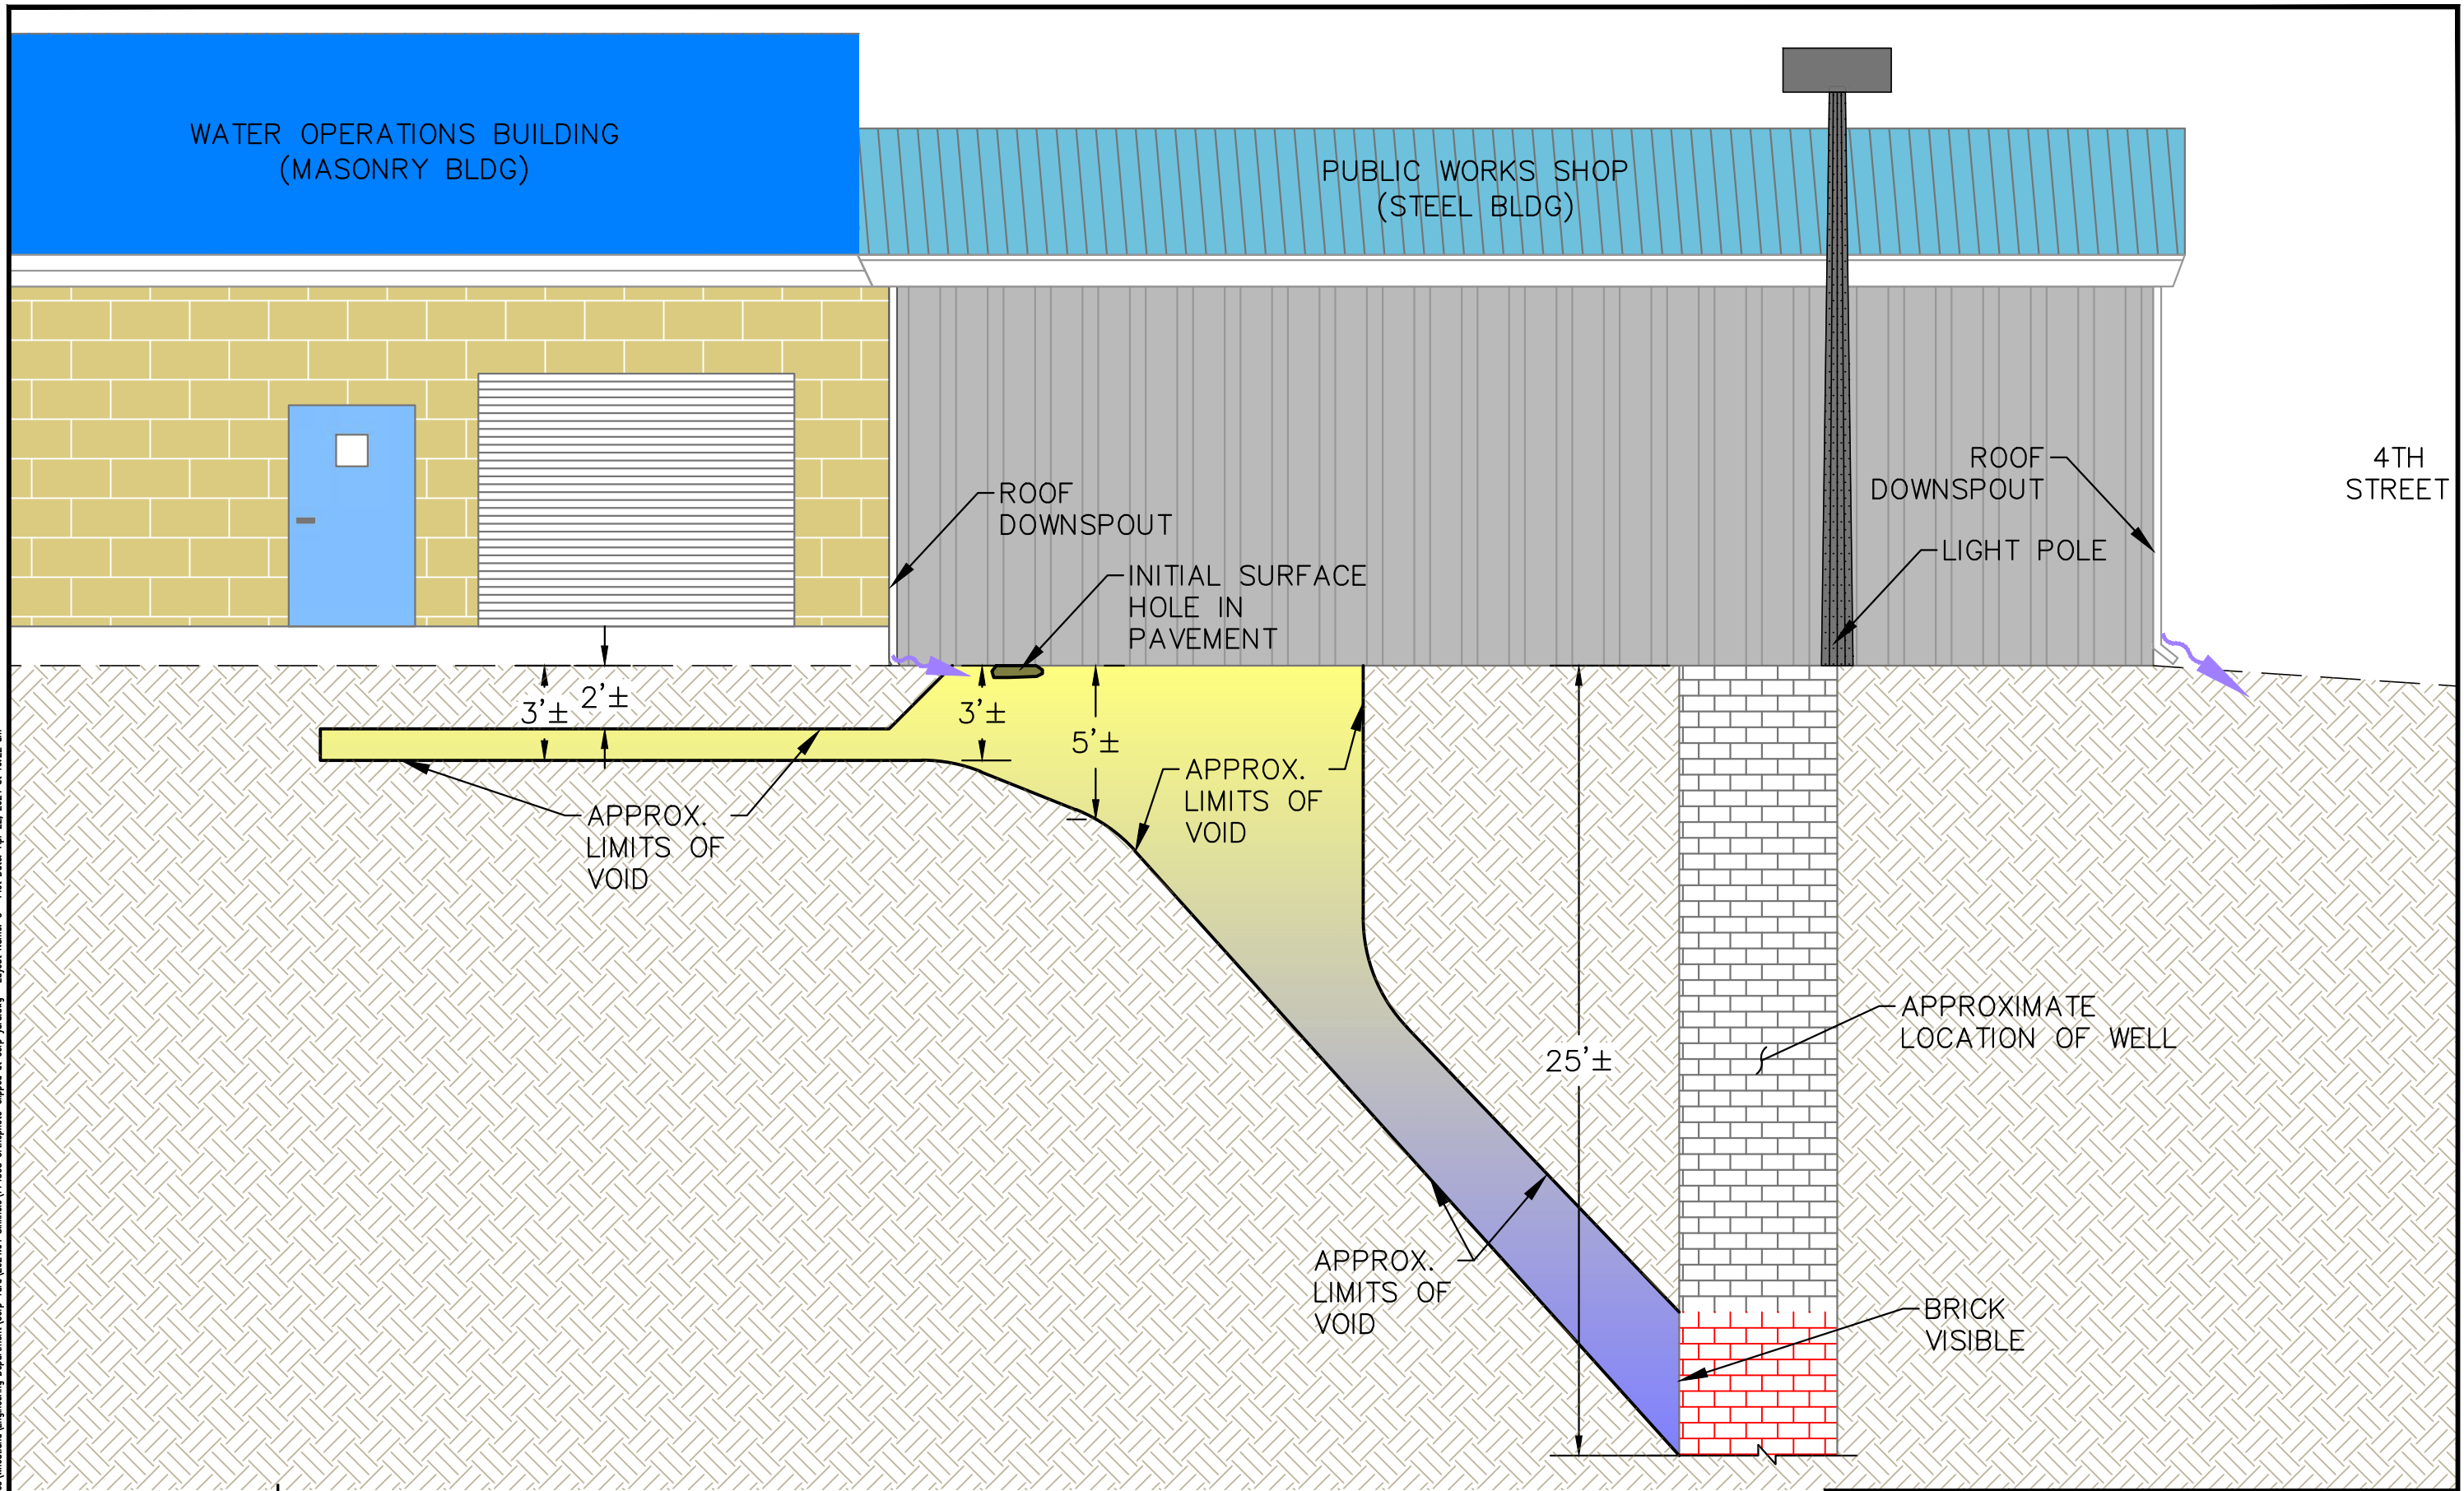
CITY OF WHEATLAND CORP YARD  
 SINKHOLE PROFILE VIEW - APPROX. LIMITS  
 APRIL 22, 2024  
 REVISION 1

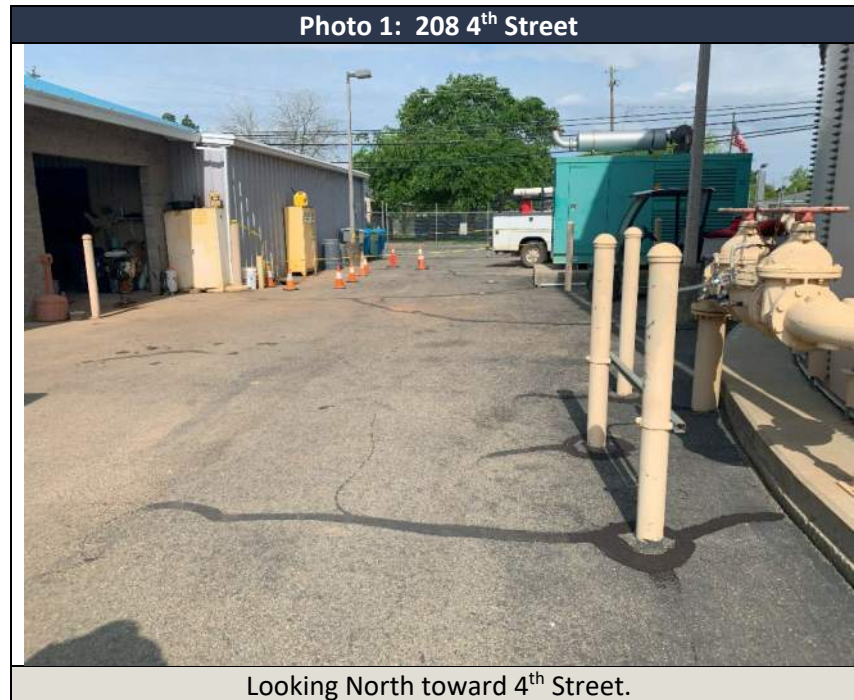
Photo 1 shows the conditions near the shop/warehouse.

We understand City of Wheatland employees found a hole in the pavement near the southeast corner of the shop/warehouse building (coned area in Photo 1) on Thursday April 11, 2024, while moving a fuel storage cabinet (yellow cabinet on east side of shop/warehouse in Photo 1). The City contacted Coastland Engineering who requested Blackburn visit the site to observe the conditions, provide a professional opinion regarding likely cause(s) of the void, and preliminary recommendations to mitigate/ fill the void. We prepared this memo to summarize our observations, conclusions, and preliminary recommendations.

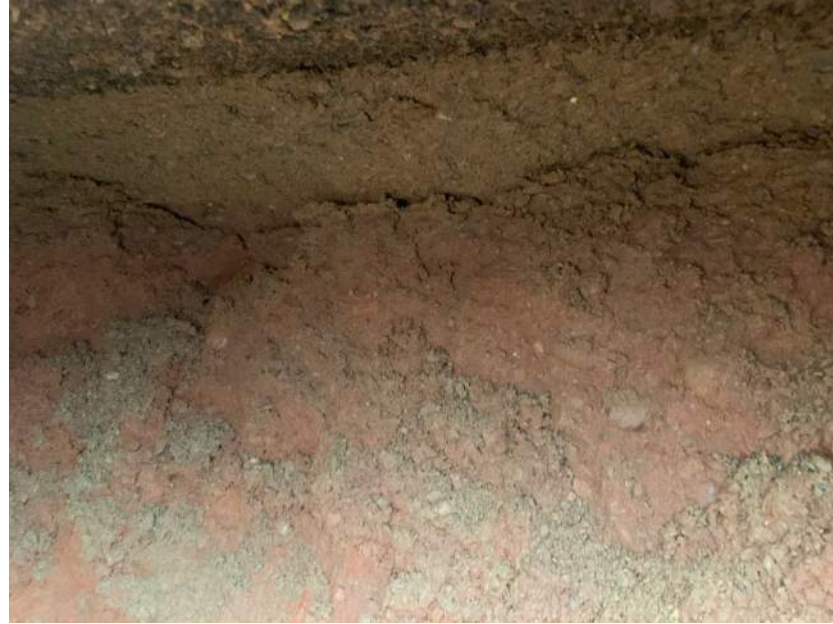
Photo 2: 208 4<sup>th</sup> Street

Undermined asphalt pavement at east edge of void. Bottom of AC is observed at top of photo.

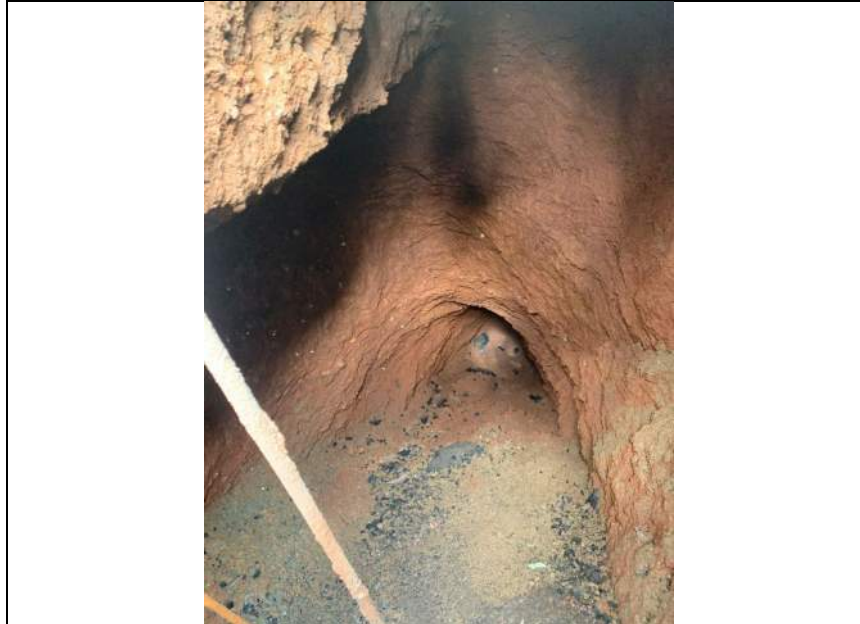
Photo 3: 208 4<sup>th</sup> Street

- A brick structure was observed at the northern end of the void (Photo 3).
- The base of the void is covered with loose soil, Aggregate Base and debris (AC pieces, leaves, etc.).

Looking North down void toward 4<sup>th</sup> Street. Eastern perimeter footing is visible at top left corner of photo, and Brick structure is observed at end of void.

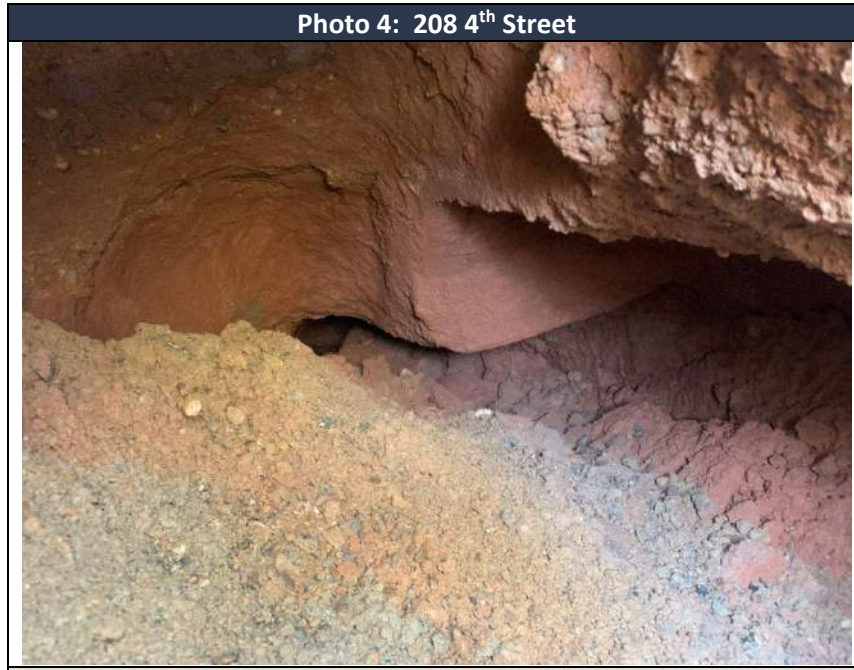
Photo 4: 208 4<sup>th</sup> Street

Looking Southwest below southeast corner of shop/warehouse building. Corner and eastern perimeter footing are visible.
