Time Range: 10/1/2025-10/31/2025

<h1 style="margin: 0;">City of Whitewater</h1>	<h2 style="margin: 0;">Storm Water Outfall Inspection Report</h2> <p style="margin: 0;">Prepared by WATER RESOURCE ASSOCIATES</p>
--	--

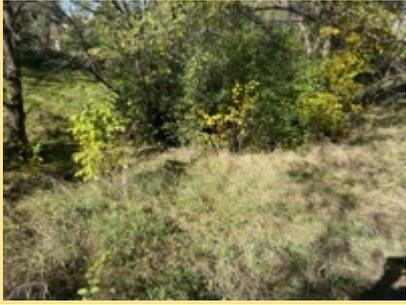
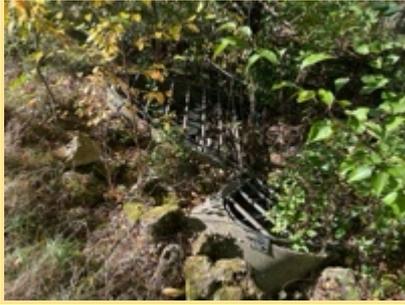
Site Photo	Outfall Photo

Outfall Condition	
Pipe Condition	Average
Rip-Rap Condition	Average
Erosion Condition	Accumulated Sediment
Comments	Larger pipe filled 25% with debris. Invasive trees at end of pipe.

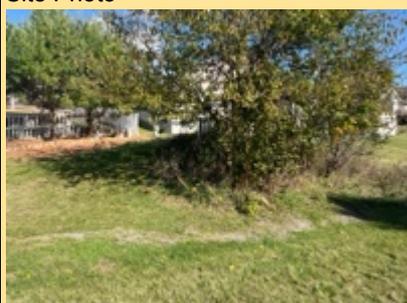
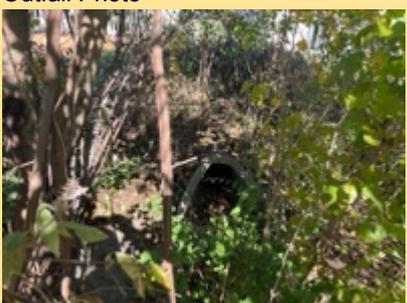
Site Photo	Outfall Photo

Outfall Condition	
Pipe Condition	Average
Rip-Rap Condition	No Rip-Rap Present
Erosion Condition	Minor Erosion
Comments	Invasive brush at end of pipe.

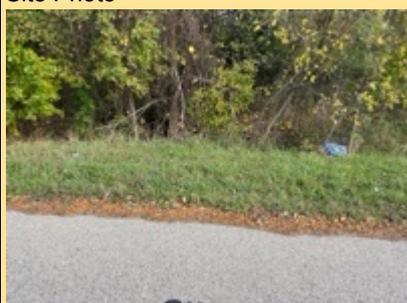
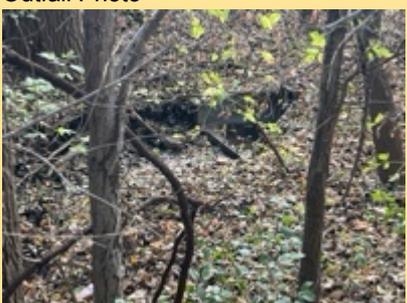
Site Photo	Outfall Photo

Outfall Condition	
Pipe Condition	Average
Rip-Rap Condition	Poor (Consider Repair)
Erosion Condition	Significant Erosion (Consider Repair)
Comments	Significant erosion extending down stream

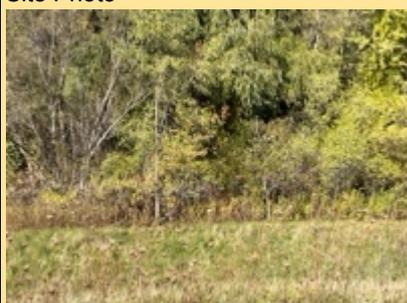
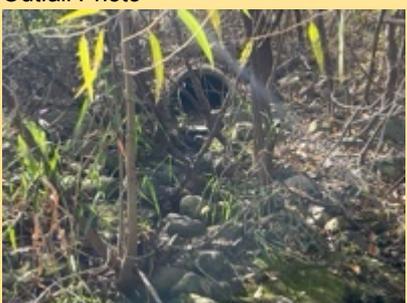
Site Photo	Outfall Photo

Outfall Condition	
Pipe Condition	Average
Rip-Rap Condition	Poor (Consider Repair)
Erosion Condition	Minor Erosion
Comments

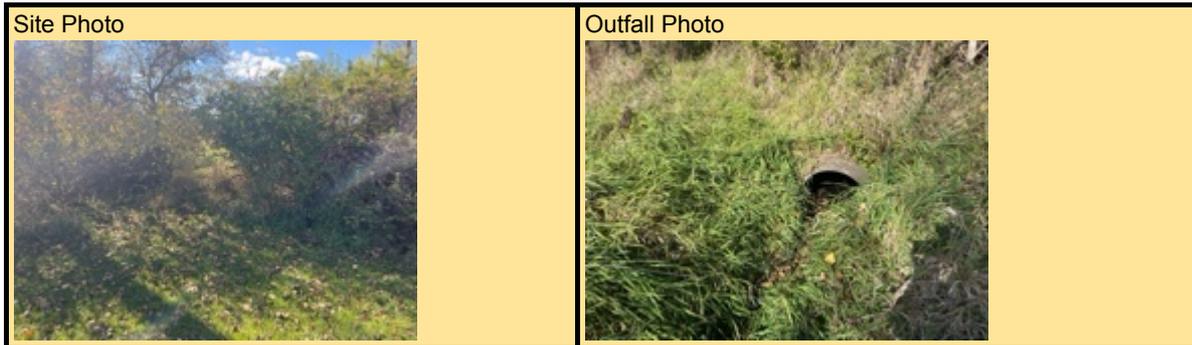
Outfall Classification	Minor	Inspection Date	10/24/2025
Outfall Size	30"	Inspected By	T Whittaker
Outfall Description	RCP with no end section

Outfall Condition	
Pipe Condition	Average
Rip-Rap Condition	No Rip-Rap Present
Erosion Condition	Accumulated Sediment
Comments	Consider clearing access path

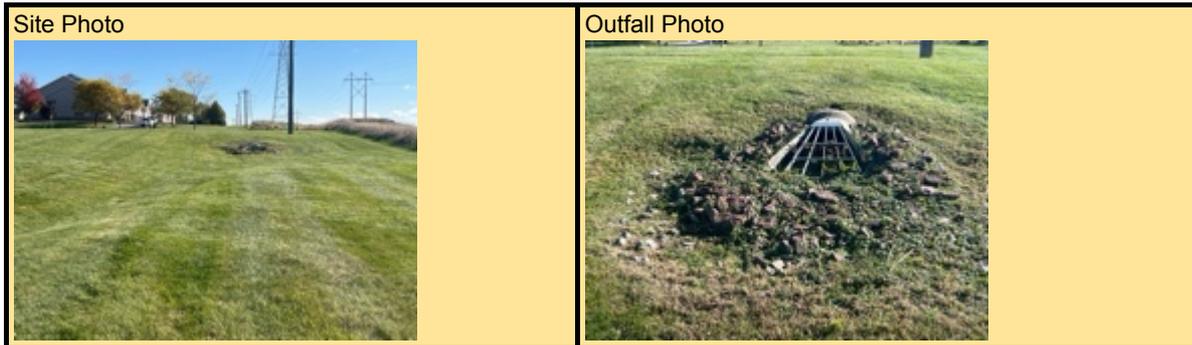
Outfall Classification	Minor	Inspection Date	10/24/2025
Outfall Size	24"	Inspected By	T Whittaker
Outfall Description	RCP end section drains to pond

Outfall Condition	
Pipe Condition	Average
Rip-Rap Condition	Average
Erosion Condition	Accumulated Sediment
Comments	Minor sediment accumulation within end section. Not an MS4 outfall.

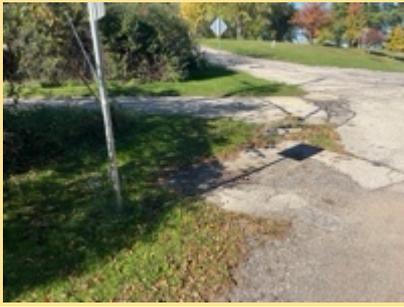
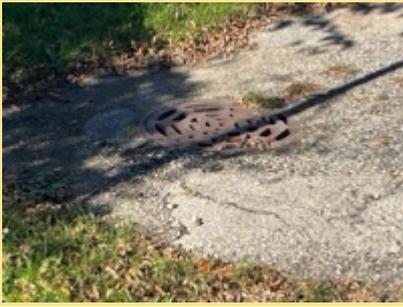
Site Photo	Outfall Photo

Outfall Classification	Minor	Inspection Date	10/24/2025
Outfall Size	21"	Inspected By	T Whittaker
Outfall Description	Pipe not found possibly buried, Monitor at manhole at edge of pavement

Outfall Condition	
Pipe Condition	No Pipe Present
Rip-Rap Condition	No Rip-Rap Present
Erosion Condition	Not Applicable
Comments	Flow monitored at inlet

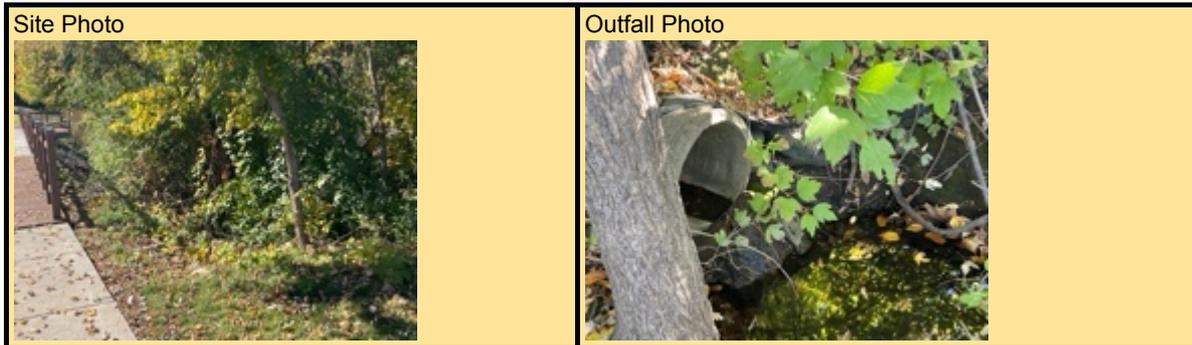
Outfall Condition	
Pipe Condition	Average
Rip-Rap Condition	No Rip-Rap Present
Erosion Condition	Minor Erosion
Comments

Flow Data			
Active Flow	Y	Flow Rate	< 1 ft/sec
Odor	No	Ammonia	* > 0.1 mg/l *
Turbidity	None	Chlorine	No
Color	N/A	pH	7.00
Floatables	No	Detergents	* > 0.5 mg/l *
Comments	Trickle flow, present at every inspection

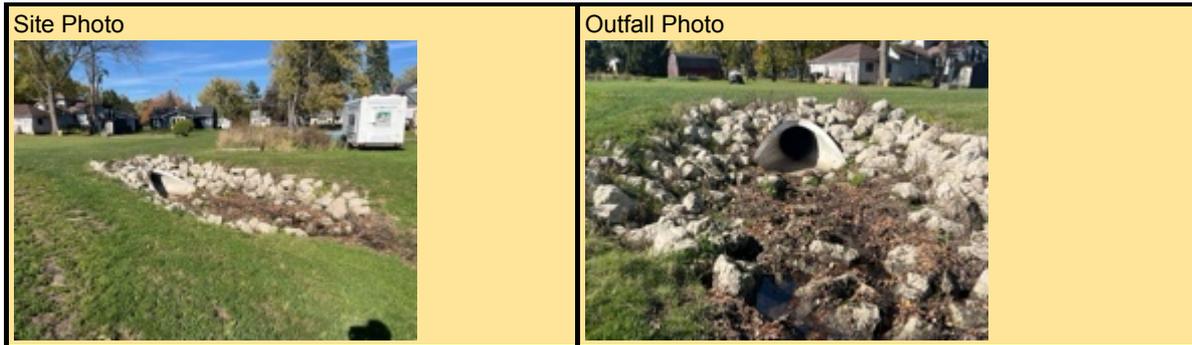
Outfall Condition	
Pipe Condition	Good
Rip-Rap Condition	Good
Erosion Condition	Minor Erosion
Comments	Some minor erosion in downstream swale
