Building Background

The structure is approximately 100 feet tall with a masonry base and steel tank (Photo 1). It was constructed in 1889 and has been a functioning water tank since that time. It was decommissioned in late 2022 and the water was removed from the tank as of December 14, 2022. The structure is comprised of a 70 foot tall masonry structure with a 30 foot tall, 185,000 gallon, cylindrical steel tank at the top.

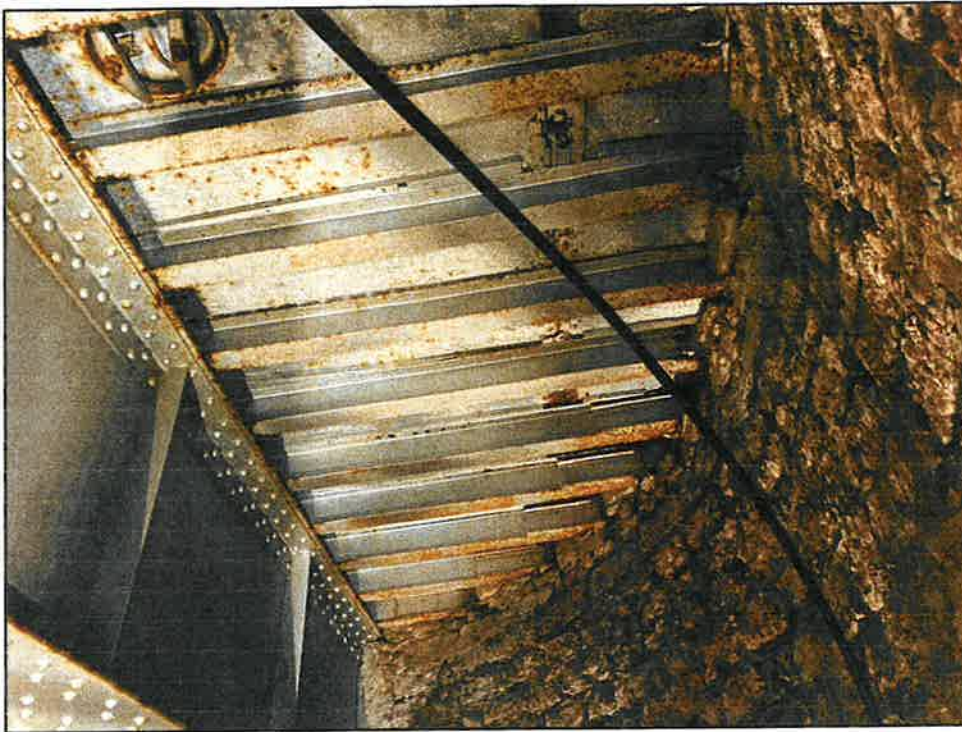
Photo 2: Steel beams below tank

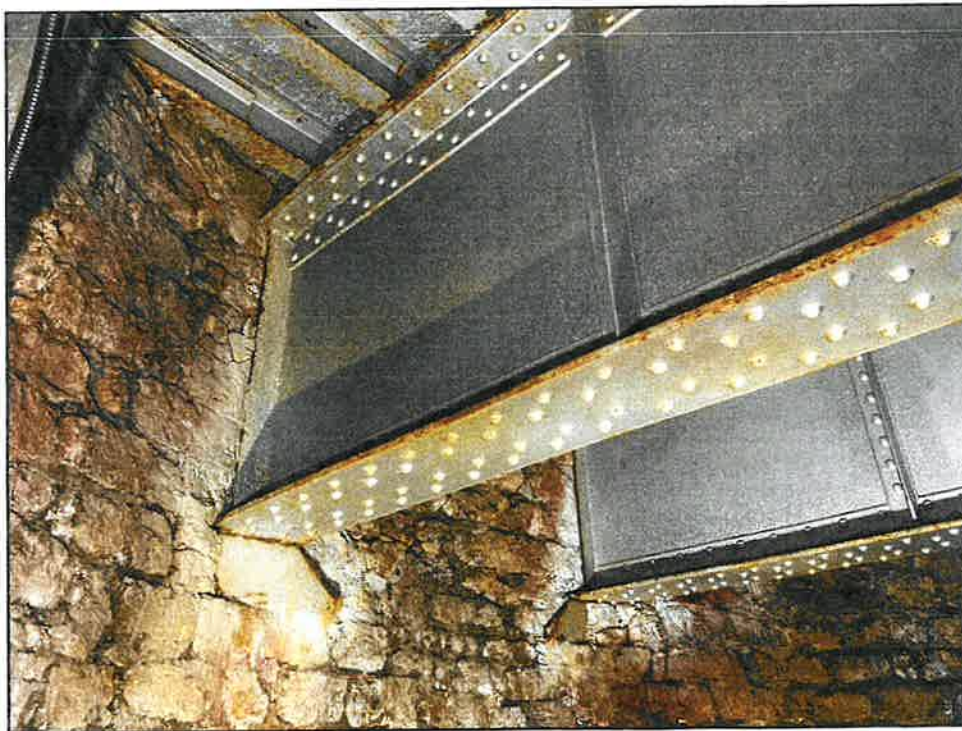
Photo 3: Steel plate girder supports

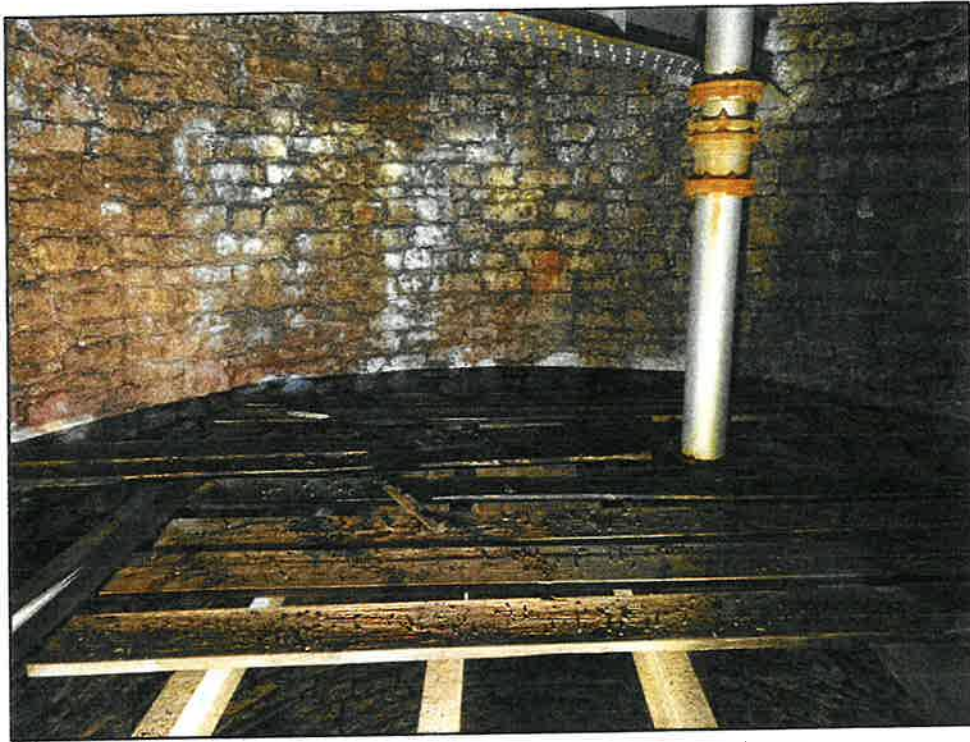
Photo 4: Floor below tank at top of masonry tower

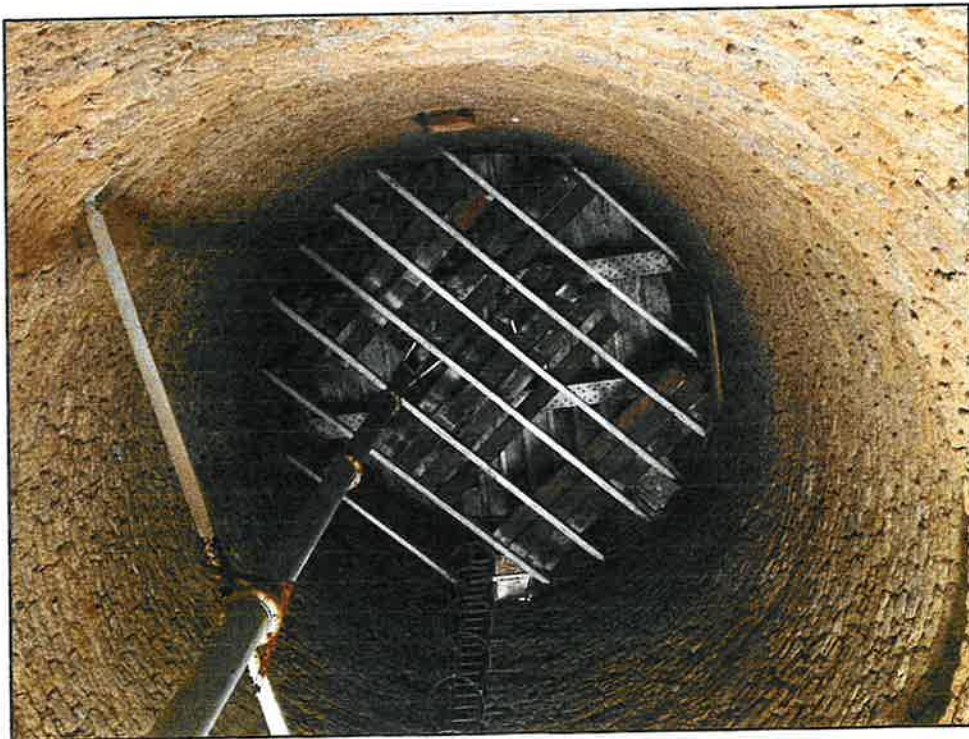
Photo 5: Floor and tank supports as viewed from below

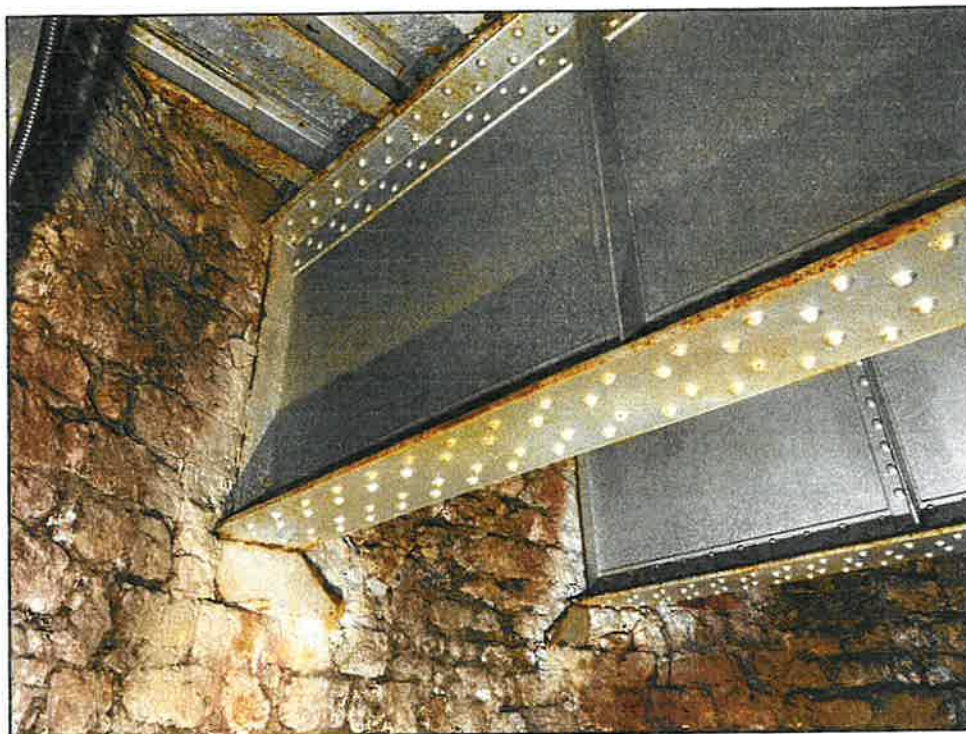
- Description:** The steel beams and plate girders holding the tank have light corrosion, particularly near the masonry walls (Photos 31 to 33). The beams that form the floor below the tank also have corrosion at the exterior walls (Photos 34 and 35).

- Priority Level:** High – beams and girders that are bearing on masonry. These are a higher priority because their condition will impact the longevity of any masonry repairs.

Photo 31: General light corrosion on support structure

- Repair:** Perform some exploratory openings at locations where beams are bearing on walls. Exposing the steel members will determine whether repairs are needed. If repairs are needed it will likely involve welding new steel plates/angles/etc to the existing steel to replace the lost steel capacity.

- At a minimum, exposed steel members should be primed and painted to extend the life of the structure.
- Once water is removed from the tank, the interior should be inspected by a tank inspector to determine whether the tank itself, or its connections to the base, require repairs.

- For all steel repairs, the weldability of the material should be determined by testing prior to implementing any repairs. Some steel of this age is not weldable. There is also a chance that some of the material is iron rather than steel.

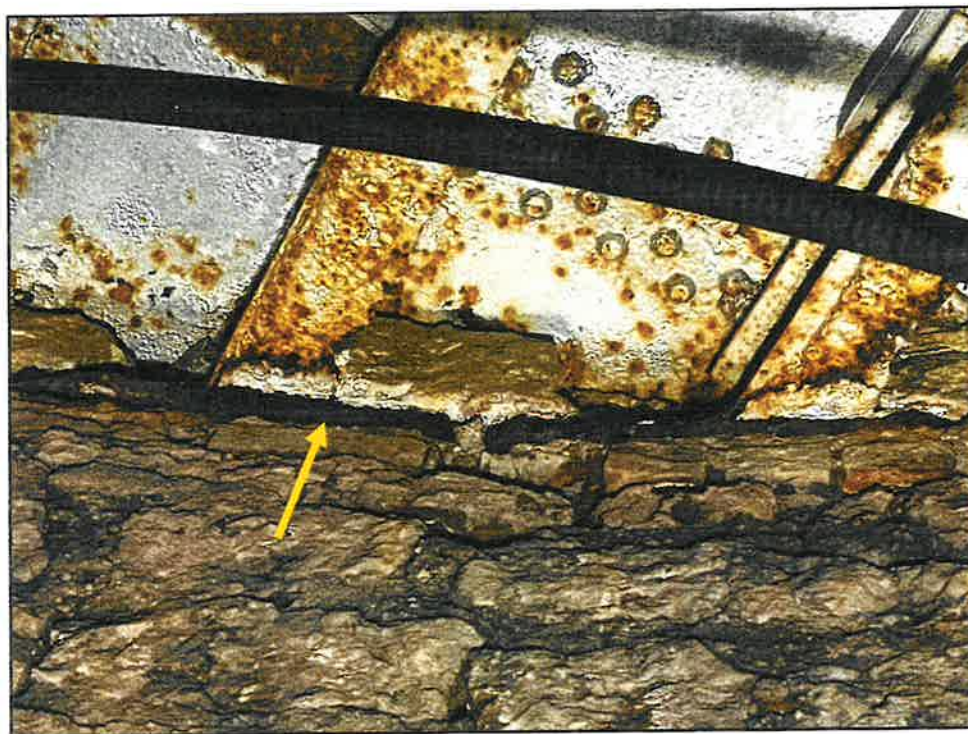
Photo 32: Close up of tank supports at wall

There is a steel plate on top of the masonry that is corroding as well as the base of the tank

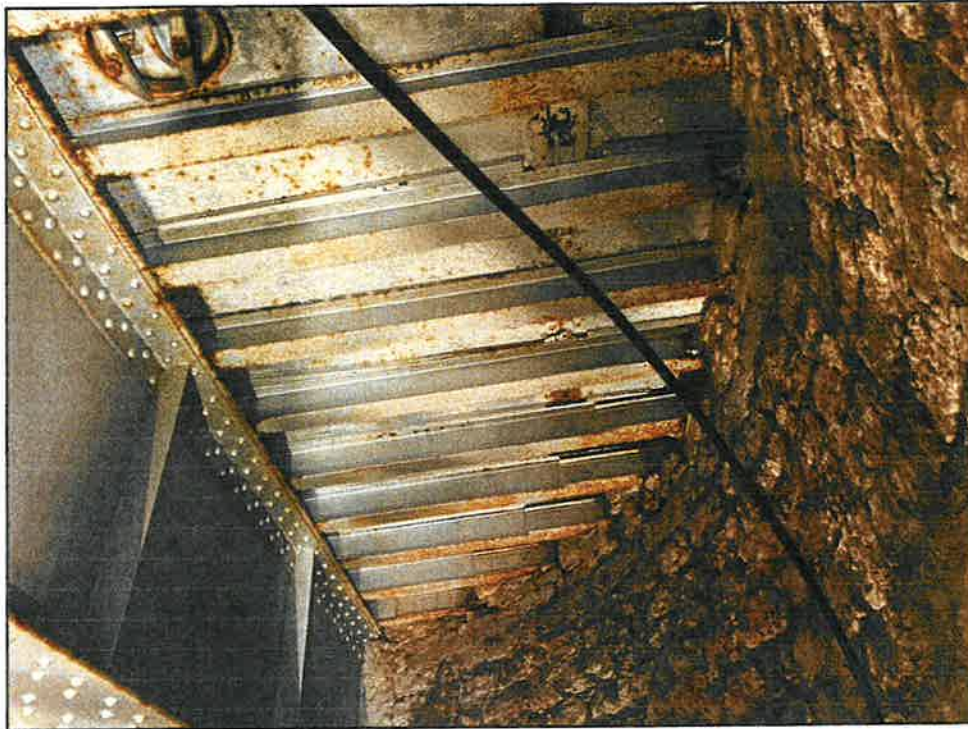
Photo 33: General surface corrosion of tank support beams with an increase near walls

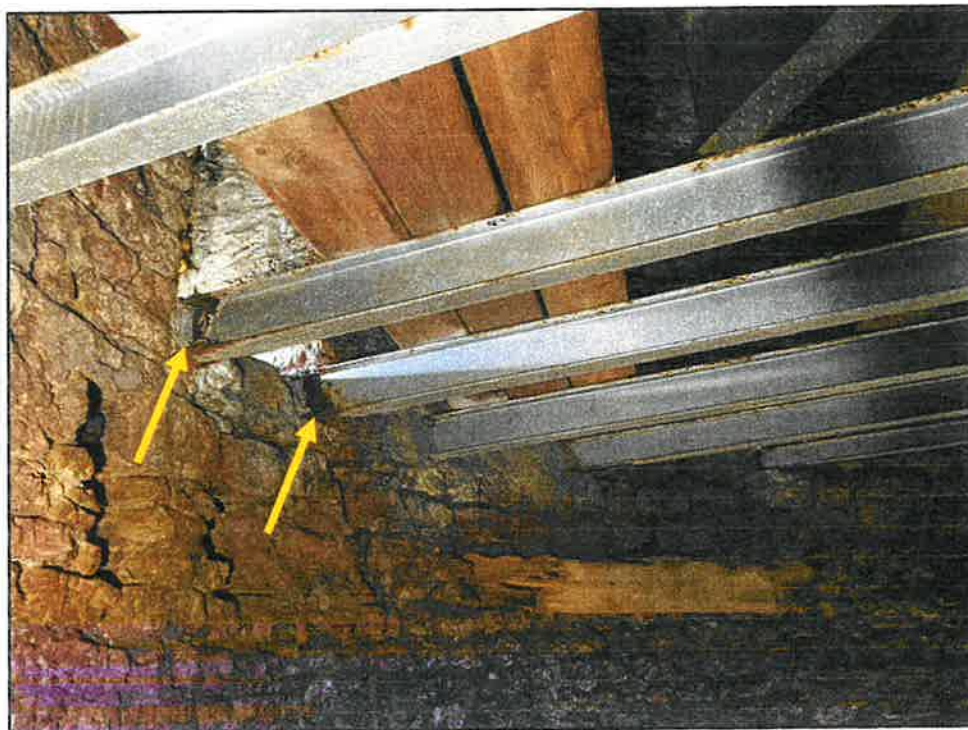
Photo 34: Signs of floor beam corrosion at walls

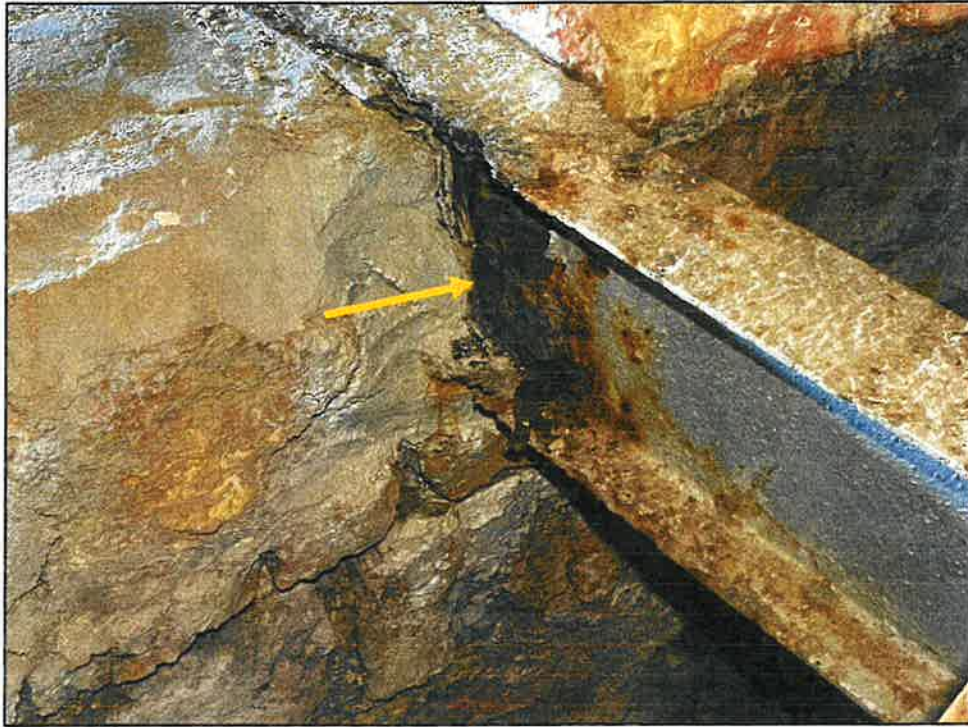
Photo 35: Corroding floor beam at exit to exterior platform

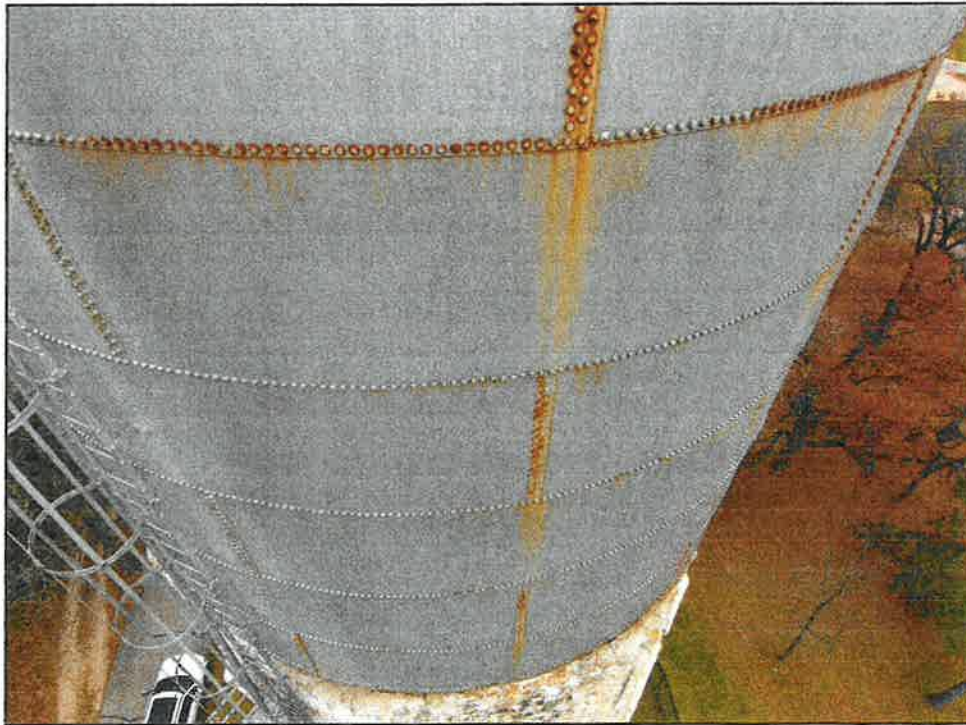
- The tank has some signs of corrosion on the exterior at the joints (Photo 36).
- The ladder on the interior of the structure has corrosion at the base and at some of the wall connections (Photos 37 and 38)

Photo 36: Rust staining on exterior of tank
