Starin Park Water Tower Structural Analysis Report

Project Address: 504 W. Starin Road
Whitewater, WI 53190

Prepared by: McEnroe Consulting Engineers, LLC
Eileen McEnroe Hankes, P.E.

Date: January 5, 2023

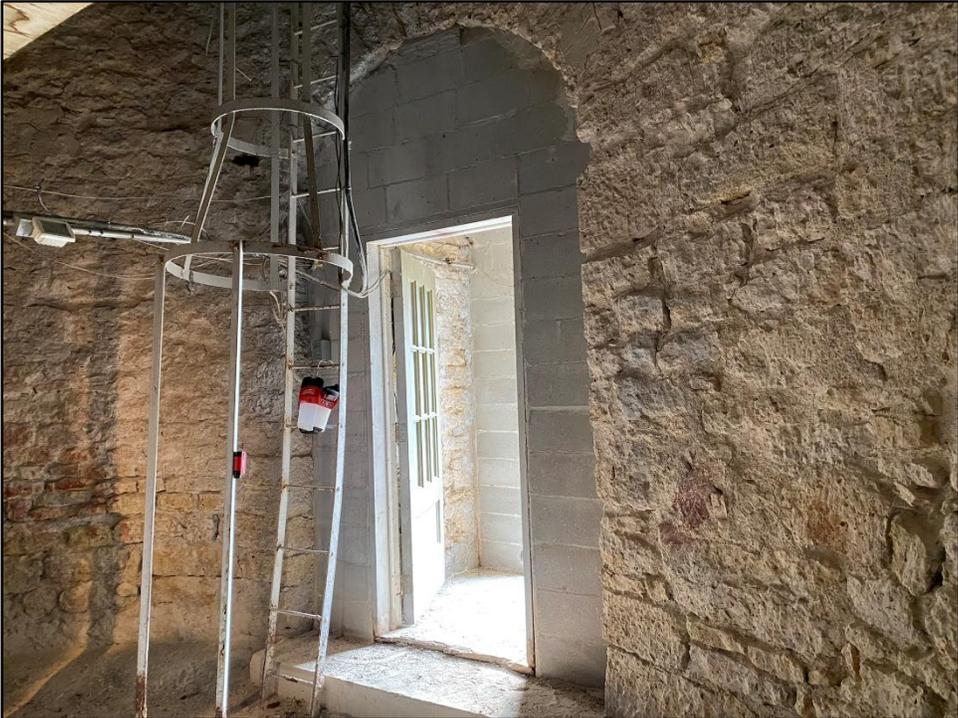
Photo 10: Modified entry door/wall

The masonry around the entry has been modified to add two concrete masonry unit (CMU) walls and a stone veneer (Photo 10 and 11).

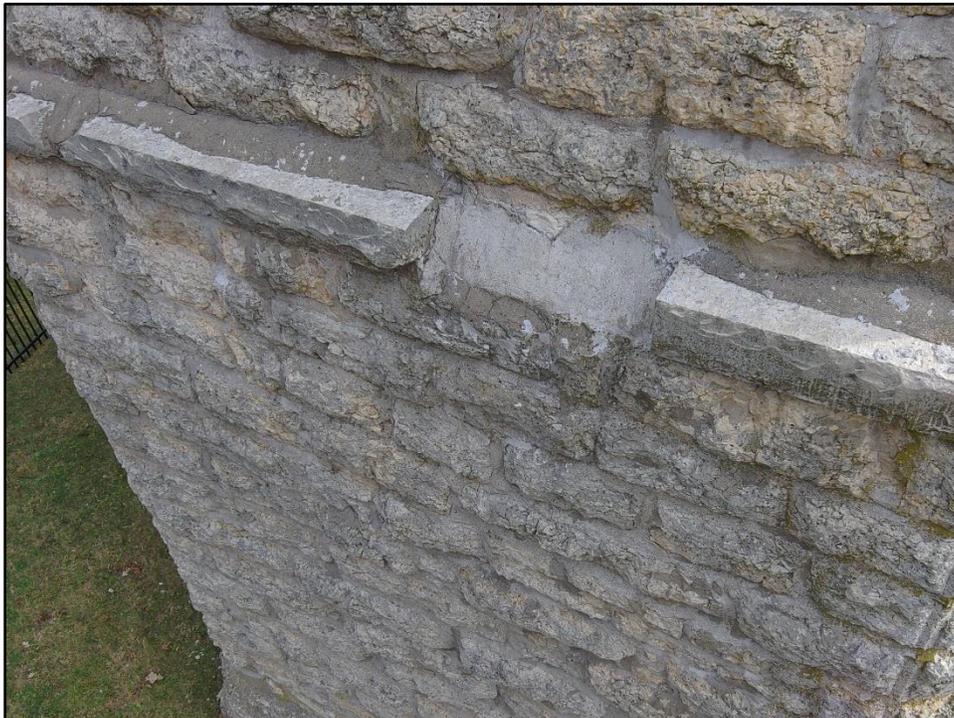
Photo 12: Missing stone

Description: Many of the stones at each belt course are in poor condition. There are stones that have fallen out or have been removed (Photo 12). Many stones that remain in place are cracked, spalled or delaminated (Photo 13 to 15).

These horizontal projections are natural places for water to enter the wall. This condition is likely due to decades of water and ice buildup along the ledges. There are mortar washes that have been installed to help shed water, but the deterioration has continued.

Repair: Replace stones that are missing as well as any that are severely deteriorated and have lots of cracking. For any stones that have minor cracking but are otherwise in generally good condition, consider pinning across the crack, or adhering the stone pieces with epoxy.

Consider adding a coping or flashing at the horizontal surfaces, particularly at the top of the wall. Keeping water out of the wall in the future will be critical to maintaining this structure. This approach comes with downsides as well though as creating a system that would be effective and also not change the appearance of the structure would be challenging. This is an architectural issue to consider during the design of repairs.

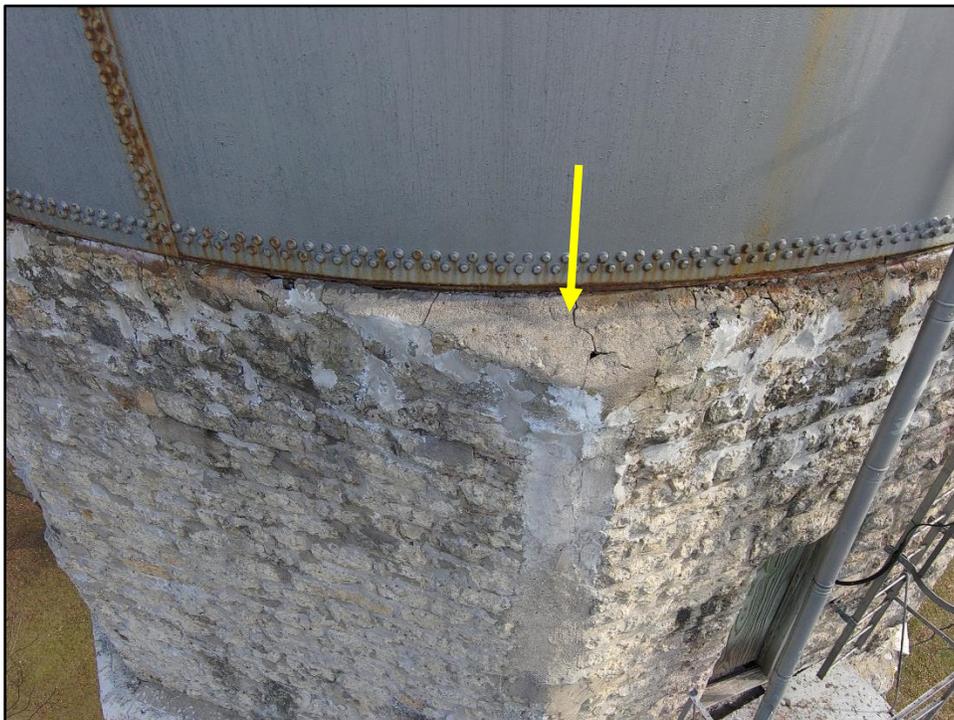
Photo 16: Deteriorating mortar wash at top of wall

This condition is particularly bad at the top of the wall (Photos 16 and 17). There is more exposed masonry here that can take on water. Also, the embedded steel tank supports are corroding and likely causing additional damage to the masonry. See Condition #7 for more discussion of the steel corrosion.

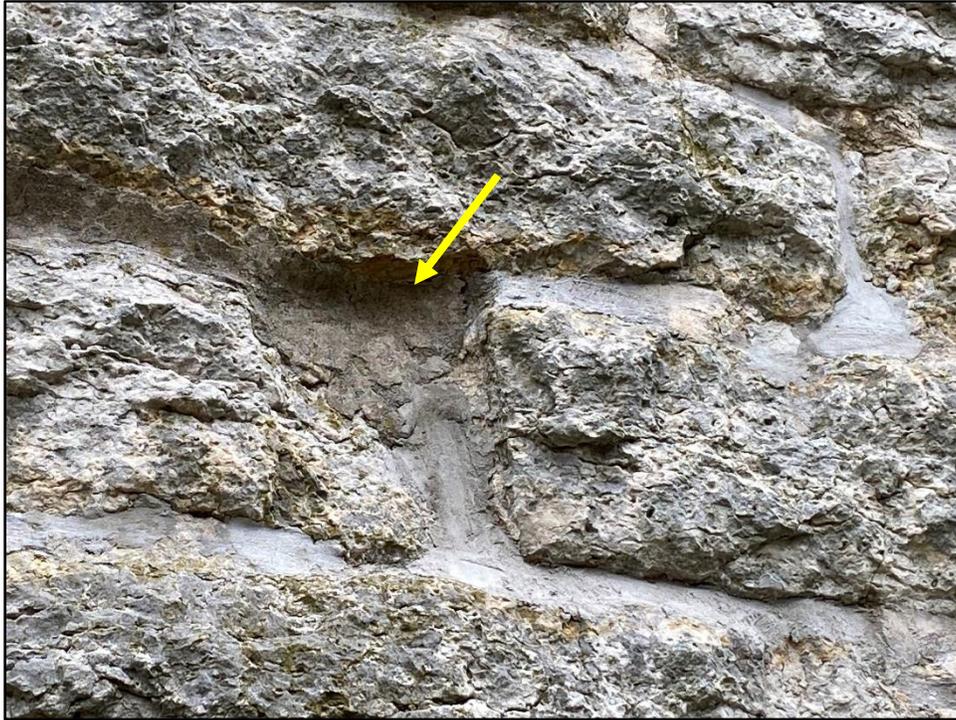
Photo 18: Isolated locations of stone spalls

Description: There are some isolated locations where stone has spalled and broken away from the structure (Photo 18). The sides of the wall openings have some spalling (Photo 19). Only one location was easily visible during this assessment, but we would expect to find conditions like this at other openings as well. One area at the top tier has a larger area that has spalled away (Photo 20). There is also some deterioration of stone near the base of the wall (Photo 21).

Repair: Areas with isolated spalled stones do not need to be repaired at this time. If a full restoration of the building is undertaken, it may be decided whether or not these locations should be addressed.

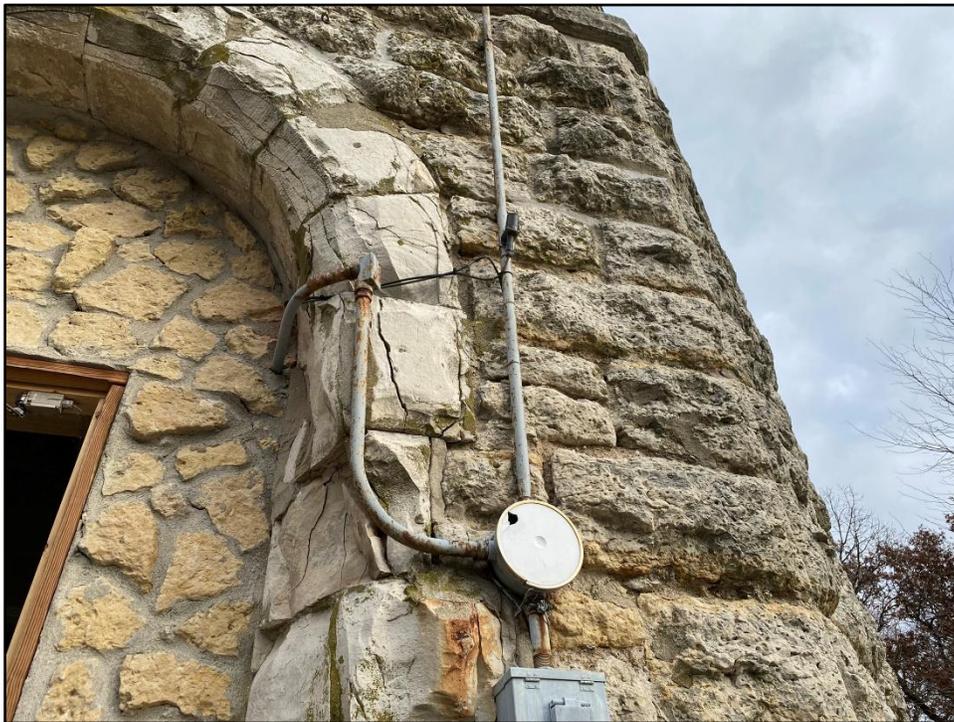
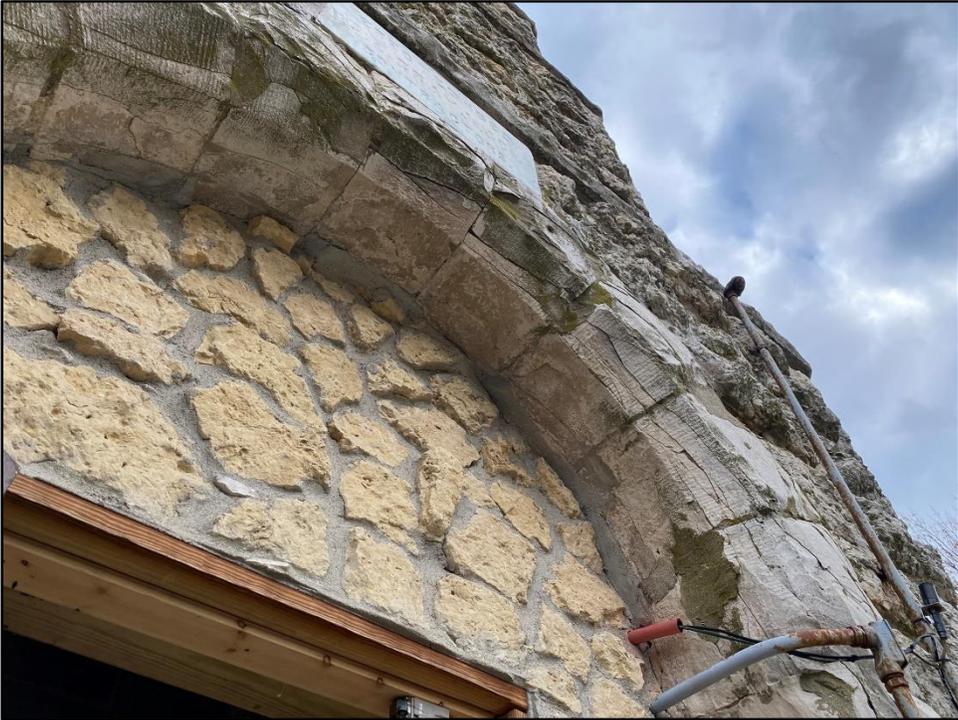
Description: Stones in some locations have significant cracking. This is particularly prevalent in the arched stones at the entryway (Photos 22 and 23). Also see Condition #1 for cracking in stones at the belt courses.

Photo 22: Cracked stone in entryway arch

Photo 23: Cracked stone in entryway arch

Repair: For a long-term repair, these stones should be replaced. The cracking is too extensive for an in-place repair to be effective.

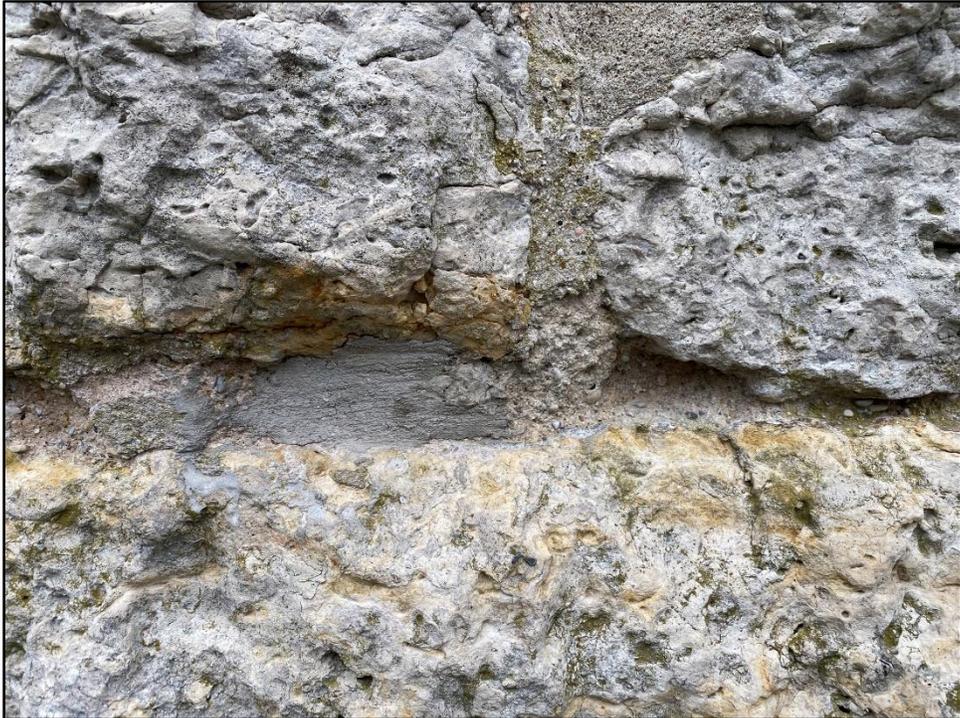
Photo 24: Different types of mortar

The exterior wall joints have had a lot of spot repointing in the past (Photos 24 to 27), which is to be expected for most structures. It does appear that some of the previous mortar may be harder than appropriate, which may be the cause of some of the isolated stone spalling and cracking.

Repair: Repoint loose mortar joints. The joints on the exterior should have a higher priority than those on the interior. Repointing can be performed in sections throughout the building over time, or when access is available. For the purpose of planning, it would be appropriate to assume that 5% to 10% of the building will need to be repointed. While most of the building is in good condition at this time, the joints will continue to deteriorate while planning progresses and if repairs are staged over time.

The mortar should be matched to the original mortar. Prior to performing any repair work on this building, the mortar should be analyzed to determine the composition of the appropriate repair mortar.

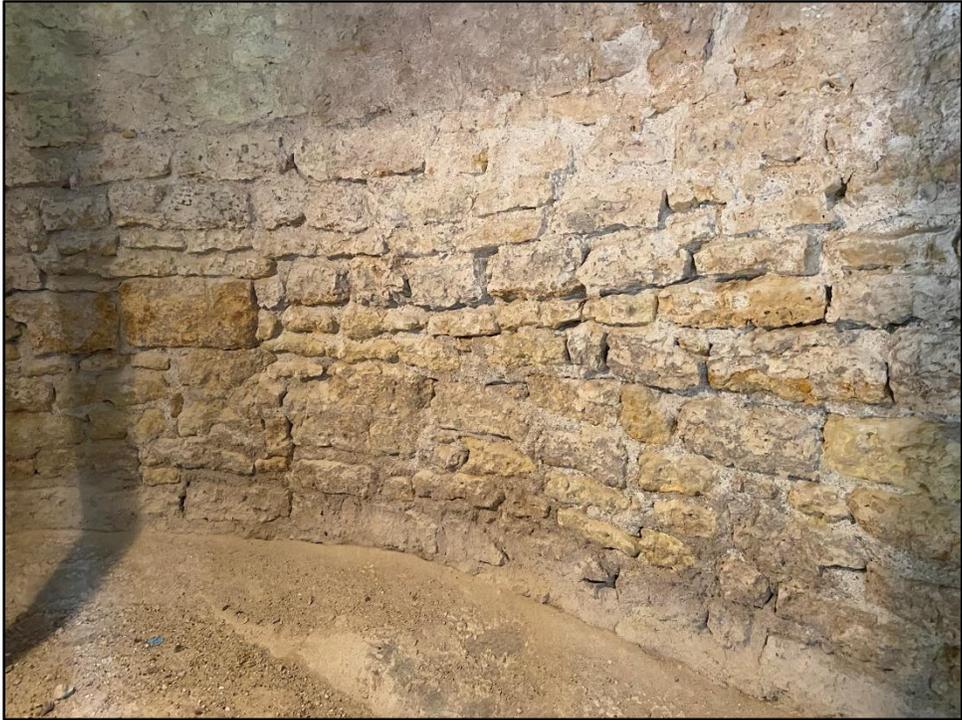
The interior wall joints are very loose and mortar is falling out of the joints and collecting on the floor (Photo 28).

Keeping mortar joints in good condition is key to the longevity of this structure. Given the age of the structure, we would anticipate that the original lime mortar used would be deteriorating and reverting to a sandy material. This is not necessarily an issue near the center of the wall as long as it is kept in place by the mortar on the wall faces.

Photo 28: Deteriorated joints on interior – dust on floor is deteriorated mortar

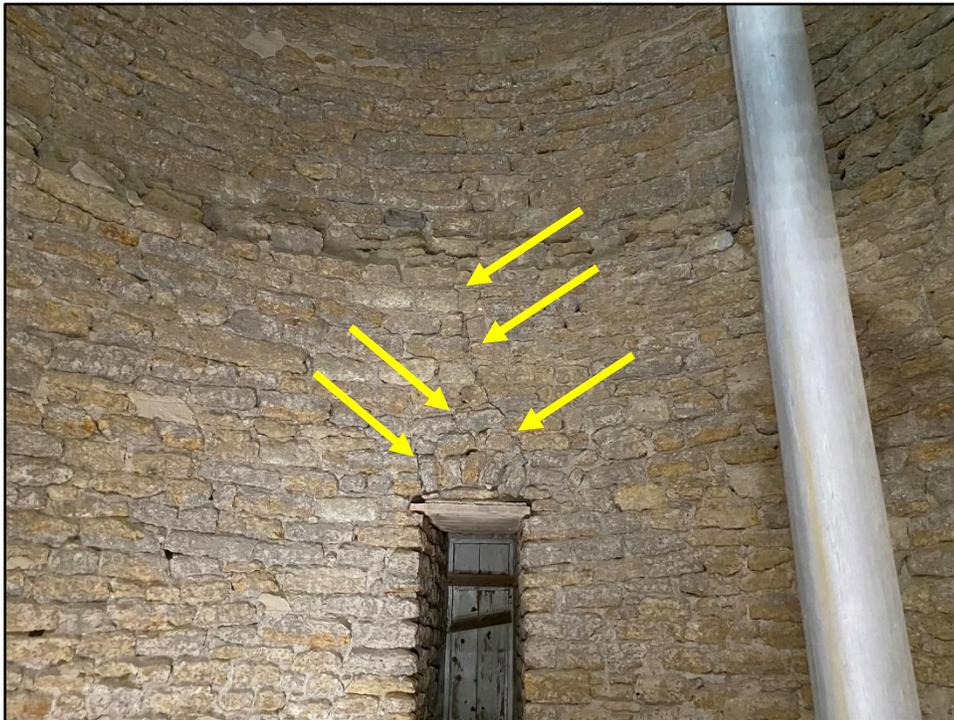
Description: A crack was noted on the interior of the structure above an opening on the north wall (Photo 29).

Photo 29: Crack on interior of tower

Repair: Repoint cracked mortar joints and epoxy or pin across cracks in the stone.

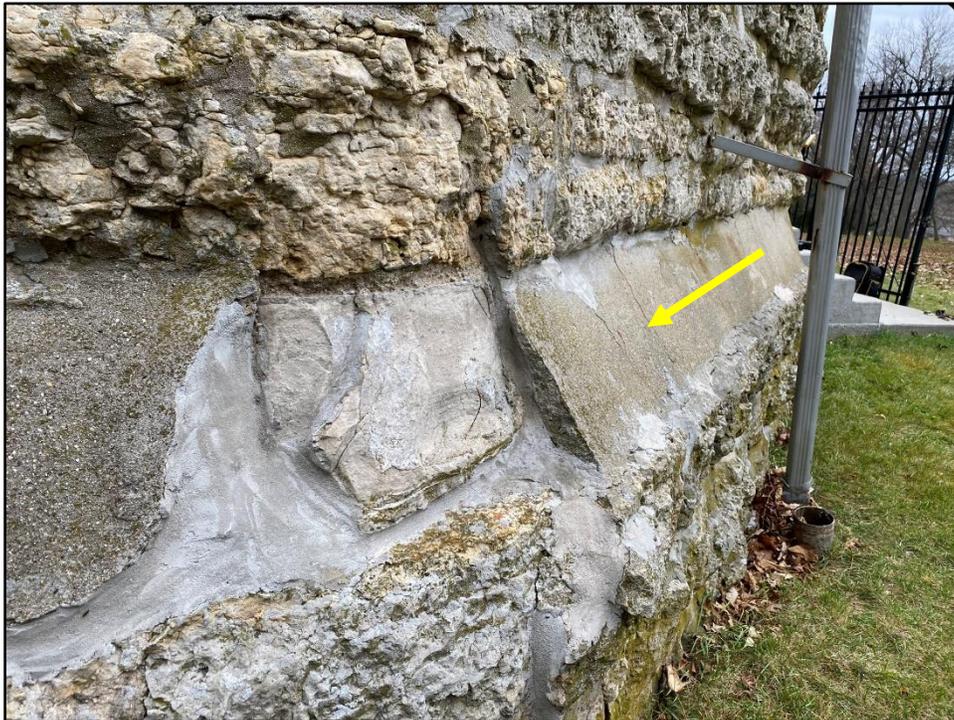
Description: There has been a concrete or mortar wash placed at the base of the wall. It has fallen off in many locations and is cracked in other locations (Photo 30). The use of concrete or a hard mortar is not appropriate for this building.

Photo 30: Cracked and missing concrete/mortar wash

Repair: When belt courses discussed in Condition #1 are being addressed, repair this as well. There may need to be stones replaced where they are cracked or spalled. Mortar joints should be replaced. If there is still a need for water deflection at this location, consider installing a mortar wash with a material matching the original building mortar, but anticipate that it will need to be maintained on a regular basis.

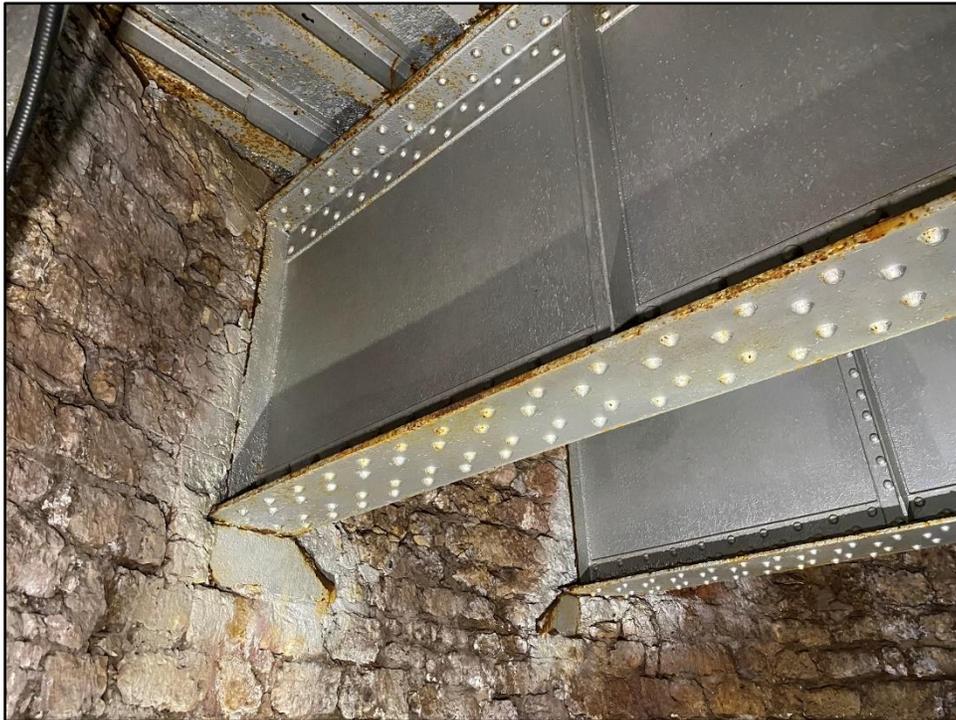
- Description:** The steel beams and plate girders holding the tank have light corrosion, particularly near the masonry walls (Photos 31 to 33). The beams that form the floor below the tank also have corrosion at the exterior walls (Photos 34 and 35).

Photo 31: General light corrosion on support structure

- Repair:** Perform some exploratory openings at locations where beams are bearing on walls. Exposing the steel members will determine whether repairs are needed. If repairs are needed it will likely involve welding new steel plates/angles/etc to the existing steel to replace the lost steel capacity.

- At a minimum, exposed steel members should be primed and painted to extend the life of the structure.
- Once water is removed from the tank, the interior should be inspected by a tank inspector to determine whether the tank itself, or its connections to the base, require repairs.

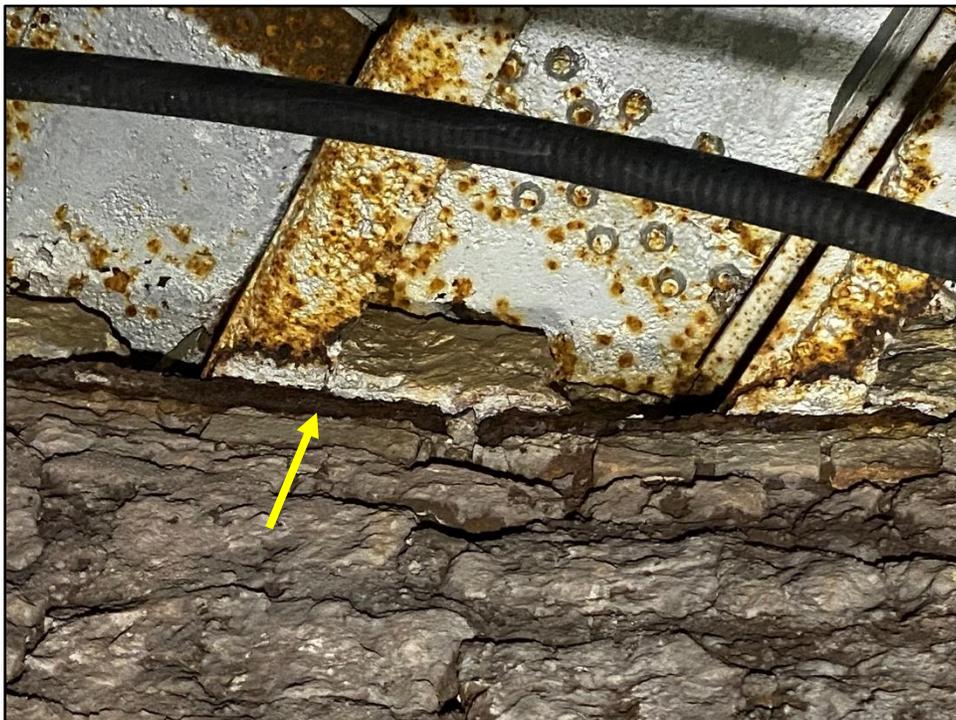
Photo 32: Close up of tank supports at wall

There is a steel plate on top of the masonry that is corroding as well as the base of the tank

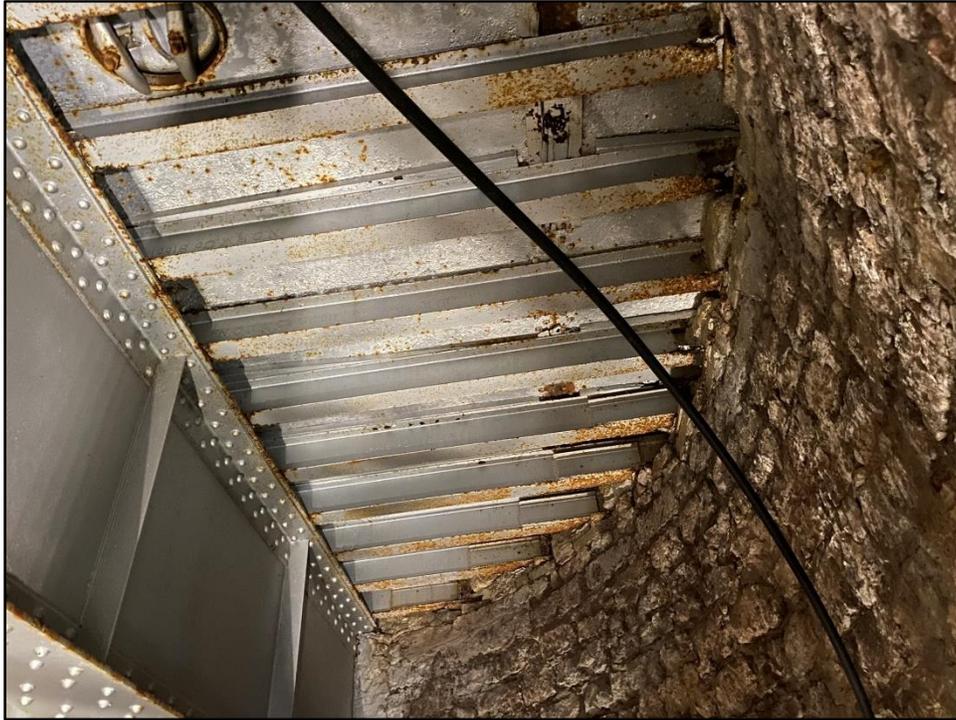
Photo 33: General surface corrosion of tank support beams with an increase near walls

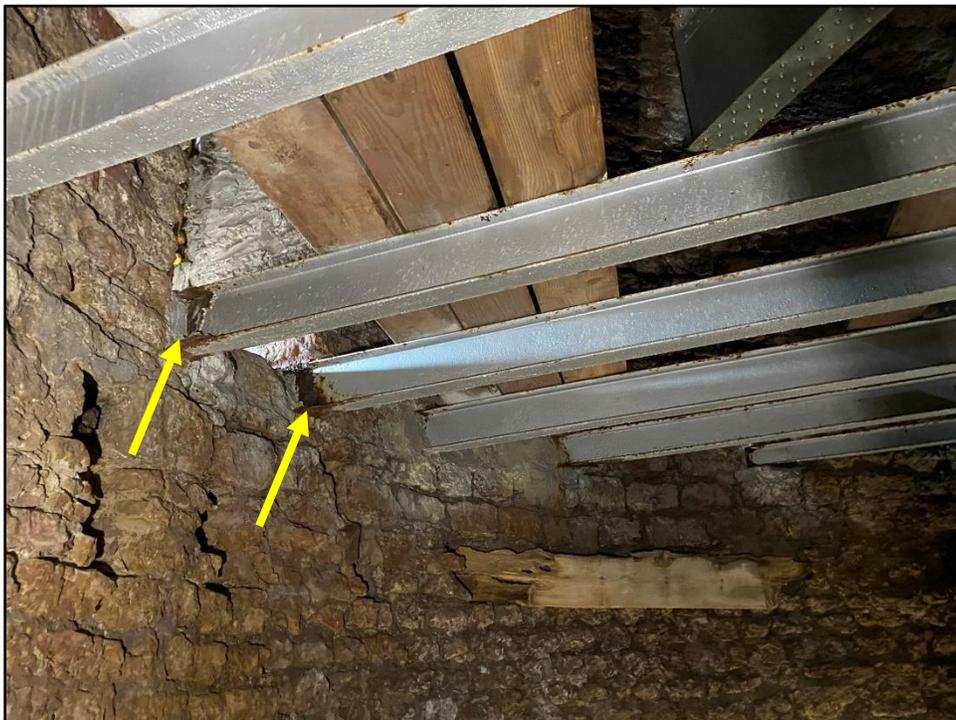
Photo 34: Signs of floor beam corrosion at walls

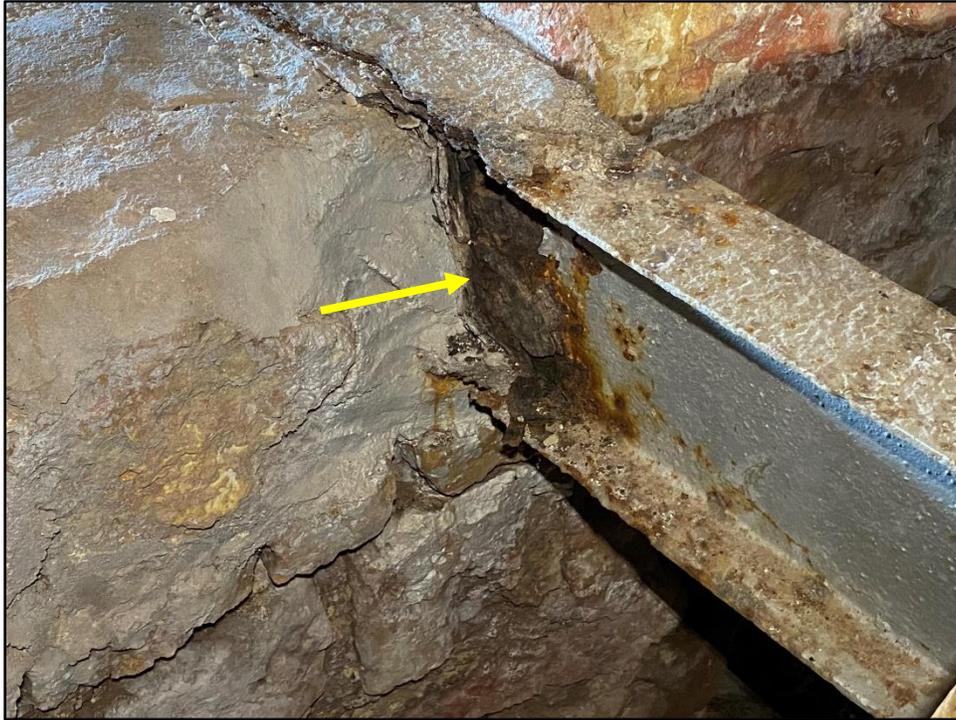
Photo 35: Corroding floor beam at exit to exterior platform

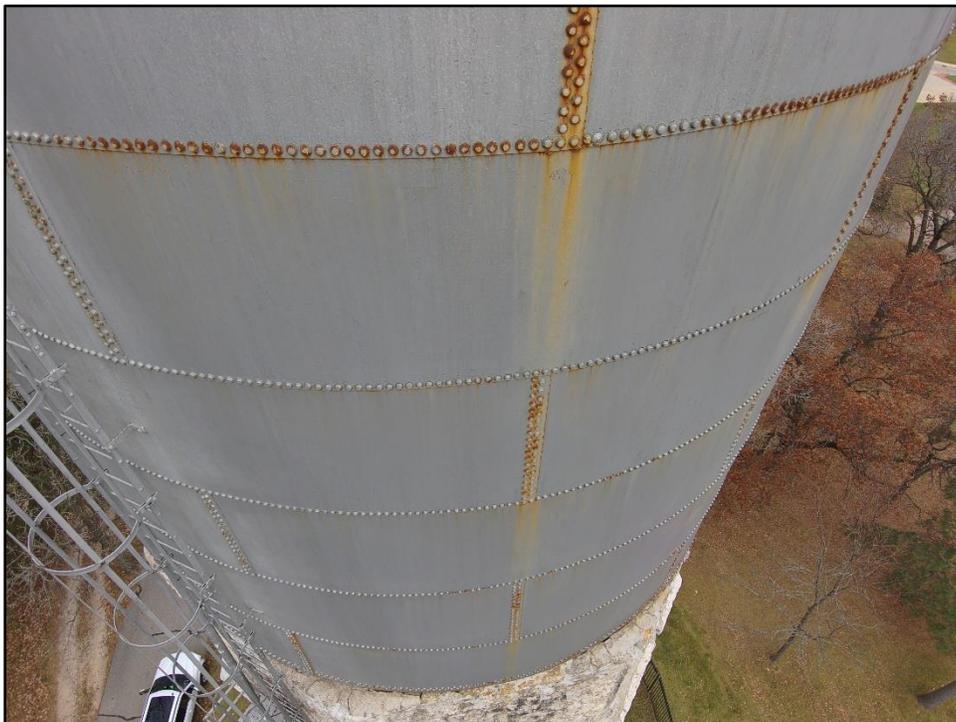
- The tank has some signs of corrosion on the exterior at the joints (Photo 36).
- The ladder on the interior of the structure has corrosion at the base and at some of the wall connections (Photos 37 and 38)

Photo 36: Rust staining on exterior of tank

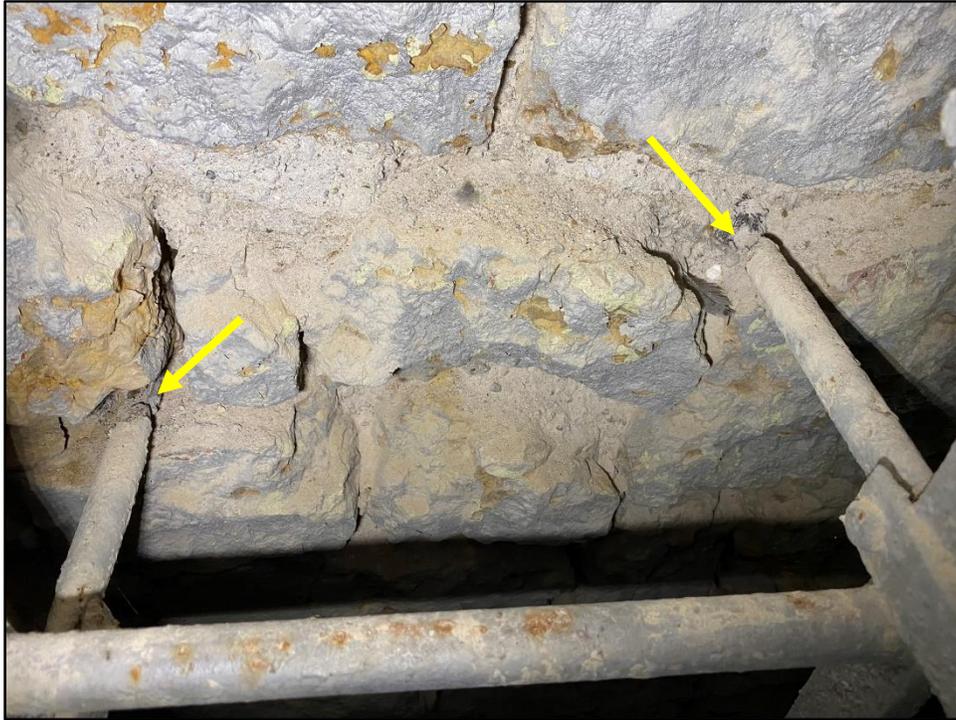
Photo 37: Corroded ladder connections at wall

- The interior ladder's base and connections to the wall should be reinforced with new steel elements. The exterior platform and ladder should be inspected in greater detail when access is available, or when repairs begin.

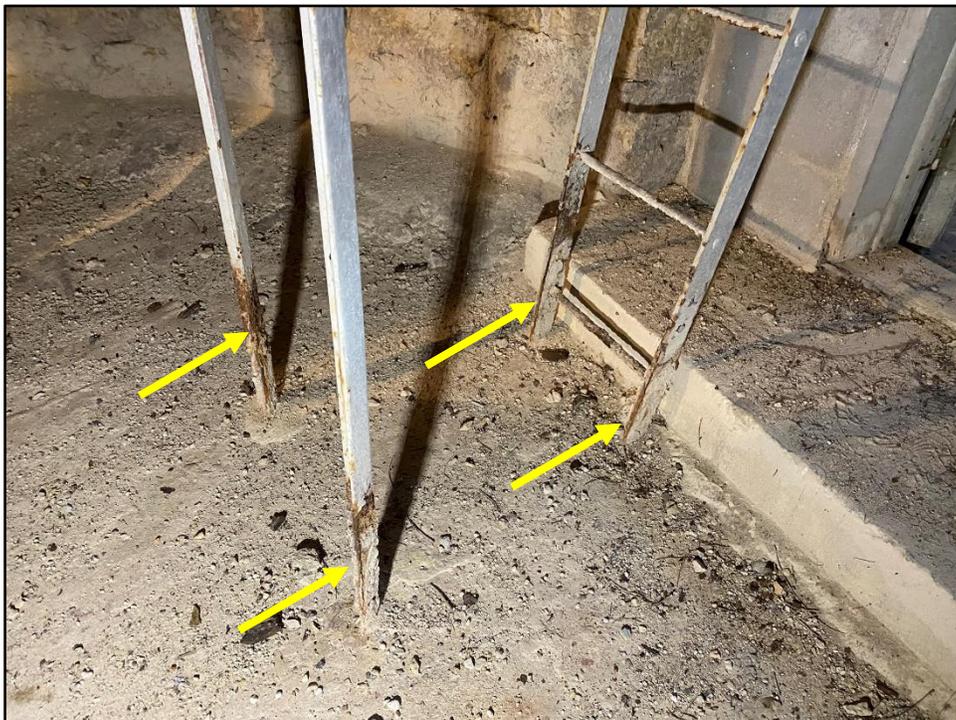
Photo 38: Base of interior ladder – corrosion on all pieces

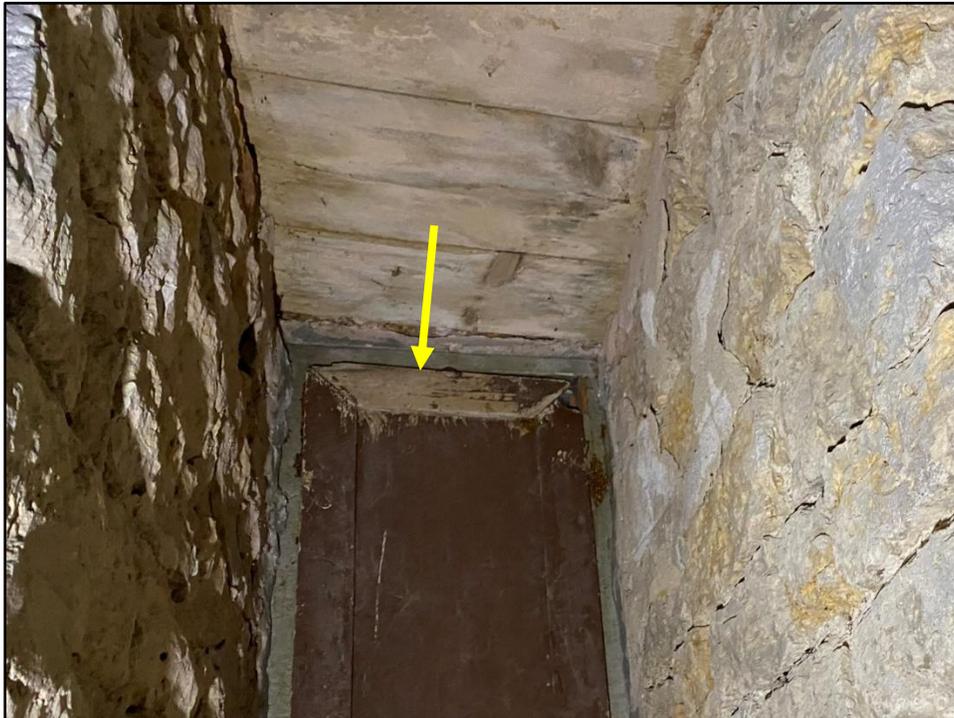
Description: The wood panels over the access openings are rotting (Photo 39). This is not a significant concern in the overall scope of this structure. However, we recommend addressing it when there is access and when the surrounding masonry is being addressed.

Photo 39: Minor wood deterioration at access panels

Repair: Replace deteriorating wood in kind.
