DATE: July 13, 2024
TO: Dustin Schull, Parks Supervisor, City of Wilsonville
FROM: Morgan Holen, Consulting Arborist
RE: Wilsonville Oregon White Oak Tree Monitoring 2024

MHA24008

Oregon White Oak MOB Assessment 2024

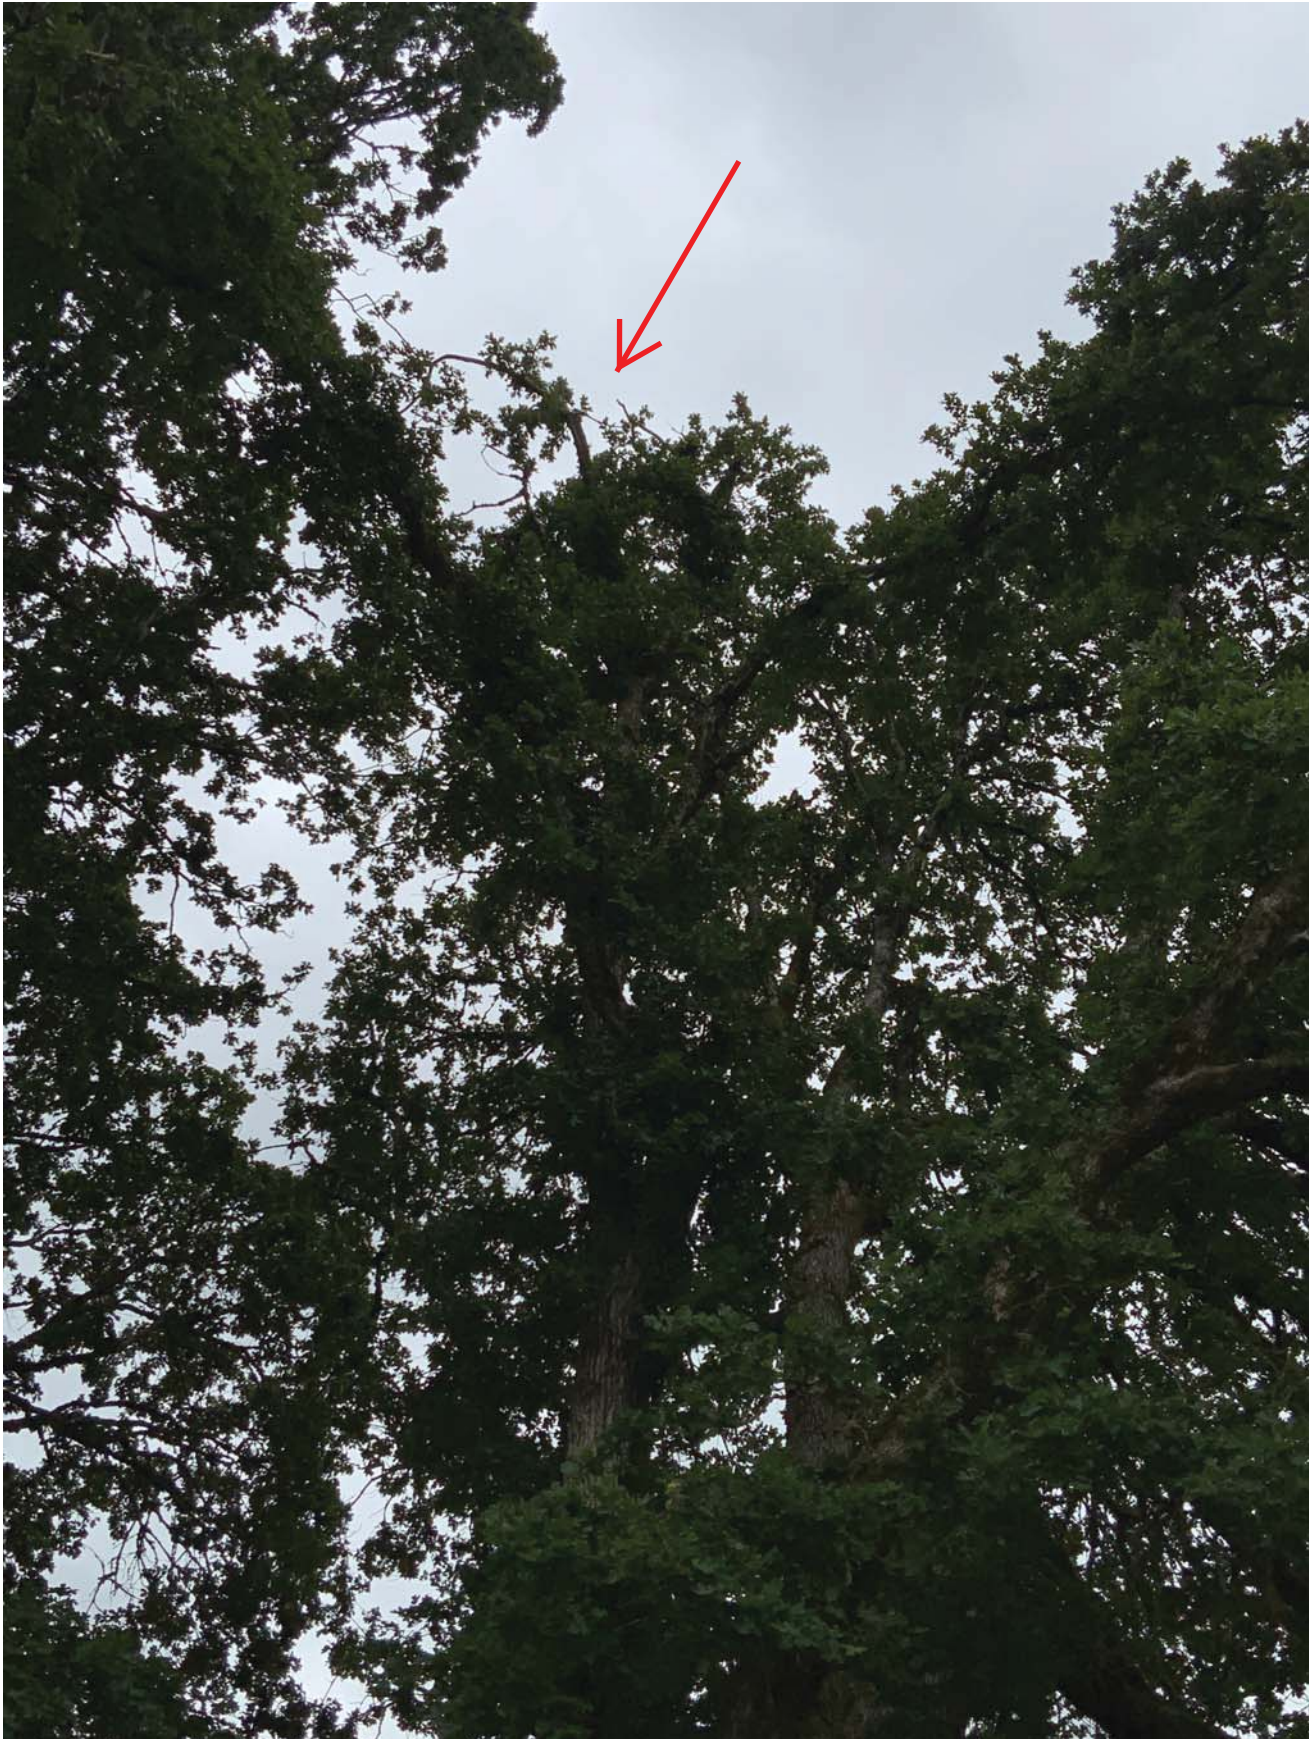
Photo 1. Tree #25563 - Arrow points to history of leader failure in one codominant stem where pruning could be conducted to clean up wounds and improve structure.

- Pruning: at tree #599 to clean the crown of dead wood and broken branches; to remove the 12-inch diameter dead stem from tree #25719; to improve the structure of one codominant stem with a history of leader failure at tree #25563; and, consider pruning the bigleaf maple (*Acer macrophyllum*) tree located adjacent to tree #56389 to improve growing space for the oak.

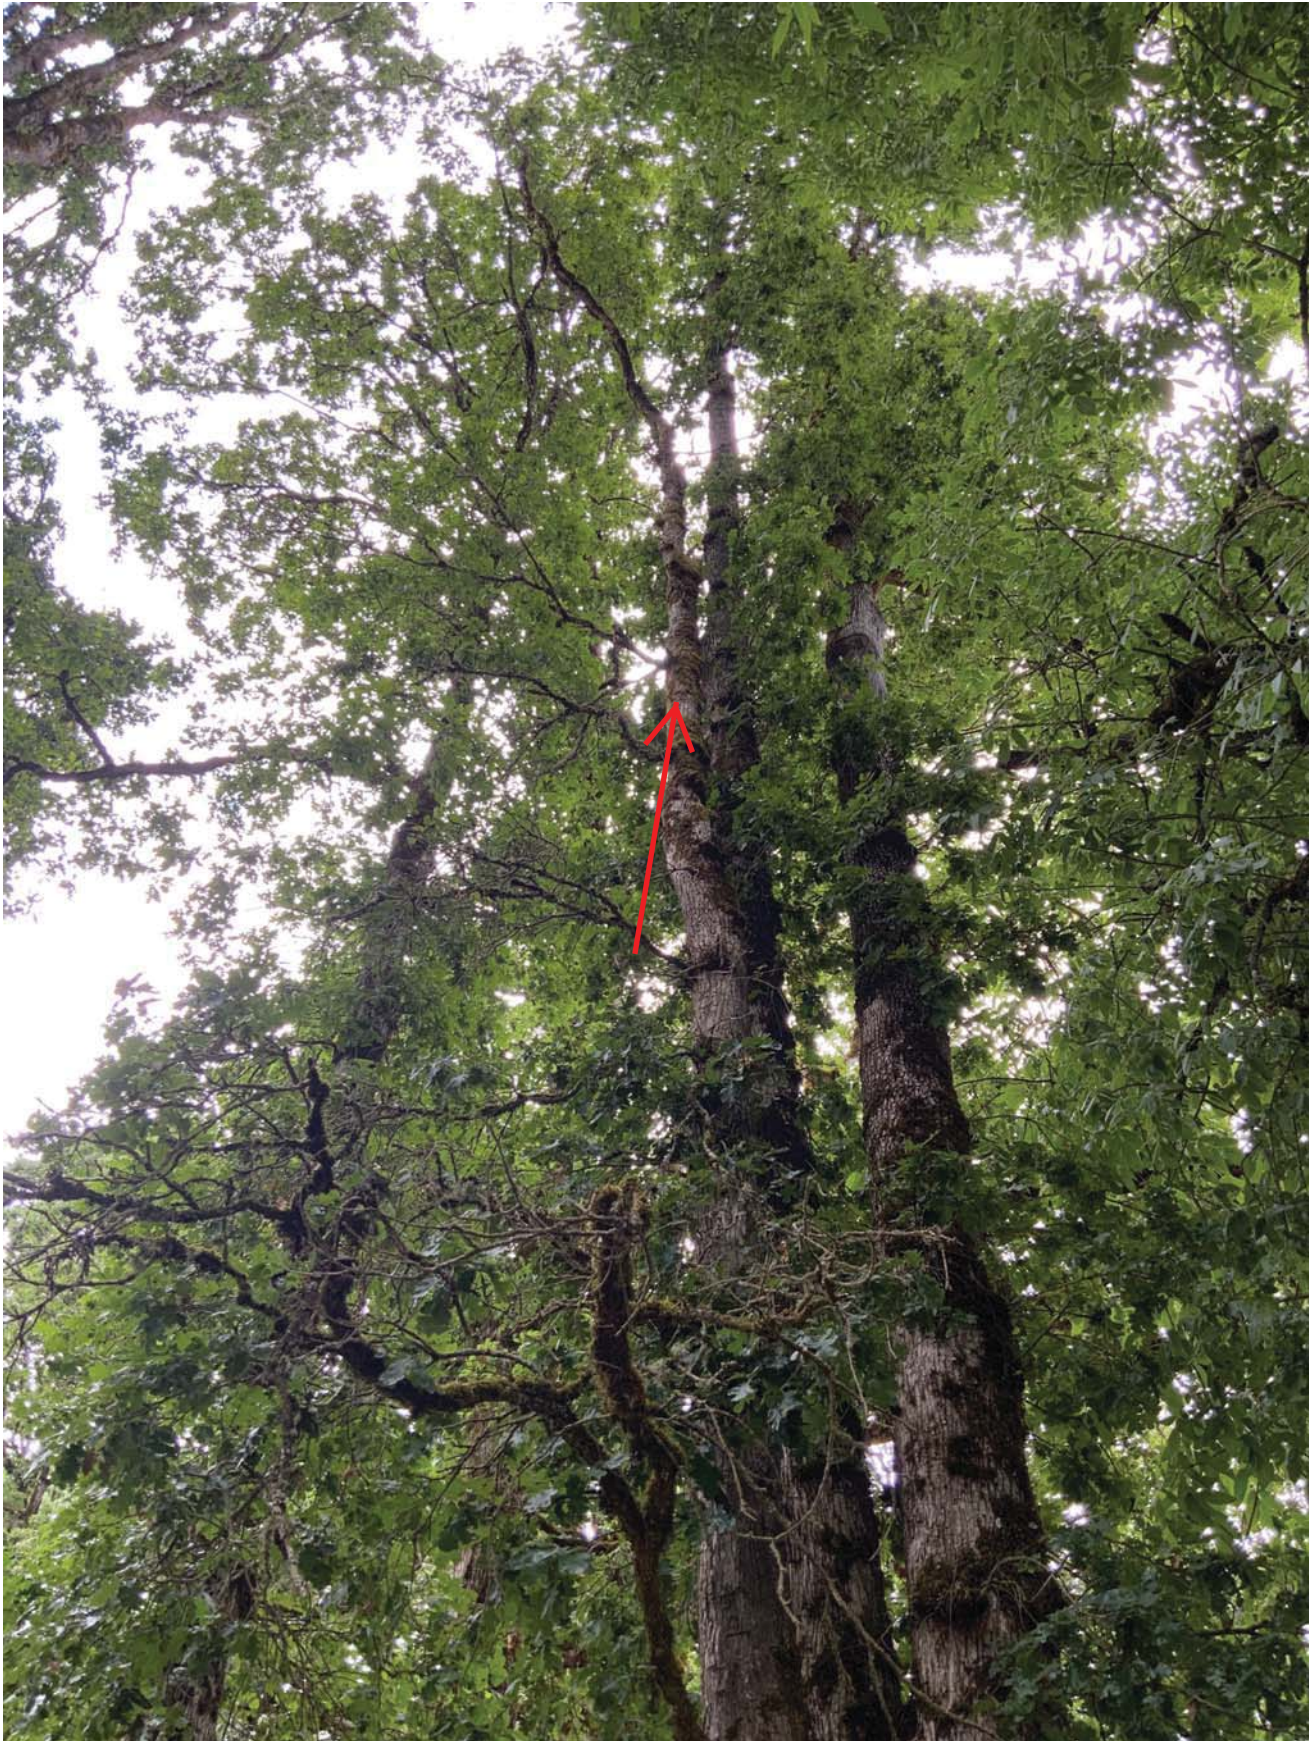
Photo 2. Tree #25719 - Arrow points to 12" diameter dead codominant stem that could be removed.

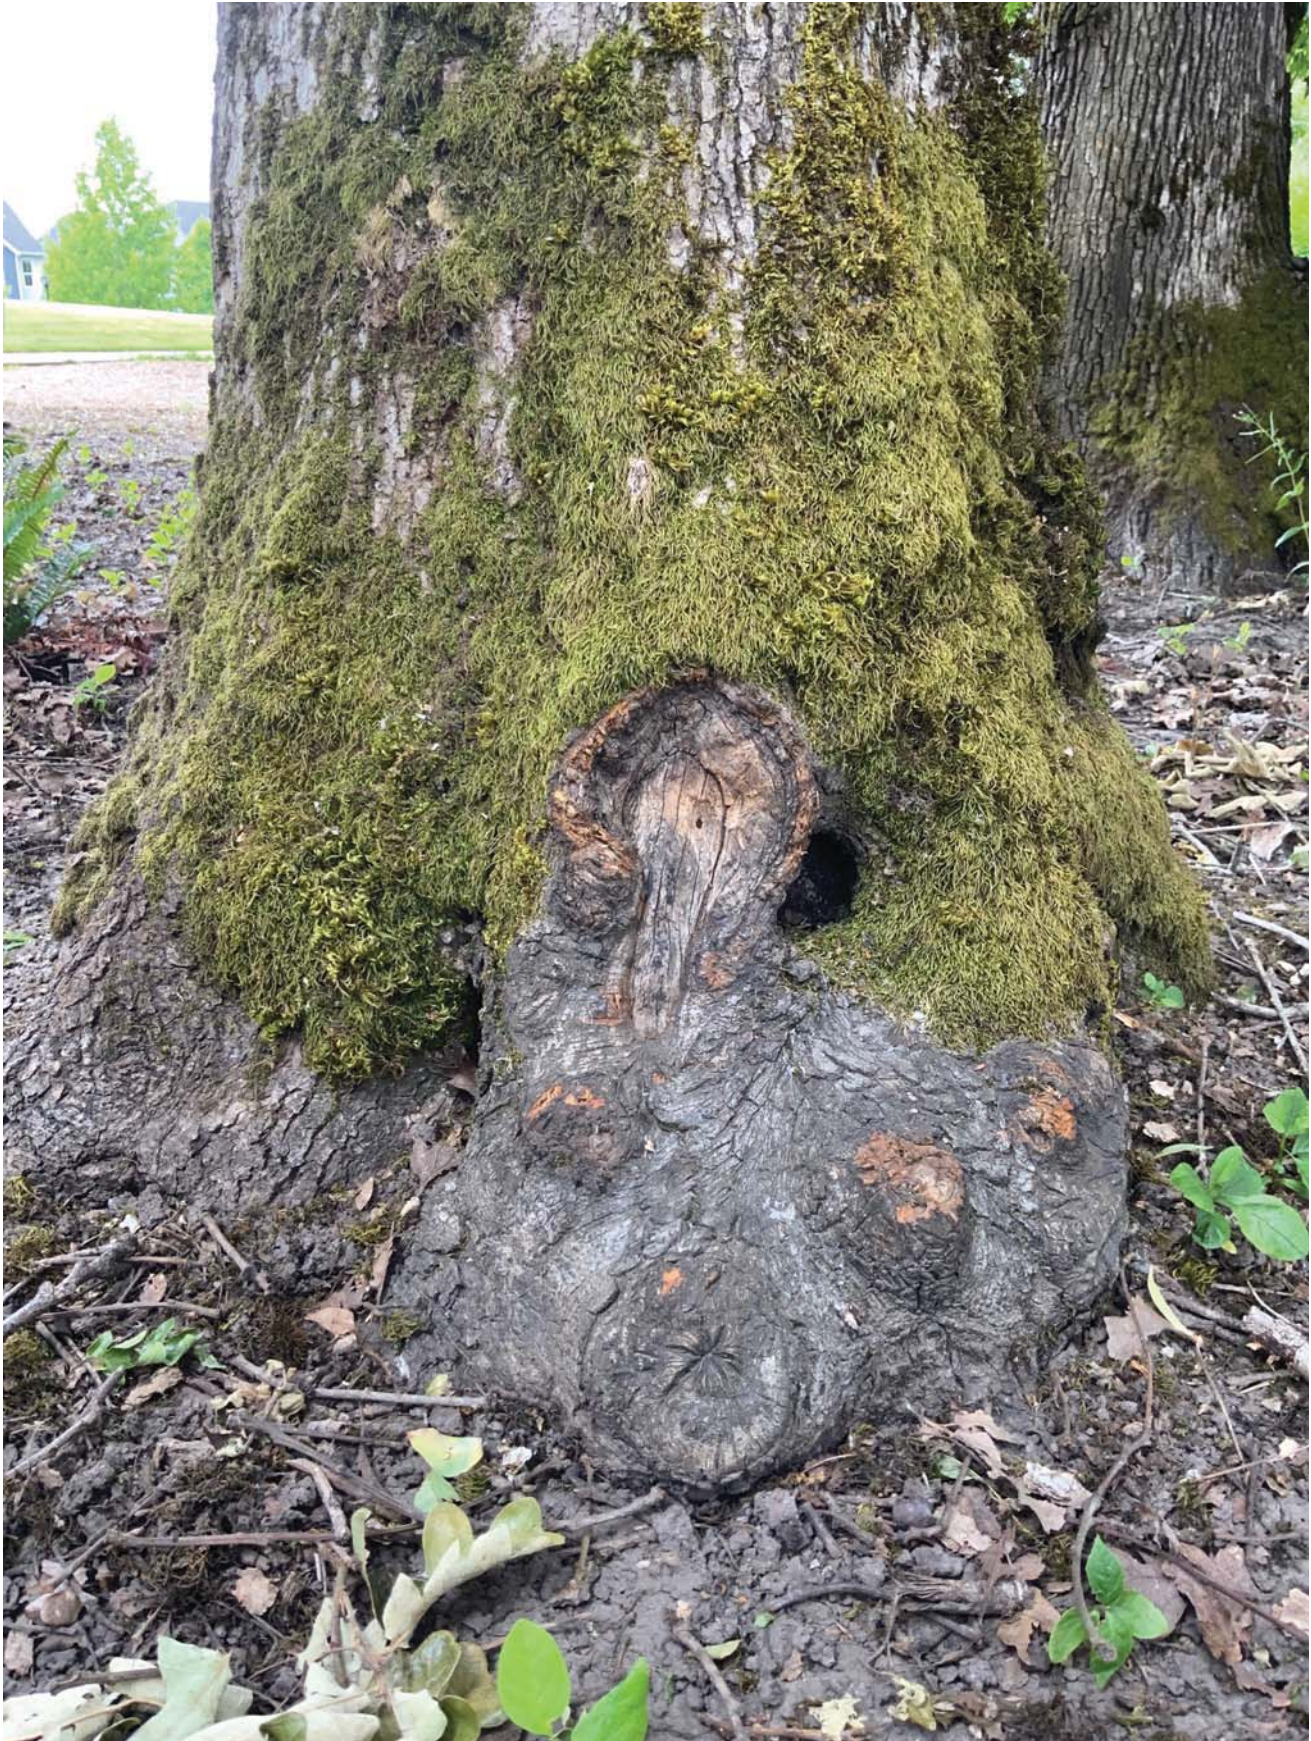
Photo 3. Tree #25722 - Lower trunk wound with hollows on northwest face.

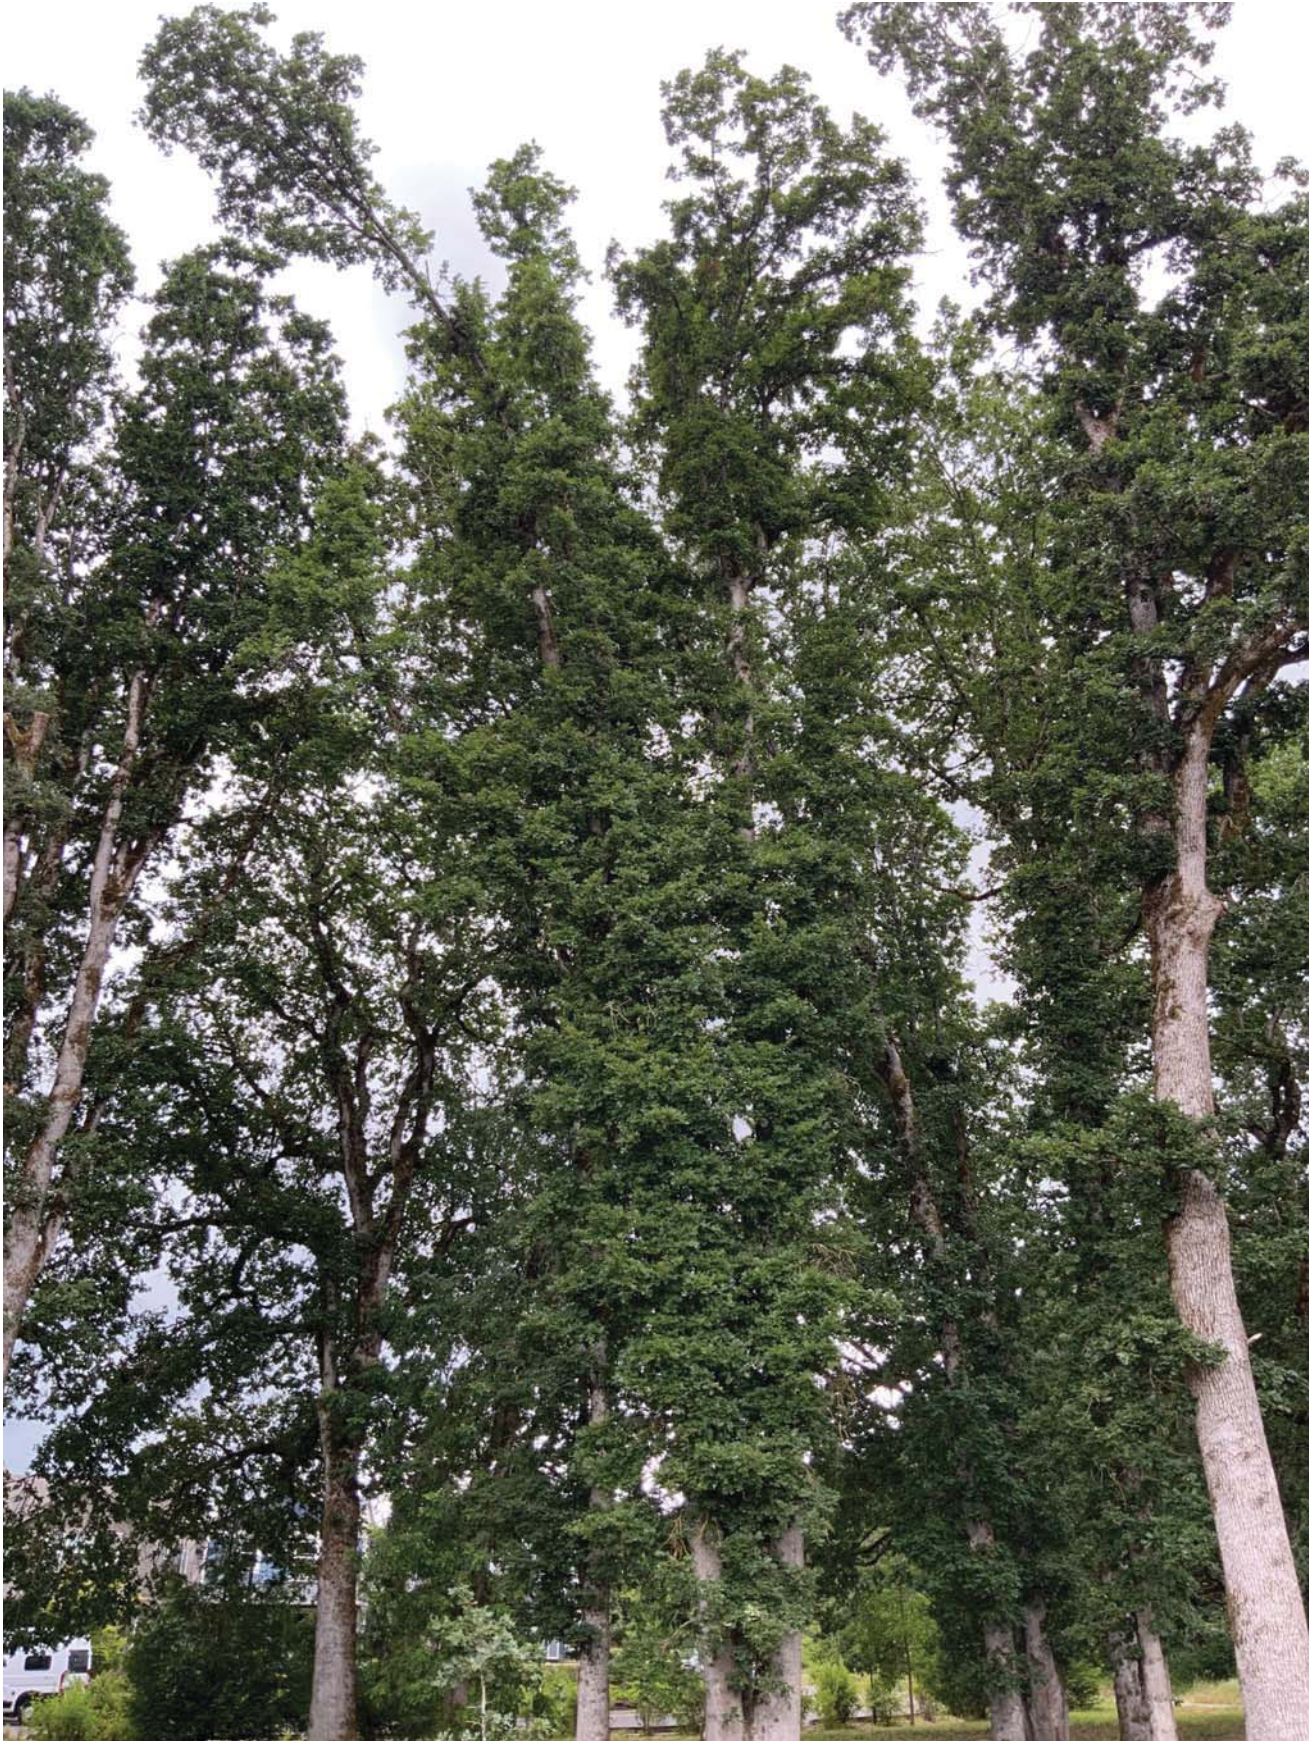
Photo 4. Tree #25738 - Three codominant leaders with high live crown, few lateral limbs, almost entirely epicormic sprouts, dead ~6" branch on west face likely not from MOB.

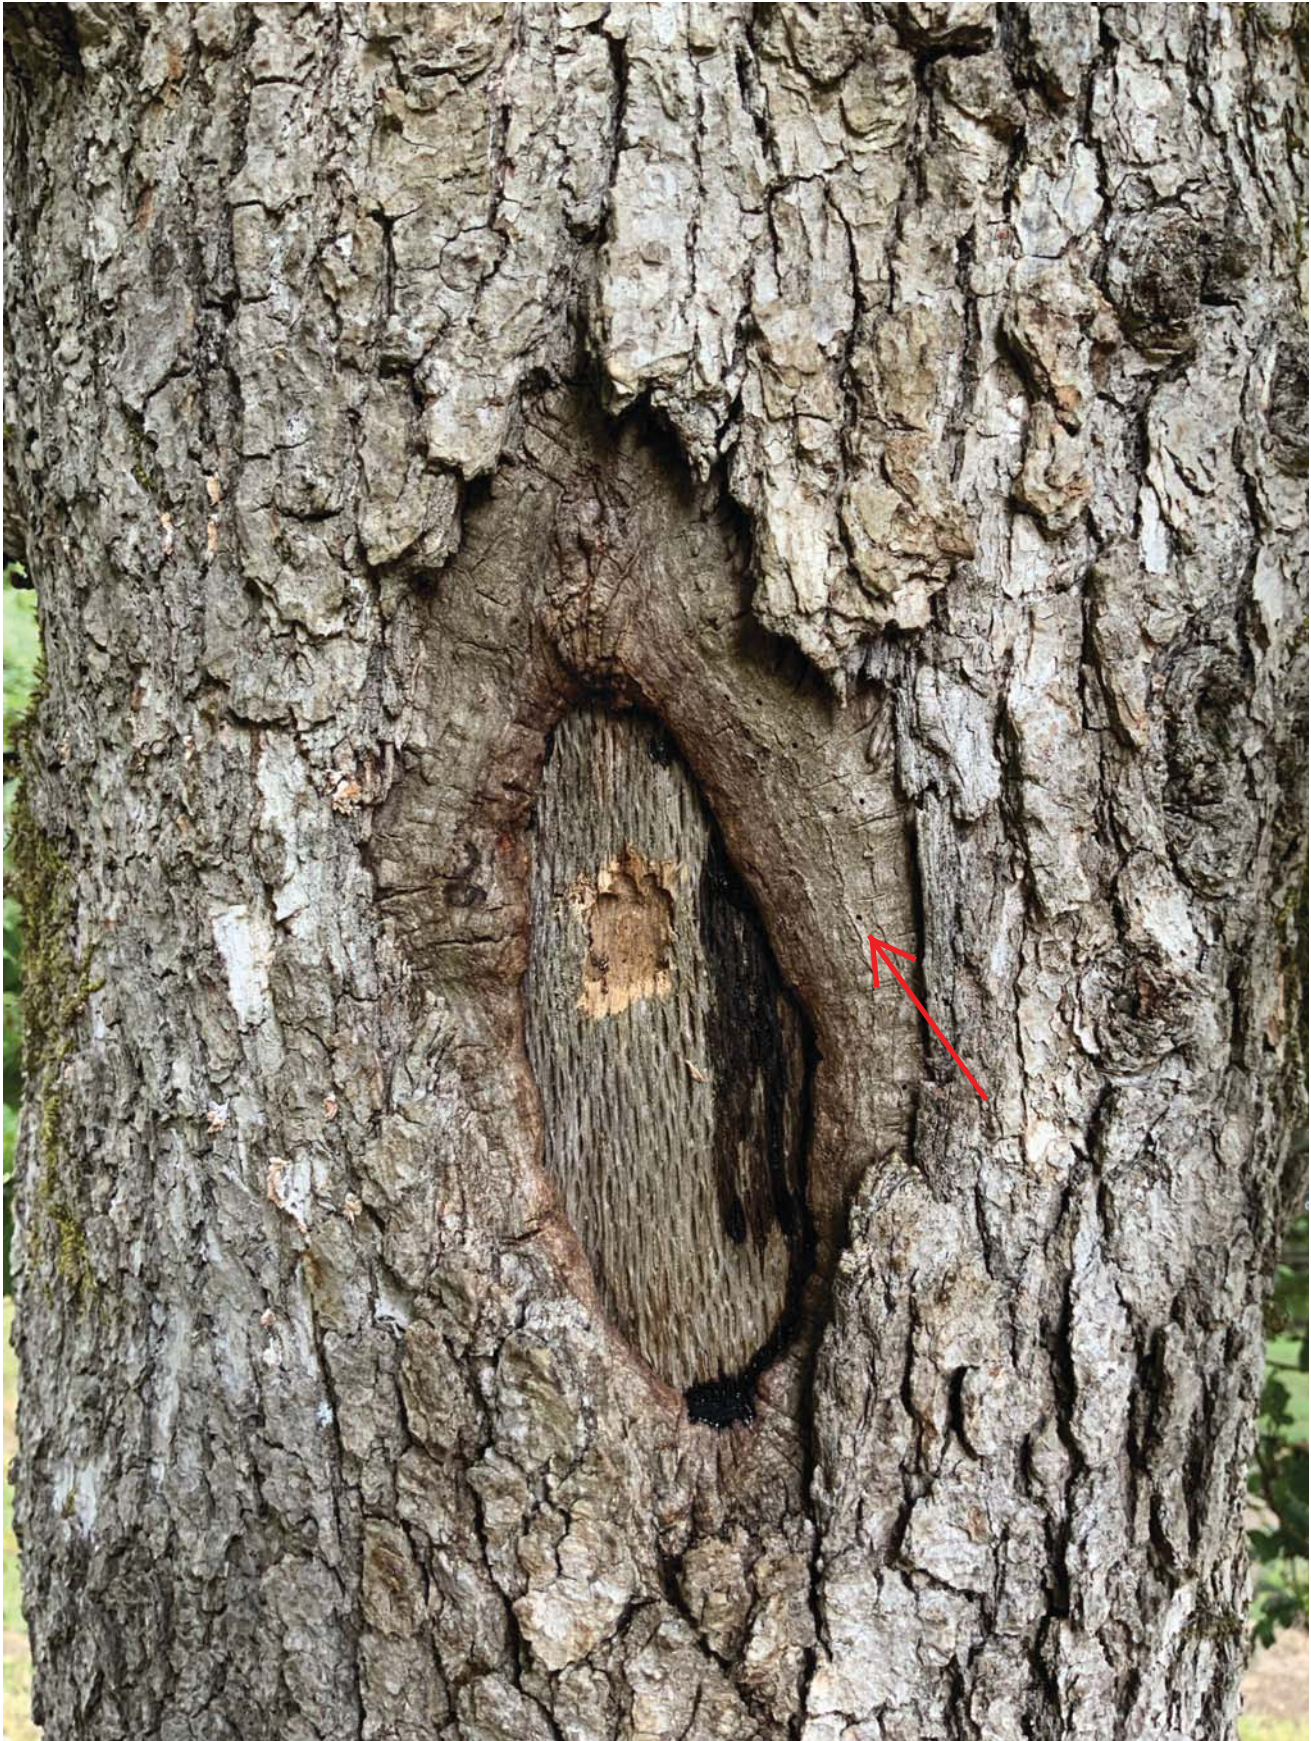
- Tree #25743, a generally health tree in fair condition where MOB was not previously identified and the tree has not been treated. No major crown dieback or fine frass was observed, but entrance and exit bore holes of three different sizes were observed at old wounds, with the tiniest holes resembling MOB. Consider systemic insecticide treatment this year, apply arborist chip mulch to improve site conditions, and monitor it on a more frequent basis.

Photo 5. Tree #25743 - No major dieback or frass, but tiny exit holes of three different sizes observed at old wounds; tiniest holes suspected to be from MOB. Arrow points to an example.

- Systemic insecticide treatment this year for tree #25743, which was not previously treated.
- Removal of MOB infested trees #60655 and #56833 because they are no longer viable. Tree #56833 could be carefully dissected to look for live or dead MOB to help inform the efficacy of last year's treatment. The stumps of both trees should also be removed by grinding the stumps below ground level.

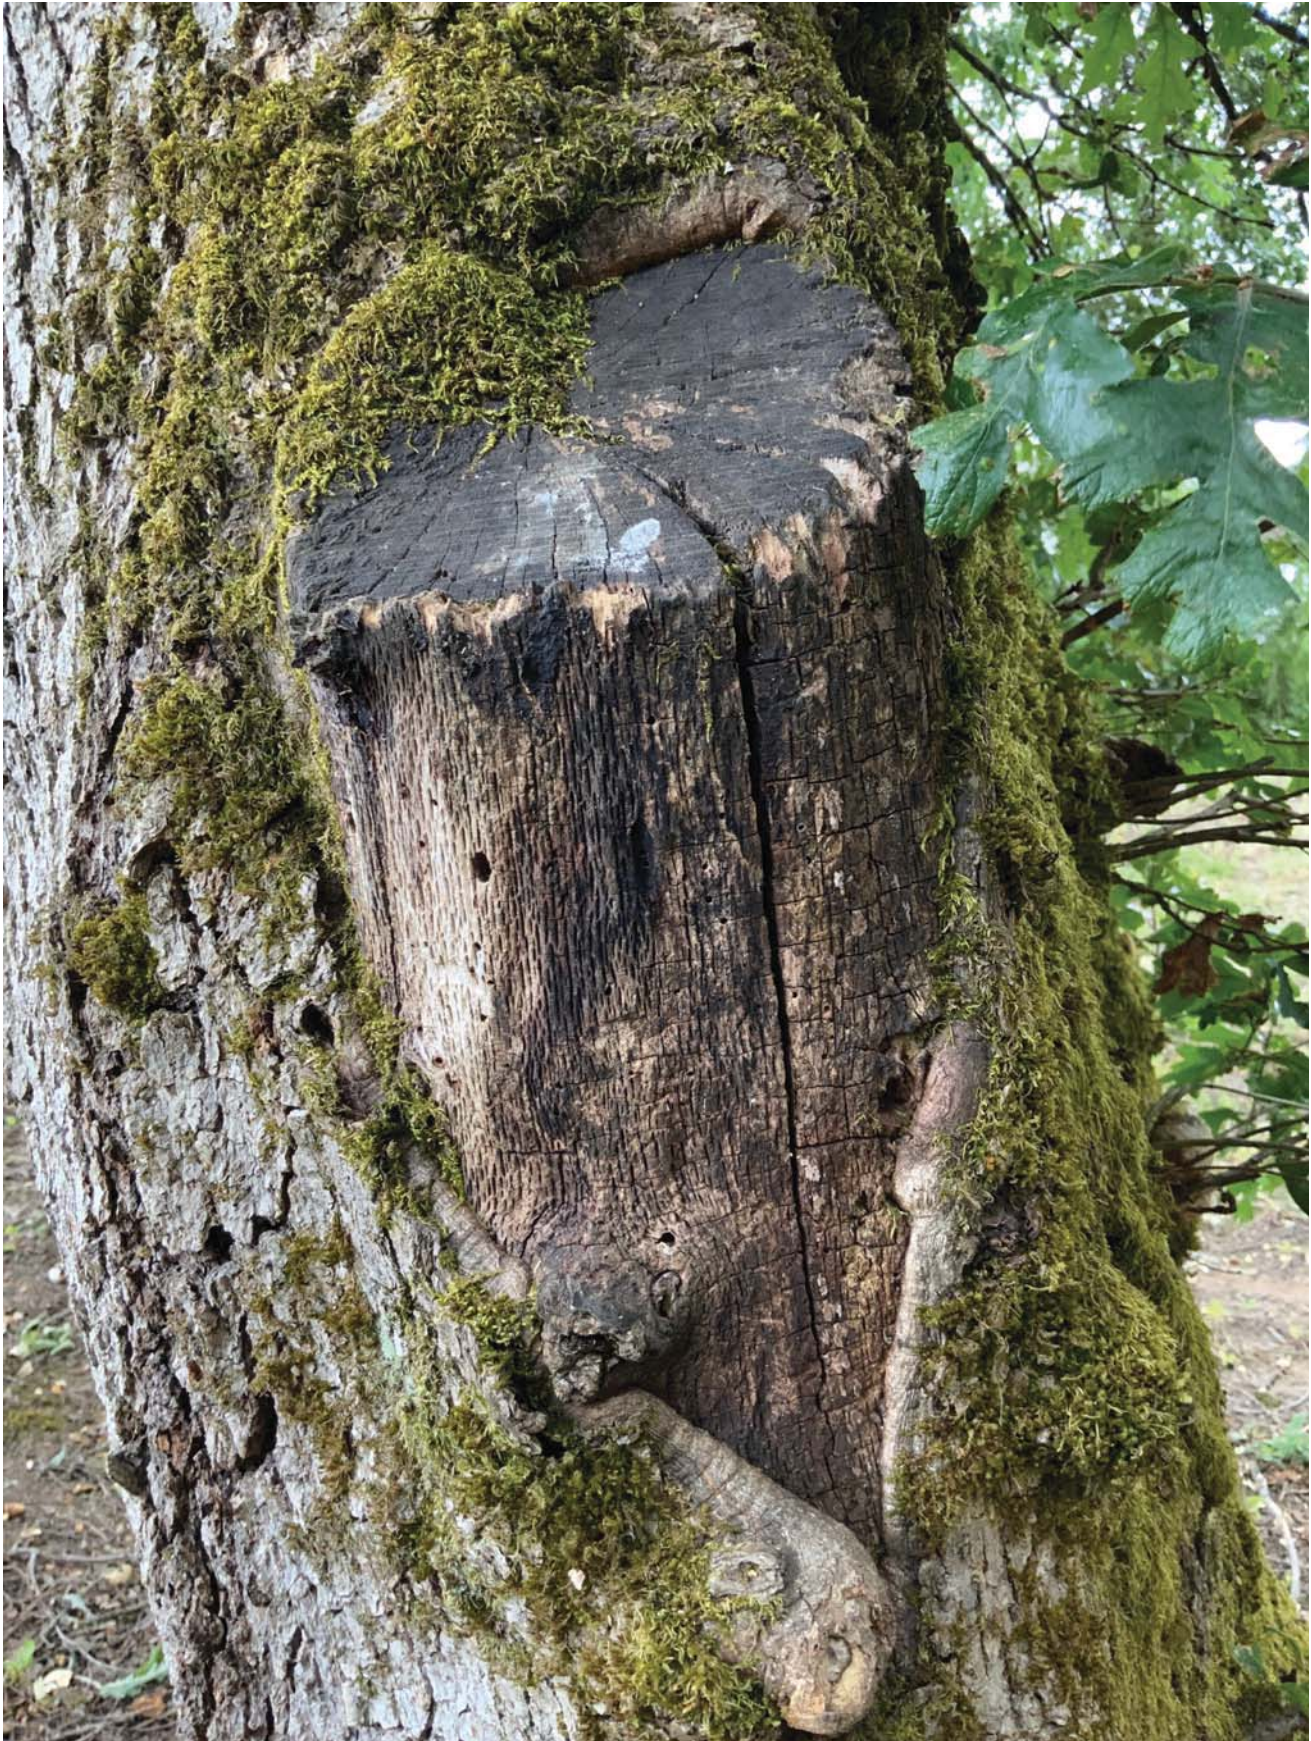
Photo 6. Tree #25743 - Large exit holes not from MOB.

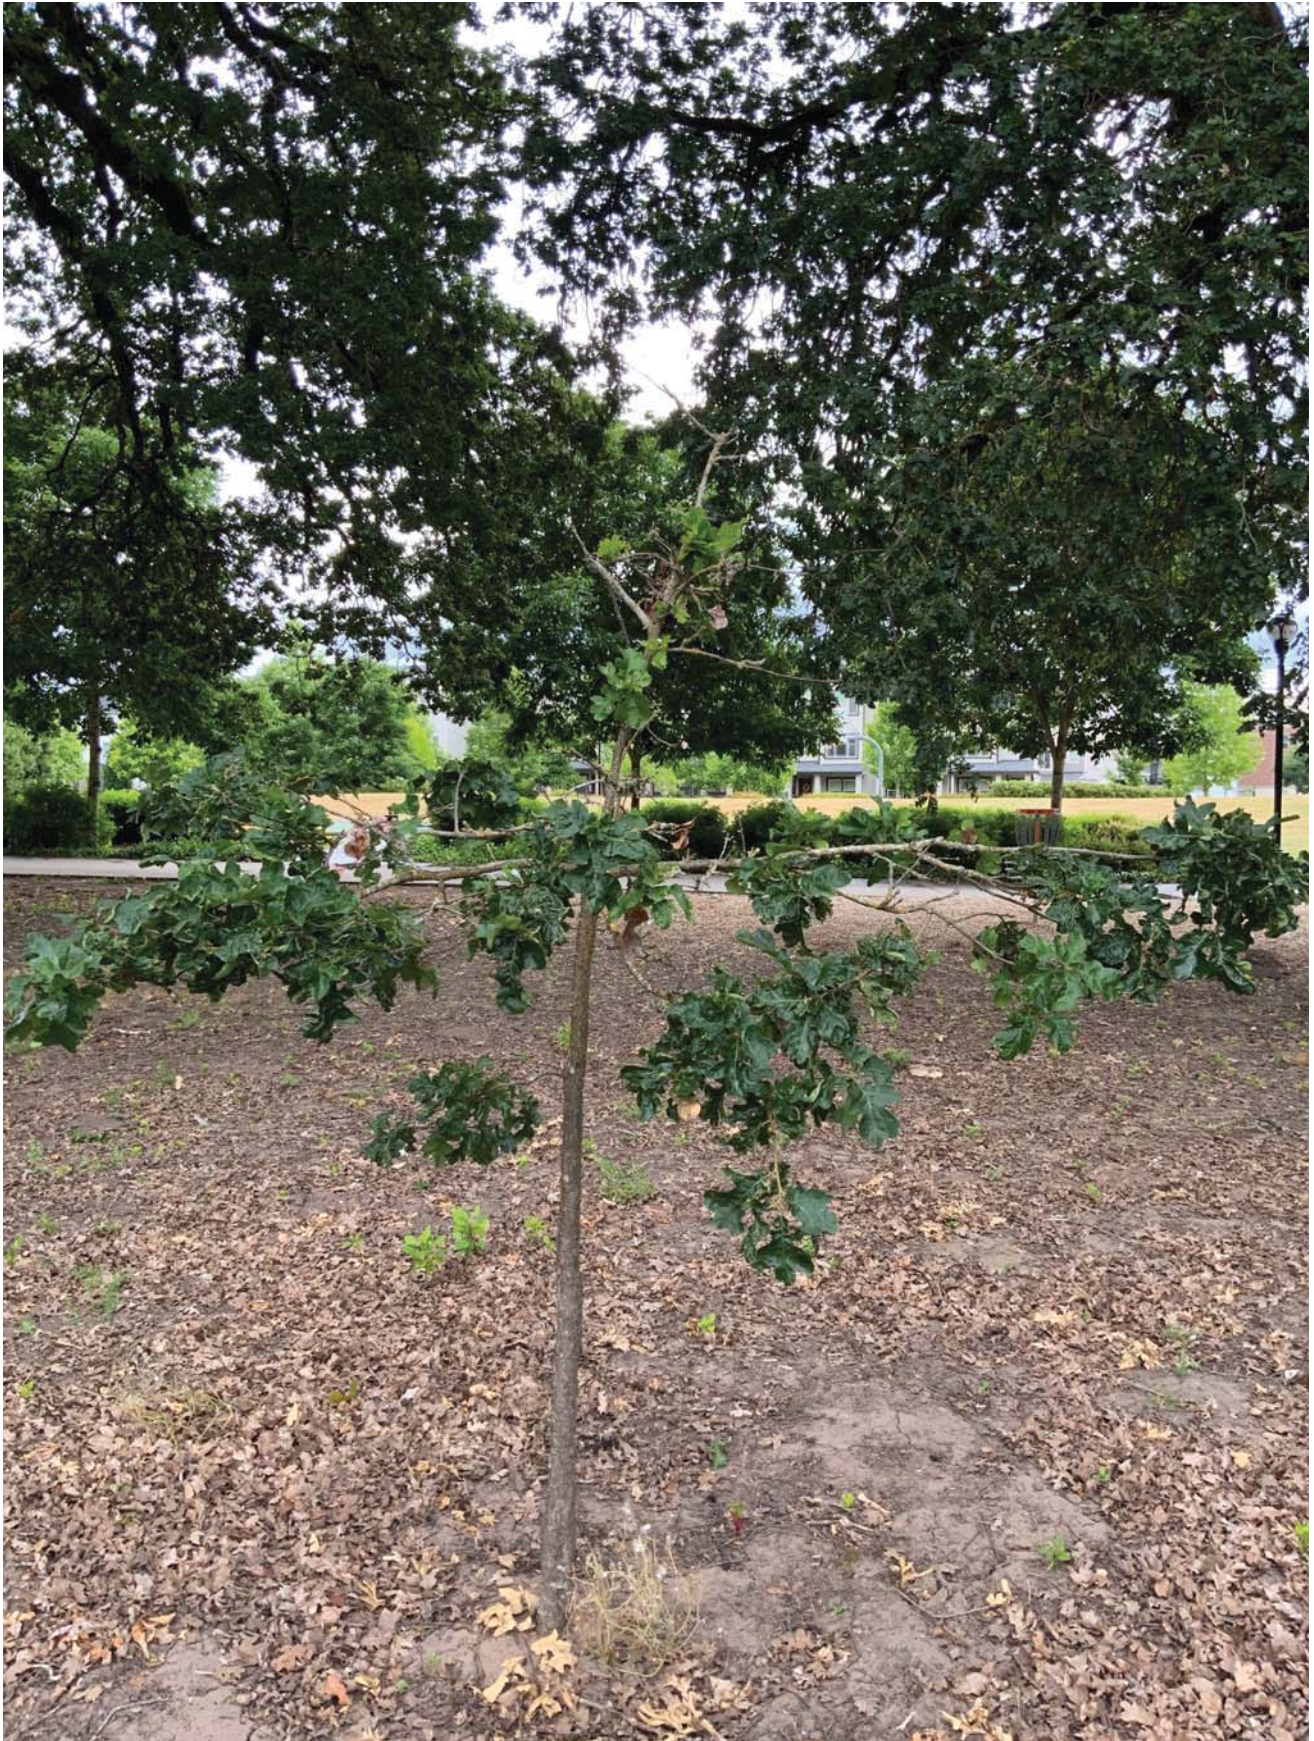
Photo 7. Tree #25818 - Small oak with dead top, lower trunk damage, wilted leaves, small live crown could be replaced sooner than later.

- Remove trees #181, #25818, #56394, #56396 and #56508, which are all 3-inches or smaller in diameter, relatively recent plantings, but these trees are already very stressed or in decline. There is insufficient growing space to replant in the vicinity of trees #56394 and #56508 due to competition with other existing trees, but the other three trees could be replaced in the same general locations.

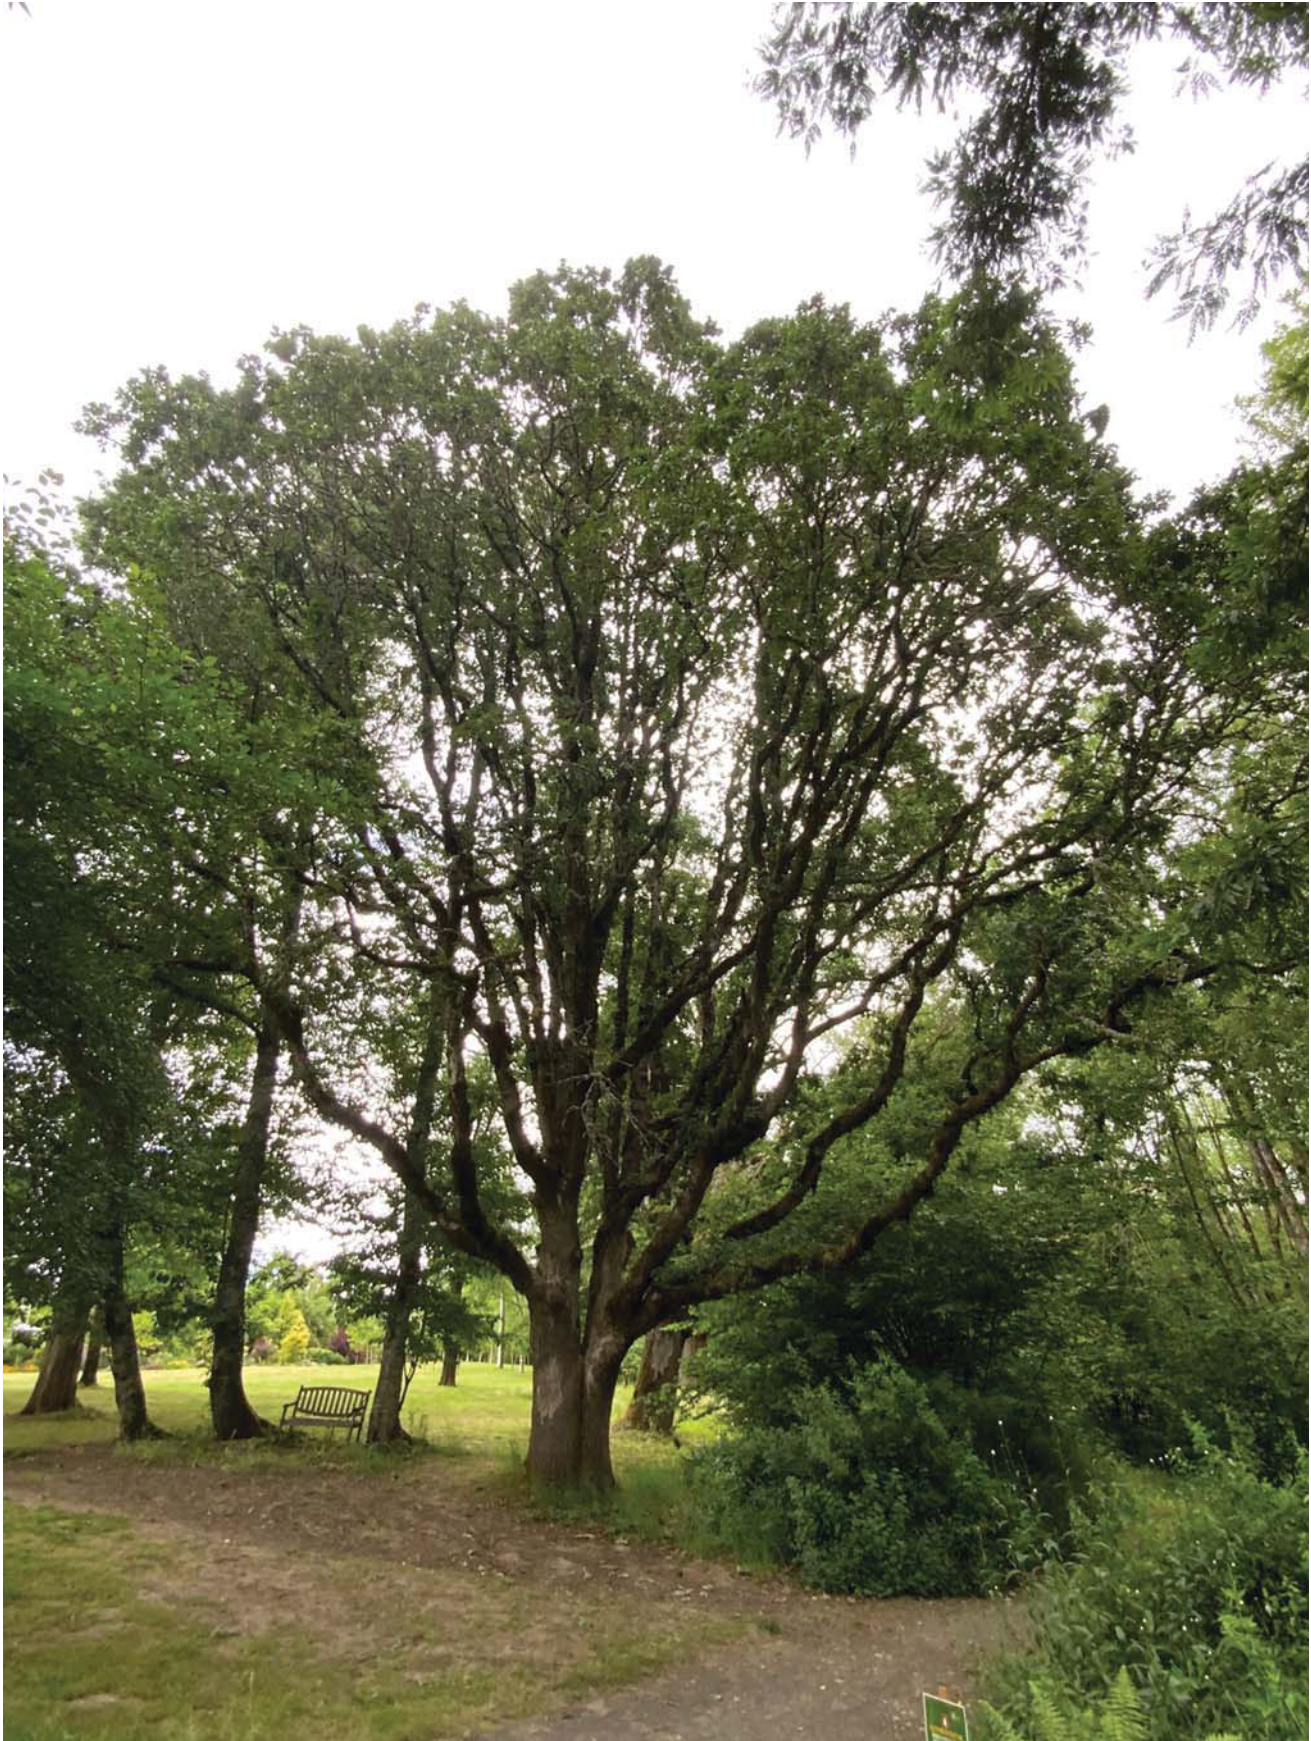
Photo 8. Tree #56830 - Consider bracing codominant stem juncture.

- Structural Support: install a brace and cables at tree #57630 and consider cabling for tree #56830.
- Adjust sprinkler heads in the lawn around trees #270 and #56367 to avoid spraying the tree trunks and prevent trunk decay.

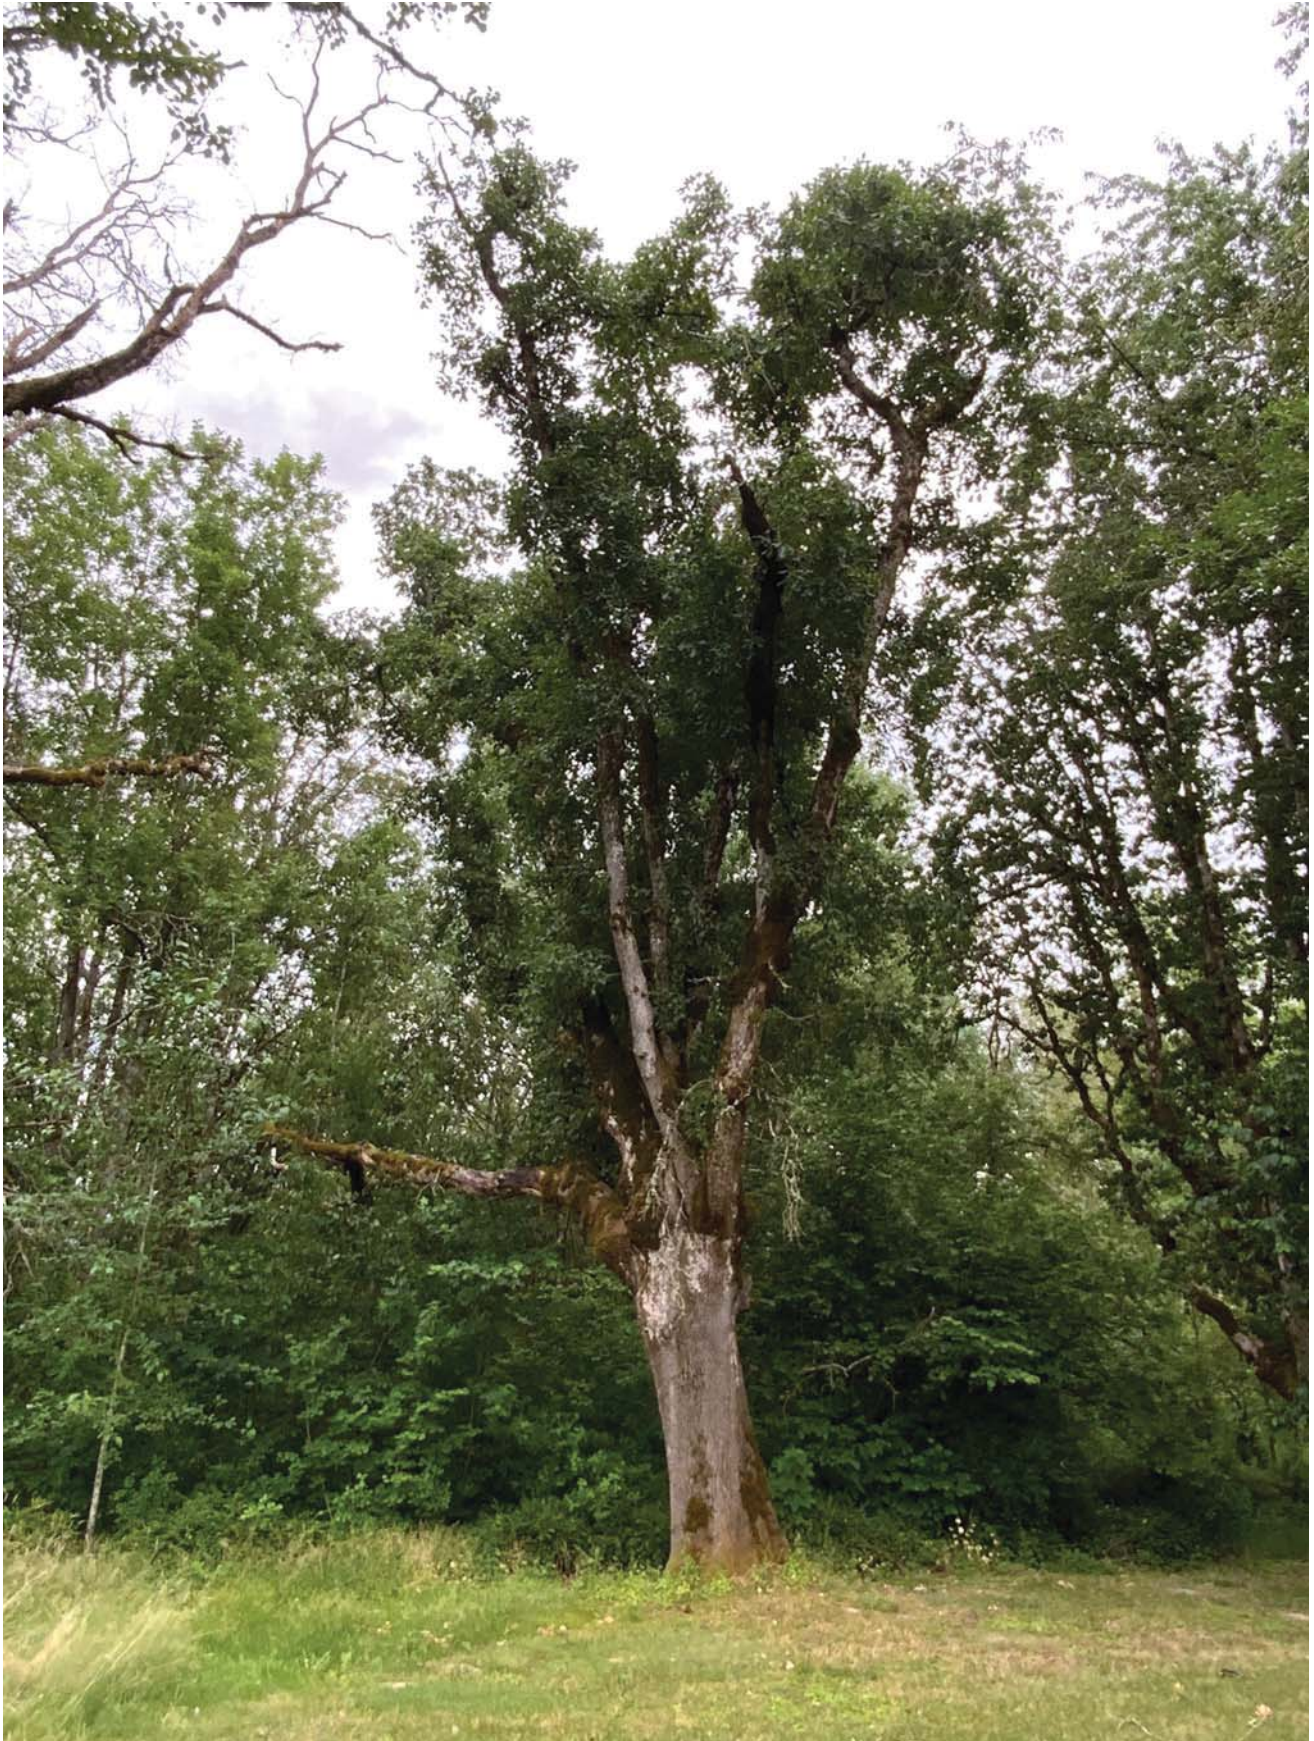
Photo 9. Tree #56832 - History of large branch failure, crown decay, large old dead and decaying scaffold branch, numerous epicormic sprouts, signs of carpenter worm but no obvious signs or symptoms of MOB.

- More frequent monitoring, on an annual basis, for four of the six oaks where signs or symptoms of MOB were observed, including trees #60526, #60529, #60534 and #25743, as well as tree #56832, the stressed oak with no obvious symptoms of MOB but a high susceptibility for infestation.
