DATE: July 13, 2024
TO: Dustin Schull, Parks Supervisor, City of Wilsonville
FROM: Morgan Holen, Consulting Arborist
RE: Wilsonville Oregon White Oak Tree Monitoring 2024

MHA24008

Oregon White Oak MOB Assessment 2024

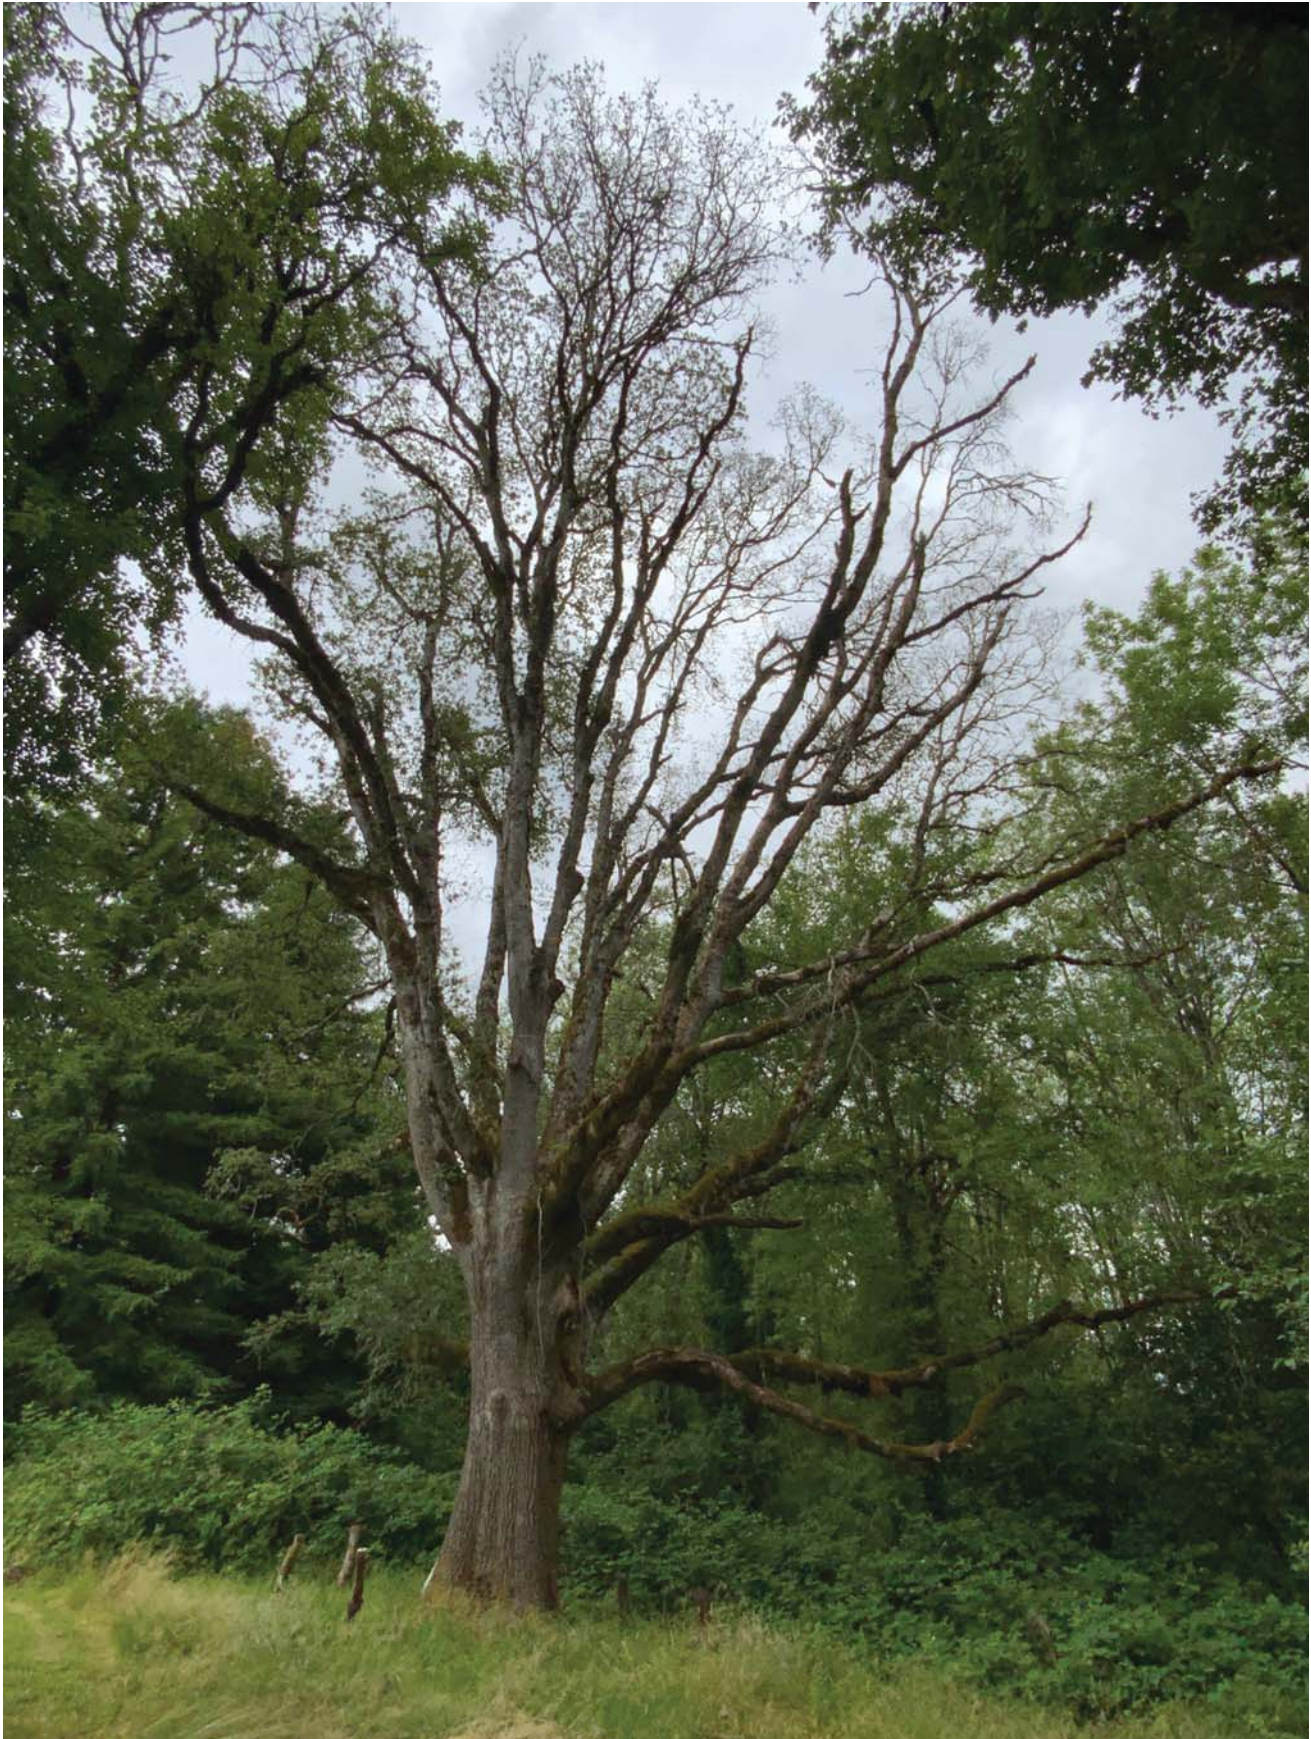
- Tree #56833, which was previously confirmed to have MOB and was treated. Progressive decline has advanced since last summer and approximately 80% of the crown is now dead. Fine frass and tiny bore holes were observed, although no adult MOB were seen. This tree is not viable and removal is recommended, along with the stump. When this tree is removed, consider carefully dissecting the wood to look for live or dead MOB, which may help inform how effective the systemic insecticide treatment may be working.

Photo 10. Tree #56833 - Progressive decline is advancing, ~80% of crown is now dead, this tree is no longer viable, lots of fine frass and tiny bore holes, no insect sighting though so maybe treatment is working to kill MOB. Recommend cutting it down and dissecting wood to investigate.

- Systemic insecticide treatment this year for tree #25743, which was not previously treated.
- Removal of MOB infested trees #60655 and #56833 because they are no longer viable. Tree #56833 could be carefully dissected to look for live or dead MOB to help inform the efficacy of last year's treatment. The stumps of both trees should also be removed by grinding the stumps below ground level.

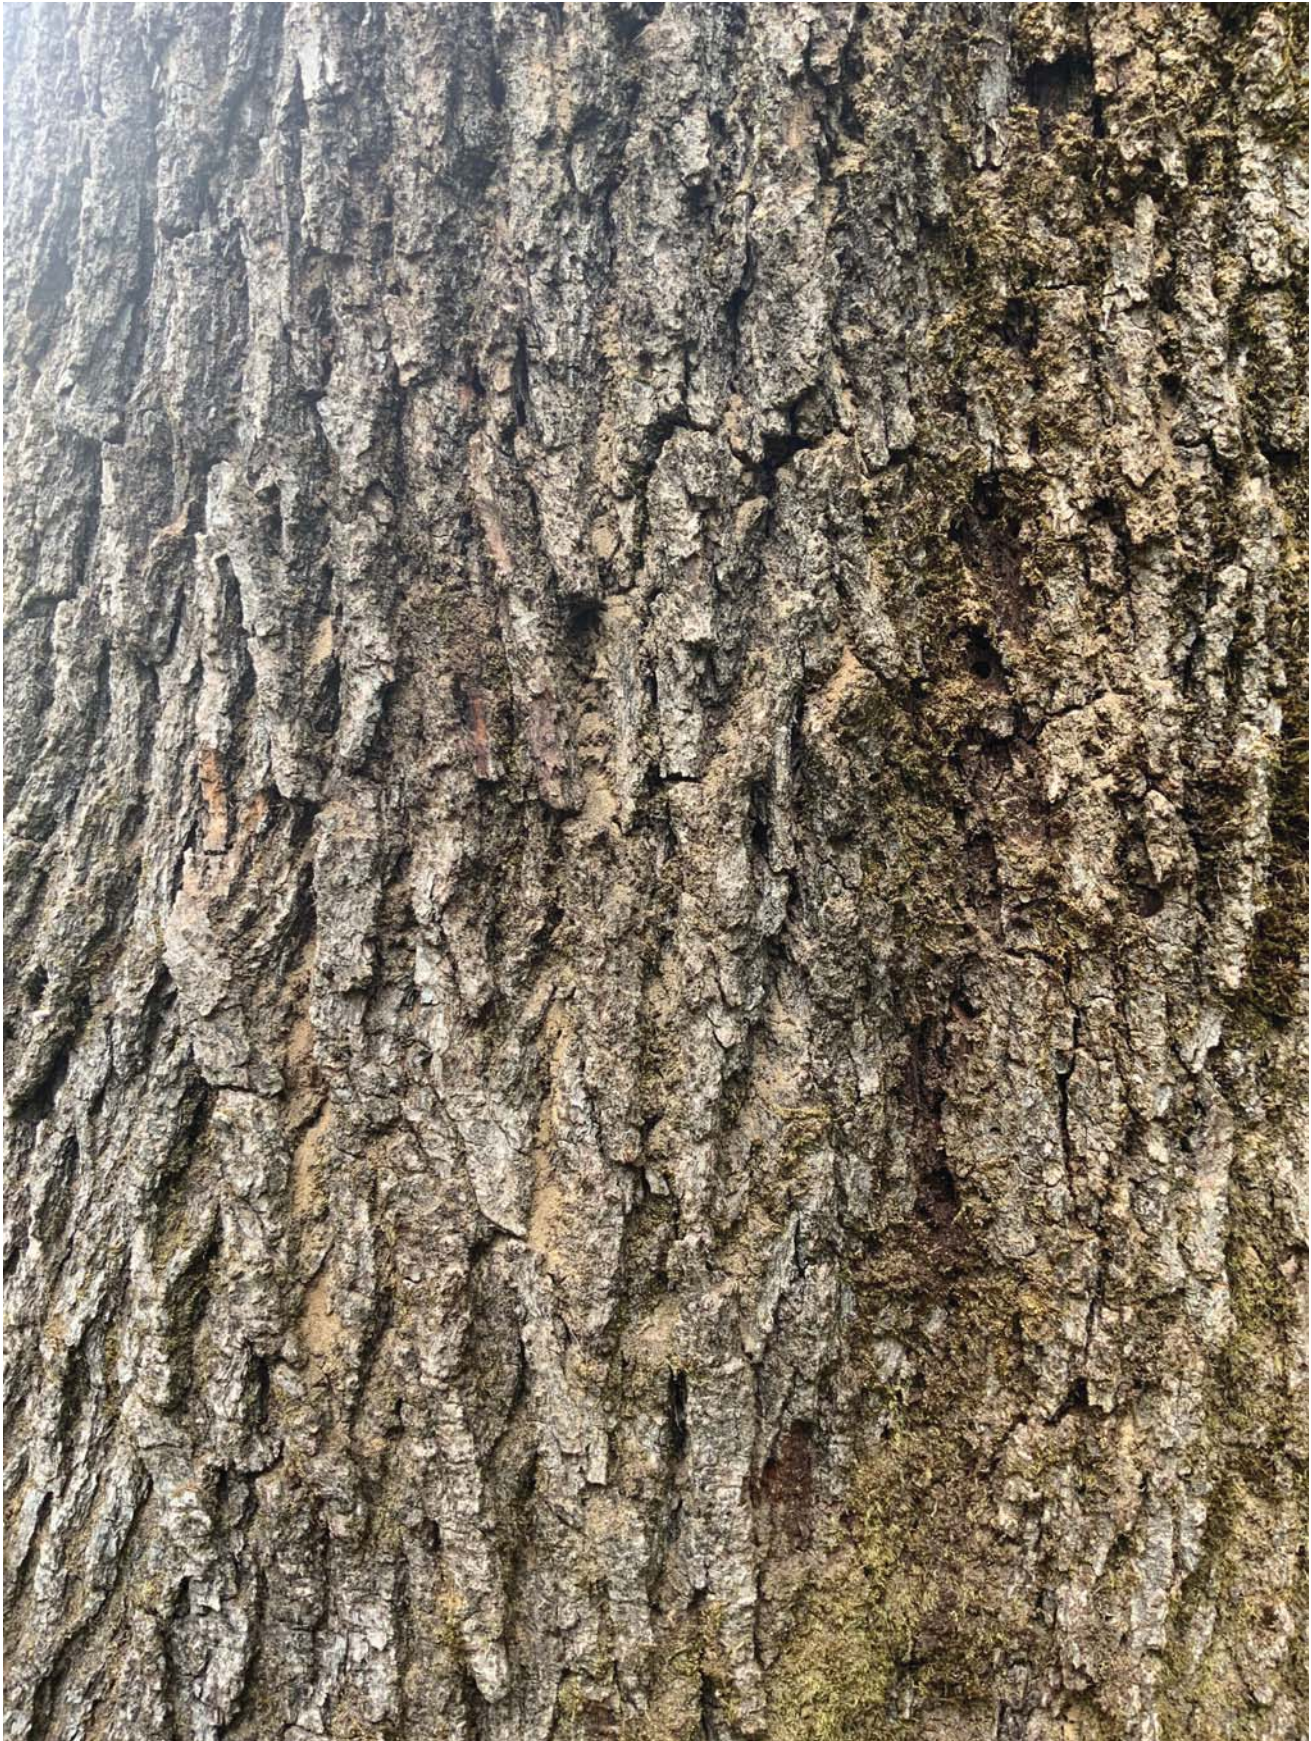
Photo 11. Tree #56833 - Fine frass did not appear to be fresh and may be from last year; regardless, this tree is no longer viable as the decline has progressed rapidly.

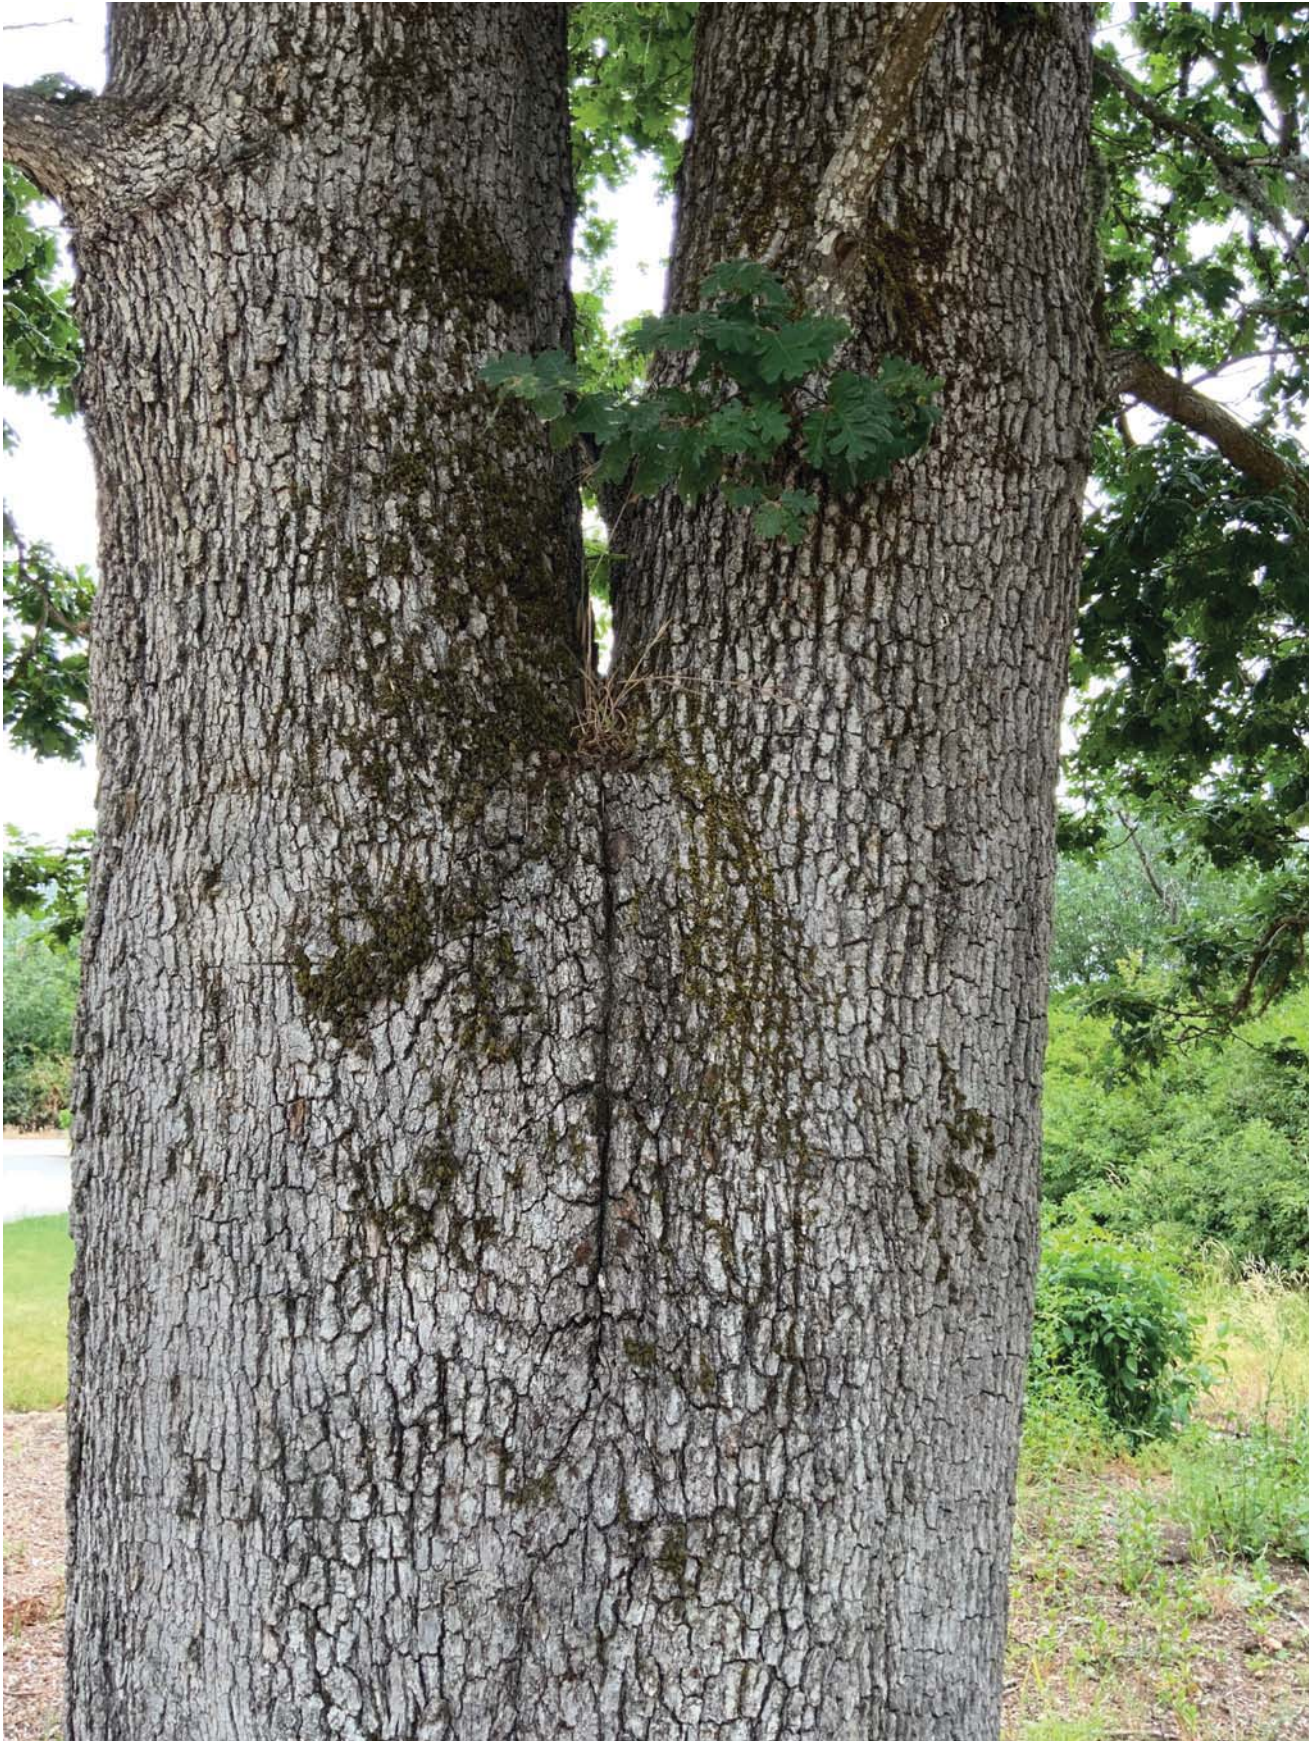
Photo 12. Tree #57630 - Codominant stems with included bark. Morgan believes she has observed a squirrel crawling into this juncture in the past, indicating that the cavity between the stems is much larger than it would seem from the outside. Recommend installing a brace and cables.

- Structural Support: install a brace and cables at tree #57630 and consider cabling for tree #56830.
- Adjust sprinkler heads in the lawn around trees #270 and #56367 to avoid spraying the tree trunks and prevent trunk decay.

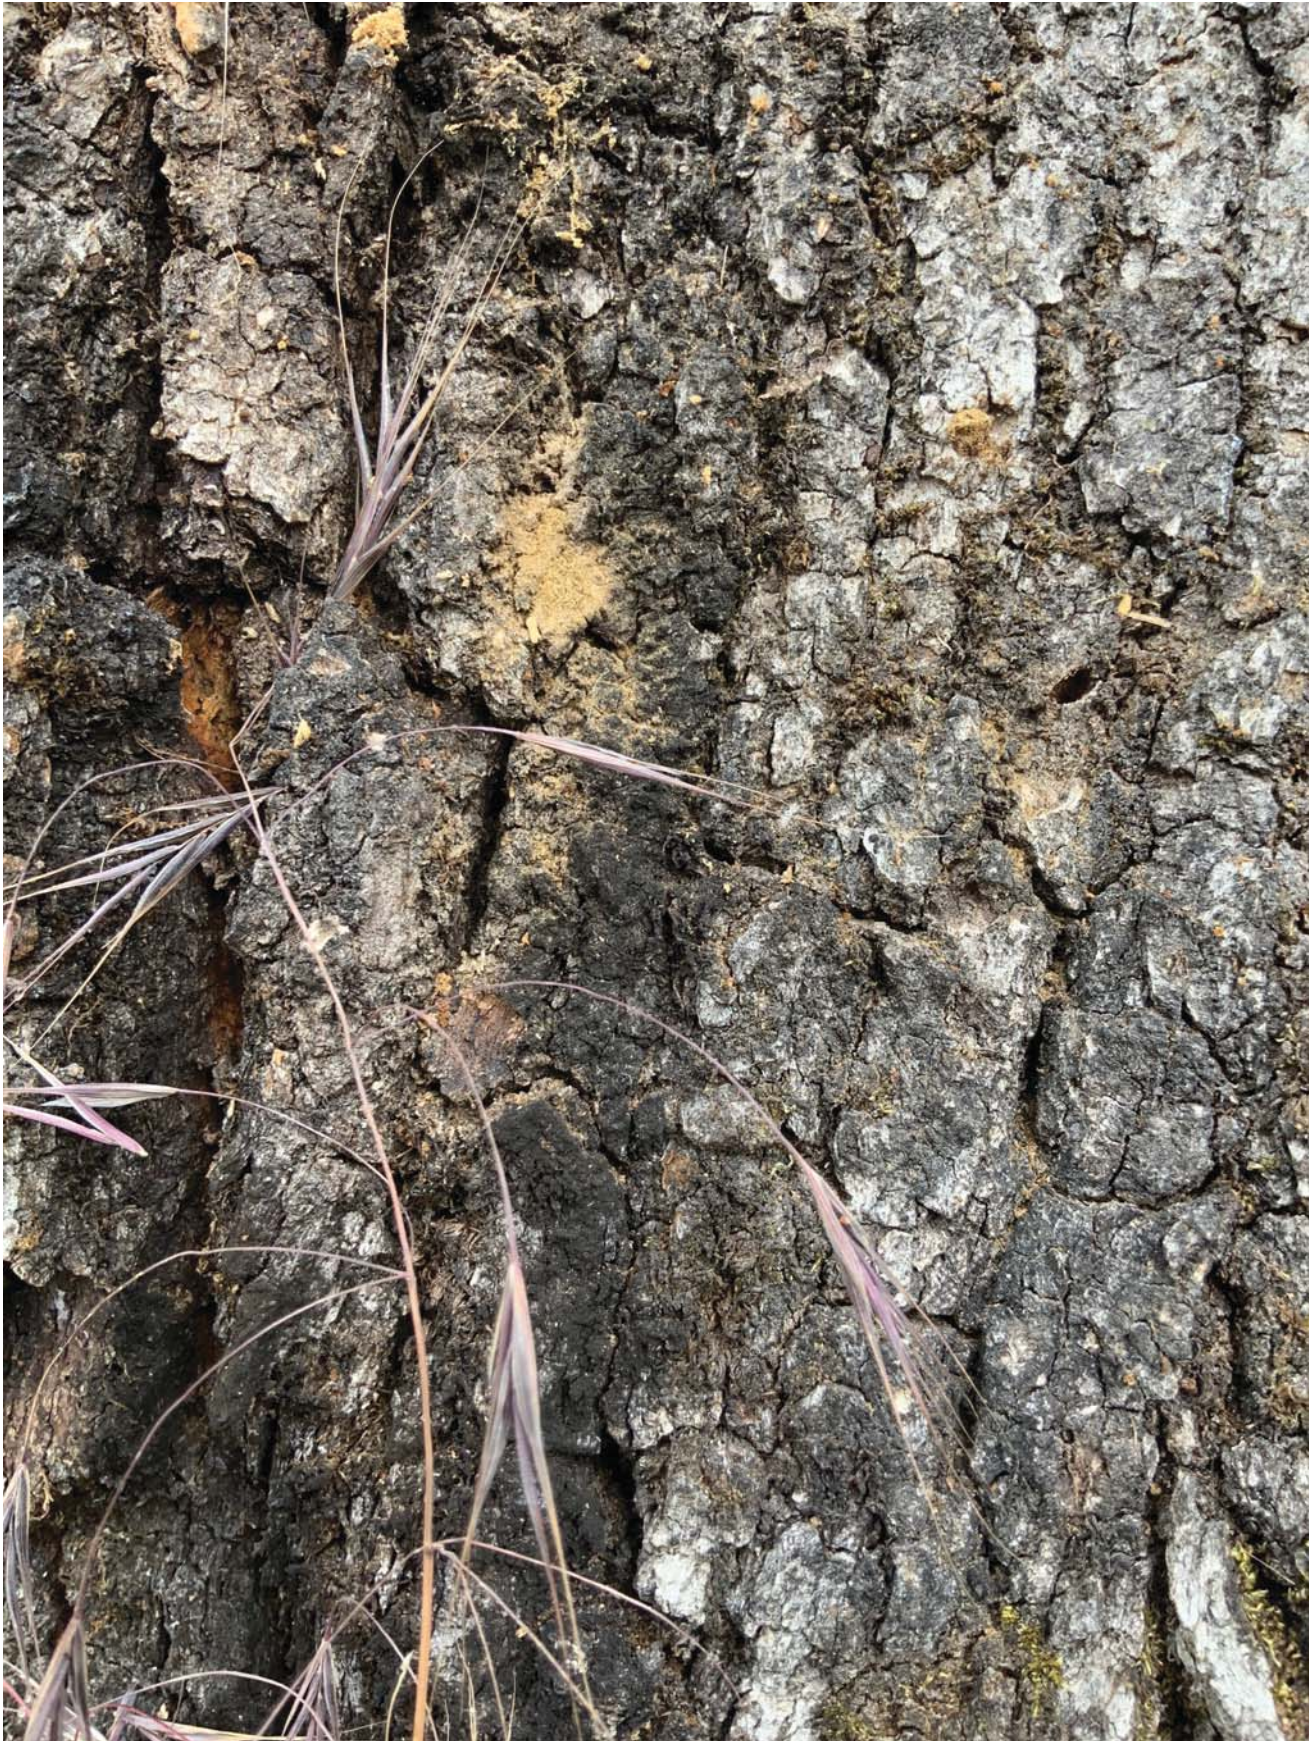
- Tree #60526, a generally healthy tree in fair condition. This tree has codominant stems with active separation and trunk decay and cables were previously installed for support. A bit of fine frass and a few tiny bore holes were observed, along with bore holes of multiple sizes and an abundance of ant activity indicative of trunk decay.

Photo 13. Tree #60526 - Showing fine frass along trunk. Crown is relatively healthy but codominant stems with active separation and trunk decay, three cables were previously installed; fine frass and a few tiny bore holes observed, along with bore holes of multiple sizes and a lot of ant activity.

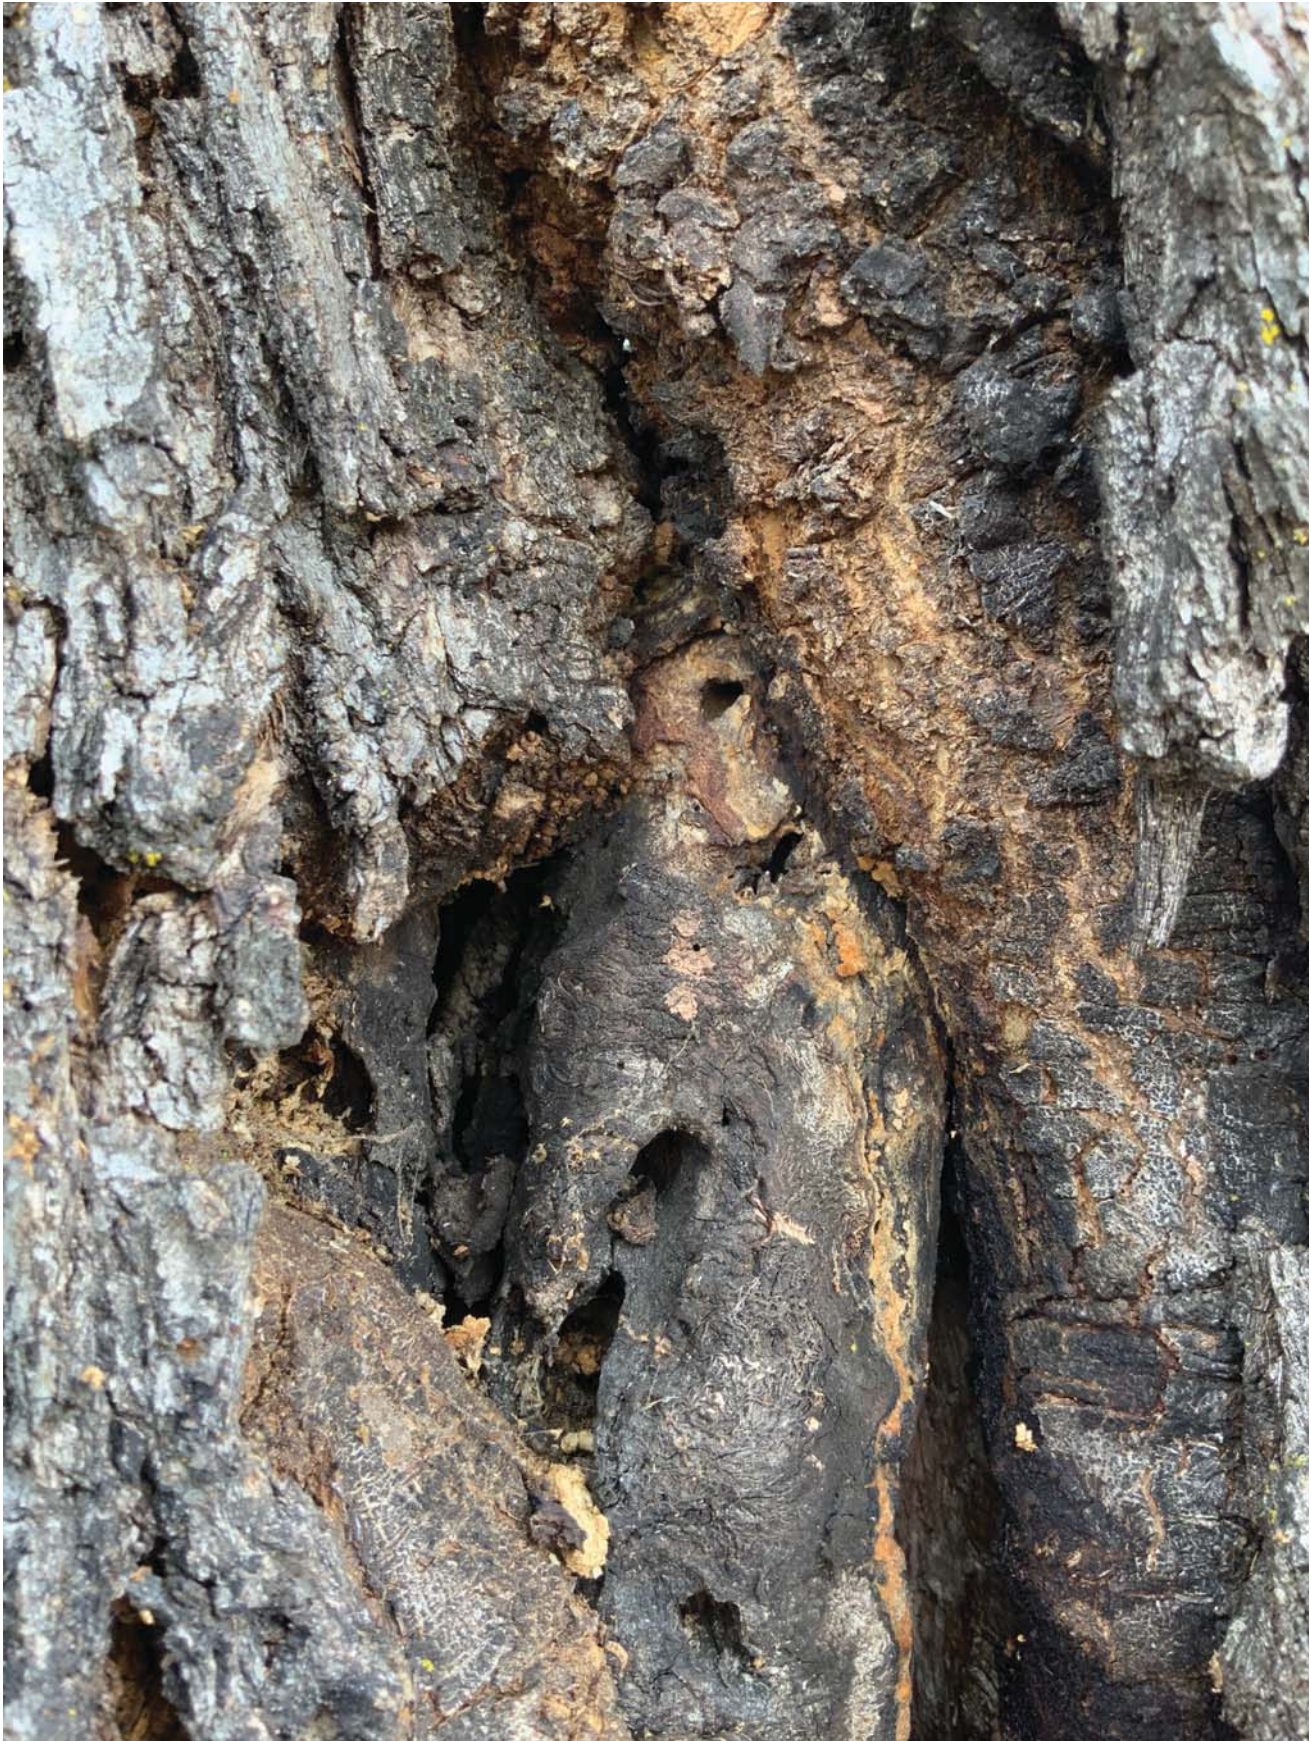
Photo 14. Tree #60526 - Showing trunk damage and bore holes of multiple sizes.

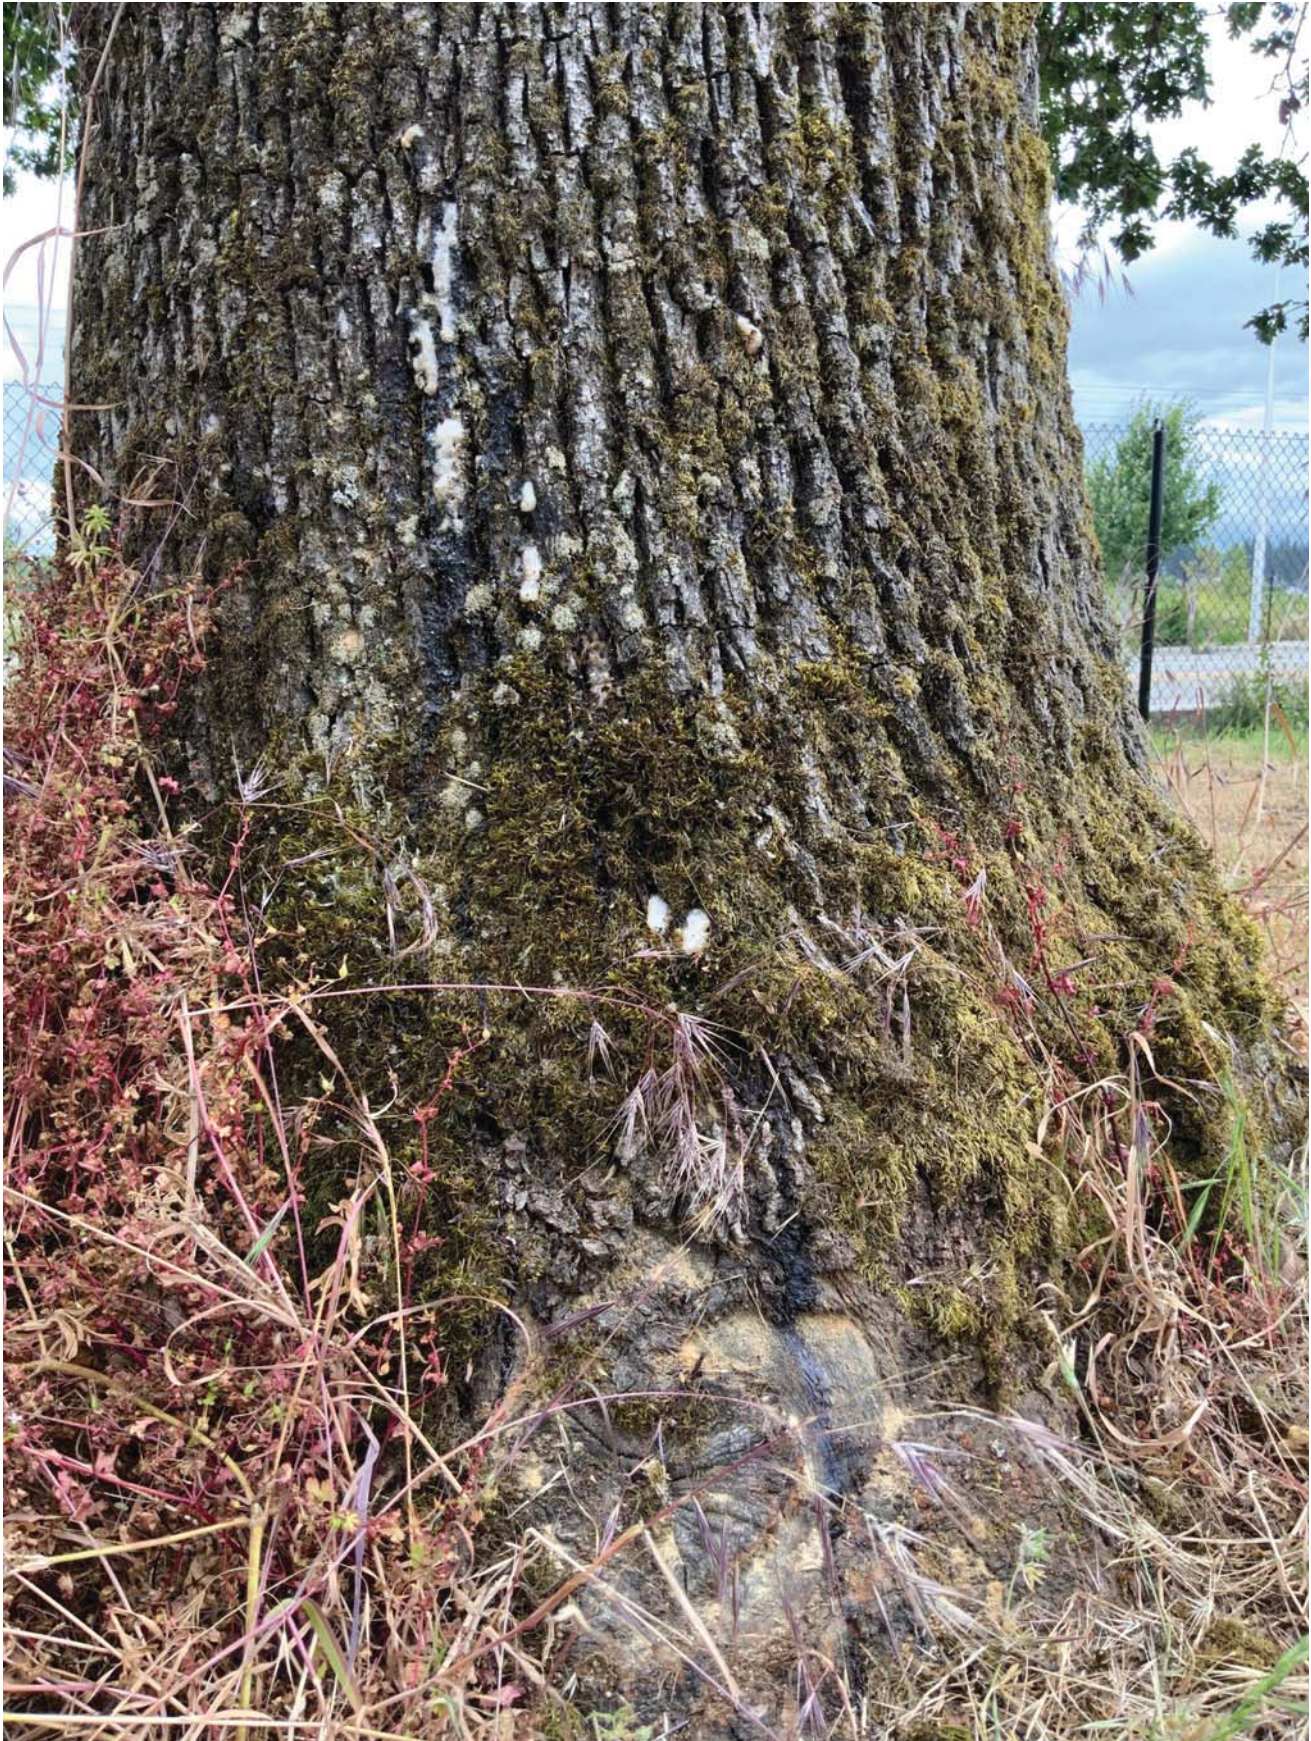
- Tree #60529, a stressed tree in fair condition. Fine frass was observed on the lower trunk of east face of east stem, along with a variety of different insects and some oozing foam. No large branch dieback was observed, but the tree has a relatively thin top and numerous epicormic sprouts indicative of stress.

Photo 15. Tree #60529 - Fine frass on lower trunk of east face of east stem, along with lots of different insect activity and oozing foam, no large branch dieback but relatively thin top and numerous epicormic sprouts.

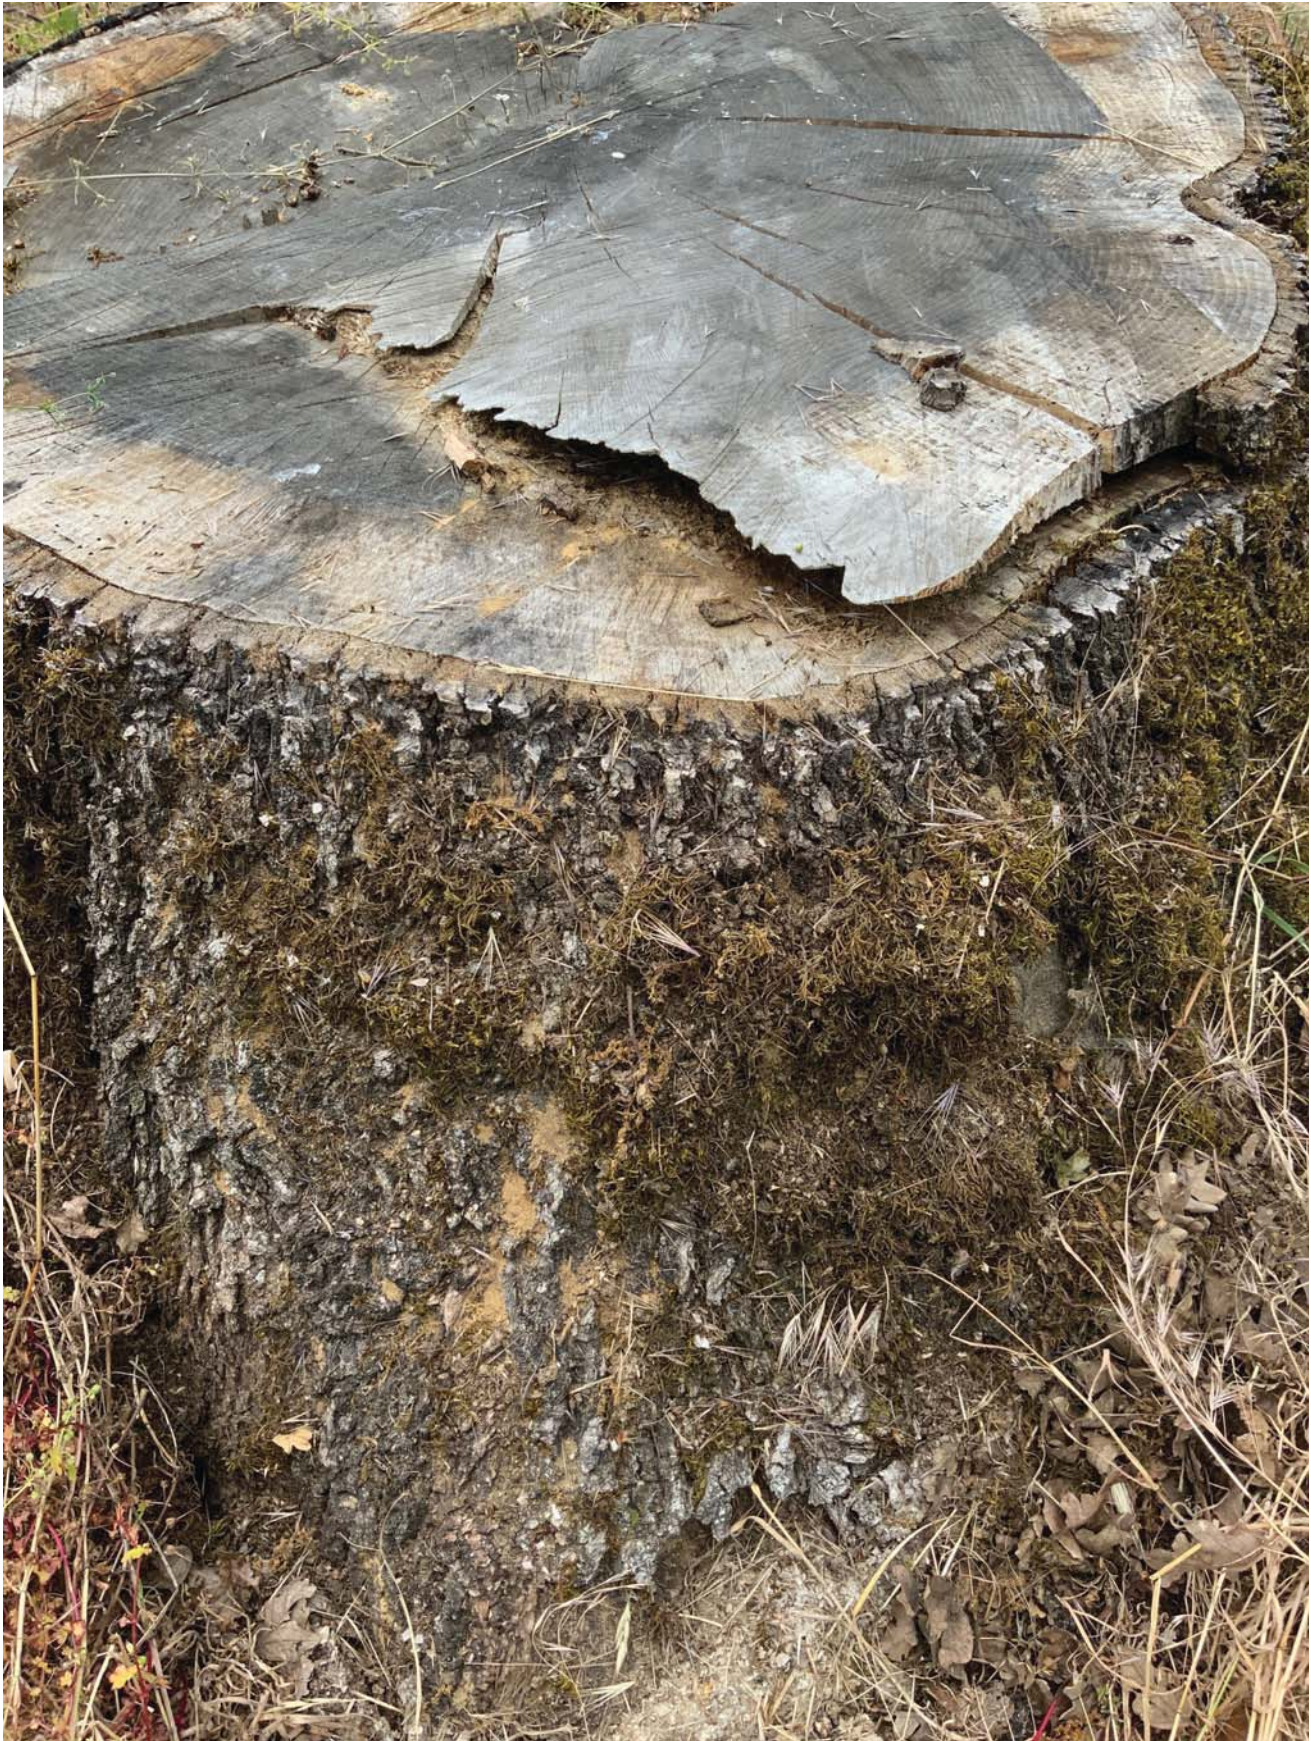
Of all 119 inventoried Oregon white oak trees, five no longer exist and one was mis-identified as an Oregon white oak. Trees #187, #12575, #56818 and #60268 no longer exist and there were no signs of a stump in these locations. Tree #60531, listed as a 24-inch diameter oak that received MOB treatment, has since been removed, but the stump remains and there are clear signs of MOB including fine frass, tiny bore holes and galleries in the stump face. Tree #12573 was located, but identified as an English oak (*Quercus robur*) and not assessed.

Photo 16. Tree #60531 - This tree was removed but the stump remains and there are clear signs of MOB including fine frass, tiny bore holes and galleries in the stump face. Stump removal is recommended.

- Remove the MOB infested stump of tree #60531, remove this tree from the inventory and consider replanting with a different species nearby.
- Arborist Chip Mulch: A 3-inch-deep layer of arborist chip mulch is recommended at 62 trees—located in Piccadilly Park, Edelweiss Park, the WES Transit Station, Murase Plaza Park, and near the Boeckman Dip—to help moderate soil temperature, retain soil moisture, provide soil nutrients, and, in some cases, to keep lawn mowers away from tree trunks. Do not allow the mulch to directly touch the tree trunks and ensure that the mulch does not exceed 4-inch depth (3-inches is ideal).

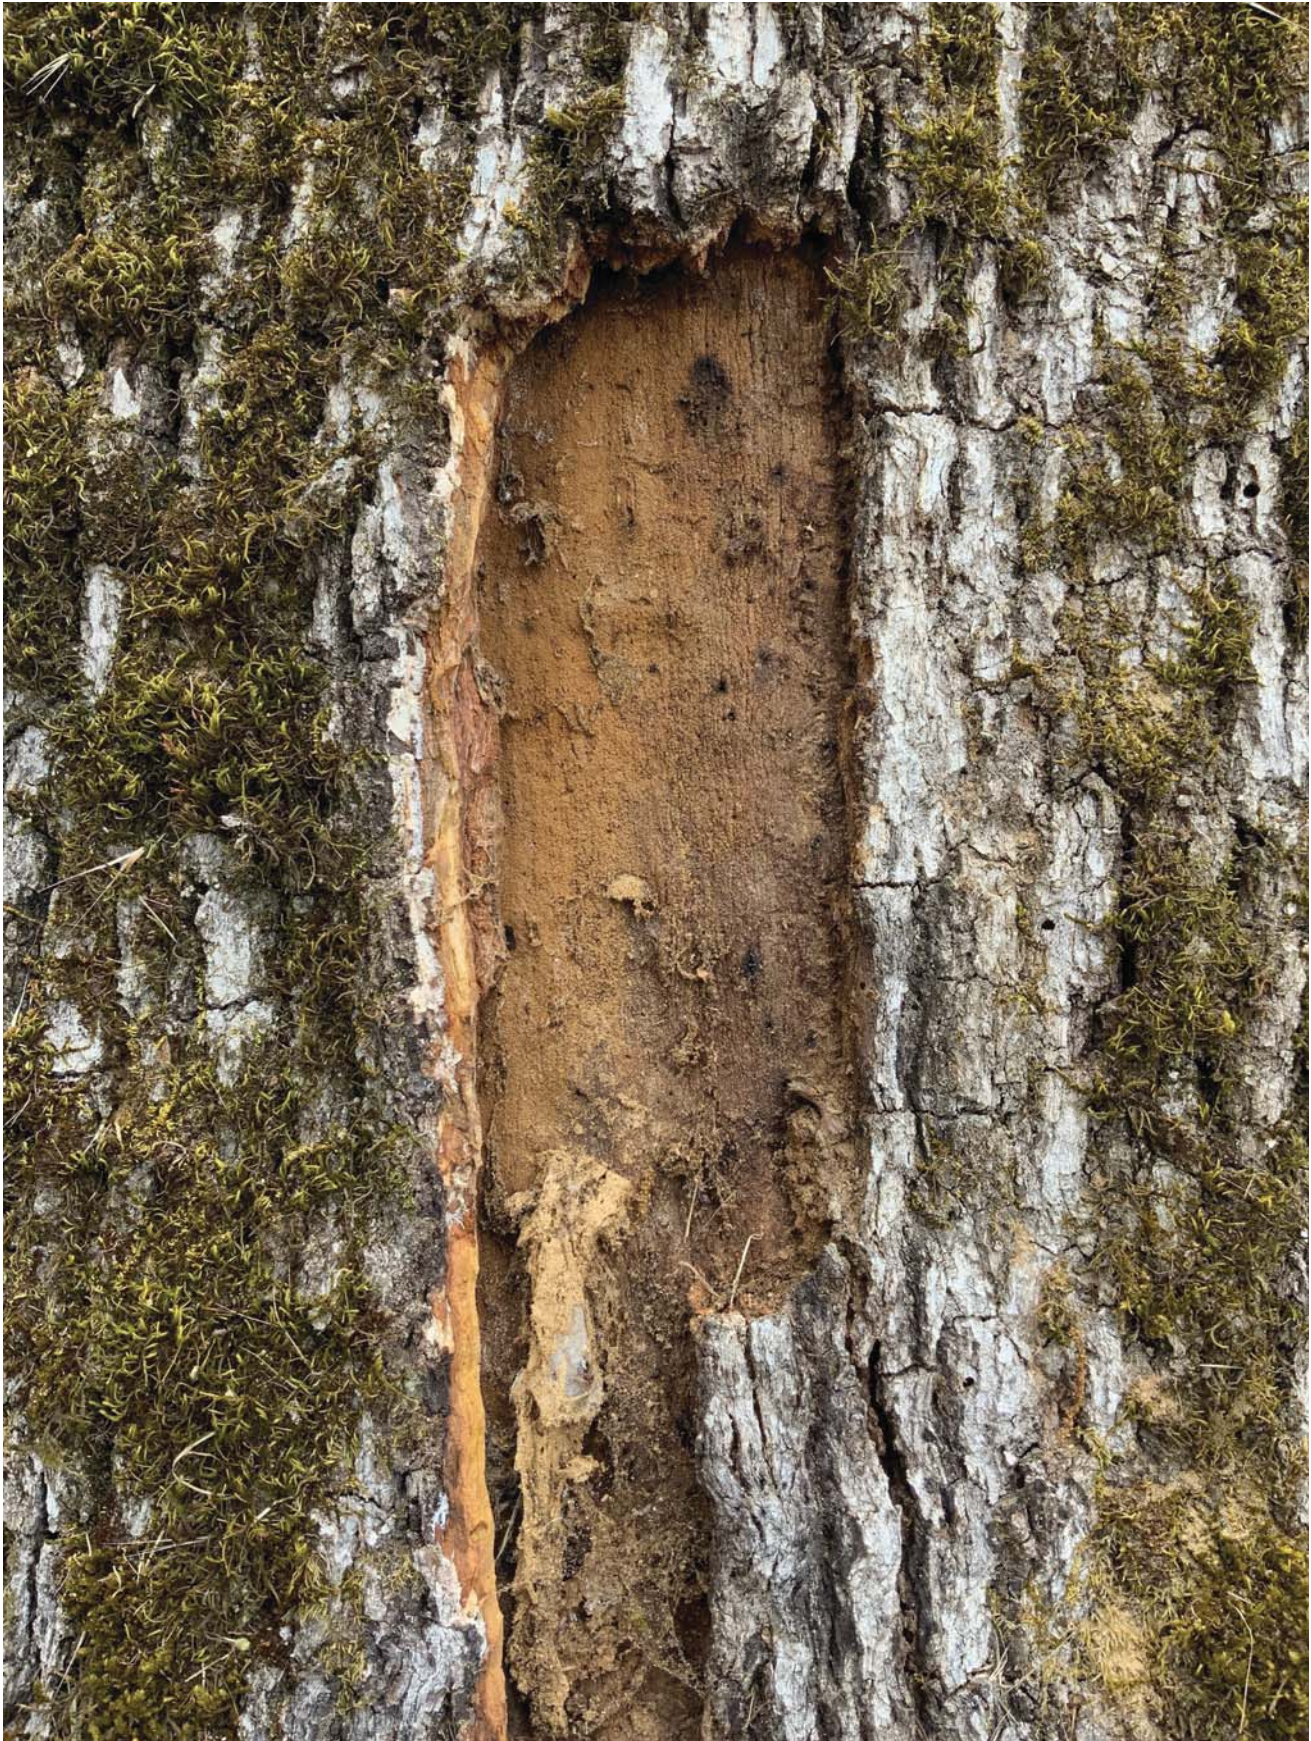
- Tree #60534, a tree in poor condition with progressive decline including tip dieback, a thin crown, epicormic sprouts, and a history of large branch failure. Fine frass and tiny bore holes were also observed.

Photo 17. Tree #60534 - Fine frass and tiny bore holes; this tree also has tip dieback, a thin crown, epicormic sprouts and history of large branch failure.

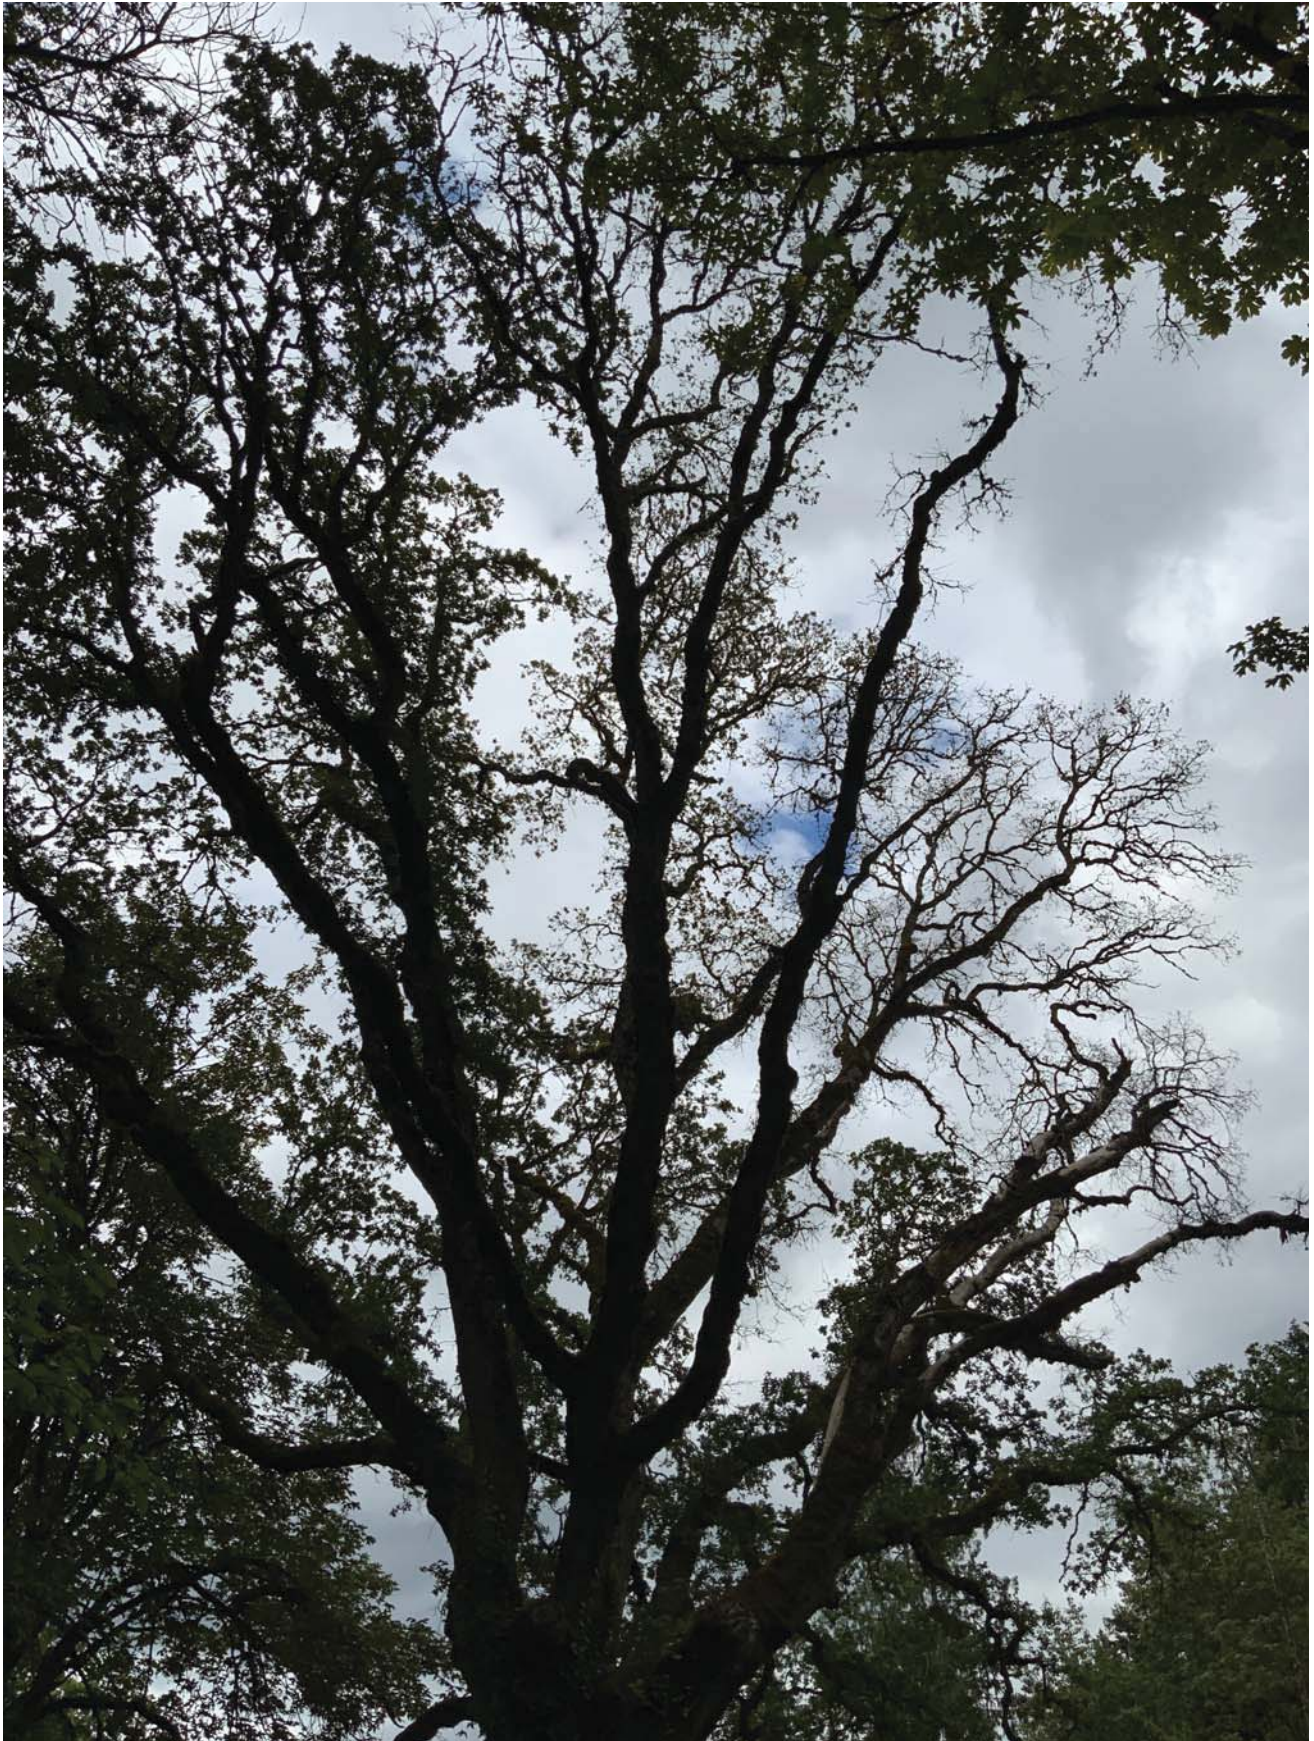
- Tree #60655, which was previously confirmed to have MOB but has not been treated. Approximately 50% of the canopy is dead. Visual assessment of the tree trunk was inhibited by ivy, but fine frass and an adult MOB were observed in a cobweb in the ivy on the trunk. Due to poor condition and severe decline, this tree is recommended for removal, along with the stump.

Photo 18. Tree #60655 - Approximately 50% of canopy is dead, assessment of trunk inhibited by ivy but I observed fine frass and a MOB in a cobweb (see photo 19).
