DATE: July 13, 2024
TO: Dustin Schull, Parks Supervisor, City of Wilsonville
FROM: Morgan Holen, Consulting Arborist
RE: Wilsonville Oregon White Oak Tree Monitoring 2024

MHA24008

Oregon White Oak MOB Assessment 2024

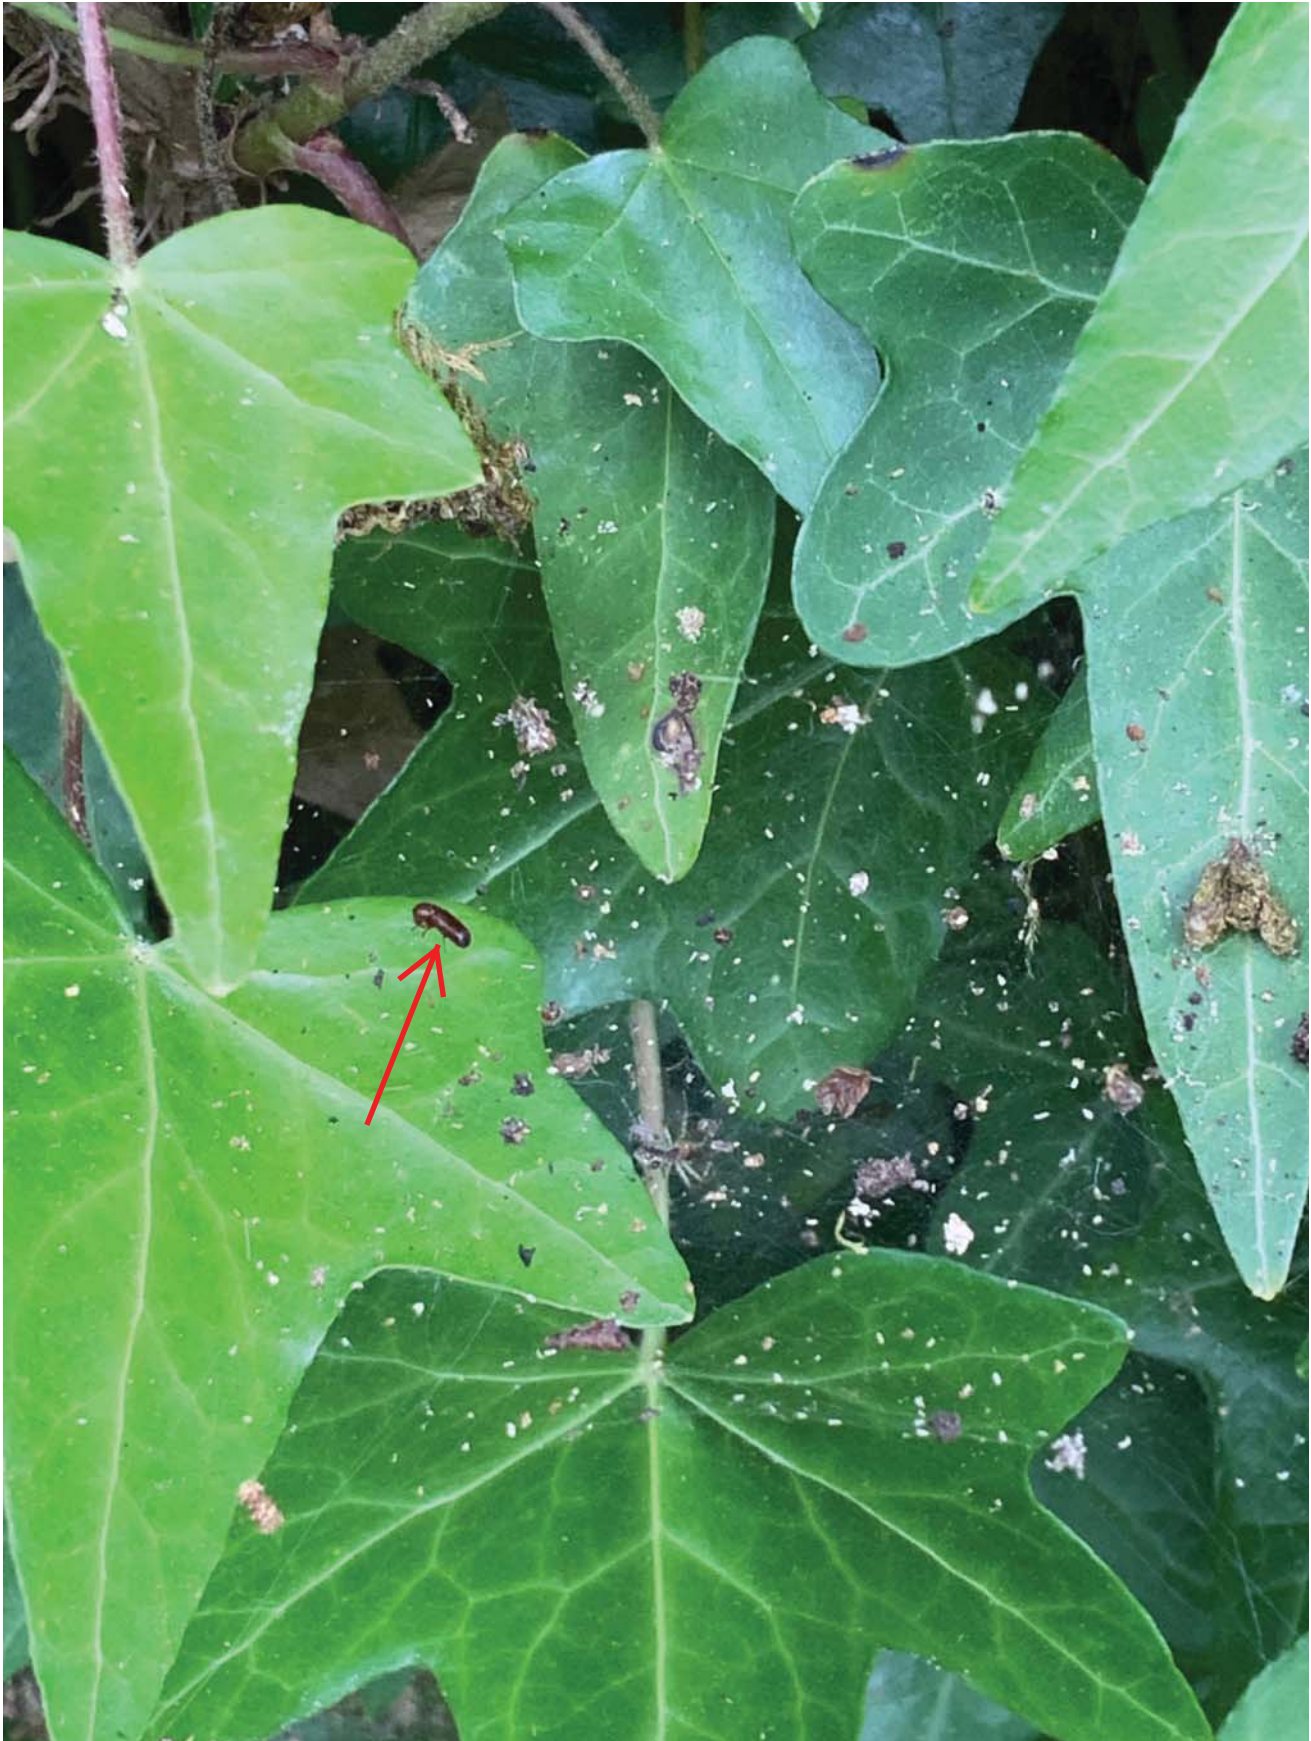
Photo 19. Tree #60655 - Arrow points to MOB observed in a cobweb in the ivy growing up the trunk of this declining tree.
