Structural Review of Box Culvert

Westfield Road
Winnebago, Illinois

Project Number: 24-125 – PH04

July 8, 2024

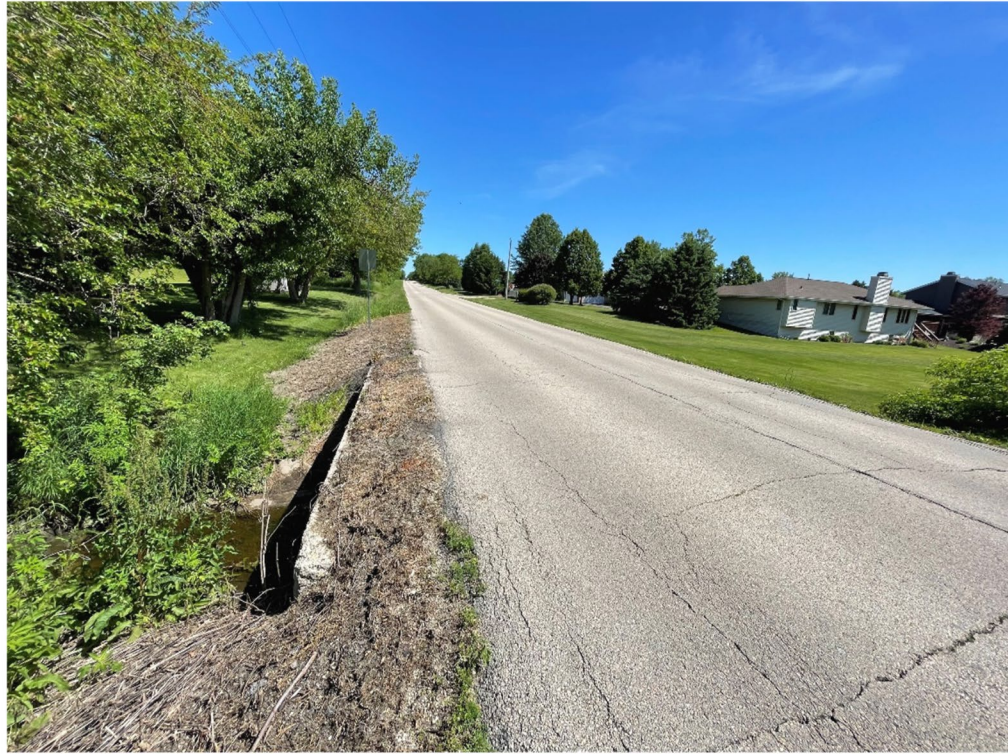
Photo 1: Roadway Over Culvert Looking North

There was minor settlement observed in the roadway above the box culvert. Alligator cracking was present along the edges of the roadway. Longitudinal and transverse cracks are seen throughout the entire width of the roadway. There is approximately one foot of cover from the top of the headwall to the crown of the roadway. The clear distance from the edge of pavement to the face of headwall is 2 ft and 3 ft for the east and west ends respectively. There are no roadside barriers on either end of the box culvert.

As a temporary solution to resolve settlement issues in the roadway above the culvert, the existing pavement and base course shall be removed and replaced. The existing roadway shall be sawcut to the extents of the culvert headwall. Upon removal of existing pavement and base course, the culvert top slab shall be assessed for structural deficiencies. If no deficiencies are observed the base course and pavement shall be replaced in compliance with IDOT roadway guidelines.

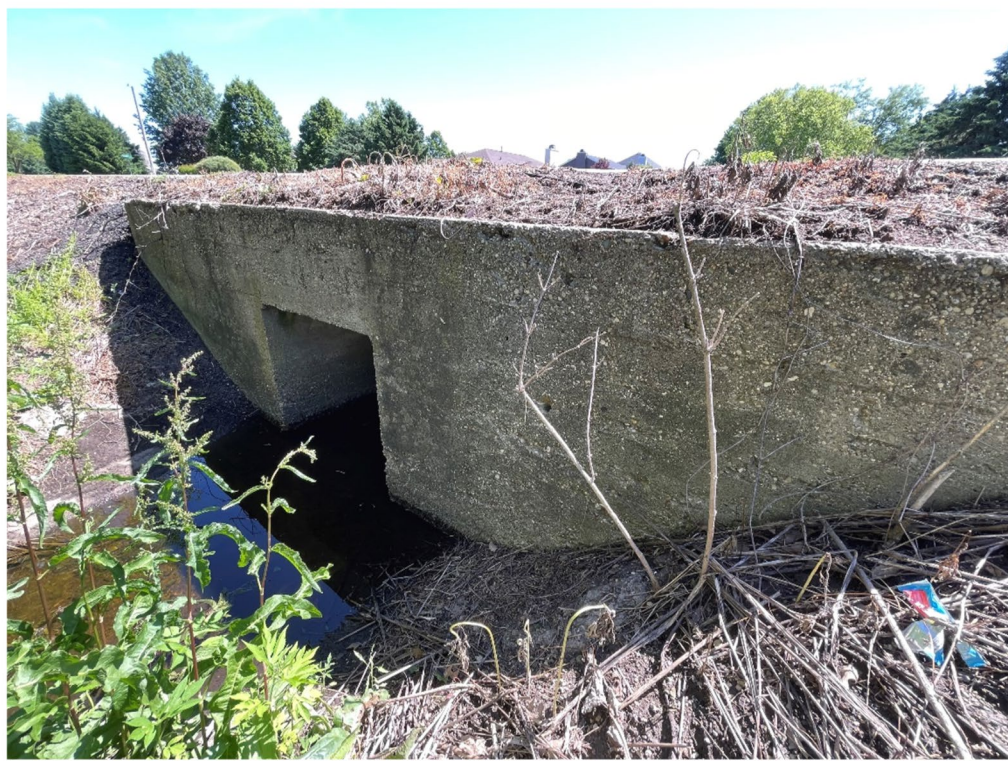
Photo 3: West Headwall Looking North

Abrasion was observed throughout most of the headwall, exposed aggregate was prominent along the exterior face of the headwall.

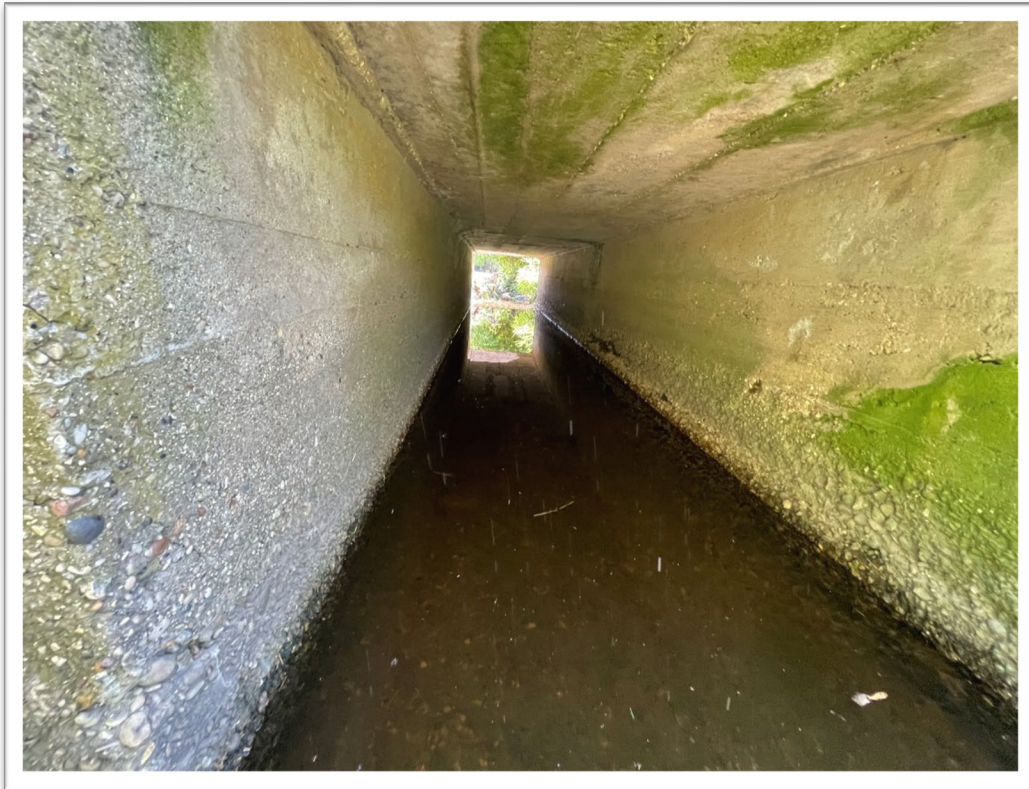
Photo 5: West End of Barrel Looking East

The barrel appeared to be in sufficient condition. Abrasion was present along the water line for the entire length of the barrel. A shear crack was observed at the southeast corner of the barrel. There did not appear to be any signs of differential settlement.
