Date: April 25, 2022

Subject: Pre-Repair Foundation Repair Evaluation
Block and base Foundation
100 South Cottonbelt Avenue, Wylie, TX

100 SOUTH COTTONBELT AVENUE, WYLIE, TX

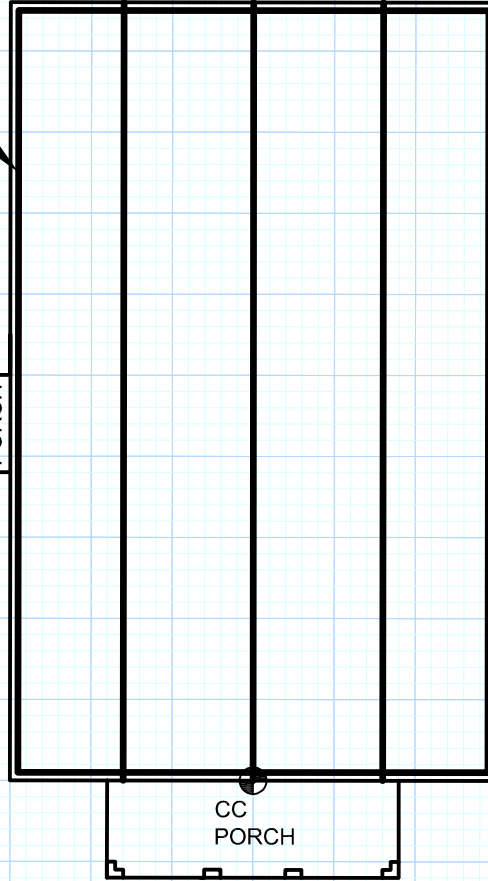
LIMITED REPAIR PLAN

Drywall cracks, window separations, frieze board separations, damaged joist, damaged beam, ponding, and a wet understructure were observed. Based on our observations of the structure, the structure's physical damage and review of the map, we believe the structure has experienced seasonal foundation movement over the life of the structure, resulting in differential movement of the block and base foundation.

ADD
SINGLE
2X6 TO
MAKE
TRIPLE

- Obtaining a framing inspection prior to any repairs.
- Installing a full guttering system with downspout extensions.
- Regrading the perimeter of the structure to pitch water away from the foundation.
- Using fans to dry the crawlspace area after the perimeter is regraded.
- Installing 300 LF of beam.
- Adding a single 2x6 to existing 2(2x6) beams to make triple.
- Installing 1,152 LF of joists at 15" spacing so they run on top of beams cohesively from one end to the other.
- Installing 156 LF of rim joist.
- Resetting/re-shimming the entire block and base portion of the foundation with steel to improve leveling.

- OBTAIN A FRAMING INSPECTION PRIOR TO ANY REPAIRS.
- INSTALL A FULL GUTTERING SYSTEM WITH DOWNSPOUT EXTENSIONS.
- REGRADE THE PERIMETER OF THE STRUCTURE TO PITCH WATER AWAY FROM THE FOUNDATION.
- USE FANS TO DRY THE CRAWLSPACE AREA AFTER THE PERIMETER IS REGRADED.
- INSTALL 300 LF OF BEAM.
- ADD A SINGLE 2X6 TO EXISTING 2(2X6) BEAMS TO MAKE TRIPLE.
- INSTALL 1,152 LF OF JOISTS AT 15" SPACING SO THEY RUN ON TOP OF BEAMS COHESIVELY FROM ONE END TO THE OTHER.
- INSTALL 156 LF OF RIM JOIST.
- RESET/RE-SHIM THE ENTIRE BLOCK AND BASE PORTION OF THE FOUNDATION WITH STEEL TO IMPROVE LEVELING.
