Subject: Request for Approval for Retaining wall.

I hope this message finds you well. I am writing to request for variance, to construct a retaining wall within the utility easement located at 3201 Trailing Vines Bnd Wylie TX 75098.

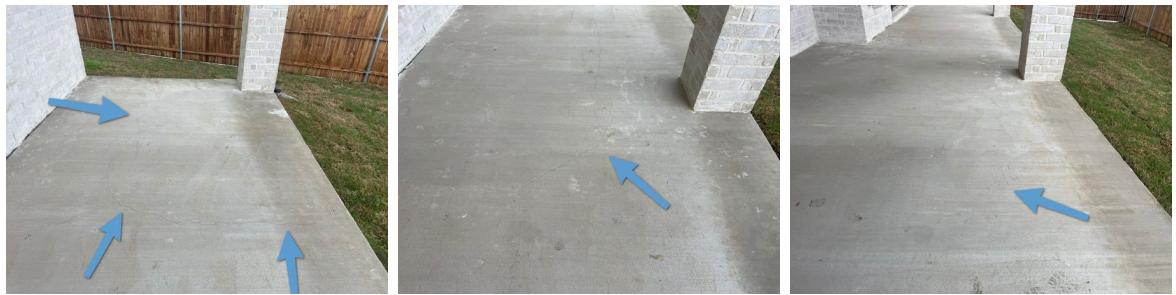
1: Patio/Porch Cracking

There is cracking noted at the patio/porch surfaces. The crack is going from edge to edge at the rear left of the back patio.

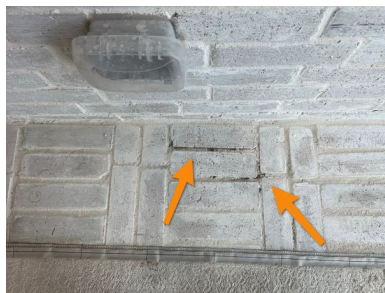
2: Mortar Cracks

There are mortar cracks in the bricks at the porch.

Recommendation: Contact a qualified professional.

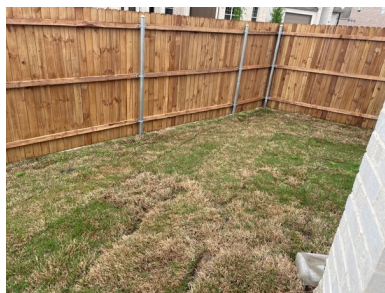
2: Steep Grading

The grade is excessively steep in areas around the home. This can lead to erosion and the soil around the home should be monitored.

Recommendation: Recommend monitoring.
