STRUCTURAL EVALUATION REPORT

DATE: January 22, 2024

PROJECT TITLE: Augusta Boathouse

Јов #: 3042.2401

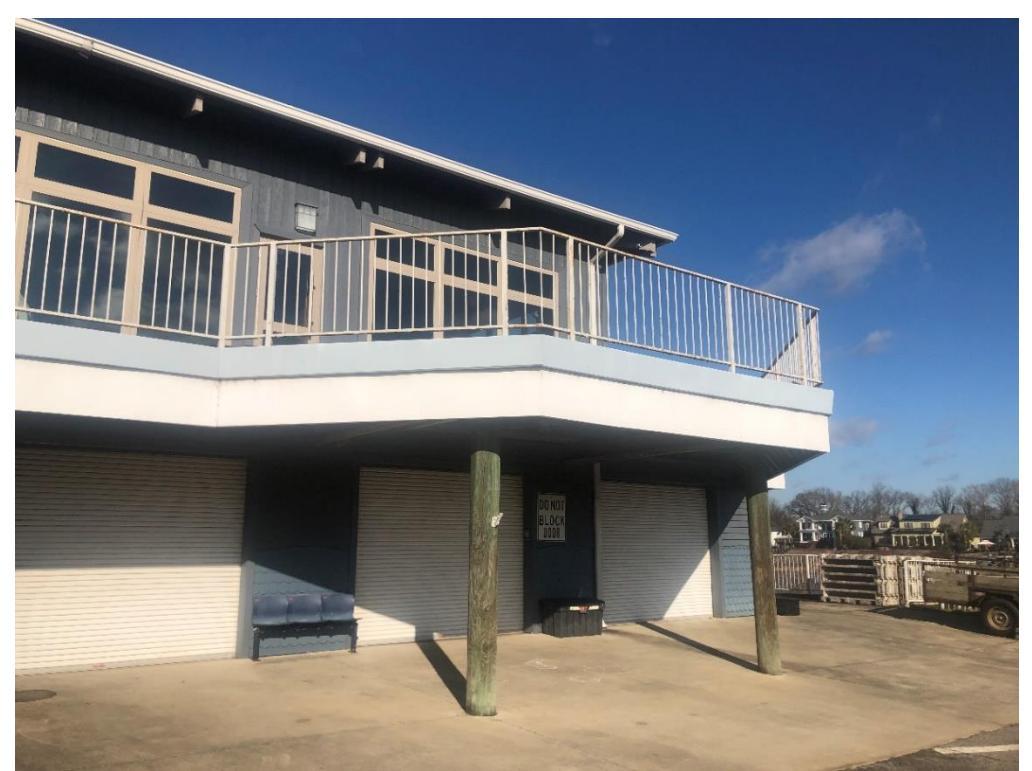
East deck. Note supporting poles and lower level garage doors.

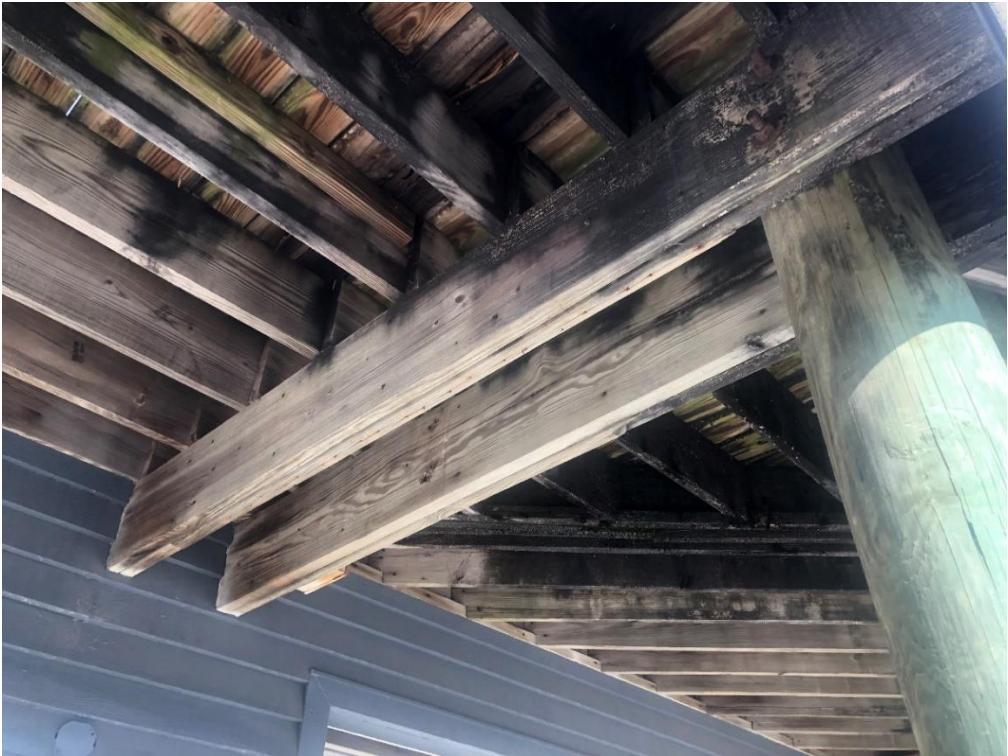
Underside of East deck showing typical poles supported construction

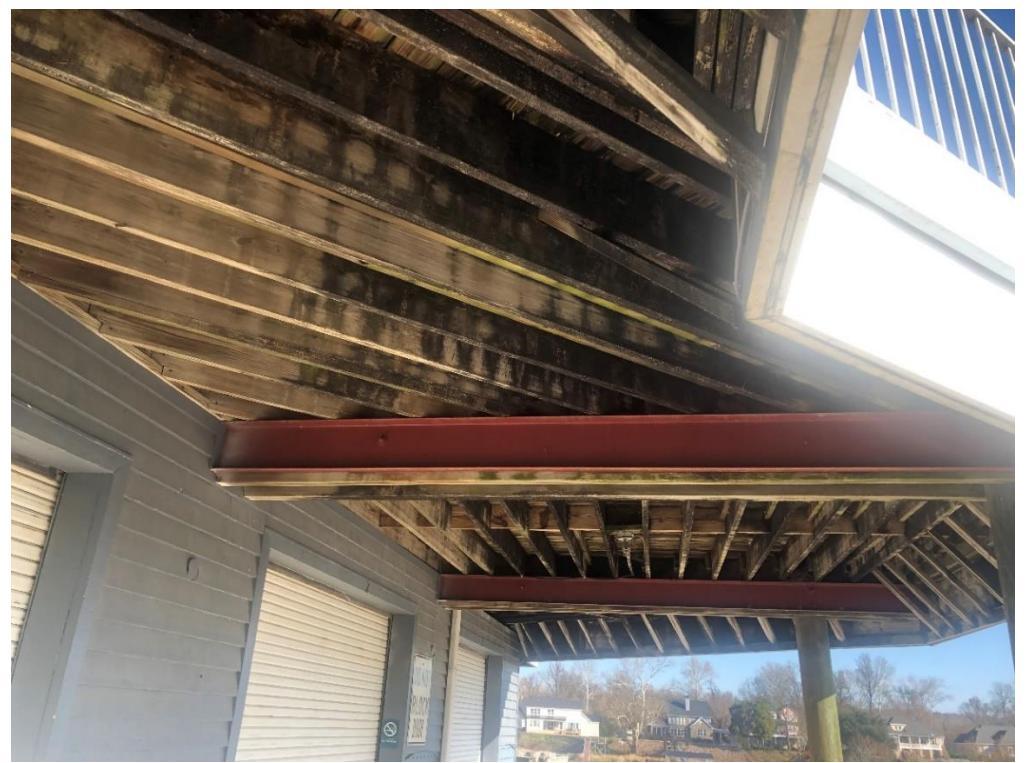
Steel reinforcement of deck girders. Note bad condition of framing beyond the protective building eaves of roof above deck.

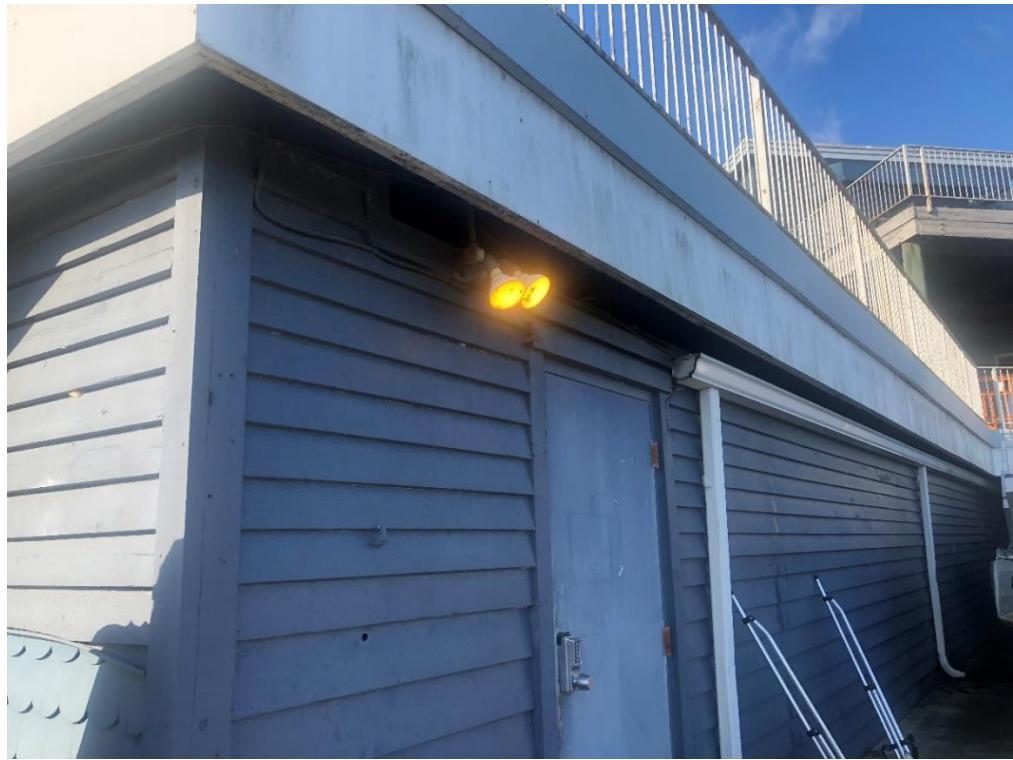
Enclosure under East Deck with independent roof/gutter.

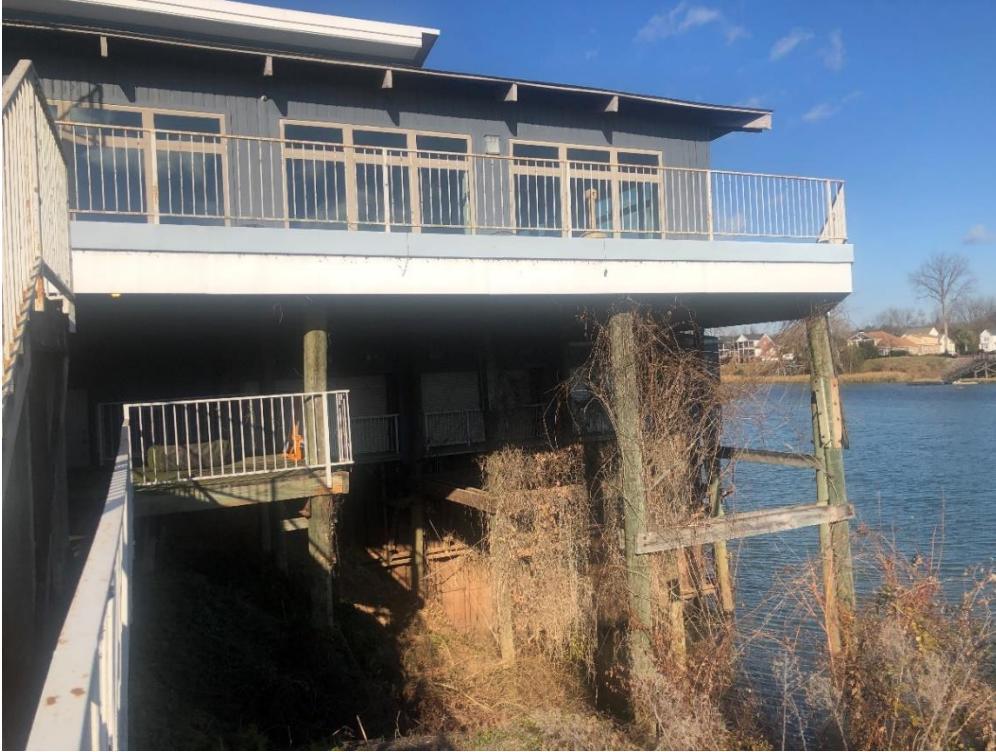
The backfilled sheet pile platform appeared to be in acceptable structural condition. Although dented and scratched from use and exposure, the weathering steel (intentional rusting to provide a protective coating) is self-healing against ordinary wear. Note that JLA was not able to examine the condition of the sheet pile (or poles) below the water level. Like the poles, deterioration would more likely be at the water level than below it and marine construction sheet piling and pole piles are usually driven deeper than potential underwater riverbed scour.

River leg showing sheet pile platform at embankment. Note garage doors with railings around perimeter.

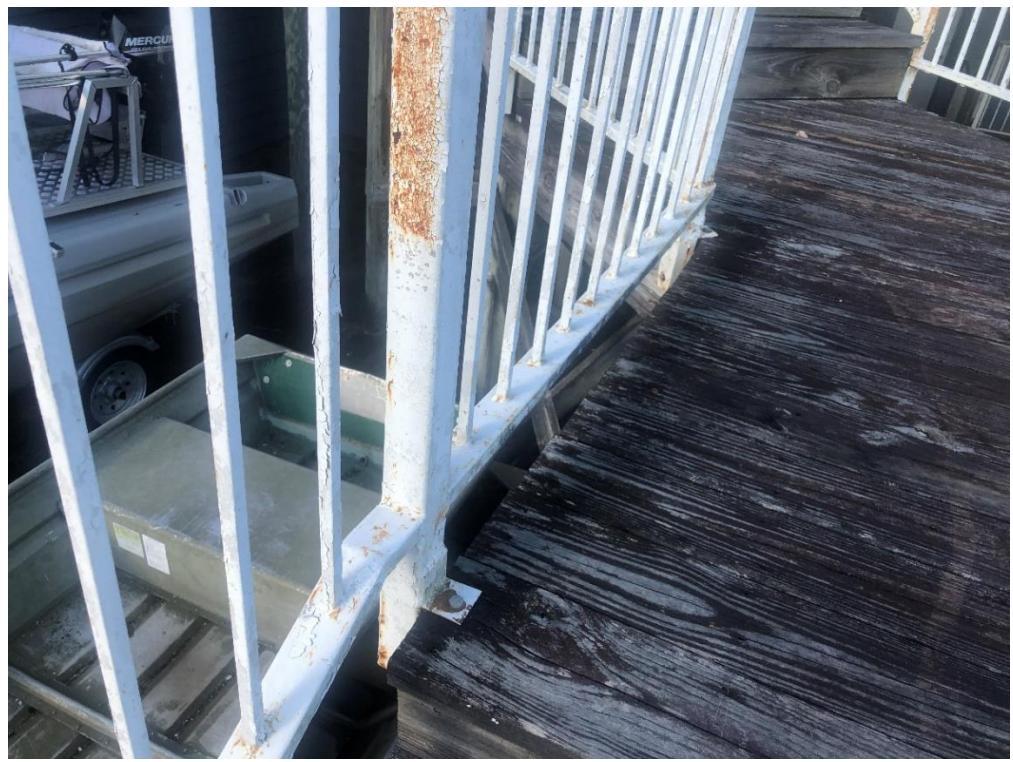
The decks surrounding the building, however, had multiple areas of significant structural failure. This was most evident in the deck boards which were soft and could be broken through with the average pressure of a person's foot. The exposed wood joists below the deck were significantly stained by water and there was widespread surface rot on the wood. While the rot did not yet appear to be significant enough to fail the floor joists, it will progress to failure if not addressed. The metal handrails around the deck perimeter were in adequate structural condition, but their attachment to the deck was compromised by the deck's condition. As previously stated, the poles supporting the deck were in acceptable structural condition, as well as the associated cross bracing. However, there were several locations where the concrete piers supporting the supplemental deck support posts were displaced due to embankment erosion.

Loose railing due to rotted deck.

- 1. Demolish and remove all deck handrails.
- 2. Demolish and remove all the deck floor boards and joists. Supporting poles and cross bracing may remain and potentially be re-used. JLA can provide specific direction as required.
- 3. Demolish and remove deck stair and ramp access. Lock and block doors leading to the decks from the inside.
- 4. Check the condition of the roof for leaks and repair/replace as required.
- 5. Demolish and remove the drywall ceiling and girder covers on the lower level to expose the wood and allow it to breathe and acclimate naturally. Repair any compromised structure, if any.
- 6. Removal of existing vegetation from deck substructures and sheet piling.

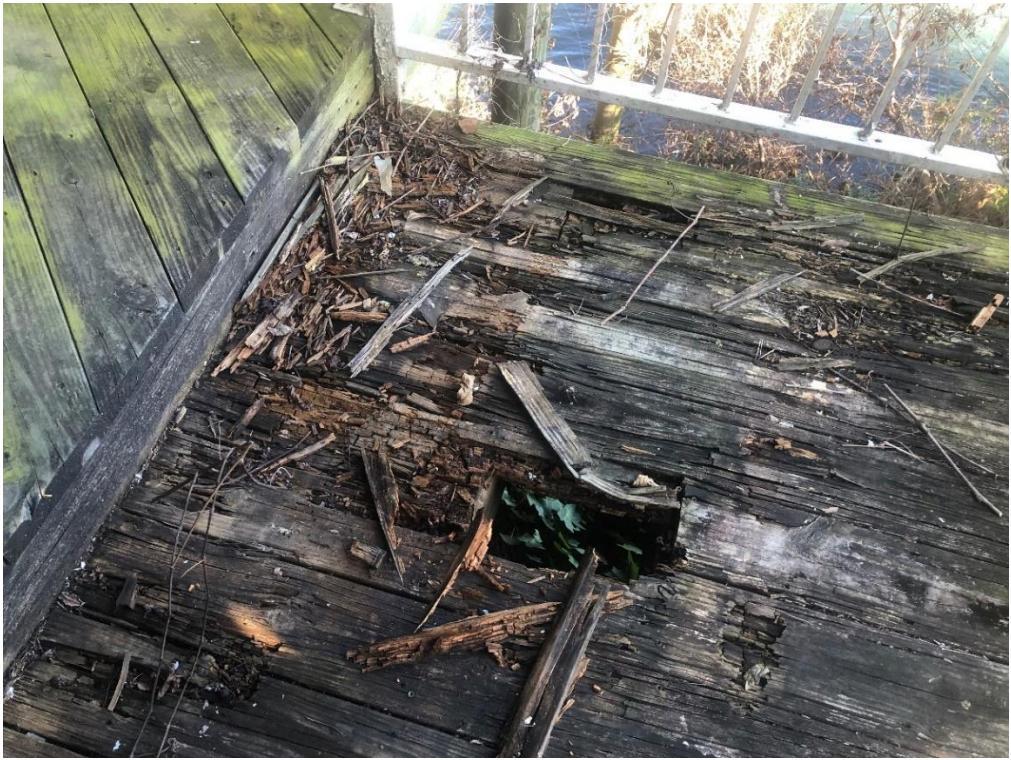
New hole in deck inadvertently created at time of observation.

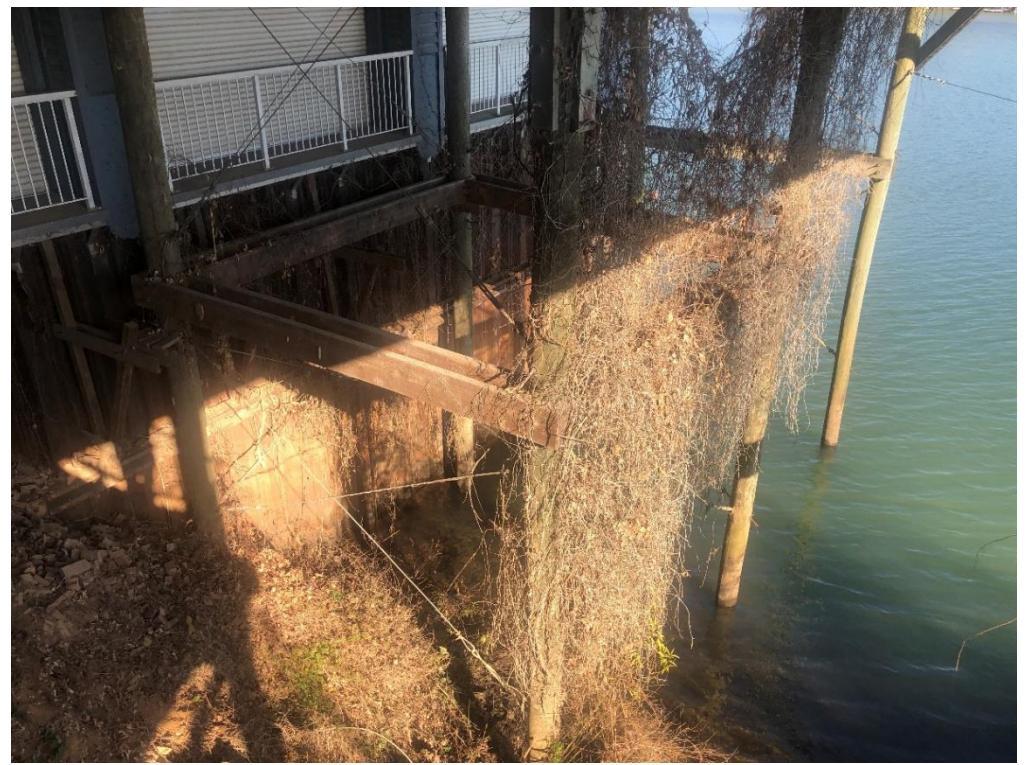
River leg deck pole supports. Some supported on concrete piers others driven into the riverbed.

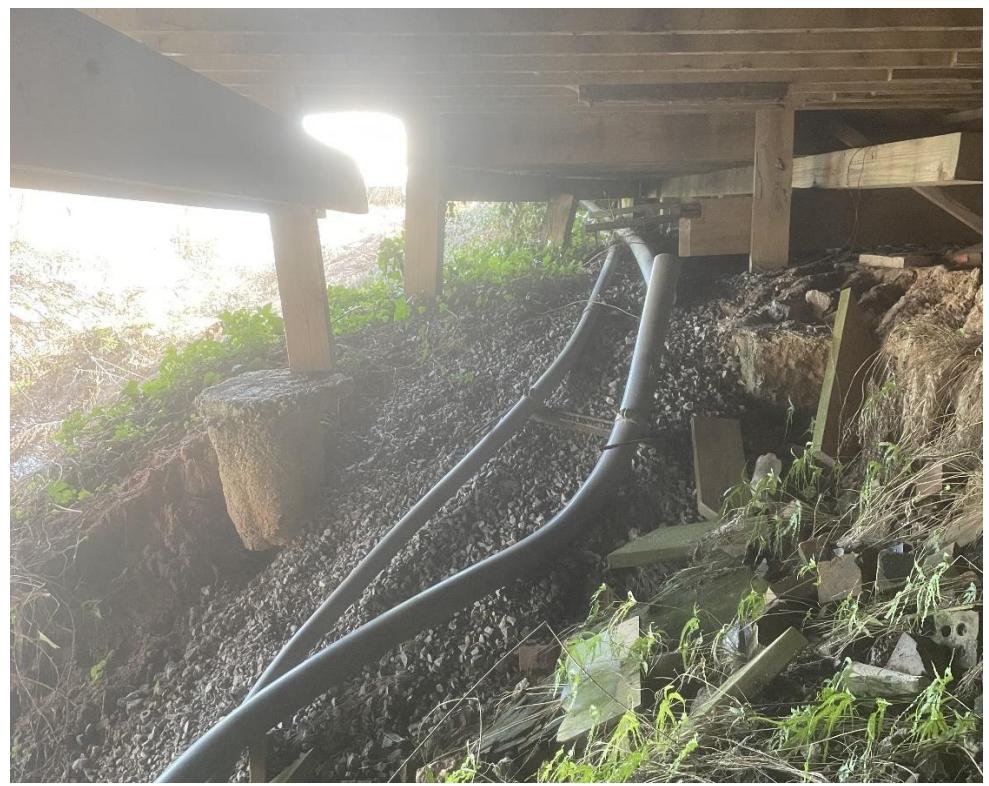
Erosion-compromised (non-pile) deck pier supports.

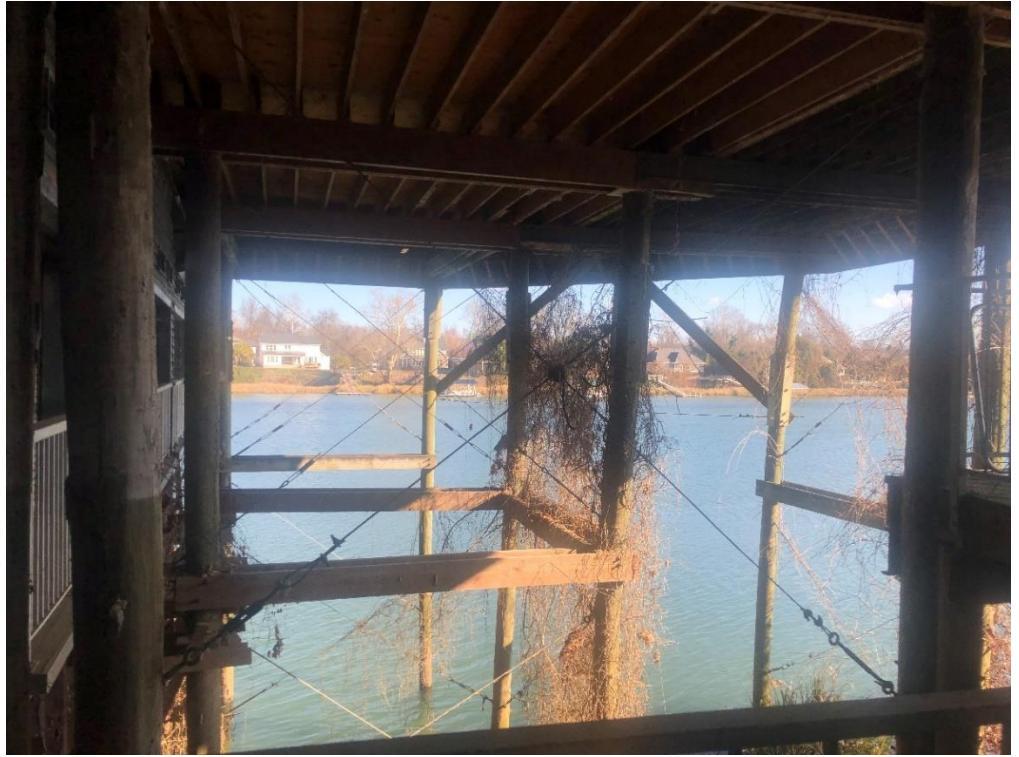
Cable cross bracing at deck support poles.

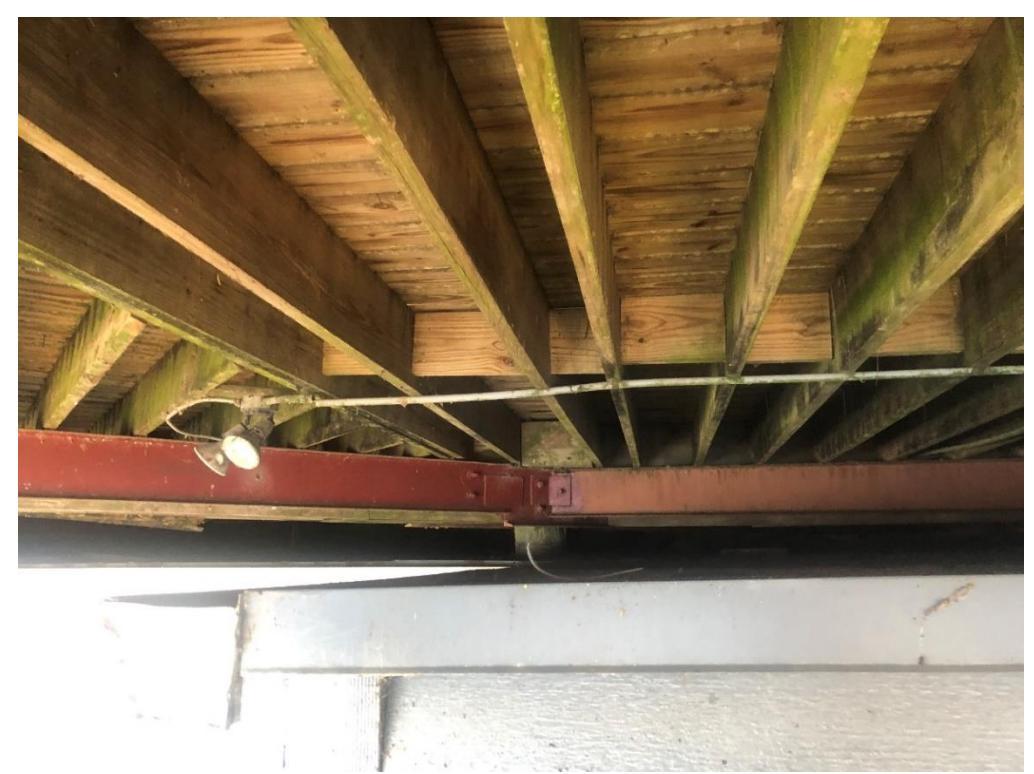
Deck framing above lower enclosure. Note pole support.

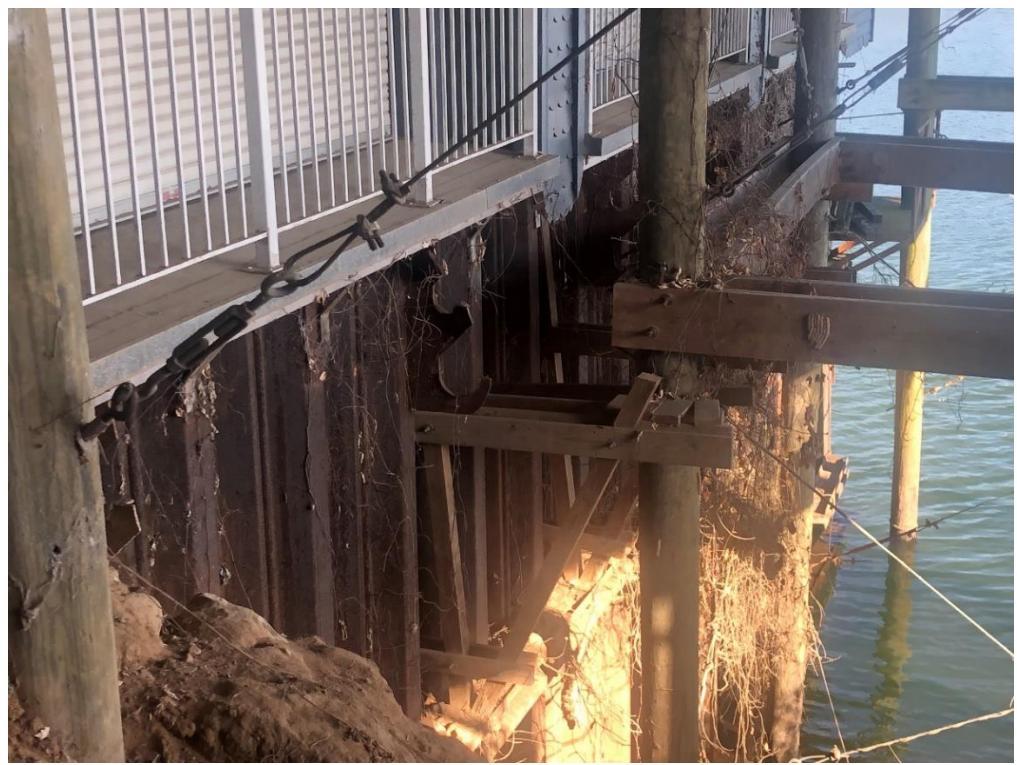
Condition of sheet pile platform and tie-back supports.

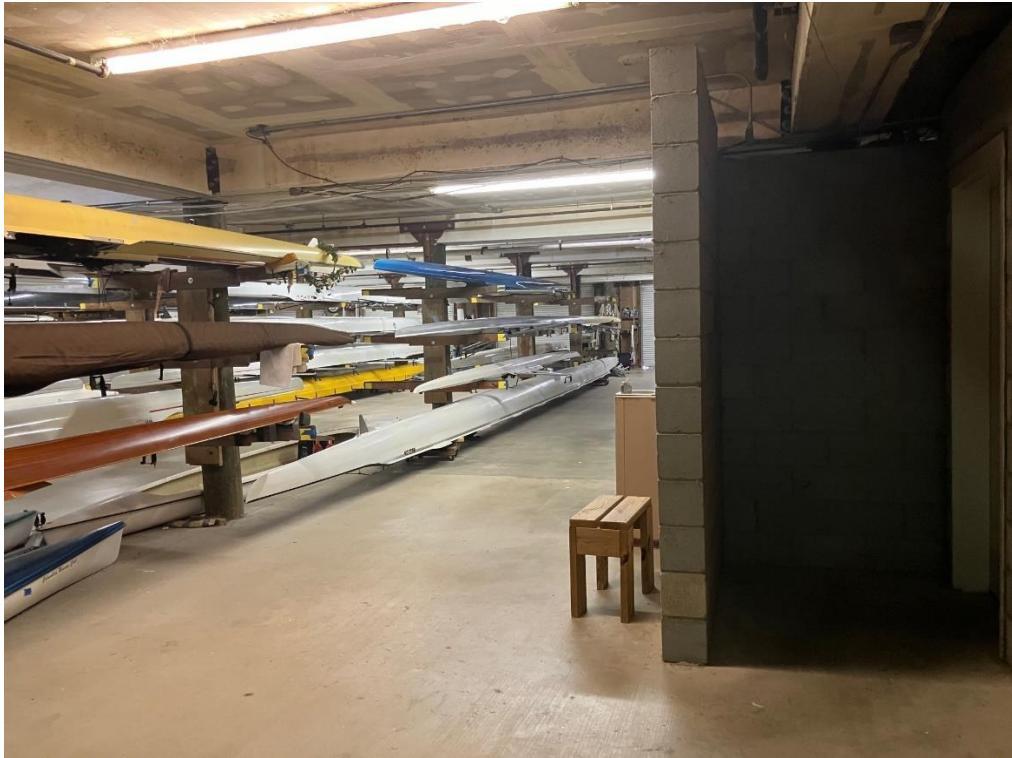
Rowing Club storage, lower level. Note pole construction and associated drywall-covered wood girder framing.

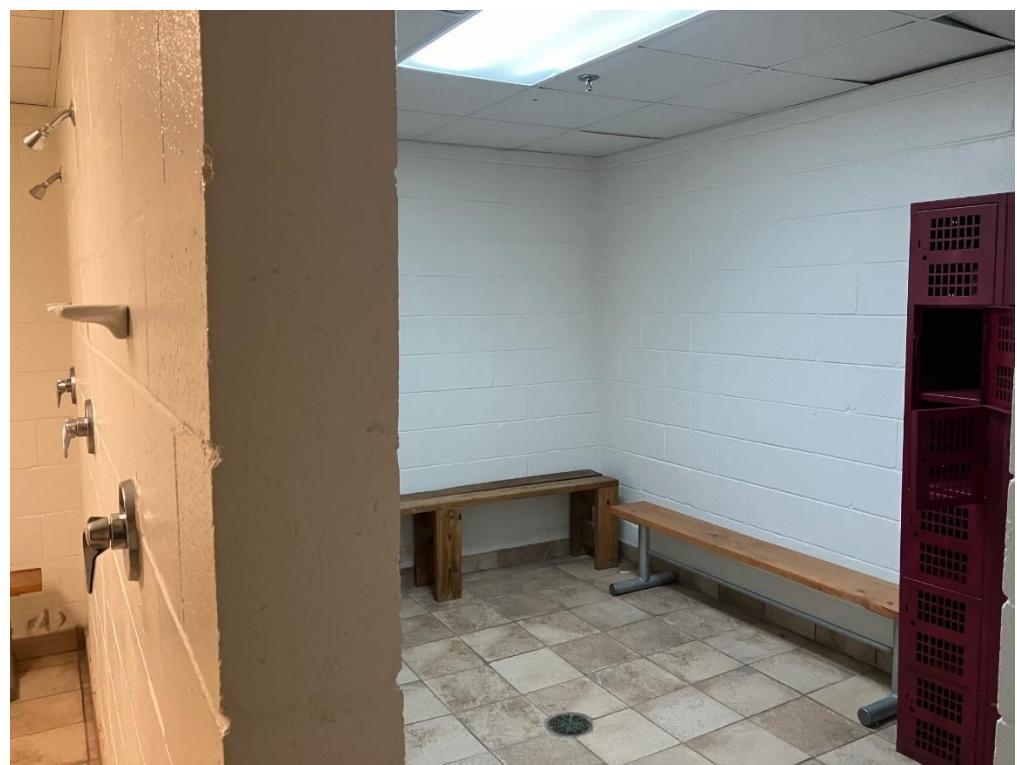
Presumably non-original concrete block locker room and shower, lower level.

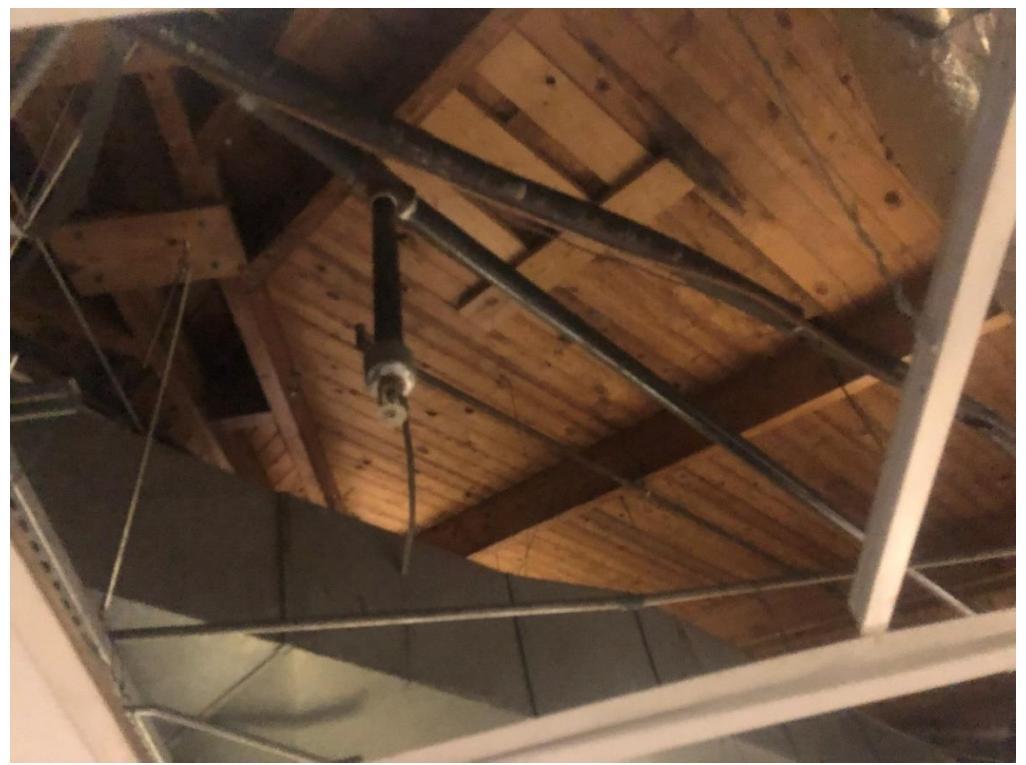
The exposed wood framing on the main level, specifically at the roof level, appeared to be in good structural condition. This included the primary girders framed between and around the poles. The secondary wood roof rafters were above a wood plank ceiling and was not observable except in the kitchen area where there was a drop ceiling. This revealed multiple roof leaks and damage (as well as previous repair attempts) to the wood deck under the shingle roof. The wood rafters were water stained in places but were not significantly structurally compromised. It was not evident at the time of the observation if any leak was active.

Roof structure above drop ceiling in kitchen. Note previous leaks and repairs.

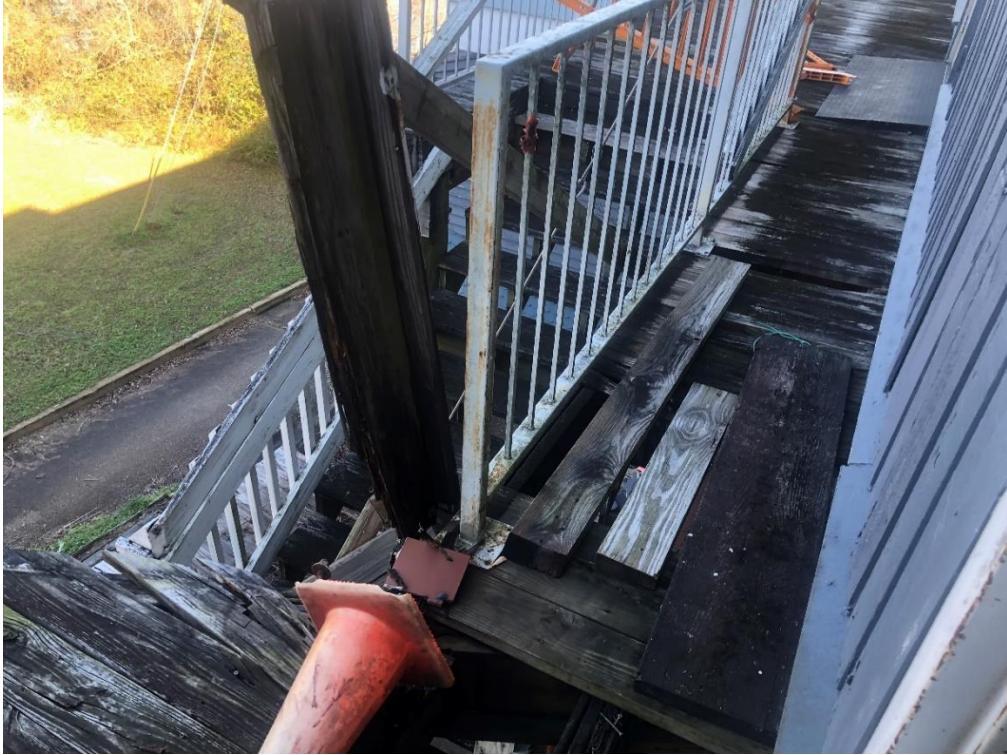
Unpassable condition of West side deck and stairs.

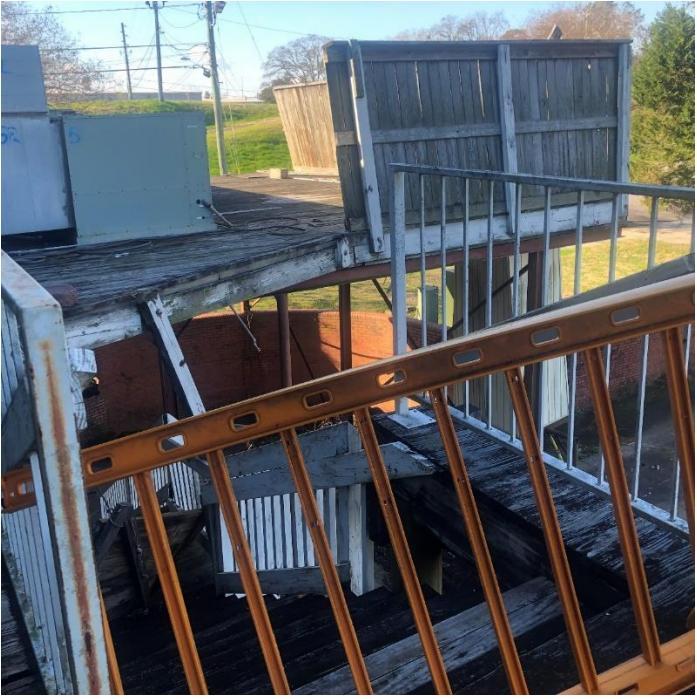
The metal deck support frame in the utility courtyard also appeared to be in acceptable condition but the wood deck on top of it had the same structural compromise as the rest of the decks.

Utility courtyard with steel-supported platform/deck.

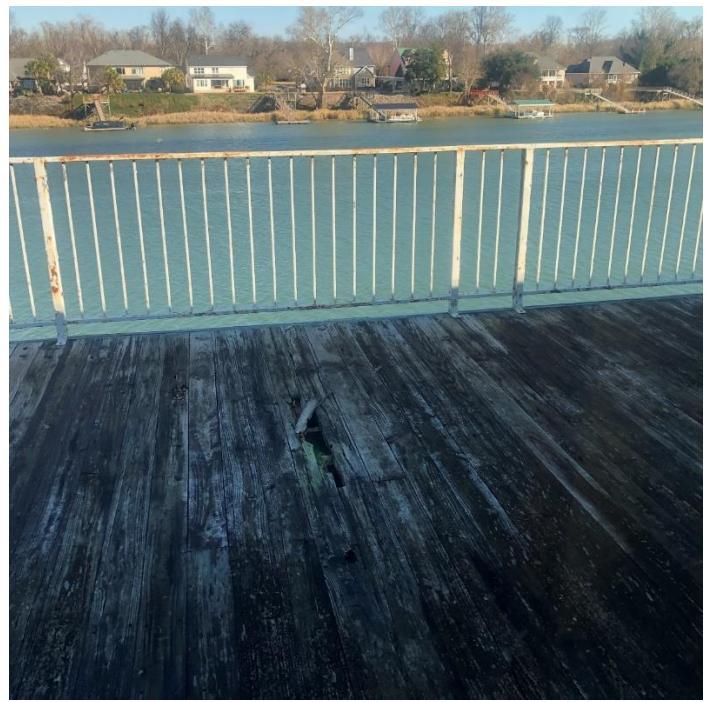
North deck (above water) showing one of many existing holes in decking.

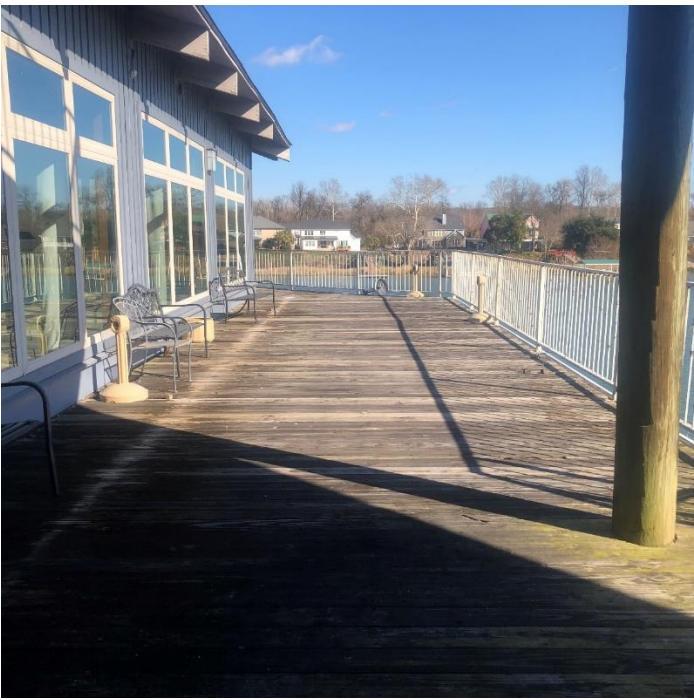
East deck of River leg. Note pole supporting deck and penthouse above.

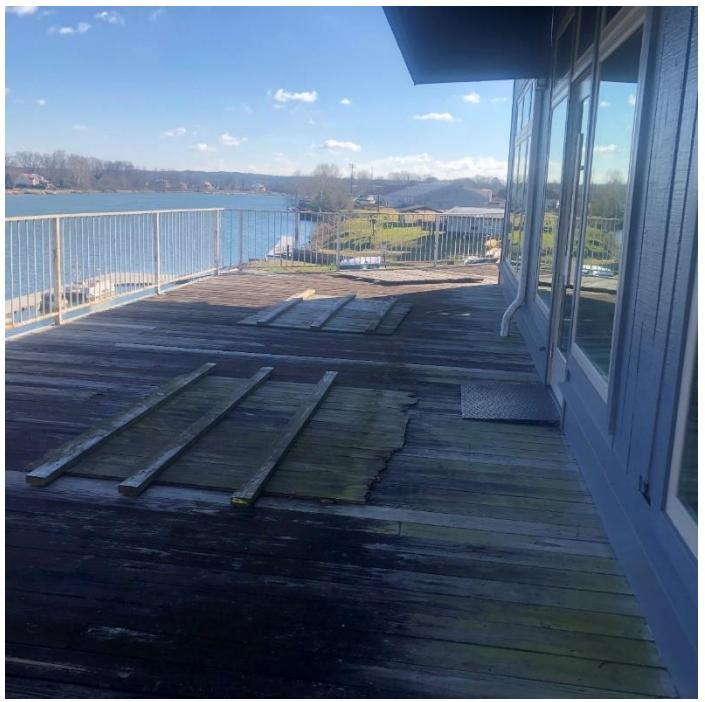
North deck showing previous "repair" attempts.

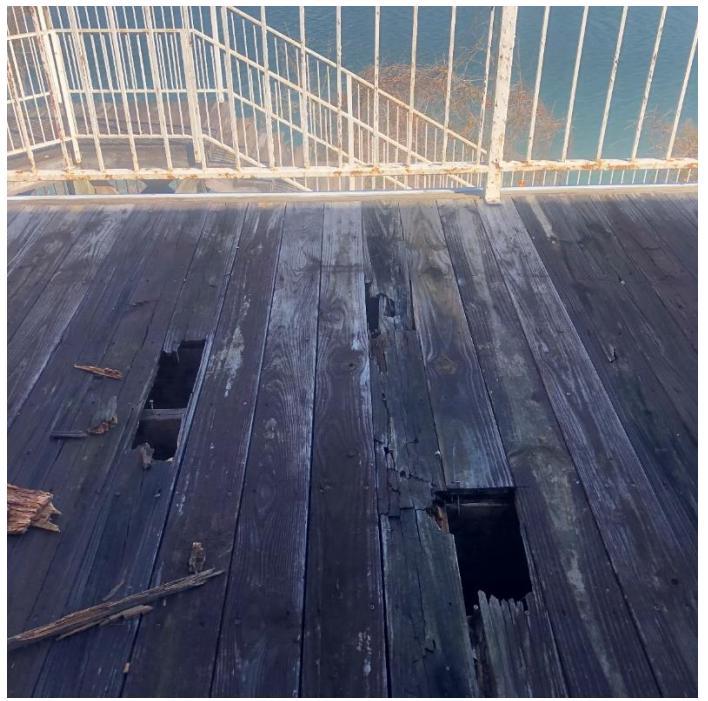
Common existing foot-sized holes in deck.

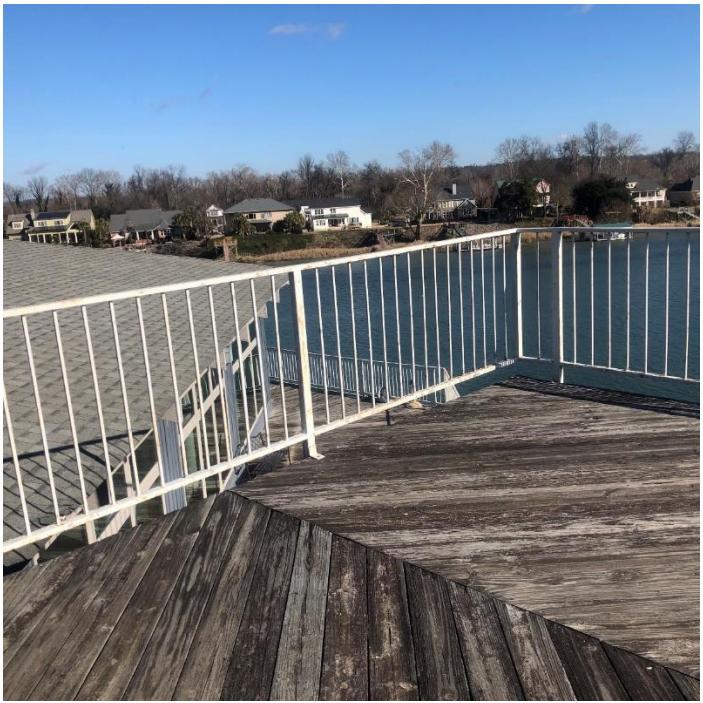
Condition of penthouse deck with roof of River leg to the left.

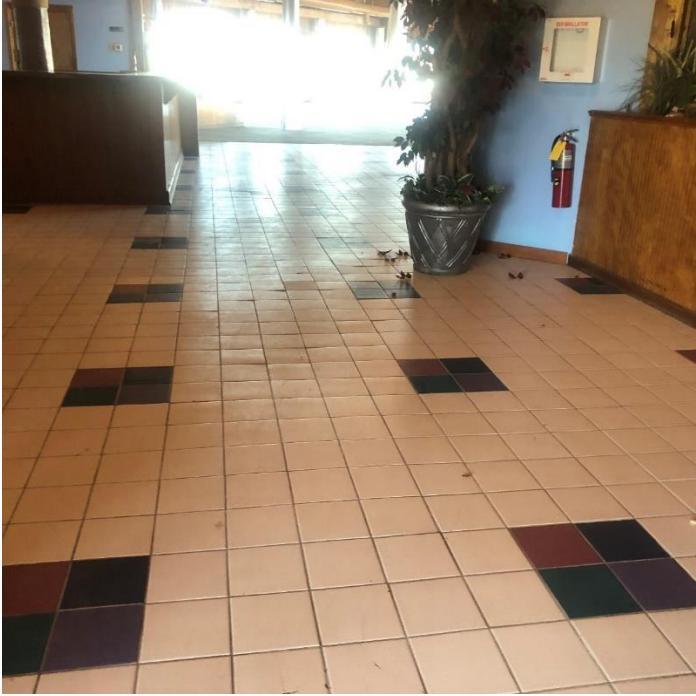
The main level floor was similarly constructed with primary wood girders framing between and around the building poles and wood floor joists on top of the girders. This framing would have likely been intentionally exposed initially in the building crawl space, allowing it to breath and dry naturally. It was subsequently (partially) enclosed to add the lower-level Rowing Club buildout. This enclosed interior space would have to either be conditioned or naturally ventilated to allow this natural breathing process in a wet humid environment. This space did not appear to be conditioned or provided with ventilation except for natural ventilation from open garage doors and it was not clear if the doors had been opened on a regular basis since the building was closed several years ago. This issue was worsened by the addition of a drywall ceiling on the bottom of the framing and the wrapping of drywall around the primary girders. Like the kitchen roof deck, there was evidence of water leak staining on the drywall ceiling and localized holes in the drywall revealed some damage/rot on the framing. However, there was no apparent evidence of significant widespread deterioration of this floor system typified by soft spots, bounce or cracked floor tile.

Entry tile floor with minimal cracks.

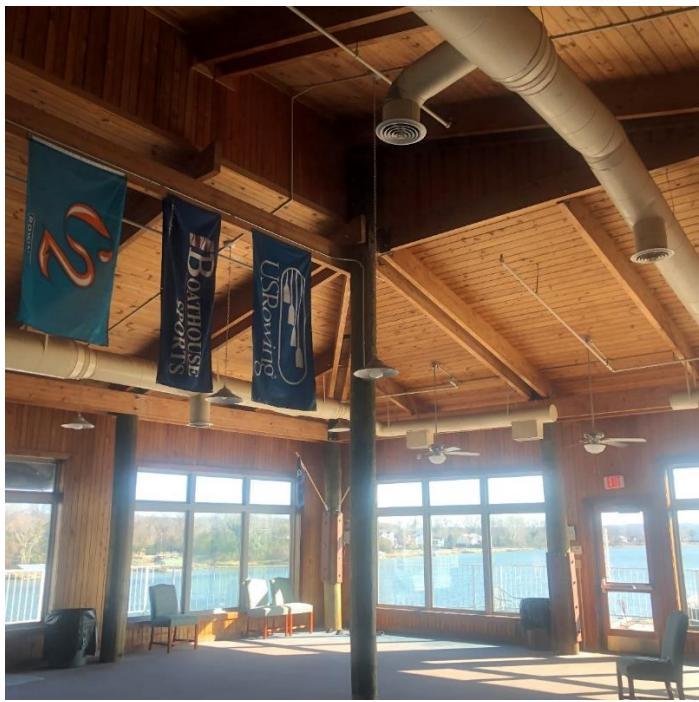
Embankment leg bar area showing typical pole and framing construction.

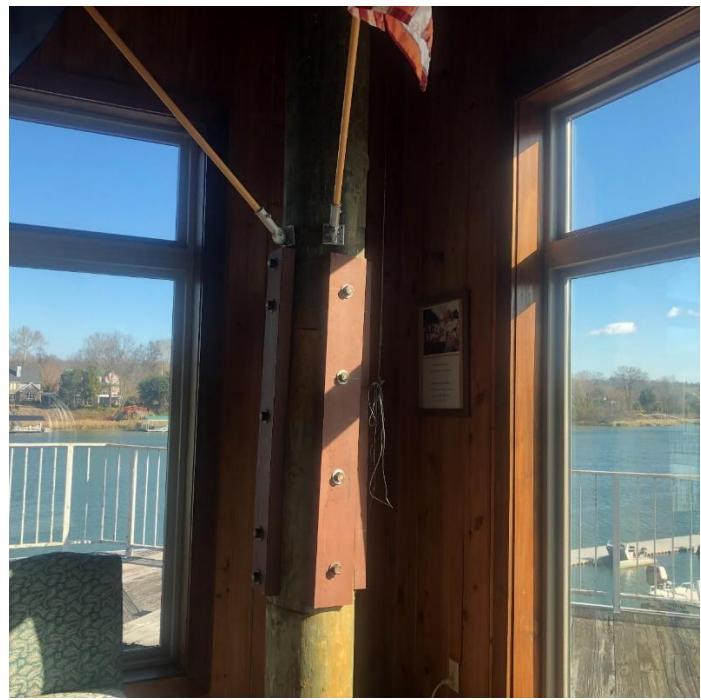
Structural splice at corner pole.
