PURCHASE REQUISITION
CITY OF BAY CITY

Emergency Repairs to Grace St Water Plant

PO Request 2023-02-01 - Felder - WWTP Grace St Water Plant

Attention: Eric Branch
Reference: Bay City Well 10

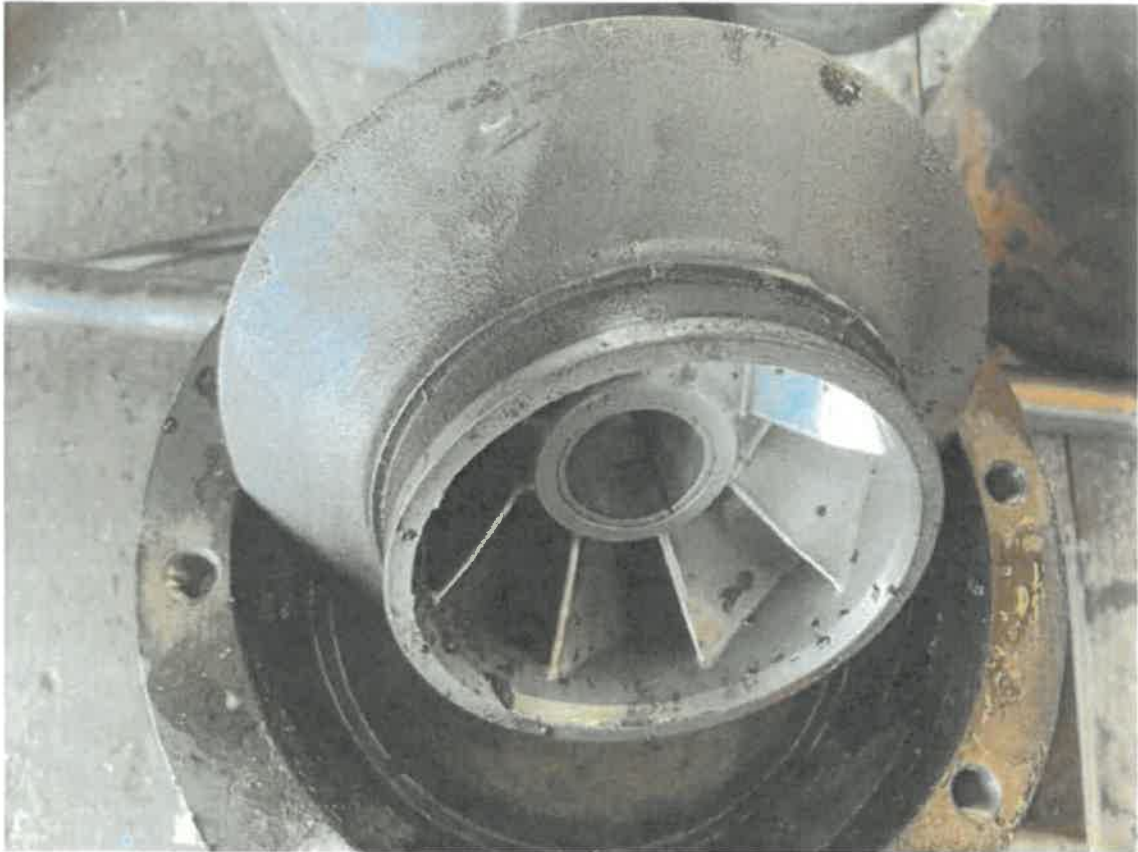
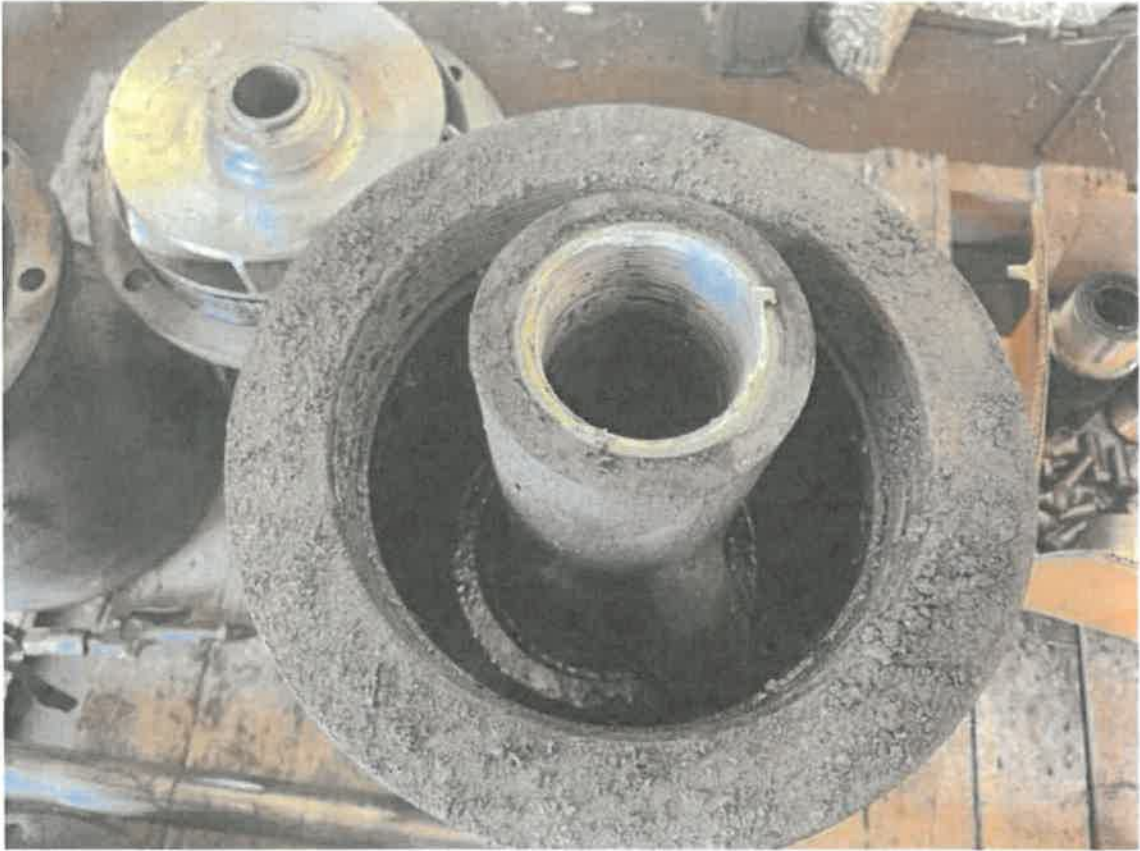
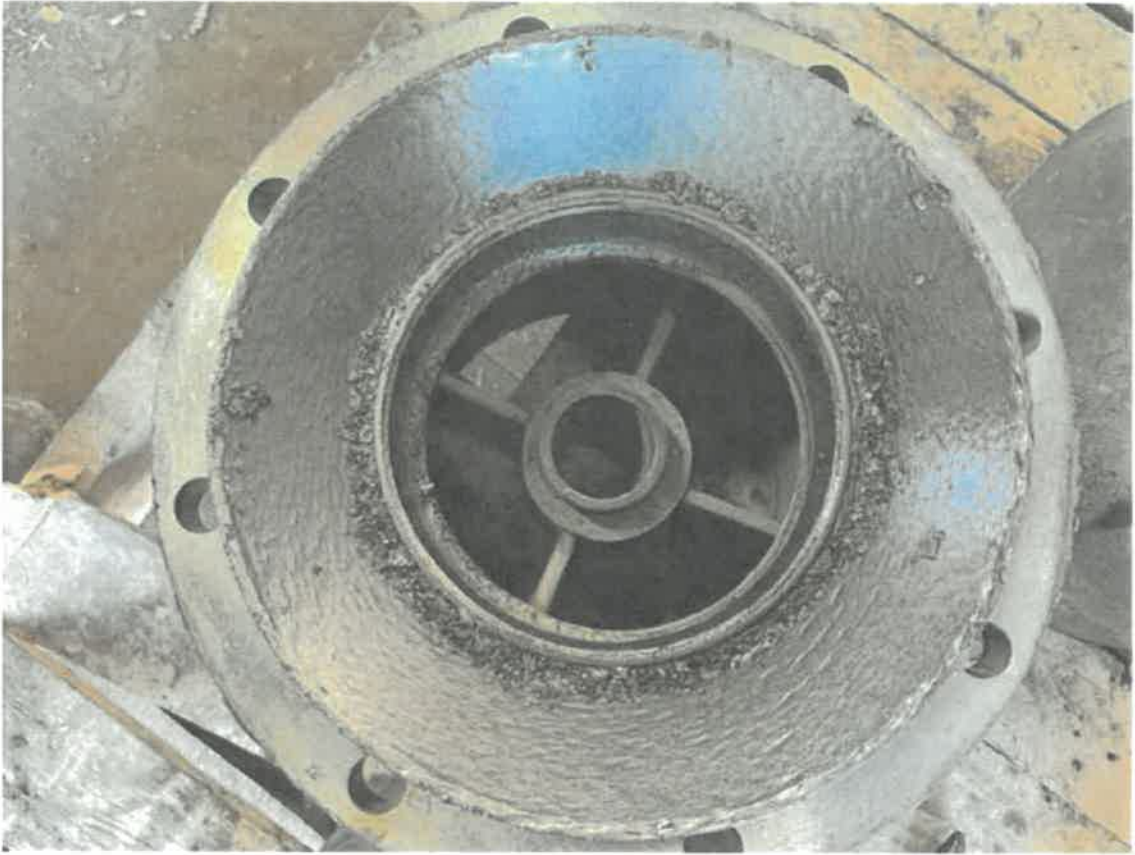
From: [Brett Patterson](#)
To: [Scott Freeman](#)
Subject: Felder WW - Bay City Well 10 Pics 1
Date: Tuesday, January 17, 2023 9:05:17 AM

At your request my pump tech disassembled and inspected the three stage 12C intermediate bowl assembly. There is noticeable wear in the top diffuser vanes. It was also noted the column pipe had erosion in all joints situated around the vanes of the rubber centering spiders. Noting that one joint of pipe had a hole located at the rubber spider. These are all signs of extreme sand intrusion. I would recommend replacing the bowls assembly and column assembly. The bowl assembly is recommended assembly with intermediate rubber bowl bearings to help with the sand wear and extend the life of the bowl.
