## Tree Removal Permit Application – Developed Property

# Arborist Report

For OIA Holdings, 3492 McCoy Rd, Belle Isle, FL, 32812

Date January 9, 2022

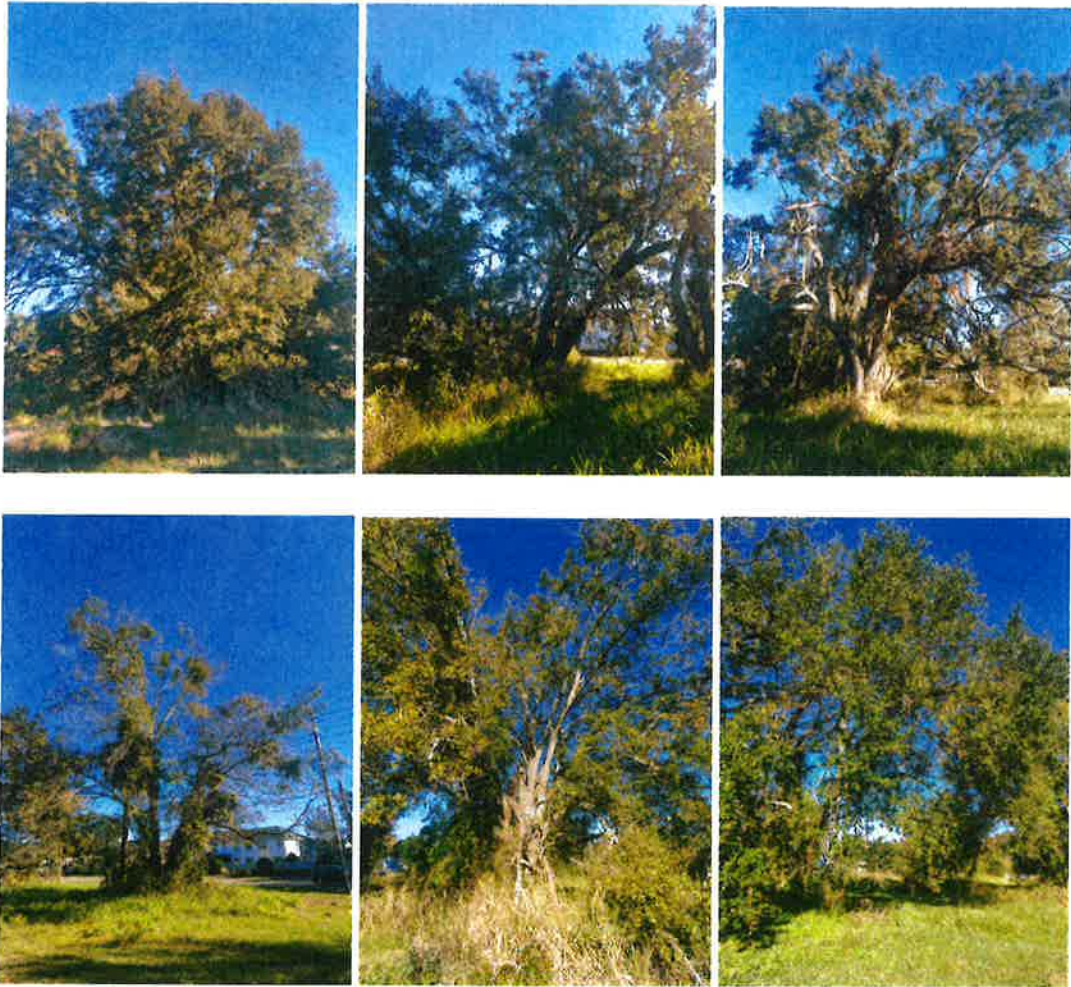
The vast majority of the trees appear to be in poor-to-fair condition overall. Many of them are clearly established volunteers, and they're relatively undesirable specimens of undesirable and/or invasive tree species. Several deficiencies were observed in most of the specimens including unbalanced canopies, heavy leans, dead and broken branches in the crowns, twig and leaf dieback, and/or indicators of decay. None of the trees have static targets in the line of fire with the exception of tree #13 (see survey) which has dead/dying branches directly overhanging the adjacent sidewalk.

*Trees located towards the north and central areas of the lot.*

Removal to ground level is the recommended course of action for the cabbage palms, ear trees, laurel oaks, and cherry laurels due to their overall conditions, site locations, structural flaws, and species characteristics. Based on the observations made at the site, it is my professional opinion that most of the aforementioned specimens are 'diseased', invasive, and/or structurally unsound. In layman's terms, they're simply garbage trees (most of which are approaching the end of their natural lifespans), and their presence provides virtually no value to the property. Furthermore, they're unlikely to survive any future construction projects if any work is to take place within their critical root zones and/or canopy spreads.

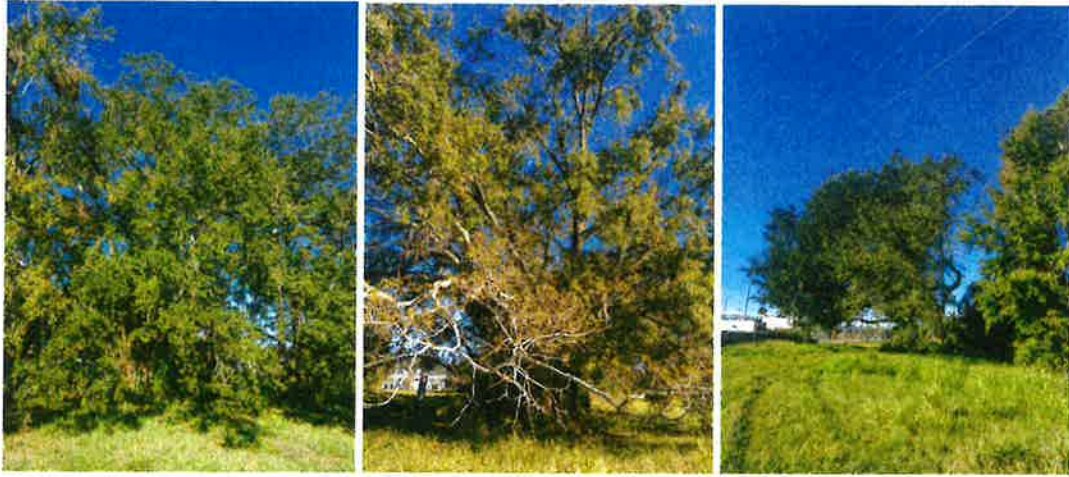
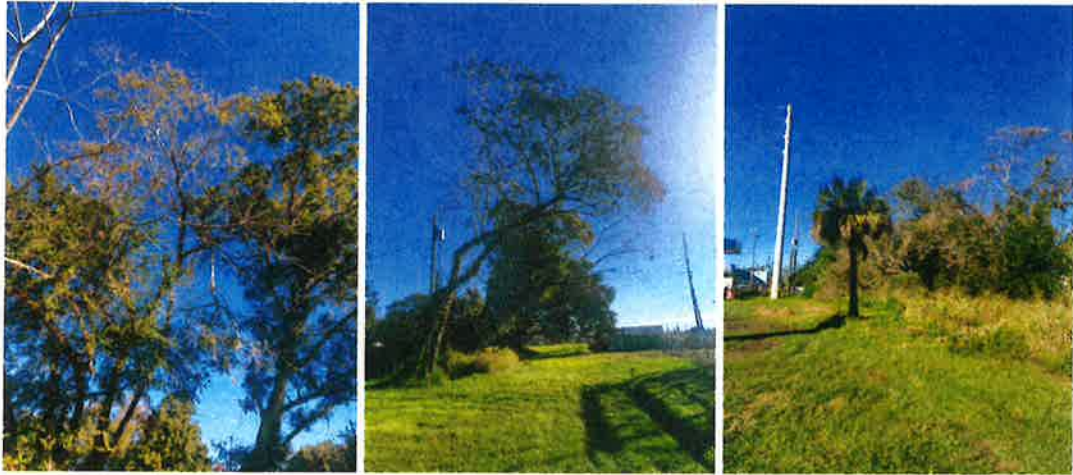
*Trees located towards the west/southwest area of the lot.*

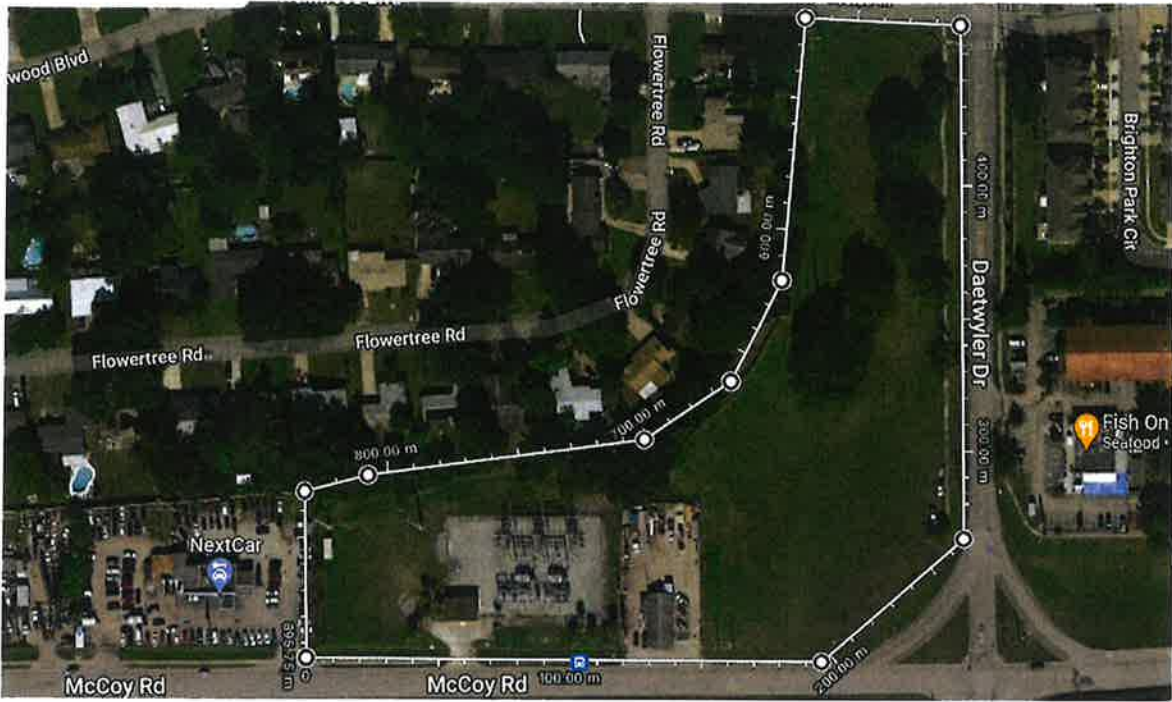
*Aerial photo of the property.*
