SARAH RILEY HOOKS COTTAGE 76 Bridge Street

VIABILITY OF PRESERVATION ASSESSMENT

Date: 12.21.2022

RE: Sarah Riley Hooks Cottage Viability of Preservation Assessment Sarah Riley Hooks House 76 Bridge Street

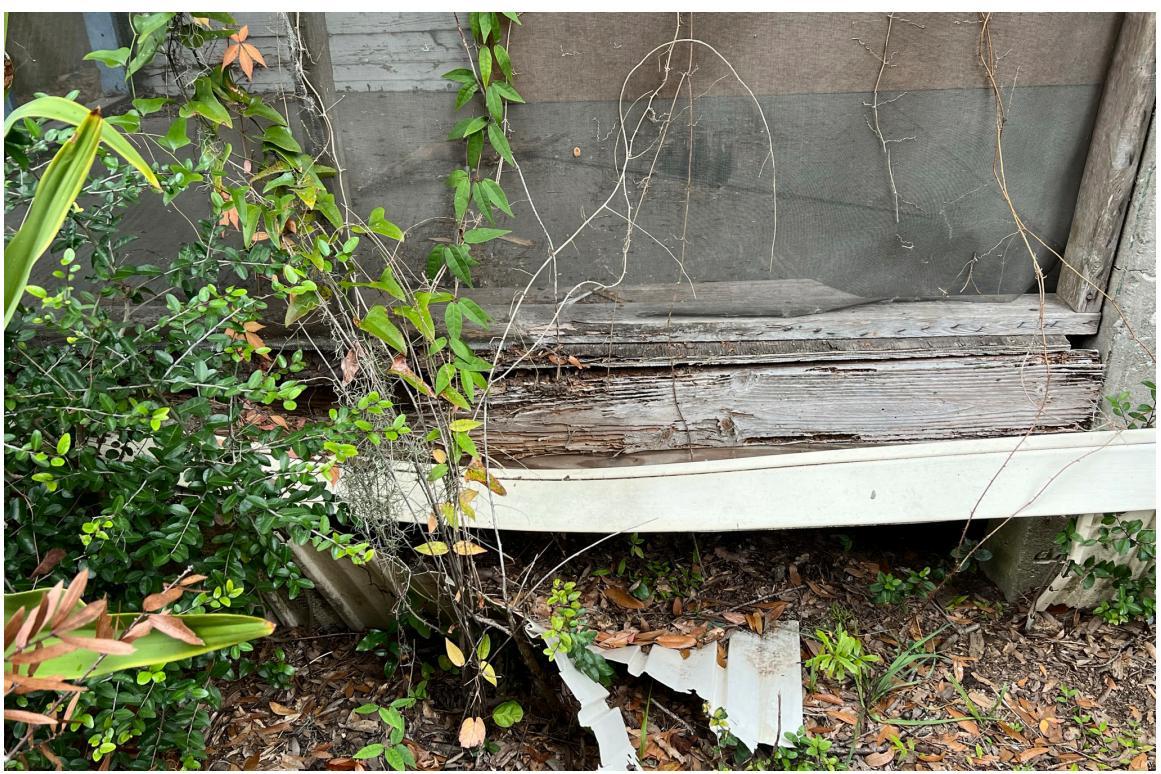
Figure 6: Front Porch: The framing and trim on the front porch is heavily deteriorated as a result of termites. Extensive section loss in the wood was observed.

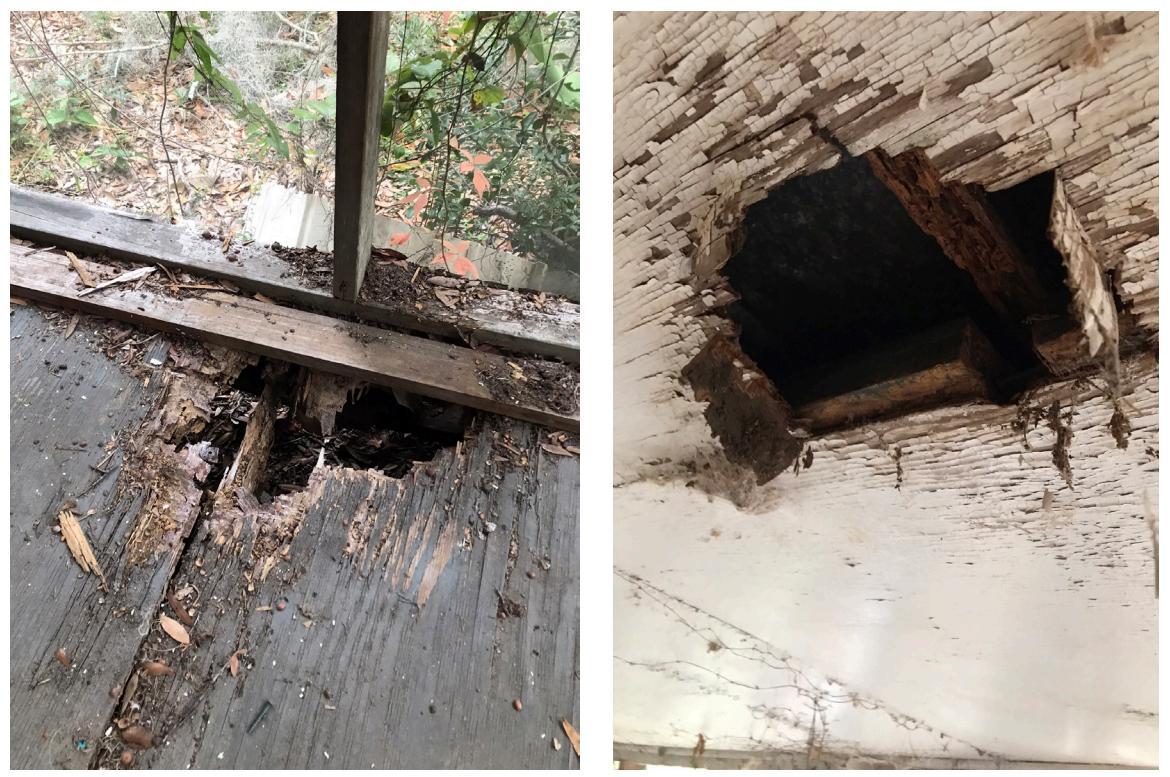
Figure 7: Front Porch: The floor of the porch is deteriorated at the edge. Select areas were extensively damaged, exposing the underlying porch framing that was deteriorated and no longer sound.

Figure 8: The roof was also open, where large animals previously entered the building. Additional structural damage was observed in the area.

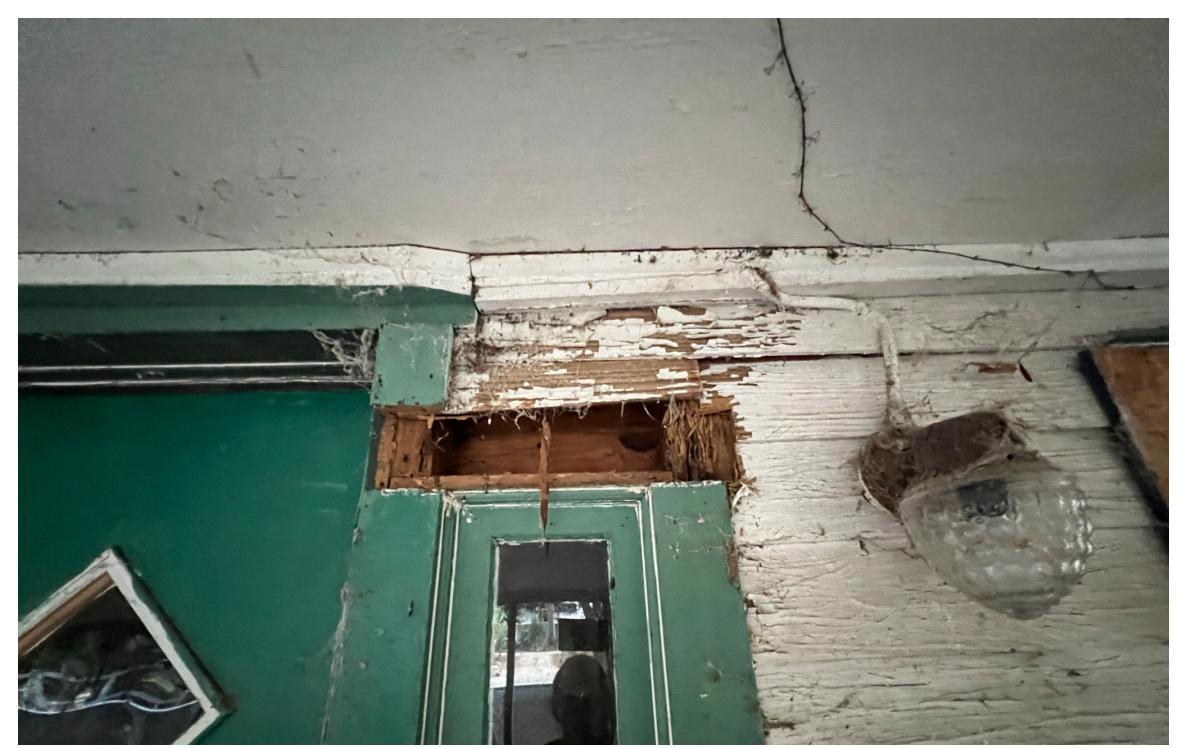
Figure 9: Front Porch: The framing behind the wood siding is deteriorated from termites.

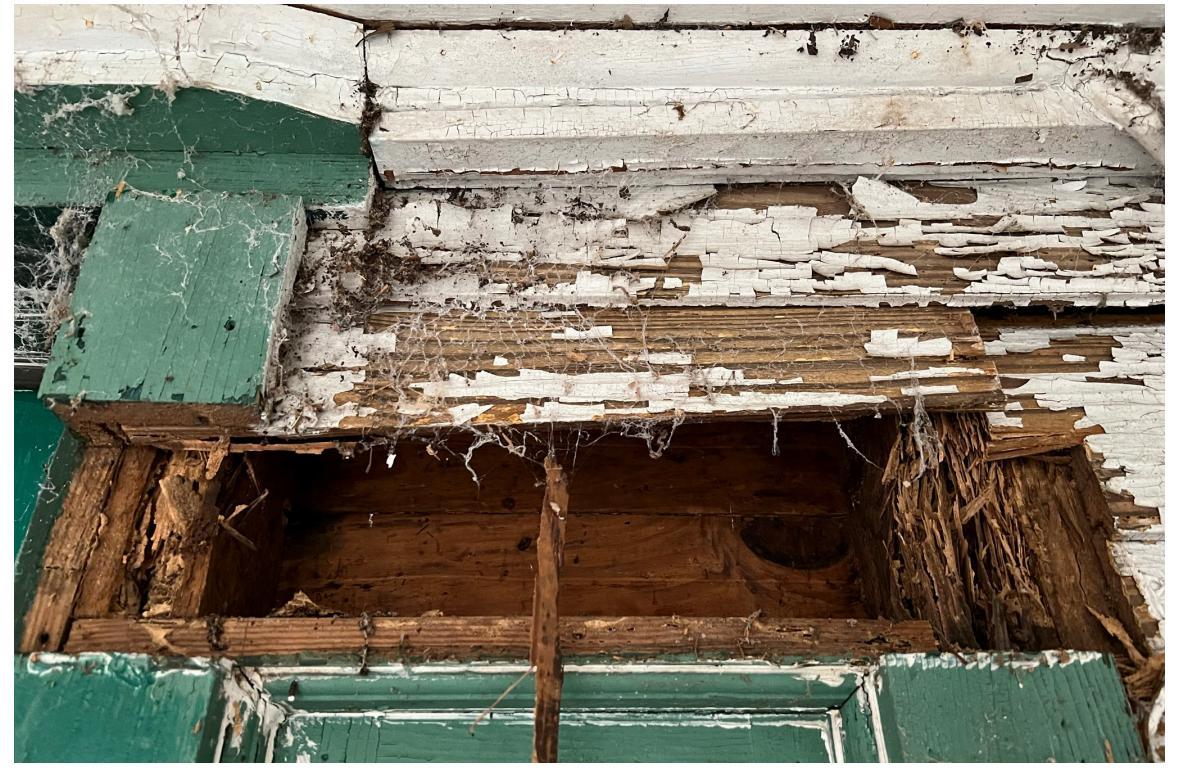
Figure 10: Close-up image of termite damage in framing members on the front elevation.

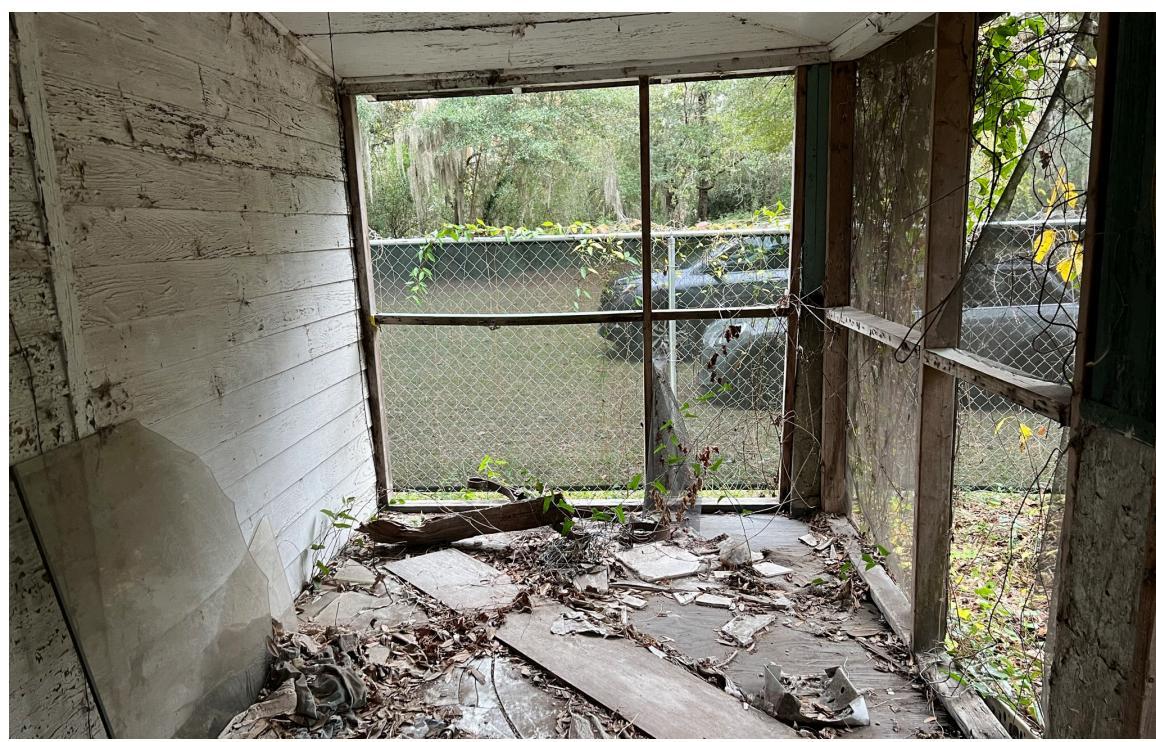
Figure 11: Front Porch: View of porch interior. Note debris, lack of site maintenance, and condition of materials.

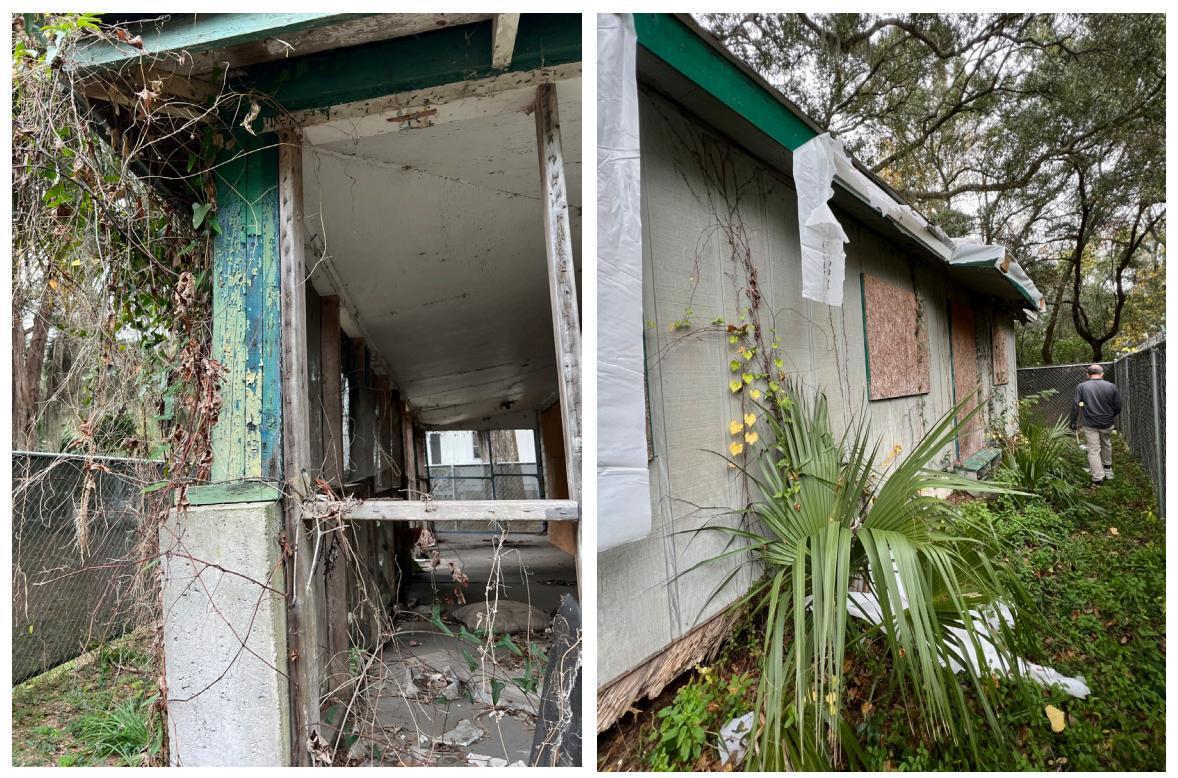
The covered porch at the front of the residence extends the width of the original structure and is covered by a shed roof terminating just below the main roof line. The roof framing is supported by a perimeter beam constructed over wood columns that rest on cast-in-place concrete piers. During the site investigation, water and termite damage was noted at the porch decking and exterior porch girders. Water damage was also noted at the roof framing adjacent to the front door entry, where portions of the ceiling are collapsing. In addition, the cast-in-place concrete piers at the porch perimeter have shifted outward, resulting in the rotation of the columns above and the deflection of the roof beam framing above.

Figure 12: Front Porch Corner. Base of the porch column is kicked out. Figure 13: Side Elevation, adjacent to open lots. The rear addition is compromised throughout and is in danger of immediate collapse.

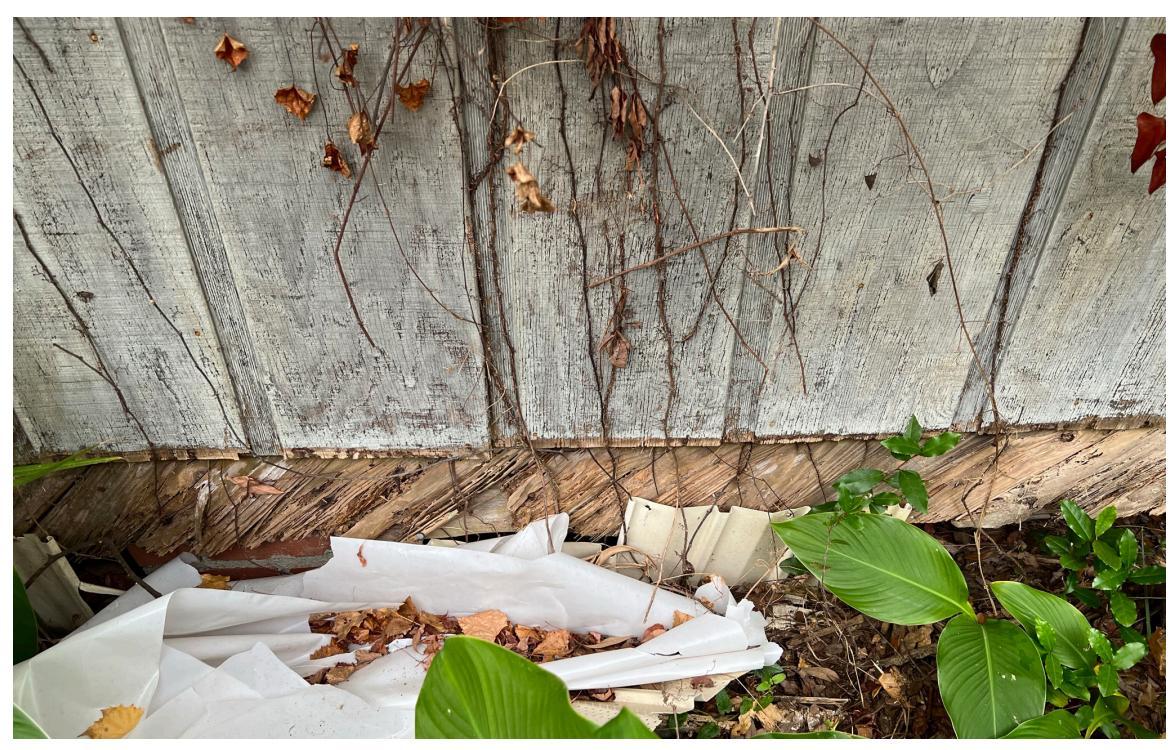
Figure 14: The diagonal sheathing boards are a complete loss at the base of the addition. Based on termite damage observed in the ceiling system and interior walls, it is assumed that the sheathing is deteriorated throughout the rear addition.

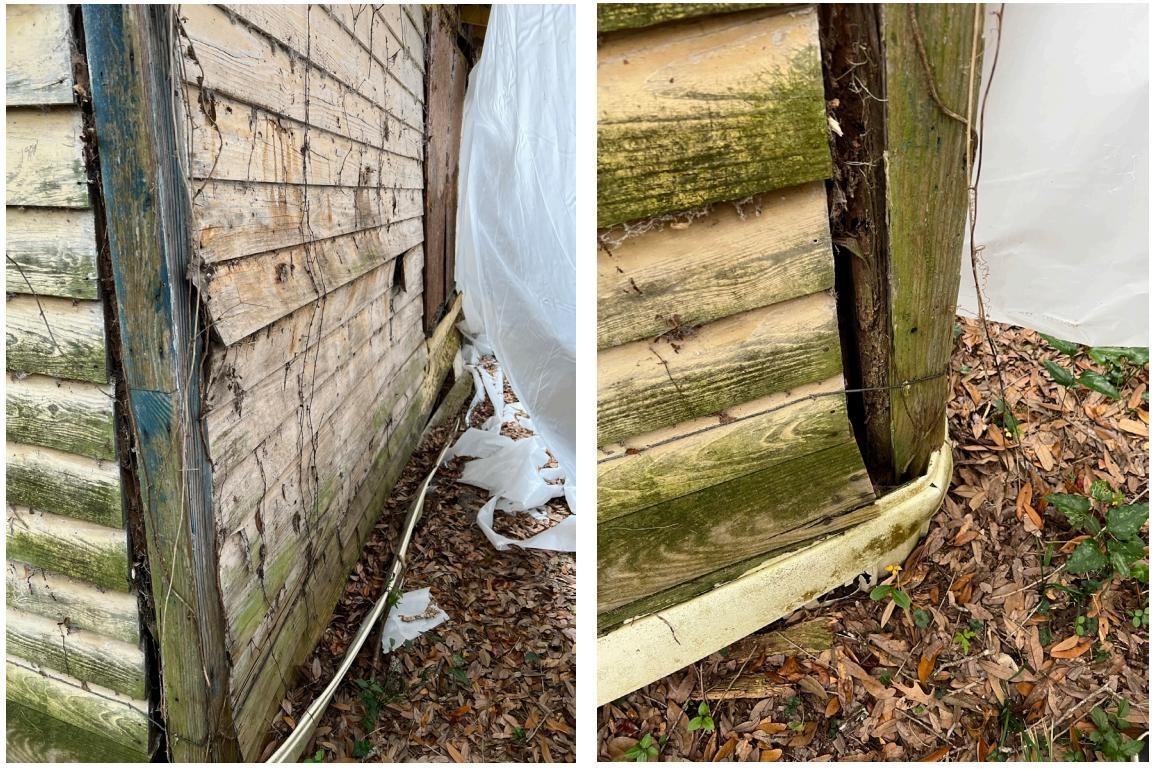
The exterior and interior walls of the original structure and rear addition are constructed of 2x4 wood studs covered with interior finishes. Exterior finishes at the structure are a combination of wood siding and asbestos siding at the east side wall. As noted previously, structural damage along the west side wall of the original structure was evident adjacent to the living room chimney stack. Portions of this wall have deteriorated entirely due to a combination of water infiltration and termite damage. Termite damage was also noted at each side of the front entry door studs and along the east side wall at the side entry door. Extensive water and termite damage were also observed on the interior walls of the living room and hallway walls extending to the rear addition. In some areas, studs have disintegrated due to a pervasive termite infestation. The corner post on the rear northeast corner elevation was noted as completely structurally compromised.

Figure 15: Rear elevation, corner of the original structure. The corner post is a complete loss. Termites have eaten through the entire member.

Figure 16: The building has dropped in this rear corner and is actively separating at the corner.

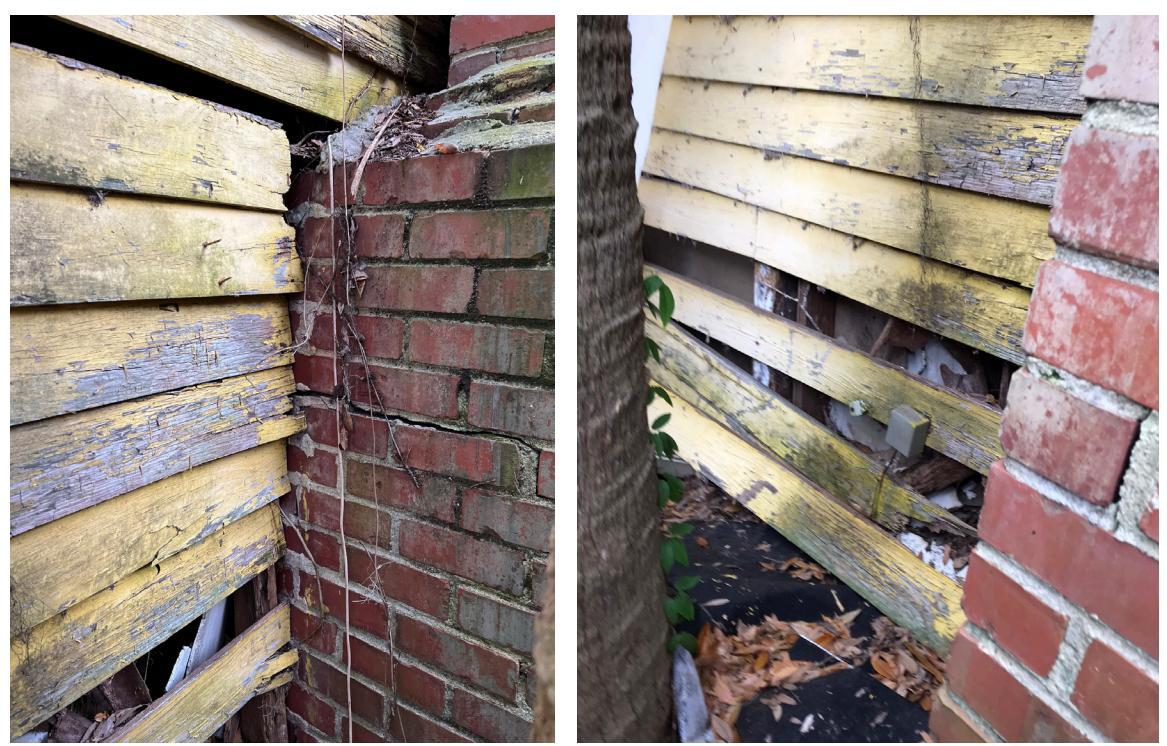
Figure 17: Side elevation, adjacent to the new construction home. The siding next to the chimney is falling away from the building.

Figure 18: The framing below has been compromised by termites and is no longer structurally sound.

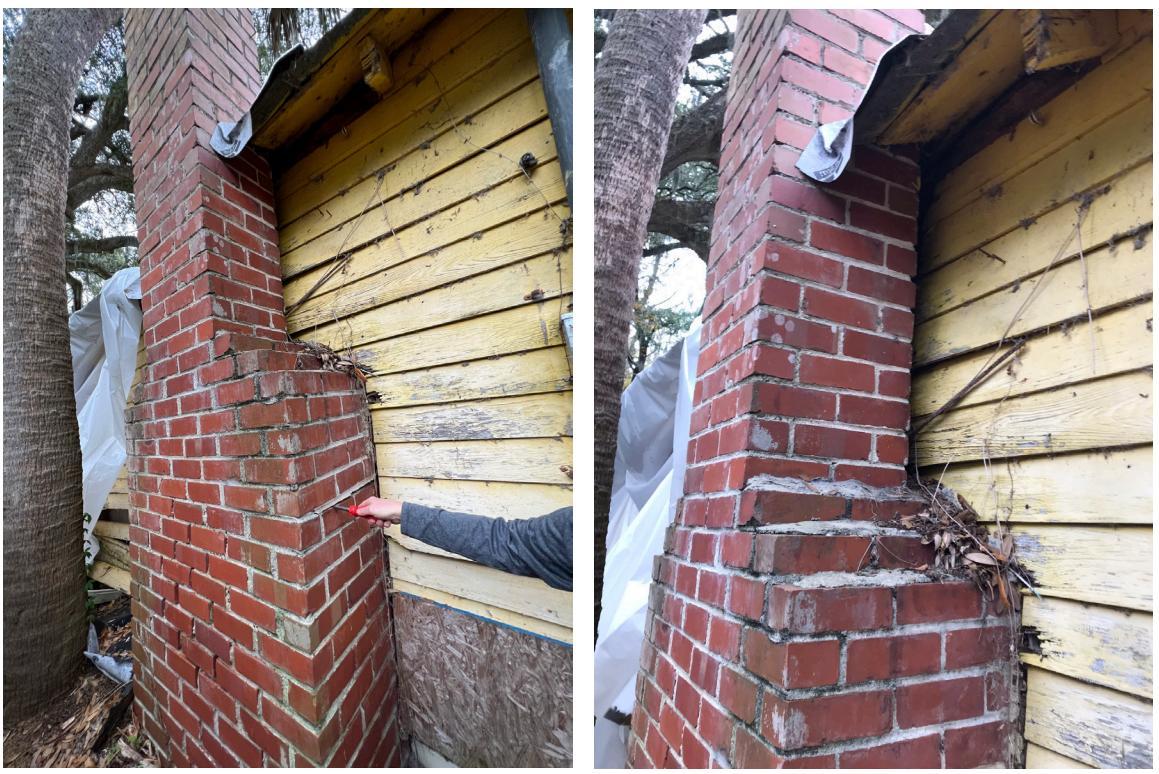
in these areas and results from ongoing roof leaks, failure of exterior wall studs, and termite infestation. In addition, the failure of roof framing at the front living room has caused rotation of the brick masonry chimney stack, and cracks within the brick masonry mortar joints have developed.

Figure 19: The chimney is being pushed out by the exterior wall of the original structure. Figure 20: Note cracks at \sim 3 ft. The side wall of the original structure is pushing out and putting load onto the chimney.

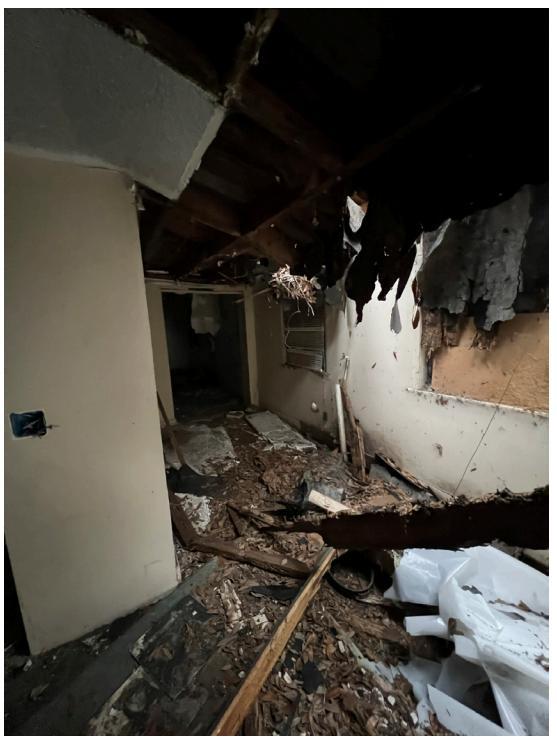
Figure 21: Rear Addition Interior: The ceiling has collapsed. Until recently, the roof was open allowing water to enter the building. Floor faming members, roof framing members, and wall studs are all damaged beyond repair from termites. Complete replacement is required.

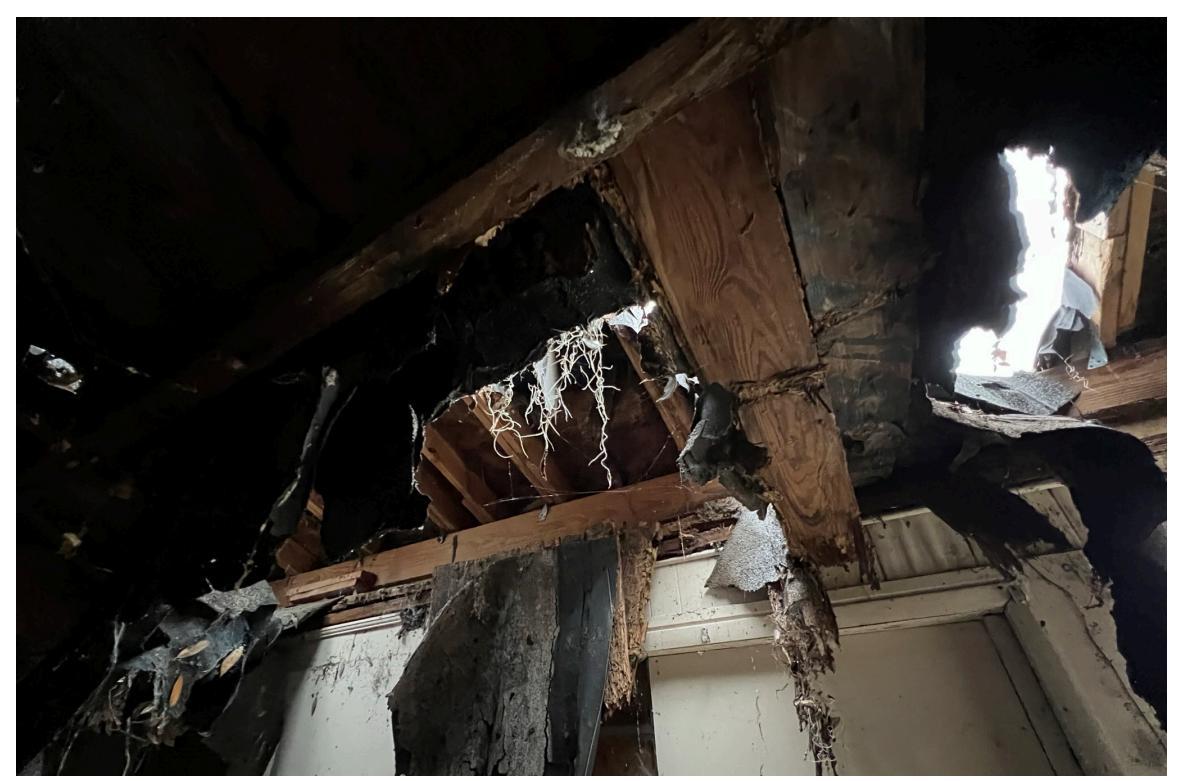
Figure 22: Rear Addition Interior: The roof has collapsed into the building interior.

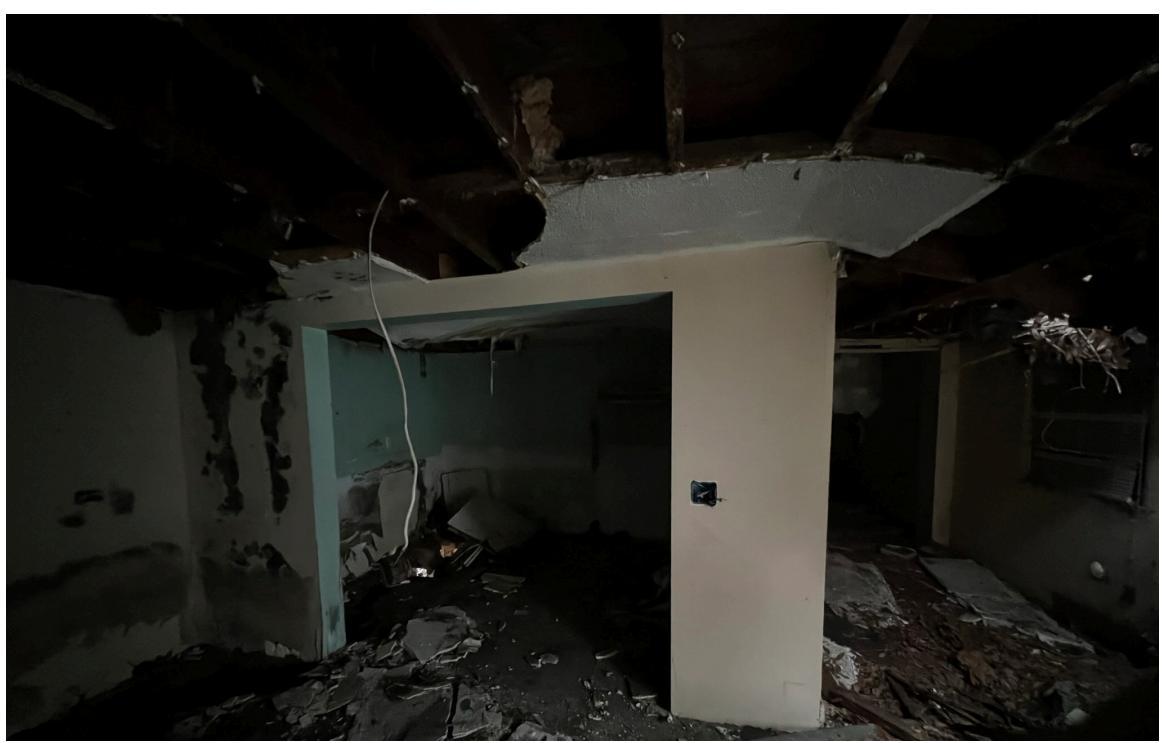
Figure 23: Rear Addition Interior: The roof has collapsed into the building interior. Floor and roof framing members are damaged from termites. The interior finishes are damaged from water and mold is actively growing on the drywall.

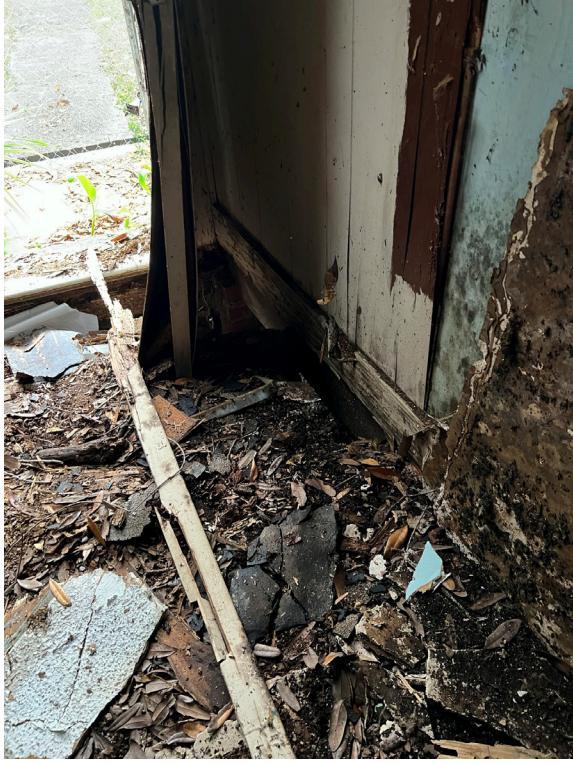
Figure 24: Rear Addition Interior: The rear wall of the original structure is structurally compromised from termites. Water damage is extensive in this area as a result of a previous roof leak.

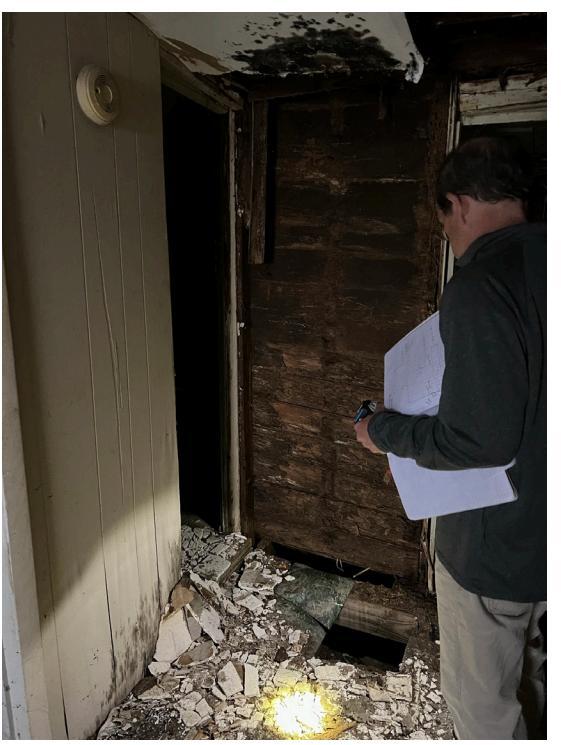
Figure 25: Rear Addition Interior: The interior wall framing on the right is a complete loss. Termites have eaten the studs.

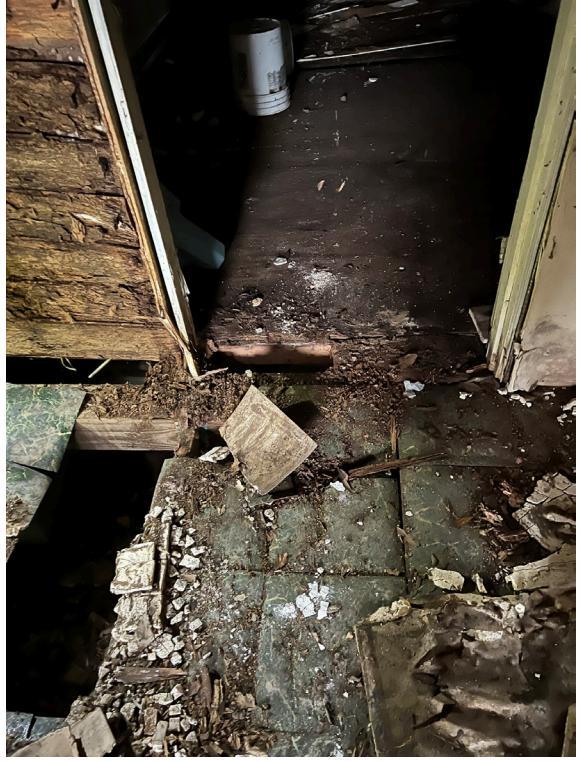
Figure 26: Rear Addition Interior: The floor system is no longer viable. Framing and flooring are compromised from water and termites. During the site investigation, a member of our team, fell through the floor.

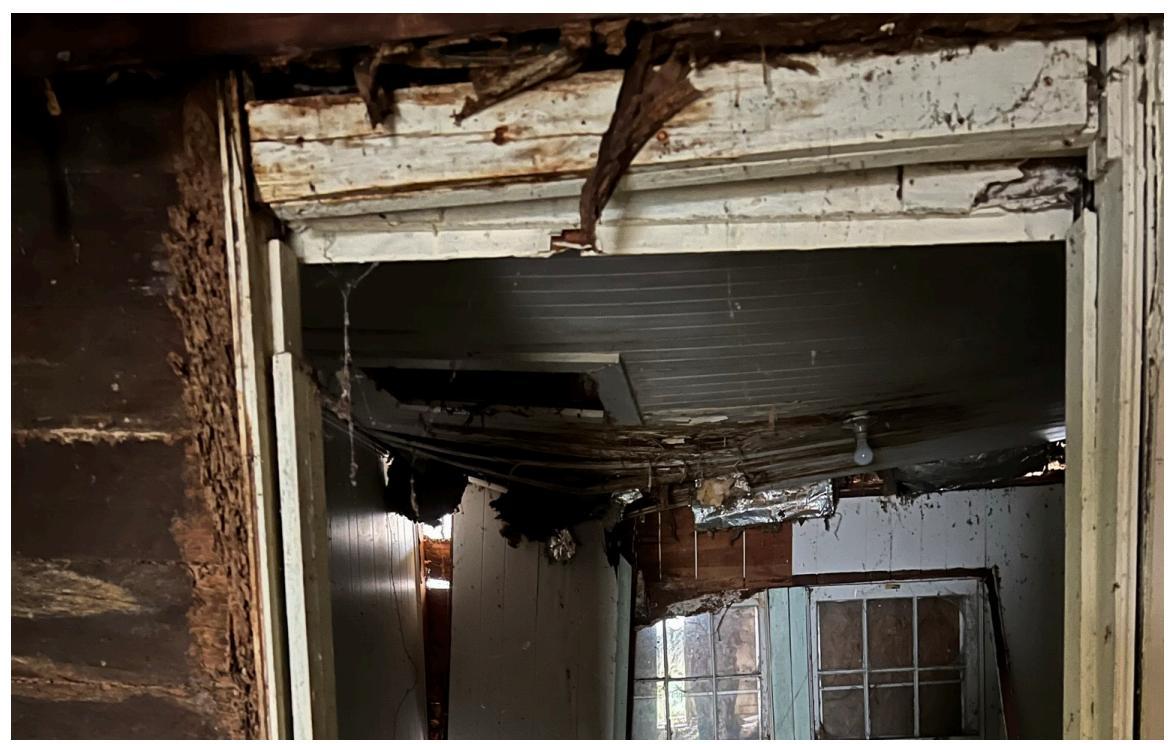
Figure 27: Rear Addition Interior: The roof is in the process of collapsing. Note bow in ceiling. Upon closer examination termite damage was noted in the wood ceiling and framing above.

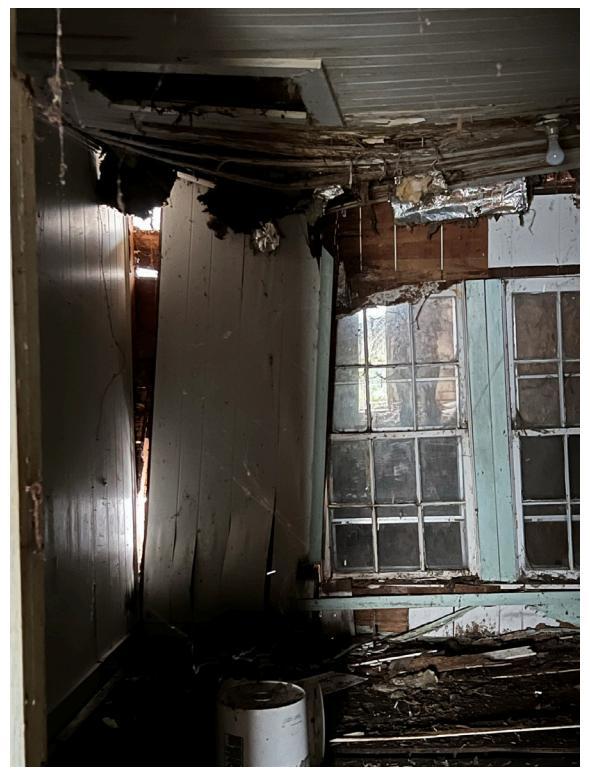
Figure 28: Rear Addition Interior: Close-up view of ceiling damage and opening in exterior wall.

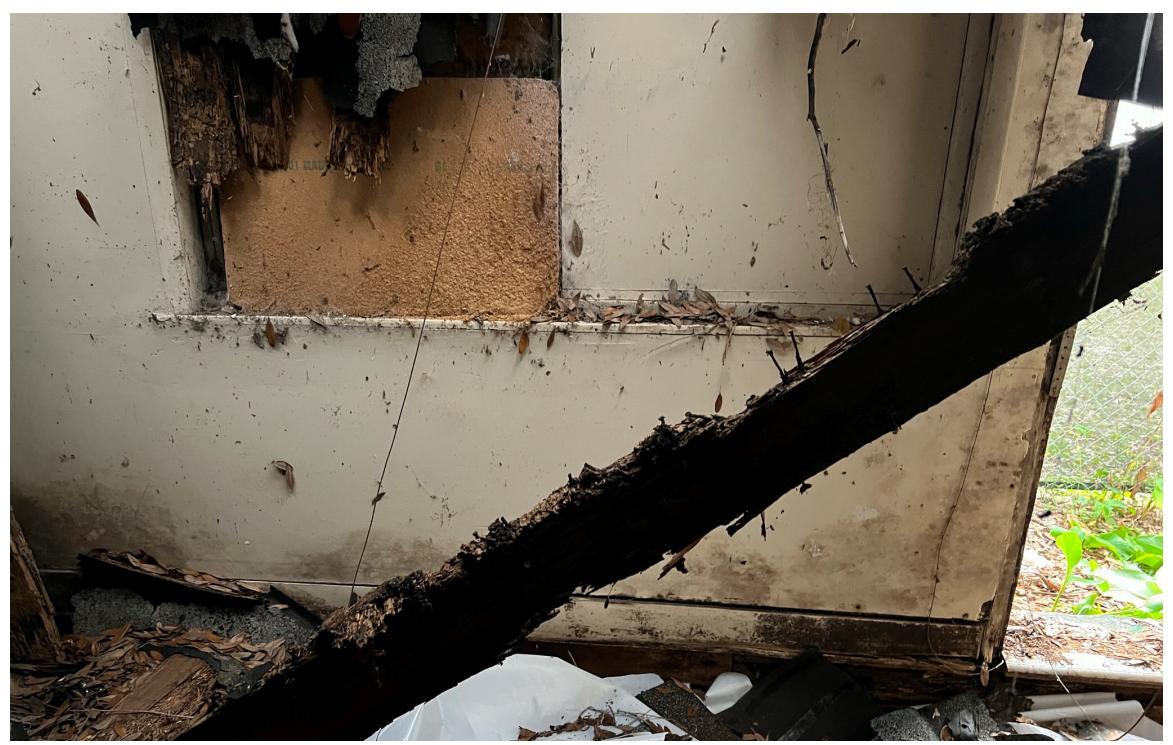
Figure 29: Rear Addition Interior: Close-up view of ceiling collapse at rear door.

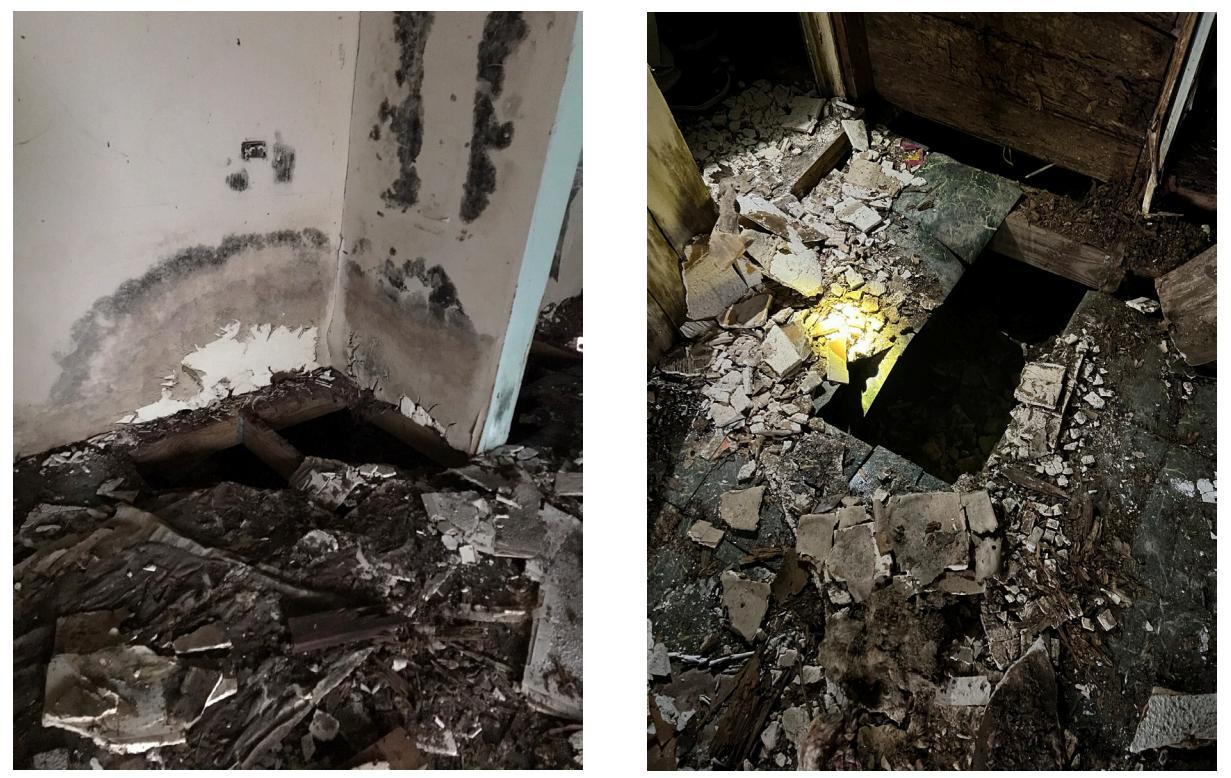
Figure 30: Detail view of mold damage. Figure 31: Detail view of floor deterioration and collapse.

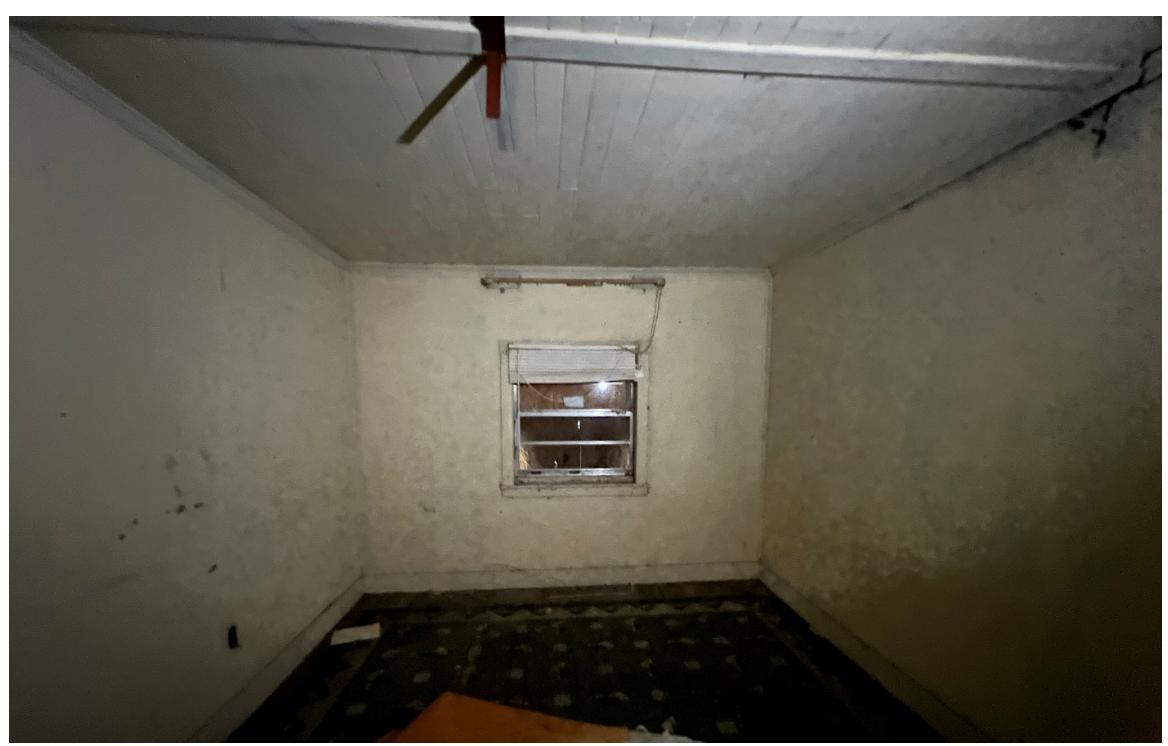
Figure 32: Original, Front Building: The rooms adjacent to the open lots are in the best condition. The floors feel sound. The finishes are intact. Structural damage to studs and sheathing was observed from the exterior. Termite damage was observed behind the walls.

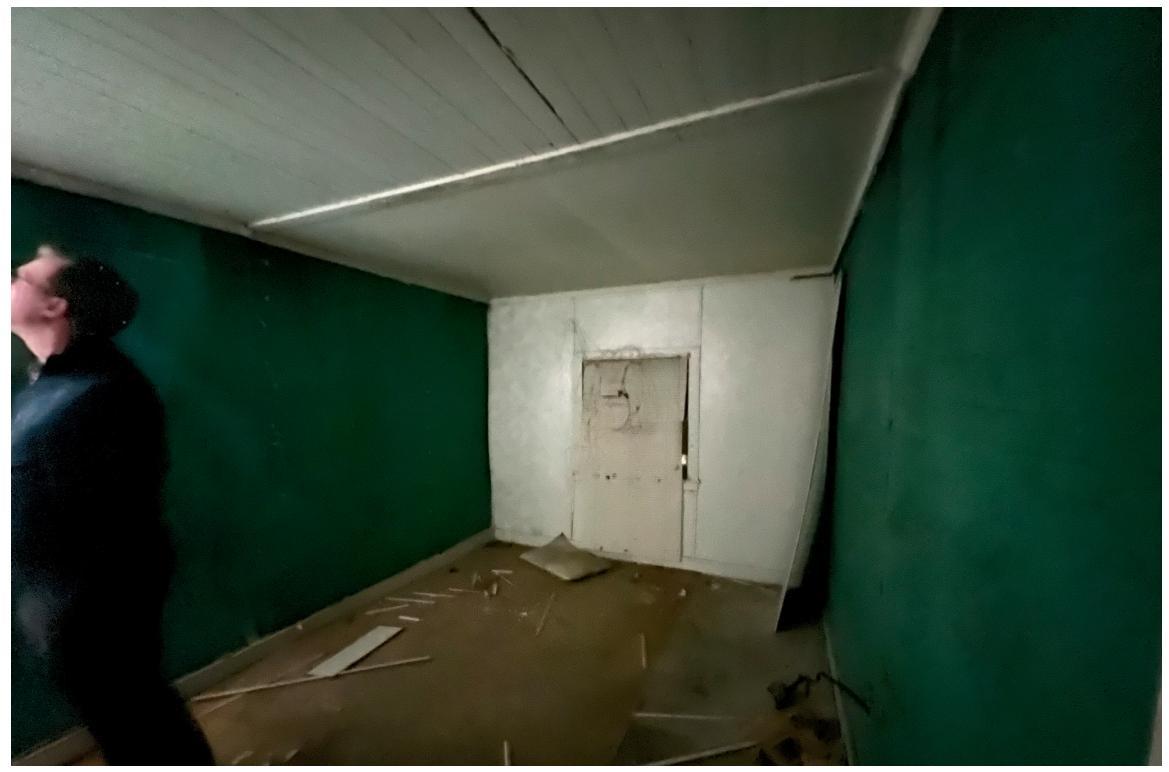
Figure 33: Original, Front Building: The rooms adjacent to the open lots are in the best condition. Floors feel sound. Finishes are intact. Structural damage to studs and sheathing was observed from the exterior. Termite damage was observed behind the walls.

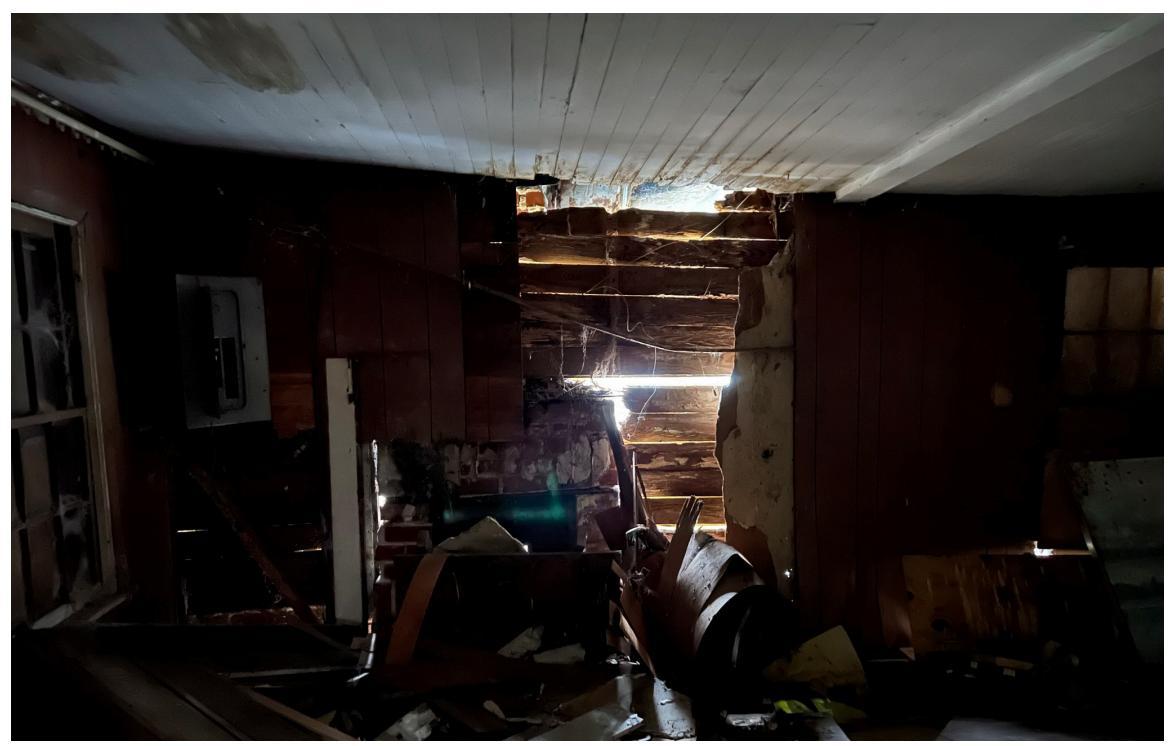
Figure 34: Original, Front Building: The exterior wall is open to the interior. Siding is heavily damaged. Studs are collapsing as a result of section loss from termites.

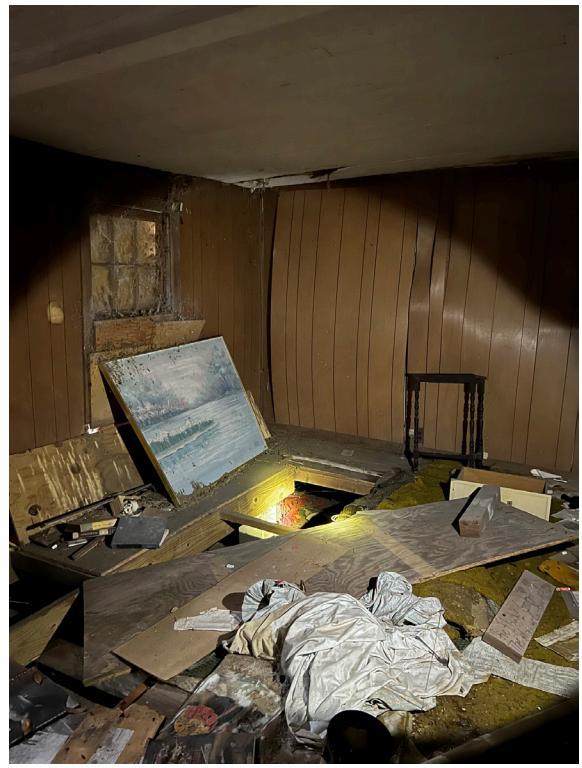
Figure 35: Original, Front Building: The rear wall finishes are bowing due to moisture intrusion. The interior of this room is covered in debris.
